# Aquatic baseline report for the proposed Crumhach Wind Farm, Co. Sligo

Prepared by Triturus Environmental Ltd. for MKO

**February 2025**

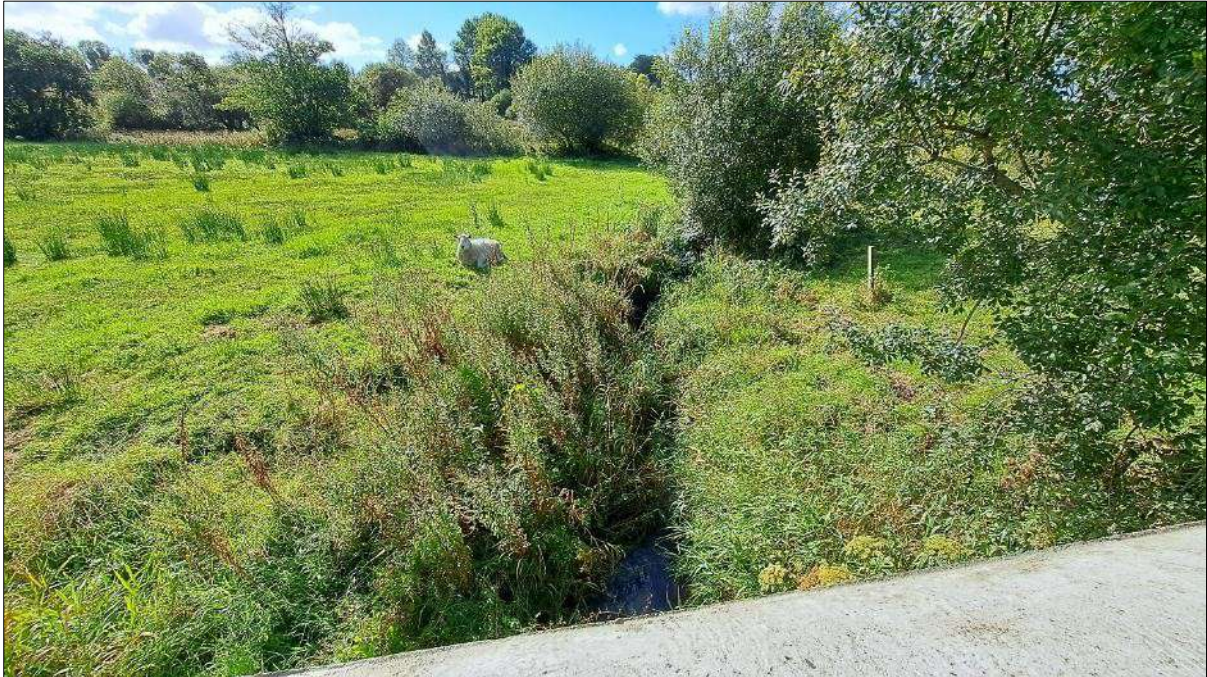
Biological water quality, based on Q-sampling, was calculated as **Q3 (poor status) (Appendix C)**. No macro-invertebrate species of conservation value greater than 'least concern', according to national red lists, were recorded via Q-sampling.

Given the utilisation by otter, the aquatic ecological evaluation of site D10 was of **local importance (higher value) (Table 4.3)**.

**Plate 7.2.25** Representative image of site D10 on the Ballygrania River, September 2024

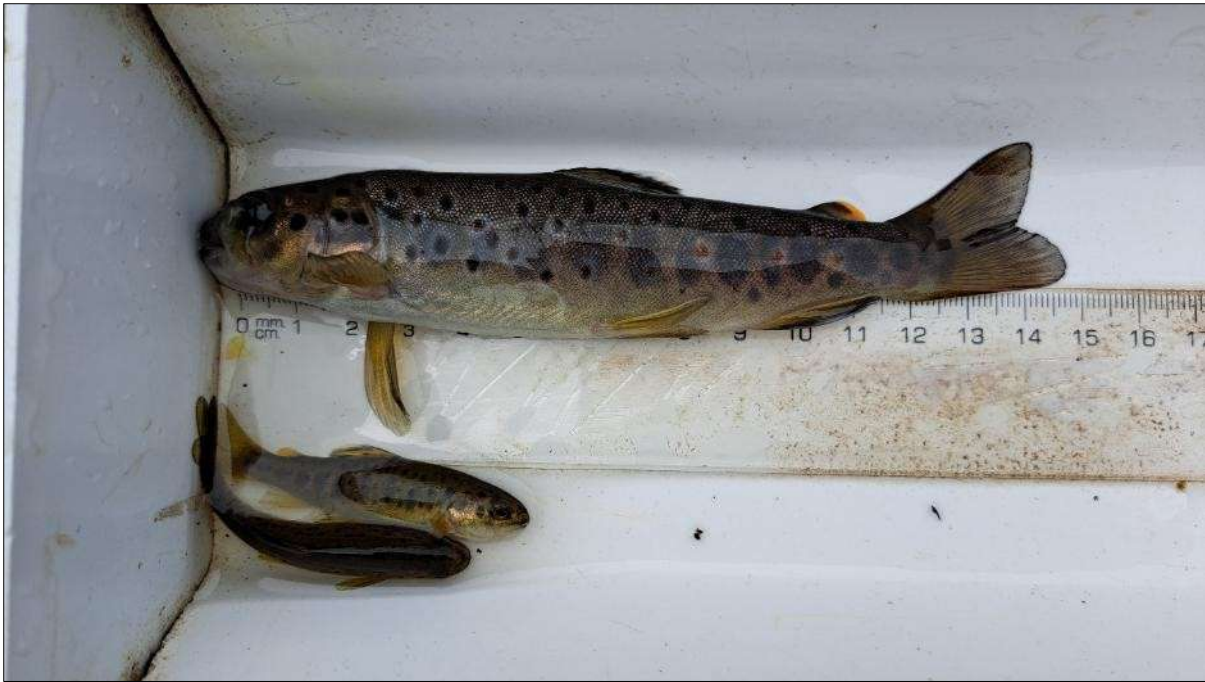
**Plate 3.1.1** Mixed cohort brown trout recorded at site A1 on an unnamed Easky River tributary, July 2024

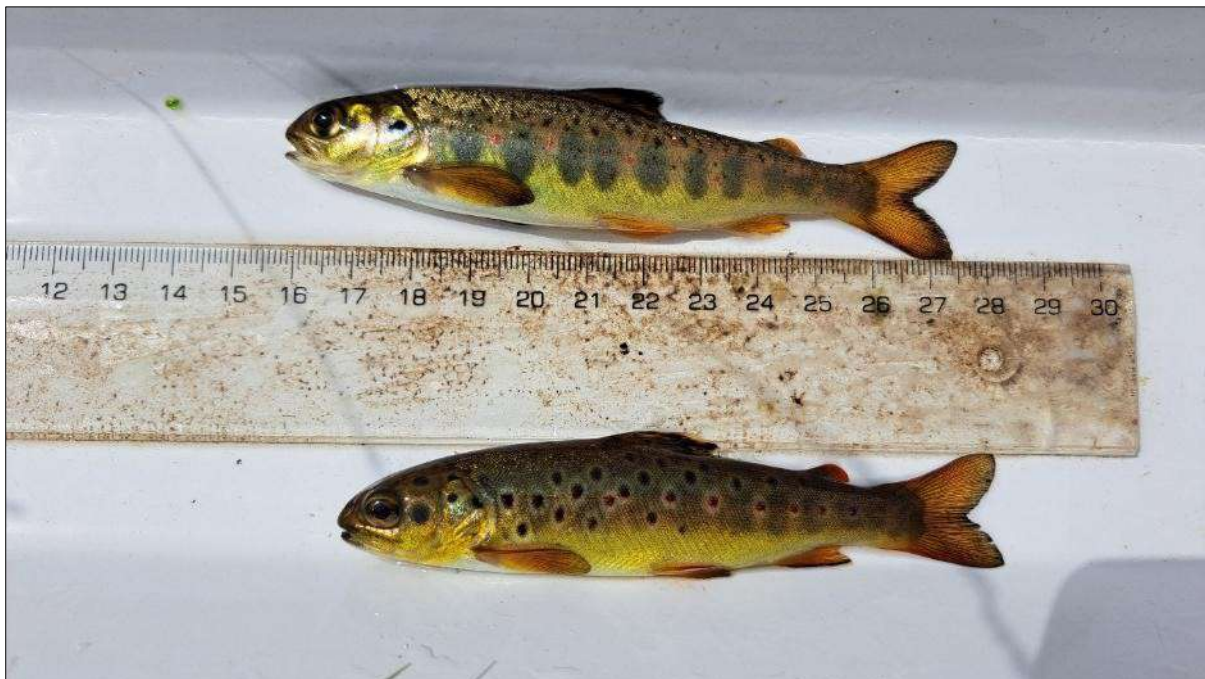
**Plate 3.1.2** Atlantic salmon (top) & brown trout recorded at site A2 on the Easky River, July 2024

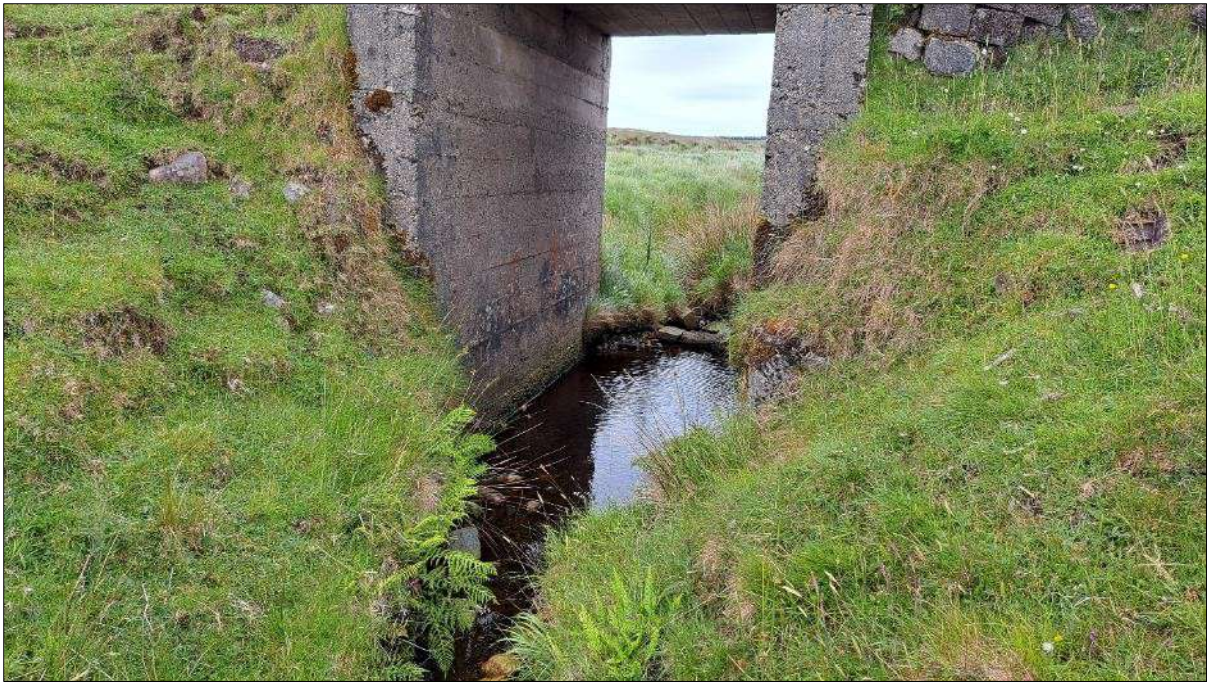
Despite some physical suitability for salmonids and European eel, no fish were recorded via electro-fishing at site A3 on the upper reaches of the Letterunshin River. The channel at this location was shallow and very narrow. It evidently suffered from poor flows in summer. Siltation pressures, natural blockages to flow and poor summer flows indicated the channel was not of fisheries value. No fish were recorded during the survey.

**Plate 3.1.3** Representative image of site A3 on the Letterunshin River, July 2024

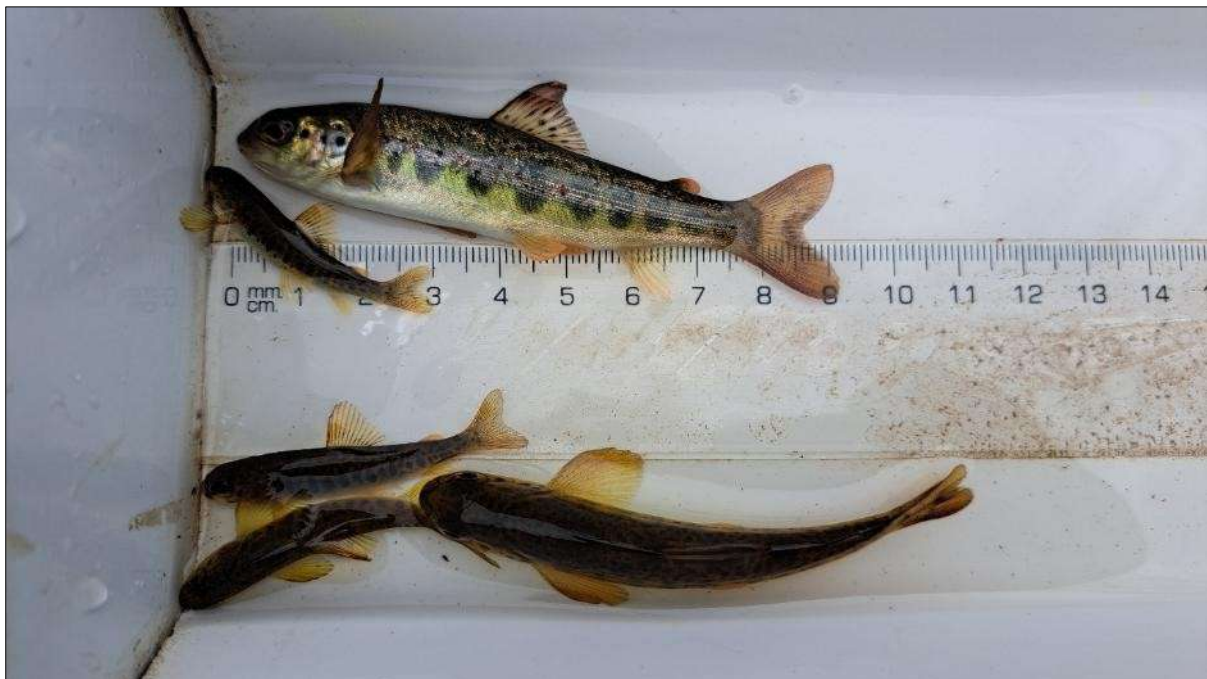
**Plate 3.1.4** Atlantic salmon parr recorded at site A4 on the Easky River, July 2024

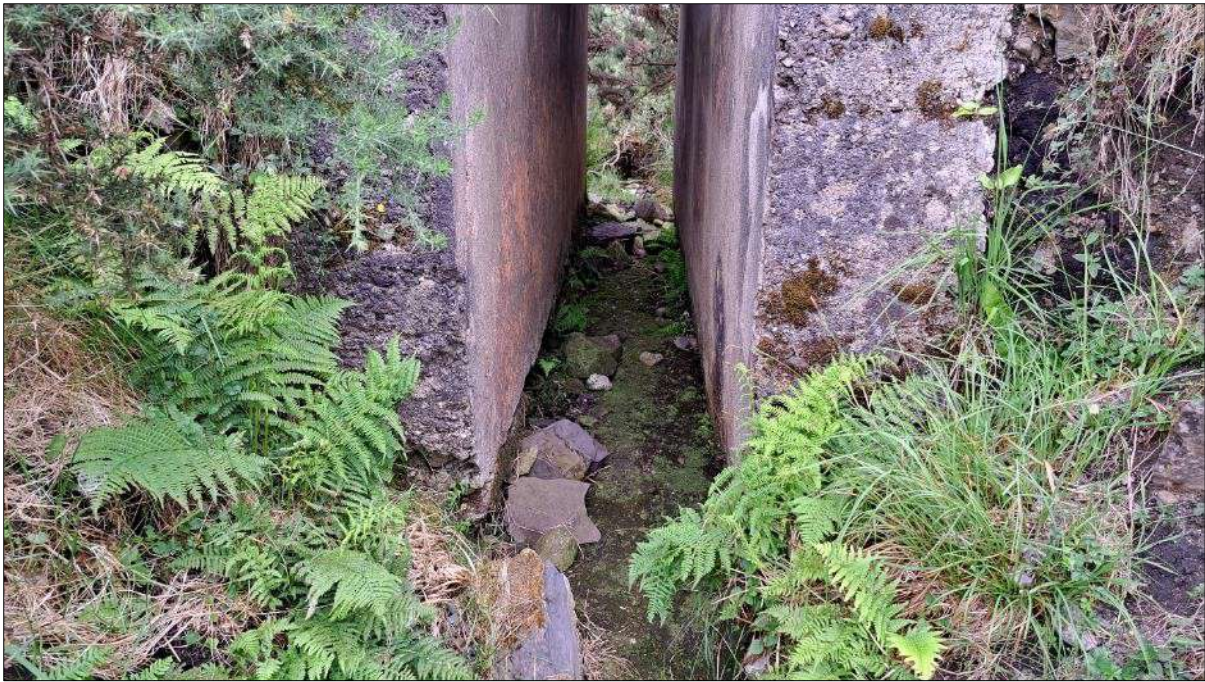
No fish were recorded via electro-fishing at site A5 on upper reaches of an unnamed stream adjacent to the EIAR site boundary. The ephemeral stream was dry at the time of survey and thus not of fisheries value (Plate 3.1.5).

**Plate 3.1.5** Representative image of an unnamed stream at site A5, July 2024 (dry, ephemeral channel)

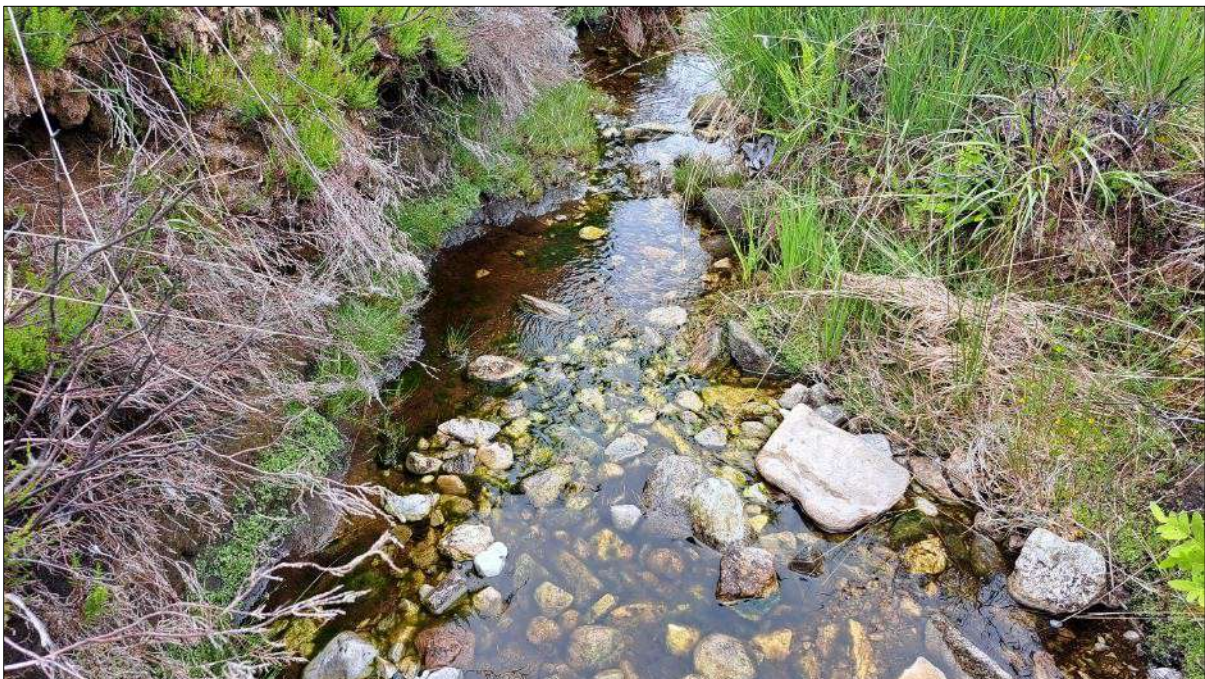
No fish were recorded via electro-fishing at site A6 on the upper reaches of an unnamed stream adjacent to the EIAR site boundary. Despite some physical habitat suitability for salmonids and European eel, the stream at this location was likely ephemeral during to very poor summer flows and shallow water. The poor flows were exacerbated by extensive straightening & deepening (Plate 3.1.6).

**Plate 3.1.6** Representative image of an unnamed stream at site A6, July 2024

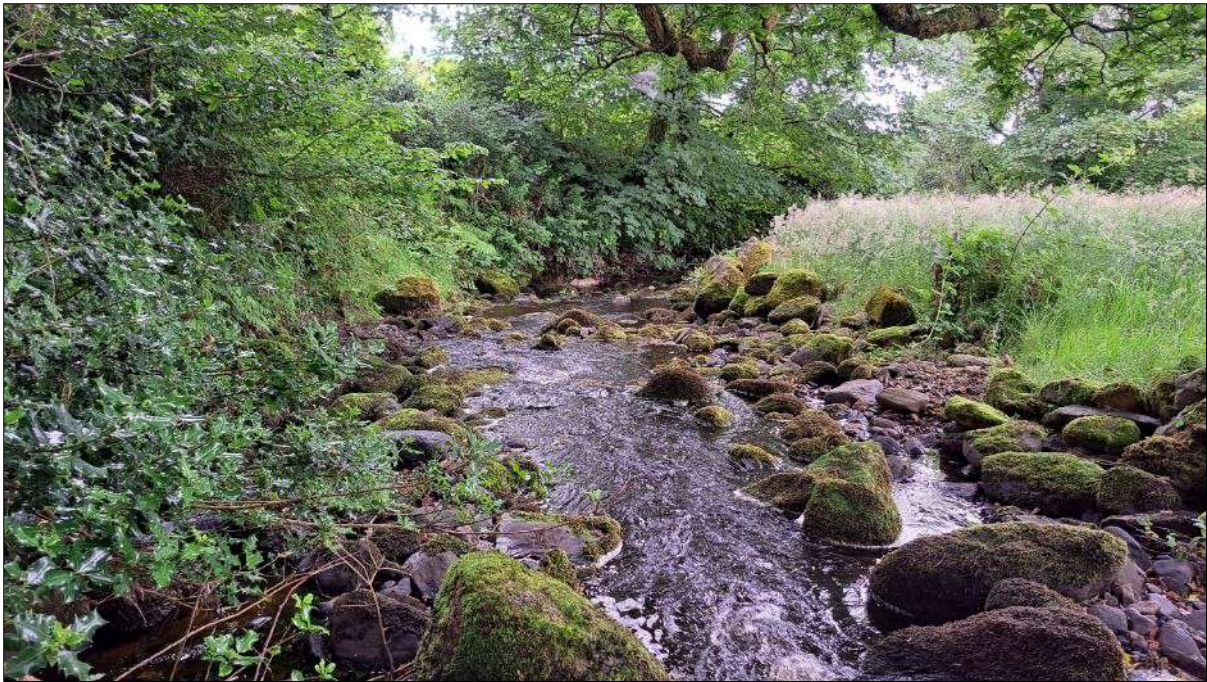
**Plate 3.1.7** Representative image of site A7 on an unnamed Easky River tributary, July 2024

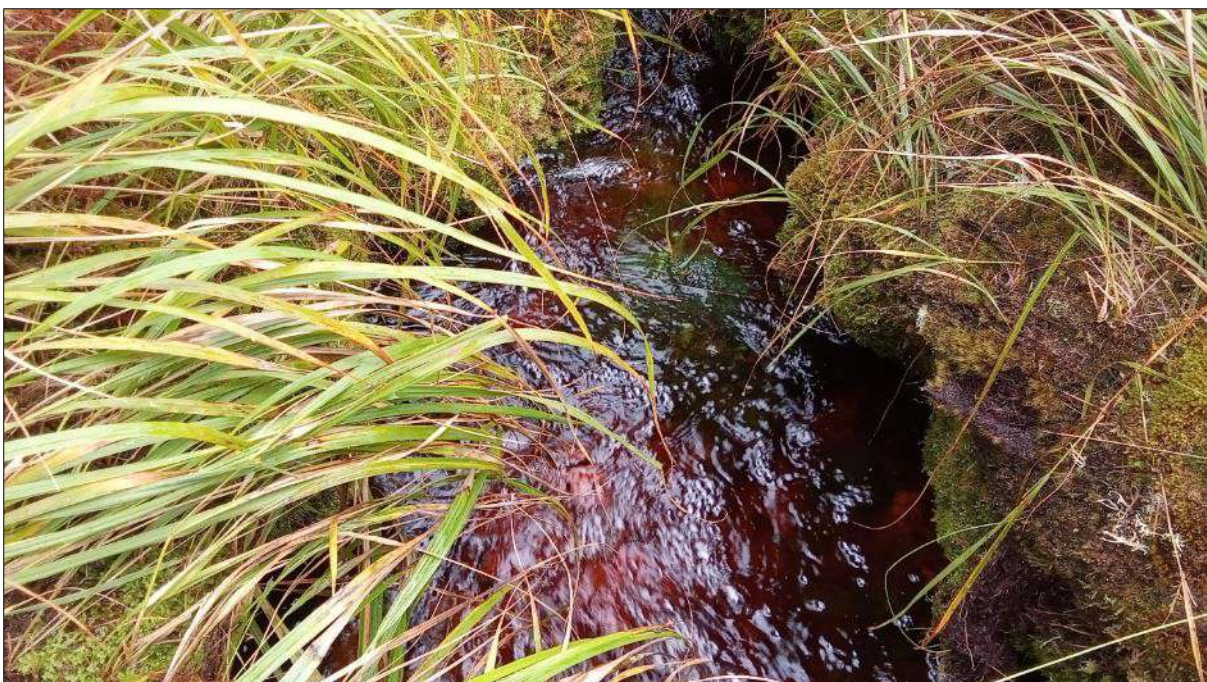
**Plate 3.1.8** Representative image of site A8 on the of the Owenminna River, September 2024

No fish were recorded via electro-fishing at site A8 on the upper reaches of the Owenminna River. The channel was considered a poor quality salmonid nursery given an absence of riparian buffers from the adjoining conifer plantations. These evidently caused acidification of the stream with very high pine needle deposition on the bed. The small size of the stream (0.5m width), acidification pressures and the location in the uppermost reaches of the catchment created conditions inimical for salmonids, European eel or lamprey. No fish were recorded during the survey.

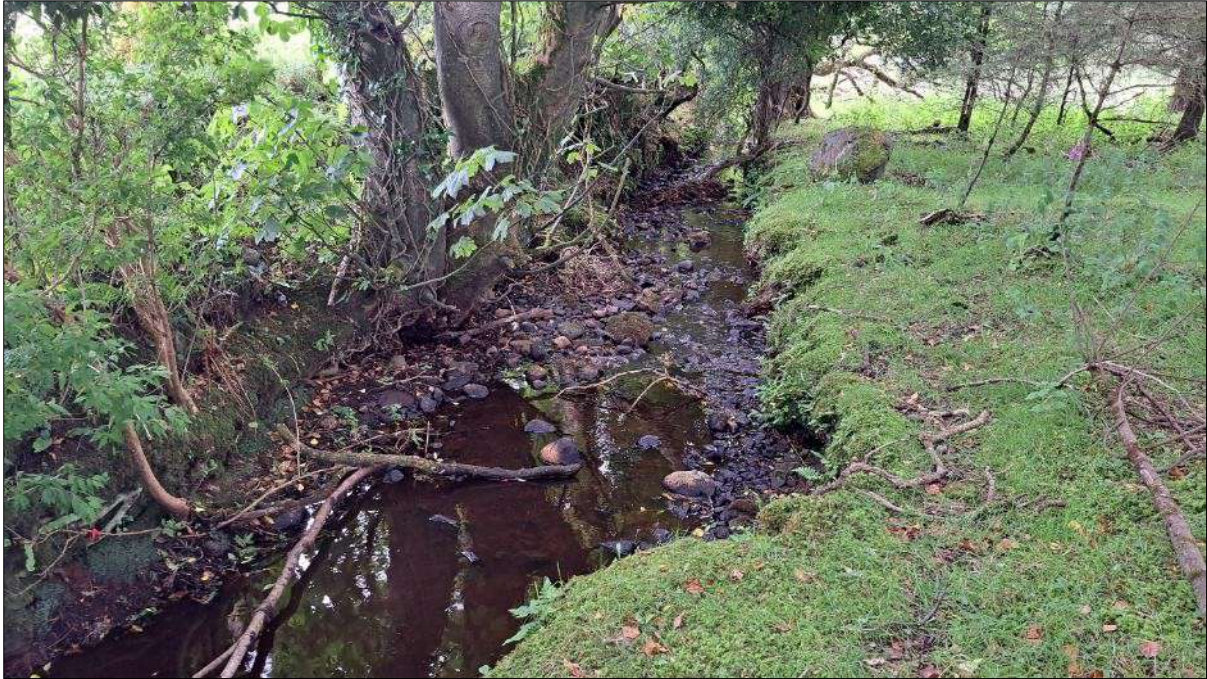
**Plate 3.1.20** Representative image of site A20 on the Carrownrush River, July 2024

Despite some suitability for salmonids and European eel, no fish were recorded via electro-fishing at site A20 on the Carrownrush River (36G76) at a local road crossing. The narrow river suffered from low summer flows and this coupled with historical modifications (straightening & deepening) and water quality pressures (i.e. siltation, including peat) precluded the presence of fish during the survey.

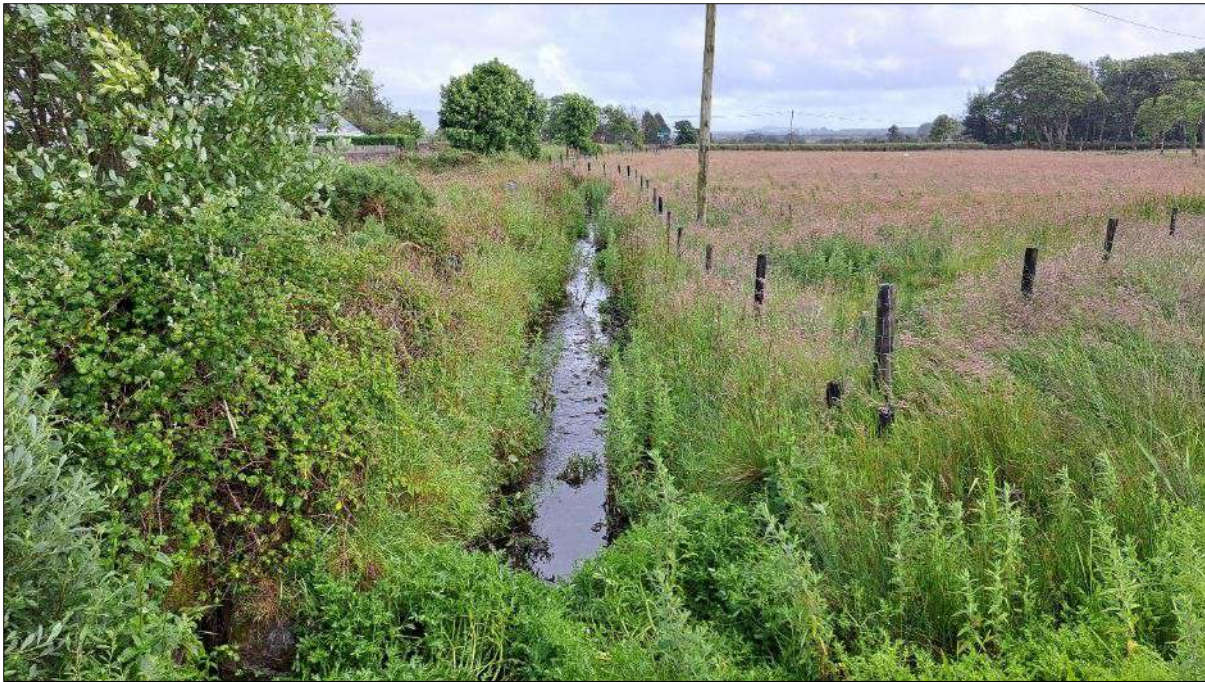
**Plate 3.1.21** Representative image of site A21 on the Carrownrush River, July 2024

Despite some good suitability for salmonids and European eel, no fish were recorded via electro-fishing at site A21 on the lower reaches of the Carrownrush River at a local road crossing. The historically straightened and deepened alkaline channel suffered from low summer flows at the time of survey. This precluded the presence of viable, nursery, spawning and holding habitat for salmonids and other fish (Plate 3.1.21). No fish were recorded during the survey.

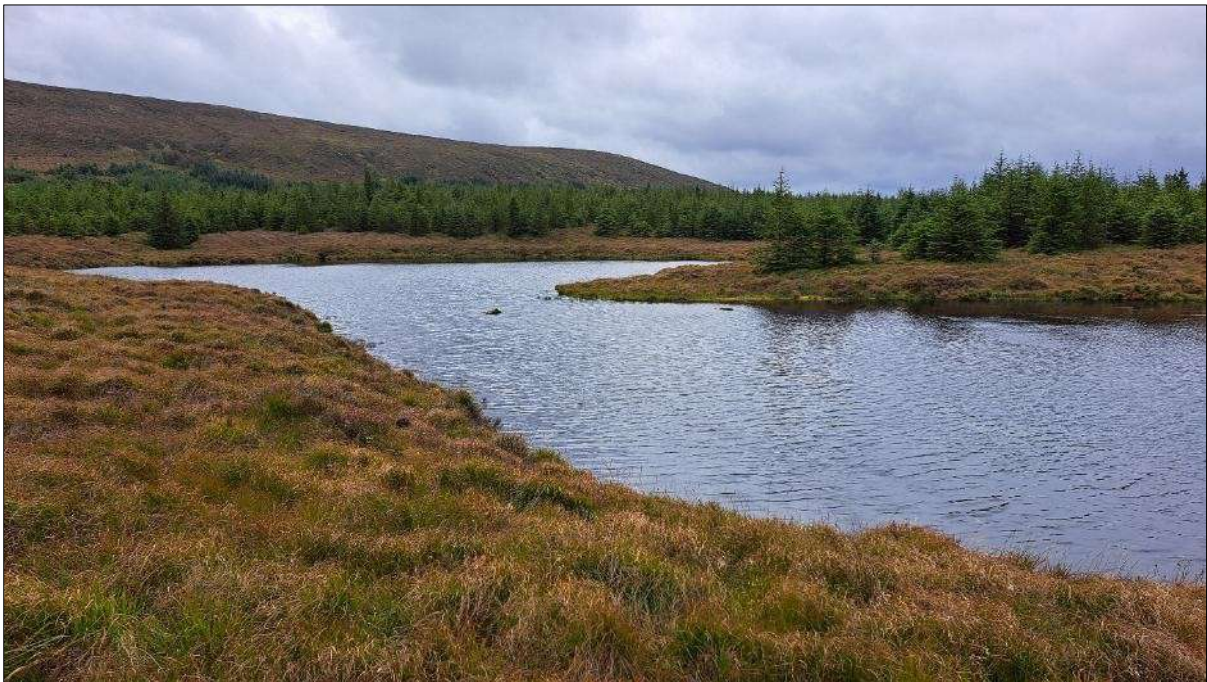
**Plate 3.1.22** Representative image of site L1 at Lough Croane, September 2024

Lough Croane was a twin basin upland lake covering 1ha surface area within the site boundary. The lake had good potential for brown trout (observed surface feeding during the site visit) with some limited littoral spawning habitat present along windward shores. Likewise, there was also suitability for European eel although the location in the upper reaches of the catchment and poor fluvial connectivity with downstream habitats reduced the likelihood of their presence.

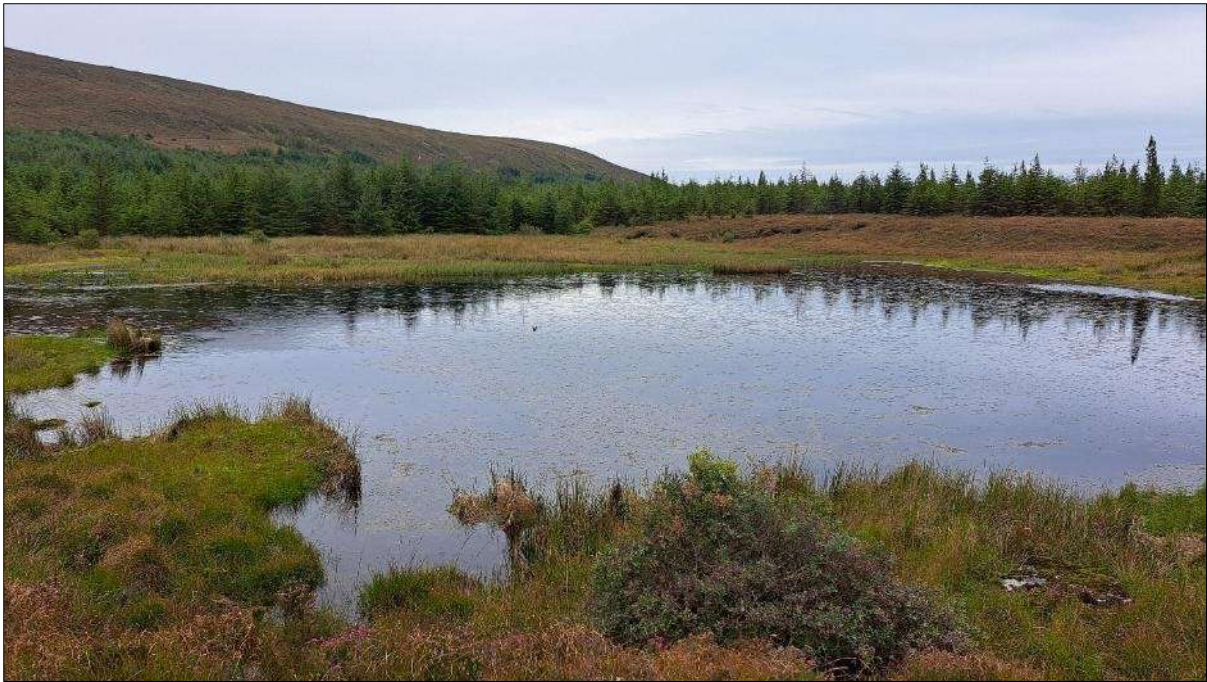
**Plate 3.1.23** Representative image of site L2 at Lough Anlaba, September 2024

Lough Anlaba was a loosely triangular shaped upland lake covering 0.5ha surface area within the vicinity of the EIAR site boundary. The very shallow (<0.5m) and homogenous lake featured a bed of compacted gravel and cobble with frequent boulder. There was a high cover of floc and flocculant peat, with high vegetation cover (mostly bulbous rush, *Juncus bulbosus*). Thus, the lake was of relatively low value for salmonids (none observed). Some salmonid spawning habitat was present at the lake outflow and also along windward shores given dominance of hard substrata, locally. Brown trout were recorded from the outflow channel via electro-fishing at site A11, downstream of the lake, in July 2024. The lake was of some suitability for European eel although the likelihood of their presence would be reduced given the location of the lake in the upper reaches of the catchment.

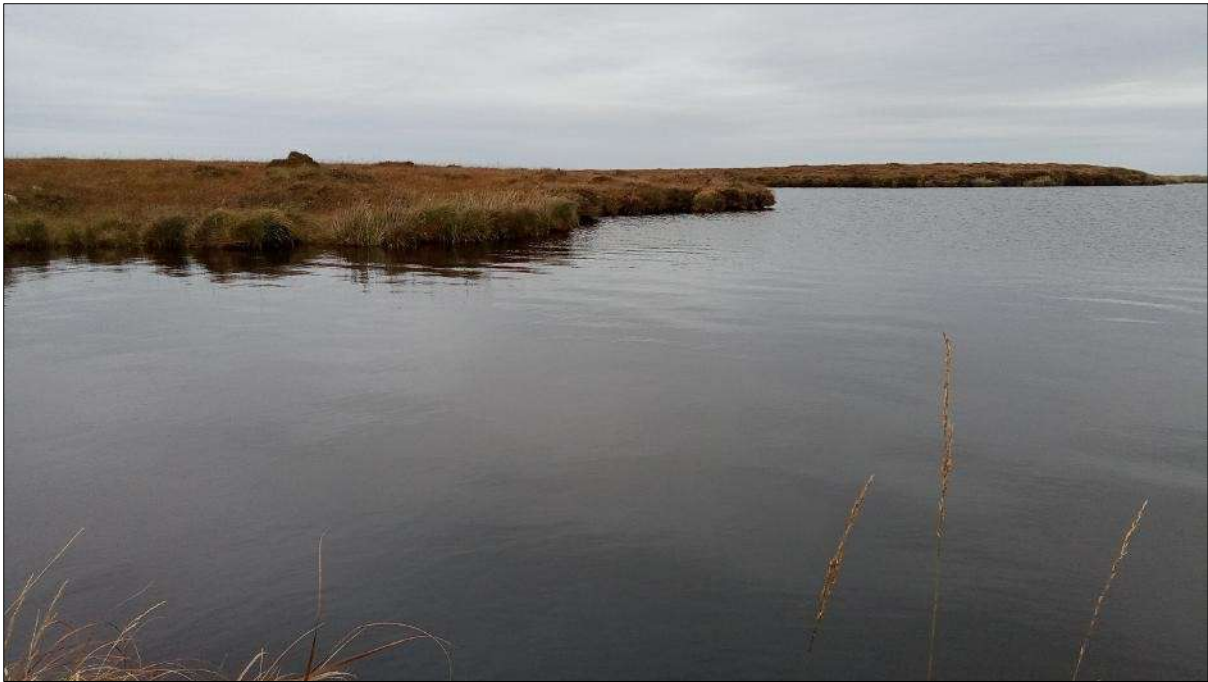
**Plate 3.1.26** Representative image of site L5 at Lough Nafullow, September 2024

Lough Nafullow was a 4ha upland oligotrophic lake bordered by blanket bog within the vicinity of the EIAR site boundary. The lake was 1-4m deep with a bed of humic soft sediment and high levels of peat staining. The lake had eroded peat margins that graded into the adjoining peatland and numerous small peninsulas and bays with an outflowing river in the northwestern corner. There was some moderate suitability for salmonids, with brown trout observed feeding during the site visit. The lake also had moderate suitability for European eel as it had connectivity with the downstream Easky River.

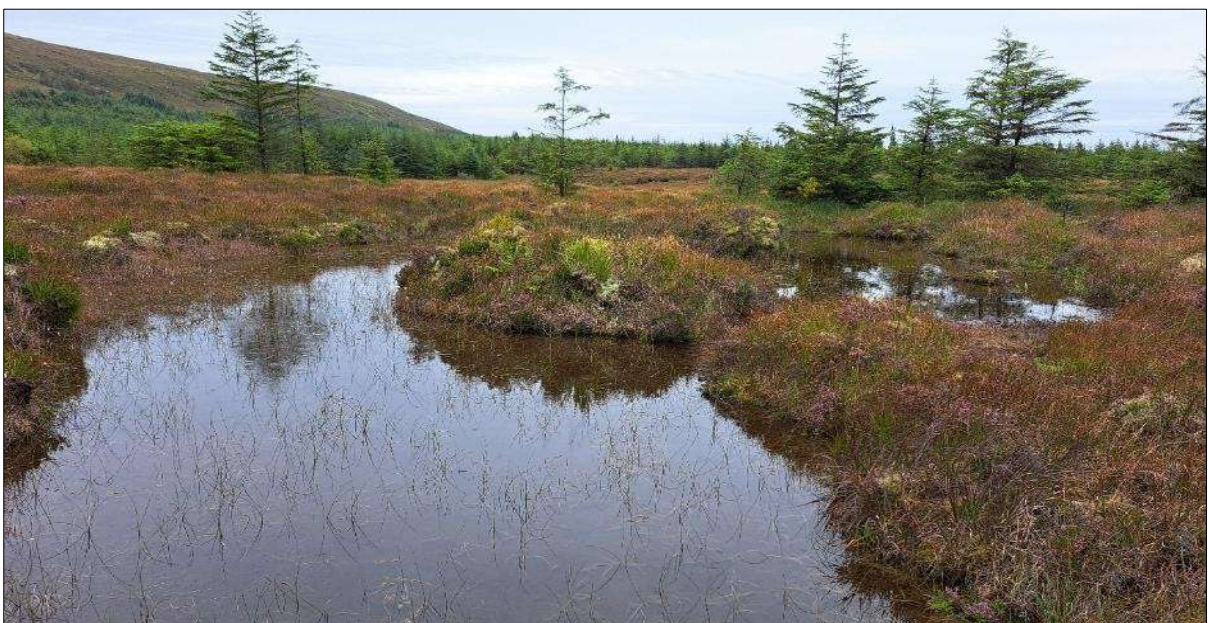
**Plate 3.1.28** Representative image of site P2, September 2024

Site P2 was a part of a small pond complex within the vicinity of the EIAR site boundary adjacent to Lough Anlaba. The site comprised a main irregular basin of 0.02ha with several smaller and very shallow connected satellite ponds/scrapes. The main basin was <0.2m deep with a bed composed entirely of flocculent peat/soft sediment of up to 0.5m in depth. Vegetation cover was high with frequent bog pondweed. The site was not of fisheries value given its very shallow depths and isolation from downstream riverine habitats.

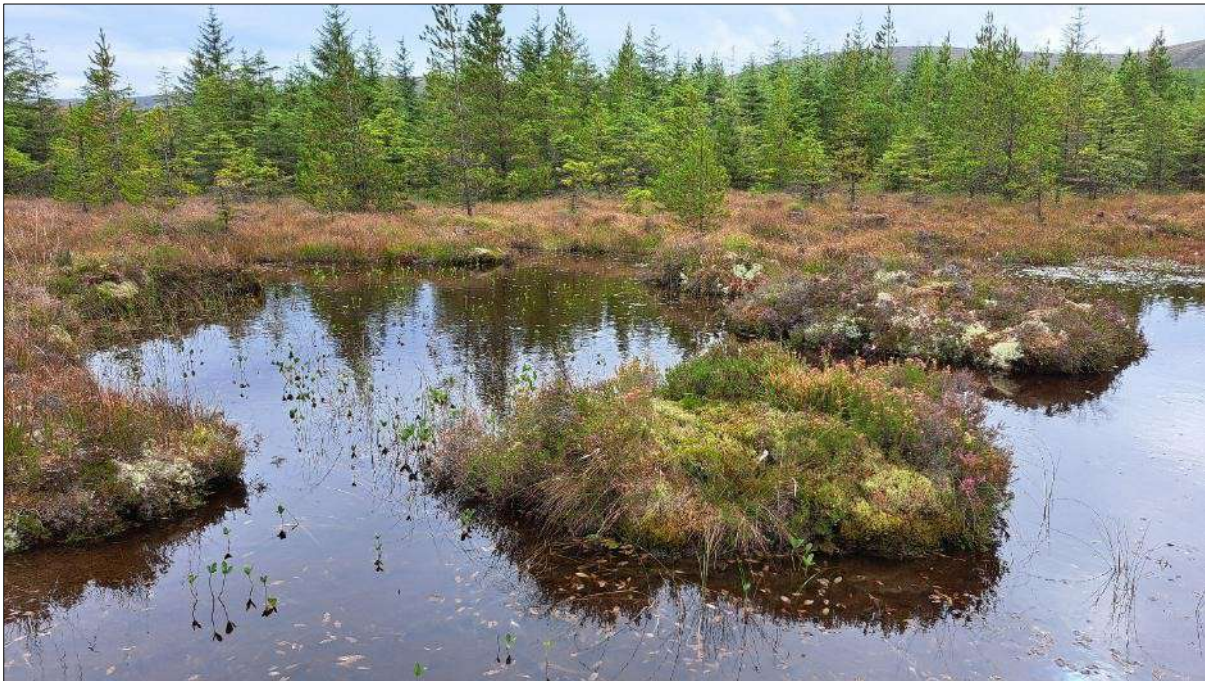
**Plate 3.1.29** Representative image of site P3, September 2024

Site P3 was located at a small pond complex within the vicinity of the EIAR site boundary. The site comprised a main irregular basin of 0.02ha with several smaller and very shallow connected satellite ponds/scrapes. The main basin was just 0.05-0.25m deep with a bed composed entirely of flocculent peat/soft sediment of up to 0.5m in thickness. Site P3 was not of fisheries value given its very shallow depths and isolation from downstream riverine habitats.

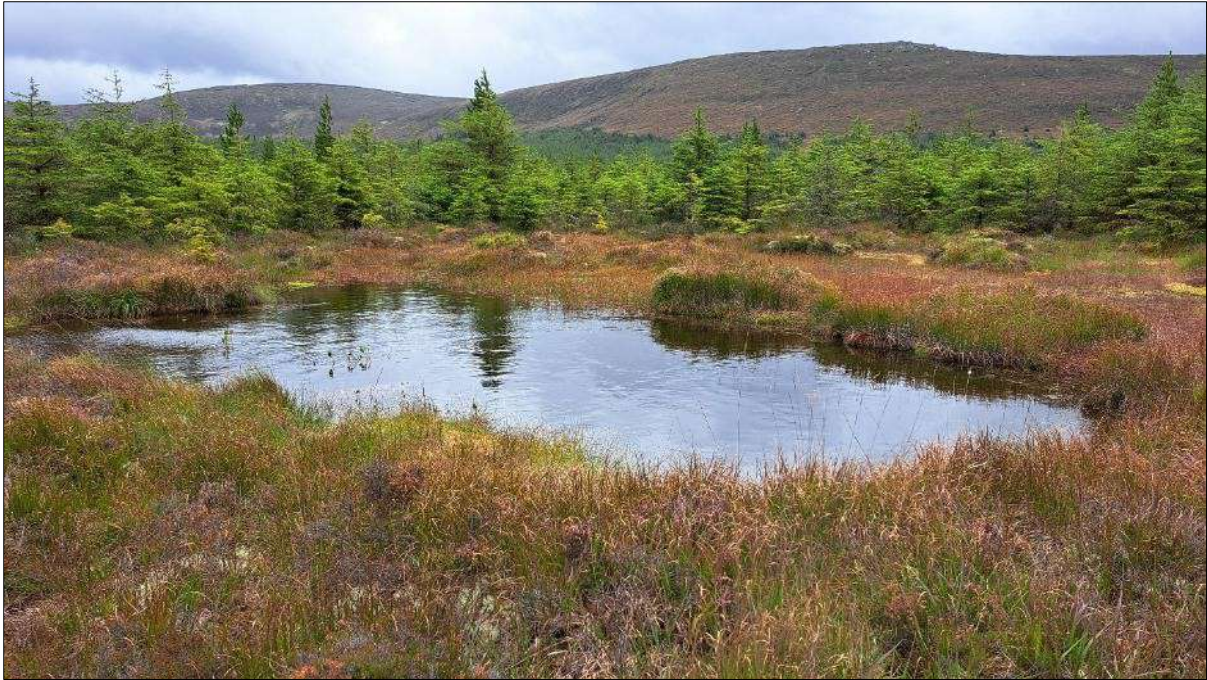
**Plate 3.1.30** Representative image of site P4, September 2024

Site P4 was located at a small pond within the vicinity of the EIAR site boundary, adjacent to Lough Croane (no surface water connectivity). The small pond complex featured a main basin of 100m<sup>2</sup> with several small very shallow satellite scrapes. The main basin was 0.2-0.3m deep with a bed composed entirely of flocculent peat/soft sediment of >1.5m in depth. The shallow, clear water pond supported sparse vegetation. Site P4 was not of fisheries value given its small size, shallow depths and isolation from downstream riverine habitats.

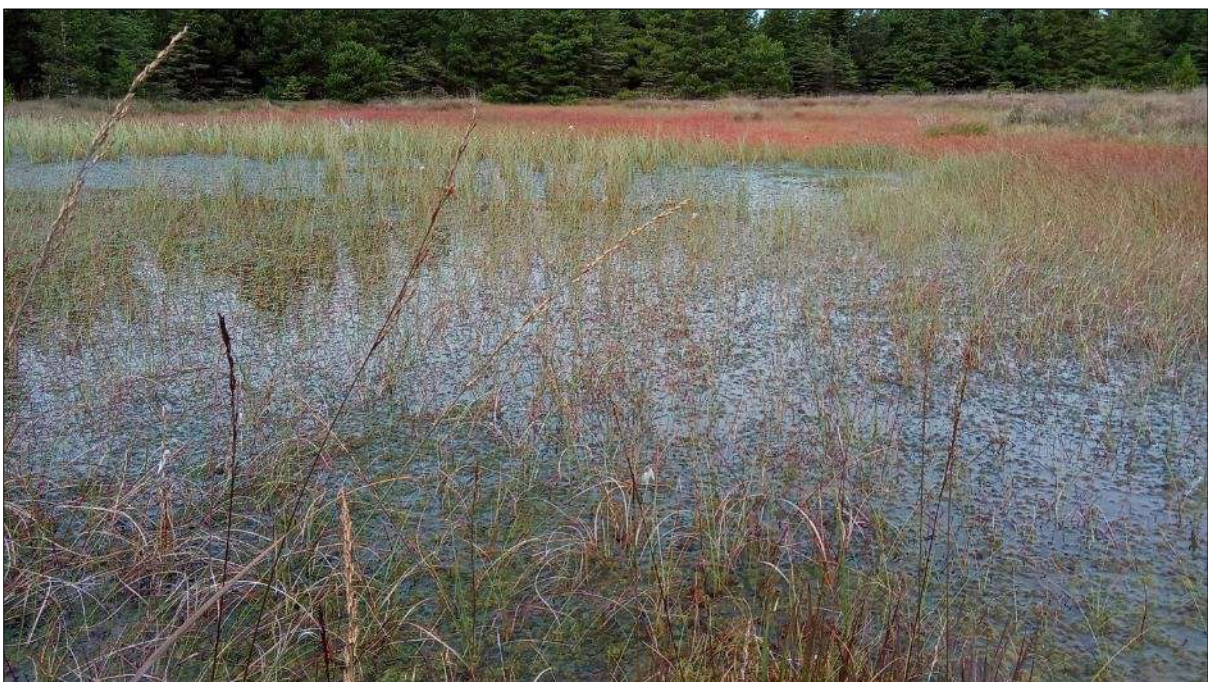
**Plate 3.1.32** Representative image of site P6, September 2024

Site P6 was a large oligotrophic wetland and pond complex of 0.3ha in size within the vicinity of the EIAR site boundary. The shallow peatland basin supported pools of water 0.1-0.2m deep with near total cover of *Sphagnum* spp. mosses. Site P6 was not of fisheries value given its small size, shallow depths, high vegetation cover (late successional basin) and the absence of connectivity to riverine watercourses.

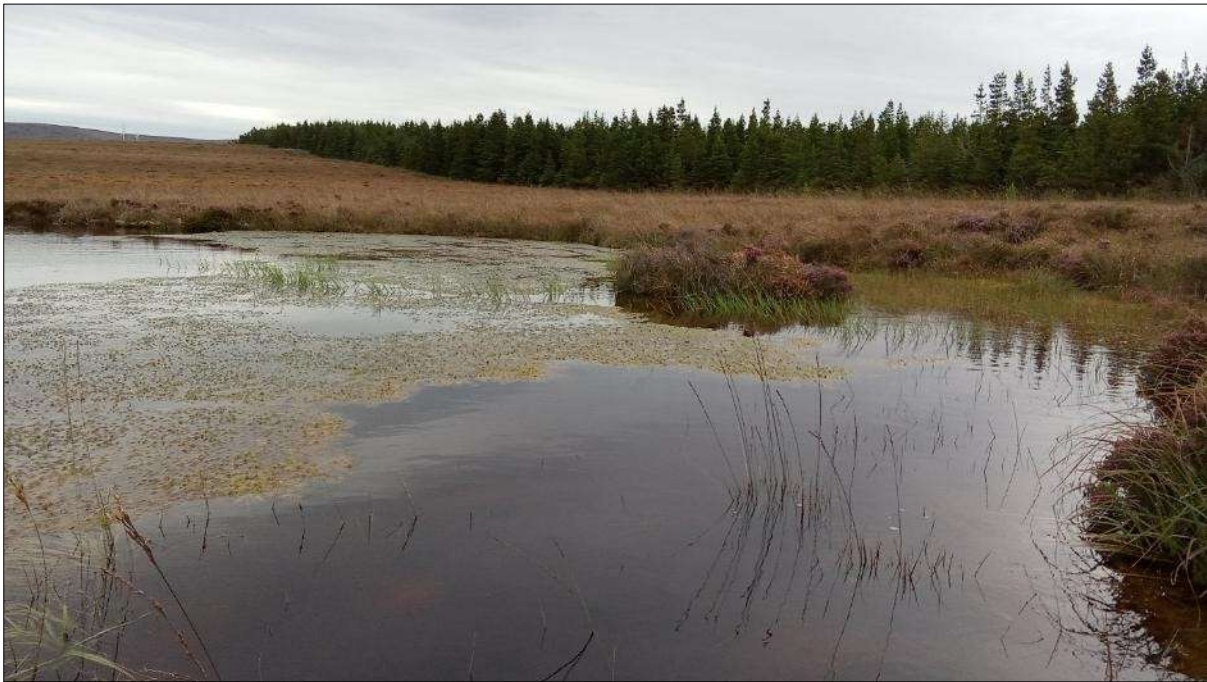
**Plate 3.1.33** Representative image of site P7, September 2024

Site P7 was a small pond and wetland complex located in blanket bog adjacent to sites P5 and L5, within the vicinity of the EIAR site boundary. The main basin was an oval pond of 0.02ha and 1-2.5m in depth. The pond had an irregular margin that was at grade with the adjoining peatland a soft peat base. Site P7 was of poor fisheries value given its small size and isolation from downstream riverine habitats. However, there was some low suitability for brown trout and European eel given the proximity to Lough Nafullow.

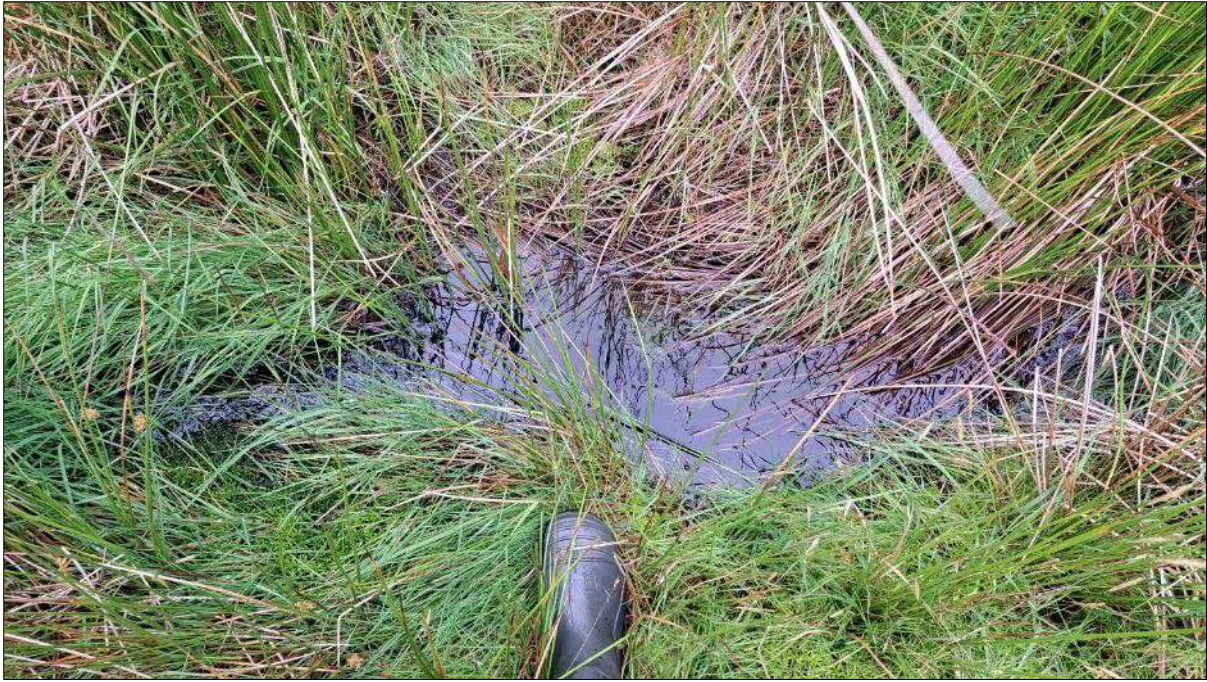
**Plate 3.1.37** Representative image of site B4 on an unnamed Ballygreighan Barr River tributary, July 2024

No fish were recorded via electro-fishing at site B4 on an unnamed stream tributary of the Ballygreighan Barr River. The narrow peat-stained channel conveyed minimal, intermittent water flows and was more of a seepage area through blanket bog rather than a flowing watercourse. The channel was not of fisheries value given high rates of siltation, shallow depths, narrow widths, poor flows and poor connectivity with downstream habitats. However, the adjoining Ballygreighan Barr River was of high value for salmonids with abundant spawning, nursery and holding habitat in the meandering channel.

No fish were recorded via electro-fishing at site B4 (**Appendix B**). The narrow peat-stained channel conveyed minimal, intermittent water flows and was more of a seepage area through blanket bog rather than a flowing watercourse. The channel was not of fisheries value given high rates of siltation, shallow depths, narrow widths, poor flows and poor connectivity with downstream habitats. However, the adjoining Ballygreighan Barr River was of high value for salmonids with abundant spawning, nursery and holding habitat in the meandering channel. There was no suitability for white-clawed crayfish. No otter signs were recorded in vicinity of the site.

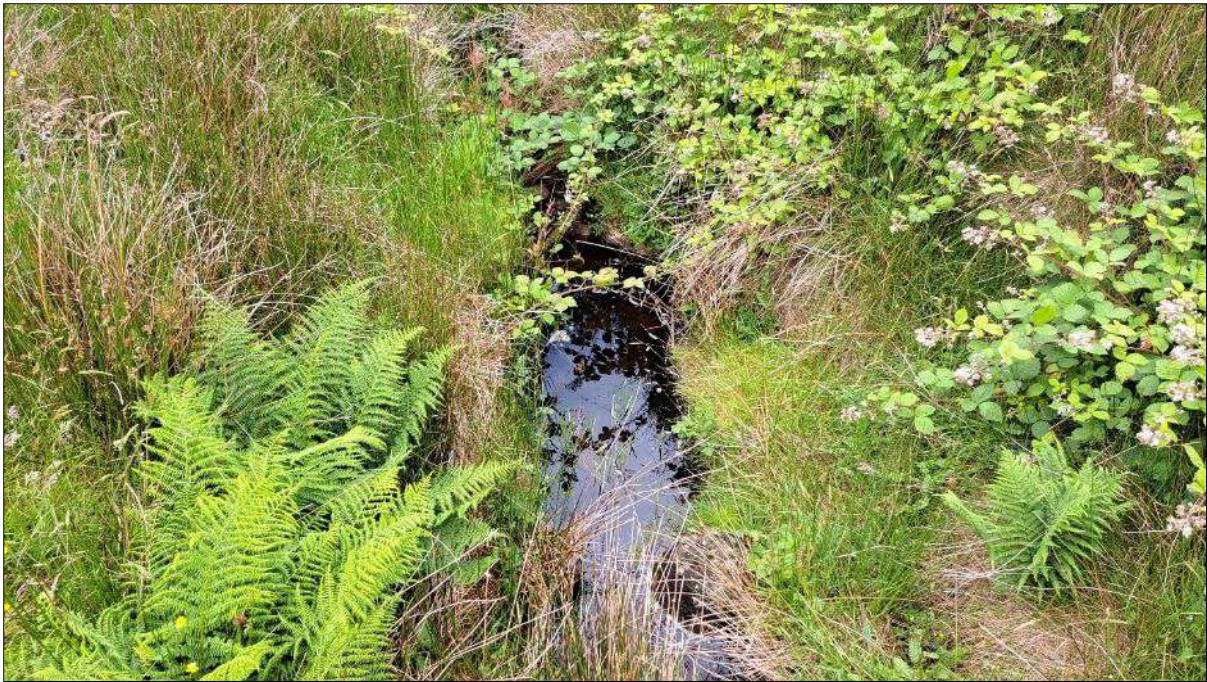
**Plate 3.1.39** Representative image of site B6 on an unnamed Dunneill River tributary, July 2024

No fish were recorded via electro-fishing at site B6 on a small tributary of the Dunneill River at an access track crossing adjacent to the Dunneill 220kV sub-station. The narrow stream suffered from low summer flows and this coupled with historical modifications and water quality pressures (including recent clear-fell downstream of the culvert) precluded the presence of fish during the survey.

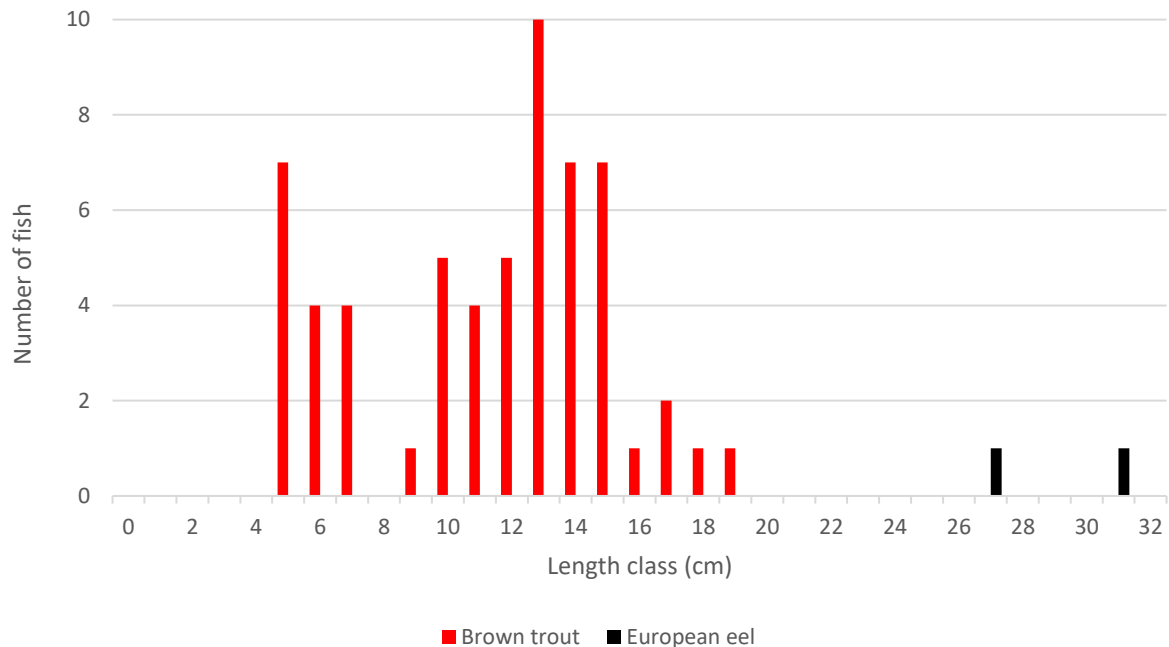
**Figure 3.1.18** Length frequency distribution recorded via electro-fishing at site B8, July 2024

The site was of good value for salmonids supporting a relatively high density of mixed cohort fish.

Deep glide and pool below the historical weir and bedrock steps provided valuable holding habitat, with bryophyte-rich cobble riffle areas providing good quality nursery habitat. The site was of relatively poor value as a salmonid spawning area given the paucity of smaller substrata. Bank scours, boulders and submerged tree root systems offered high quality eel refugia and supported a low density of fish. Flocculent soft sediment accumulations were not suitable for lamprey ammocoete burial, with no lamprey spawning habitat present. No lamprey were recorded during the survey.

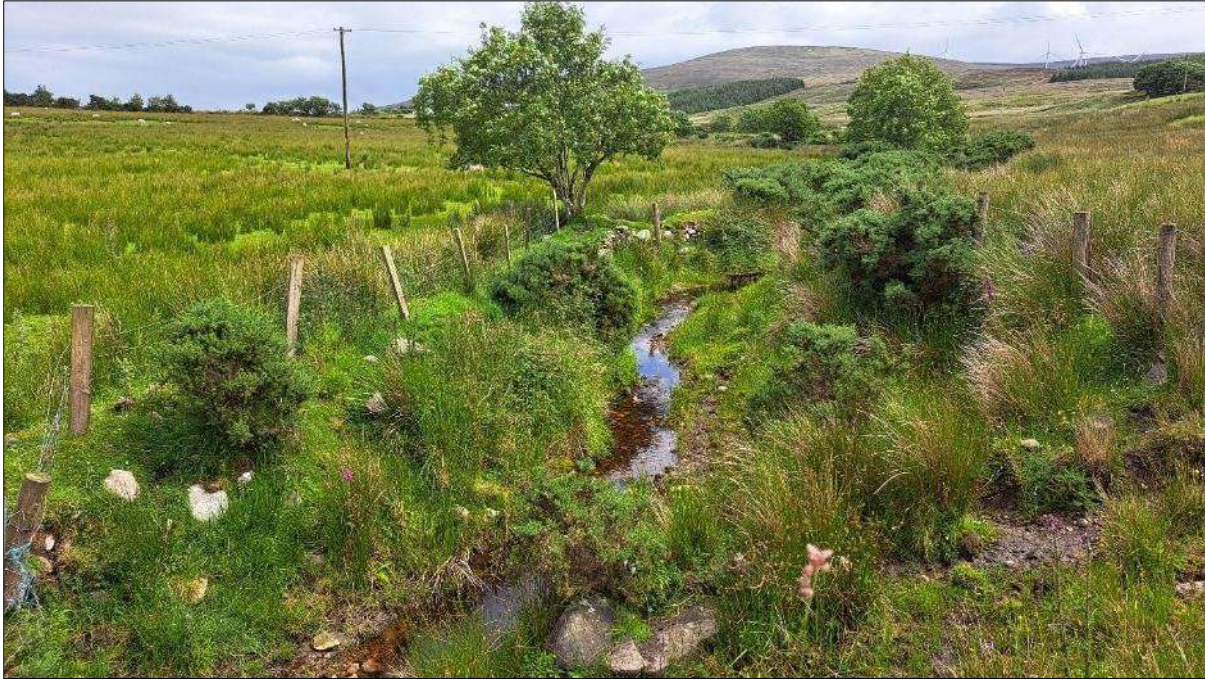
**Plate 3.1.42** Representative image of site B9 on the Doonbeakin River, July 2024

No fish were recorded via electro-fishing at site B9 on the upper reaches of the Doonbeakin River at a local road crossing (single masonry arch) on the Proposed Grid Connection Route. The narrow upland stream was not of fisheries value at the time of survey given low summer flows, poor fluvial connectivity with downstream habitats and significant siltation.

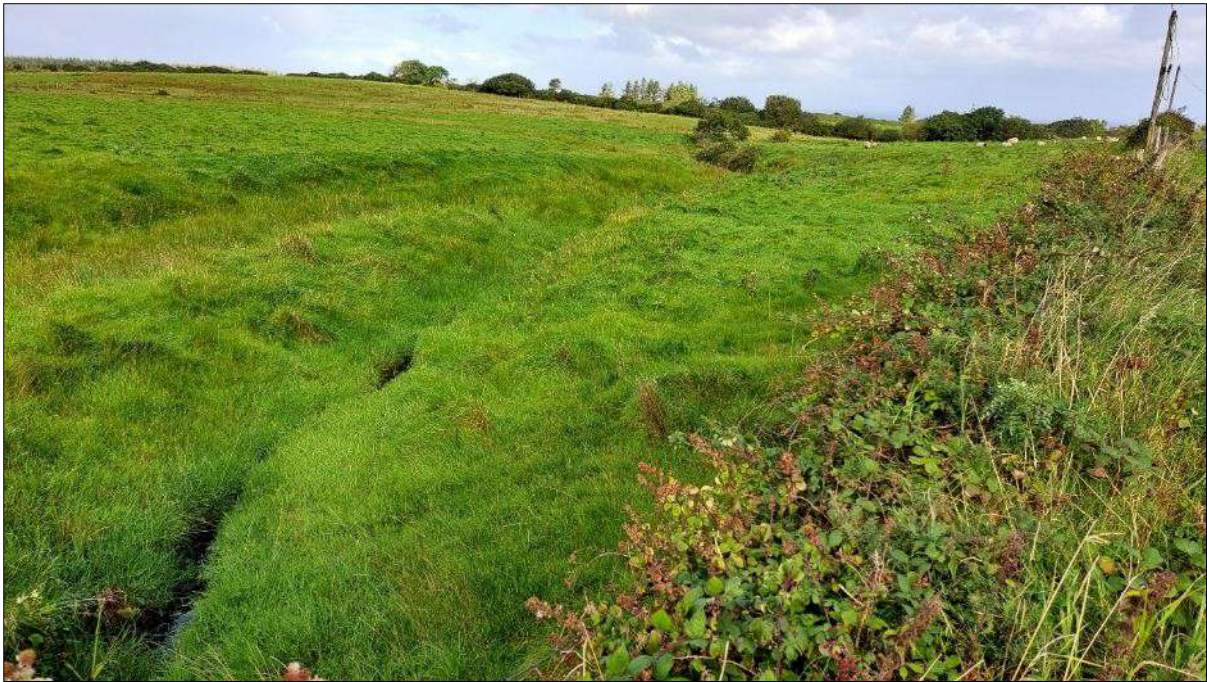
**Plate 3.2.1** Representative image of site C1 on the Altans Stream, September 2024
