# Aquatic baseline report for the proposed Crumhach Wind Farm, Co. Sligo

Prepared by Triturus Environmental Ltd. for MKO

**February 2025**

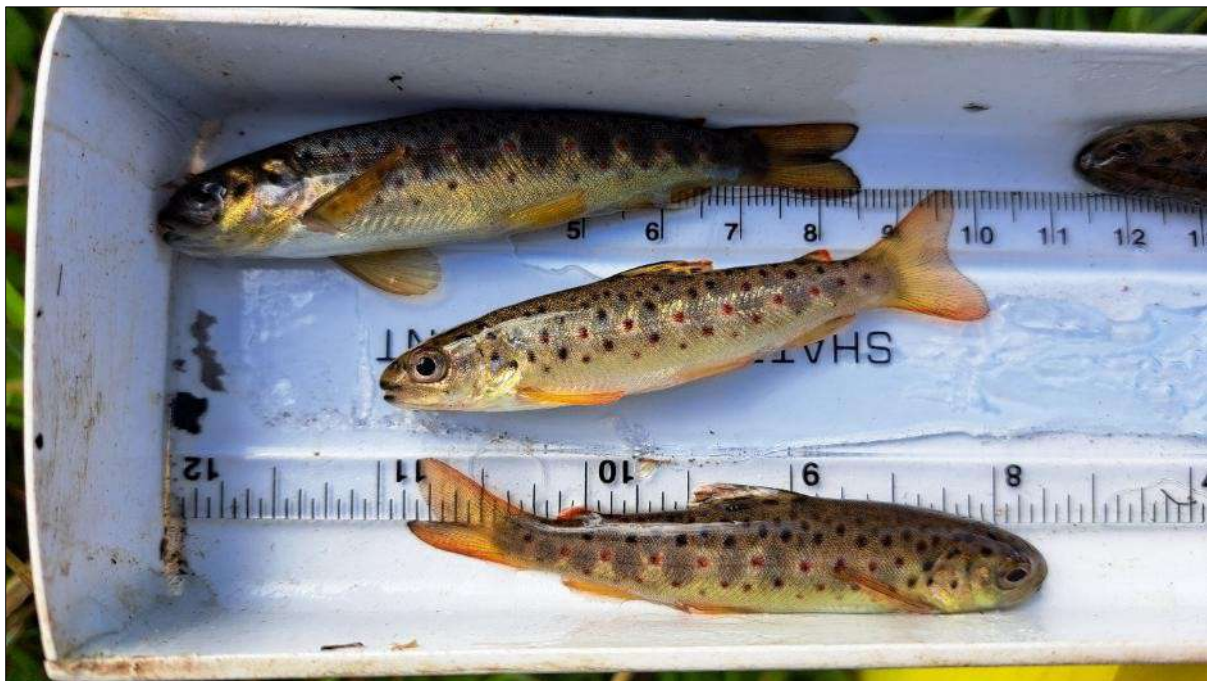
**Plate 3.2.2** Juvenile cohort brown trout recorded at site C2 on an unnamed Altans Stream tributary, September 2024

The site was of some value as a salmonid nursery supporting a low density of juveniles with no adults. This reflected the paucity of deeper holding habitat. Good quality spawning habitat was present locally (where smaller substrata dominated) with the site considered a moderate value nursery overall. European eel suitability was moderate with a single individual recorded from a pool area underneath the bridge. The small stream was not of value for lamprey at this location with an absence of nursery areas (none recorded).

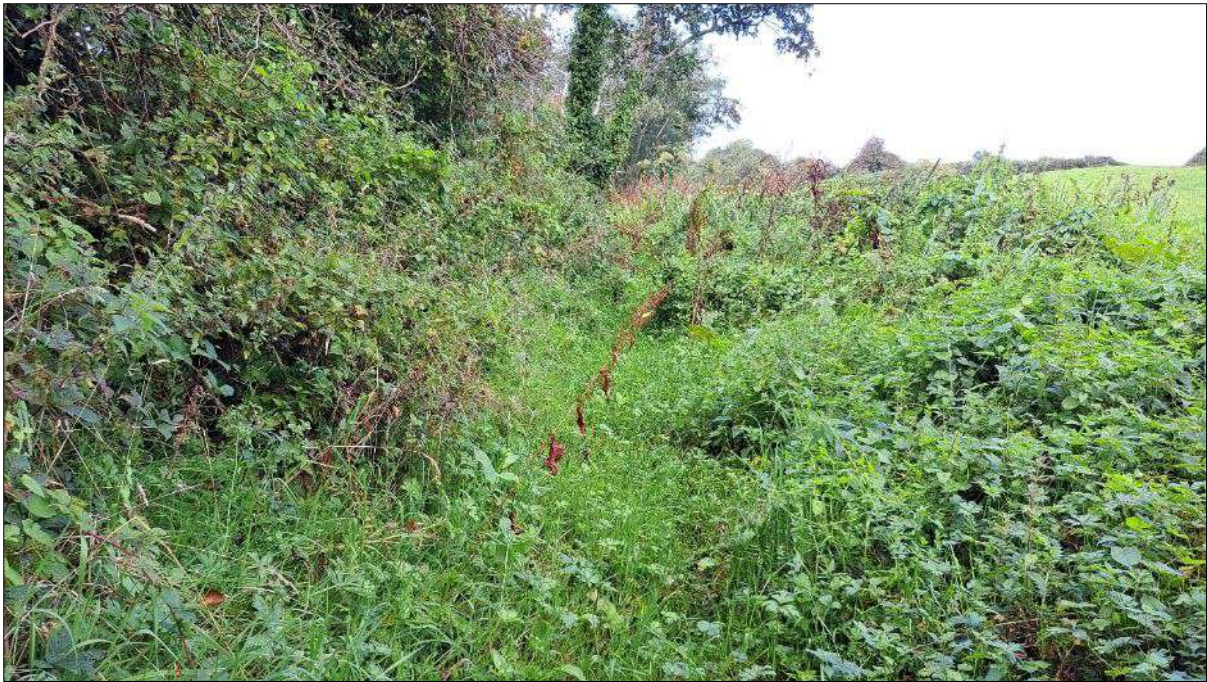
**Plate 3.2.6** Representative image of site C6 on the Portavaud River, September 2024 (dry, ephemeral channel)

Site C6 was located on the Portavaud River at the N59 road and Proposed Grid Connection Route crossing. The narrow (1m wide) watercourse was dry at this location at the time of survey and was thus not of fisheries value given its ephemeral nature.

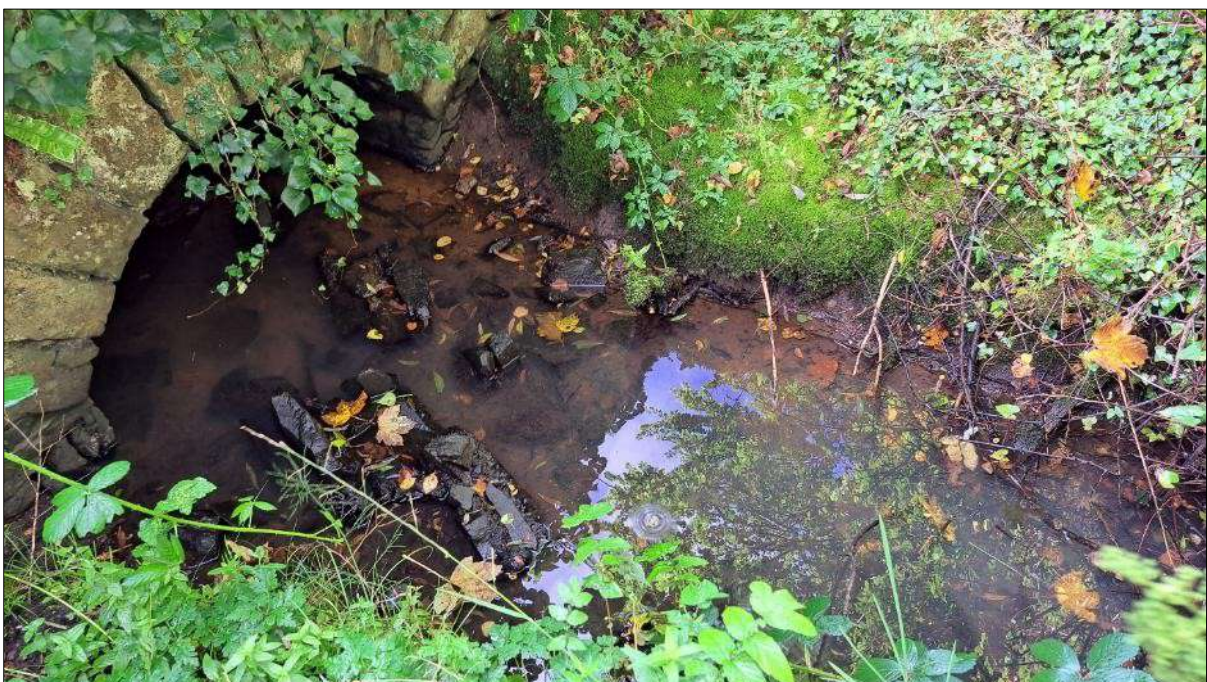
**Plate 3.2.12** Representative image of site C12 on the Stonehall River, September 2024

No fish were recorded via electro-fishing at site C12 was located on the Stonehall River at the N59 road and Proposed Grid Connection Route crossing. The narrow channel was semi-dry at this location at the time of survey with isolated standing water pools of water near the road culvert only. The site was not of fisheries value given its ephemeral nature and poor connectivity to downstream habitats.

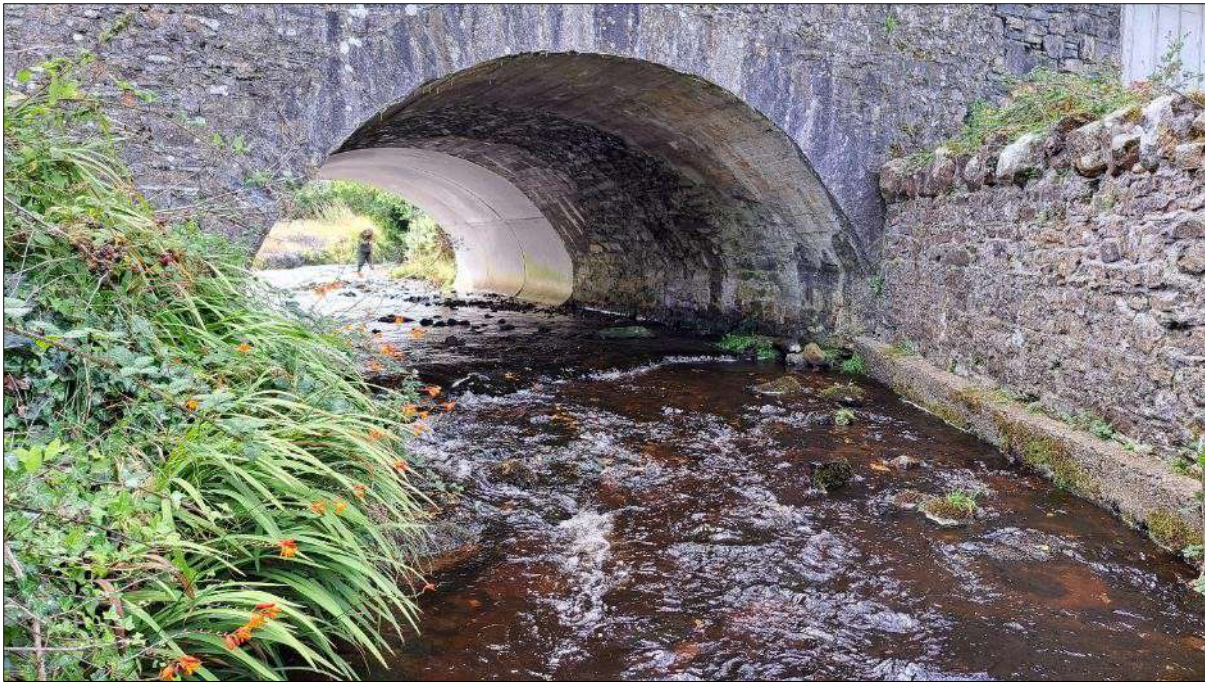
**Plate 3.2.16** Representative image of site D1 on the Doonflin River, September 2024

Electro-fishing was not undertaken at site D1 on the Doonflin River at the N59 road and Proposed Grid Connection Route crossing. The site was of high value for salmonids, with widespread suitability as a spawning and nursery habitat for both Atlantic salmon and brown trout. The site was of highest value as a nursery given a high frequency of bryophyte-rich instream refugia. Some localised holding habitat by way of deeper pools was also present for adult salmonids, particularly downstream of the culvert where a series of bedrock steps/falls created plunge pools (falls fish passable at higher water levels). The site also had high suitability for European eel with abundant instream refugia present. Despite some localised spawning habitat for lamprey, the absence of suitable nursery areas (soft sediment accumulations) likely precluded the species at this high energy site.

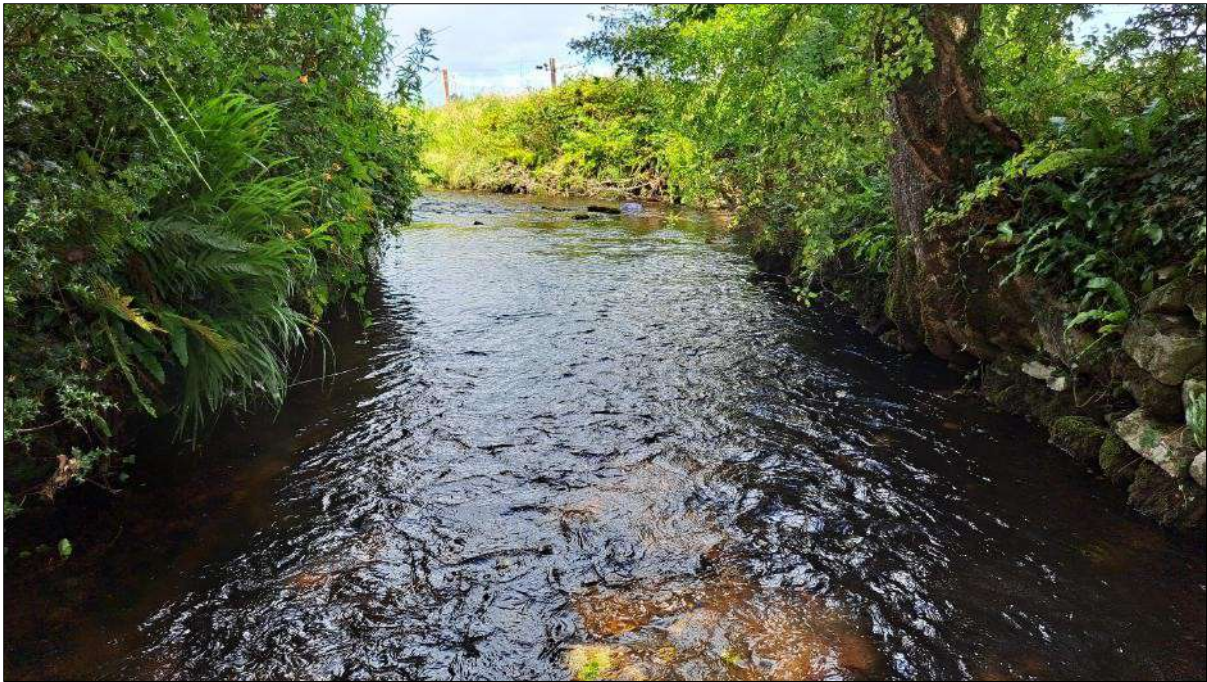
**Plate 3.2.17** Representative image of site D2 on the Dunmorán Trib West River, September 2024

Electro-fishing was not undertaken at site D2 on the Dunmorán Trib West River at the N59 road and Proposed Grid Connection Route crossing. However, the site was of high value for salmonids, with widespread suitability as a nursery and holding habitat for both Atlantic salmon and brown trout. The site was of highest value as a nursery given a high frequency of bryophyte-rich instream refugia. Some localised holding habitat by way of deeper pools was also present for adult salmonids (e.g. under bridge). Good quality salmonid spawning habitat was present but more localised. The site had high suitability for European eel with abundant instream refugia present. The high energy site was unsuitable for lamprey with no suitable nursery areas.

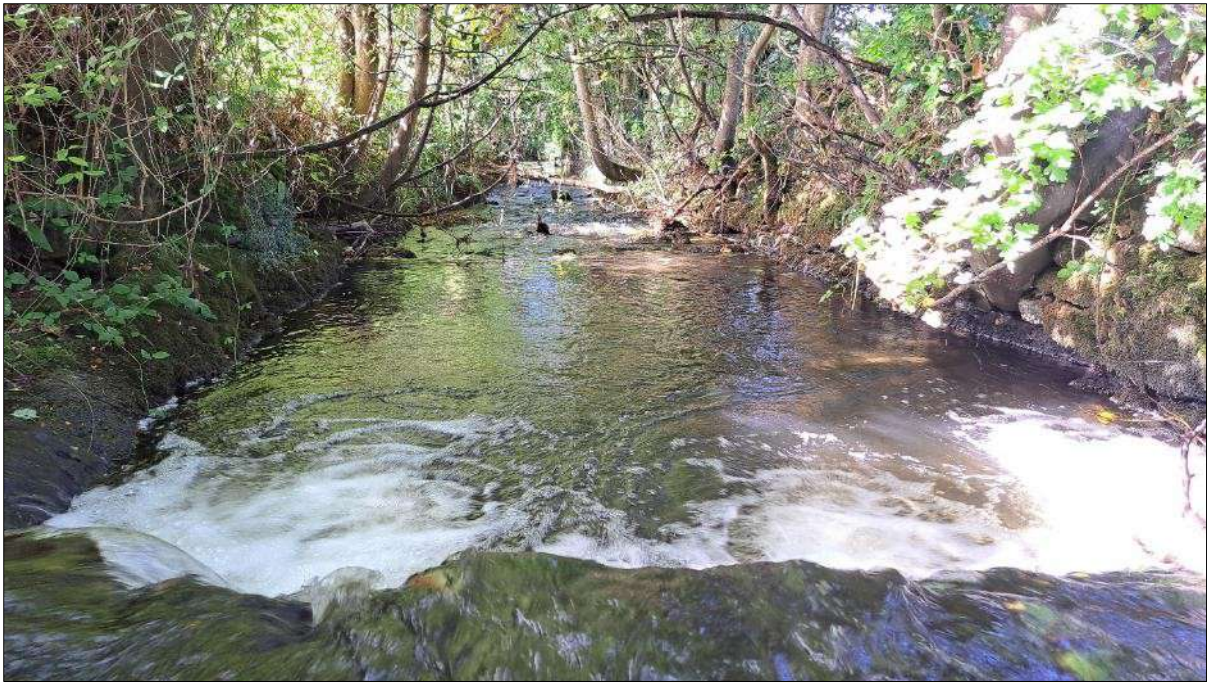
**Plate 3.2.18** Representative image of site D3 on the Dunmorán River, September 2024

Electro-fishing was not undertaken at site D3 on the Dunmorán River at the N59 road and Proposed Grid Connection Route crossing. The site was of moderate value for salmonids only given bed compaction and calcification which reduced the availability of suitable spawning habitat. However, the site was of better value as a salmonid nursery with abundant instream refugia throughout. Localised plunge pools associated with cascades provided some valuable holding habitat for adult salmonids although this was highly localised. The site had some good suitability for European eel with abundant instream refugia present. The high energy site was unsuitable for lamprey with no suitable nursery areas.

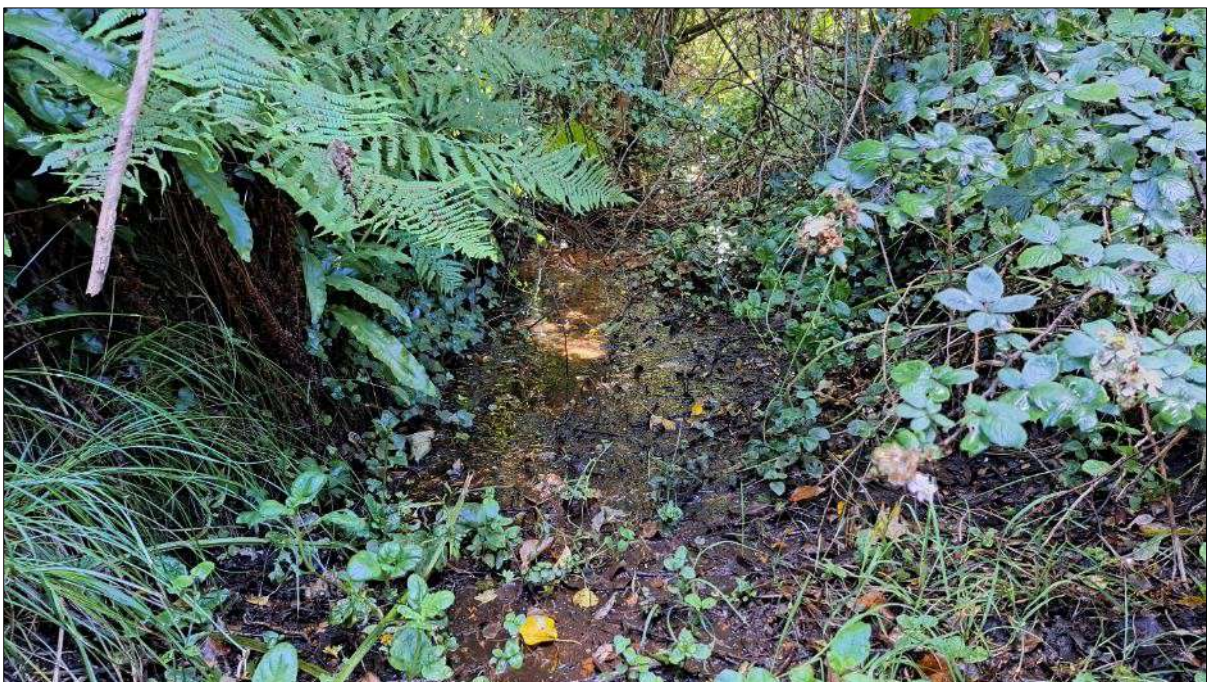
**Plate 3.2.19** Representative image of site D4 on an unmapped stream, September 2024

Electro-fishing was not undertaken at site D4 on an unmapped stream at the N59 road and Proposed Grid Connection Route crossing. The 1-2m wide channel was semi-dry at the time of survey with only localised, shallow (<0.05m) standing water in vicinity of the single arch bridge. The site was not of fisheries value given its ephemeral nature in addition to siltation/water quality pressures.

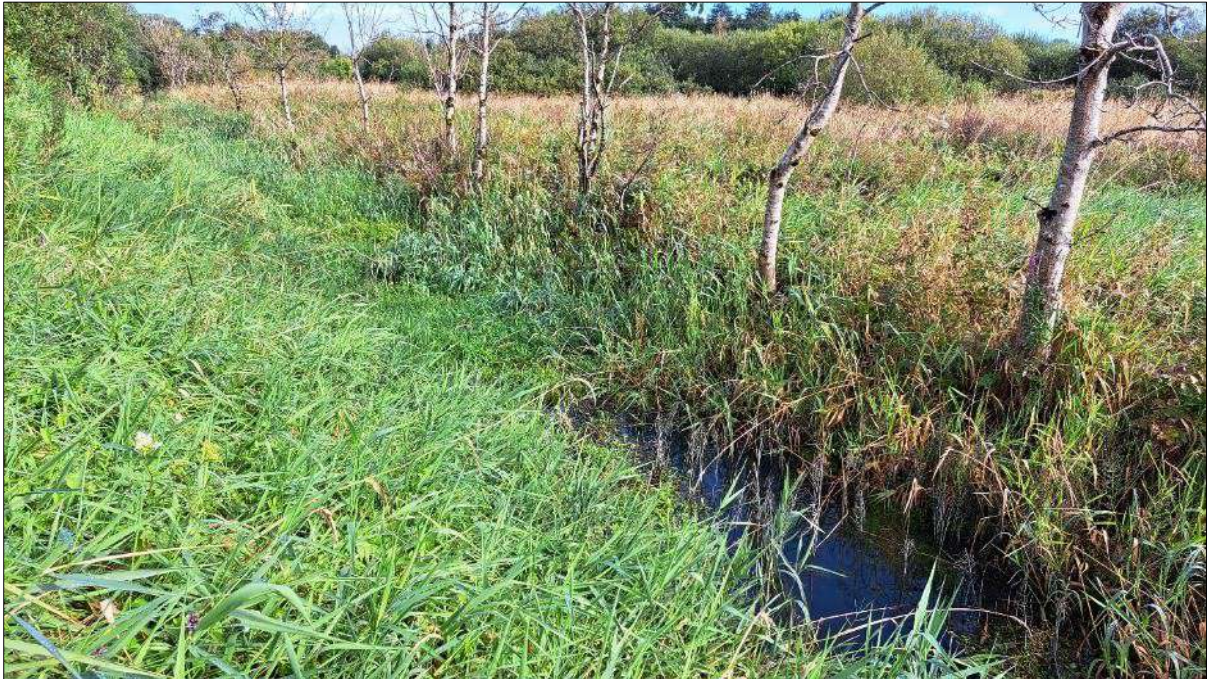
**Plate 3.2.20** Representative image of site D5 on the Knoxspark River, September 2024

Electro-fishing was not undertaken at site D5 on the Knoxspark River at the R290 road and Proposed Grid Connection Route crossing. The site was of very poor fisheries value and not of value for salmonids given extensive modifications, poor flows, high macrophyte cover, poor hydromorphology and siltation pressures. However, there was some low value for European eel, and three-spined stickleback (the latter of which were recorded via macro-invertebrate sweep sampling).

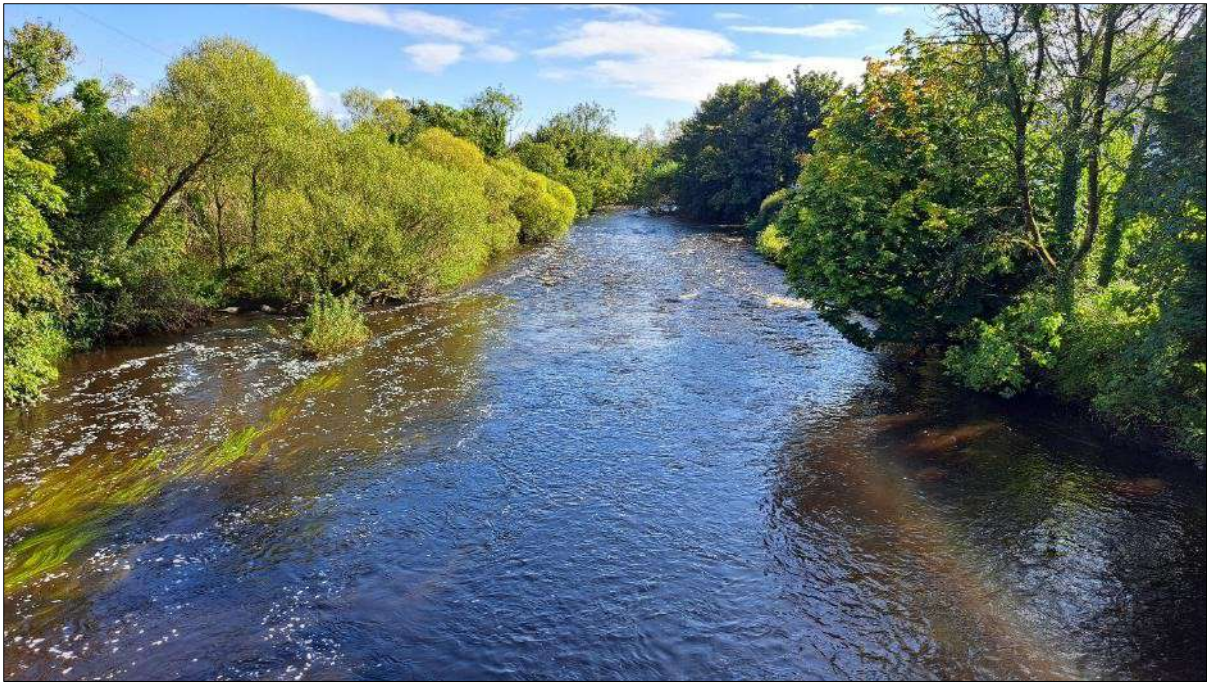
**Plate 3.2.21** Representative image of site D6 on the Owenmore River, September 2024

Electro-fishing was not undertaken at site D6 on the Owenmore River at the R290 road and Proposed Grid Connection Route crossing, located within the Unshin River SAC (001898). The large spate river at this location was of very high value for salmonids, including Atlantic salmon, with combinations of very good quality spawning, nursery and holding habitat present. Localised areas of boulder and larger cobble provided good quality European eel habitat. Suitability for lamprey was low given high flow rates although some localised spawning habitat was present. Access for anadromous sea and river lamprey is blocked by Ballysodare Falls located c. 4.5km downstream. The Owenmore River is known to support Atlantic salmon, brown/sea trout, European eel, lamprey (*Lampetra* sp.), minnow (*Phoxinus phoxinus*), three-spined stickleback, pike (*Esox lucius*), roach (*Rutilus rutilus*) and perch (*Perca fluviatilis*) (Kelly et al., 2011a).

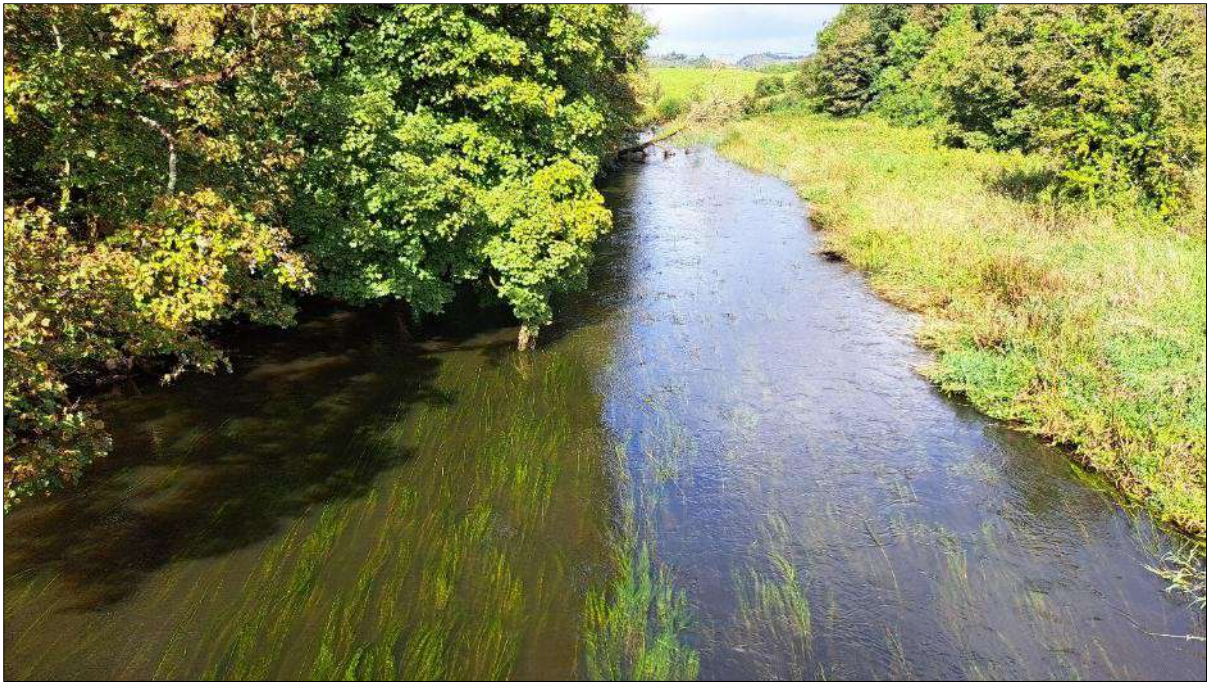
**Plate 3.2.22** Representative image of site D7 on the Unshin River, September 2024

Electro-fishing was not undertaken at site D7 on the Unshin River at the R290 road and Proposed Grid Connection Route crossing, located within the Unshin River SAC (001898). The site was of high value for salmonids, including Atlantic salmon. Although the heavily vegetated site, with siltation pressures, was not of significant spawning value, good quality holding opportunities (for adult salmonids) and nursery habitat were widespread. The site was also of high suitability for European eel. Whilst spawning habitat was largely absent, abundant soft sediment areas were suitable for lamprey ammocoetes (likely present in low densities). Access for anadromous sea and river lamprey is blocked by Ballysodare Falls located c. 7.5km downstream. The Unshin River, a tributary of the Owenmore/Ballysodare, is known to support Atlantic salmon, brown trout, European eel, pike, perch and minnow (Kelly et al., 2015, 2011b).

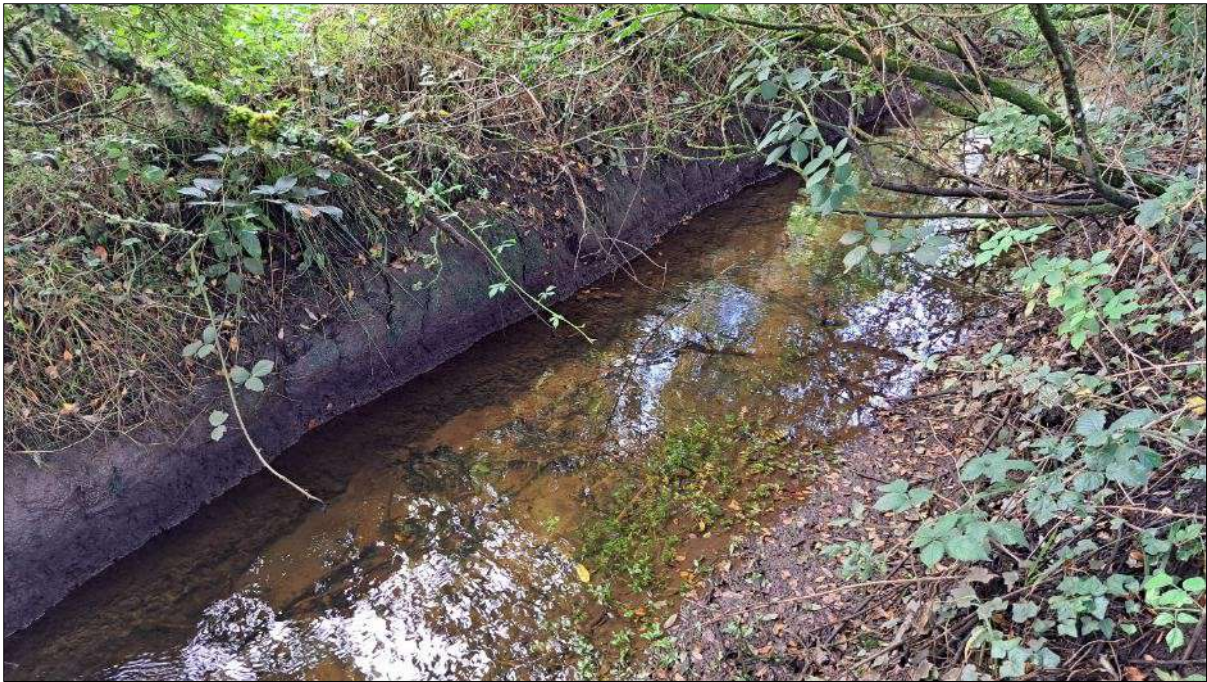
**Plate 3.2.23** Representative image of site D8 on the Carrigeenboy River, September 2024

Electro-fishing was not undertaken at site D8 on the Carrigeenboy River at the R290 road and Proposed Grid Connection Route crossing. The heavily modified site was not of significant salmonid value given poor hydromorphology and siltation pressures. However, some low holding suitability was present and the river likely supports brown trout in low densities. Likewise, European eel were also likely present given abundant instream refugia. Whilst lamprey nursery habitat was abundant, the absence of spawning habitat likely restricted the species' distribution at the site.

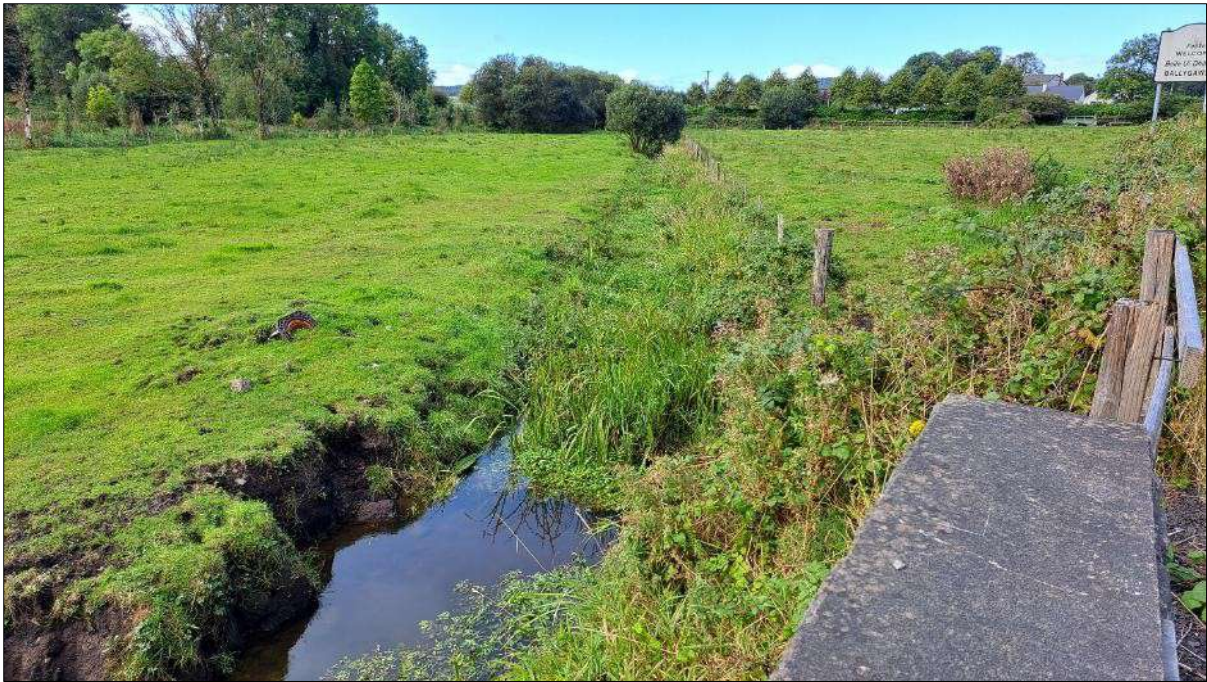
**Plate 3.2.24** Representative image of site D9 on an unmapped Carrigeenboy River tributary, September 2024

Electro-fishing was not undertaken at site D9 on an unmapped Carrigeenboy River tributary at the R284 road and Proposed Grid Connection Route crossing. The channel had been straightened and deepened both along the roadside (upstream of box culvert) and downstream of the crossing, resulting in a channel with very poor hydromorphology, low flows, high siltation and very high macrophyte coverage. Suitability for salmonids and lamprey was very low although there was some low suitability for European eel. Three-spined stickleback were recorded during macro-invertebrate sweep sampling.

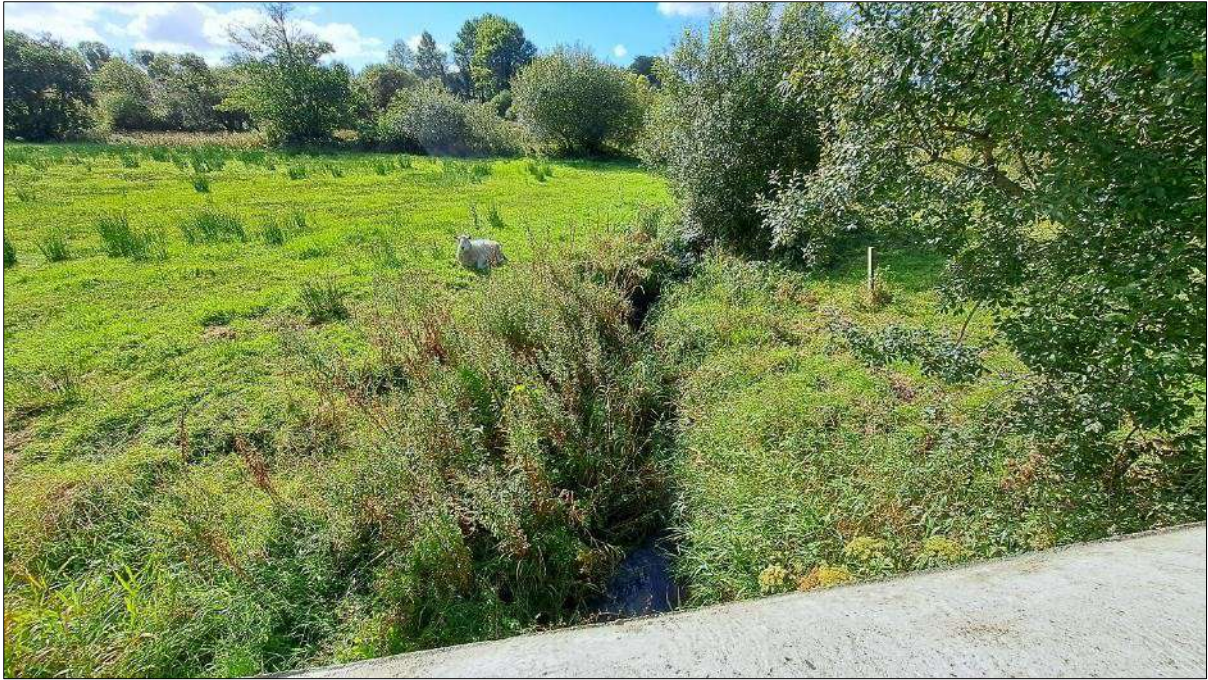
**Plate 3.2.25** Representative image of site D10 on the Ballygrania River, September 2024

Electro-fishing was not undertaken at site D10 on the Ballygrania River at the R284 road and Proposed Grid Connection Route crossing. The site was of moderate fisheries value only given historical modifications and siltation pressures. However, the deep glide habitat (>1m) with frequent bank scours likely supported adult brown trout and European eel. Salmonid and lamprey spawning habitat was largely absent from the narrow channel. Soft sediment accumulations had some potential to support juvenile lamprey but the high clay content would reduce the quality of the bed for ammocoete burial. Three-spined stickleback were recorded during sweep/kick sampling.

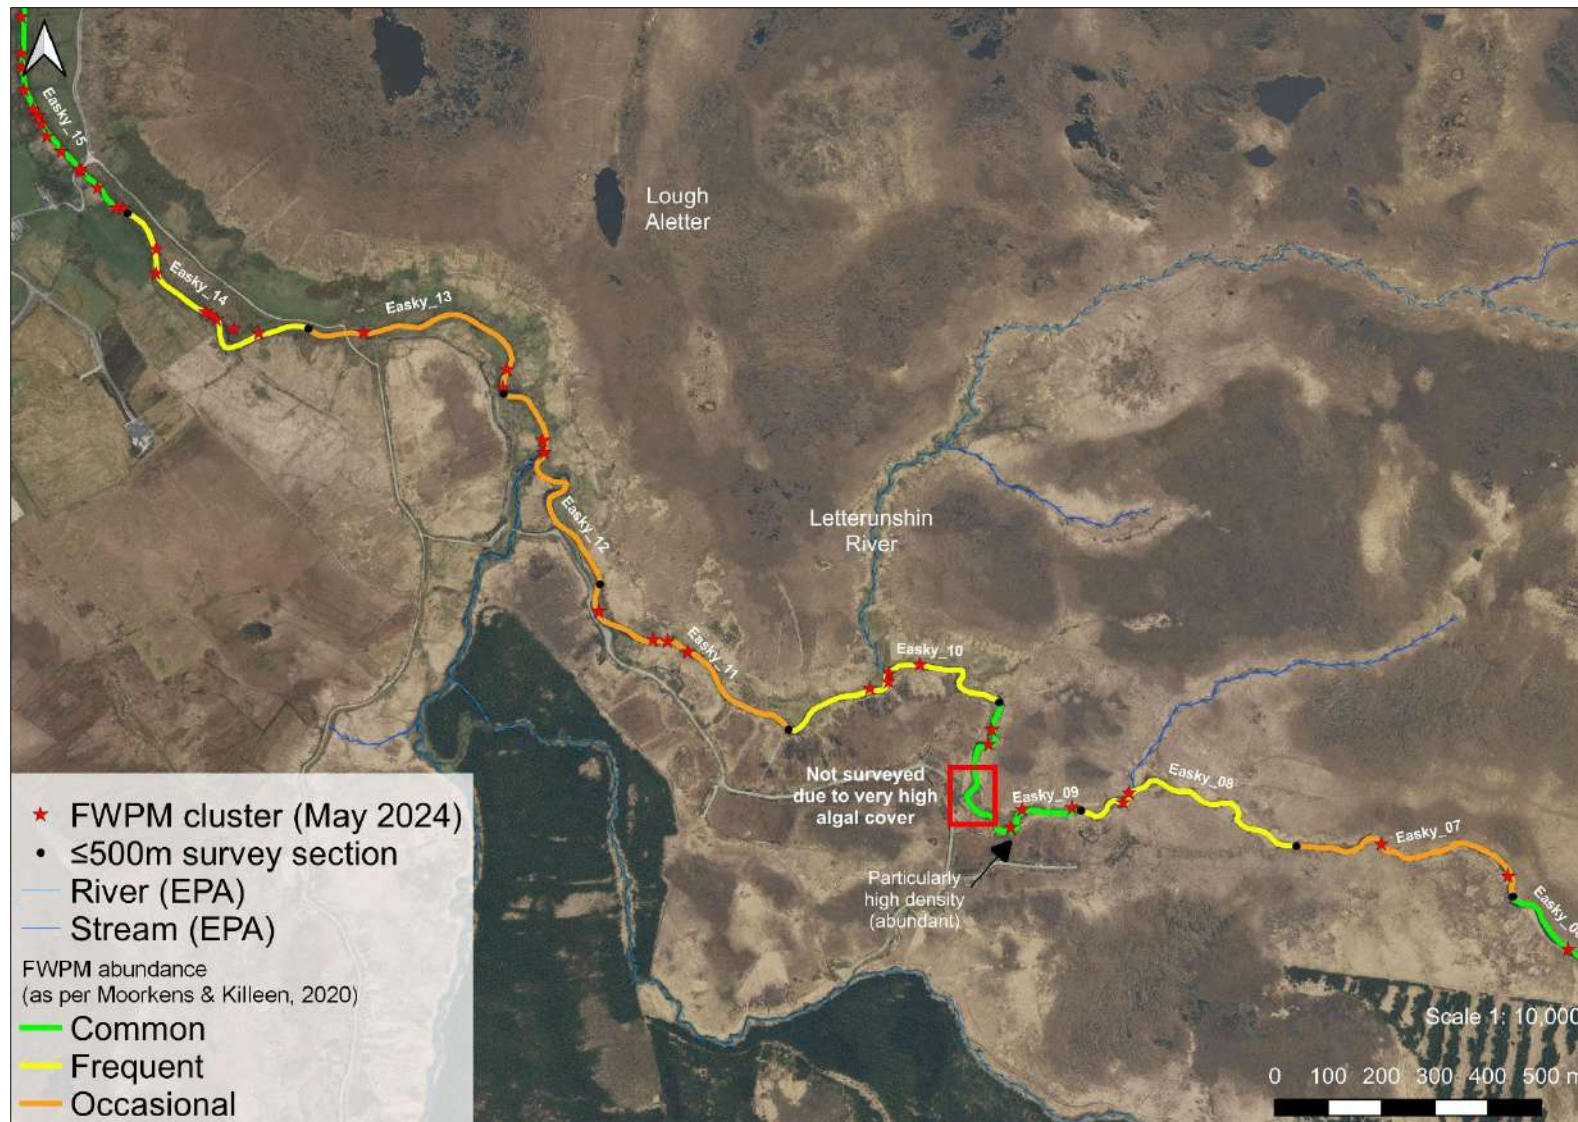
**Figure 3.4** Freshwater pearl mussel distribution and abundance in sections 7-14, May 2024

The upper survey reaches of the Easky River featured a greater frequency of lower gradient riffle and glide areas supporting less mobile mixed gravel and cobble substrata that provided more optimal conditions for mussel footing (Hastie et al., 2000). Such areas were often located between boulder zones/cascades and also along bank scours. However, mussels were well distributed throughout the survey area, with over 160 discrete clusters (agglomeration) of mussels recorded in addition to scattered mussels (**Appendix A**). Sections Easky\_02, Easky\_03, Easky\_04, Easky\_05, Easky\_06, Easky\_09 and Easky\_15 supported particularly high numbers of mussels, respectively (**Table 3.1; Figures 3.3-3.5**).

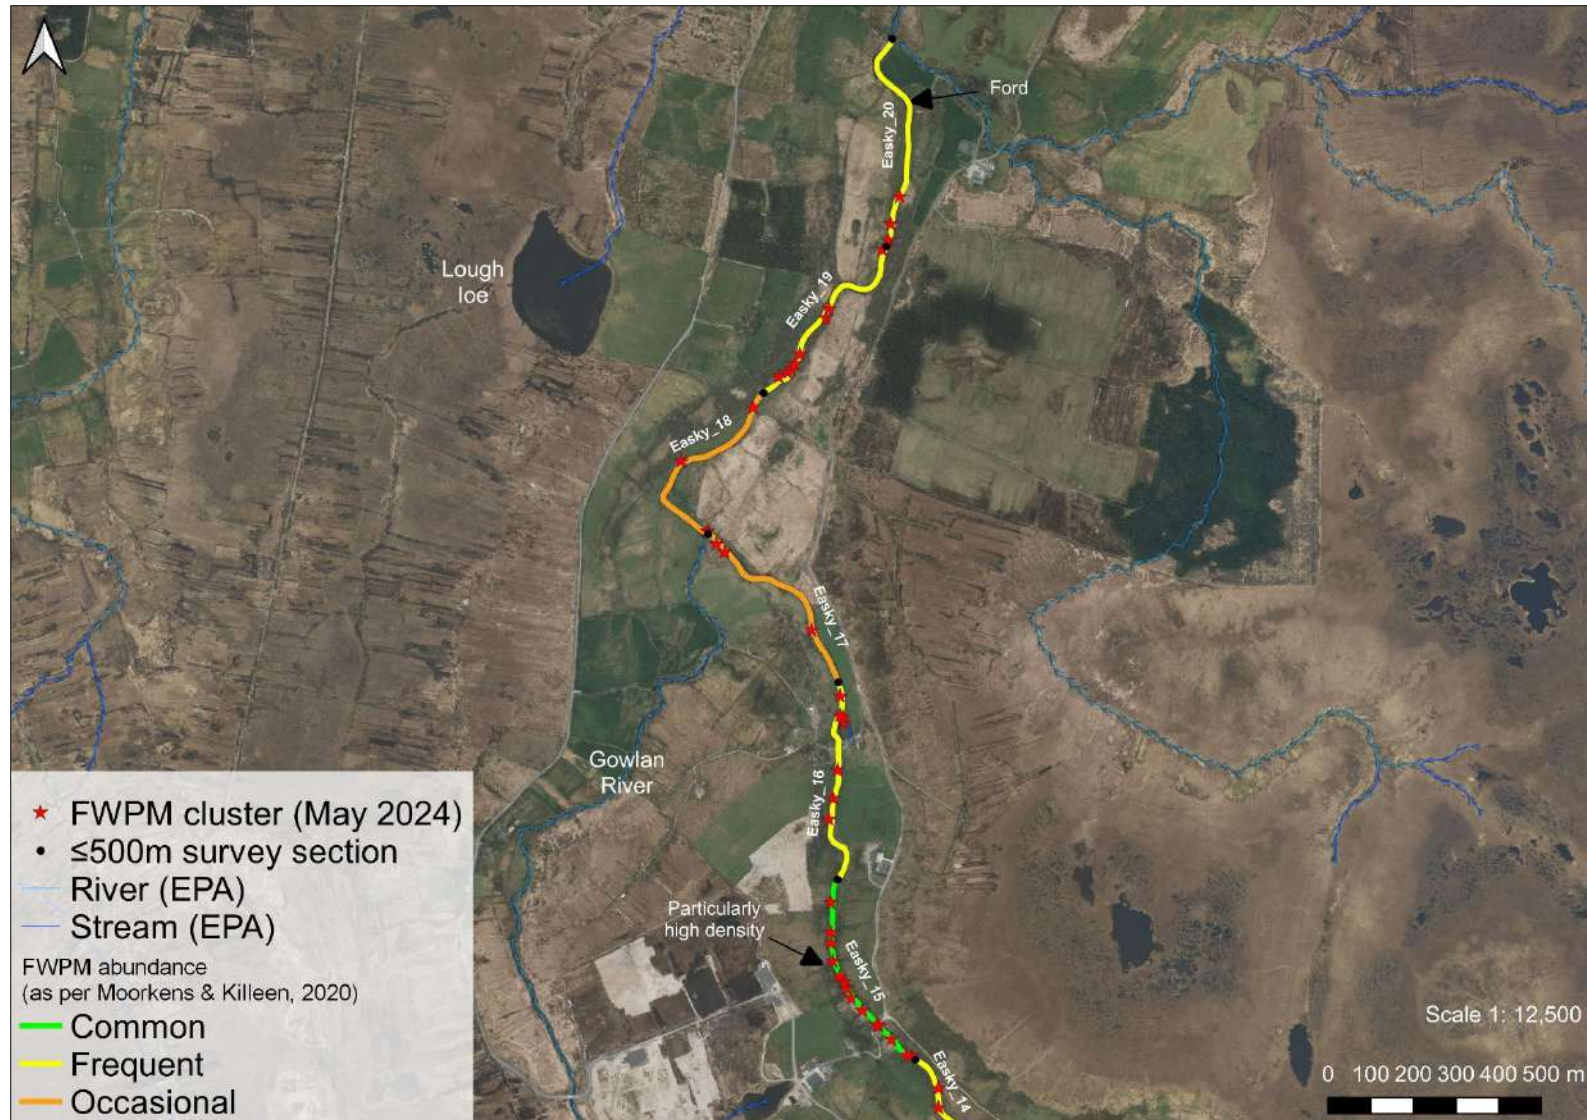
**Figure 3.5** Freshwater pearl mussel distribution and abundance in sections 15-20, May 2024

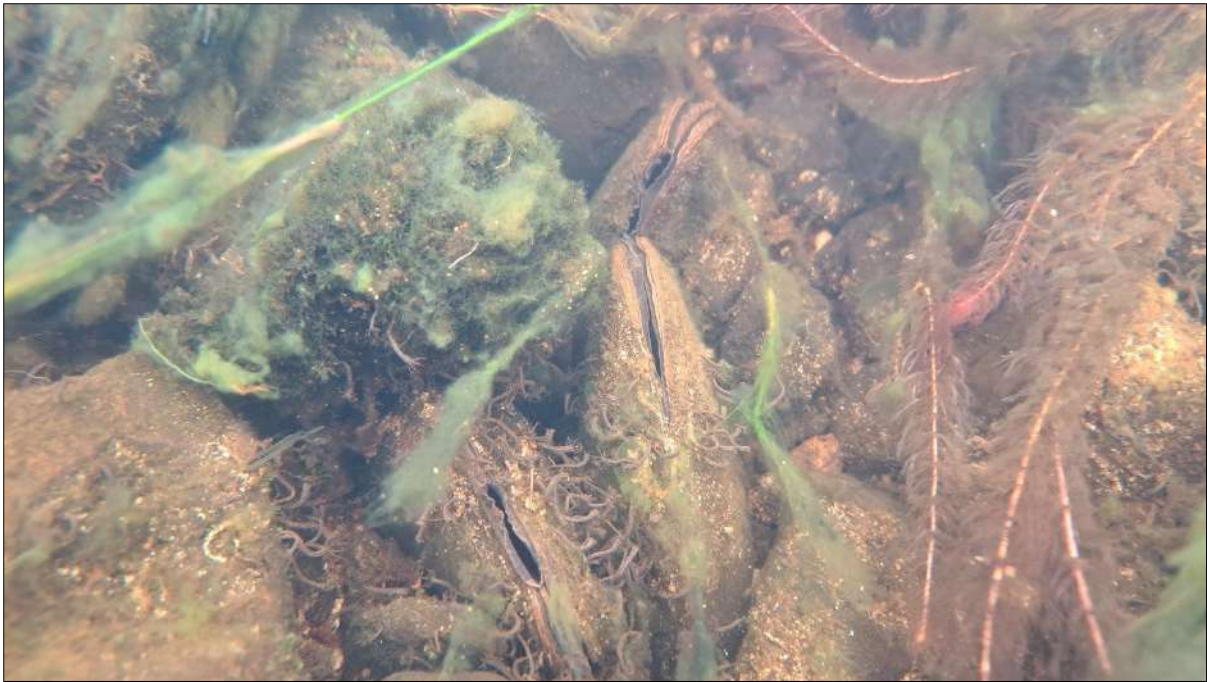
**Plate 3.1** Filtering adult mussels on the upper reaches of the Easky River (section Easky\_02) with high cover of filamentous algae, May 2024

Very high concentrations of mussels were present in sections Easky\_03 to Easky\_06 (**Figure 3.3**). However, very significant water quality pressures, resulting in very high filamentous algae and floc<sup>2</sup> cover (eutrophication), high iron-oxidising bacterial cover and increased turbidity, were evident in section Easky\_07 downstream of the Meenamaddo River (EPA code: 35M44) confluence (ITM 542306, 824466). Pearl mussel abundance dropped noticeably at this point with a sudden increase in the number of dead shells and moribund mussels indicating a toxic effect from the adjoining tributary (a channel draining blanket bog and coniferous afforestation). High rates of eutrophication were also evidently originating from the unnamed tributary at ITM 540218, 825404 in section Easky\_12 (a channel again draining coniferous afforestation).

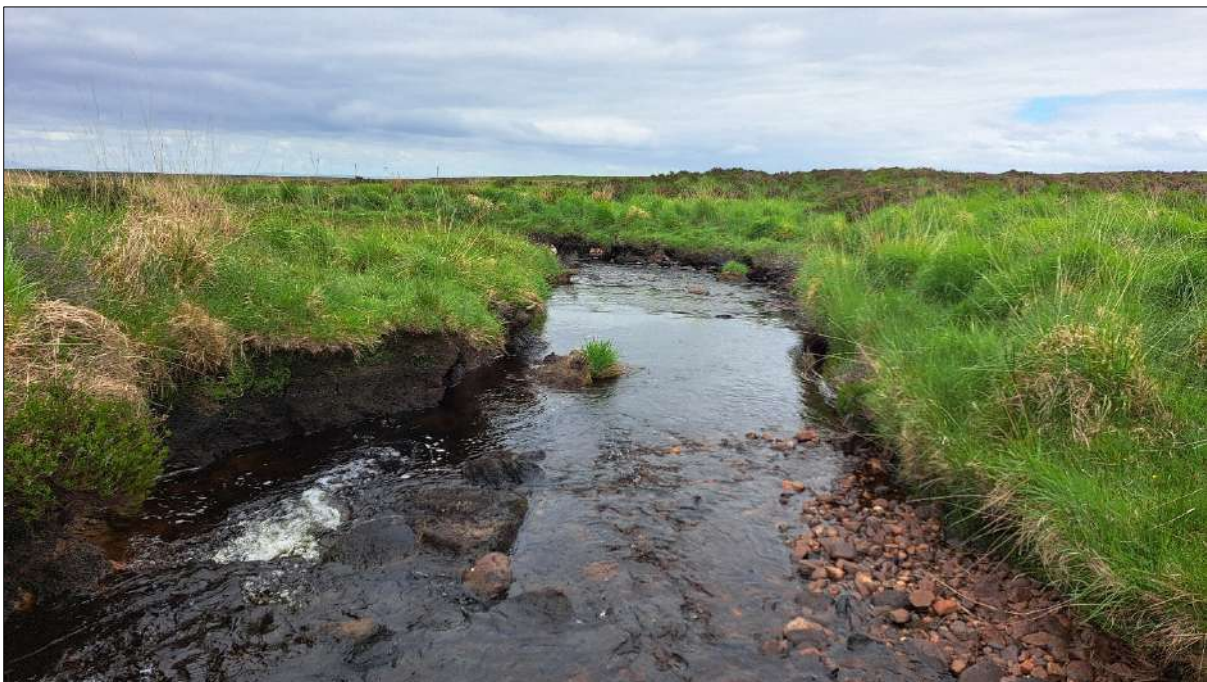
**Plate 3.2** Example of the upper survey area with stable mixed substrata supporting high densities of pearl mussel

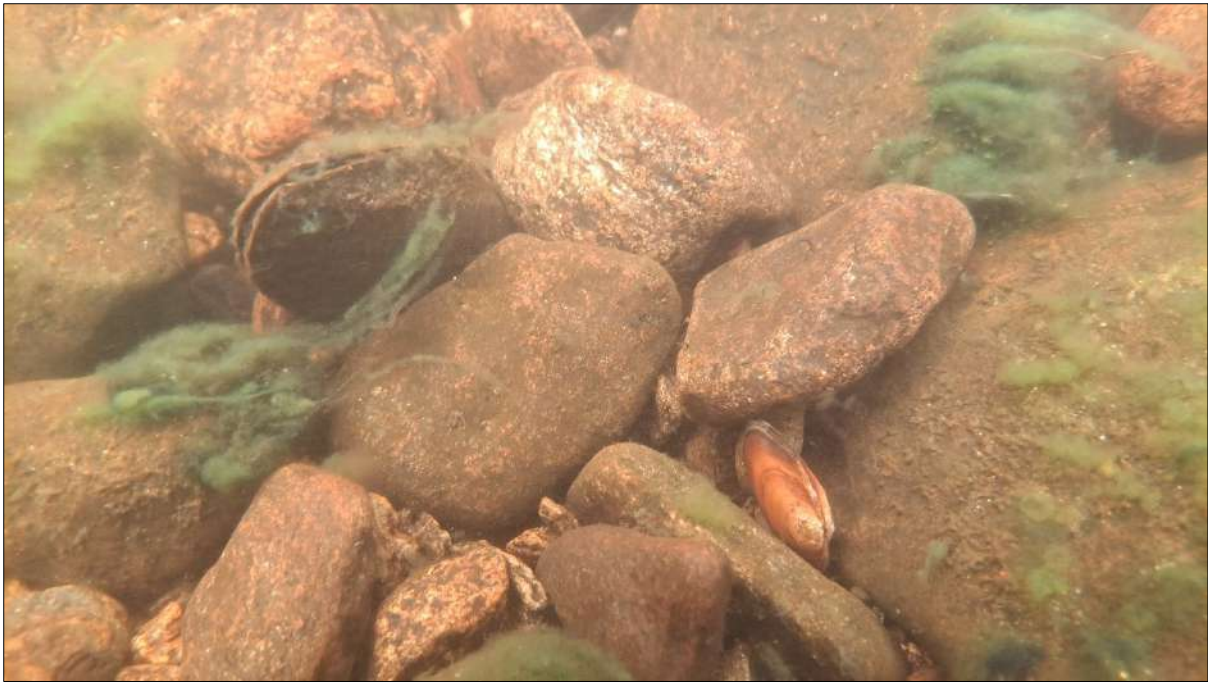
**Plate 3.3** Different size (age) classes of mussel in the upper survey area

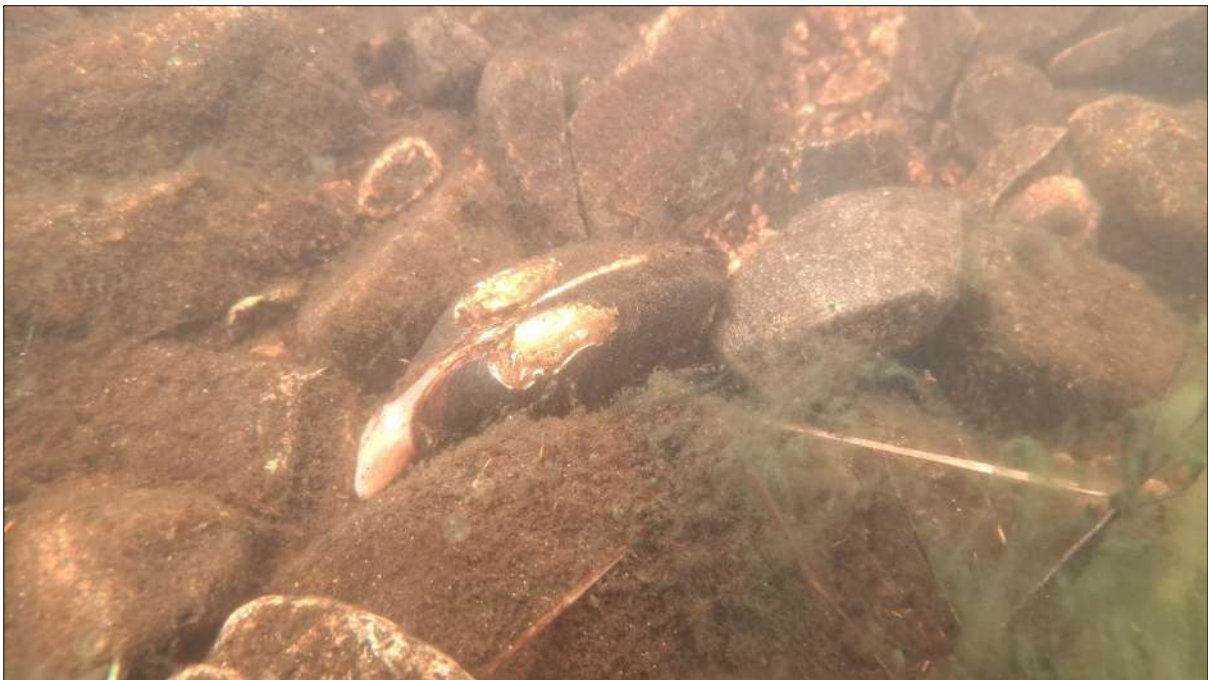
**Plate 3.4** Moribund adult mussel were common in the upper reaches of the Easky River (section Easky\_10)

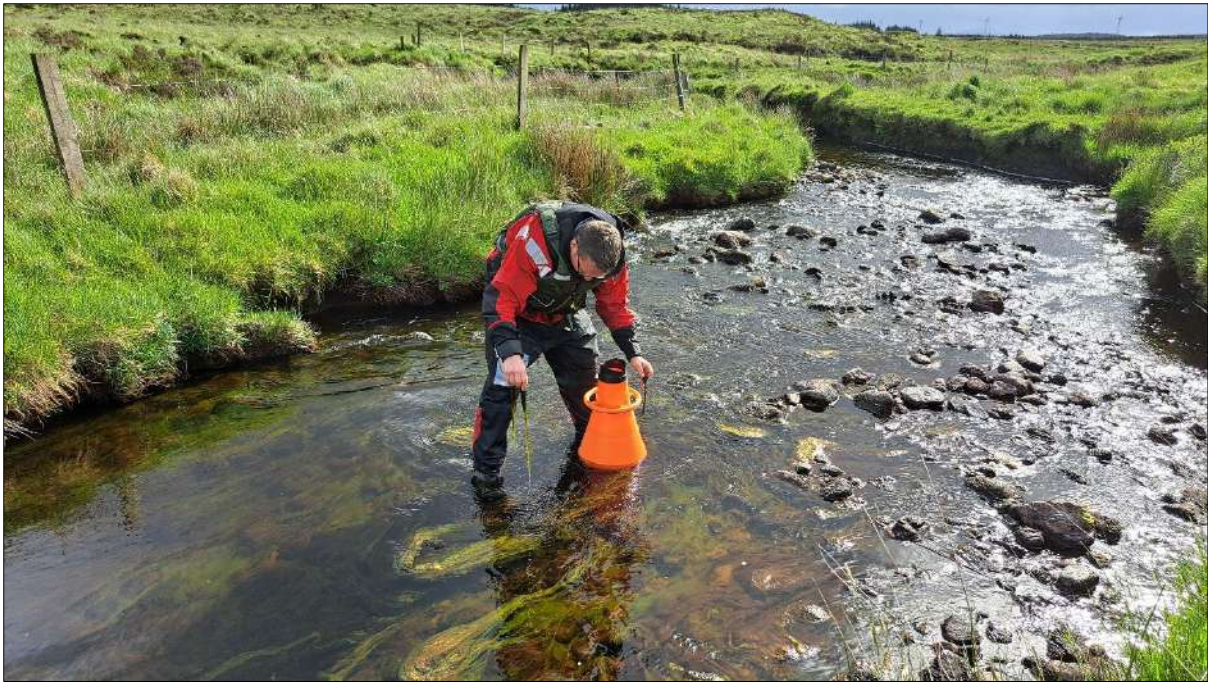
**Plate 3.5** Very high cover of filamentous algae indicating significant eutrophication in the upper reaches of the Easky River (Easky\_07)

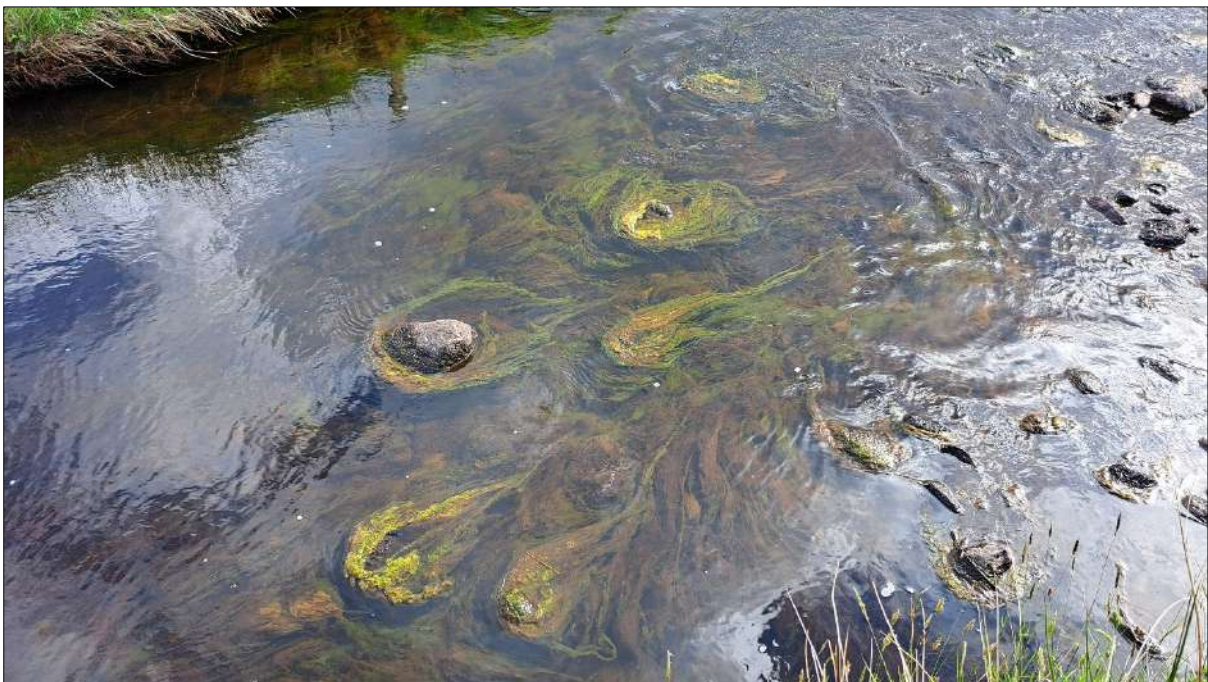
**Plate 3.6** Extremely high cover of filamentous algae in section Easky\_09 made it impossible to safely record pearl mussels (present in high numbers)
