# Aquatic baseline report for the proposed Crumhach Wind Farm, Co. Sligo

Prepared by Triturus Environmental Ltd. for MKO

**February 2025**

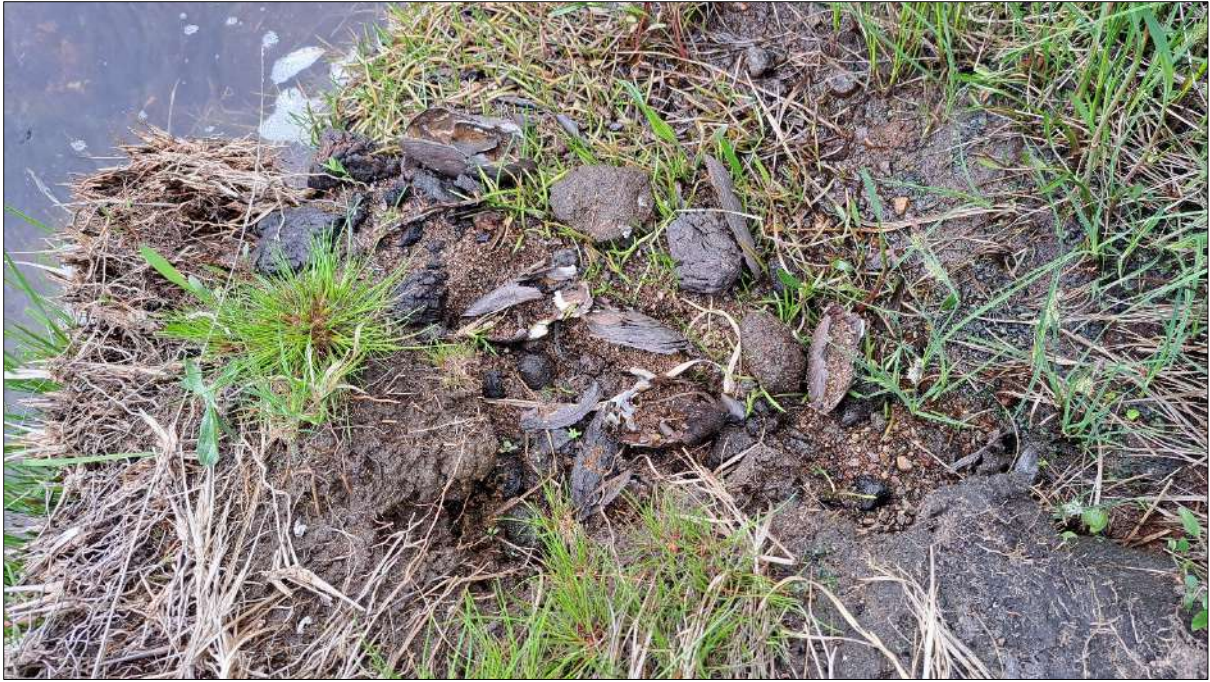
**Plate 3.7** Dead shells were abundant in section Easky\_09

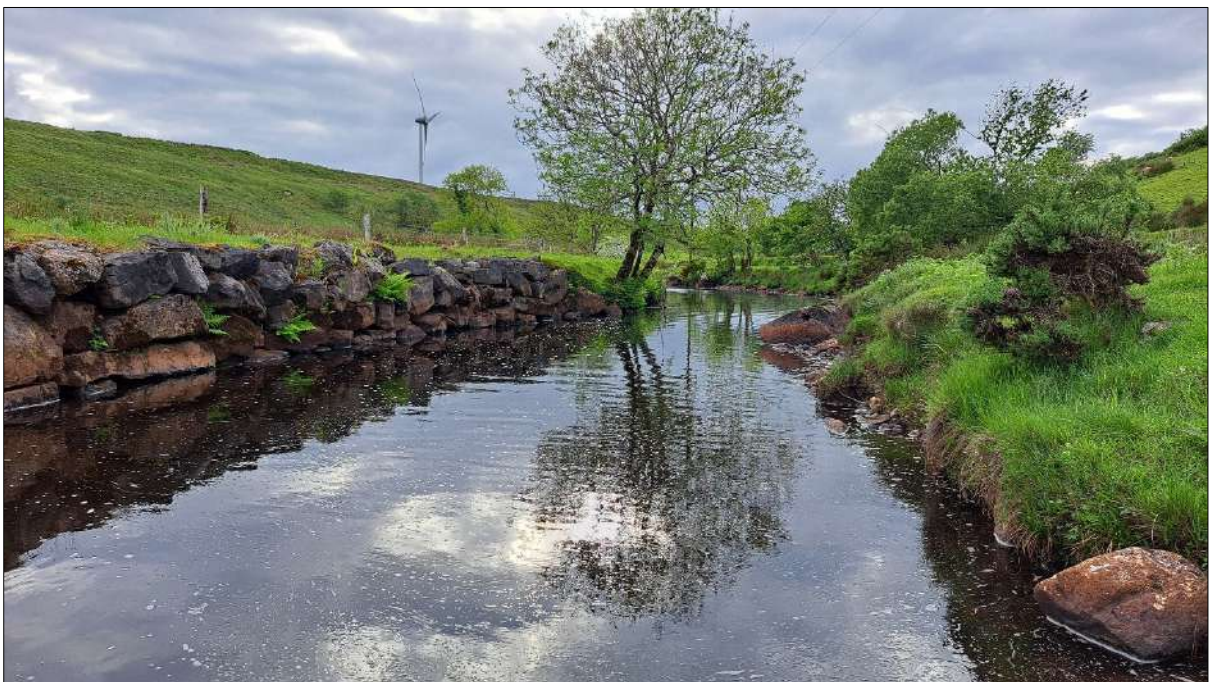
**Plate 3.8** Localised bank works in section Easky\_14

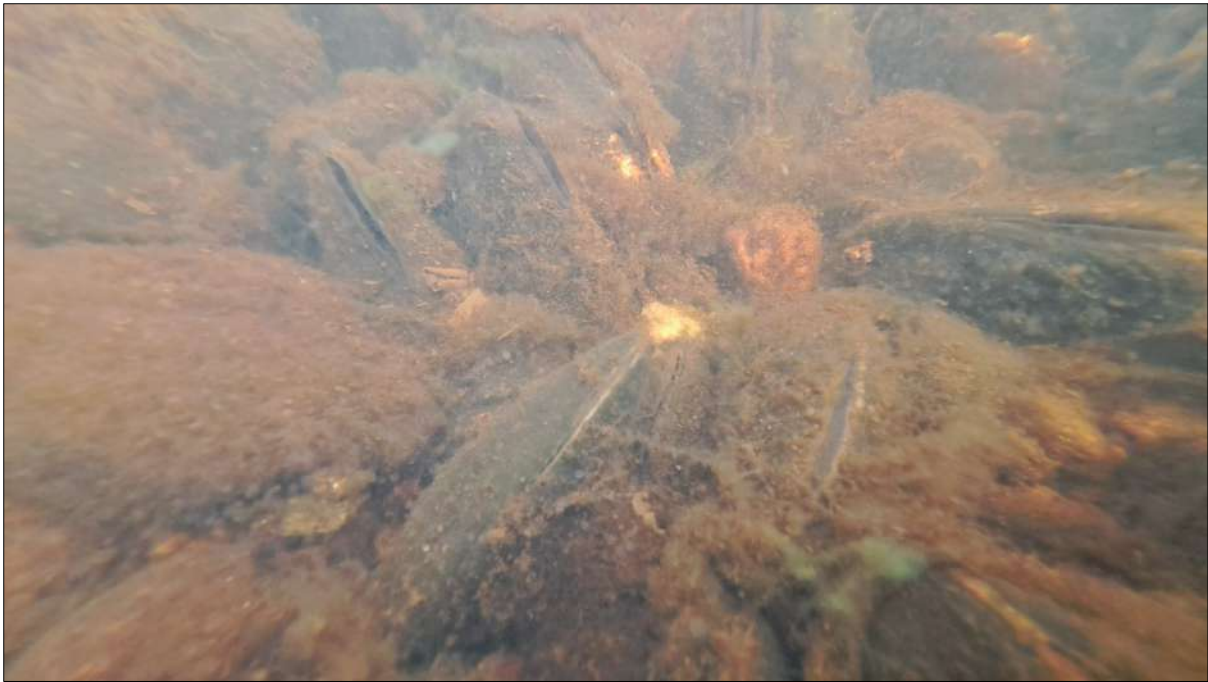
**Plate 3.9** Adult mussels with very high cover of floc and filamentous algae (significant eutrophication)

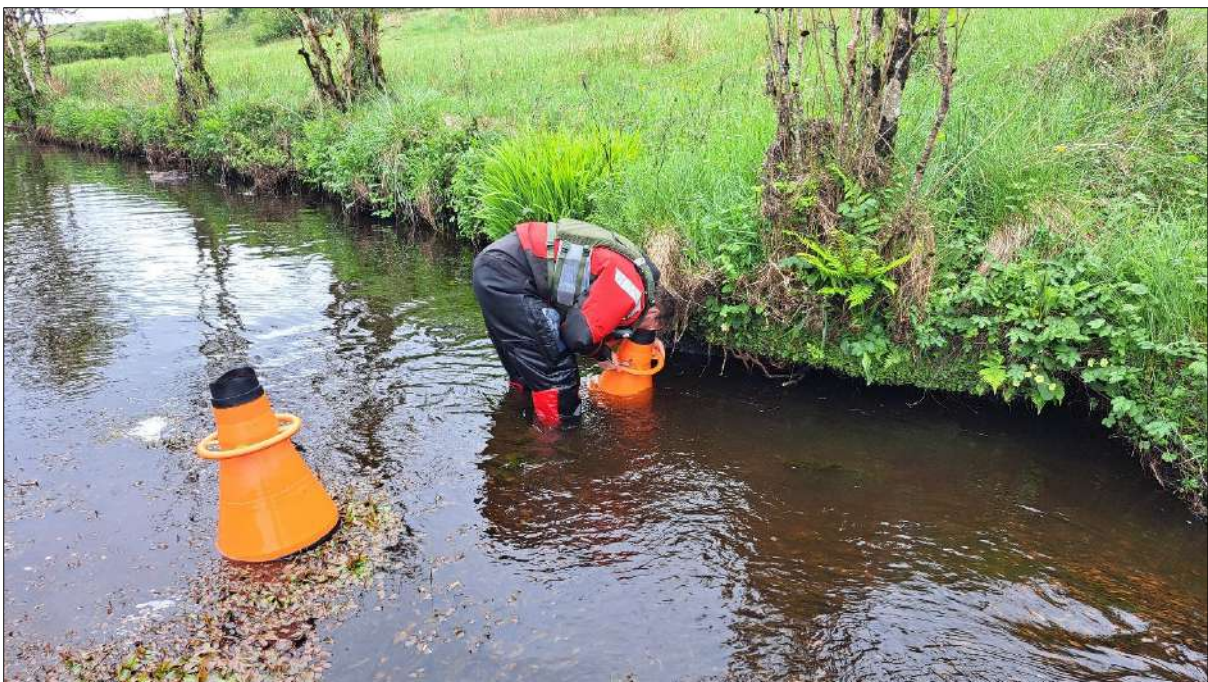
**Plate 3.10** High densities of pearl mussel were typically found in the shade of bank scours / undercuts (e.g. section Easky\_15)

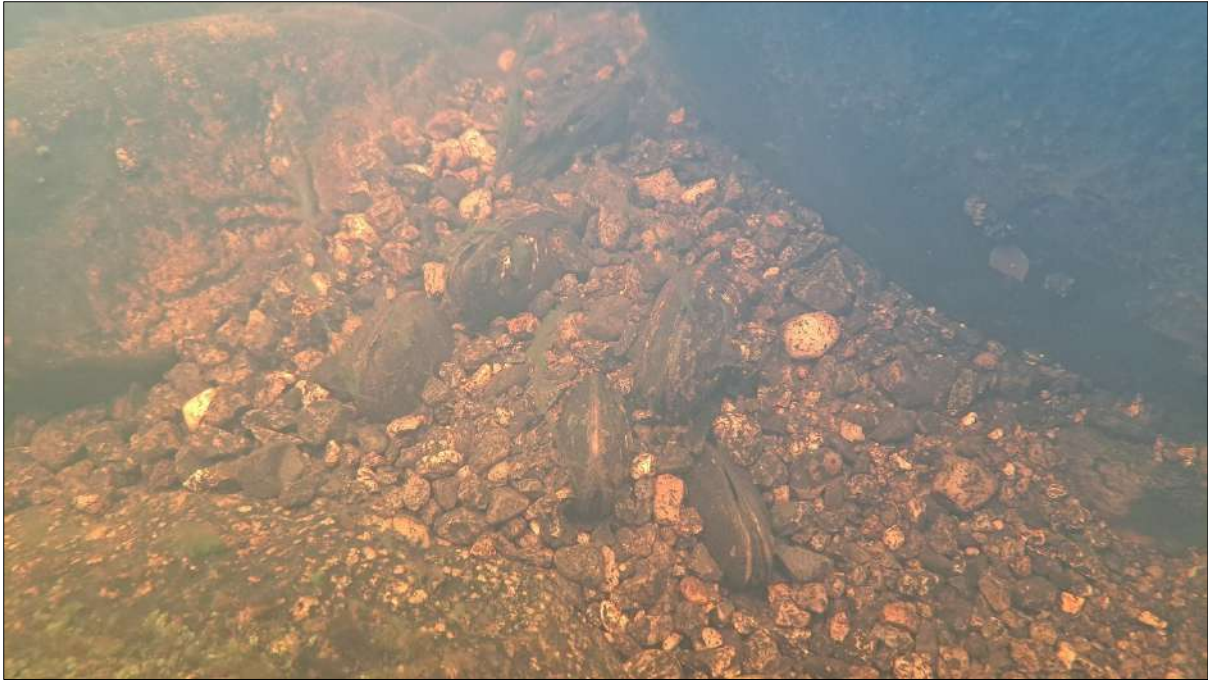
**Plate 3.11** Small cluster of mussels in mixed gravel flow refuge between large boulders in high energy cascade area (section Easky\_17)

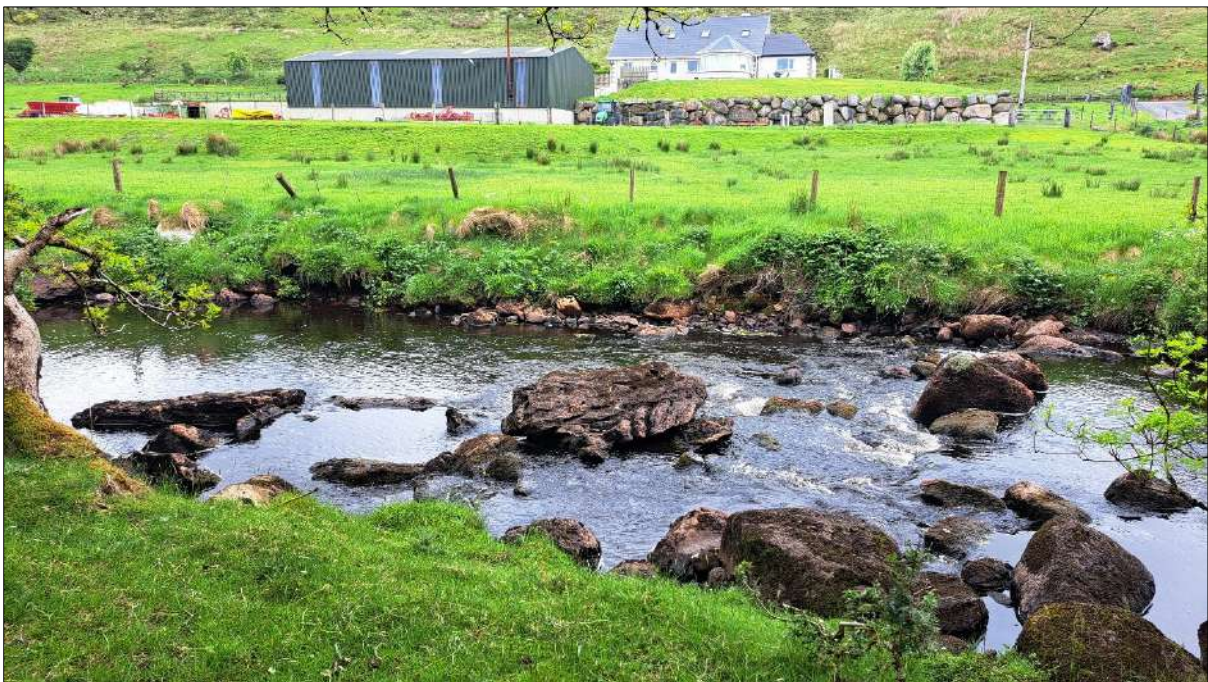
**Plate 3.12** Land use pressures increased in the lower survey reaches (e.g. semi-improved pasture with bank clearance & some localised instream works)

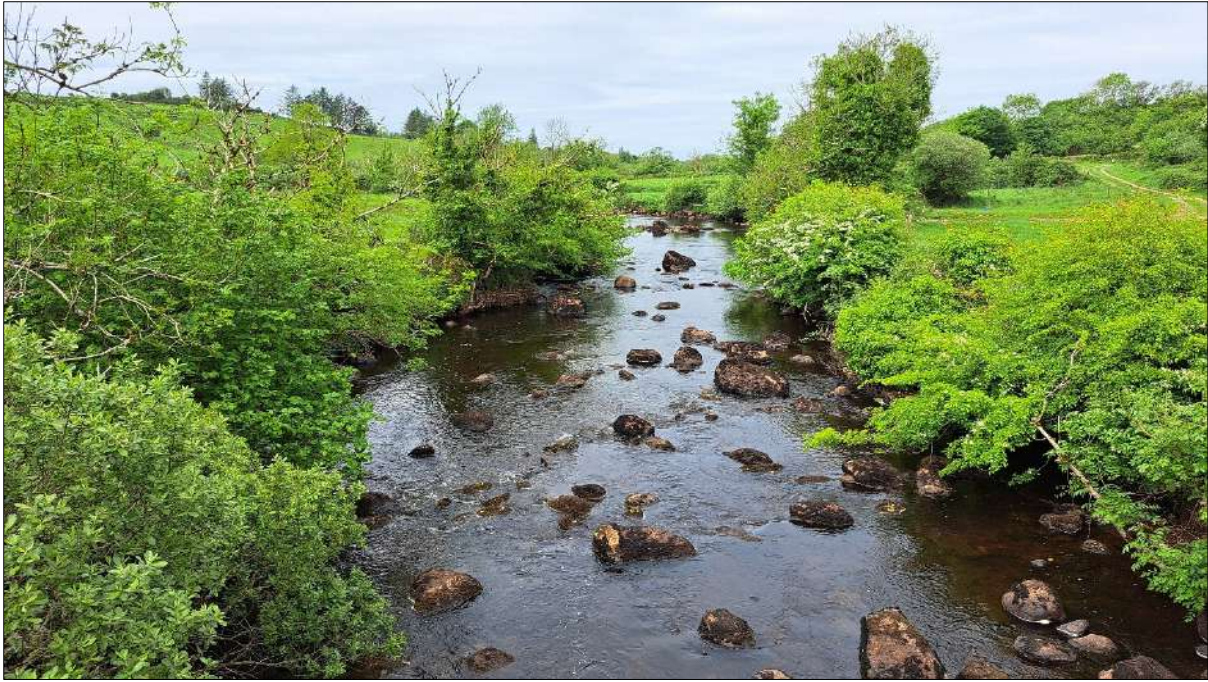
**Plate 3.13** Mussel suitability decreased moving downstream in the survey area (high energy cascade/boulder reaches with poor footing opportunities). Easky River near the end of the survey area (section Easky\_20)

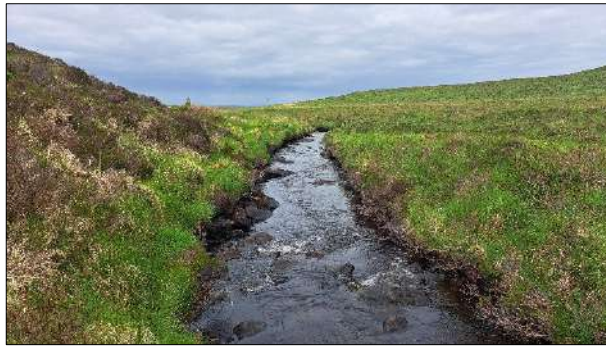
**Plate 8.1** Representative image of survey section Easky\_01

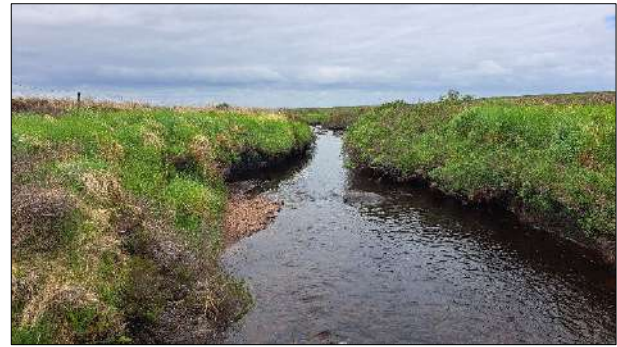
**Plate 8.2** Representative image of survey section Easky\_02

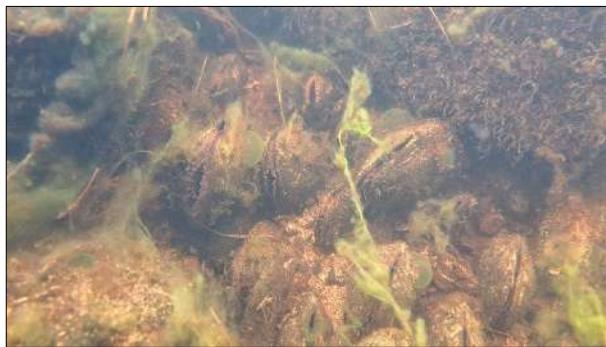
**Plate 8.3** Pearl mussel with high cover of floc & filamentous algae in Easky\_02

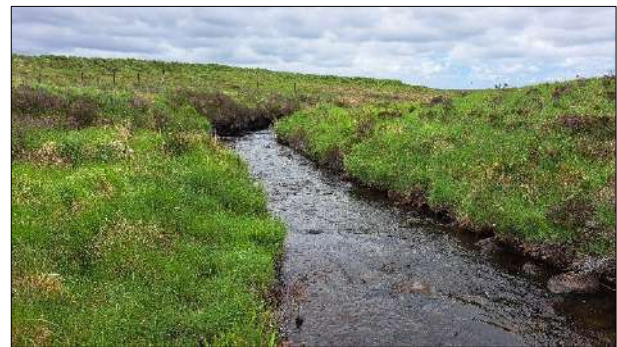
**Plate 8.4** Representative image of survey section Easky\_03

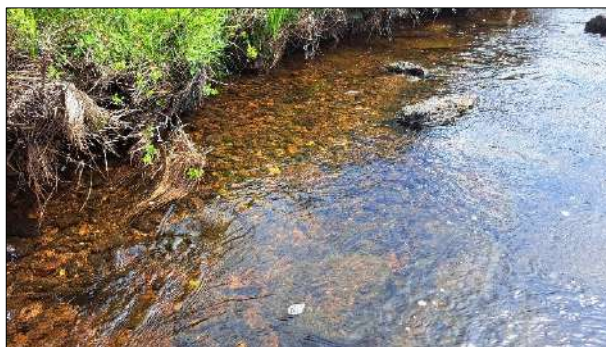
**Plate 8.5** Clean mixed substrata along river margins supporting pearl mussel in Easky\_03

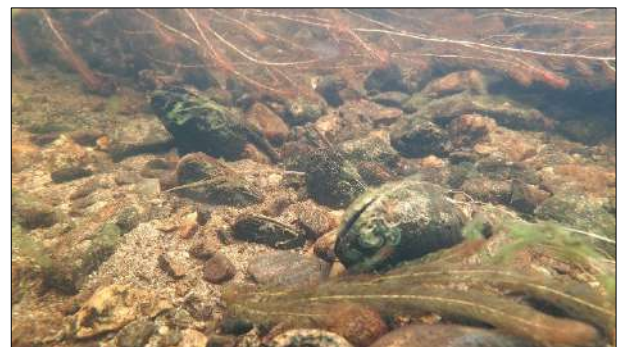
**Plate 8.6** Mussels in stable mixed substrata adjoining *Myriophyllum* bed in Easky\_03

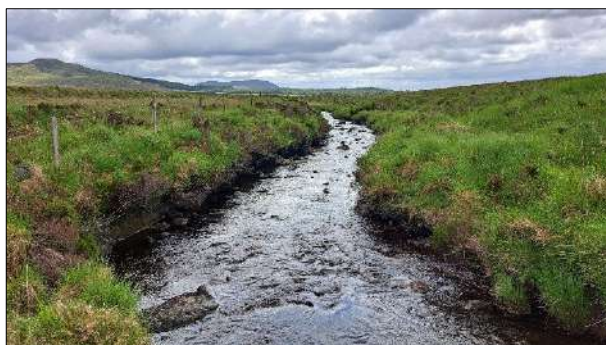
**Plate 8.7** Representative image of survey section Easky\_04

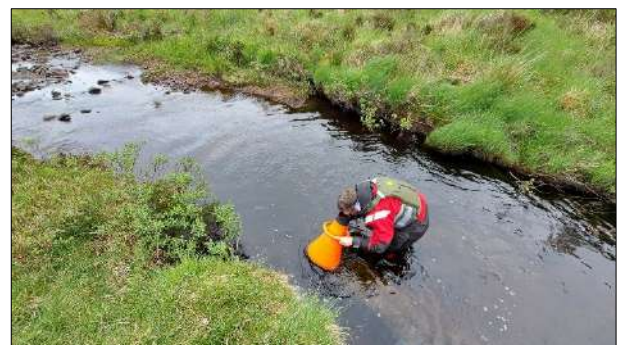
**Plate 8.8** Observing mussels in deeper glide habitat in Easky\_05

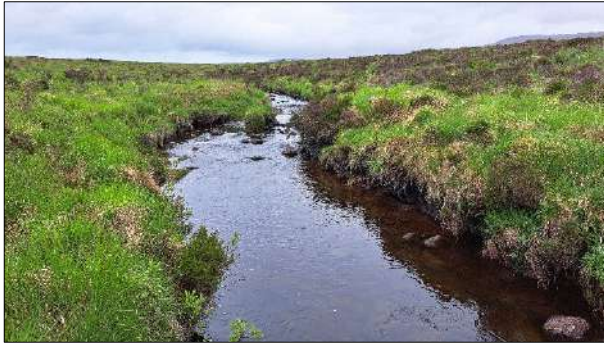
**Plate 8.9** Representative image of survey section Easky\_05

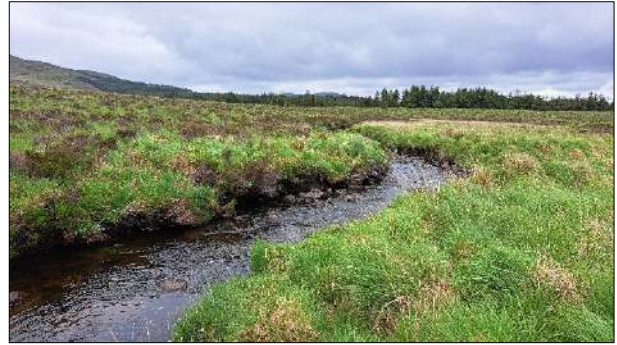
**Plate 8.10** Representative image of survey section Easky\_06

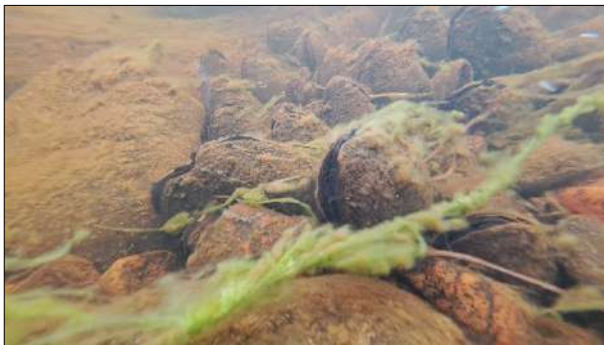
**Plate 8.11** Pearl mussel with high cover of floc & filamentous algae in Easky\_06

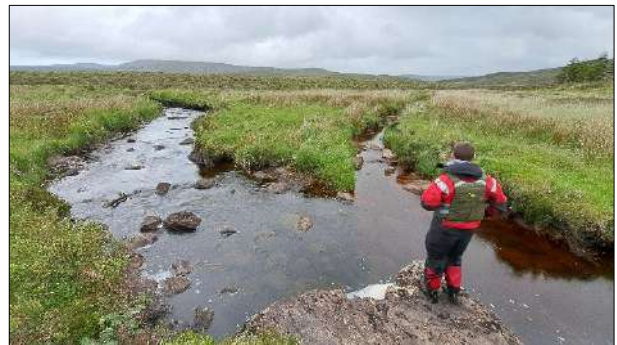
**Plate 8.12** The Meenamaddo River tributary (right) was causing very significant water quality declines (Easky\_06)

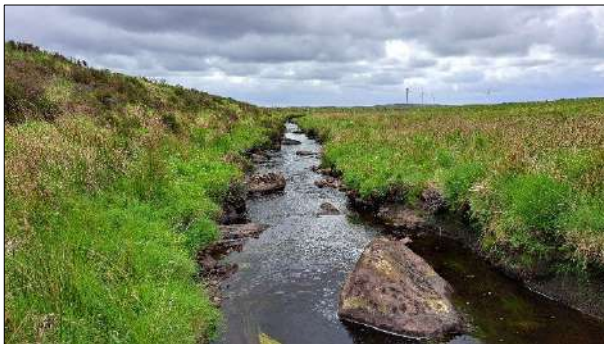
**Plate 8.13** Representative image of survey section Easky\_07

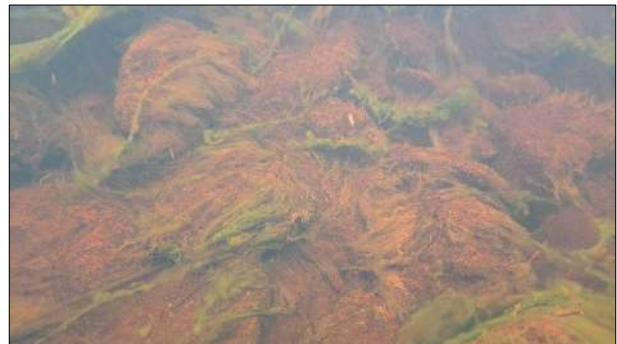
**Plate 8.14** Mussels barely visible under very high cover of floc & filamentous algae downstream of the Meenamaddo River confluence (Easky\_07)

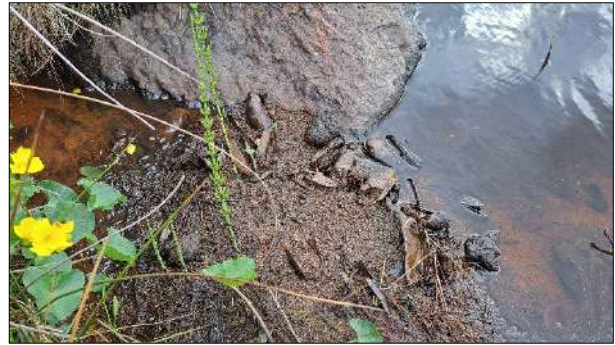
**Plate 8.18** Dead shells in **Easky\_10**

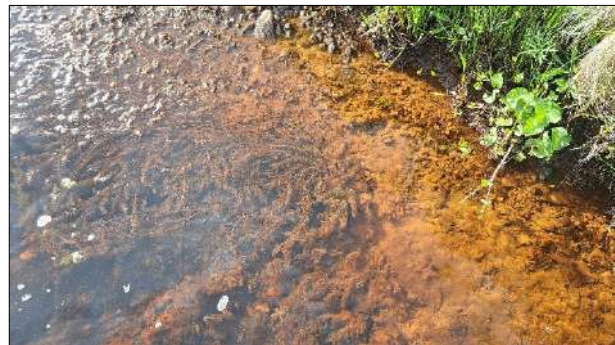
**Plate 8.20** Iron-oxidising bacterial deposits were abundant in section **Easky\_11** (indicative of pH changes)

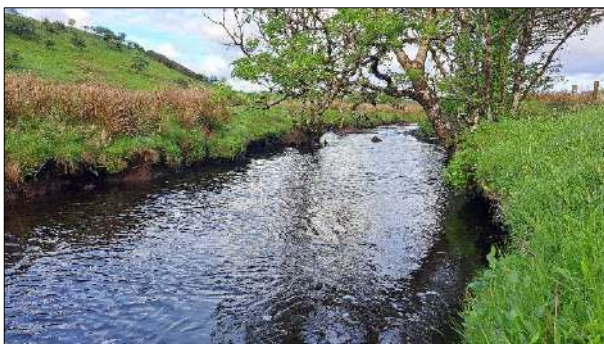
**Plate 8.23** Representative image of survey section **Easky\_14** with undercut banks supporting pearl mussel (right of image)

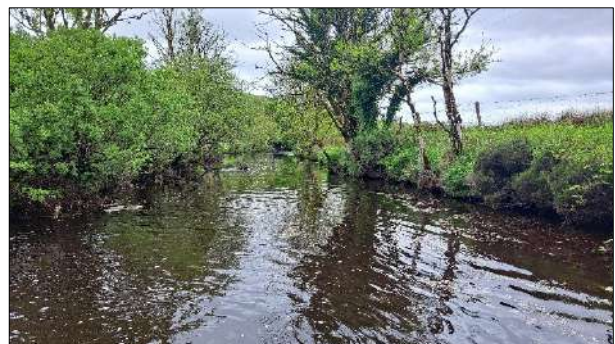
**Plate 8.24** Representative image of survey section **Easky\_15** with valuable riparian shading (left of image, west bank) supporting highly abundant pearl mussel

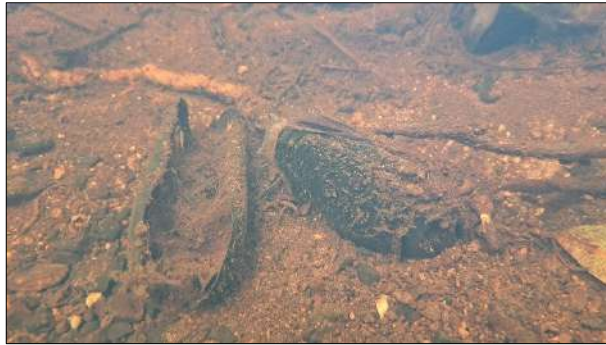
**Plate 8.25** Dead and live pearl mussel in **Easky\_15**

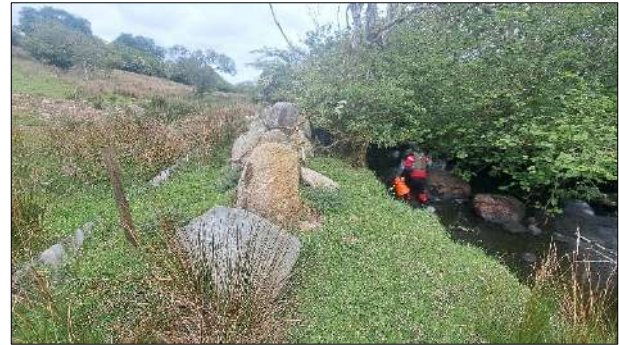
**Plate 8.26** Evidence of historical instream boulder/bed removal works in **Easky\_15**

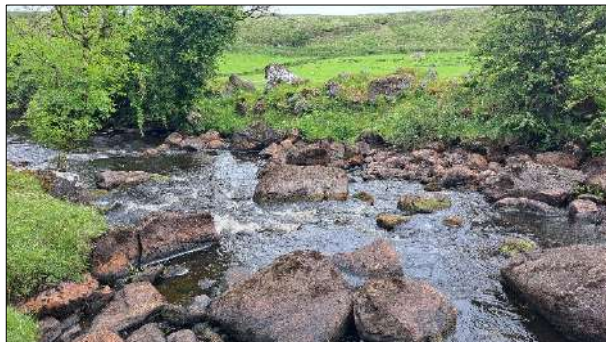
**Plate 8.27** Representative image of survey section **Easky\_16** (higher gradient cascading reach with limited mussel suitability)

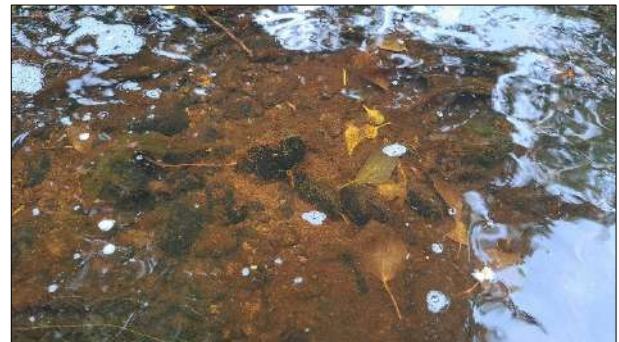
**Plate 8.28** Pearl mussels in very shallow littoral under cover of riparian treeline in **Easky\_16**

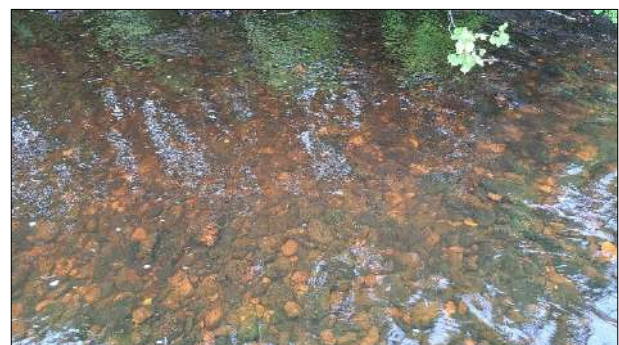
**Plate 8.32** High bed mobility precluded mussels from many areas in **Easky\_19**

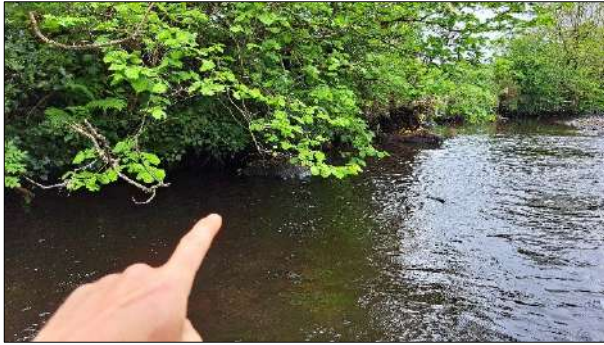
**Plate 8.33** Location of large mussel cluster under cover of riparian treeline in **Easky\_19**
