# CRUMHACH WIND FARM

## GEOTECHNICAL & PEAT STABILITY REPORT

**Document No:**  
**P23240-FT-EGT-XX-RP-GE-0001**

## Crumhach Wind Farm Geotechnical & Peat Stability Assessment Report

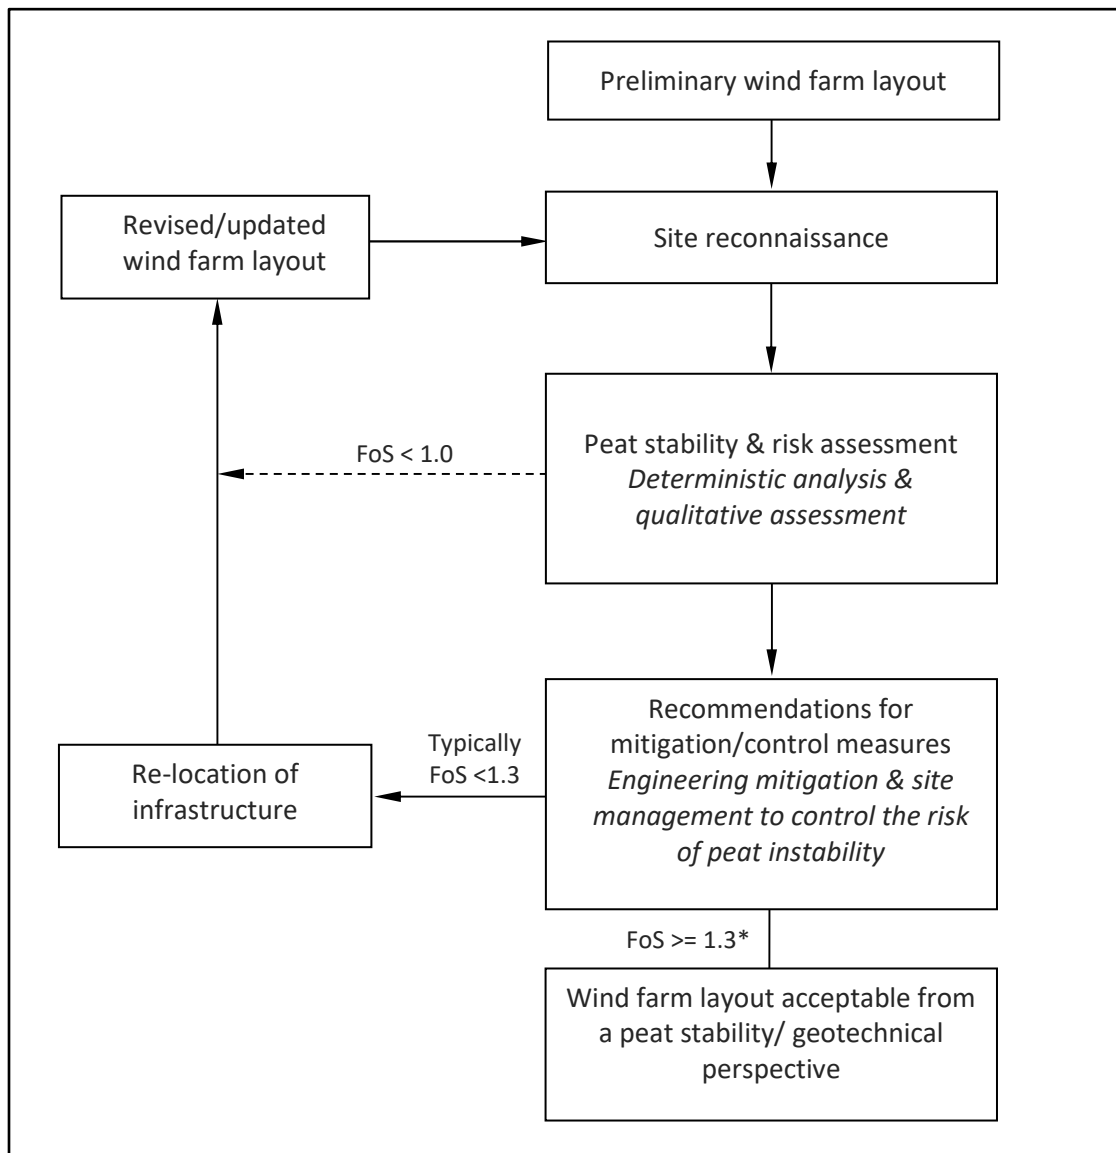
**Figure 2.1: Methodology for Peat Stability Assessment**

A flow diagram showing the general methodology for the peat stability assessment is shown in Figure 2.1. The methodology illustrates the optimisation of the wind farm layout based on the findings from the site reconnaissance and stability analysis and subsequent feedback.

\*An FoS of between 1.0 and 1.3 does not mean that a failure will occur, but that the area requires attention. Mitigation measures can be provided for areas with an FoS of between 1.0 and 1.3 to reduce the risk of failure.

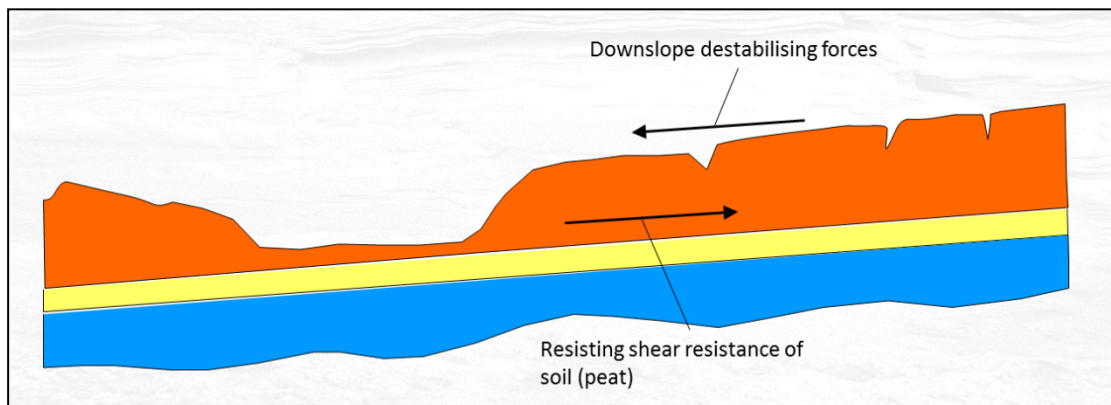
**Figure 2.2: Peat Slope Showing Balance of Forces to Maintain Stability**

The factor of safety is a measure of the stability of a particular slope. For any slope, the degree of stability depends on the balance of forces between the weight of the soil/peat working downslope (destabilising force) and the inherent strength of the peat/soil (shear resistance) to resist the downslope weight, see Figure 2.2.

The factor of safety provides a direct measure of the degree of stability of a slope and is the ratio of the shear resistance over the downslope destabilising force. Provided the available shear resistance is greater than the downslope destabilising force then the factor of safety will be greater than 1.0 and the slope will remain stable. If the factor of safety is less than 1.0 the slope is unstable and liable to fail. The acceptable factor of safety for assessment purposes is 1.3 (BS6031, 1981).

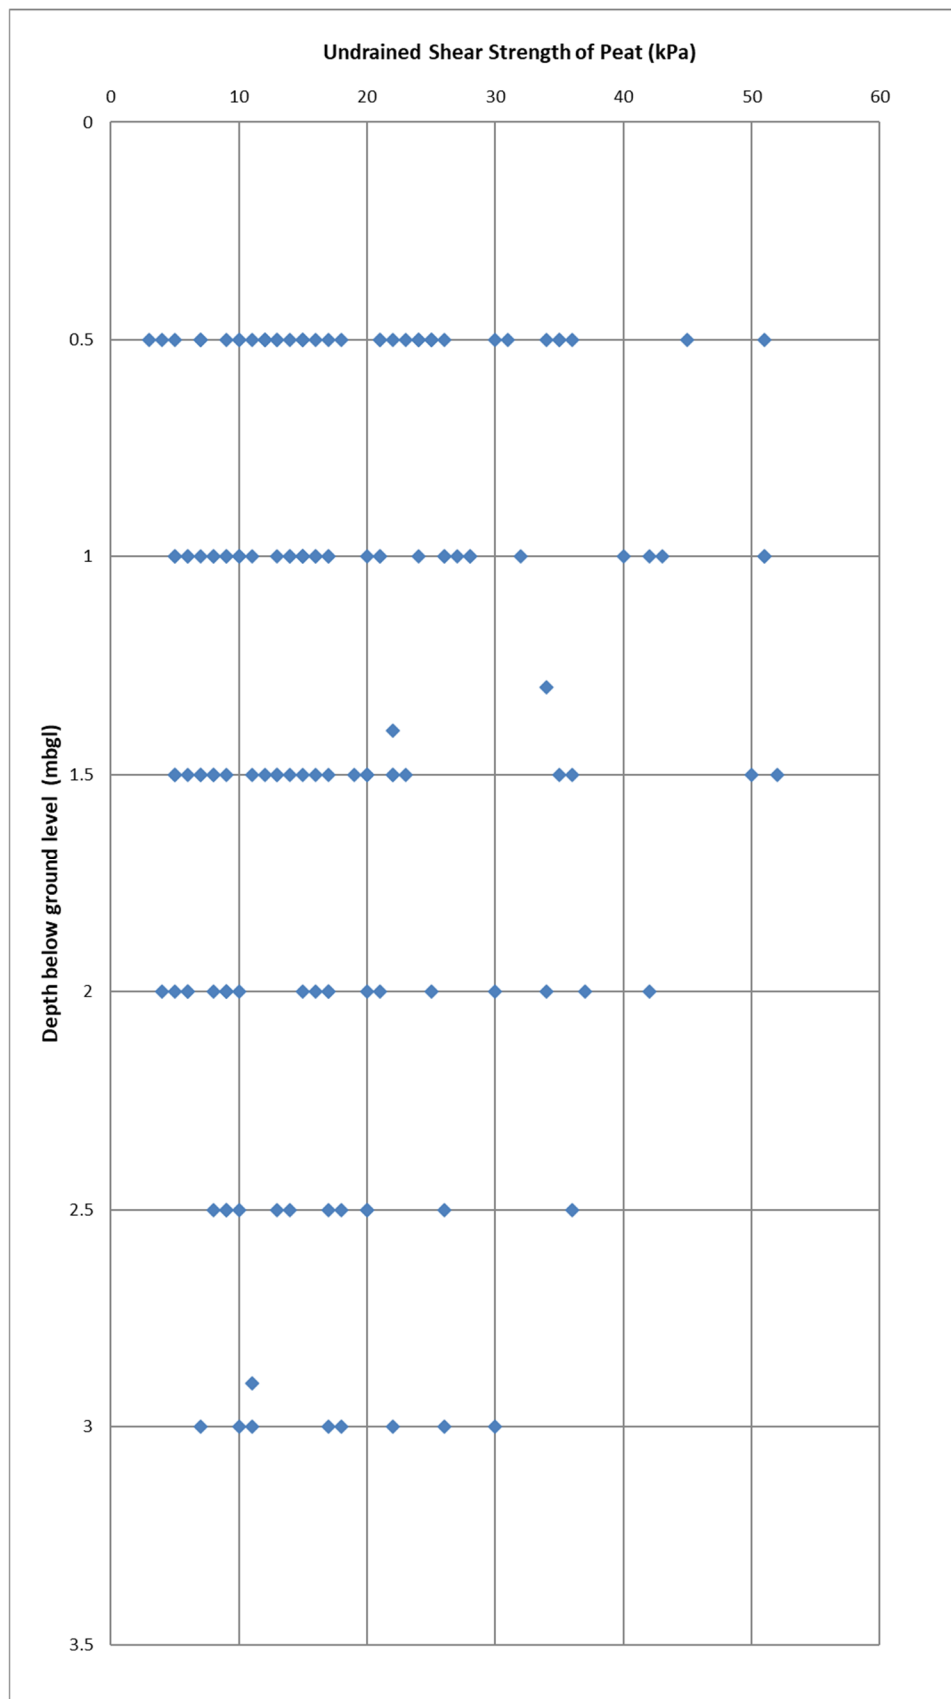
**Figure 6.1: Undrained Shear Strength ( $c_u$ ) Profile for Peat with Depth**

Peat strength at sites of known peat failures (assuming undrained loading failure) are generally very low, for example the undrained shear strength at the Derrybrien failure (AGEC, 2004) as derived from back-analysis, was estimated at 2.5kPa. The recorded undrained strength at the Proposed Wind Farm is significantly greater than the lower bound values for Derrybrien indicating that there is no close correlation to the peat conditions at the Derrybrien site and that there is significantly less likelihood of failure on the Proposed Wind Farm.

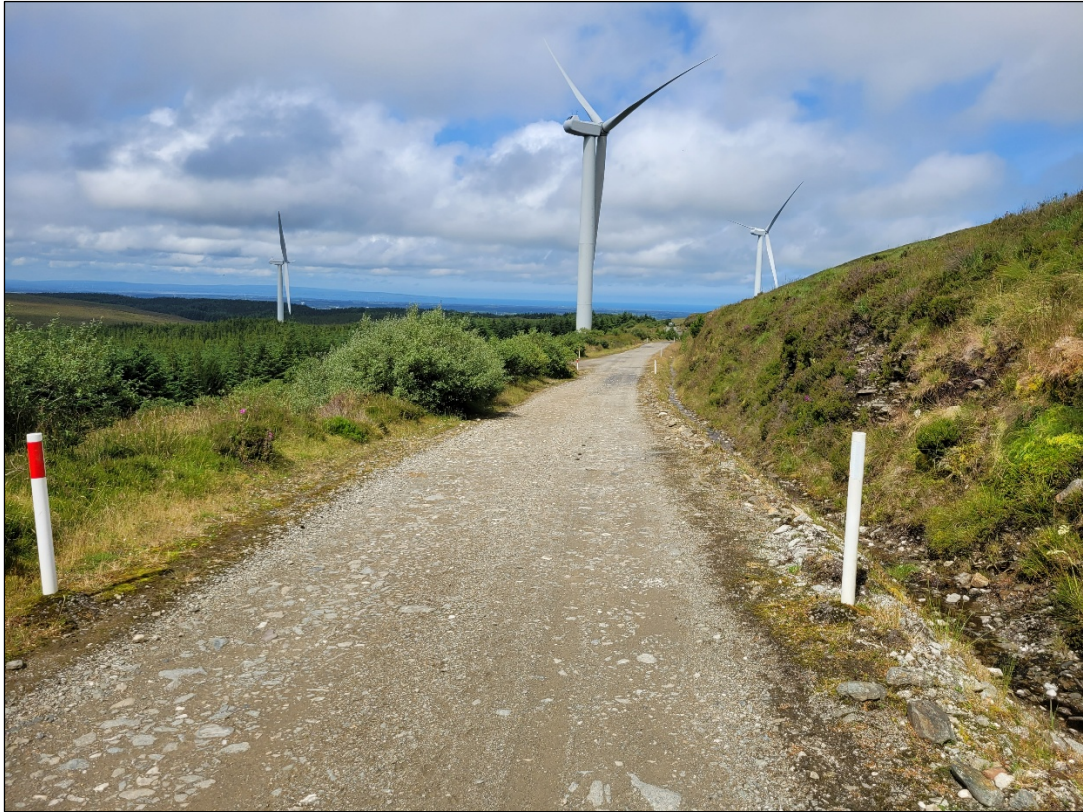
Existing founded access road on east side of site, close to BP3

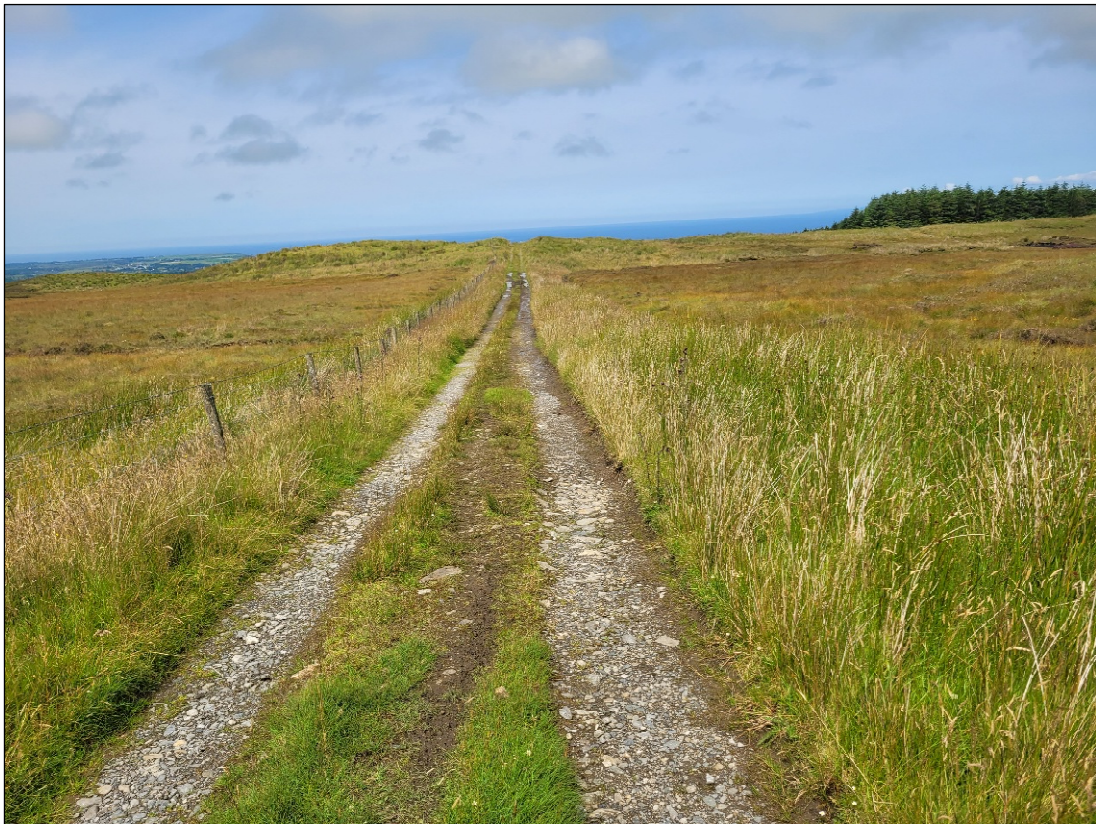
Existing floating access road on site, looking south towards T12

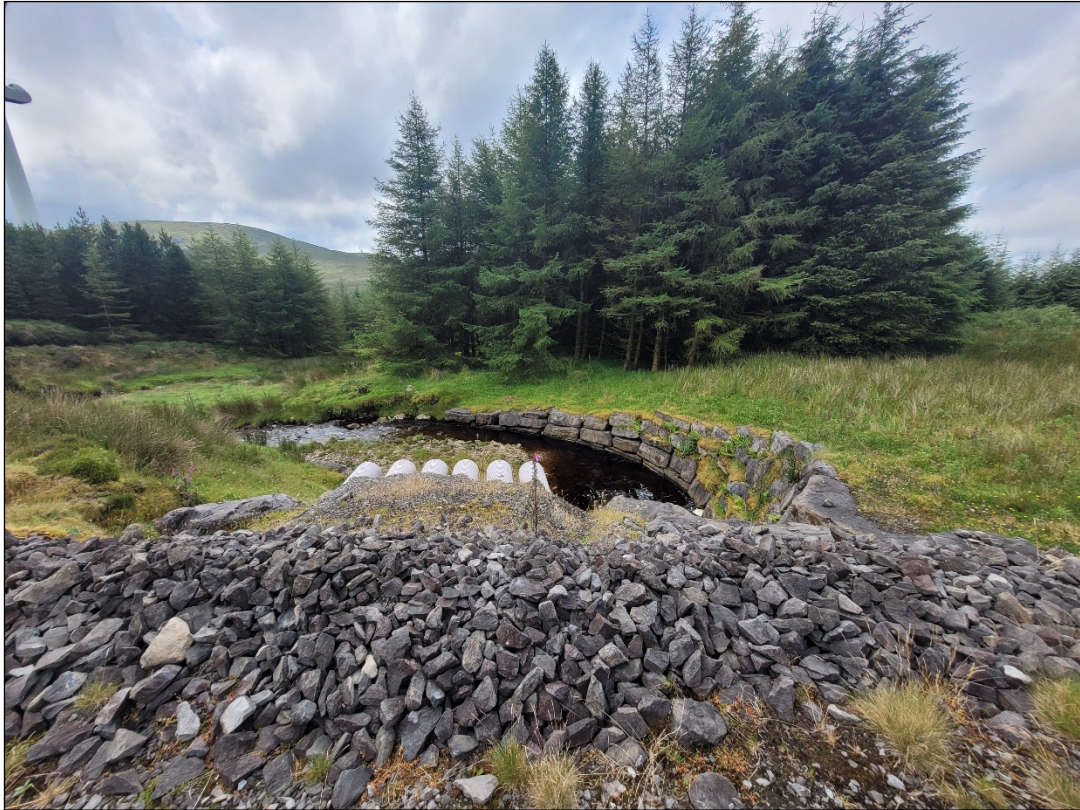
Water crossing on existing wind farm, east of BP3

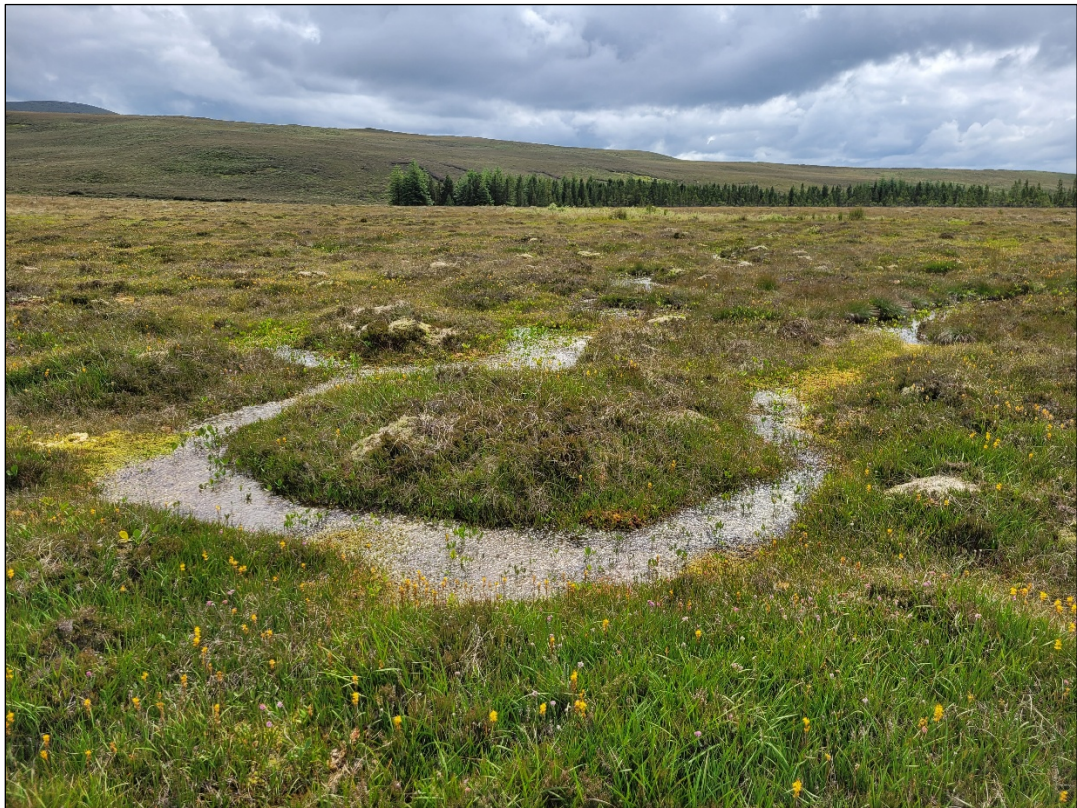
Area of open peatland and bog pools to the south of T12

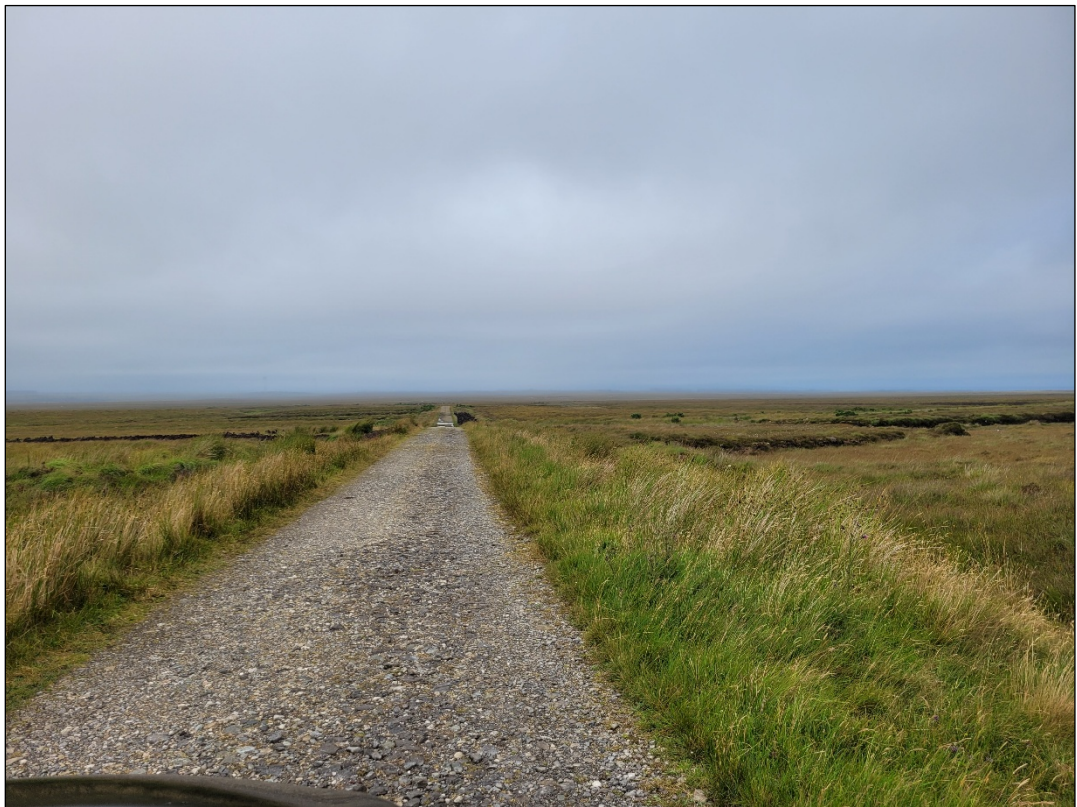
Existing floating road in western section of the Site, close to T05

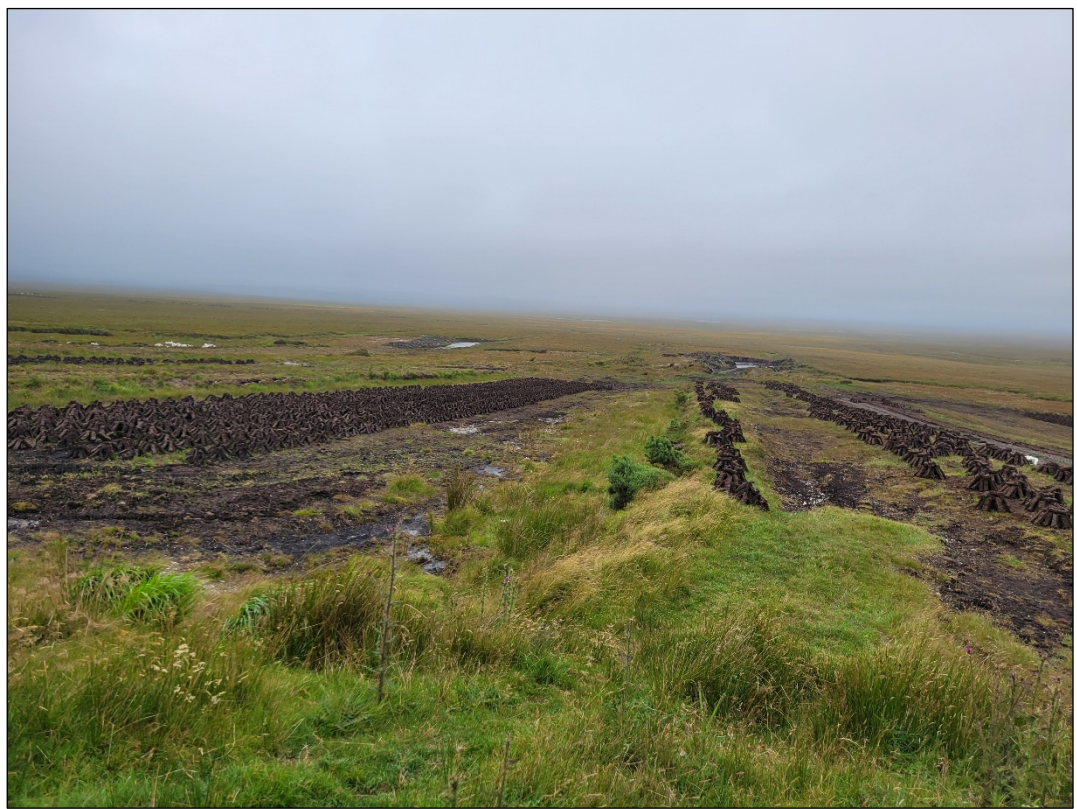
Area of worked peat in western section of Site, south of T01

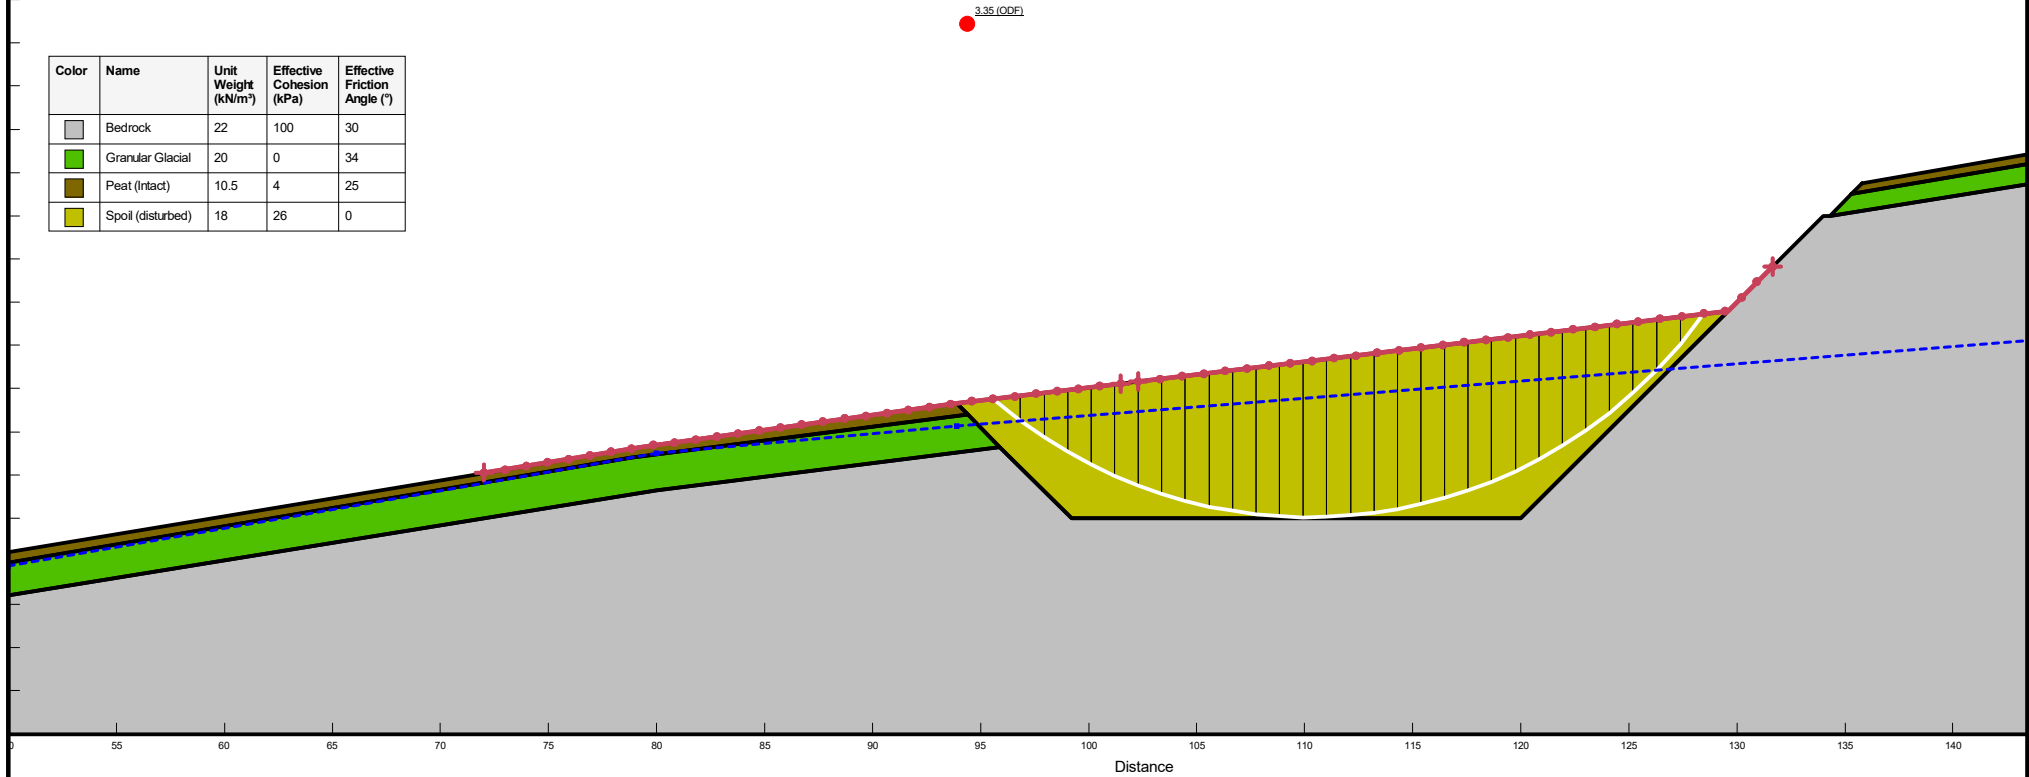
Borrow Pit 2 DR.gsz

Slope Stability (DA1C1)

2.73 (CDF)

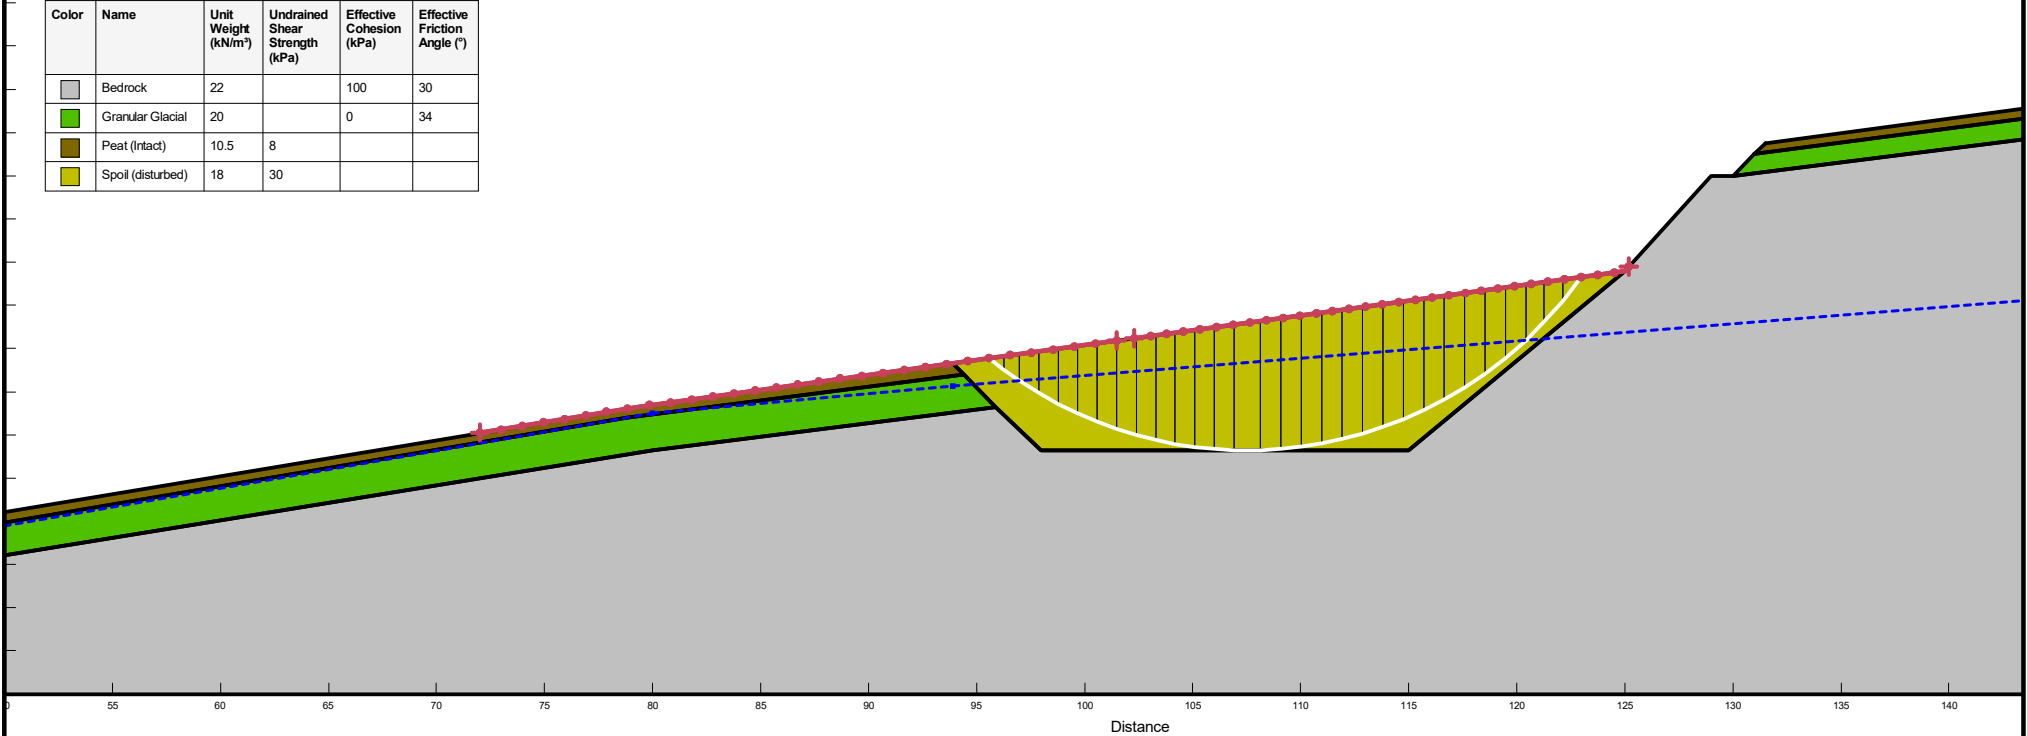
Borrow Pit 3 UD.gsz

Slope Stability (DA1C1)

2.95 (ODF)
