## **Stage 1 Road Safety Audit & Quality Audit including Walking and Cycle Audits**

**Hodson Bay,  
Waterfront Project**

***Hodson Bay, Barrymore,  
Co. Roscommon***

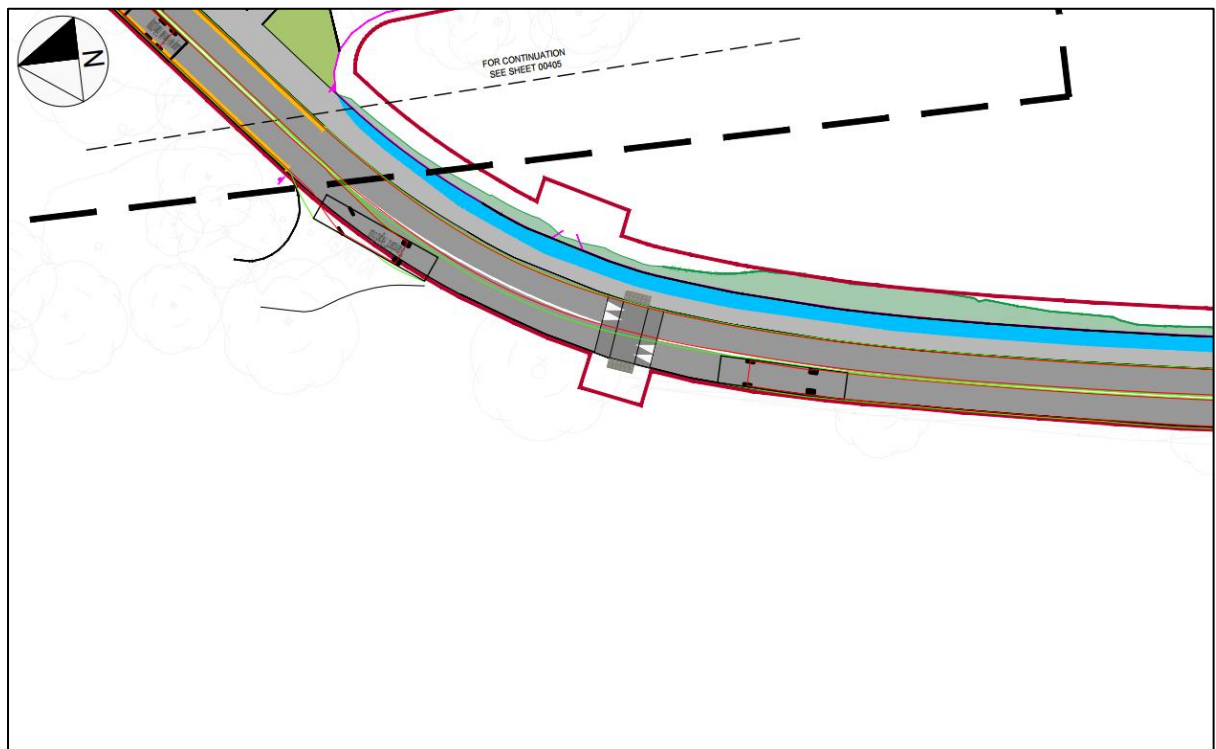
**Figure 2 – Example Swept Path Analysis Bus Sheet 6 of 9  
(31022-CIV-XX-XX-D-C-00400-Hodson Bay Vehicle Tracking Drawings)**

While the proposed narrowing of the carriageway is expected to reduce vehicle speeds, larger vehicles, particularly buses, may overrun the centreline on tight bends due to their swept path and rear overhang. This could result in opposing vehicles being forced to take evasive action or lead to side-swipe or head-on collisions.

The carriageway widths should be reviewed, in particular at tight bends using swept path analysis. Where necessary, the road carriageway should be widened locally to accommodate the largest anticipated vehicle, while maintaining the traffic calming objectives of the scheme.

| Paragraph No. in Safety Audit Report | To be Completed by Designer | | | To be completed by Audit Team Leader |
|---|---|---|---|---|
| 3.1 | Yes | No | The proposed narrowing forms an integral part of the traffic calming strategy and is intended to reduce vehicle speeds within the scheme area. Vehicle tracking has been undertaken to confirm that two 15 m coaches can safely pass at all proposed carriageway narrowing locations. The existing sections of the L2020 that are outside the scope of the proposed works and are not being altered and will remain unchanged. Accordingly, the proposed layout is considered capable of accommodating the anticipated vehicle movements while maintaining the objectives of the scheme. | Yes |

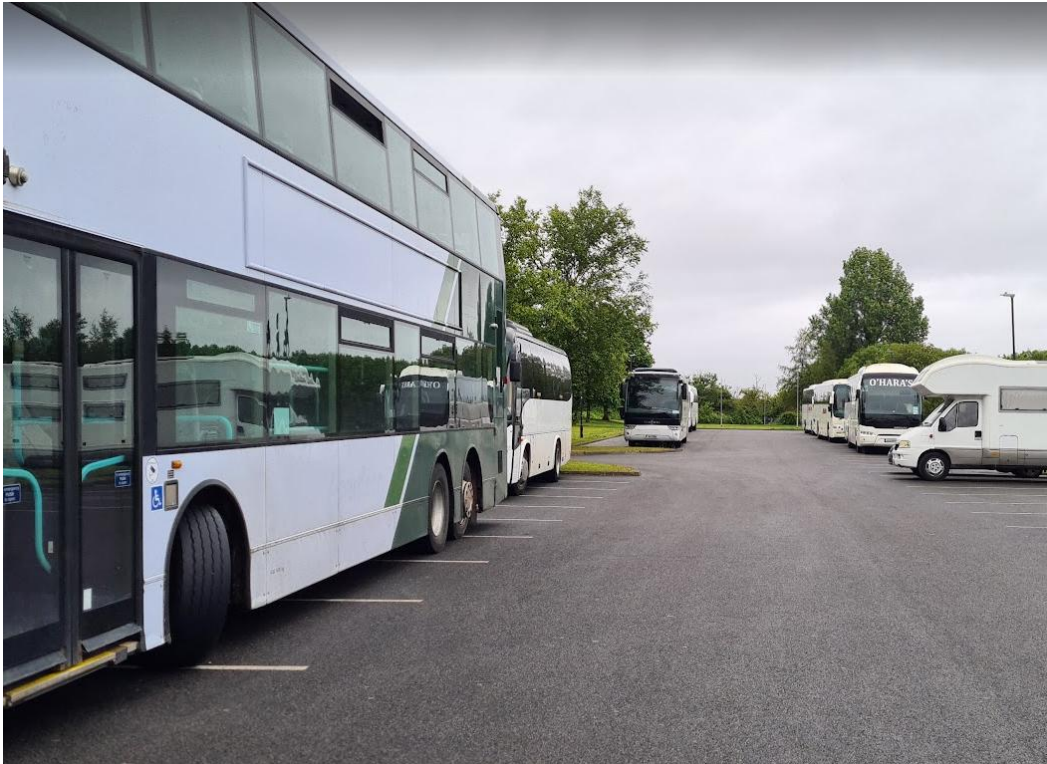
***Figure 3 – Various Bus Sizes noted on Site***

Swept path analysis has been undertaken using a standard bus, however, it is not clear that the largest anticipated vehicle expected to use the route has been assessed, as large 3-axle buses were seen on site. If a larger design vehicle cannot safely negotiate the layout, it may overrun opposing traffic lanes, footways or verges, resulting in conflicts with other road users and resulting in collisions.

Swept path analysis should be undertaken using the largest anticipated vehicle expected to regularly use the route. Where necessary, the road layout should be updated to ensure the largest anticipated vehicle can safely negotiate the alignment without encroaching onto opposing traffic lanes, footways or other areas intended for vulnerable road users.

| Paragraph No. in Safety Audit Report | To be Completed by Designer | | | To be completed by Audit Team Leader |
|---|---|---|---|---|
| 3.2 | Yes | Yes | | |

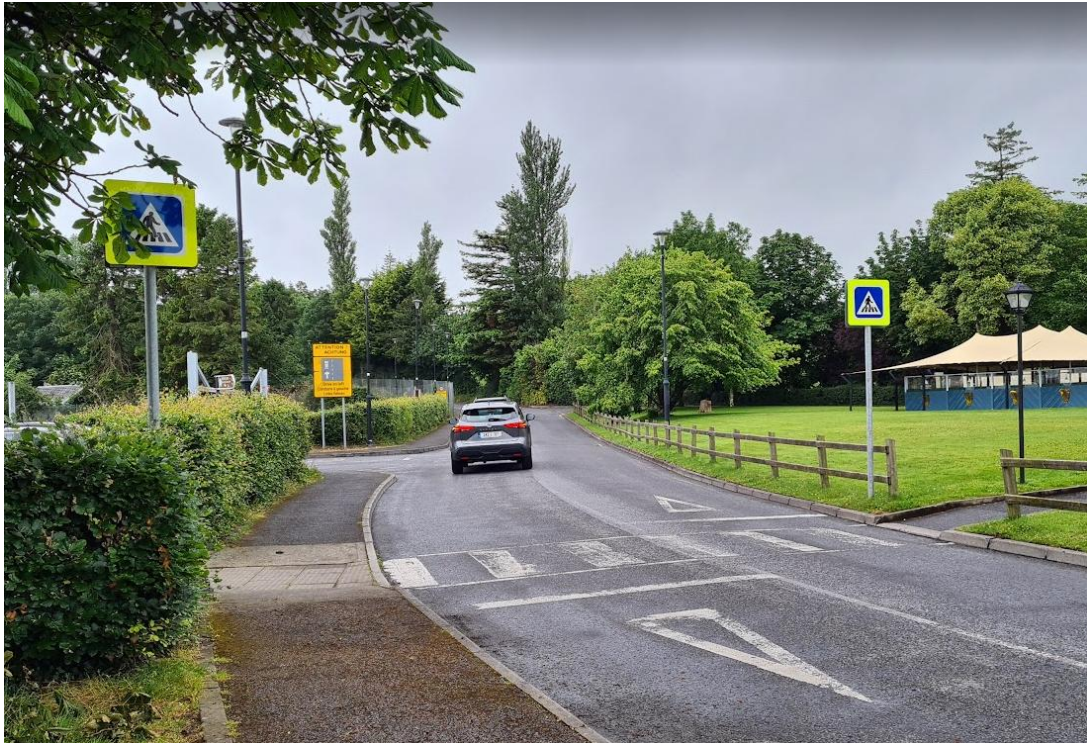
**Figure 4 – Existing Zebra Crossings**

It is unclear whether the existing zebra crossings are to be retained or replaced with uncontrolled crossing points. If the existing zebra crossings are removed, regular users may continue to expect pedestrian priority at these locations based on their familiarity with the existing layout. This could result in pedestrians entering the carriageway when drivers do not anticipate the need to yield, resulting in pedestrian-vehicle collisions.

The existing zebra crossings should be retained as part of the proposed layout to maintain pedestrian priority and ensure continuity for regular site users. Consideration should also be given to providing zebra crossings across the L2020, instead of uncontrolled crossings, to provide a consistent pedestrian crossing treatment throughout the scheme.

| Paragraph No. in Safety Audit Report | To be Completed by Designer | | | To be completed by Audit Team Leader |
|---|---|---|---|---|
| 3.3 | Yes | Yes | | |

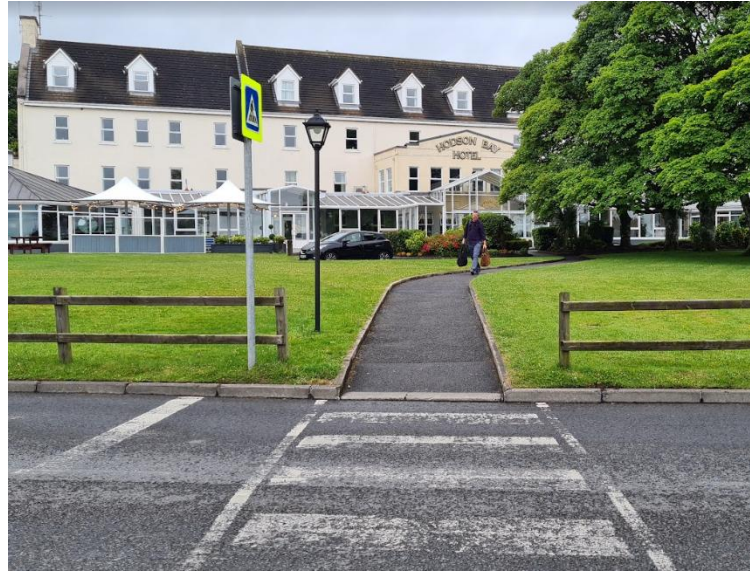
**Figure 5 – Existing Footpath**

The existing footpath and pedestrian crossing are insufficiently wide to accommodate the anticipated pedestrian demand. The proposed raised crossing provides a flat-top width of only 1.6 m, which may result in pedestrians stepping onto the ramped sections when crossing in groups or passing one another, resulting in trips and falls.

The flat-top section of the raised crossing should be widened, and the footpath should be widened locally at the crossing to provide sufficient space for pedestrians to cross safely and comfortably.

| Paragraph No. in Safety Audit Report | To be Completed by Designer | | | To be completed by Audit Team Leader |
|---|---|---|---|---|
| 3.4 | Yes | Yes | | |

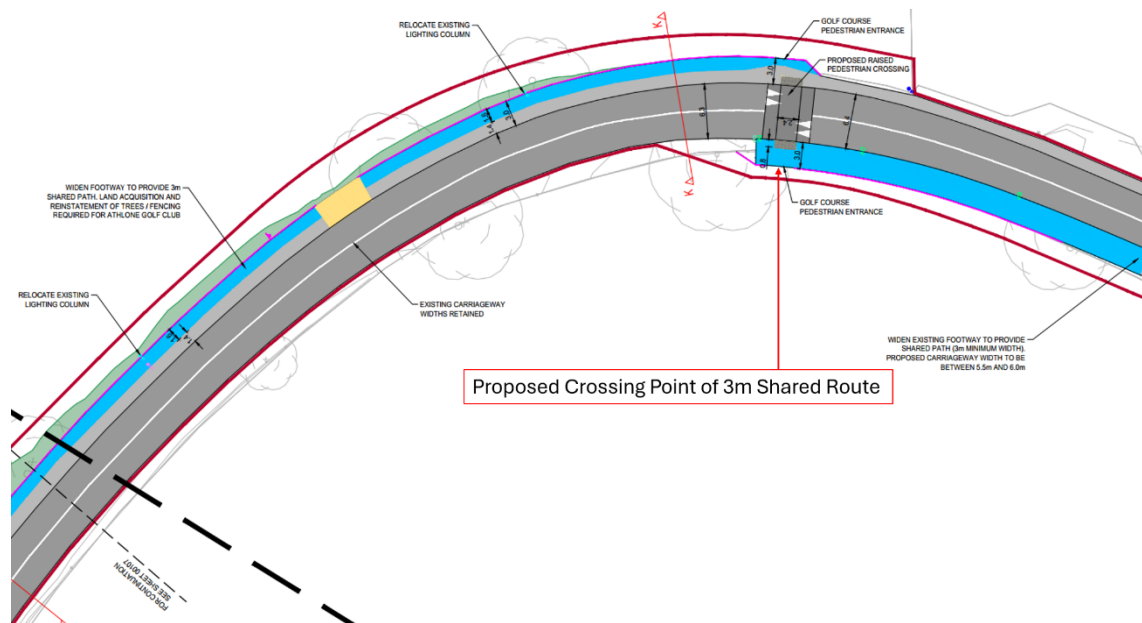
**Figure 7 – Existing Zebra Crossings**

The proposed crossing point forms part of the 3.0m wide pedestrian / cycle route serving the development. However, it is unclear whether the proposed crossing provides an appropriate level of priority for both pedestrians and cyclists. In addition, visibility of the crossing on the vehicle approach appears restricted, which may reduce driver awareness of crossing users. This could result in conflicts between vehicles, pedestrians and cyclists, resulting in a collision.

The proposed crossing arrangement should be reviewed to determine whether a controlled crossing, such as a Zebra or Toucan crossing, is more appropriate. The crossing should safely accommodate both pedestrians and cyclists, reflecting the function of the active travel route. Given the restricted approach visibility, appropriate advance warning signage and road markings should also be provided to improve driver awareness of the crossing.

| Paragraph No. in Safety Audit Report | To be Completed by Designer | | | To be completed by Audit Team Leader |
|---|---|---|---|---|
| 3.5 | No | No | The proposed crossing has been assessed in the context of anticipated pedestrian and cyclist demand, vehicle flows, visibility and proposed operating speeds, subject to approval of the Roads Authority. The crossing is located within a traffic-calmed environment incorporating raised crossing facilities and speed-reduction measures. Available visibility exceeds the required stopping sight distance for the design speed and vehicle movements are expected to occur at low speeds. Consequently, a controlled crossing is not considered necessary or proportionate at this location, and the proposed raised | Yes |

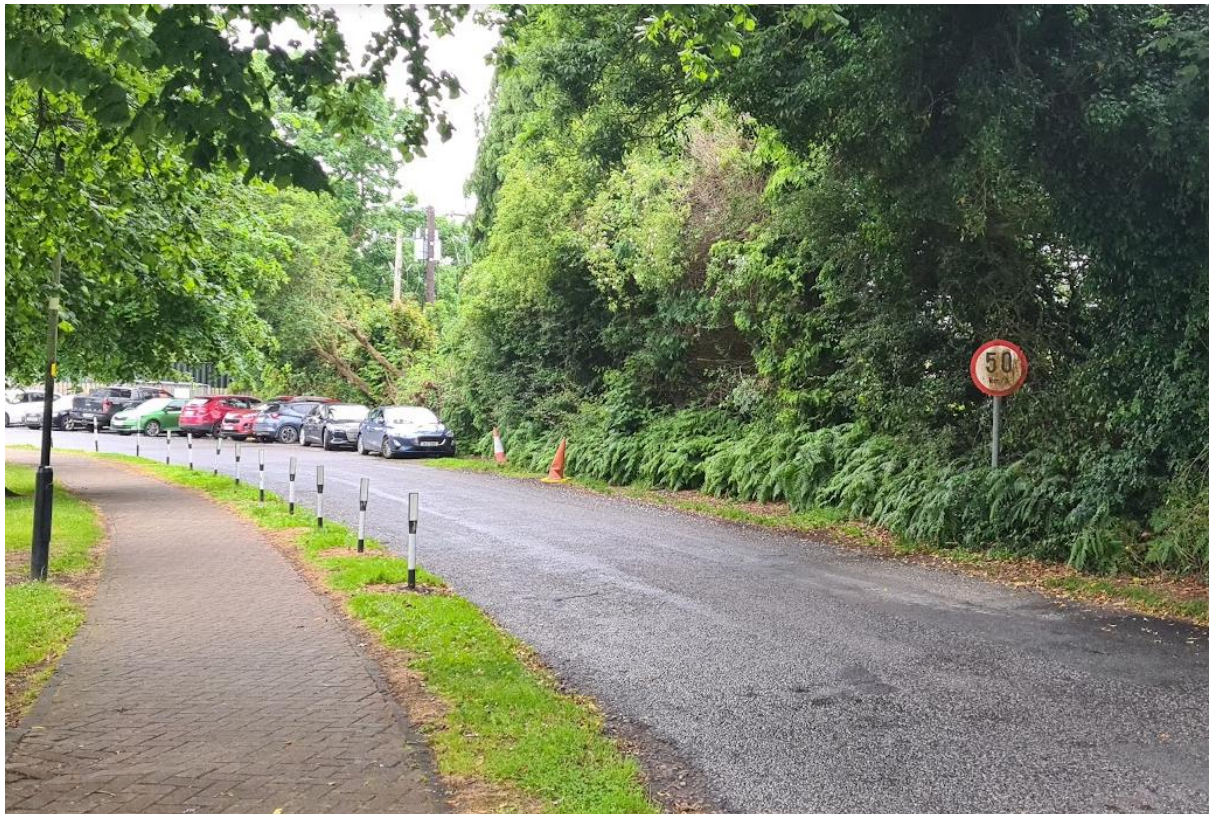
**Figure 8 – Existing Posted Speed Limit**

A posted speed limit of 50 km/h is provided on the internal access road from the northern car park towards the hotel. Given the high levels of pedestrian activity, the proposed increase in parking provision, multiple pedestrian crossing points and the presence of community facilities, this speed limit appears excessive for the function of the road. This may encourage some drivers to travel at excessive speeds, increasing the risk and severity of collisions with pedestrians and other road users.

The posted speed limit should be reviewed to reflect the function of the road and the high levels of pedestrian activity. Where appropriate, the existing 50 km/h speed limit should be removed and replaced with a lower speed limit.

| 3.6 | Yes | Yes | The concern regarding the existing speed limit is accepted. Consideration will be given to a review of the existing speed limit on the L2020 in light of the proposed development, increased pedestrian activity and enhanced public realm environment. However, any amendment to the statutory speed limit is subject to the approval of the Roads Authority and is outside the direct control of this project. Notwithstanding this, the proposed scheme incorporates traffic calming measures, raised crossings and carriageway narrowing features which are intended to encourage lower vehicle speeds and improve safety for all road users | |

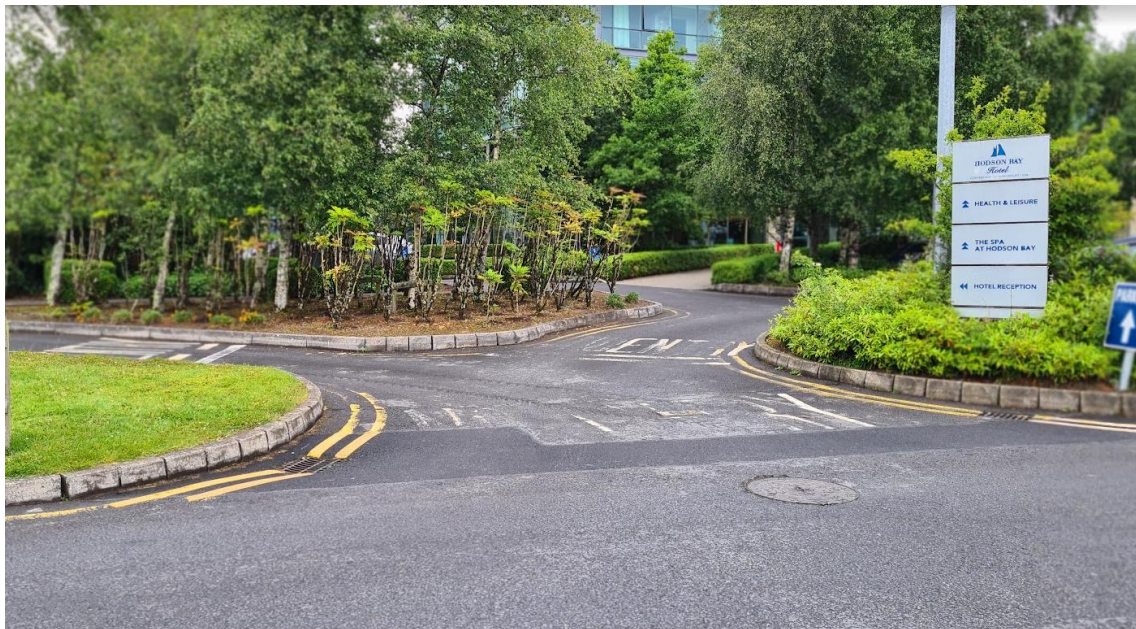
**Figure 9 – Existing Hotel Exit**

The proposed development includes an expanded car park; however, the existing directional signage appears inadequate and potentially confusing. In particular, there is no clear signage directing motorists to the hotel reception at the site entrance, while a sign for the hotel reception is provided at the exit. This inconsistency may cause driver uncertainty, resulting in sudden braking, late manoeuvres or erratic vehicle movements, resulting in rear-end and other vehicle collisions. Furthermore, the existing NO ENTRY road markings are worn and faded away.

A comprehensive wayfinding strategy should be provided throughout the site. Clear and consistent directional signage should be installed at all decision points, particularly at the hotel entrance and exit, to guide motorists safely to the hotel reception, new car parking areas and other key destinations, thereby reducing driver confusion and the potential for collisions.

| 3.7 | Yes | No | A comprehensive wayfinding strategy has been developed as part of the scheme and the no-entry road markings will be reinstated. However, the existing sign identified by is in private ownership. The safety concern will be brought to the attention of Hodson Bay Hotel for their consideration. | Yes |

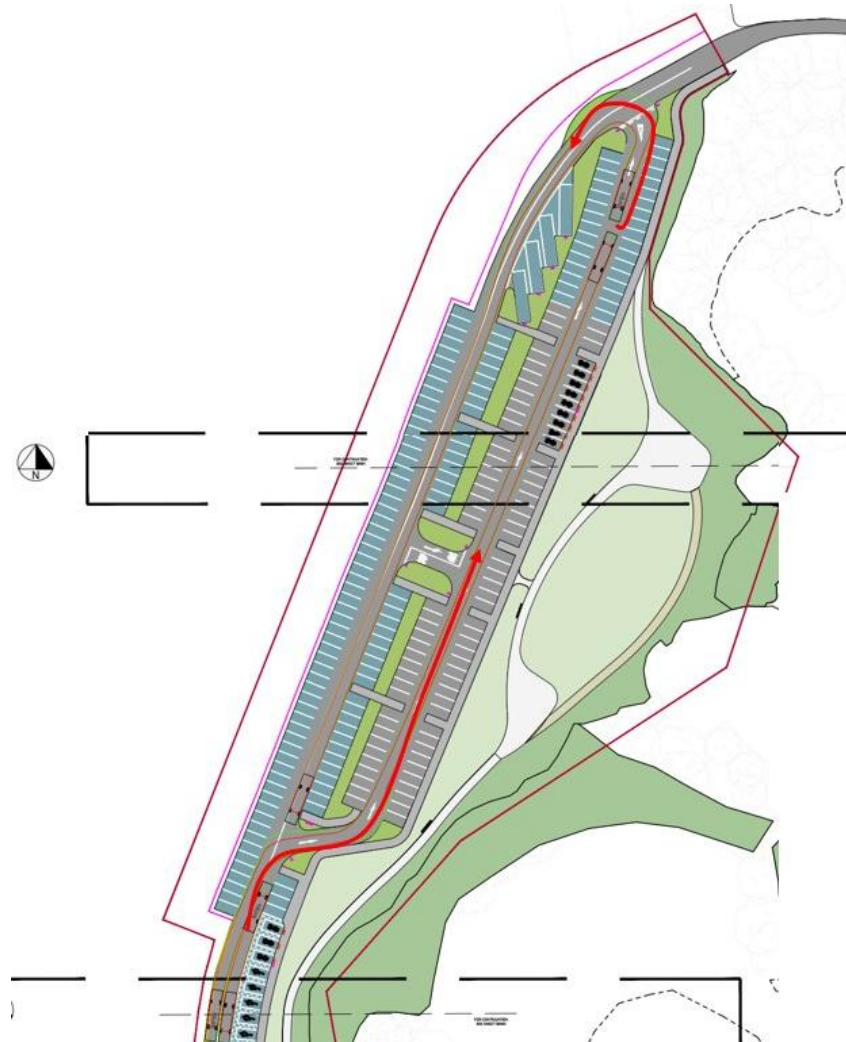
**Figure 10 – Proposed Bus Route**

The proposed angled bus parking spaces can only be accessed if buses circulate through the site in an anti-clockwise direction. Should bus drivers fail to follow this route, there are limited opportunities for buses to turn around within the site, which may result in unsafe reversing or turning manoeuvres, increasing the risk of collisions with other vehicles, pedestrians and site infrastructure.

A comprehensive bus wayfinding strategy should be implemented throughout the site. Clear and consistent directional signage should be provided at all decision points to direct buses along the intended circulation route and safely to the designated bus parking areas. The internal layout should also be reviewed to ensure buses can safely manoeuvre in the event of driver error or missed turns.

| 3.8 | Yes | Yes | | |

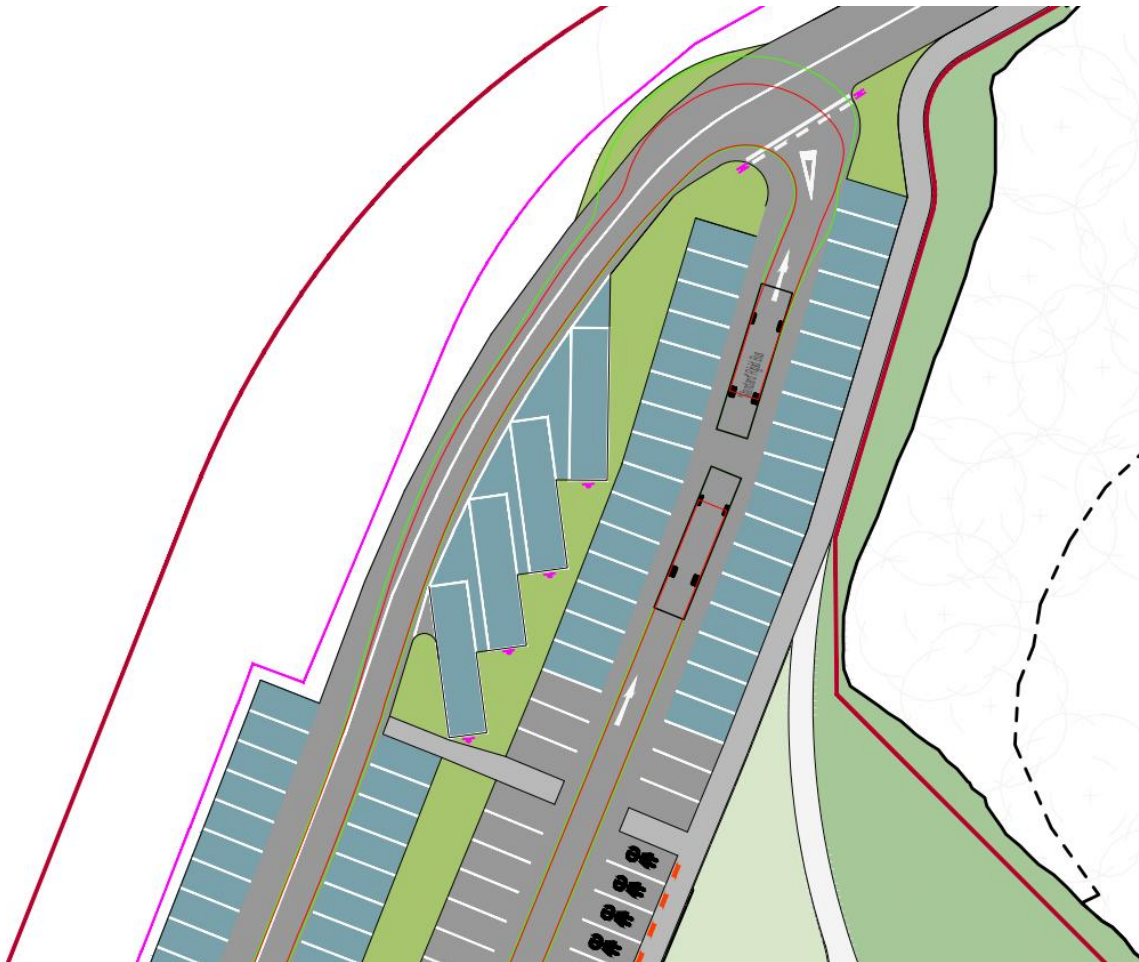
**Figure 11 – Proposed Bus Parking**

No dedicated pedestrian route is shown for passengers alighting from the bus parking area to access the main pedestrian network or site facilities. As a result, bus passengers may walk through areas used by moving vehicles, increasing the risk of conflicts and collisions between pedestrians and vehicles.

A continuous, safe and clearly defined pedestrian route should be provided from the bus parking area to the main building entrances and pedestrian network.

| 3.9 | No | No | Dedicated coach pick-up and drop-off facilities are proposed immediately adjacent to the Watersports Pavilion and associated amenities. As such, coach passengers will be able to embark and disembark in close proximity to their destination without the need to traverse vehicular circulation areas. The northern coach parking spaces are intended solely for coach parking purposes, with no proposal for passengers to embark/disembark at this location. Consequently, the potential for pedestrian-vehicle conflict associated with passengers walking from the coach parking area to site facilities is significantly reduced. The proposed arrangement is therefore considered appropriate for the anticipated coach operations | Yes |

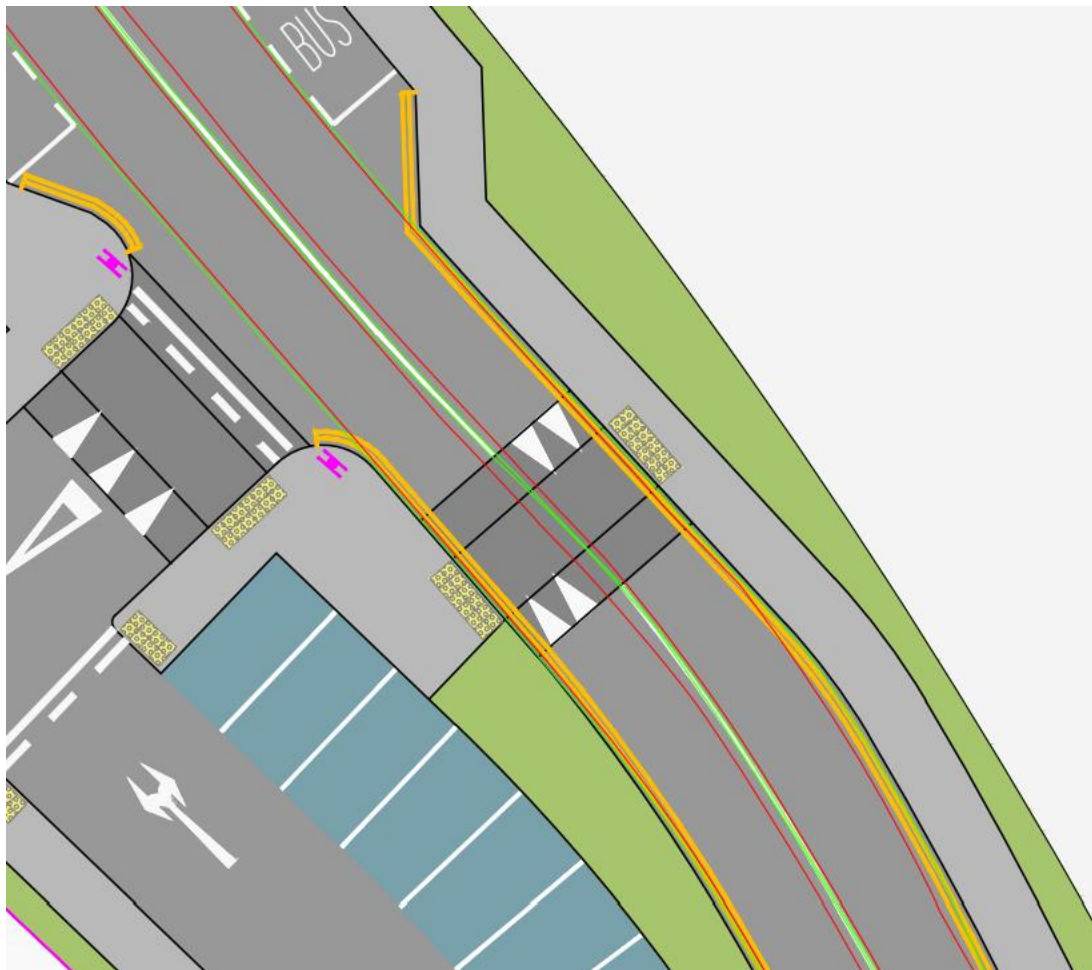
**Figure 12 – Proposed Raised Pedestrian Crossing**

A significant number of buses were observed using the site. The proposed raised pedestrian crossings appear to incorporate relatively short flat-top tables. This may result in buses experiencing excessive vertical deflection when traversing the crossings, leading to discomfort for passengers and potentially encouraging drivers to brake sharply before, and accelerate after the crossings.

The raised pedestrian crossings should incorporate a minimum 6.0 m flat-top table to provide a smoother transition for buses while maintaining effective speed reduction and pedestrian priority.

| 4.1 | Yes | Yes | | |

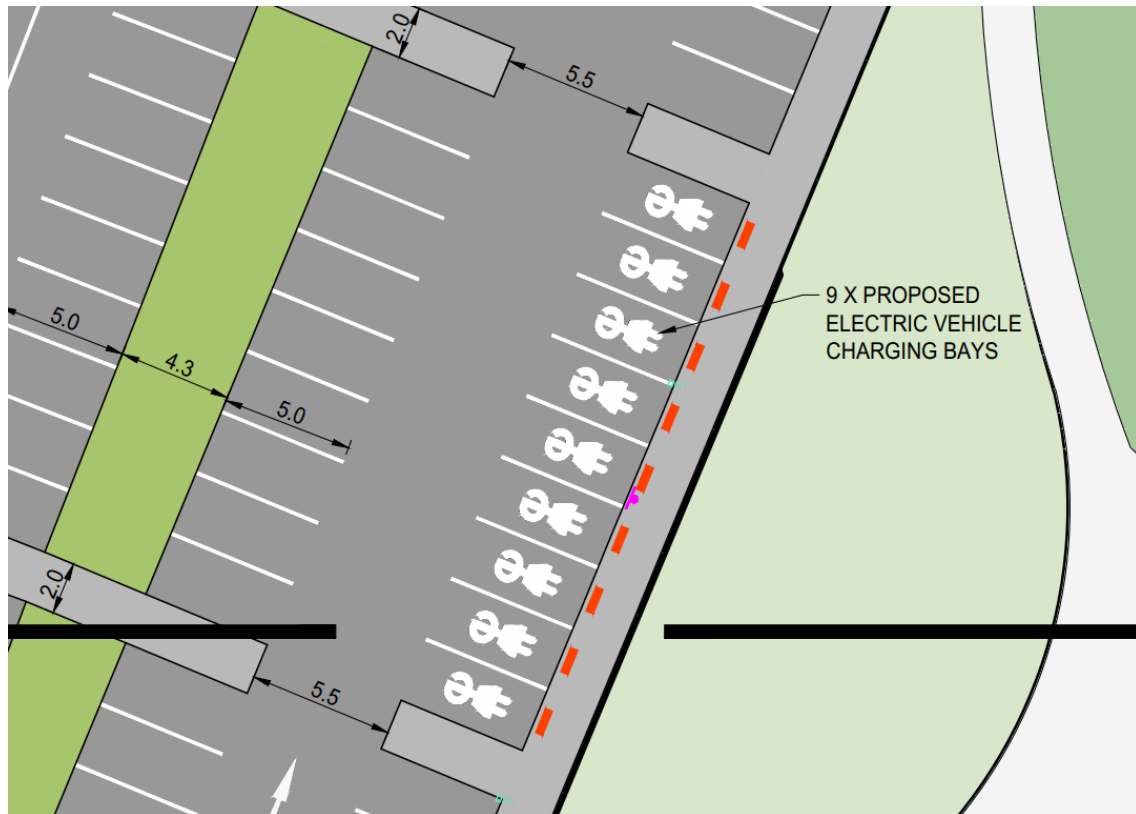
**Figure 13 – EV Charging Bays (Sheet 1 of 9)**

The proposed development includes a number of EV charging spaces; however, the associated charging equipment appears to be located within the pedestrian footway. EV charging units are often substantial in size, and charging cables may extend across pedestrian routes during use. This could obstruct the footway and increase the risk of trips and falls, particularly for visually impaired pedestrians and wheelchair users.

The EV charging equipment should be located outside the pedestrian desire line, with dedicated space provided adjacent to the parking bays to ensure the footway remains clear and unobstructed. The layout should be designed to minimise the potential for charging cables to encroach onto pedestrian routes during operation.

| 4.2 | Yes | Yes | | |

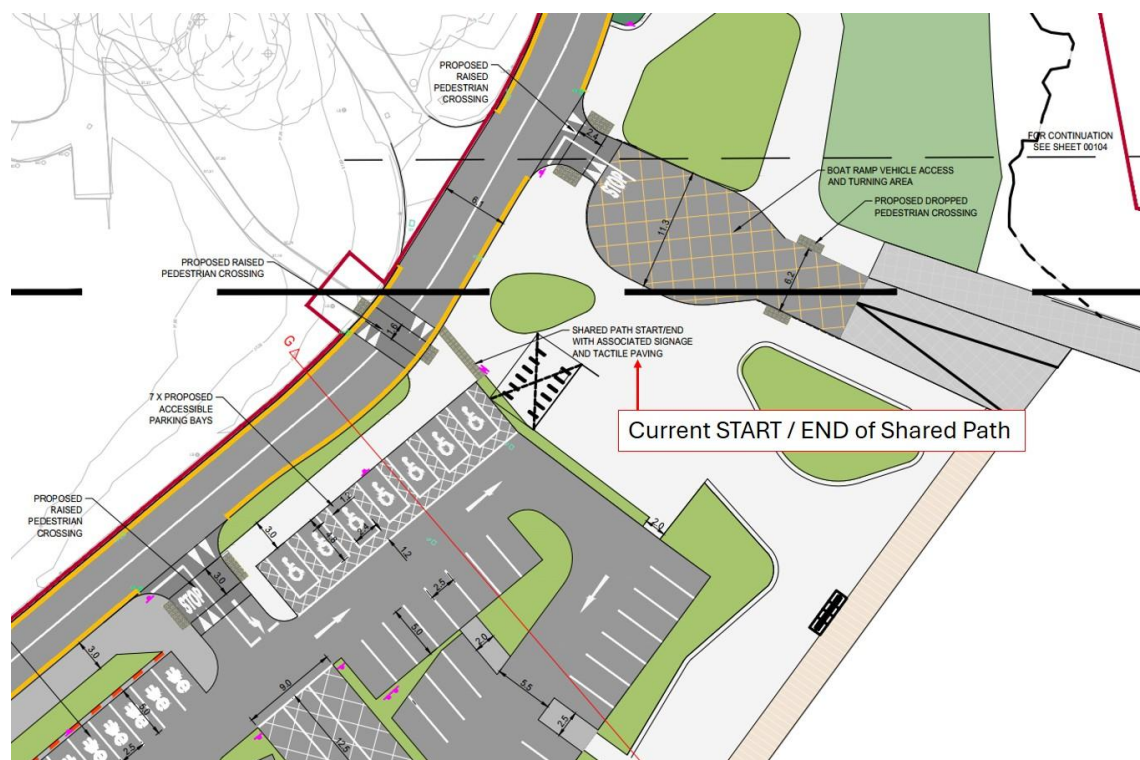
**Figure 14 – Proposed end of Shared Route**

The proposed shared pedestrian/cycle path ends approximately 200m south of the proposed Water Sports Pavilion, despite the overall active travel scheme extending for approximately 1.6 km. Cyclists travelling to the Water Sports Pavilion are therefore likely to continue beyond the end of the shared facility. The remaining pedestrian routes are relatively narrow and may not safely accommodate shared use, resulting in conflicts / collisions between pedestrians and cyclists.

The shared pedestrian/cycle route should be extended to the Water Sports Pavilion. The connecting routes and crossing points should be designed to accommodate the anticipated levels of pedestrian and cyclist activity, with sufficient width provided to minimise conflicts between users.

| 5.1 | No | No | The promenade is intended to operate as a pedestrian-only environment and is not proposed to accommodate cycling activity due to the anticipated high levels of pedestrian use and the constrained nature of the space". Cyclists will be directed to park at the marina cycle parking facilities before continuing on foot along the promenade or alternatively remain on the adjacent carriageway. Introducing cycling onto the promenade would conflict with the intended pedestrian function of the space | Yes |

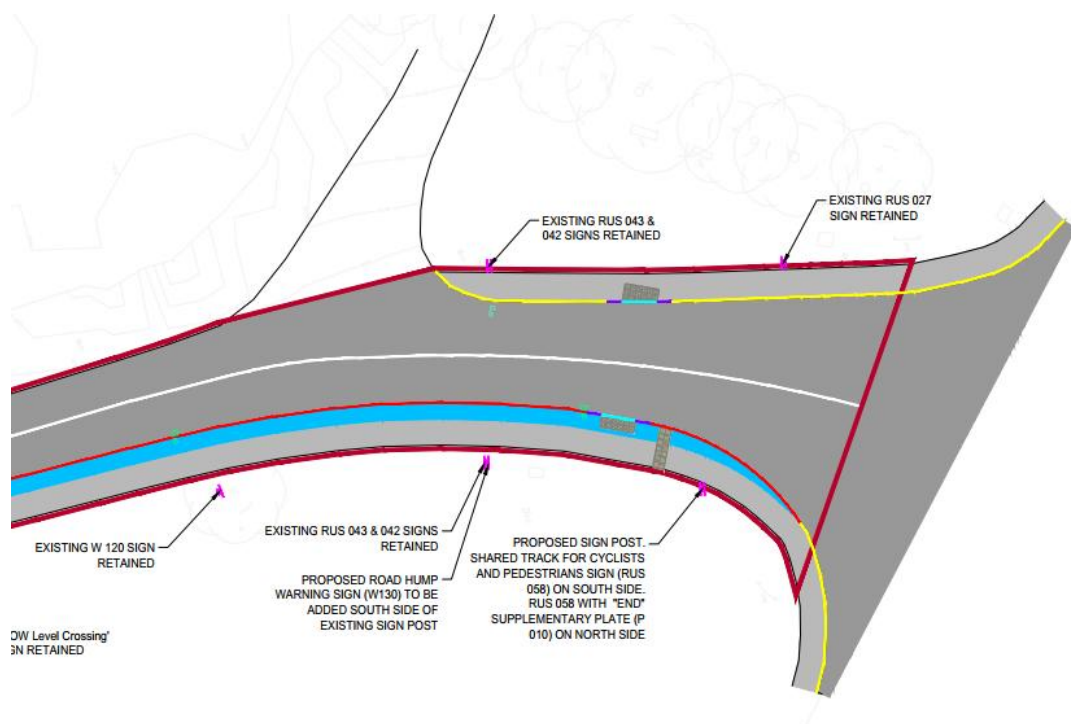
**Figure 15 – Proposed Raised Pedestrian Crossing**

There is no dropped kerb or other transition arrangement shown to enable cyclists to safely enter or leave the proposed shared pedestrian/cycle path from the carriageway. It is therefore unclear how cyclists are expected to access the facility, which may result in cyclists mounting kerbs or joining and leaving the shared path at unsuitable locations, increasing the risk of loss of control or conflict with pedestrians and vehicles. In addition, the junction corner radii appear generous, which may encourage higher vehicle turning speeds and increase the risk of collisions with vulnerable road users.

The junction should be redesigned to provide appropriate transition arrangements, including dropped kerbs and flush connections, to facilitate the safe entry and exit of cyclists between the carriageway and the shared pedestrian/cycle path in accordance with the Cycle Design Manual. The junction corner radii should also be tightened to reduce vehicle turning speeds and improve safety for pedestrians and cyclists crossing the junction.

| 5.2 | Yes | No | While the issue identified is acknowledged, the recommended alterations relate to the N61 junction and are outside the scope of the current project. Any changes to the national road network would require separate assessment and approval by TII. Opportunities to improve cyclist connectivity at this location may be considered as part of the future design and development of the Lough Ree Greenway | Yes |

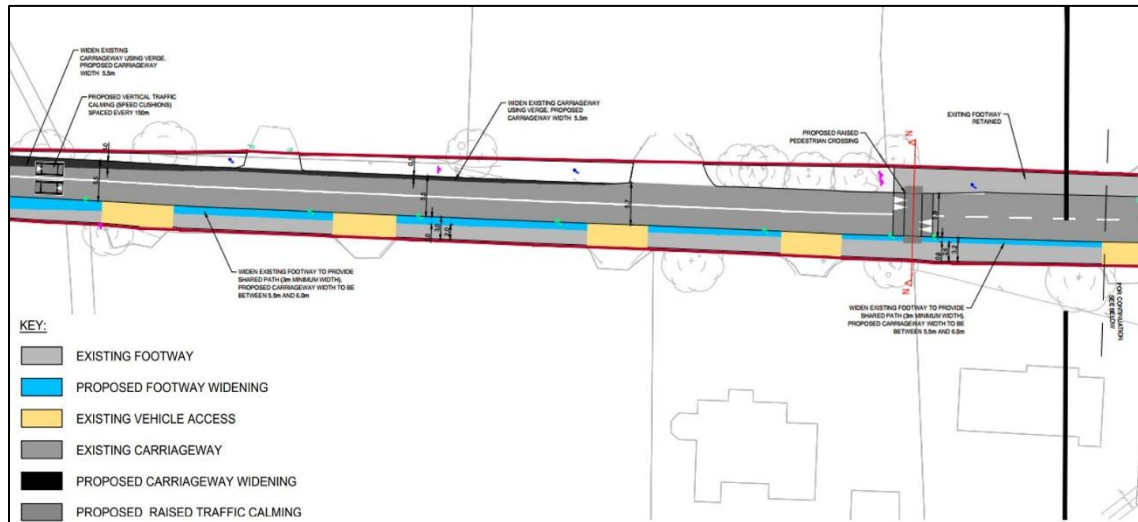
**Figure 16 – Existing Vehicle Access Points**

The treatment of the minor access crossing is unclear. If the shared pedestrian/cycle route is interrupted by kerbs or changes in level, pedestrians and cyclists may be required to give way unnecessarily or negotiate an uneven surface. This may reduce the attractiveness of the route and increase the potential for conflicts, loss of control by cyclists, and trips or falls.

The minor access should be designed as a continuous pedestrian and cycle crossing in accordance with the principles of the Cycle Design Manual. The footway/shared path should be carried across the access at a consistent level, with a bevel kerb provided to facilitate access for vehicles.

| 5.3 | Yes | Yes | | |

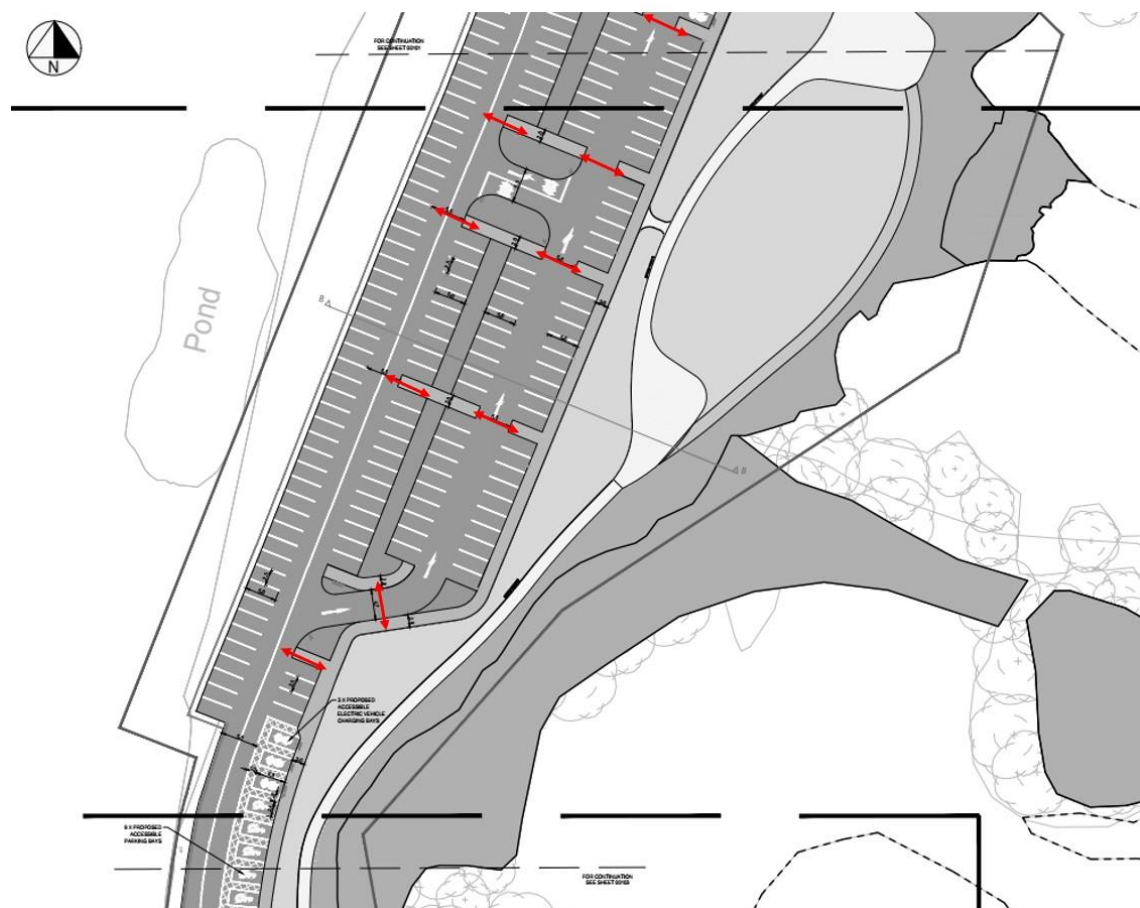
**Figure 17 – Proposed Crossing Points**

Dropped kerbs and tactile paving are not shown on the footpaths through the car park. In the absence of these facilities, pedestrians, particularly mobility-impaired users, wheelchair users, and those with visual impairments, may experience difficulty crossing the road. The absence of appropriate crossing infrastructure may also result in trips and falls.

Dropped kerbs and tactile paving should be provided either side of the proposed crossing points.

| 6.1 | Yes | Yes | | |

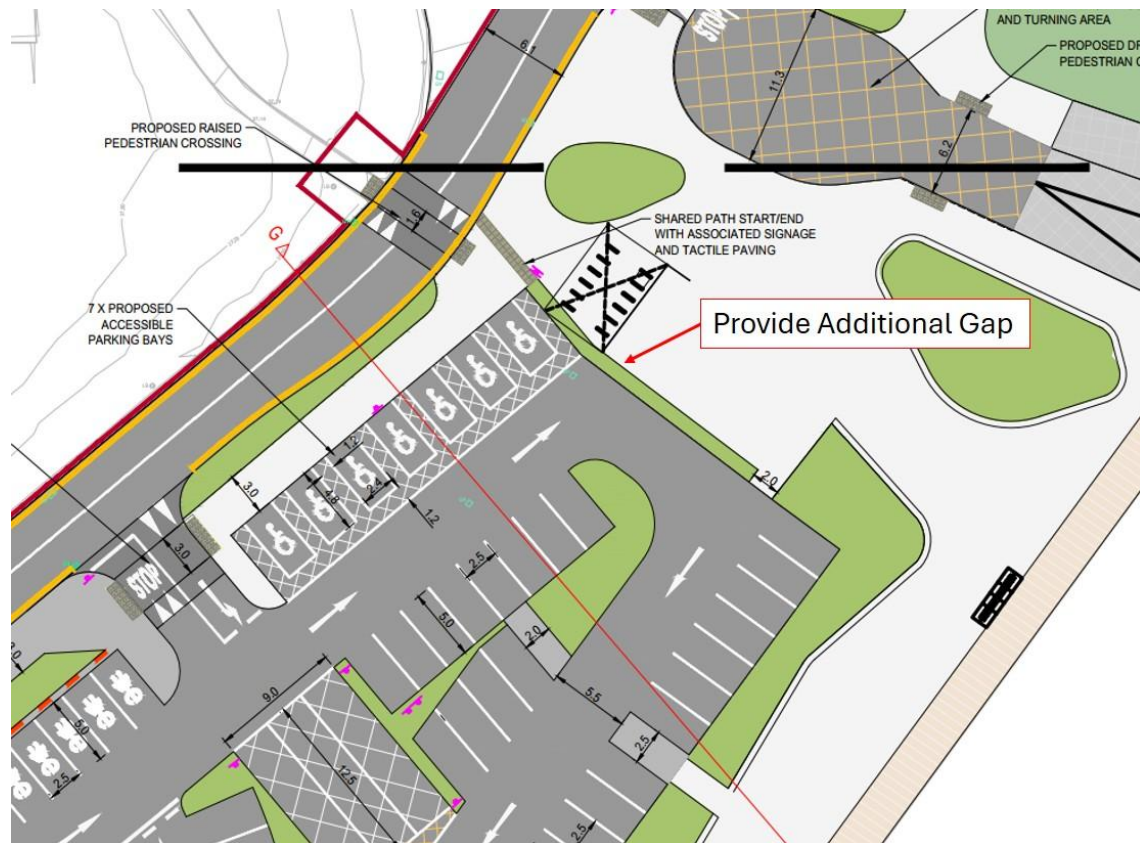
**Figure 18 – Car Parking**

A large, shared pedestrian space is proposed adjacent to the car park; however, a landscaped strip separates the car park from the shared area, with only one direct pedestrian access provided to the south. As a result, pedestrians, particularly wheelchair users and those with reduced mobility, may be required to take indirect routes or cross the landscaped area, reducing accessibility and potentially leading to unsafe pedestrian movements through the car park.

A direct, accessible pedestrian connection should be provided between the car park and the shared space. The route should include a flush crossing point with dropped kerbs where appropriate, be fully accessible to wheelchair users and those with reduced mobility and align with the principal pedestrian desire lines.

| 6.2 | Yes | Yes | | |

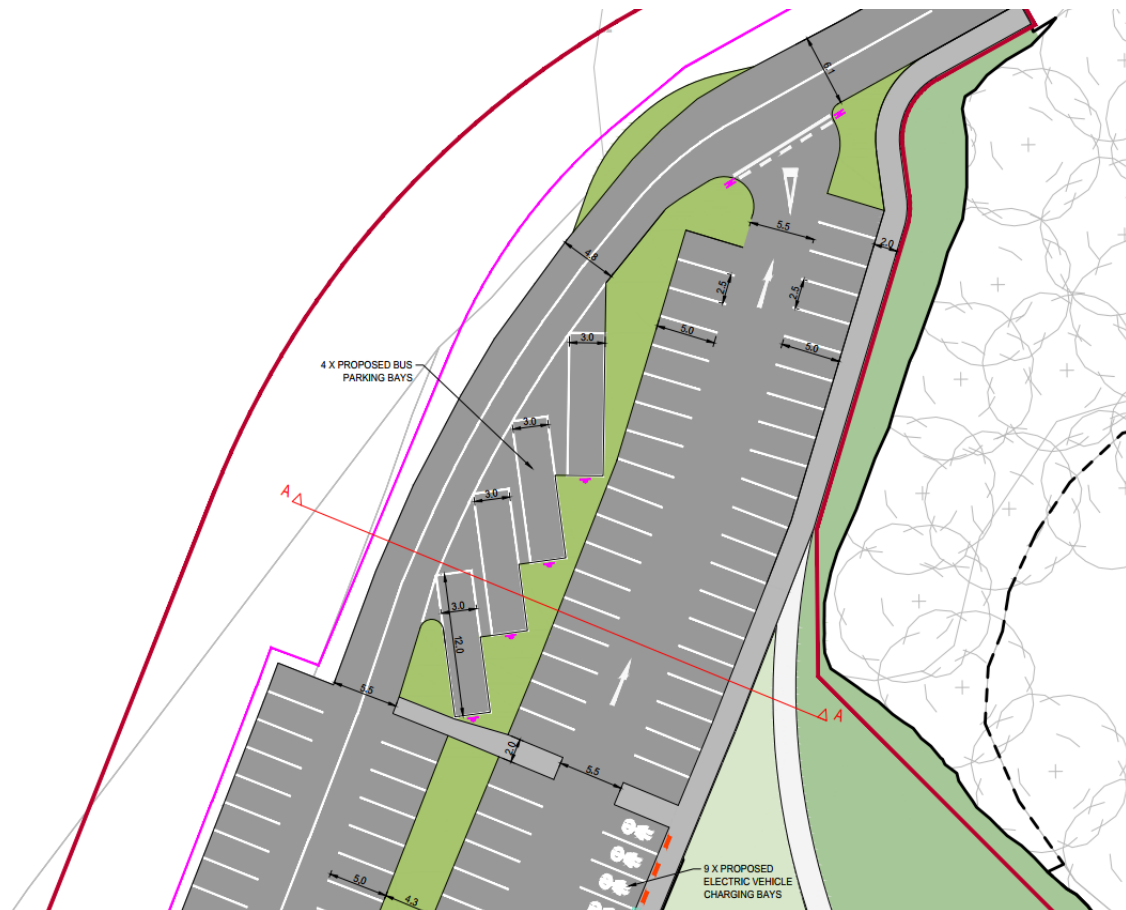
**Figure 19 – Proposed Bus Parking**

Only 4 no. dedicated bus parking spaces are shown on the proposed drawings. However, during the site visit, 10 no. buses were observed parked on site. If the proposed provision is insufficient to accommodate operational demand, buses may park in inappropriate locations, resulting in obstruction of vehicle circulation
