# **Greenhills Solar Farm**

## **Site Investigation Results**

Civil & Structural Works

**Report Ref:** 300101185-CS-R-02-00

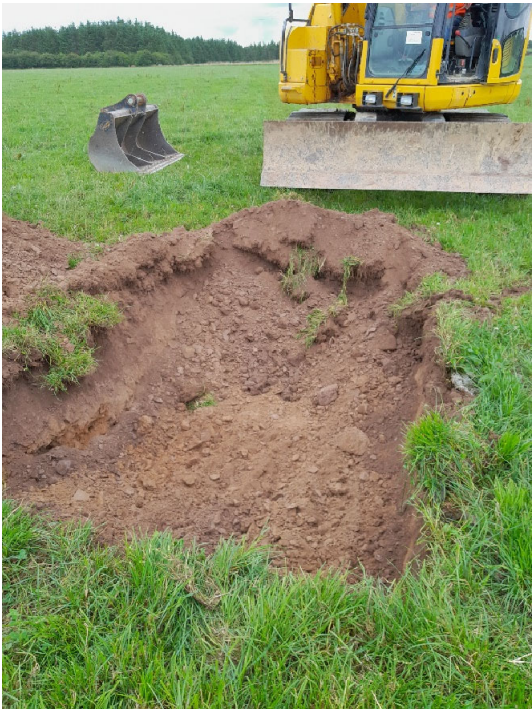
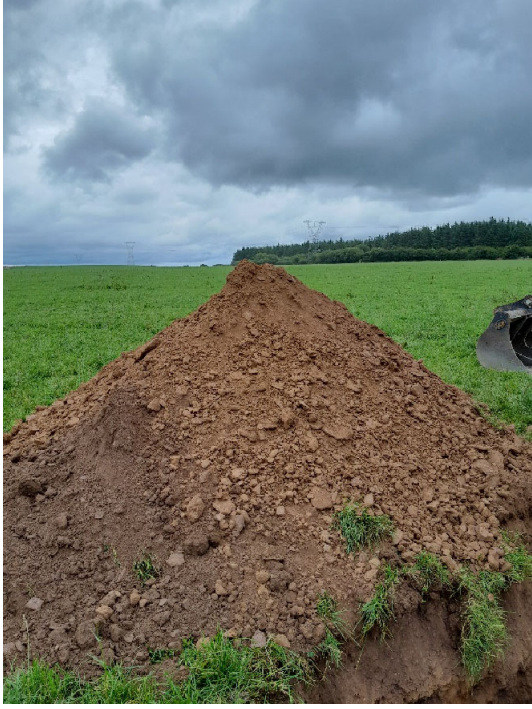
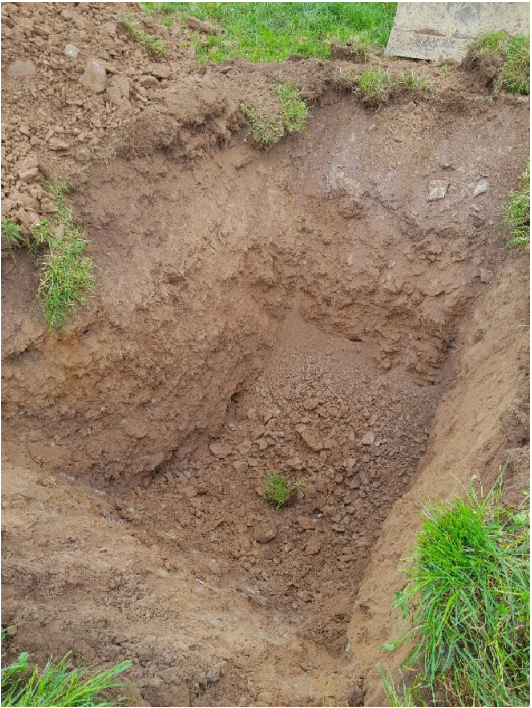
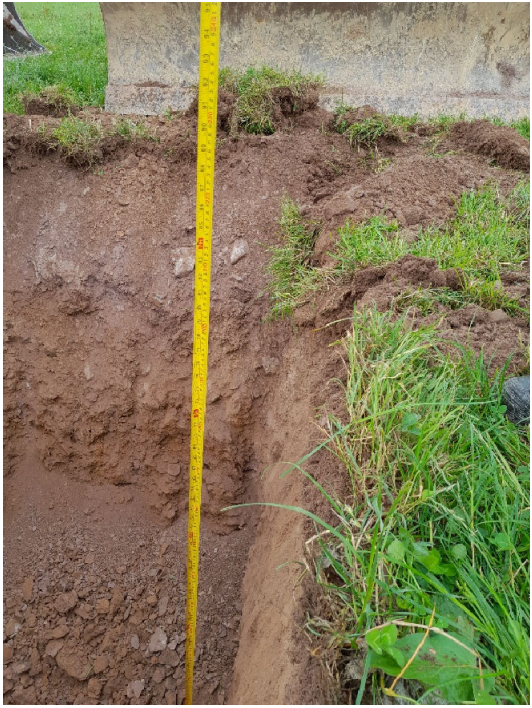
Trial Pit 1

| Trial Pit | Depth (m) | Groundwater (m) | Soil Description | Additional Comments |
|---|---|---|---|---|
| 1 | 2.1 | N/A | Silty Clay soil with high cobble content | Pit terminated due to presence of stone. Sidewalls stable. |

Additional notes: Trial pit terminated at 2.1m below ground level due to presence of stone. Ground water was not encountered. Sidewalls stable.

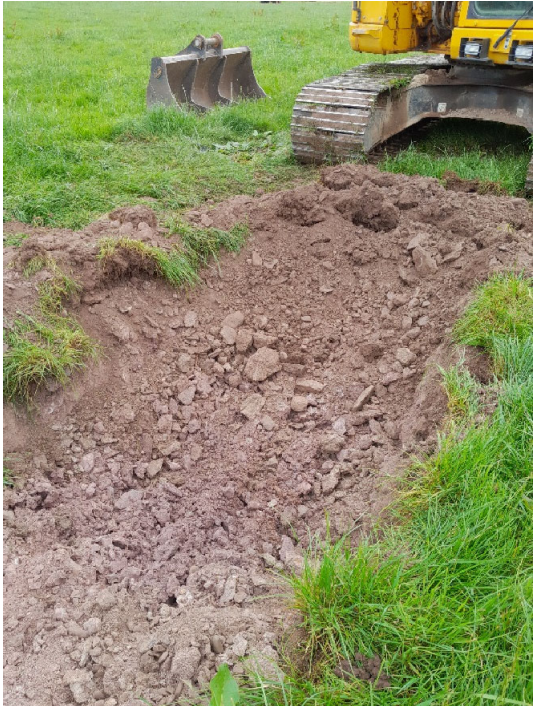
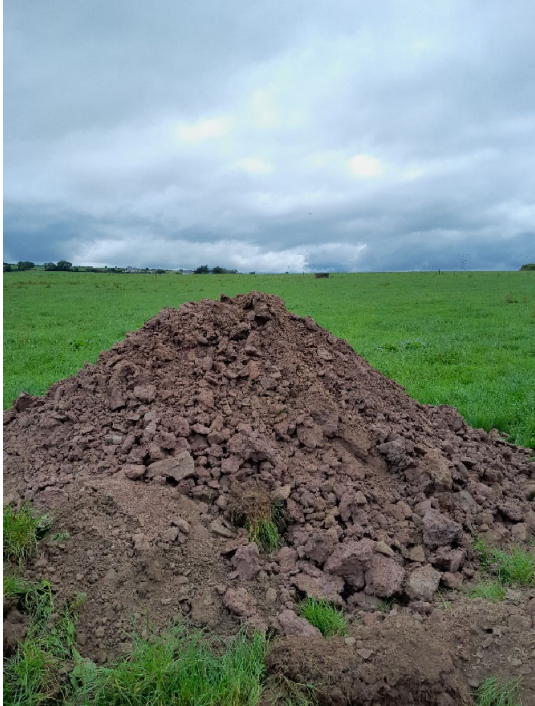
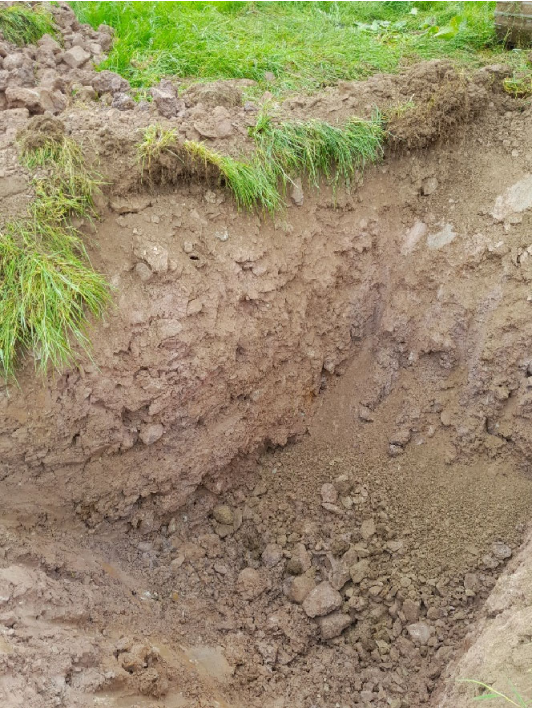
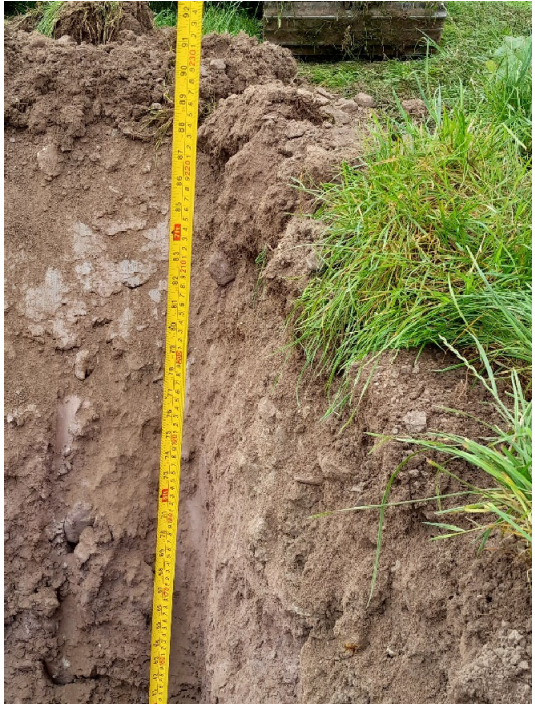
Trial Pit 2

| Trial Pit | Depth (m) | Groundwater (m) | Soil Description | Additional Comments |
|---|---|---|---|---|
| 2 | 2.1 | N/A | Clayey soil with high cobble content and low boulder content | Pit terminated due to presence of stone. Sidewalls stable. |

| 1 | A photograph showing a trial pit excavation. The soil is dark brown and appears to be a mix of clay and gravel. A yellow excavator bucket is visible in the background, partially obscured by the pit's edge. The surrounding area is grassy. |
| 2 | A photograph showing a large pile of excavated soil and gravel. The pile is conical and sits on a grassy field. The sky in the background is overcast with grey clouds. |
| 3 | A close-up photograph of the trial pit wall. The soil is dark brown and shows signs of being disturbed, with some gravel visible. Grass is growing along the top edge of the pit. |
| 4 | A close-up photograph of the trial pit wall. A yellow measuring tape is placed vertically against the soil face to indicate depth. The soil is dark brown and appears to be a mix of clay and gravel. Grass is growing along the top edge of the pit. |

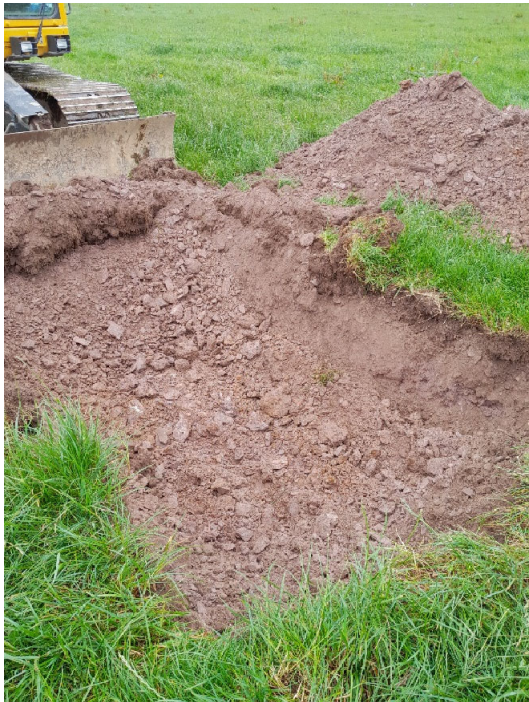
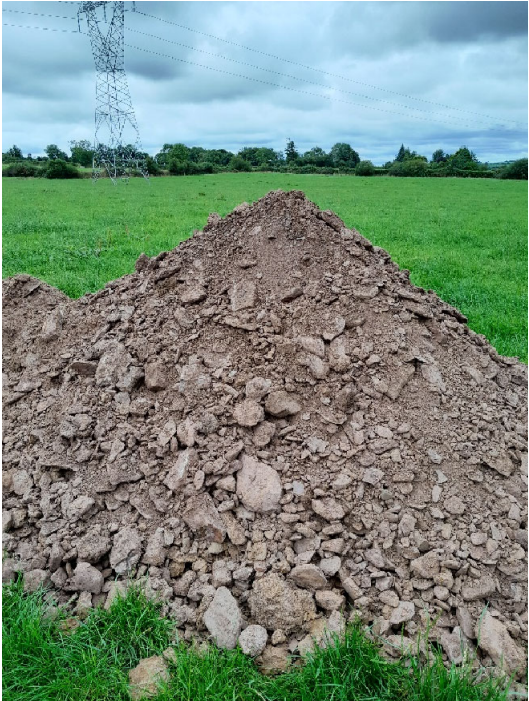
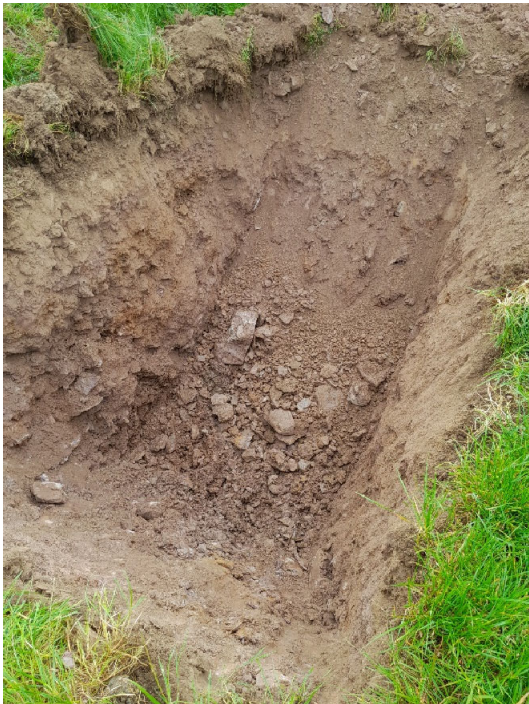
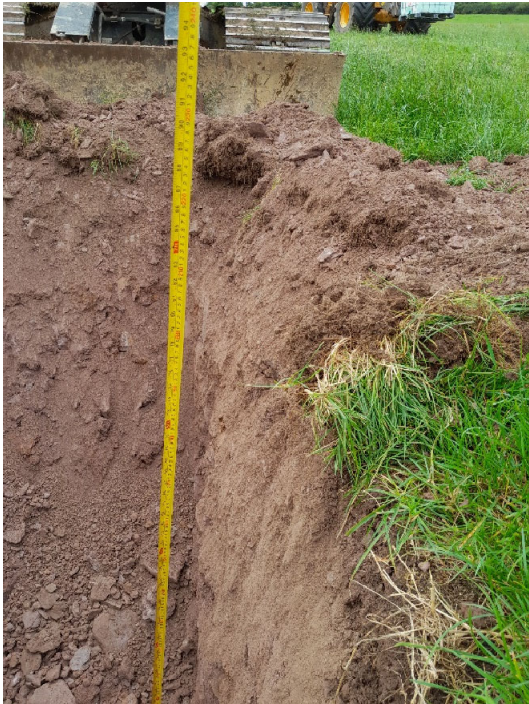
Trial Pit 3

| Trial Pit | Depth (m) | Groundwater (m) | Soil Description | Additional Comments |
|---|---|---|---|---|
| 3 | 2.0 | N/A | Clayey soil with high cobble and boulder content | Pit terminated due to presence of stone. Sidewalls stable. |

Additional notes: Trial pit terminated at 2.0m below ground level due to presence of stone. Ground water was not encountered. Sidewalls stable.

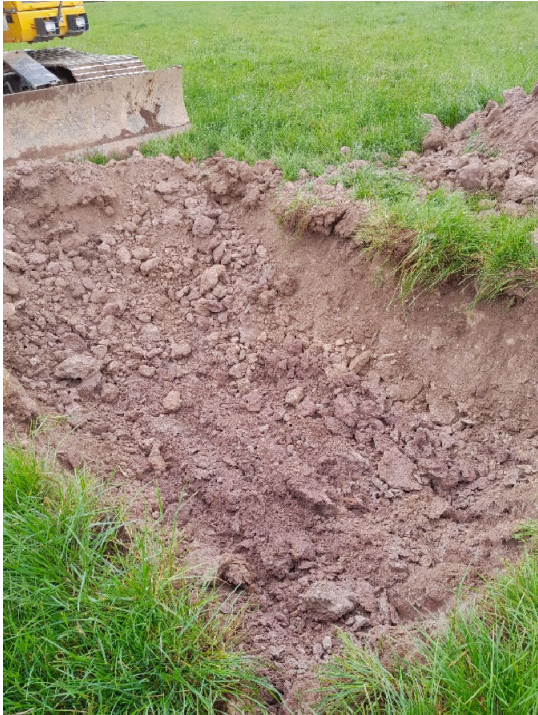
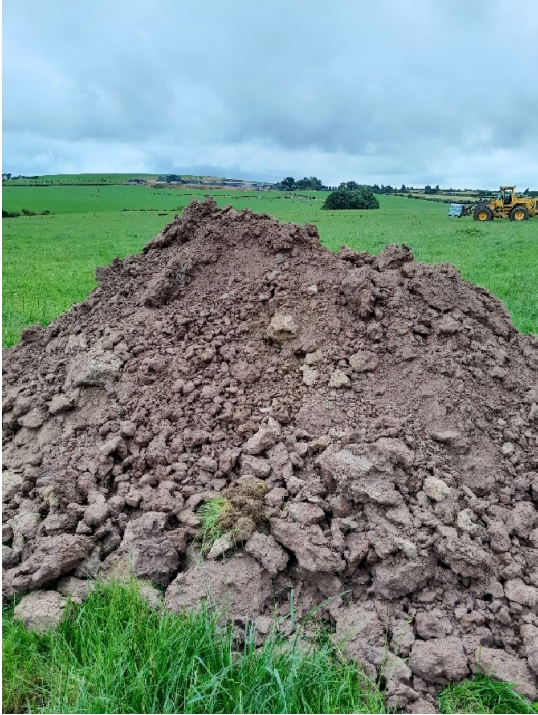
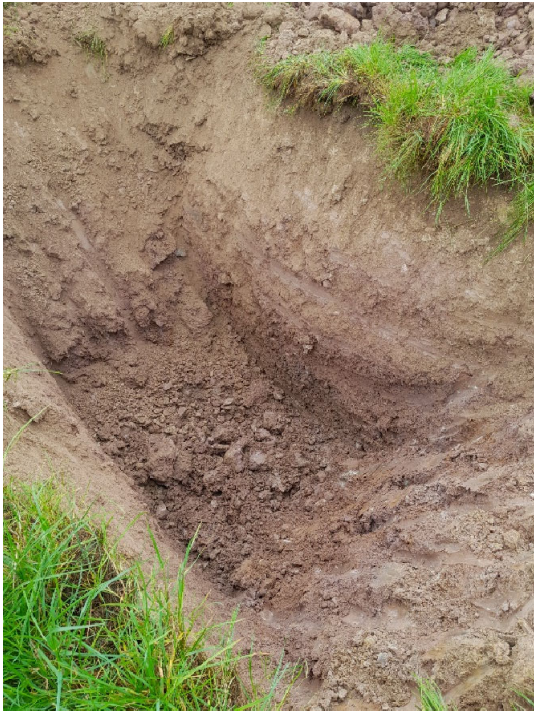
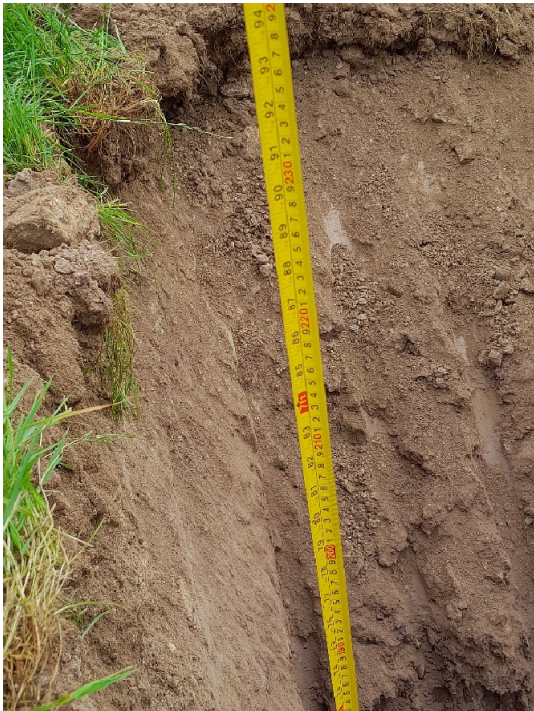
Trial Pit 4

| Trial Pit | Depth (m) | Groundwater (m) | Soil Description | Additional Comments |
|---|---|---|---|---|
| 4 | 2.3 | N/A | Clayey soil with low cobble content | Pit terminated due to presence of stone. Sidewalls stable. |

| 1 | A photograph showing the edge of a trial pit. The soil is reddish-brown and appears to be composed of loose, clumpy material. Green grass is visible on the left and right sides of the pit. A yellow excavator bucket is partially visible in the upper left corner. |
| 2 | A photograph showing a large pile of excavated soil. The soil is dark brown and clumpy. In the background, there is a green field, a line of trees, and a yellow excavator under a cloudy sky. |
| 3 | A close-up photograph of the soil face of the trial pit. The soil is light brown and appears to be a mix of sand and silt. There are some small clumps of green grass at the top of the face. |
| 4 | A close-up photograph of the soil face of the trial pit. A yellow measuring tape is placed vertically against the soil face for scale. The soil is light brown and appears to be a mix of sand and silt. There are some small clumps of green grass at the top of the face. |

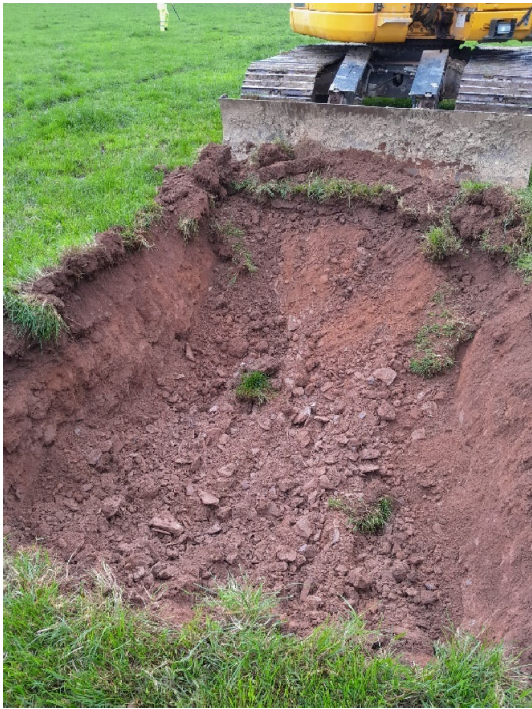
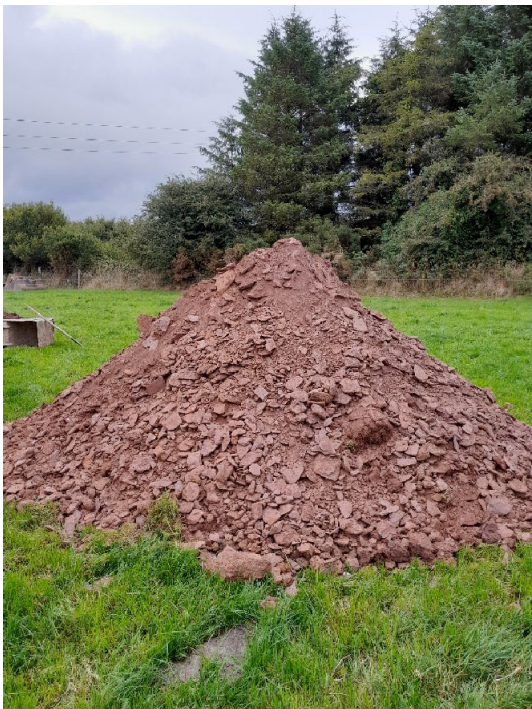
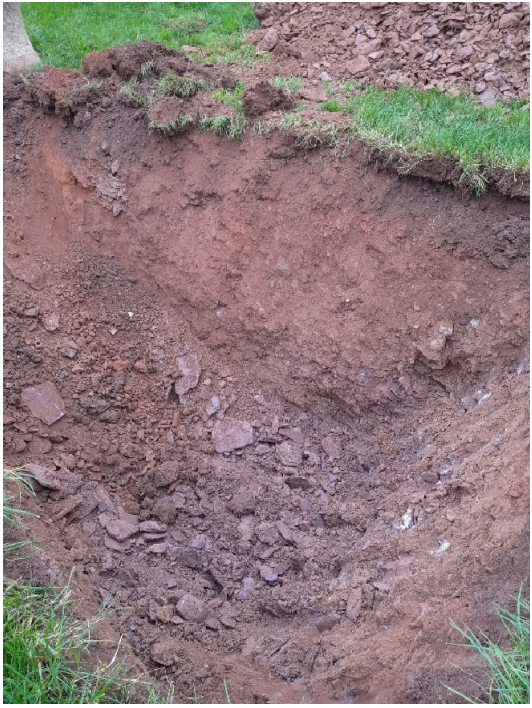
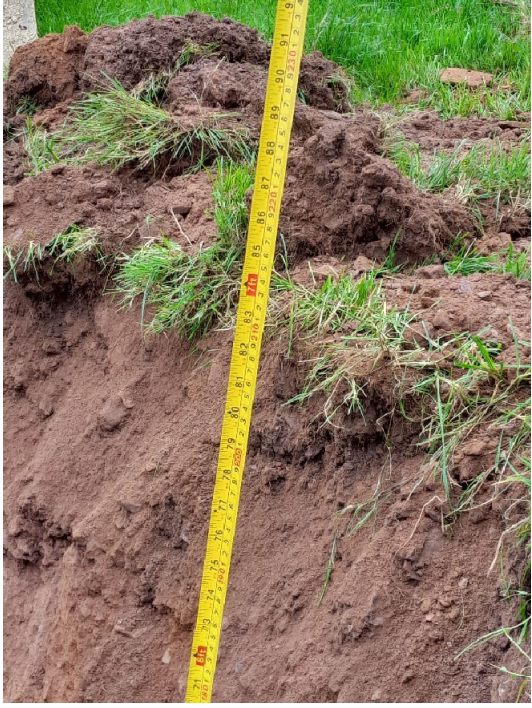
Trial Pit 5

| Trial Pit | Depth (m) | Groundwater (m) | Soil Description | Additional Comments |
|---|---|---|---|---|
| 5 | 2.1 | N/A | Silty Clay soil with high cobble content and low boulder content (shale) | Pit terminated due to presence of stone. Sidewalls stable. |

Additional notes: Trial pit terminated at 2.1m below ground level due to presence of stone. Ground water was not encountered. Sidewalls stable.

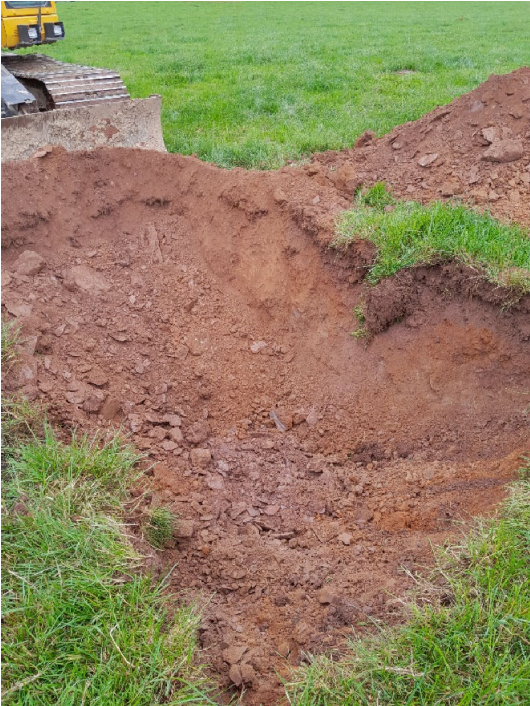
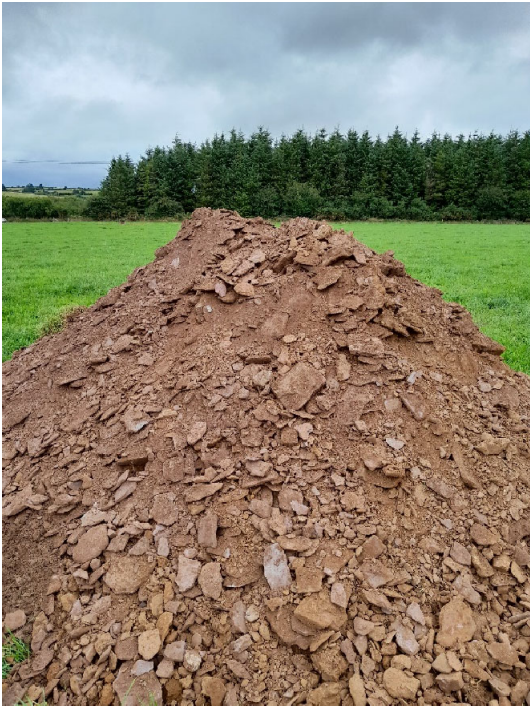
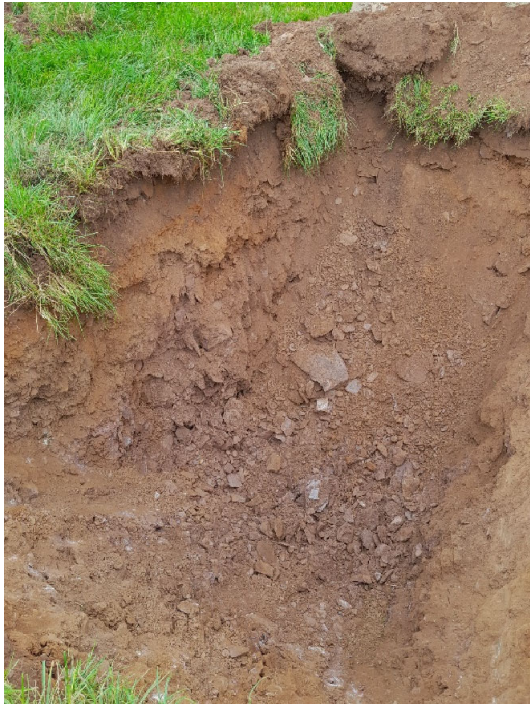
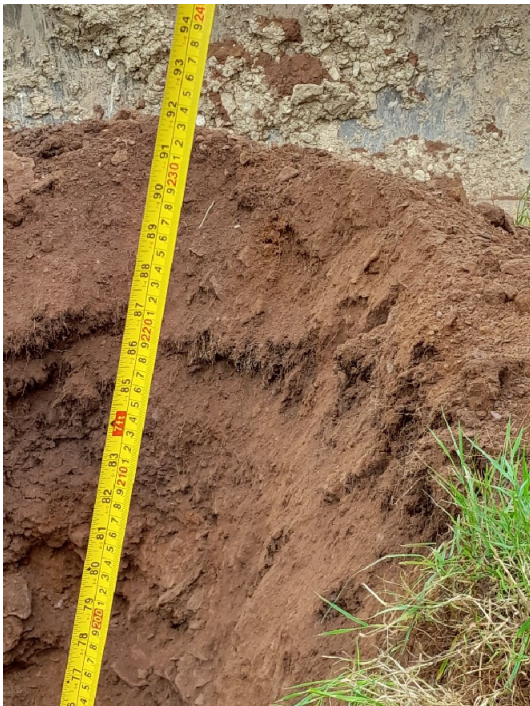
Trial Pit 6

| Trial Pit | Depth (m) | Groundwater (m) | Soil Description | Additional Comments |
|---|---|---|---|---|
| 6 | 2.2 | N/A | Silty Clay soil with high cobble content and low boulder content (shale) | Pit terminated due to presence of stone. Sidewalls stable. |

Additional notes: Trial pit terminated at 2.2m below ground level due to presence of stone. Ground water was not encountered. Sidewalls stable.

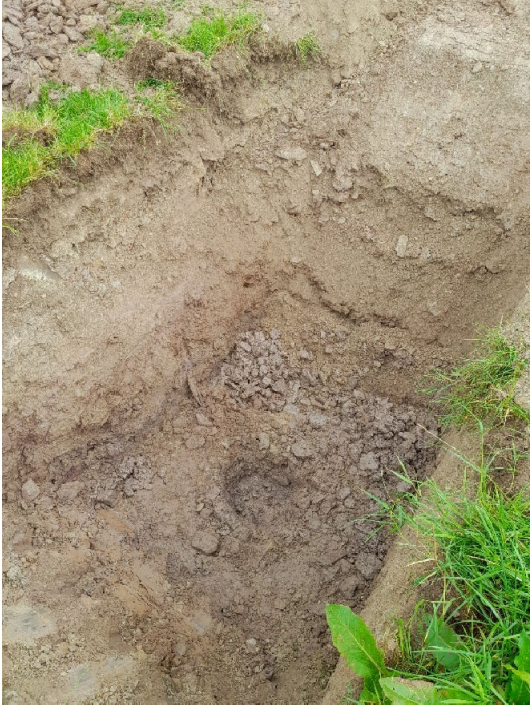
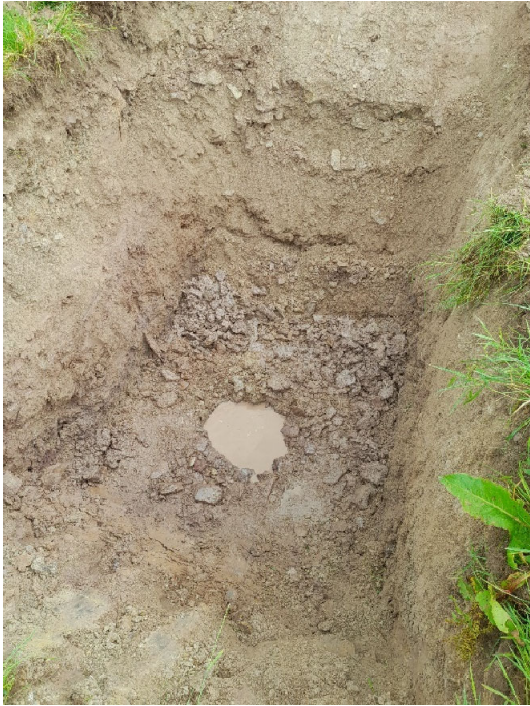
T-Test 1

| | Dimensions<br>(mm) | Volume<br>(m <sup>3</sup> ) | Time Filled | Time<br>(¾ Full) | Time<br>(¼ Full) | Time<br>(¾ – ¼) |
|---|---|---|---|---|---|---|
| <b>T-Test 1</b> | 400 x 350 x 300 | 0.042 | 09:46 | 10.21 | 11.27 | 66 |

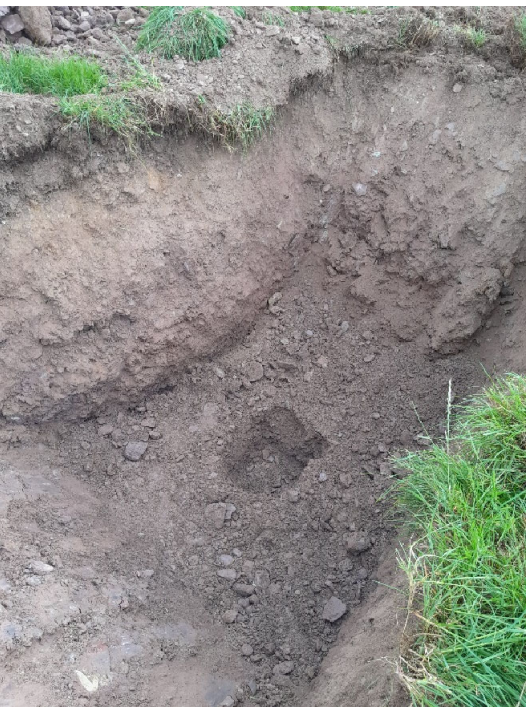
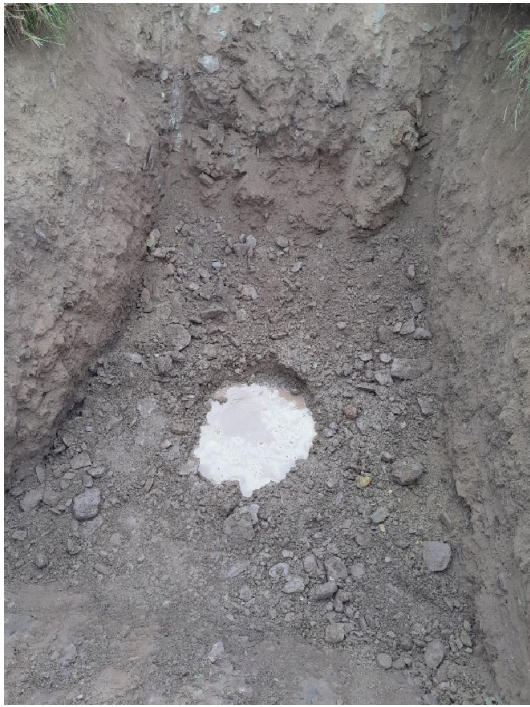
T-Test 2

| | Dimensions<br>(mm) | Volume<br>(m <sup>3</sup> ) | Time Filled | Time<br>(¾ Full) | Time<br>(¼ Full) | Time<br>(¾ – ¼) |
|---|---|---|---|---|---|---|
| <b>T-Test 2</b> | 400 x 350 x 300 | 0.042 | 09:56 | 10.04 | 10.33 | 19 |

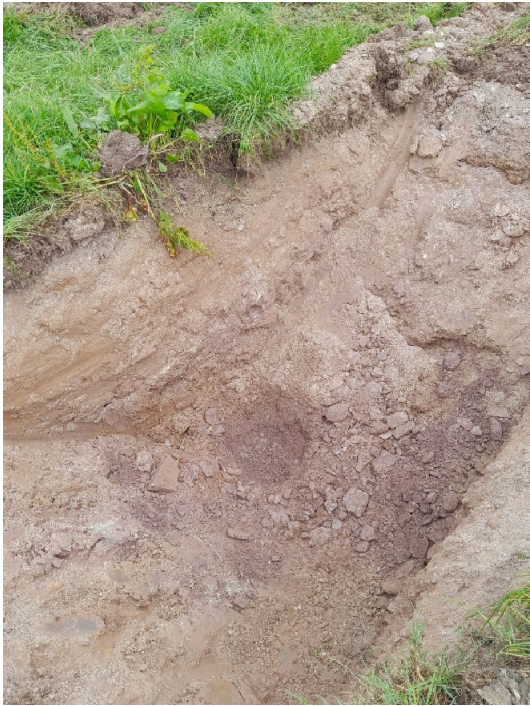
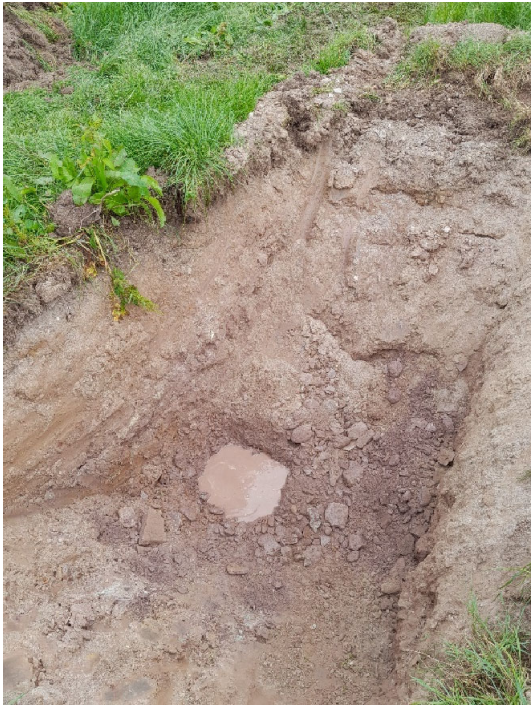
T-Test 3

| | Dimensions<br>(mm) | Volume<br>(m <sup>3</sup> ) | Time Filled | Time<br>(¾ Full) | Time<br>(¼ Full) | Time<br>(¾ – ¼) |
|---|---|---|---|---|---|---|
| <b>T-Test 3</b> | 400 x 400 x 300 | 0.048 | 09:50 | 10.35 | 12.04 | 89 |

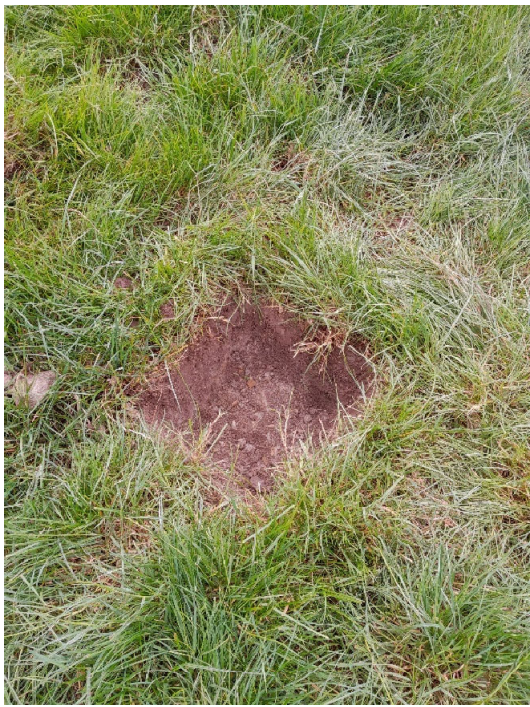
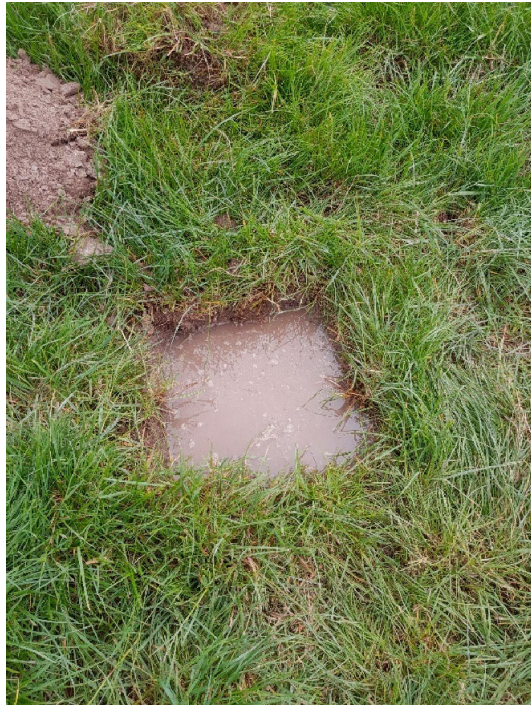
P-Test 1

| | Dimensions<br>(mm) | Volume<br>(m <sup>3</sup> ) | Time Filled | Time<br>(¾ Full) | Time<br>(¼ Full) | Time<br>(¾ – ¼) |
|---|---|---|---|---|---|---|
| <b>P-Test 1</b> | 350 x 350 x 300 | 0.037 | 09:32 | 09:42 | 11:44 | 122 |

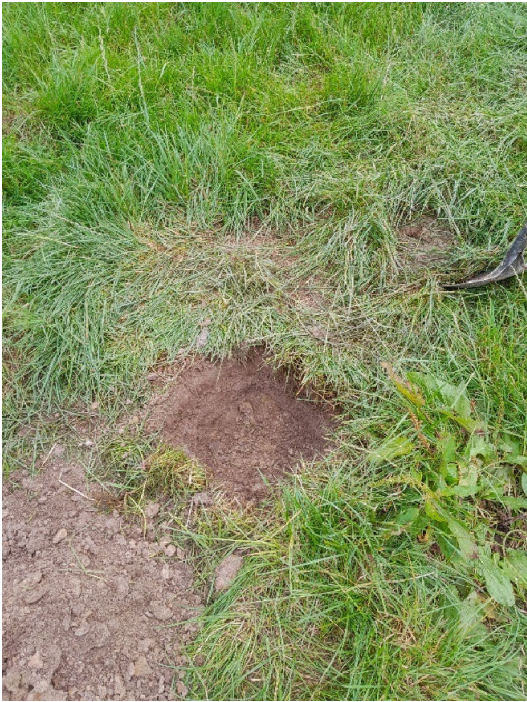
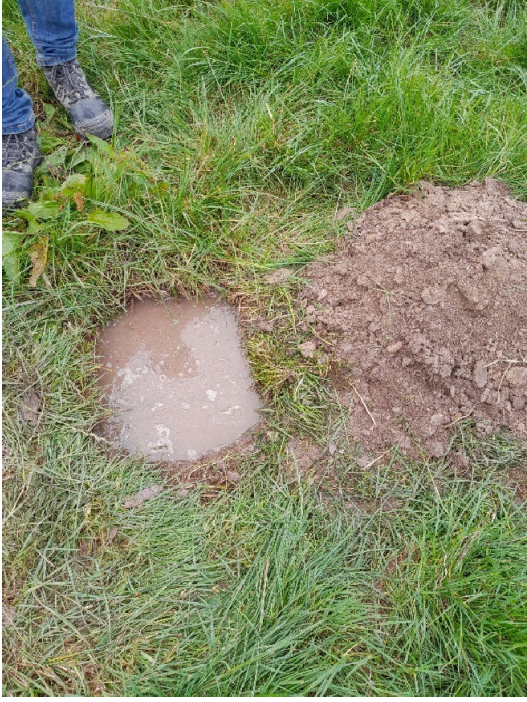
P-Test 2

| | Dimensions<br>(mm) | Volume<br>(m <sup>3</sup> ) | Time Filled | Time<br>(¾ Full) | Time<br>(¼ Full) | Time<br>(¾ – ¼) |
|---|---|---|---|---|---|---|
| <b>P-Test 2</b> | 300 x 300 x 300 | 0.027 | 09:28 | 09:37 | 11:03 | 86 |

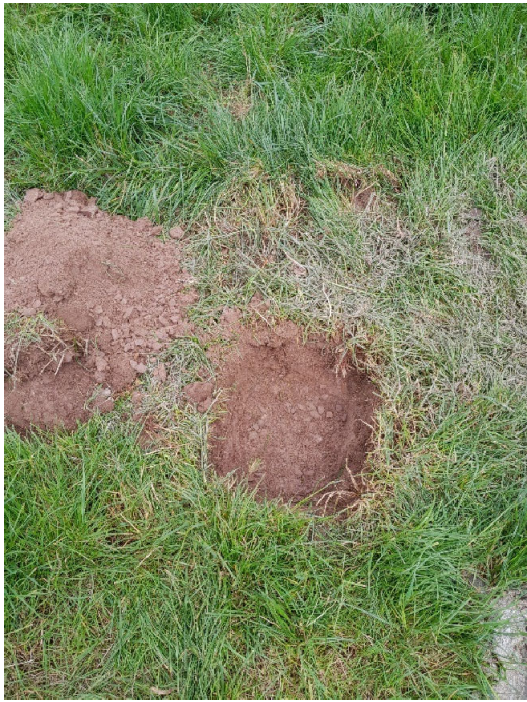
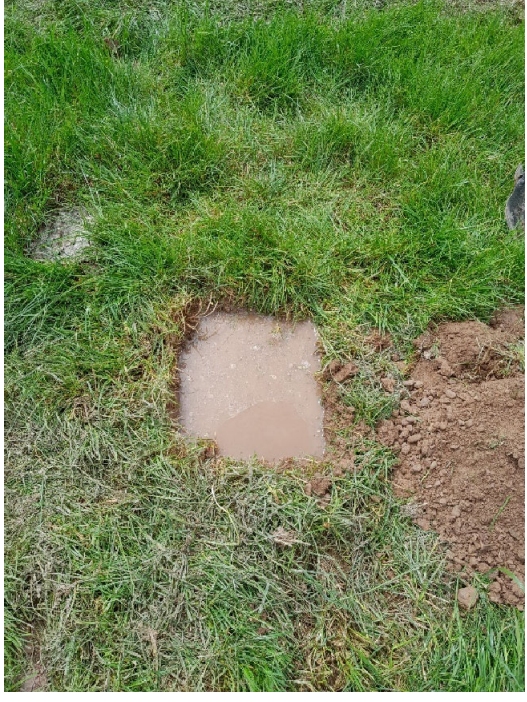
P-Test 3

| | Dimensions<br>(mm) | Volume<br>(m <sup>3</sup> ) | Time Filled | Time<br>(¾ Full) | Time<br>(¼ Full) | Time<br>(¾ – ¼) |
|---|---|---|---|---|---|---|
| <b>P-Test 3</b> | 350 x 350 x 300 | 0.037 | 09:38 | 09:49 | 10:30 | 41 |
