**PROPOSED RESIDENTIAL DEVELOPMENT  
PARK WEST AVENUE, CHERRY ORCHARD,  
DUBLIN 10**

**Stage 1 Quality Audit**

**(Incorporating a DMURS Street Design Audit, and Audits  
of Accessibility, Cycling, Walking and Road Safety)**

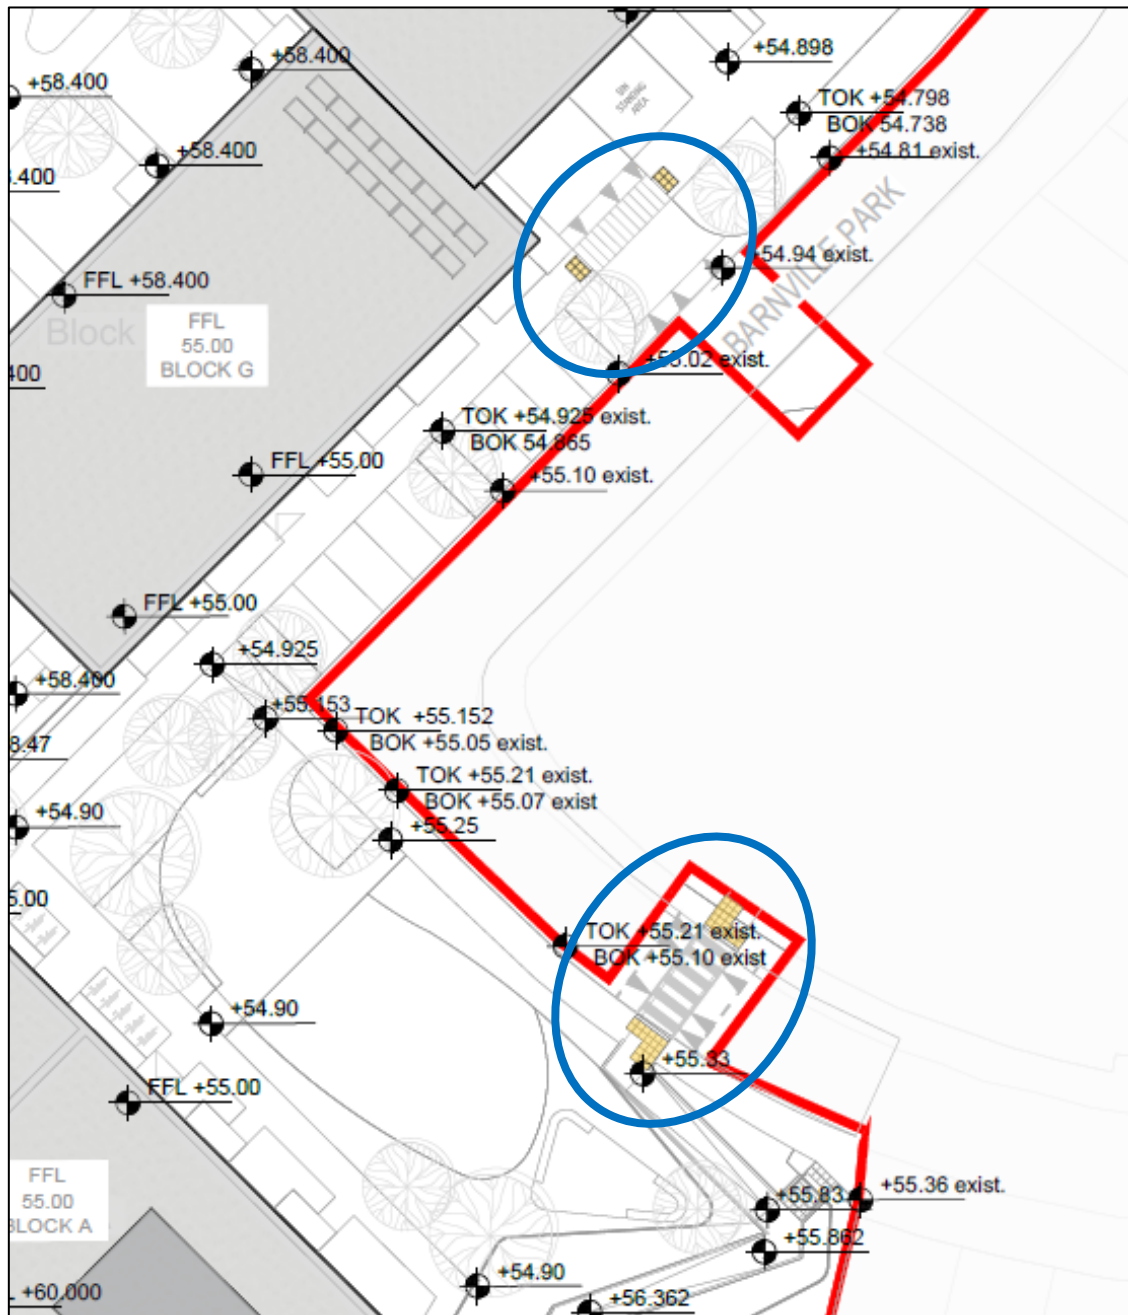
**Figure 5.1 Drainage**

### 5.1 **Problem**

It is unclear what the proposed drainage arrangement will be at proposed raised crossings. Ponding of water and silting can pose a slipping hazard, especially for vulnerable road users.

Ensure adequate drainage measures at all proposed raised crossings throughout the scheme.

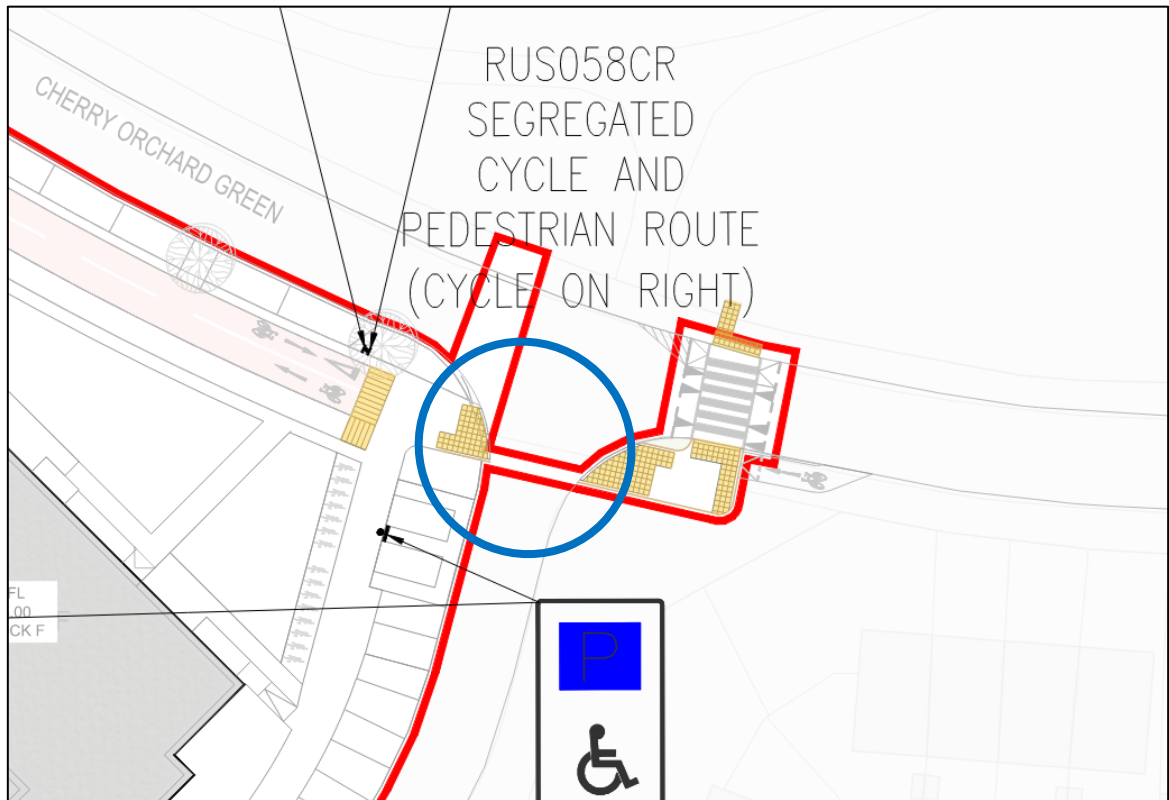
**Figure 5.2 – Junction Priority**

The existing Cherry Orchard Green / Barnville Park junction is not provided with road markings. The absence of appropriate road markings may result in uncertainty regarding junction priority and vehicle positioning, which could lead to driver confusion, inappropriate manoeuvres, and an increased risk of collisions.

Provide appropriate road markings at the existing Cherry Orchard Green / Barnville Park junction.

| Paragraph No. in Safety Audit Report | To Be Completed By Designer | | | To Be Completed by Audit Team |
|---|---|---|---|---|
| 5.2 | YES | YES | There is currently no stop line at this junction. This can be added if required by Dublin City Council. | --- |

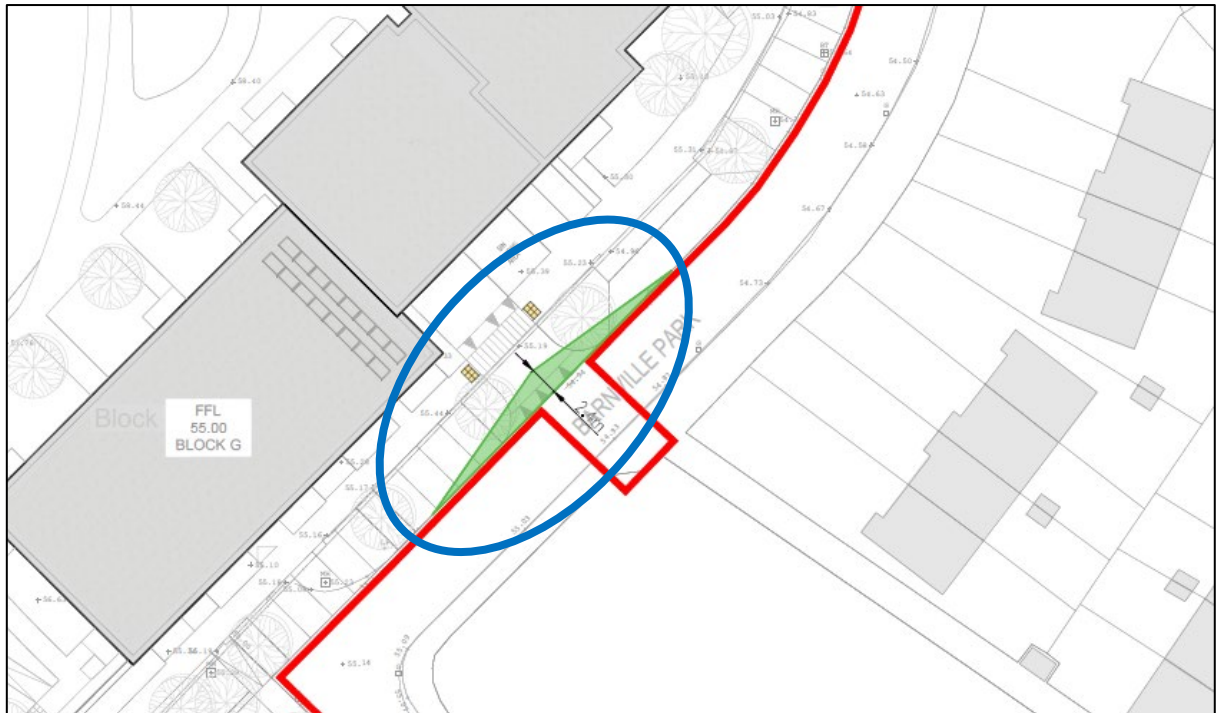
**Figure 5.3 – Visibility Splay Across Proposed Parking and Trees**

The proposed visibility splay extends across parking areas and proposed landscaping/planting. Vehicles parked within the visibility splay, together with the future growth of planting, may obstruct intervisibility between drivers. This could reduce the ability of road users to observe approaching vehicles in sufficient time and may increase the risk of vehicular collisions.

Ensure all visibility splays are adequate, complete and free from obstacles including, but not limited to, parking and planting/trees. Relocate parking and trees as required.

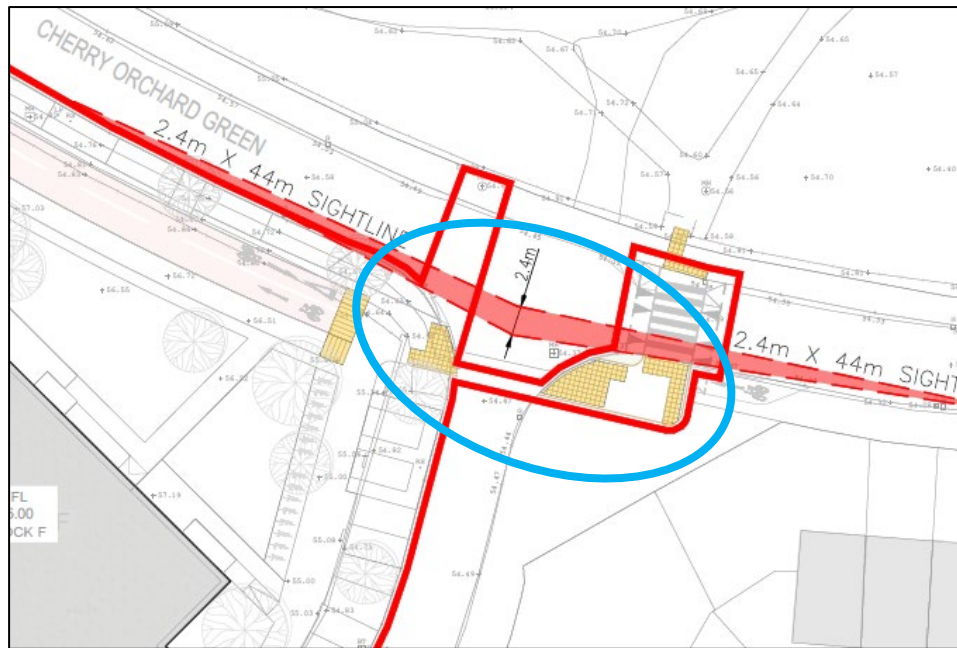
**Figure 5.4 – Visibility Splay Incorrectly Superimposed**

The proposed visibility splay does not appear to be correctly superimposed on the drawings. As a result, it is unclear whether the required visibility standards can be achieved. Inadequate visibility splays may compromise intervisibility between drivers, increasing the risk of vehicular collisions.

Review and amend the drawings to clearly demonstrate the correct location and extent of the required visibility splays. Ensure all visibility splays are adequate, complete and free from obstacles including, but not limited to, parking and planting/trees. Relocate parking and trees as required.

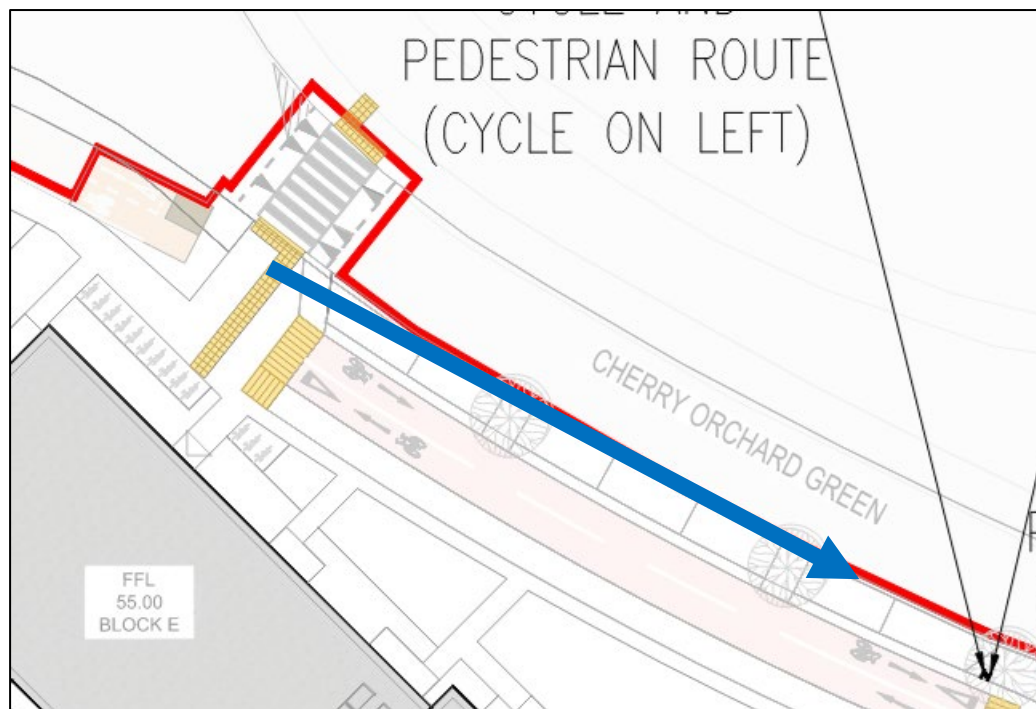
Intervisibility between pedestrians crossing pedestrian crossings and drivers of vehicles approaching the crossings may be restricted by vehicles parked in the adjacent car parking spaces or landscaping adjacent to the pedestrian crossings. A lack of adequate intervisibility may contribute to a collision at these locations.

**Figure 6.2 – Visibility Compromised at Pedestrian Crossing**

Ensure adequate intervisibility between pedestrians and motorists. Relocate parking and landscaping as required.

| Paragraph No. in Safety Audit Report | To Be Completed By Designer | | | To Be Completed by Audit Team |
|---|---|---|---|---|
| 5.5 | YES | YES | The lack of intervisibility between vehicles and pedestrians at this location is noted. The proposed parking spaces along Cherry Orchard Green have been shifted to facilitate clear visibility between vehicles and pedestrians using the road crossing. | --- |

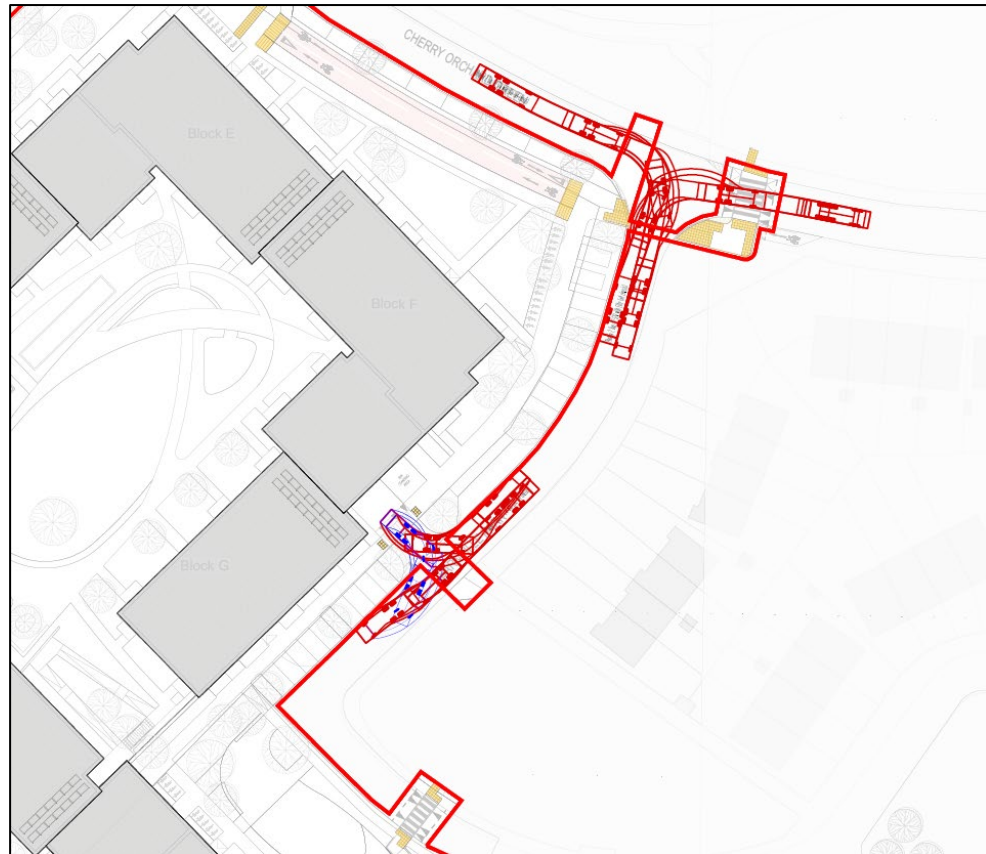
**Figure 5.5 – Swept Path Analysis**

Swept Path Analysis drawings have been provided for certain vehicle movements; however, they do not demonstrate vehicle manoeuvrability throughout the proposed internal car park. As a result, it is unclear whether sufficient space is available for all vehicles to manoeuvre safely within the development. Inadequate manoeuvring space may result in encroaching into opposing traffic lanes or pedestrian areas, or undertaking multi-point turns, increasing the risk of vehicular collisions and injuries to vulnerable road users

Ensure adequate manoeuvrability space on all road networks for all vehicle types.

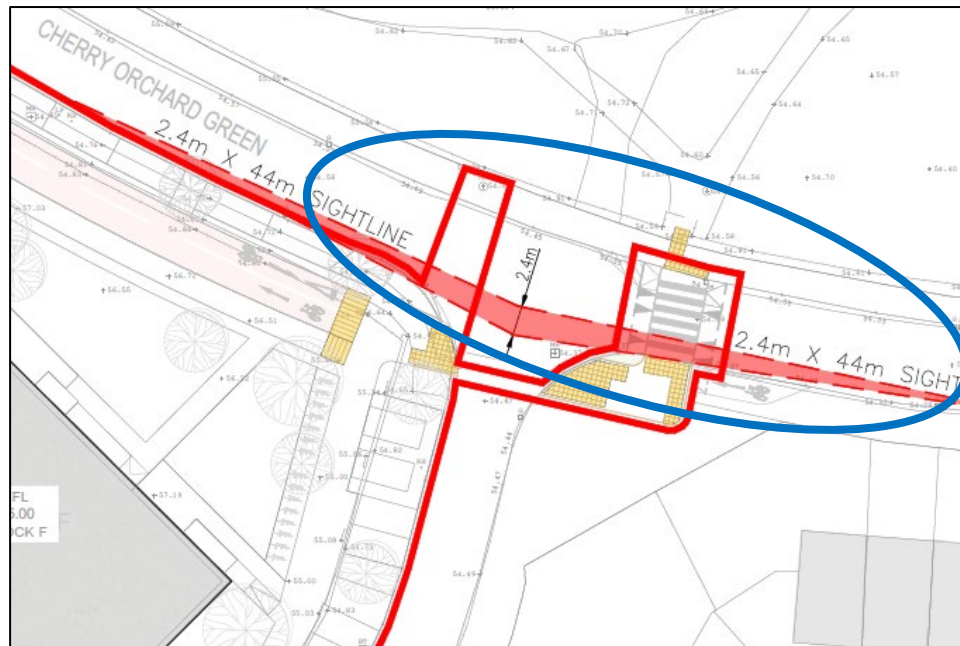
A raised pedestrian crossing is proposed on the eastern side of the Cherry Orchard Green / Barnville Park junction. It was noted during the site visit that existing speed ramps are currently located on both the western and eastern approaches to the junction, approximately 15 m to 20 m from the proposed raised crossing. The close proximity of multiple vertical traffic calming features may result in inconsistent driver behaviour, discomfort for vehicle occupants, and increased braking and acceleration manoeuvres. This could lead to driver distraction and an increased risk of vehicle conflicts in the vicinity of the junction and crossing.

**Figure 5.6 – Raised Ramps in close proximity to the Raised Pedestrian Crossing**

Review the spacing and interaction between the proposed raised pedestrian crossing and the existing speed ramps to ensure an appropriate and consistent traffic calming strategy is provided. Consider the removal, relocation, or modification of existing traffic calming measures where necessary to reduce the potential for driver confusion and to maintain a safe environment for all road users.

| 5.7 | YES | YES | Both existing speed ramps will be replaced by the proposed speed ramps at the northeast of the development, at the junction of Cherry Orchard Green and Barnville Park, and at the northwest of the development on Cherry Orchard Green. | --- |

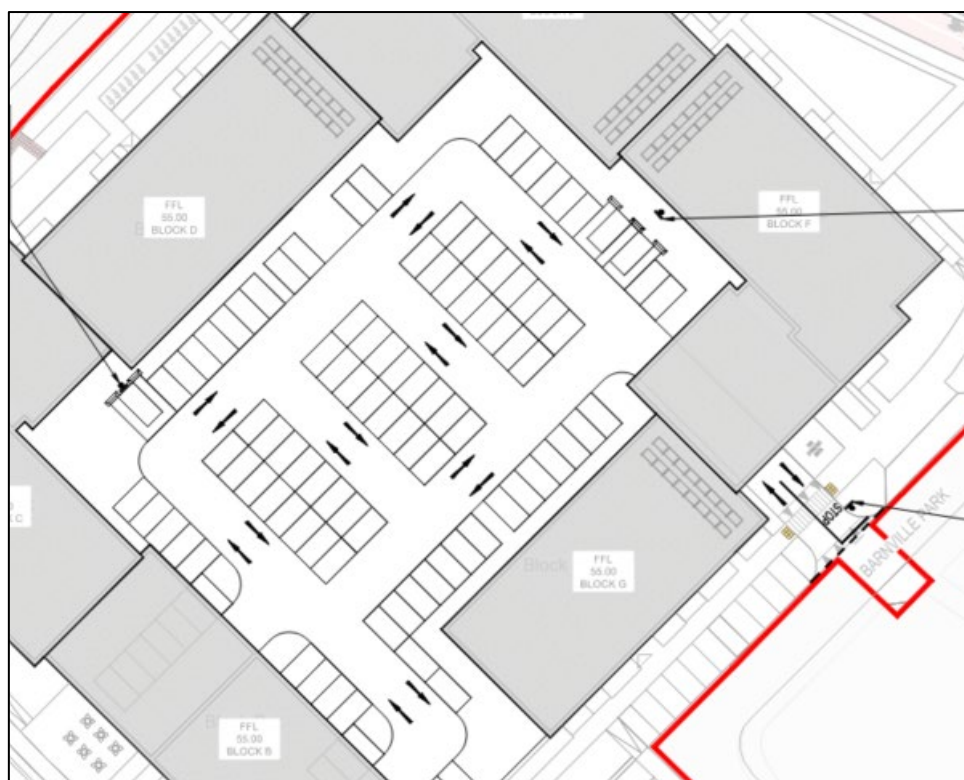
**Figure 5.7 – Junction Priority**

Priority arrangements at the internal junctions within the proposed car parking area are not indicated on the drawings. The absence of clearly defined priority may result in uncertainty among drivers regarding right-of-way, leading to hesitation, inappropriate manoeuvres, or conflicting vehicle movements. This could increase the risk of vehicular collisions and may also present a hazard to pedestrians moving through the car parking area.

Provide appropriate road markings at the internal junctions within the car park area.

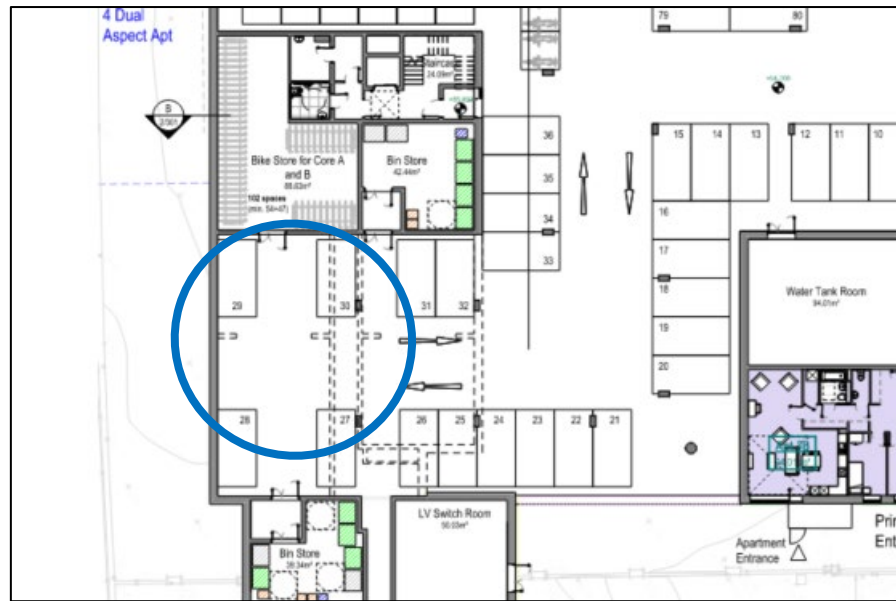
**Figure 5.8 – Turning Area**

It is unclear if an appropriate tuning is provided at the end of the cul-de-sac within the car parking area at the location shown in the image below. A lack of an appropriate turning area may lead to long reversing manoeuvres along the car park access road increasing collision risk at this location.

Ensure that an appropriate turning area is provided at this location.

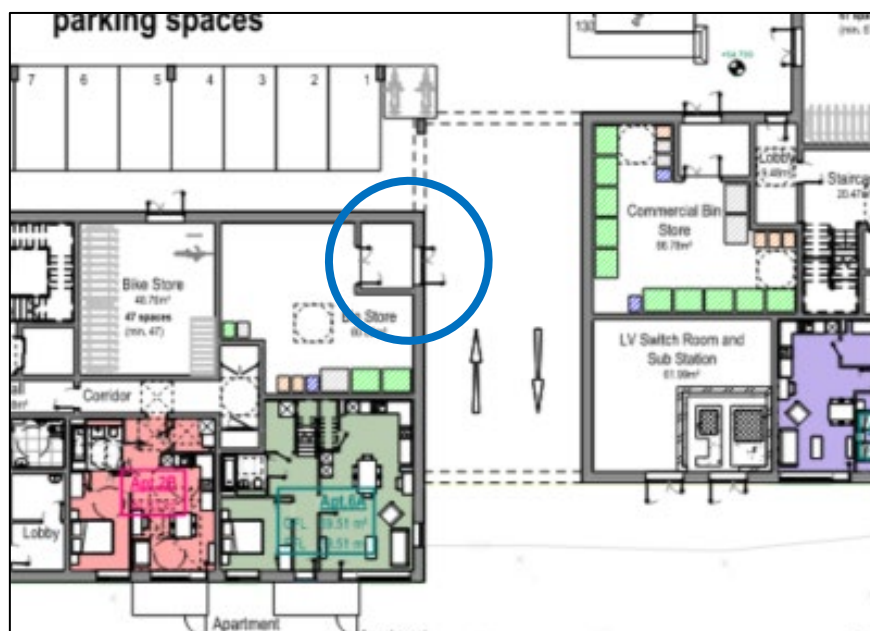
**Figure 8.9 – Pedestrian Access**

A door serving a bin storage area is proposed to open directly onto the vehicle access to the car parking area. Users exiting the bin storage area may step directly into the path of moving vehicles with limited opportunity to observe approaching traffic. Similarly, drivers may have insufficient time to react to pedestrians emerging from the doorway. This may increase the risk of collisions between vehicles and pedestrians, particularly during periods of servicing and waste collection activity.

Review the layout of the bin storage area and associated access arrangements to ensure that pedestrians are not required to emerge directly into vehicular routes.

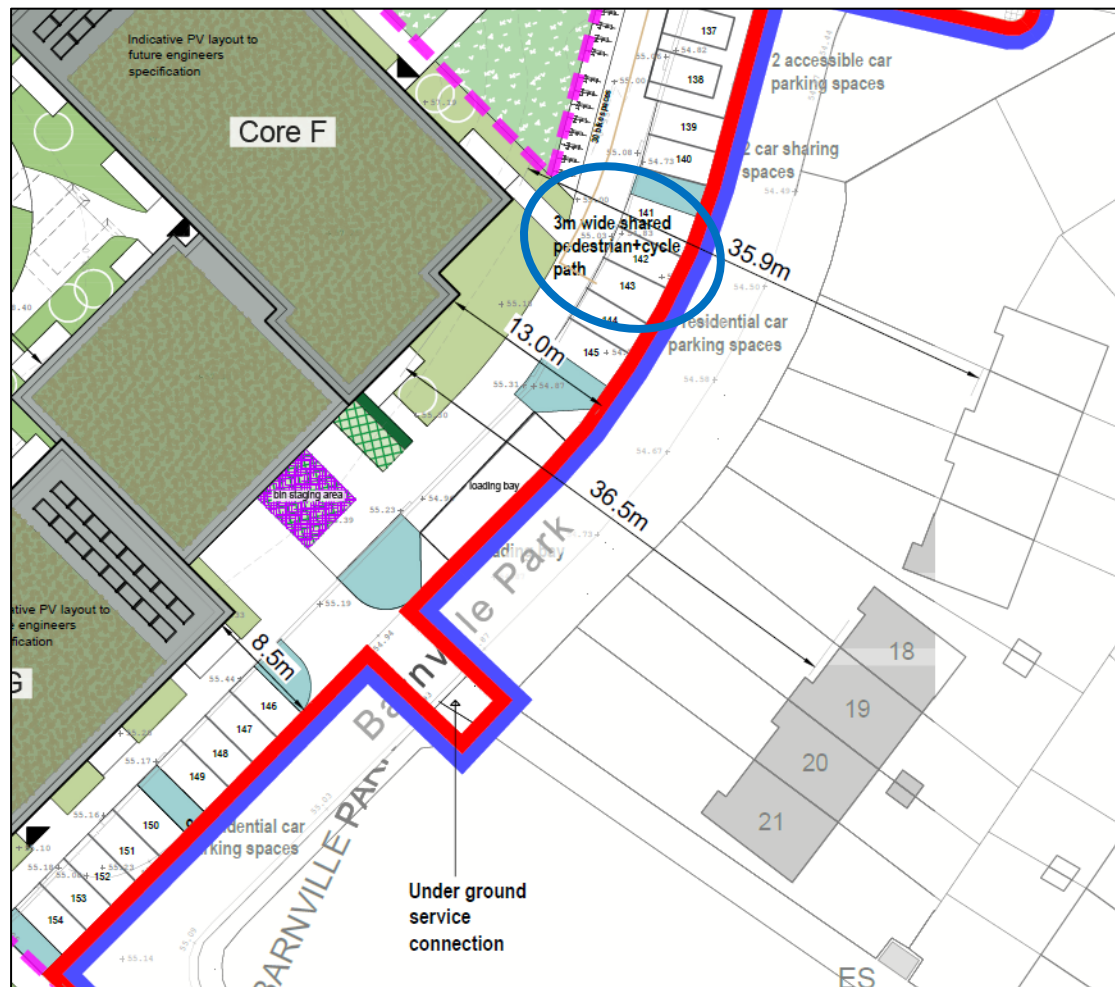
Figure 6.1 – Shared Footpath

A proposed shared footway (pedestrians and cyclists) will result the user comfort for both modes, especially in a development with reduced parking levels.

Consider segregated footway and cycleway. Ensure adequate cross-sectional width, and thereby level of service, for both modes of transport based on anticipated volumes of users.

| Paragraph No. in Audit Report | To Be Completed By Designer | | |
|---|---|---|---|
| 6.1 | YES | PARTIALLY | The recommendation to consider segregated cycle and pedestrian facilities is noted. A segregated cycle track and footpath are provided along the northern and eastern fronts of the development, in line with the primary roads and main cyclist routes. |

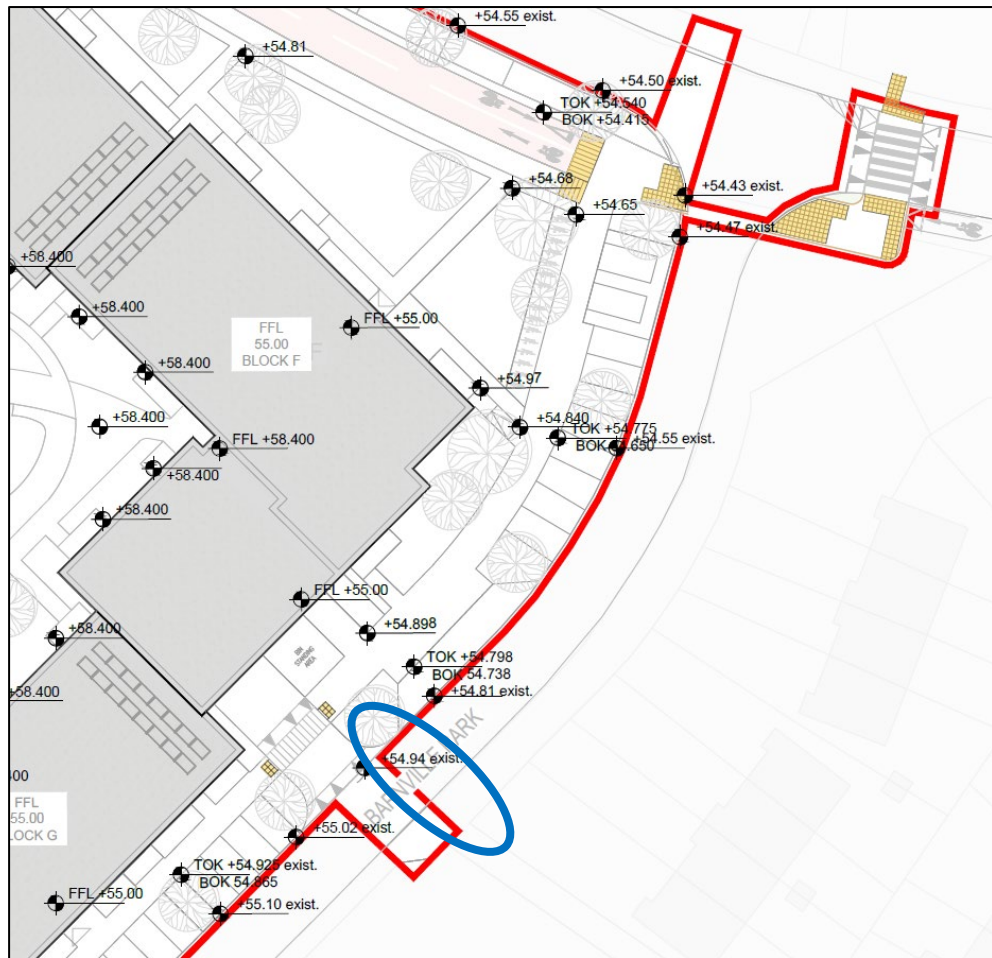
Infrastructure along pedestrian desire lines is not exhaustive along likely desire lines. This may reduce the attractiveness of walking as a mode of transport.

**Figure 6.2 – Likely Pedestrian Desire Lines without Crossing**

Ensure adequate pedestrian infrastructure along all likely crossing points and desire lines.

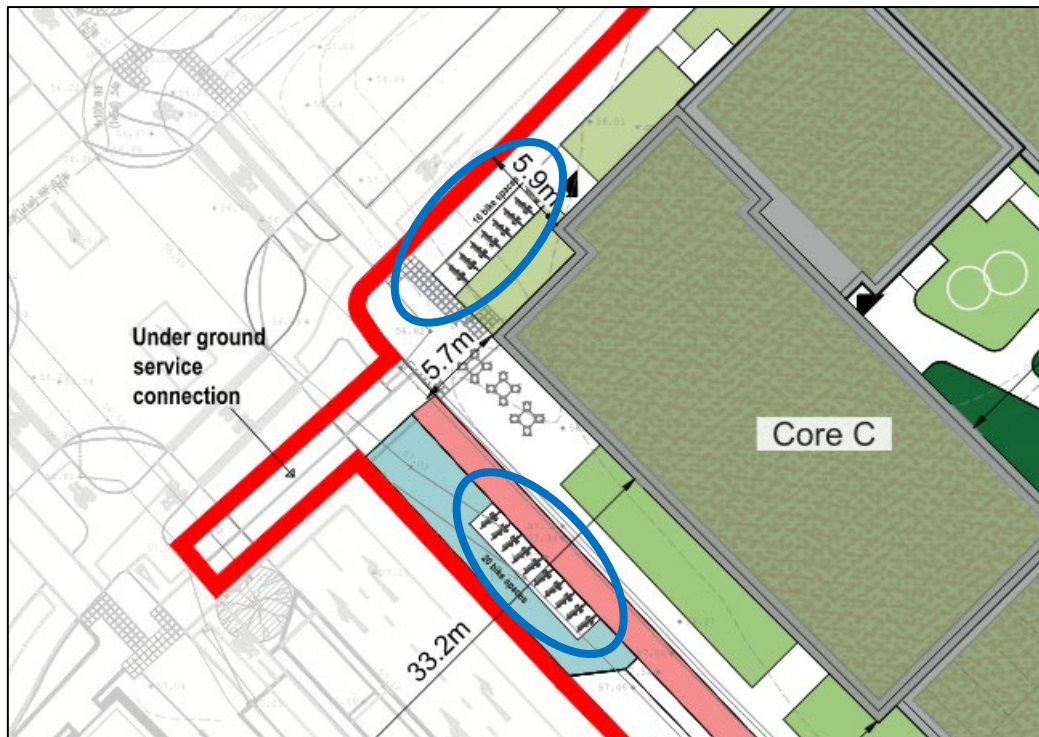
Sheffield Stands are proposed immediately adjacent to footpaths/shared space/cycletracks in a number of locations including but not limited to the locations shown in the image below. Poorly stored cycles may overhang onto the footpath/shared space area reducing its capacity.

**Figure 6.3 – Pedestrian Routes adjacent to Sheffield stands**

Ensure adequate separation between the cycle parking areas and the adjacent footpaths/shared space/cycletracks.

| Paragraph No. in Audit Report | To Be Completed By Designer | | |
|---|---|---|---|
| 6.3 | YES | PARTIALLY | The interface between the proposed cycle parking facilities and adjacent footpaths, shared spaces and cycle tracks is noted. The location and arrangement of the cycle parking facilities will be reassessed where appropriate to ensure suitable integration with the surrounding pedestrian and cyclist facilities. |

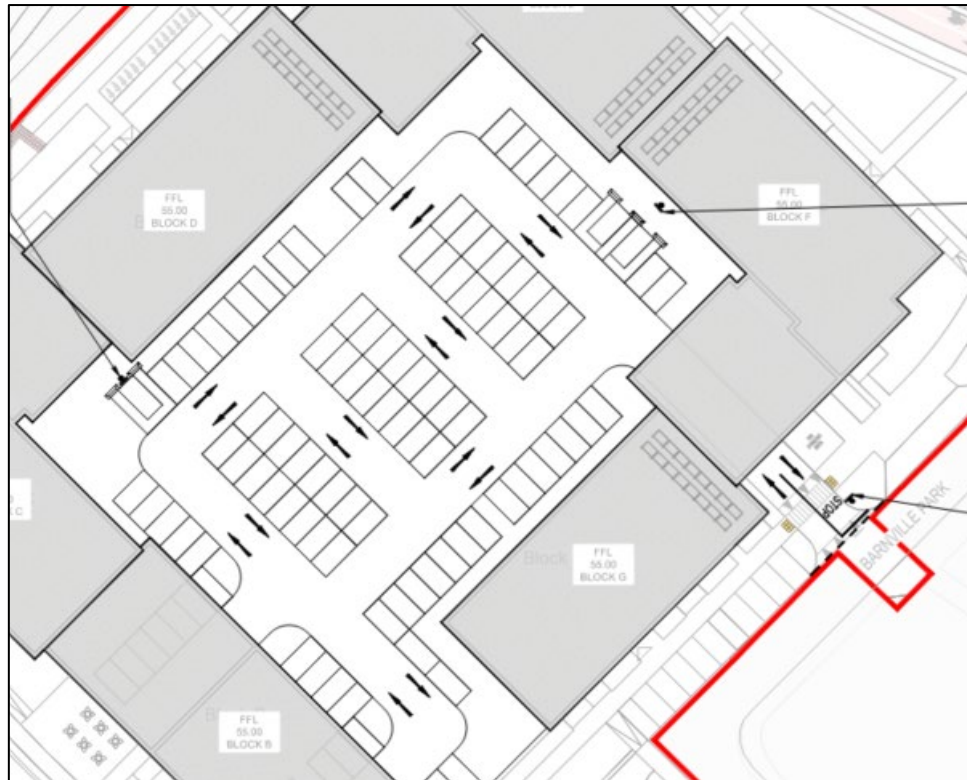
Adequate pedestrian links have not been provided within the proposed car parking area. As a result, pedestrians may be required to walk within vehicular circulation routes to access parking spaces, building entrances, and other facilities. The absence of dedicated pedestrian routes may lead to increased interaction between pedestrians and vehicles manoeuvring within the car park, thereby increasing the risk of pedestrians being struck by passing or reversing vehicles

**Figure 6.4 – Pedestrian Routes within the Car Park**

Provide dedicated pedestrian routes within the car parking area to facilitate safe and convenient pedestrian movement between parking spaces and key destinations within the development.

| Paragraph No. in Audit Report | To Be Completed By Designer | | |
|---|---|---|---|
| 6.4 | YES | PARTIALLY | The provision of dedicated pedestrian routes within the car parking area is noted. Dedicated pedestrian facilities are provided along the perimeter of the undercroft parking area, providing a safe route between the parking spaces and the wider pedestrian network. Given the scale and layout of the undercroft parking area, the provision of additional dedicated pedestrian routes through the parking aisles is not considered necessary. |

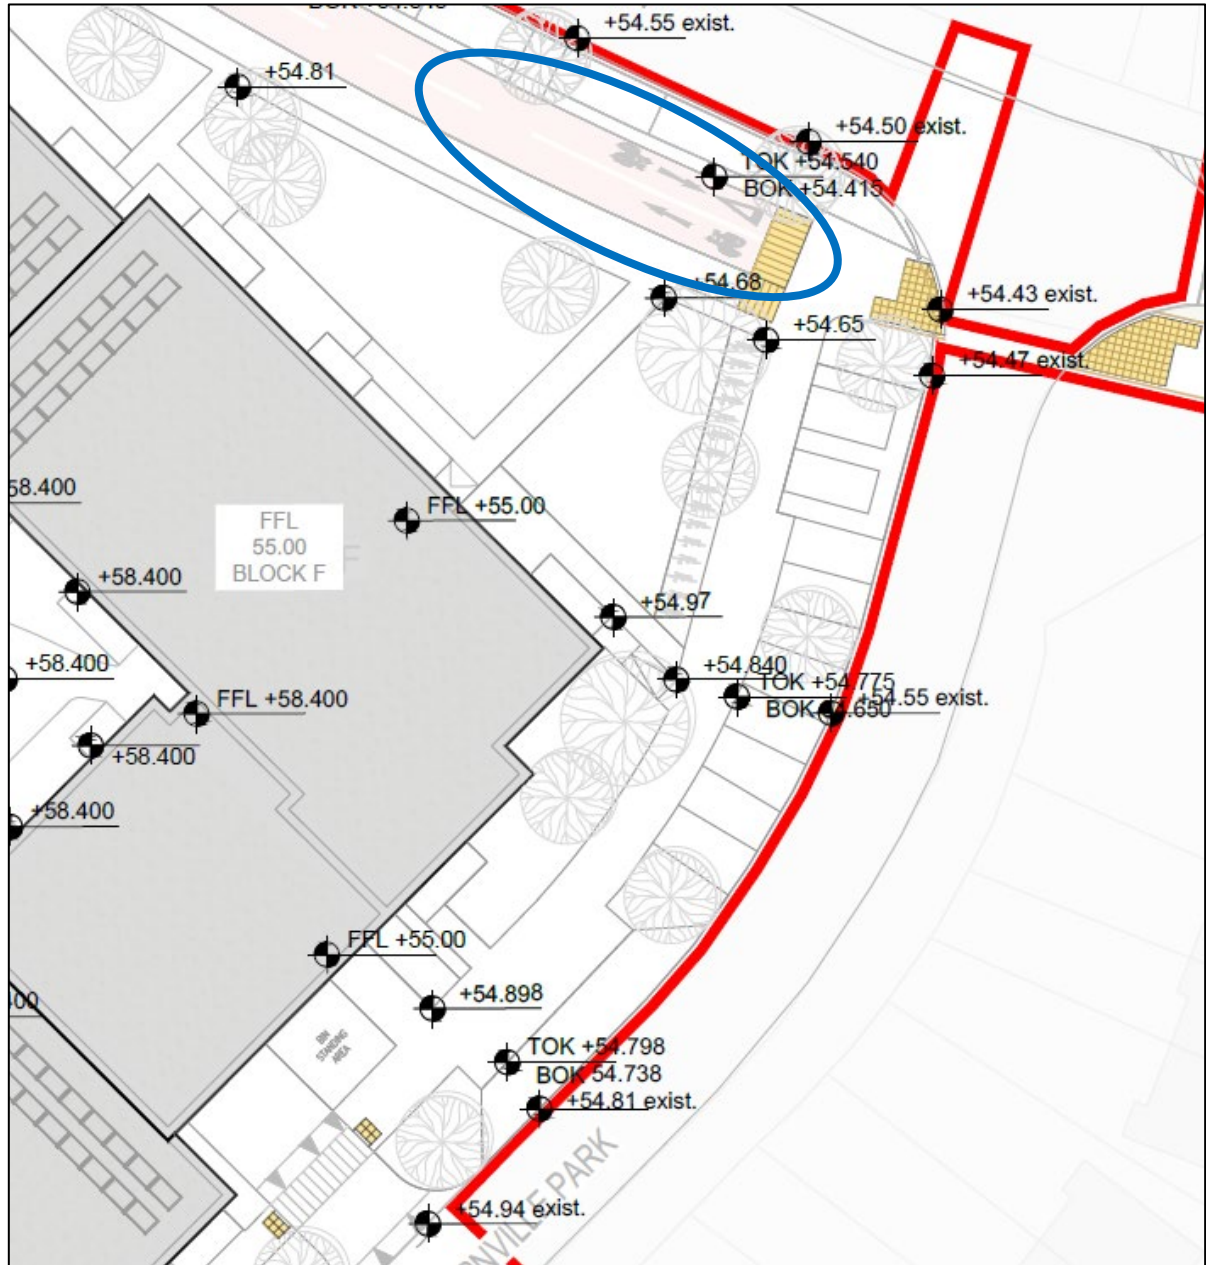
Figure 7.1 – Pedestrian Routes adjacent to Sheffield stands

Bi-directional cycleway ends at a congested area including shared space area and pedestrian crossings. It is unclear how cyclists will tie-in to/from this cycleway from surrounding/adjacent cycling routes or desire lines.

Ensure infrastructure provides ample opportunity for tie-in to adjacent/future infrastructure.

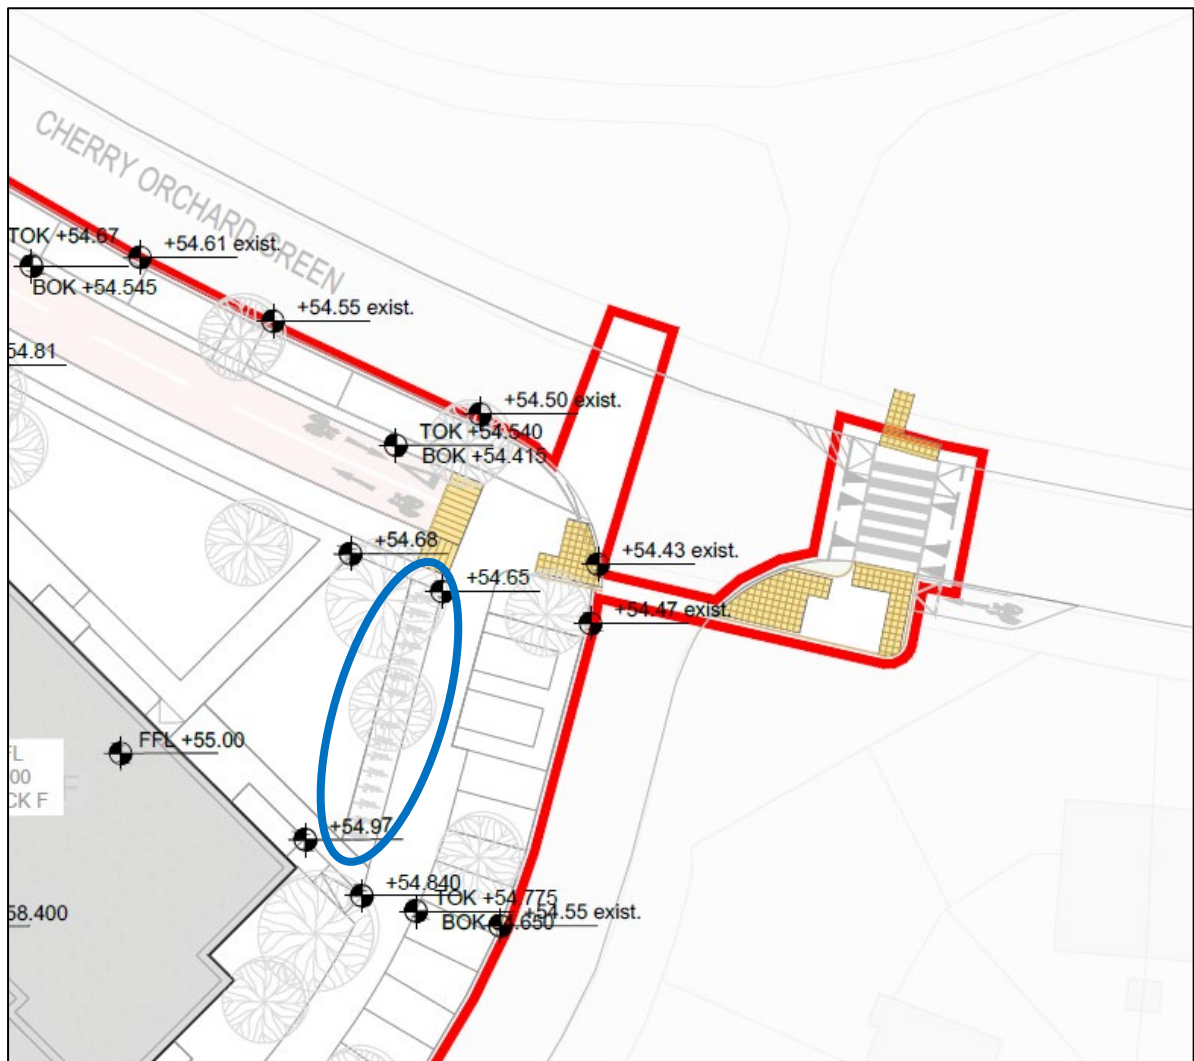
**Figure 7.2 – Sheffield stands**

It is unclear how the proposed Sheffield stands will be fixed to the ground. If these are bolted to the ground, where the bolt is accessible, this can give rise to theft by the removal of the Sheffield stand using a socket set (or similar). Risk of theft or non-secure storage may reduce the attractiveness or uptake of the mode.

Ensure secure storage.

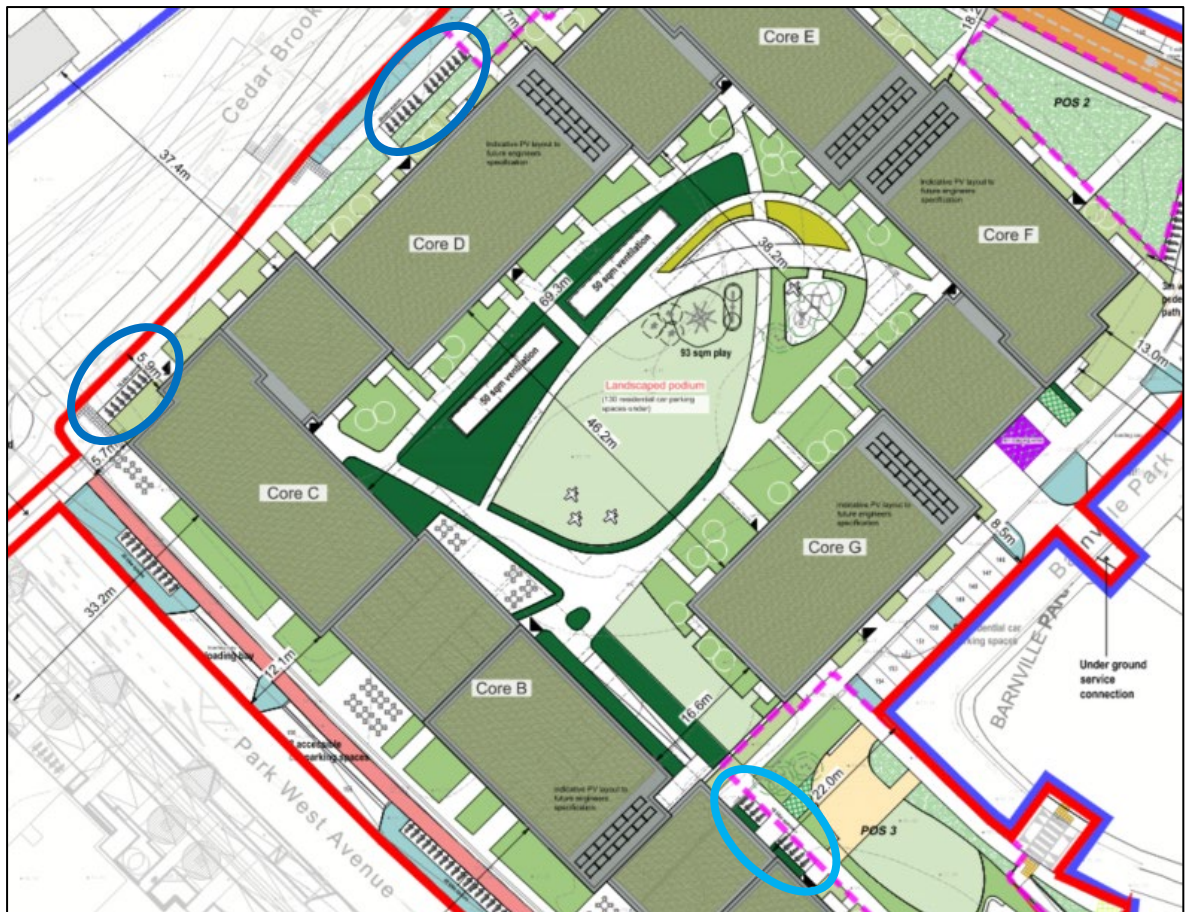
**Figure 7.3 – Cycle Access**

It is unclear how cyclists will access some of the cycle parking areas from the proposed cycle facility. A lack of appropriate connections may lead to conflicts with other road users

Ensure appropriate access is provided from the cycle facility to all the cycle parking areas.

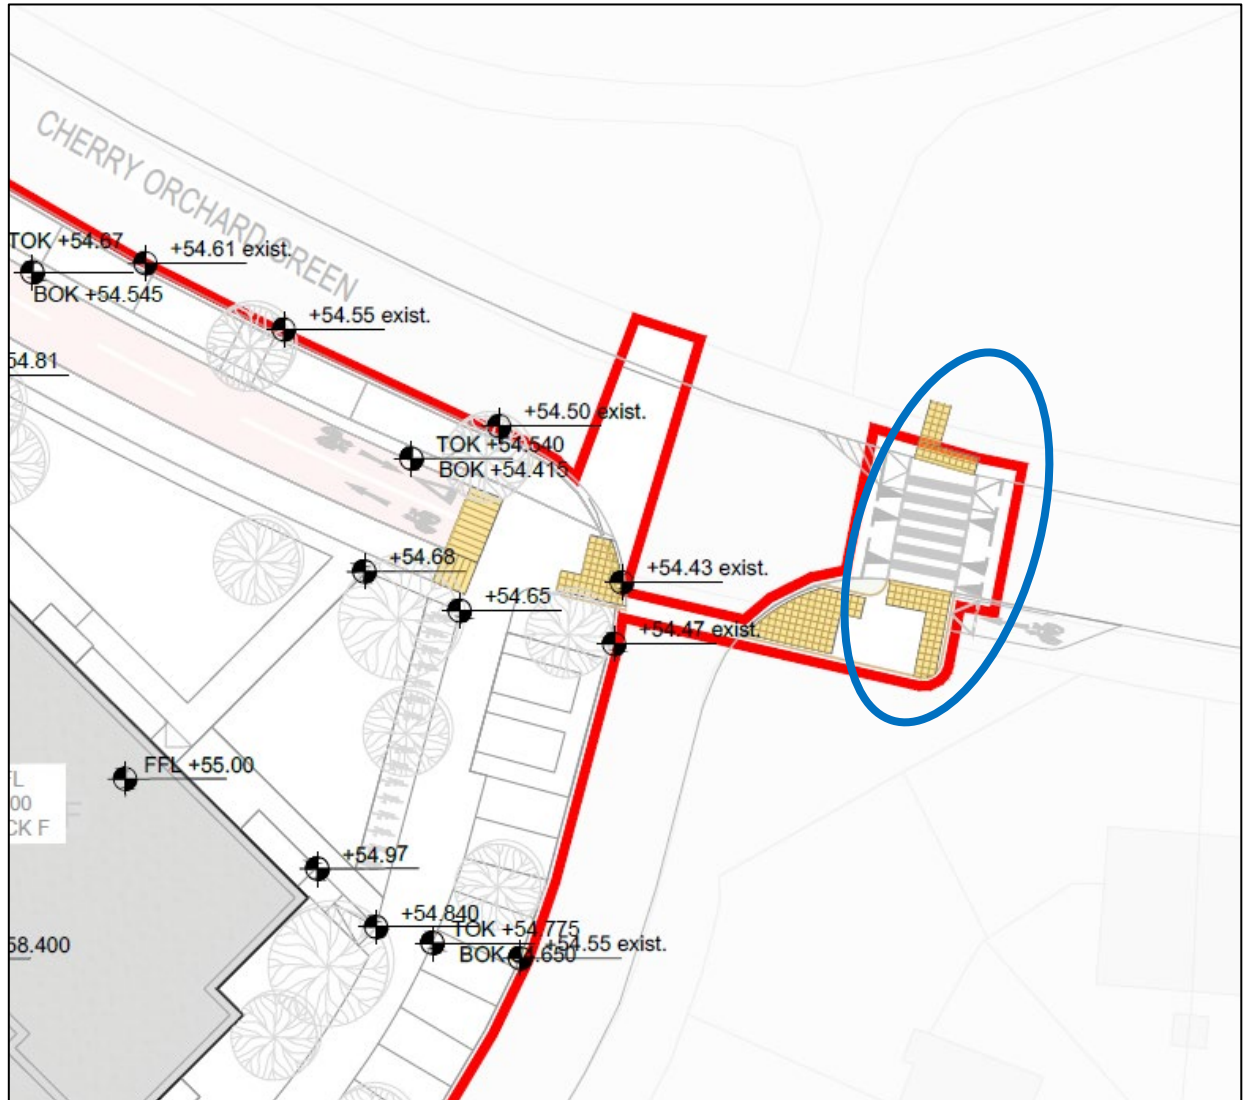
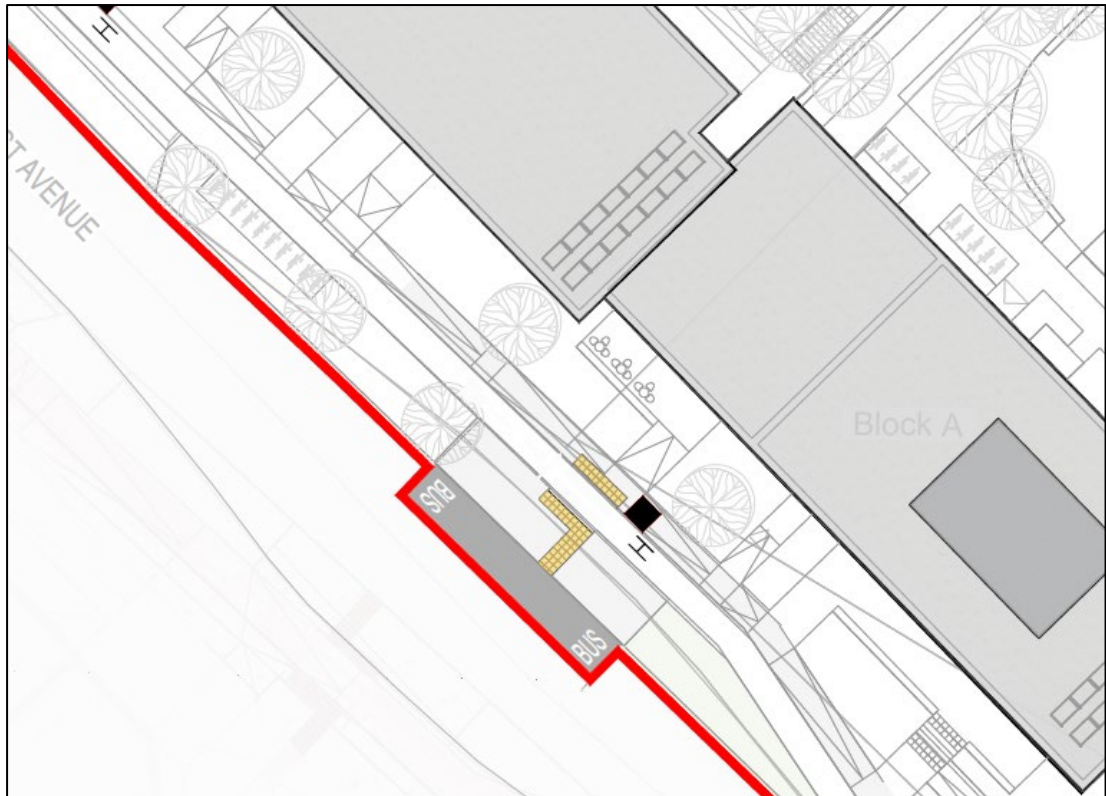
Proposed tactile paving appears to be incorrect (Buff coloured with a tail). Incorrect usage of tactile paving may result in confusion, causing disorientation, for vision impaired users.

**Figure 8.1 – Incorrect Tactile Paving Layout.**

**Figure 8.2 – Incorrect Tactile Paving Layout.**

Ensure compliance with tactile paving standards to support independent navigation for white cane users.

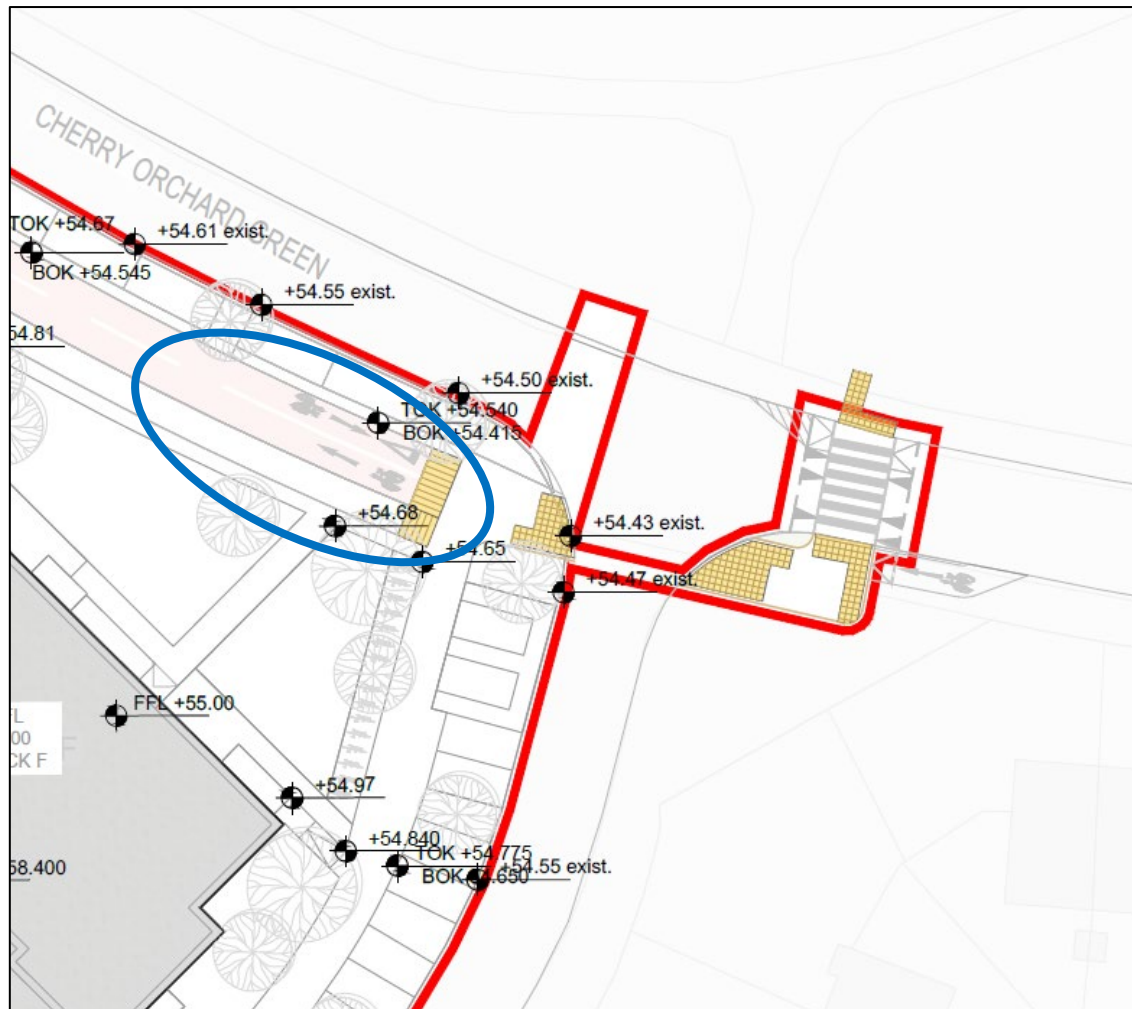
**Figure 8.3 – Footway / Cycleway Arrangement**

It is unclear if there will be any segregation between the footway and cycleway. Where installed at grade without tactile delineation, this arrangement can cause disorientation for vision impaired users who may walk inadvertently onto adjacent cycleways, creating a conflict.

Consider upstand between footway and cycleway or tactile delineation.
