**PROPOSED RESIDENTIAL DEVELOPMENT  
PARK WEST AVENUE, CHERRY ORCHARD,  
DUBLIN 10**

**Stage 1 Quality Audit**

**(Incorporating a DMURS Street Design Audit, and Audits  
of Accessibility, Cycling, Walking and Road Safety)**

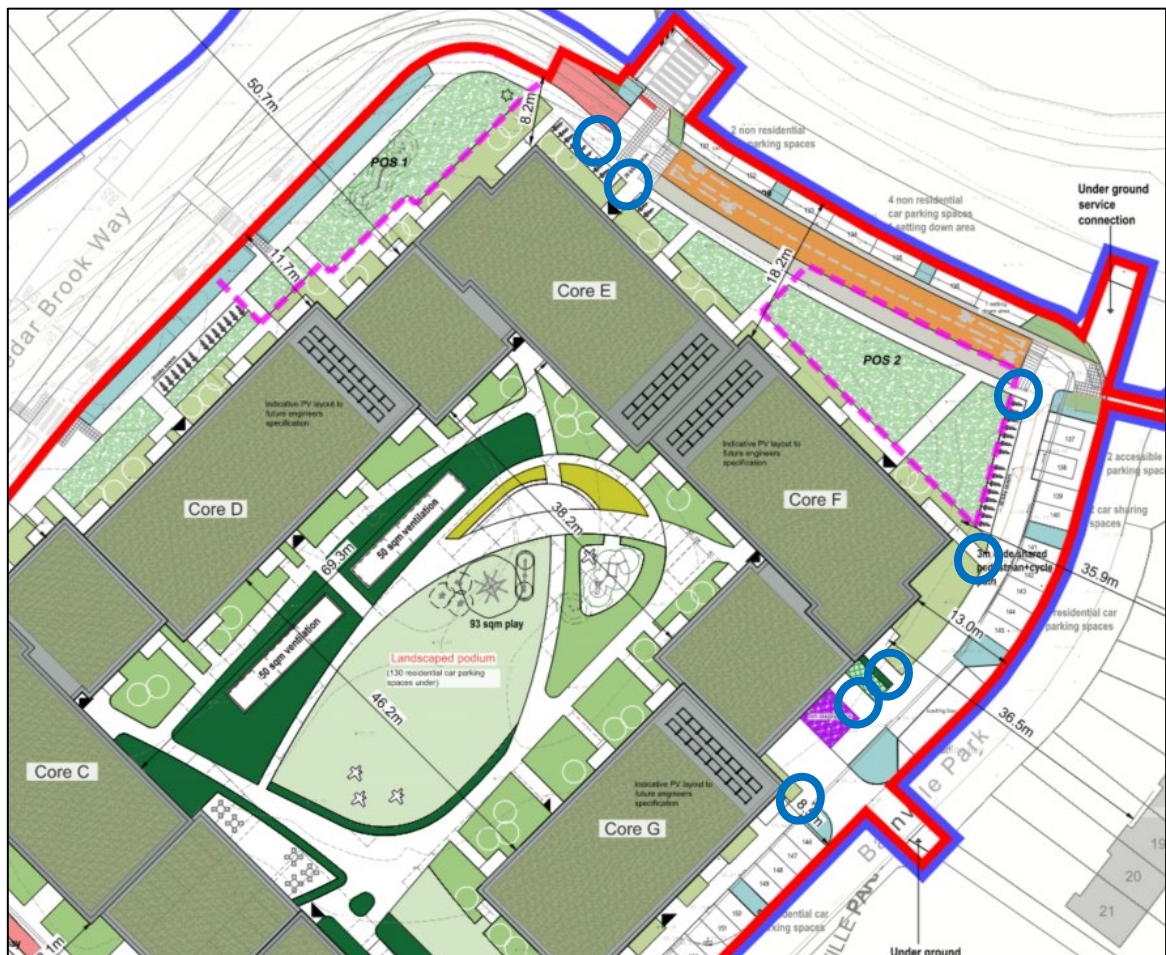
**Figure 8.4 – Tactile Paving**

Footpaths intersect with shared pedestrian/cycle facilities at a number of locations throughout the proposed development. However, no measures are indicated to warn pedestrians that they are entering an area where cyclists may be present. The absence of appropriate warning measures may result in pedestrians inadvertently entering the path of cyclists, leading to uncertainty and increasing the risk of collisions between cyclists and pedestrians, particularly vulnerable users such as children, older people, and those with visual impairments.

Provide appropriate tactile paving at locations where footpaths intersect with shared pedestrian/cycle facilities to alert pedestrians to the potential presence of cyclists.
