**STAGE 1 ROAD SAFETY AUDIT**

**PROPOSED N25 GLENMORE BUS STOP RELOCATION SCHEME**

**TRANSPORT INFRASTRUCTURE IRELAND**

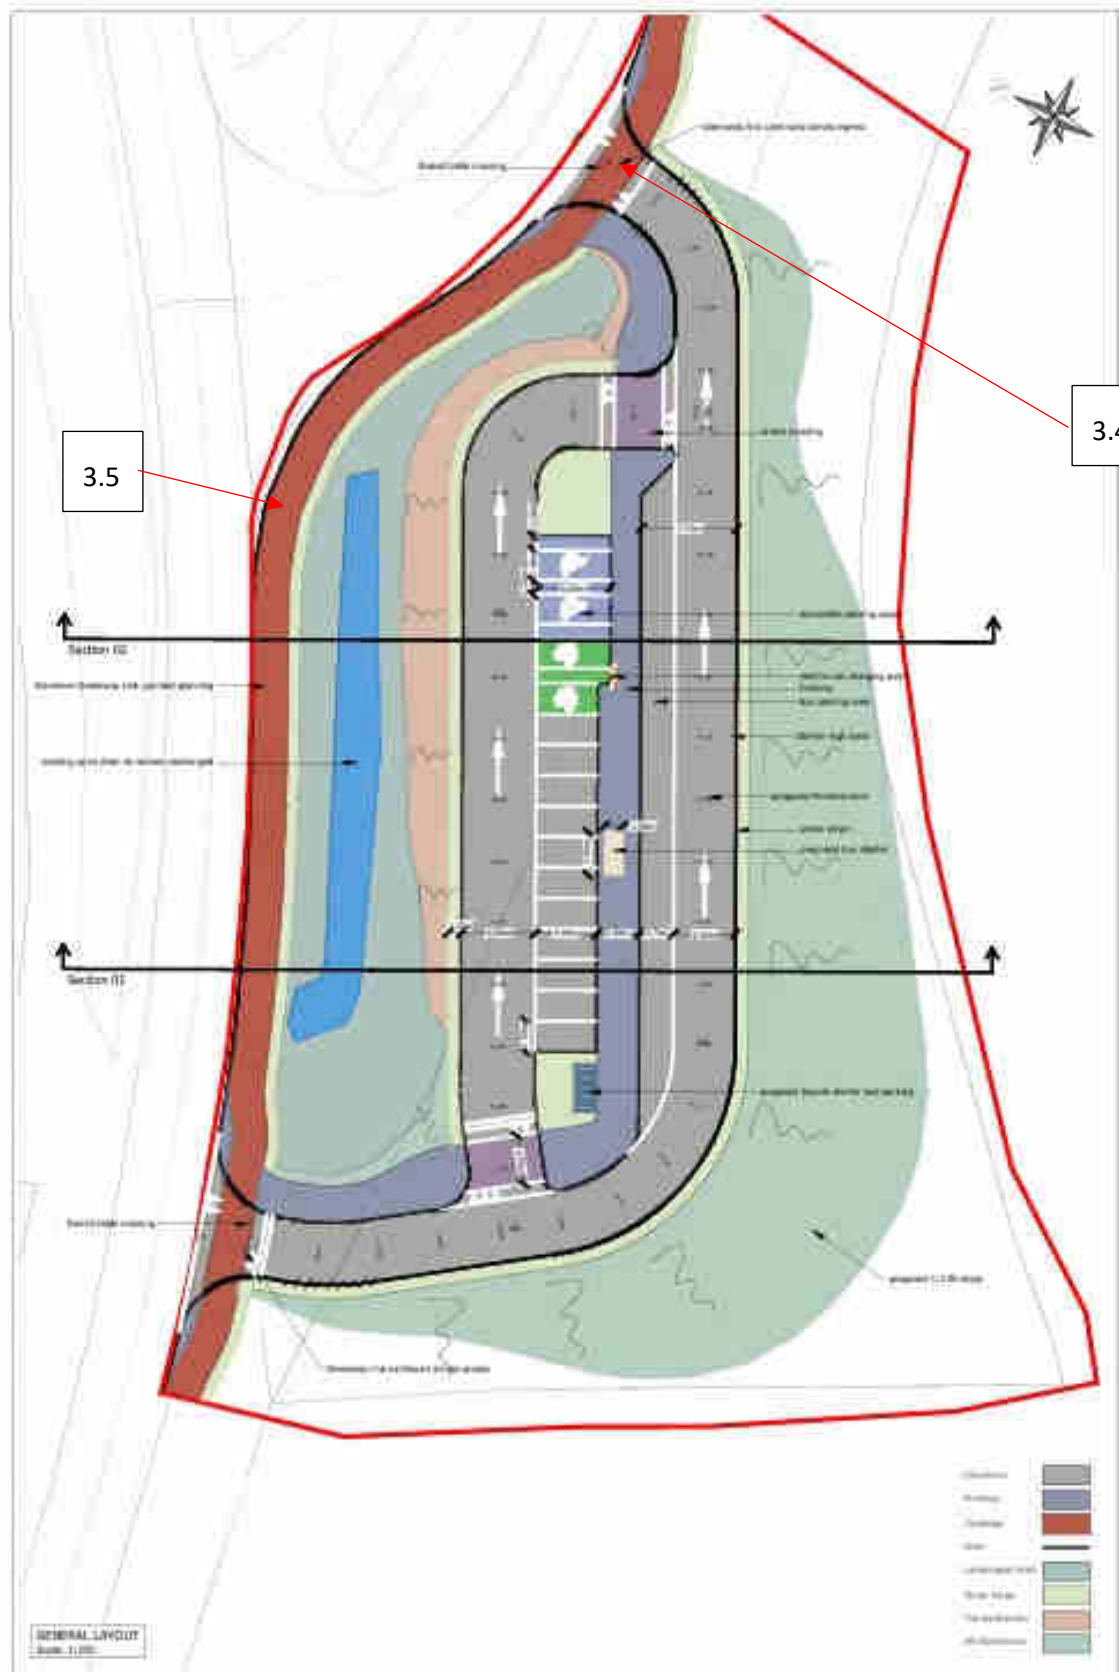
## Appendix B – Problem Locations

At the exit from the proposed bus stop onto the L7539 public road, the swept path analysis indicates a wide turning movement for buses. As a result, buses may cross the centreline of the L7539, potentially bringing them into conflict with opposing traffic. The nearby existing L7510 junction is also wide with high entry speeds, which may further increase the risk. This creates a potential hazard, with an increased risk of vehicle collisions between buses and opposing traffic, which could result in injury to road users.

At the proposed cycle track bounding the proposed bus stop, it is unclear whether a buffer is provided between Greenway link users and vehicles travelling along the adjacent carriageway. This presents a potential hazard, as cyclists/pedestrians may not be adequately separated from live traffic, increasing the risk of conflict with passing vehicles and potential injury to vulnerable road users.

3.1 to 3.3 throughout scheme

Bus stop exit geometry should prevent encroachment onto the opposing lane, and the L7510 junction entry should be tightened to reduce vehicular speeds.

Provide a buffer between the greenway link active travel measures and carriageway.
