## **APPENDIX 9-5**

### ***FLOOD RISK ASSESSMENT***

This Stage 2 Flood Risk Assessment (FRA) supplements Chapter 9: *Hydrology and Hydrogeology* of the Environmental Impact Assessment Report (EIAR) for the proposed Slievegrine Renewable Energy Development, located approximately 5 km southwest of Dungarvan, Co. Waterford

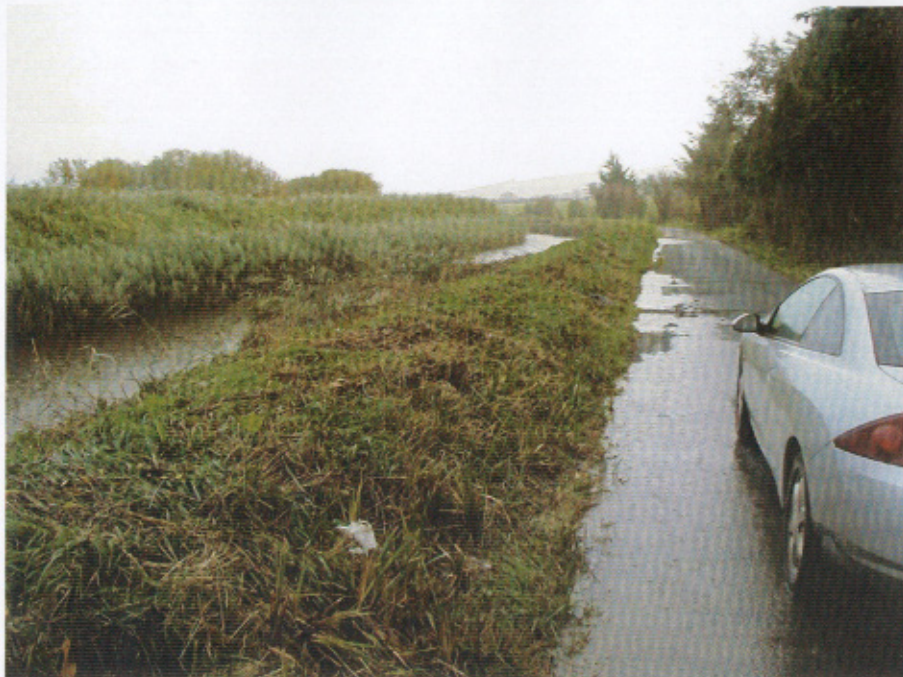
Photo 6

Bricker  
C.D.S.
