Figures 7-1 to 7-5

CHAPTER 7: Land, Soils and Geology

- 7.1 This 'Land, Soils and Geology' (LSG) chapter of the Environmental Impact Assessment Report (EIAR) has been prepared for a lateral extension of the eastern boundary of an existing working quarry at Ardgaheen, Claregalway, Co. Galway .

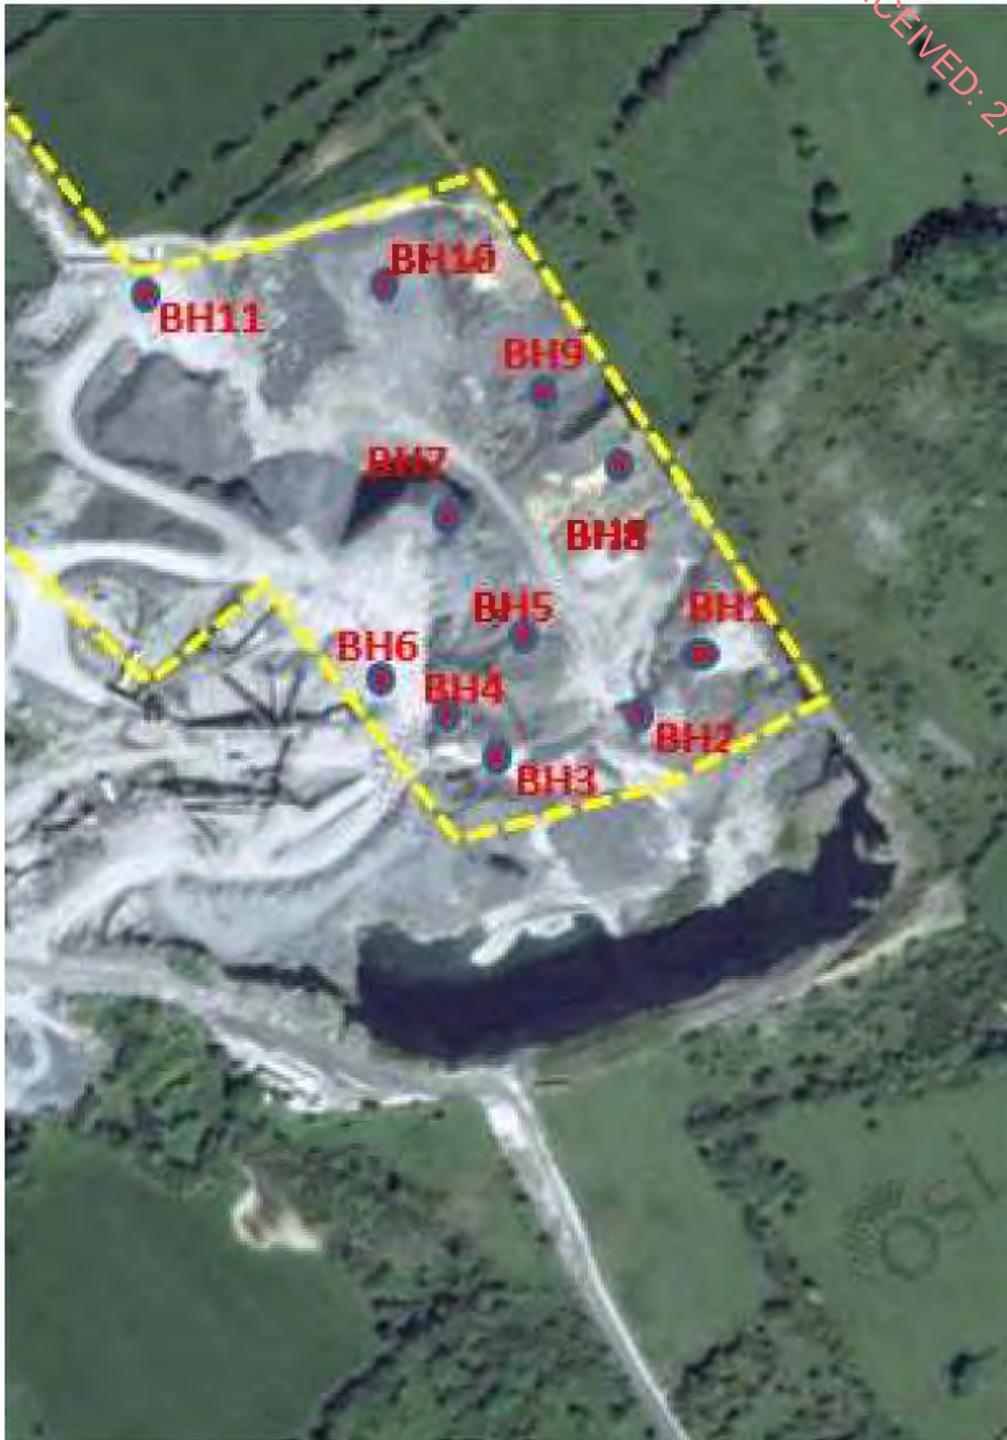
Figure 7-6 Floor BH IDs (2017) with reference to Table 7-2 data for Ksat.

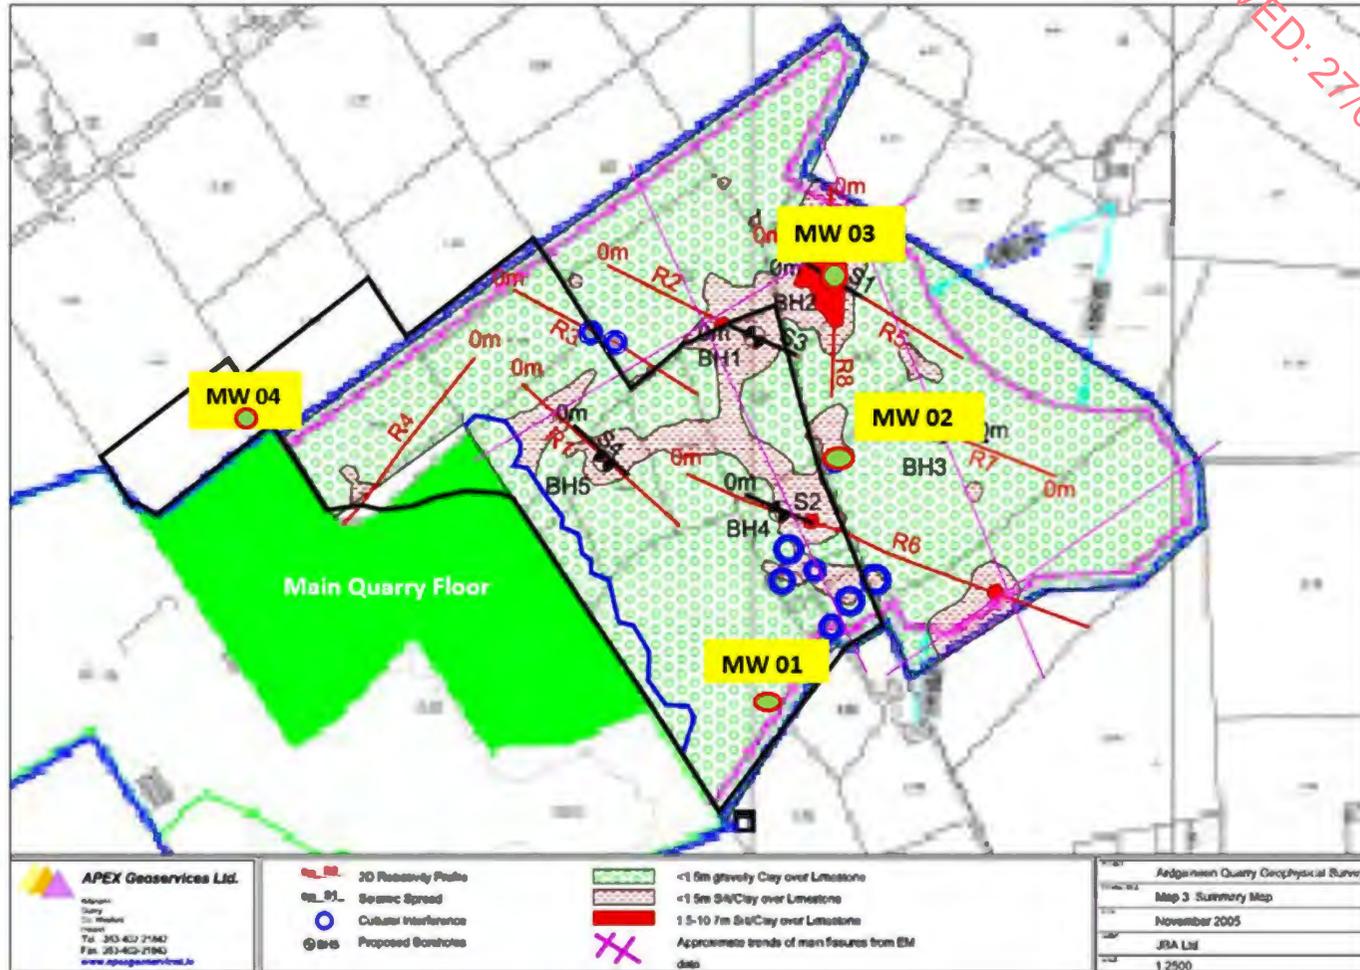
Figure 7-7 Greenfield MW Installation Locations 2020 (●), overlaid with Apex (2005) Geophysical Results.

The four Monitoring Wells were completed at Ground Level with above ground steel casing and protective fences. Two of the four Monitoring Well locations were chosen to target solid limestone and two locations were selected to target the weathered zones indicated in the Apex 2004 geophysical survey. For each Monitoring Well, both the drillers notes and Borehole Logs are presented in the Site Investigation Appendix VI. The conditions encountered at each MW were related to ground level elevations and drilling details of note are summarised in Table 7-3.

- **MW 01 = Targeting Solid Limestone (Apex, 2005, Appendix VI):**
 - Ground Level Elevation = 41.37m OD
 - Topsoil to 0.4m bgl, broken rock @ 0.4m bgl and solid limestone @ 1.5m bgl.
 - This suggests a 1.1m deep Epikarst at the top of the rock from 0.4m bgl to 1.5m bgl.
 - Well drilled to a total depth of 45m (i.e. base elevation = -3.63m OD).
 - Solid limestone rock from 1.5m to 45m bgl, with no voids, no clay bands and no heavily weathered zones. Mostly a black soft rock, with strong odour that can normally occur when a historic organic matter layer in the sedimentary limestone bedrock is encountered. Some layers of slightly harder grey to dark grey rock.

- **MW 02 = Targeting Geophysical Anomaly zone (Apex, 2005, Appendix VI):**
 - Ground Level Elevation = 40.86m OD.
 - Topsoil to 0.3m bgl, Gravelly Cobbly Clayey Sands and some rock from 0.3m until 3.7m bgl = Glacial fill above rock with epikarst broken limestone at 3.7m to 4.5m bgl.

- **MW 03 = Targeting Geophysical Anomaly zone (Apex, 2005, Appendix VI):**
 - Ground Level Elevation = 37.38m OD
 - Topsoil to 0.4m bgl.
 - Clayey sandy Gravel or very weathered rock from 0.4m until 7m bgl = Glacial fill above solid bedrock.
 - 7m to 7.5 m is broken rock = epikarst.

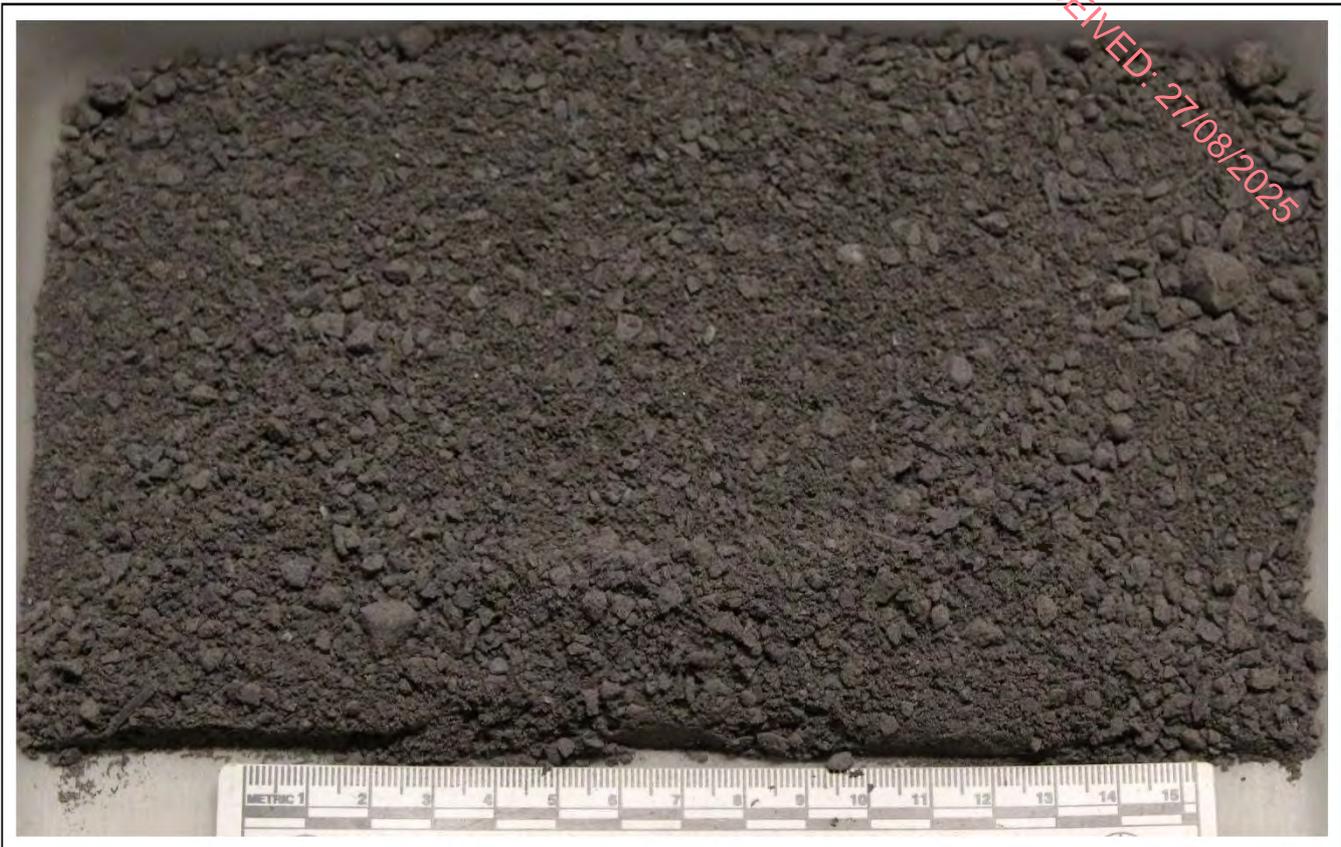
Hand specimen (unwashed)
cm scale

Damp, sub-angular to sub-rounded, dark grey, limestone CRF.

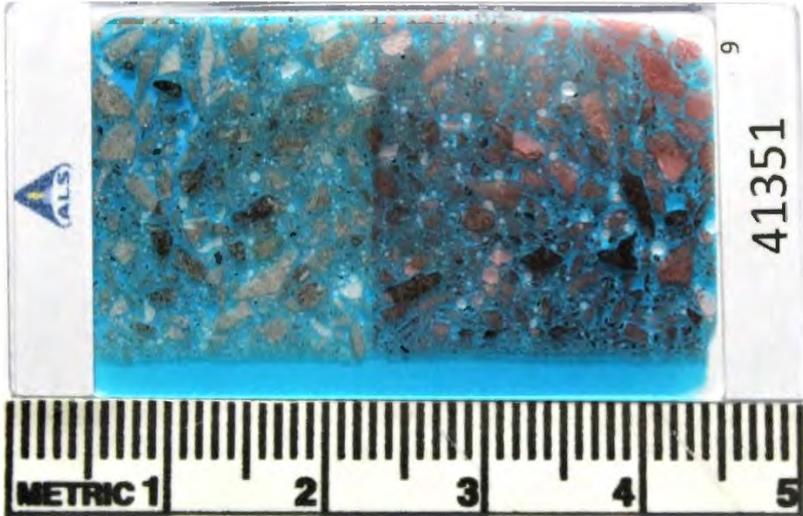
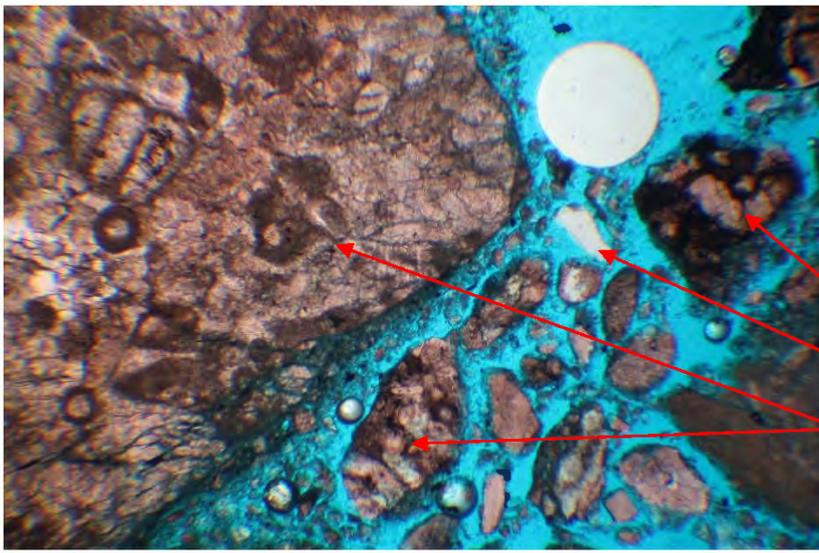
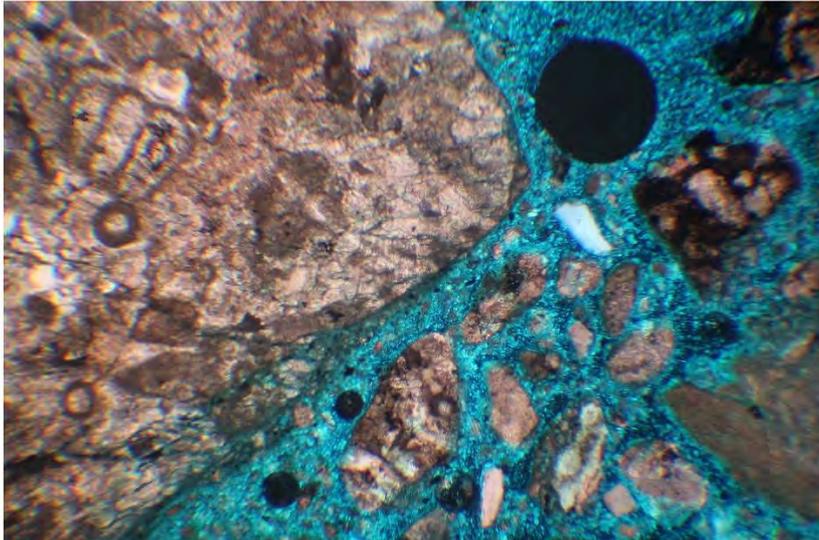
Figure 2 Photographic Record of 41351, CRF (hand specimen and under microscope)

<p>41351</p> <p>CRF</p> <p><i>Hand specimen</i></p> <p>cm scale</p> <p>Mounted in blue glue, polished thin section of CRF, half stained for carbonates (right).</p>

<p><i>Plane Polarised Light</i></p> <p>Field of view: 4mm</p> <p>Stained area of thin section: pink indicates calcite, black indicates fine-grained material, colourless indicates quartz and dolomite.</p> <ul style="list-style-type: none"> Fine-grained limestone Quartz Bioclastic limestone

<p><i>Cross Polarised Light</i></p> <p>Field of view: 4mm</p>

This sample consists of fresh, sub-angular to sub-rounded CRF; these particles consist of approximately 92% bioclastic limestone / calcite spar, 5% fine-grained limestone, 1% dolomite, <1% quartz, <1% calcareous mudstone, <0.1% chert, and <0.1% limonite. No free mica is observed. There is very rare pyrite observed overall. The sample is compliant with SR16: 2016, provided the aggregate meets all the strength, durability and soundness criteria.

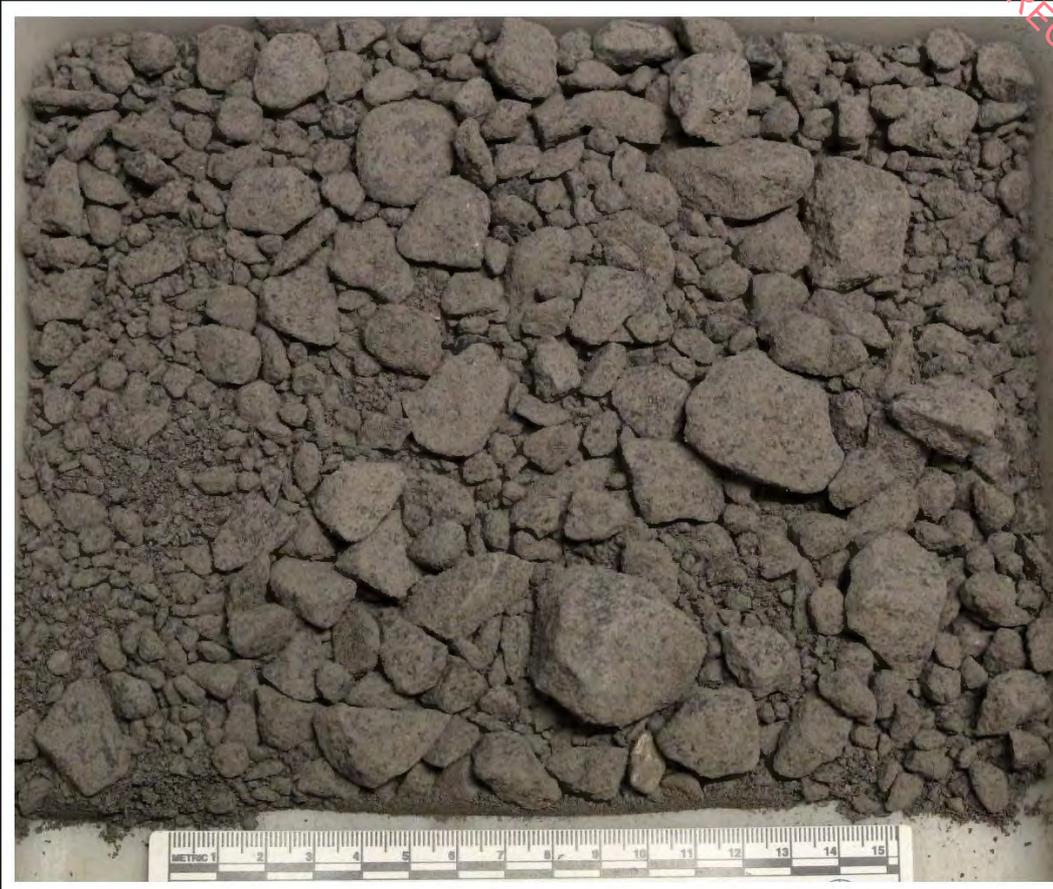
<p>RECEIVED: 27/08/2023</p> <p>Hand specimen (unwashed) cm scale</p> <p>Damp, angular to rounded, fresh limestone aggregate.</p>

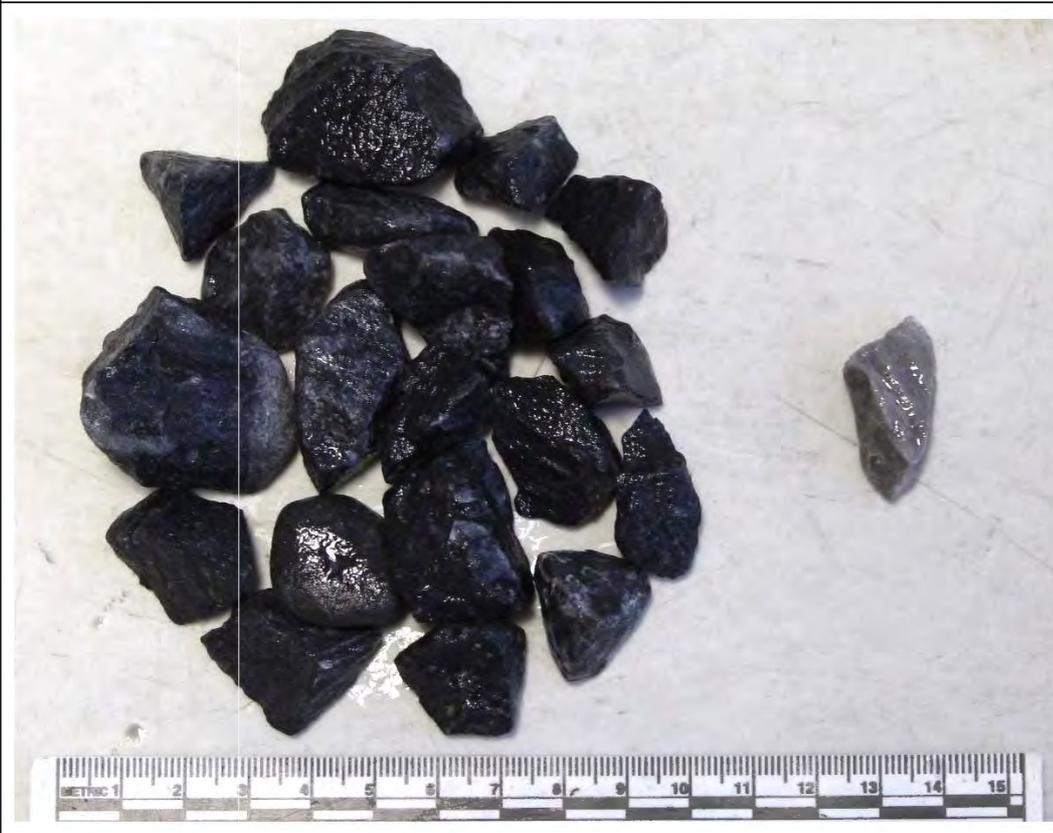
<p>Hand specimen (washed) cm scale</p> <p>Clean, angular to rounded, fresh, bioclastic limestone (left) and dolomite (right) aggregate.</p>

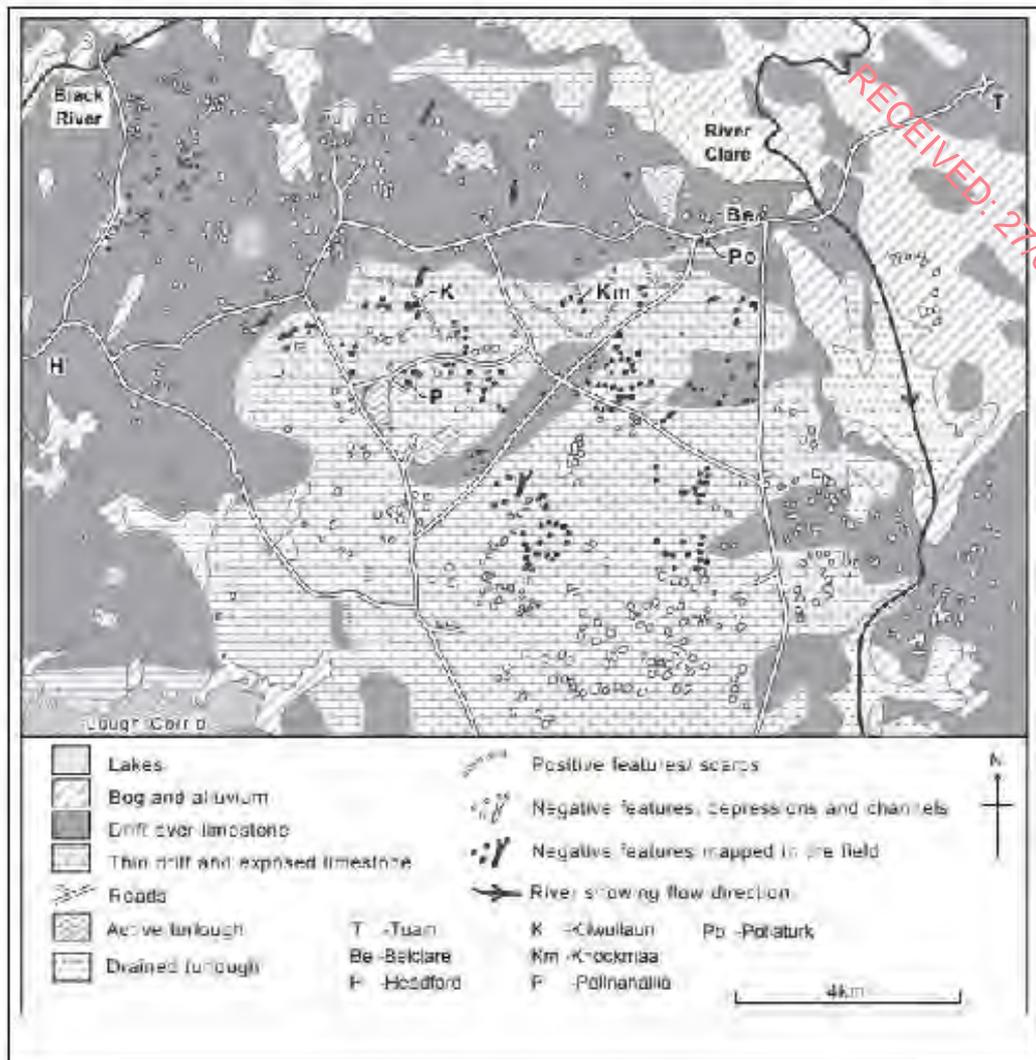
Detailed map from Pete Coxon's 2005 paper on the Knockmaa area.

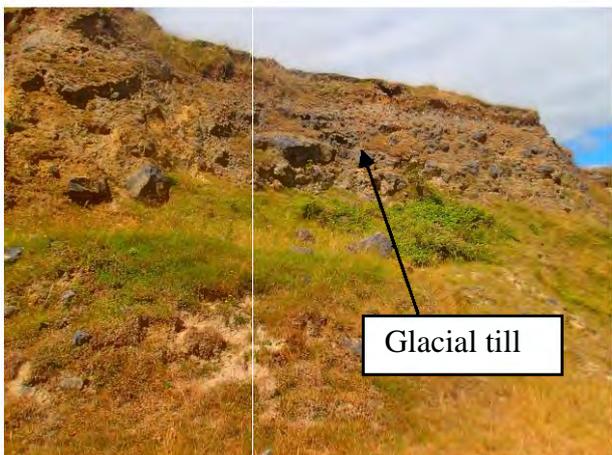
Glacial till above sand in the northern face of the Pollnahallia pit.

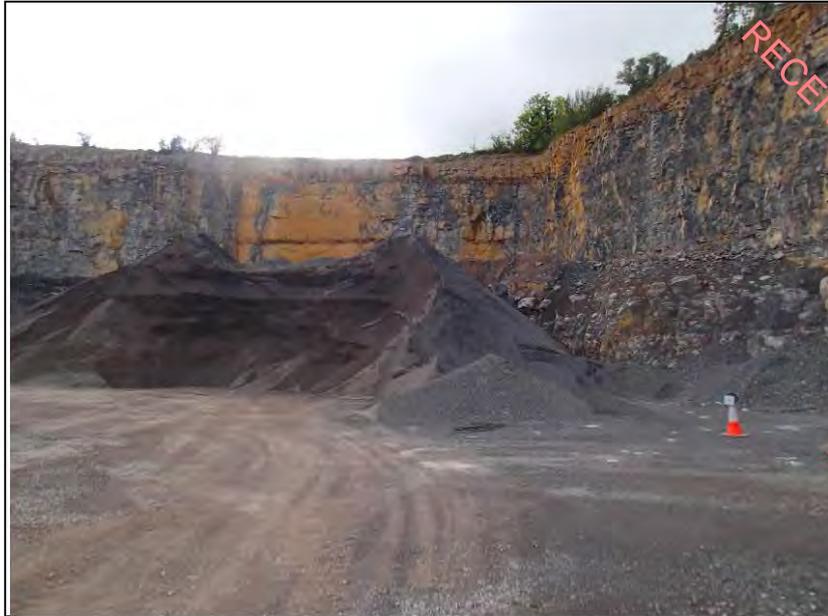
The main face in McTigue Quarry, showing bedded limestones overlying massive rock.

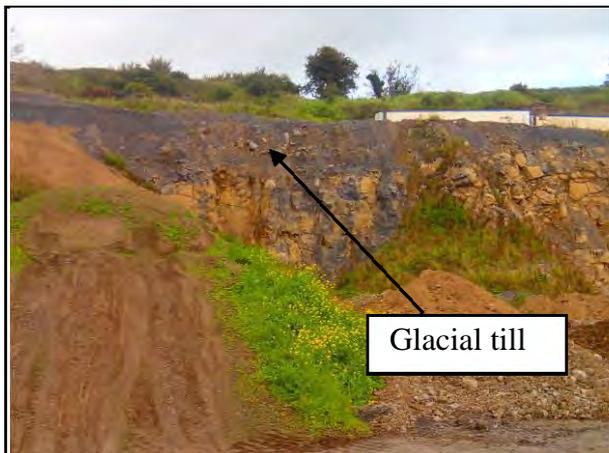
Glacial till above bedrock in the northern face of McTigue Quarry.

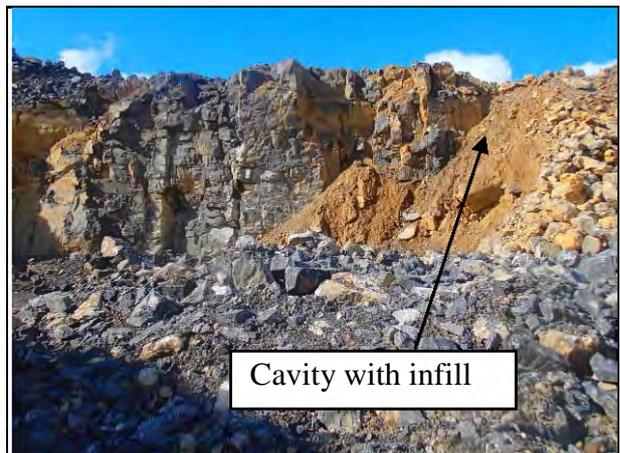
Clay-filled cavity in the northern face of Mortimer Quarry.

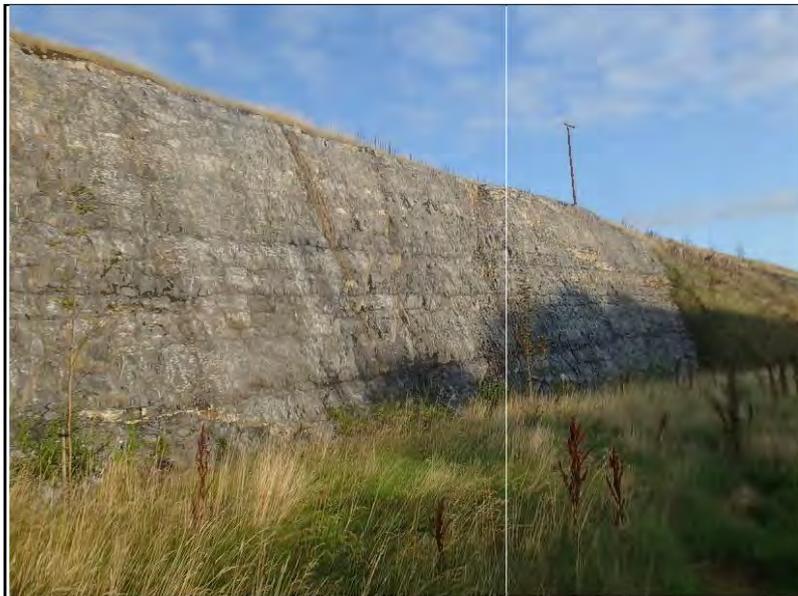
Gently dipping beds of limestone, along the western section of the outcrop. The clay wayboards are clearly seen as black lines through the section.

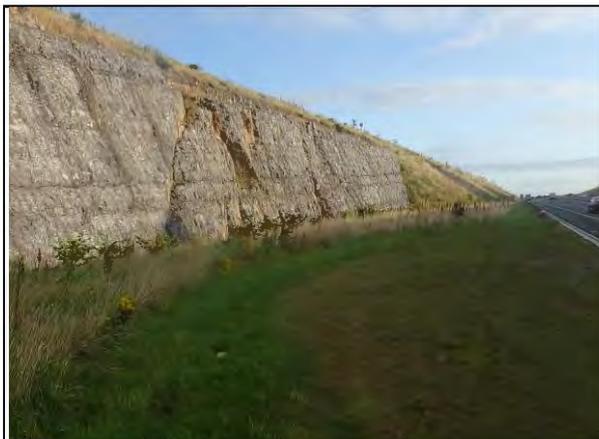
Groundwater seepage beneath epikarst layer, and potential karstified bedrock cavities.

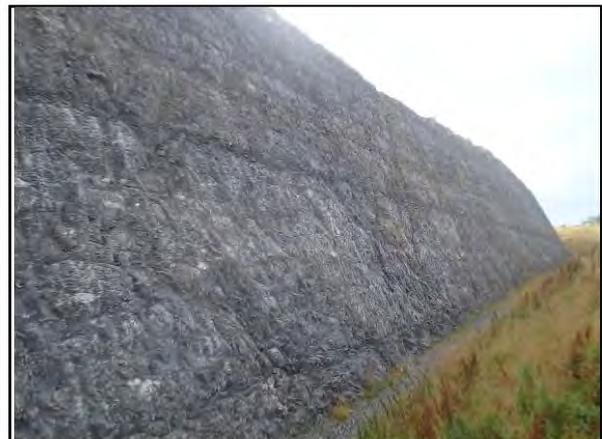
Nodules of calcite seen as white blobs in the left hand side of this, the eastern section.

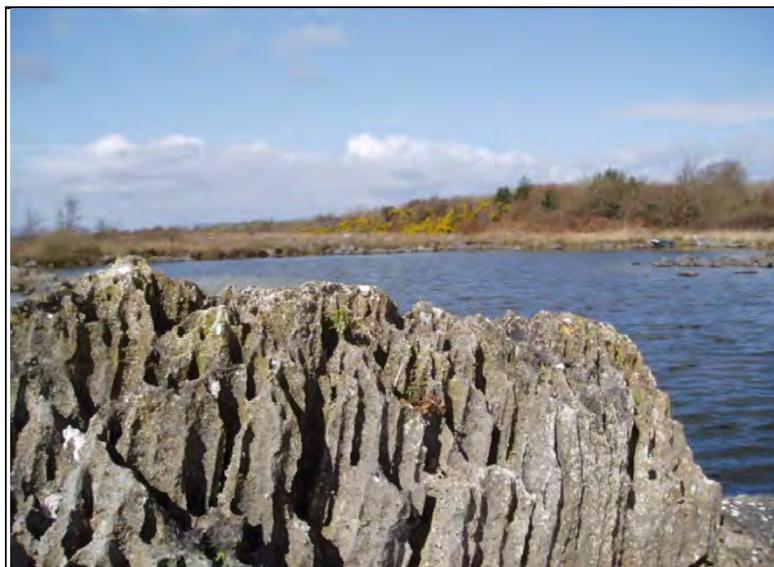
Karstified bedrock at Kilbeg Quay, Lough Corrib.
