**KELLYSTOWN WIND FARM  
CO. LOUTH**

**CONSTRUCTION ENVIRONMENTAL  
MANAGEMENT PLAN  
(CEMP)**

**MANAGEMENT PLAN 4  
SPOIL MANAGEMENT PLAN**

### Desktop Study and Walkover Survey for Preliminary Determination of Ground Conditions

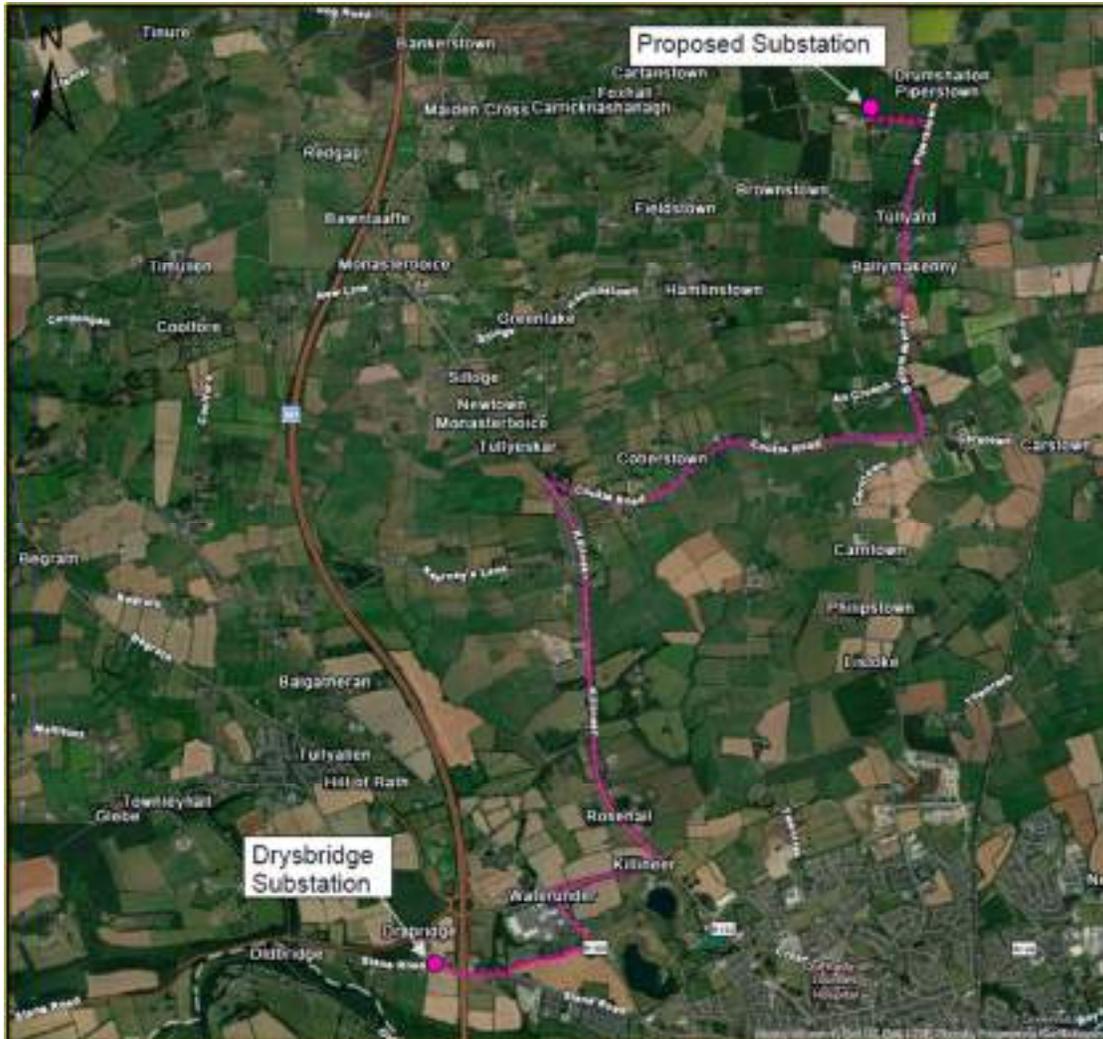
**Figure 2.1 Kellystown Wind Farm Grid Connection Route**

A Grid Connection will be sought from the grid system operators by application to EirGrid. The substation will connect via underground 38kV cable. The route of this underground Grid Connection is provided in **Figure 2.9**. The overall length of the Grid Connection between the substation and the existing Drybridge 110kV substation is 11.78km, of which 823m is within the Site of the Development and 10,957m is located along the public road corridor.

The Grid Connection will be constructed to the requirements and specifications of ESB Networks Limited. The three conductors will be laid in separate ducts which will be laid in accordance with the ESN functional specifications for 38kV Networks Ducting/Cabling (Minimum Standards). The width of a 38kV cable trench with a trefoil formation will be 600mm. The depth of the trench for 38kV cables is 1.22m. A separate duct will be provided

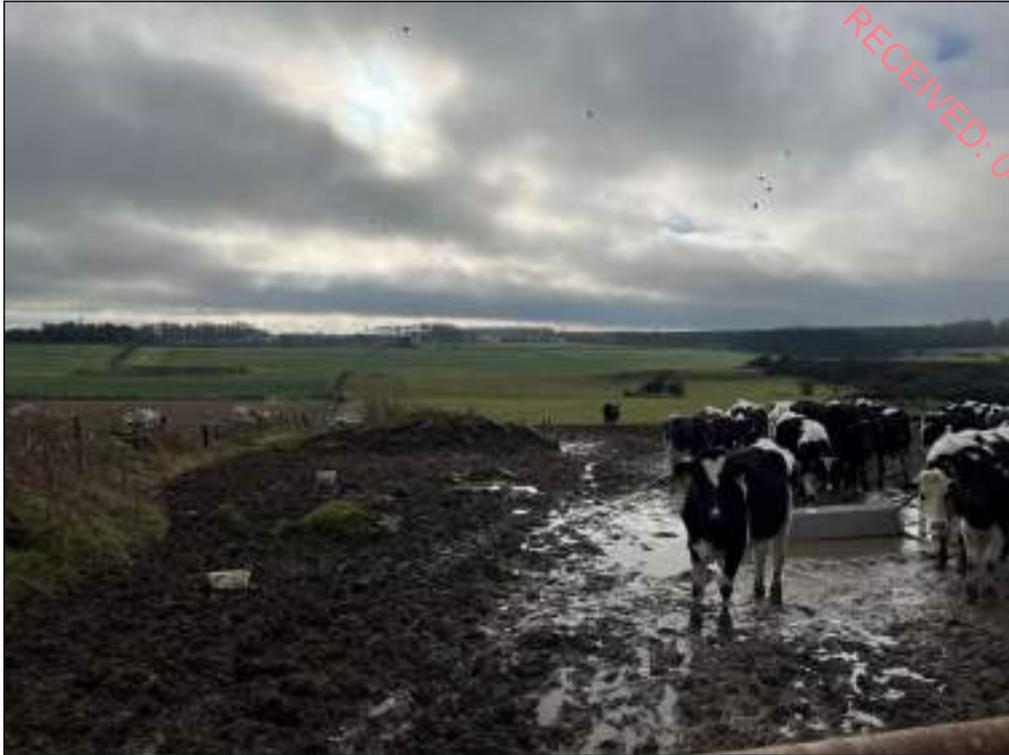
Plate 3—Typical conditions around T4, just inside gate off track

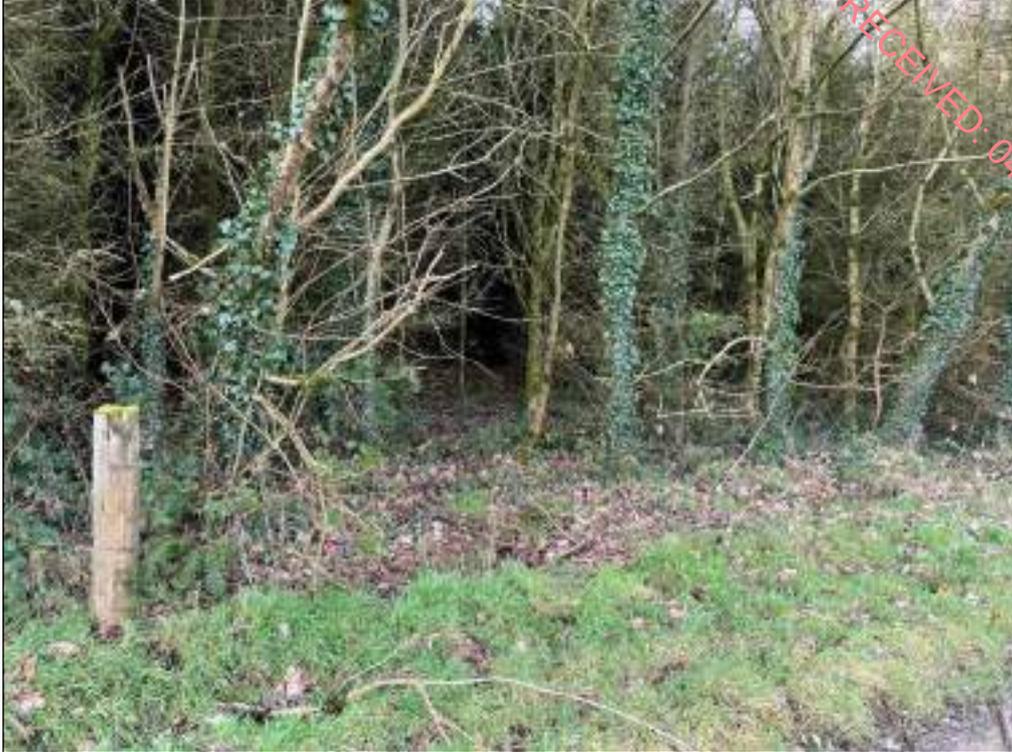
Plate 9—T7 within trees. Exploratory hole at edge of lane
