# Kellystown WindFarm

Aquatic Ecology Surveys Report Final

P00011358

November 2023

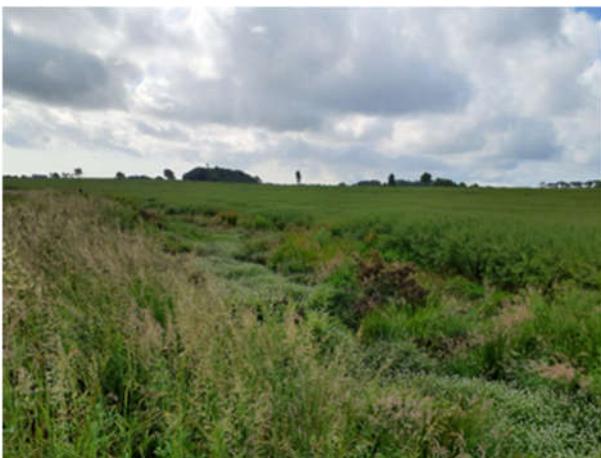
**Plate 10 Site 4 unsuitable for water quality or kick sampling**

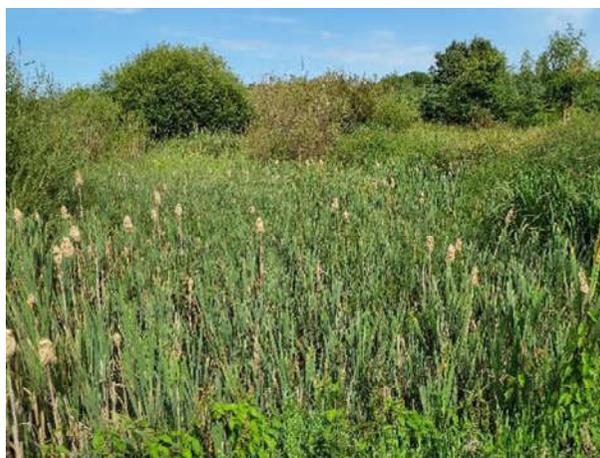
**Plate 11 Site 5 water quality location, unsuitable for kick sampling**

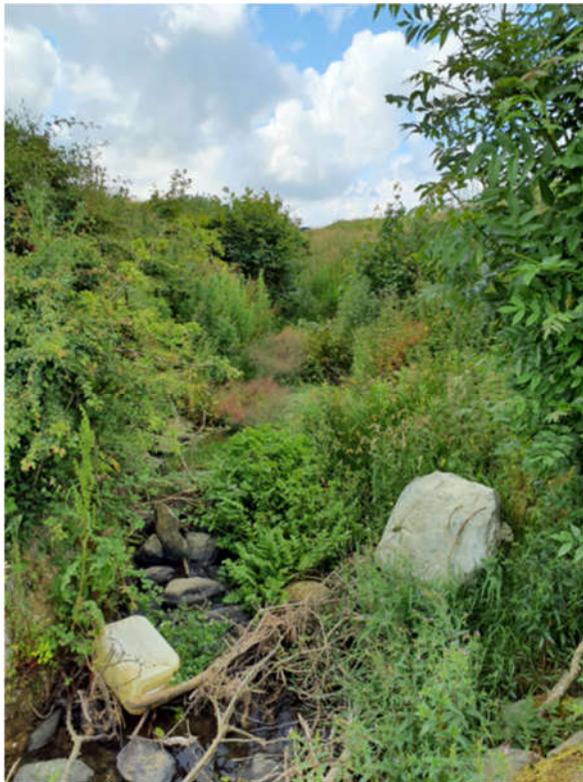
**Plate 22 Drumshallon Lough Stream Fish Habitat Walkover, east section, facing upstream, some flow and cobbles recorded along with in stream litter**

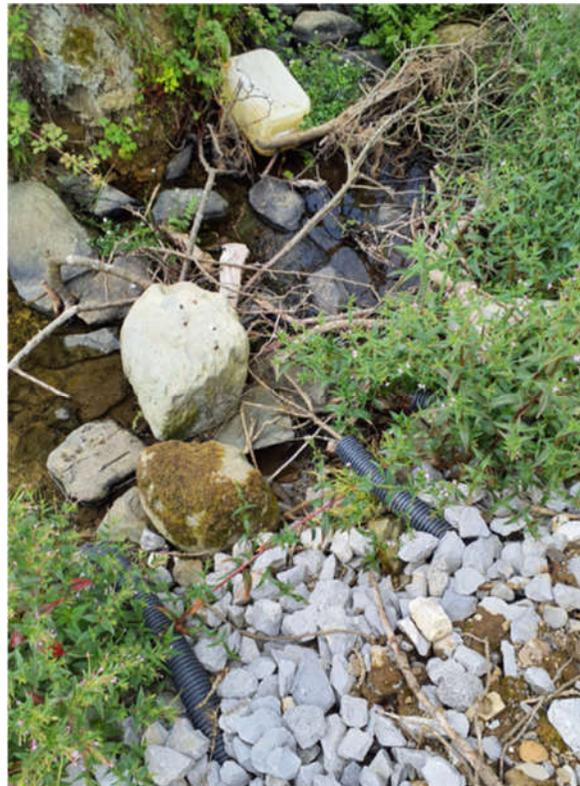
**Plate 23 Drumshallon Lough Stream Fish Habitat Walkover, east section, outflows and instream litter**

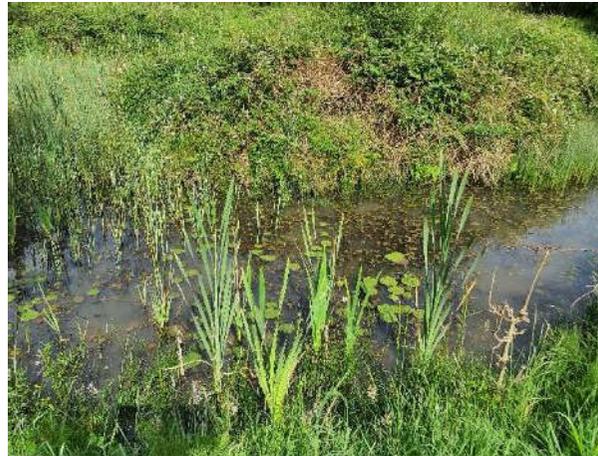
**Plate 26 Hammondstown Stream Fish Habitat walkover, large stagnant U shaped area at eastern end of survey showing water turbidity**

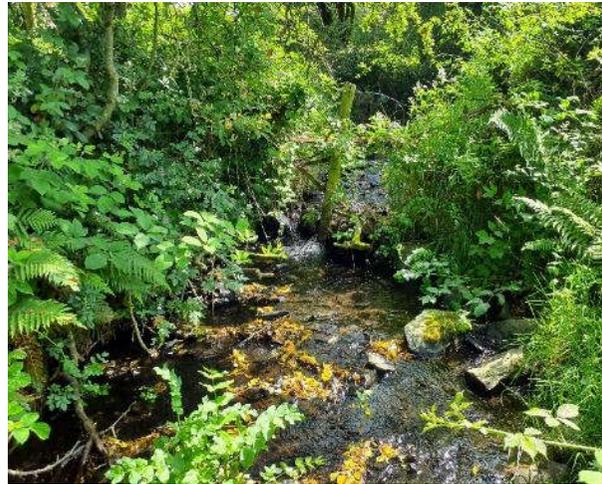
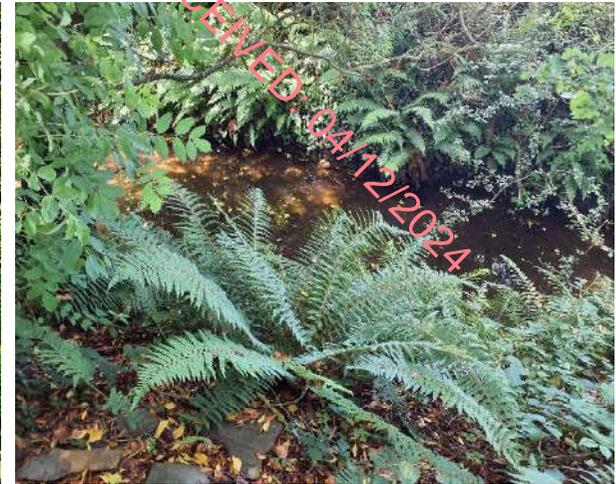
Downstream of this structure <5 m an unmapped channel joins the stream from the left-hand bank (Plate 52-Plate 53). This channel was approximately 2 m wide and flowing at the confluence. At this confluence, the substrate is mainly boulder and cobble and there are undercut banks present with tree roots in the water, some stickleback were observed in this area and a kingfisher feather was found in the channel. Possible otter spraint was also observed at this location. Downstream of this confluence the channel varies between pockets of riffle, glide and slow/stagnant areas with emergent vegetation.

Plate 52 Hammondstown Stream Fish Habitat walkover, unmarked tributary facing upstream from confluence

Plate 53 Hammondstown Stream Fish Habitat walkover, unmarked tributary stagnant upstream

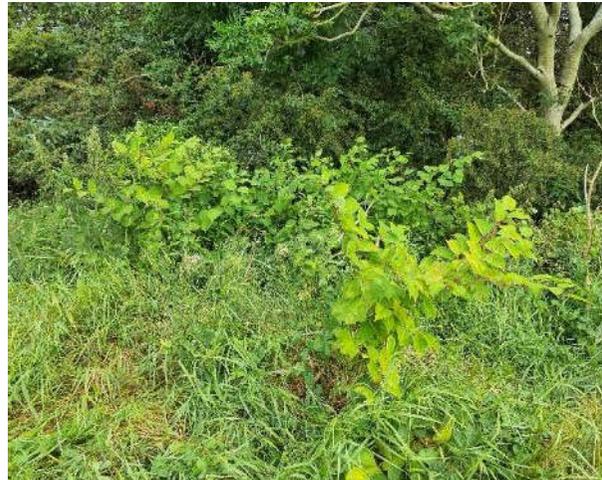
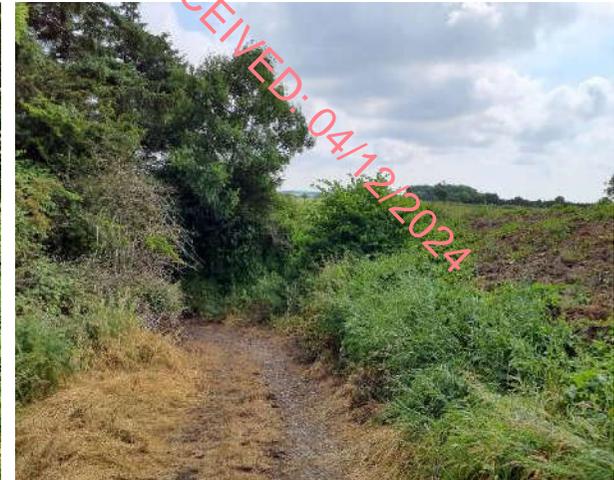
Plate 58 Japanese knotweed, *Fallopia japonica*, found on Site approximately 330 m south of the Drumshallon Lough and 340 m south of the Drumshallon Lough Stream, and approximately 180 m north of turbine T07 location

Plate 59 Japanese knotweed, *Fallopia japonica*, found on Site approximately 330 m south of the Drumshallon Lough and 340 m south of the Drumshallon Lough Stream, and approximately 180 m north of turbine T07 location

Incidental sightings of third schedule invasives species were noted at the Site. The European Communities (Birds & Natural Habitats) Regulations 2011 – 2023 restrict the importation, distribution, sale or release of approximately 70 species of plants and animals considered to be the most harmful Invasive Alien Species. Japanese knotweed and Himalayan balsam are two of the plant species listed in Part 1 of the Third Schedule of the 2011 - 2023 regulations. Japanese knotweed is also listed as a vector material in Part 3 of the Third Schedule. It is an offence to plant, disperse, allow or cause to disperse, spread or otherwise cause to grow in any place any plant included in the Third Schedule. It is an offence under the Wildlife Acts 1976 – 2022 to plant or otherwise cause to grow in a wild state in any place in the State any species of (exotic) flora, or the flowers, roots, seeds or spores of (exotic) flora. Therefore care must be taken and appropriate mitigation must be put in place not to further disperse these species during the construction of the windfarm at Kellystown.
