- 12.1 This Chapter of the Environmental Impact Assessment Report (EIAR), commissioned by SLR Consulting Ireland on behalf of Roadstone Ltd. addresses the impacts on the archaeological, architectural and cultural heritage of the application site and the surrounding area of a proposal for a Bio-Renewables Plant on land in the townland of Gaile, Co. Tipperary. The site location and study area are indicated in **Figure 12-1**.

- 12.2 In summary, the proposed development will consist of:
1. An overall planning application site area of c. 6.3 hectares consisting of a proposed bio-renewables production facility, buffer screening, ancillary facilities and site access via the existing permitted quarry entrance.

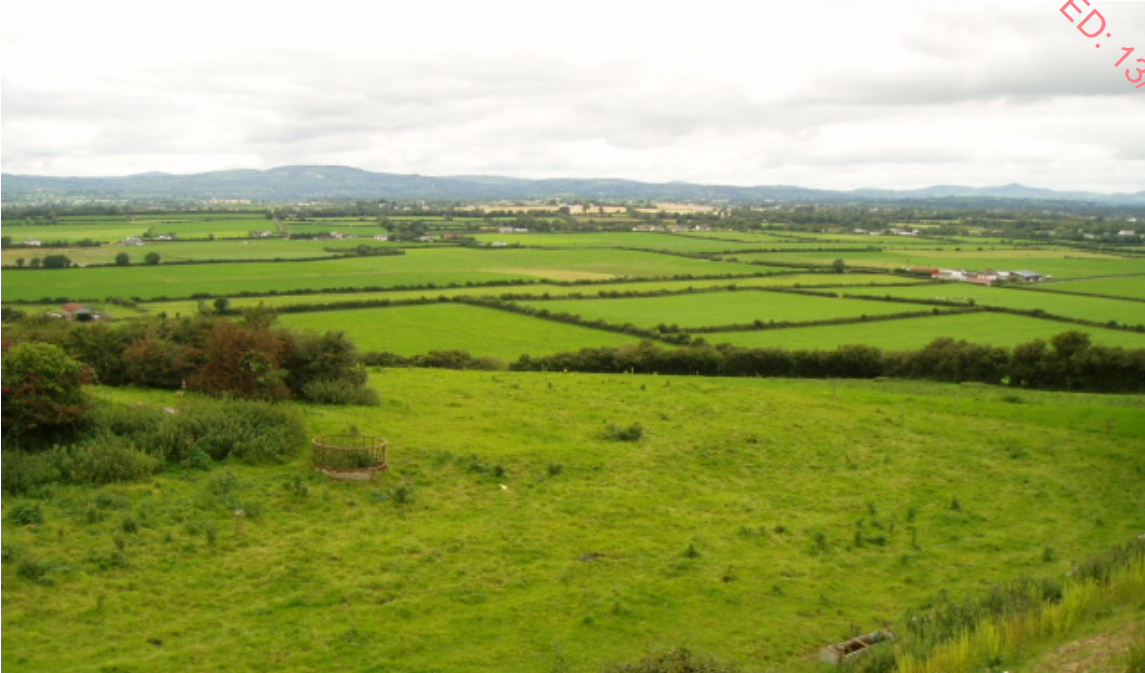
Plate 12-1 View of RMP site TS047-085—looking north-west.

- 12.46 This monument is situated c. 35m west of the application area (see **Figure 12-1** and **Plates 12-1** and **12-2**). This monument is not directly or indirectly impacted by the proposed development. Views from the monument to the proposed development area are screened by a high landscaped screening berm (see **Plate 12-2**).

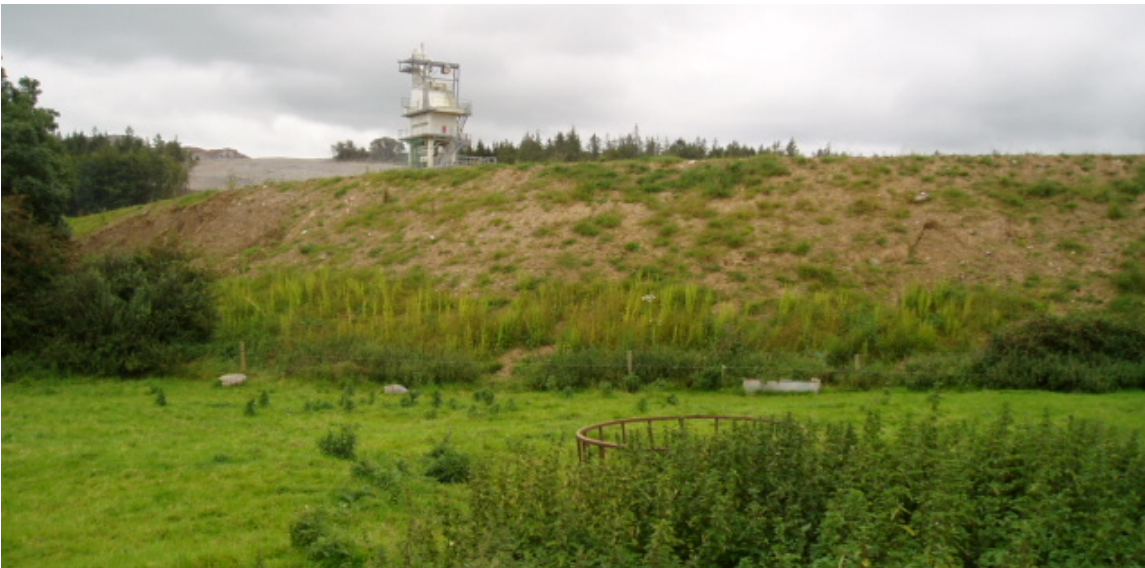
Plate 12-2 View from RMP site TS047-085—looking east towards the application area.
