## Natura Impact Statement

THE ORCHARD,  
CARPENTERSTOWN ROAD,  
DUBLIN 15,  
CO. FINGAL

<b>REPORT NO:</b>	PES_NIS_10339	<b>AUTHOR:</b>	Soraia Branco, MSc.
<b>DATE:</b>	18 <sup>th</sup> December 2025

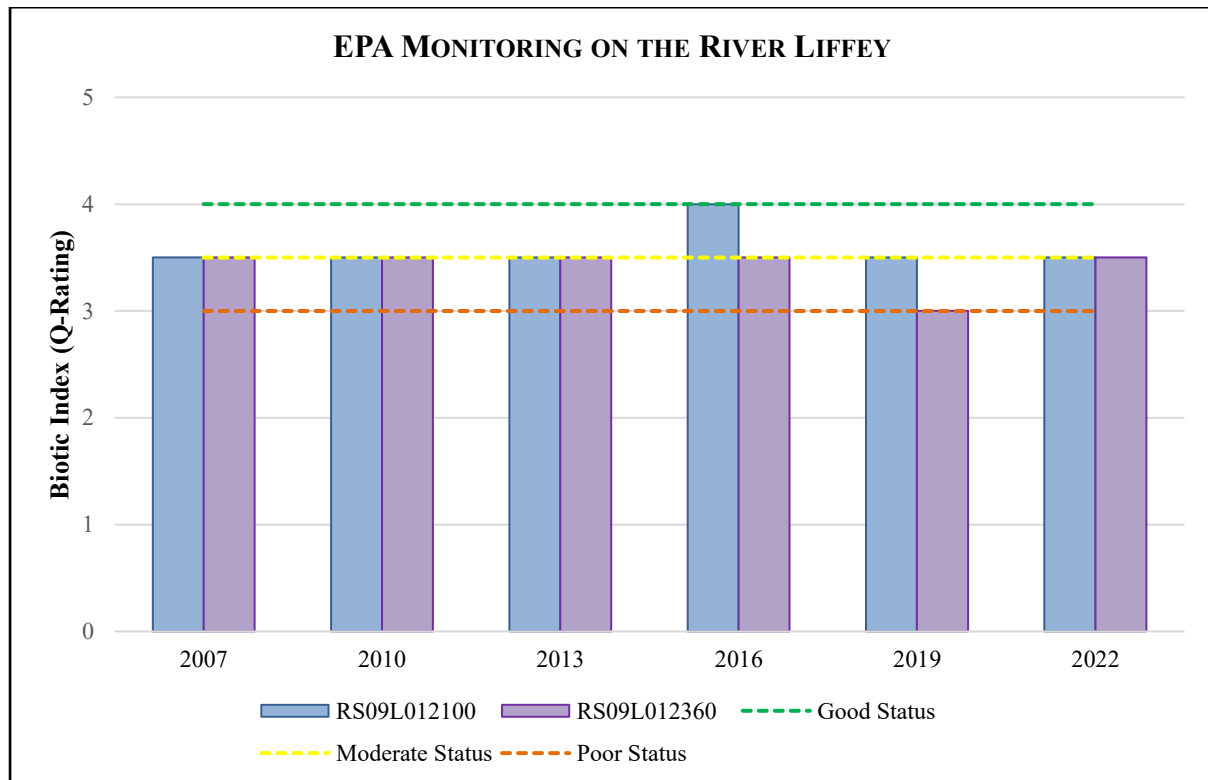
**Figure 5.** EPA Ecological Monitoring of the River Liffey from 2007-2022

EPA comments on the most recent monitoring results for the River Liffey are as follows: *“The Liffey remained mostly unchanged in June 2022, with satisfactory ecological conditions at the majority (14) of the 16 stations surveyed. The only improvement was found at station 0200 (Br E of Ballysmuttan) which recorded the highest ecological condition, Q5, with a dominance of pollution-sensitive taxa recorded. The only decline occurred at 0850 (Connell Ford) which was found to be at good ecological conditions in 2022 after an improvement in 2019. As previously found, stations 2100 (Lucan) and 2360 (Chapelizod) remain moderate and poor, respectively”.*

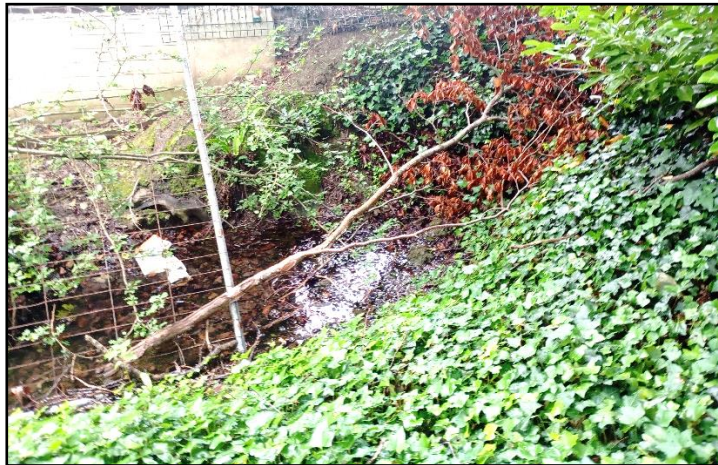
Plate 7: Drainage ditch to the west (FW4). To be infilled.

There is a drainage ditch onsite along the west boundary of the site. Drainage maps of the area show that there is a 10mm dia. pipe potentially connecting this drainage ditch to a surface water drainage pipe under the Carpenterstown Road. This drainage ditch will be infilled. There is another drainage ditch outside of the red line boundary of the site, adjacent to the east boundary, that drains into the surface water drainage pipe under the Carpenterstown Road. Surface water flows towards the east within the existing pipes under the Carpenterstown Road. It was not possible to ascertain whether this existing infrastructure is connected to a mapped watercourse downstream. Therefore, a potential hydrological connection between the drainage ditches that border the site and the unnamed stream to the east cannot be ruled out.

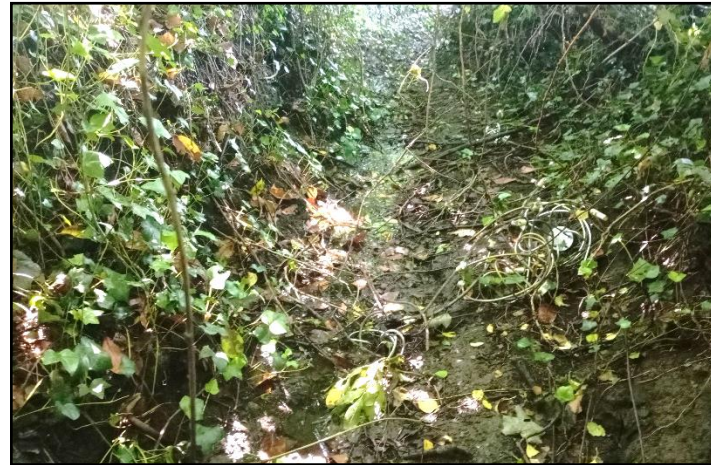
Plate 8: Drainage ditch to the east (FW4). To be retained.
