**REPORT  
ON THE  
GEOPHYSICAL INVESTIGATION  
AT  
BENNETTSBRIDGE QUARRY,  
CO. KILKENNY  
FOR  
BENNETTSBRIDGE LIMESTONE  
QUARRIES.**

**APEX Geophysics Limited**  
Unit 6, Knockmullen Business Park  
Gorey  
Co. Wexford

**4<sup>TH</sup> FEBRUARY 2025**

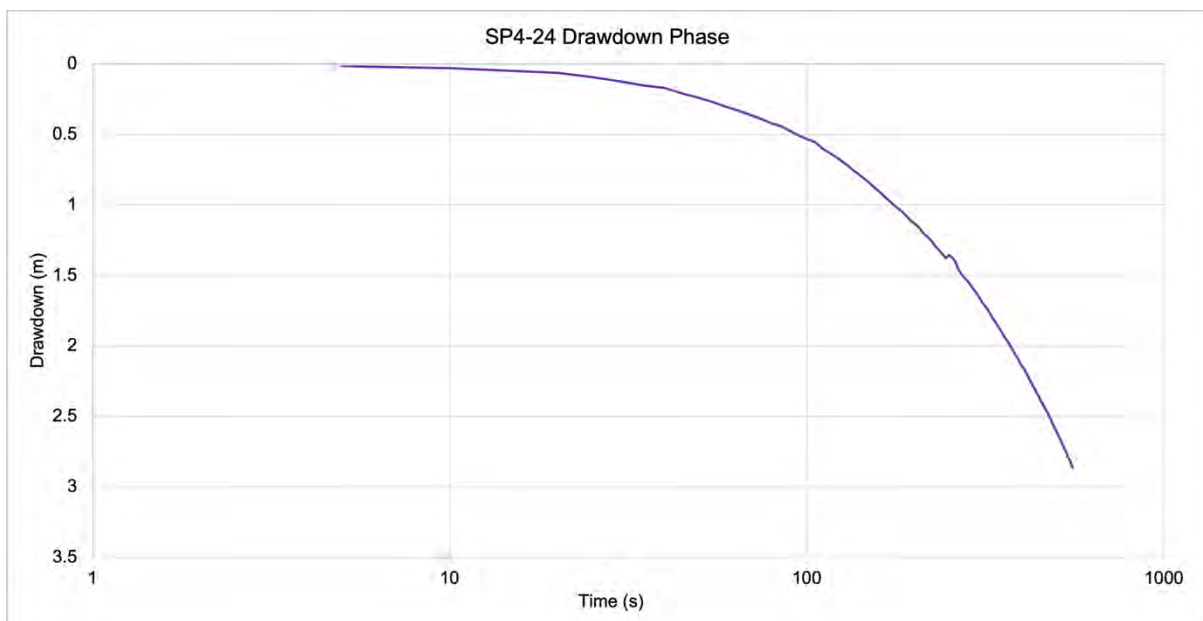
**Graph 10 – SP4-24 small-scale pumping test drawdown plotted against time on a log scale**

Drawdown of 2.87 m was reached over a pumping period of 9 minutes. Drawdown was plotted against time on a log scale which showed drawdown over one log cycle as being equivalent to 2.38 m (Graph 10).

Transmissivity was initially calculated using the Cooper Jacob's Method (Cooper & Jacob, 1946):
