# Appropriate Assessment Screening & Natura Impact Statement Report

## Cam Quarry Continuance of Use

### Roadstone Ltd.

Cam Quarry, Brideswell, Co. Roscommon

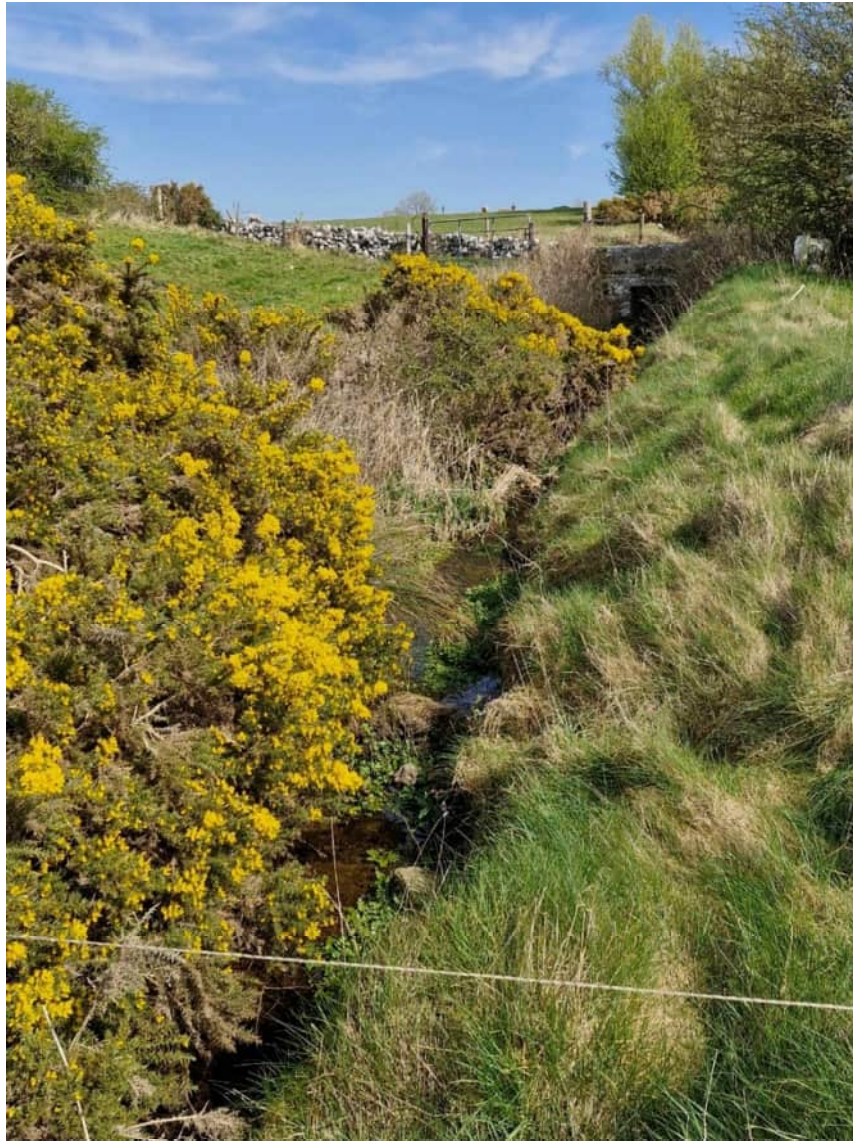
**Plate 7-1: The sampling location for the Ballyglass River Q survey (SW2) March 2025**

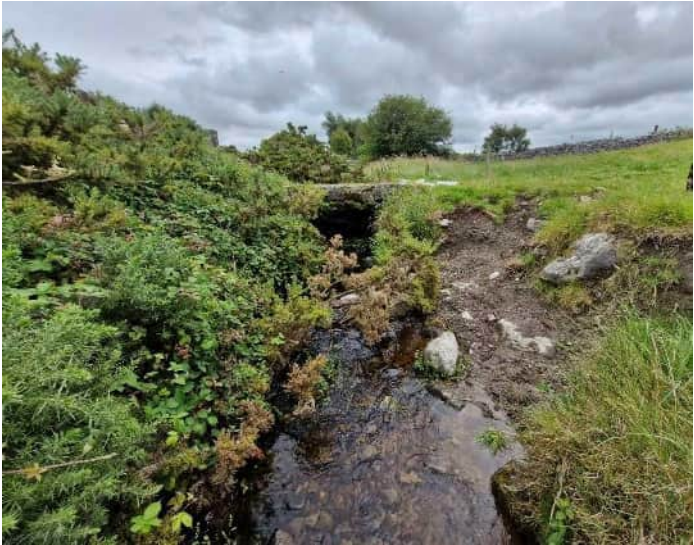
| Monitoring Site | Description |
|---|---|
| <p>Plate 7 Banks of SW2 damaged by livestock trampling</p> | |

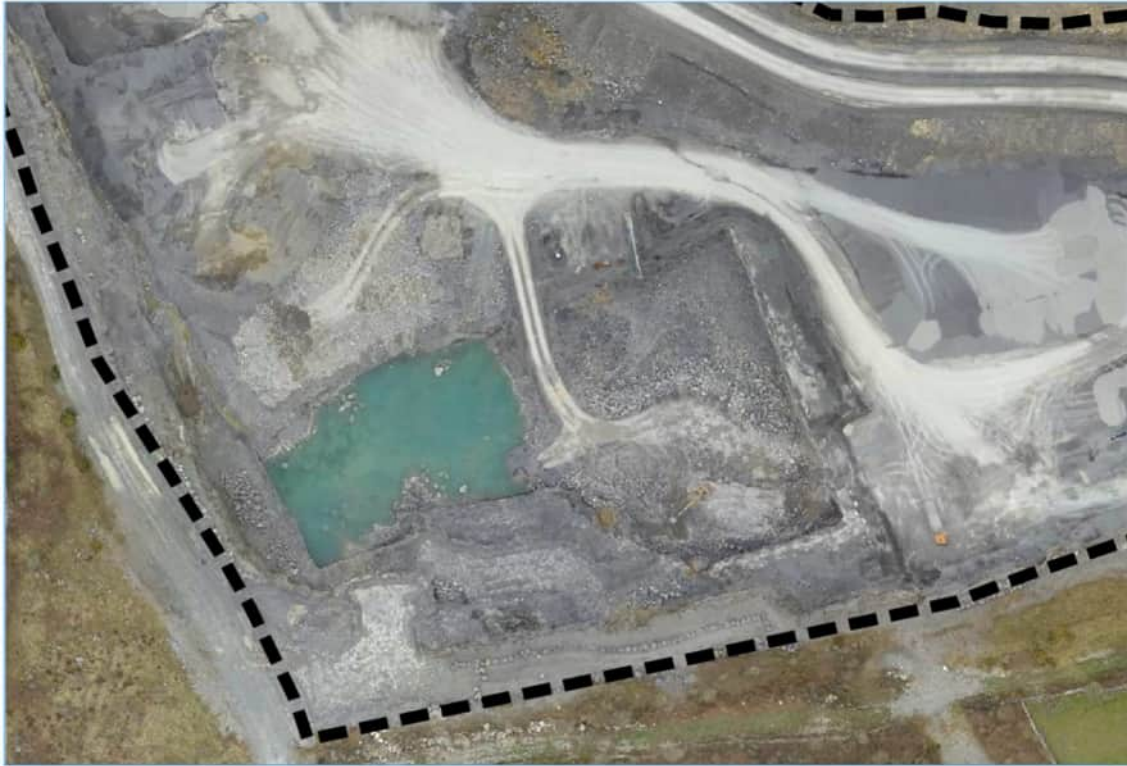
**Plate 1: April 2025 – Southwest Corner (Lowest Point c. 62-63mOD) of Quarry – Sump / Infiltration Area showing surface water run-off accumulation**

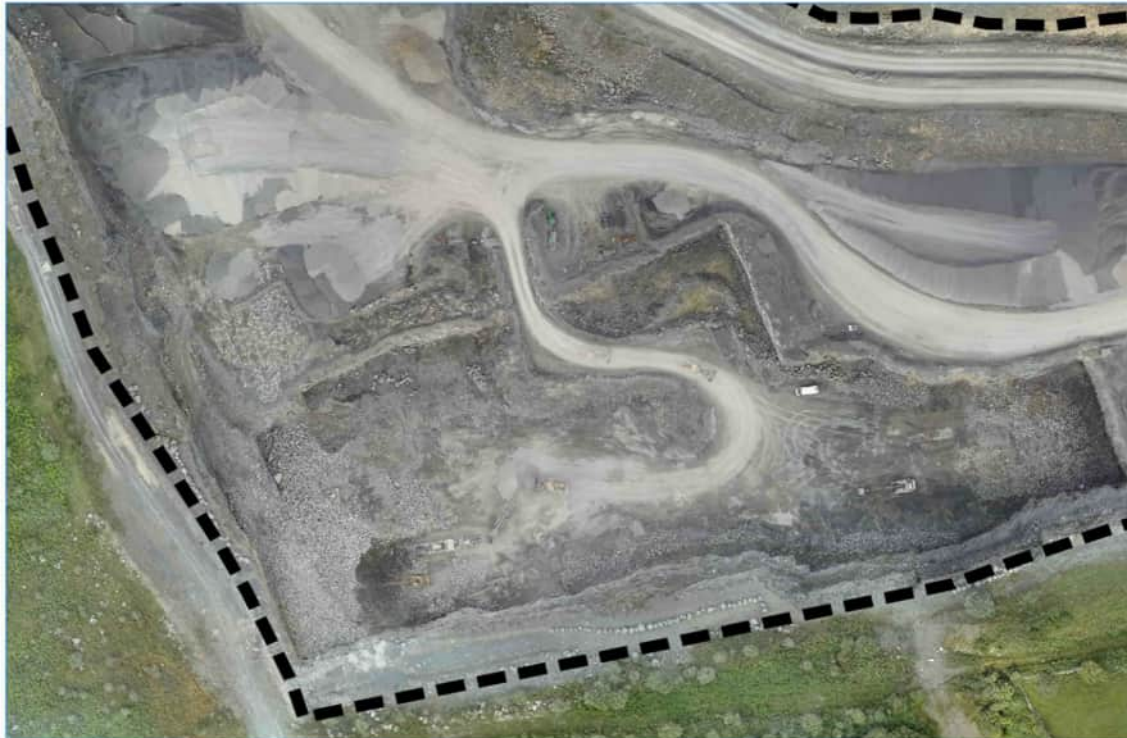
**Plate 2: August 2026 - Southwest Corner (Lowest Point) of Quarry – Sump / Infiltration Area showing no water (dry)**

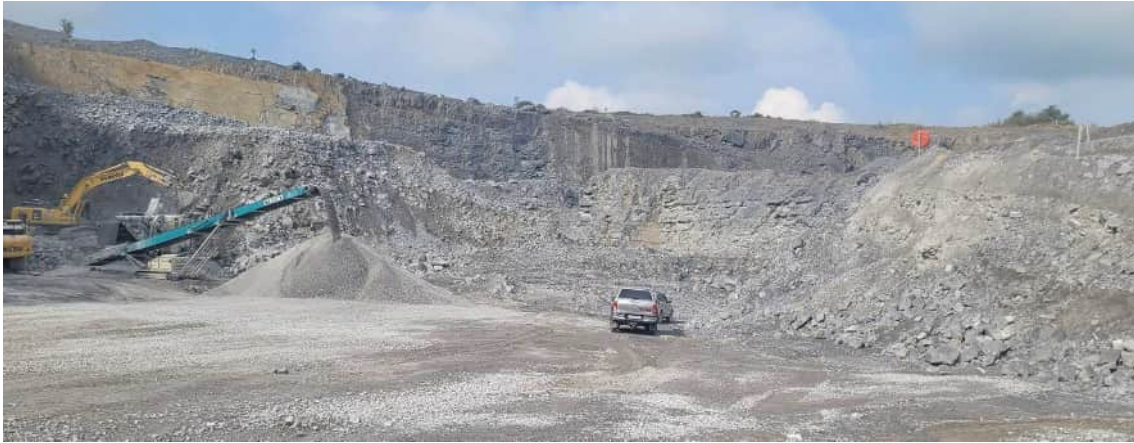
**Plate 3: August 2026 - Southwest Corner (Lowest Point c. 62–63mOD) of Quarry – Sump / Infiltration Area showing No Water Present (dry)**
