Hydrogeological Assessment
for Hammond Lane Metal
Company by O'Callaghan
Moran & Associates (2011)

**HYDROGEOLOGICAL ASSESSMENT
HAMMOND LANE METAL COMPANY
RINGASKIDDY
CORK**

23rd August 2011

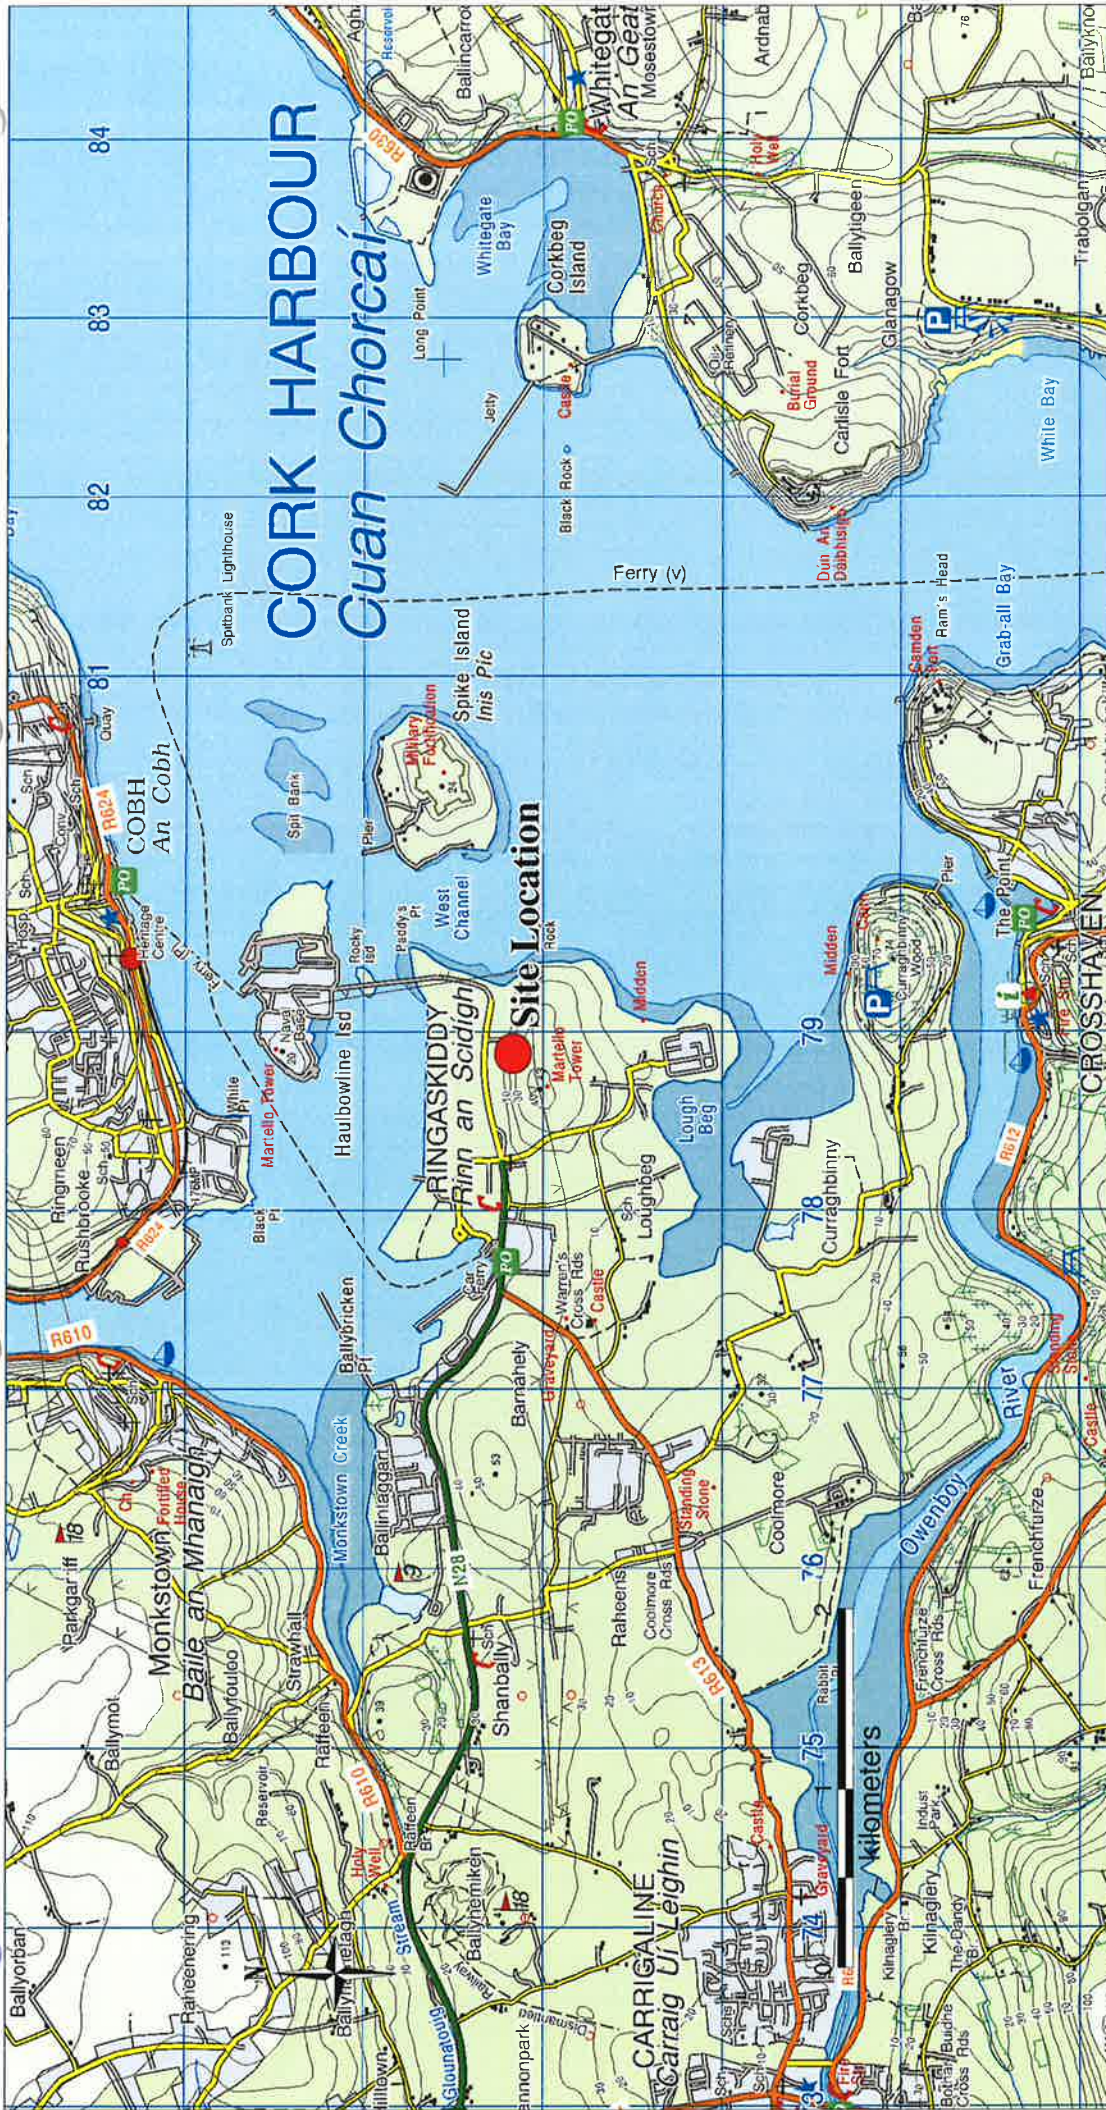
2.1

The site location and layout is shown on the Figure 2.1. The site encompasses approximately 1 hectare (ha) and is benched into the hillside to the south of the main Ringaskiddy to Haulbowline Island road.

Site Location

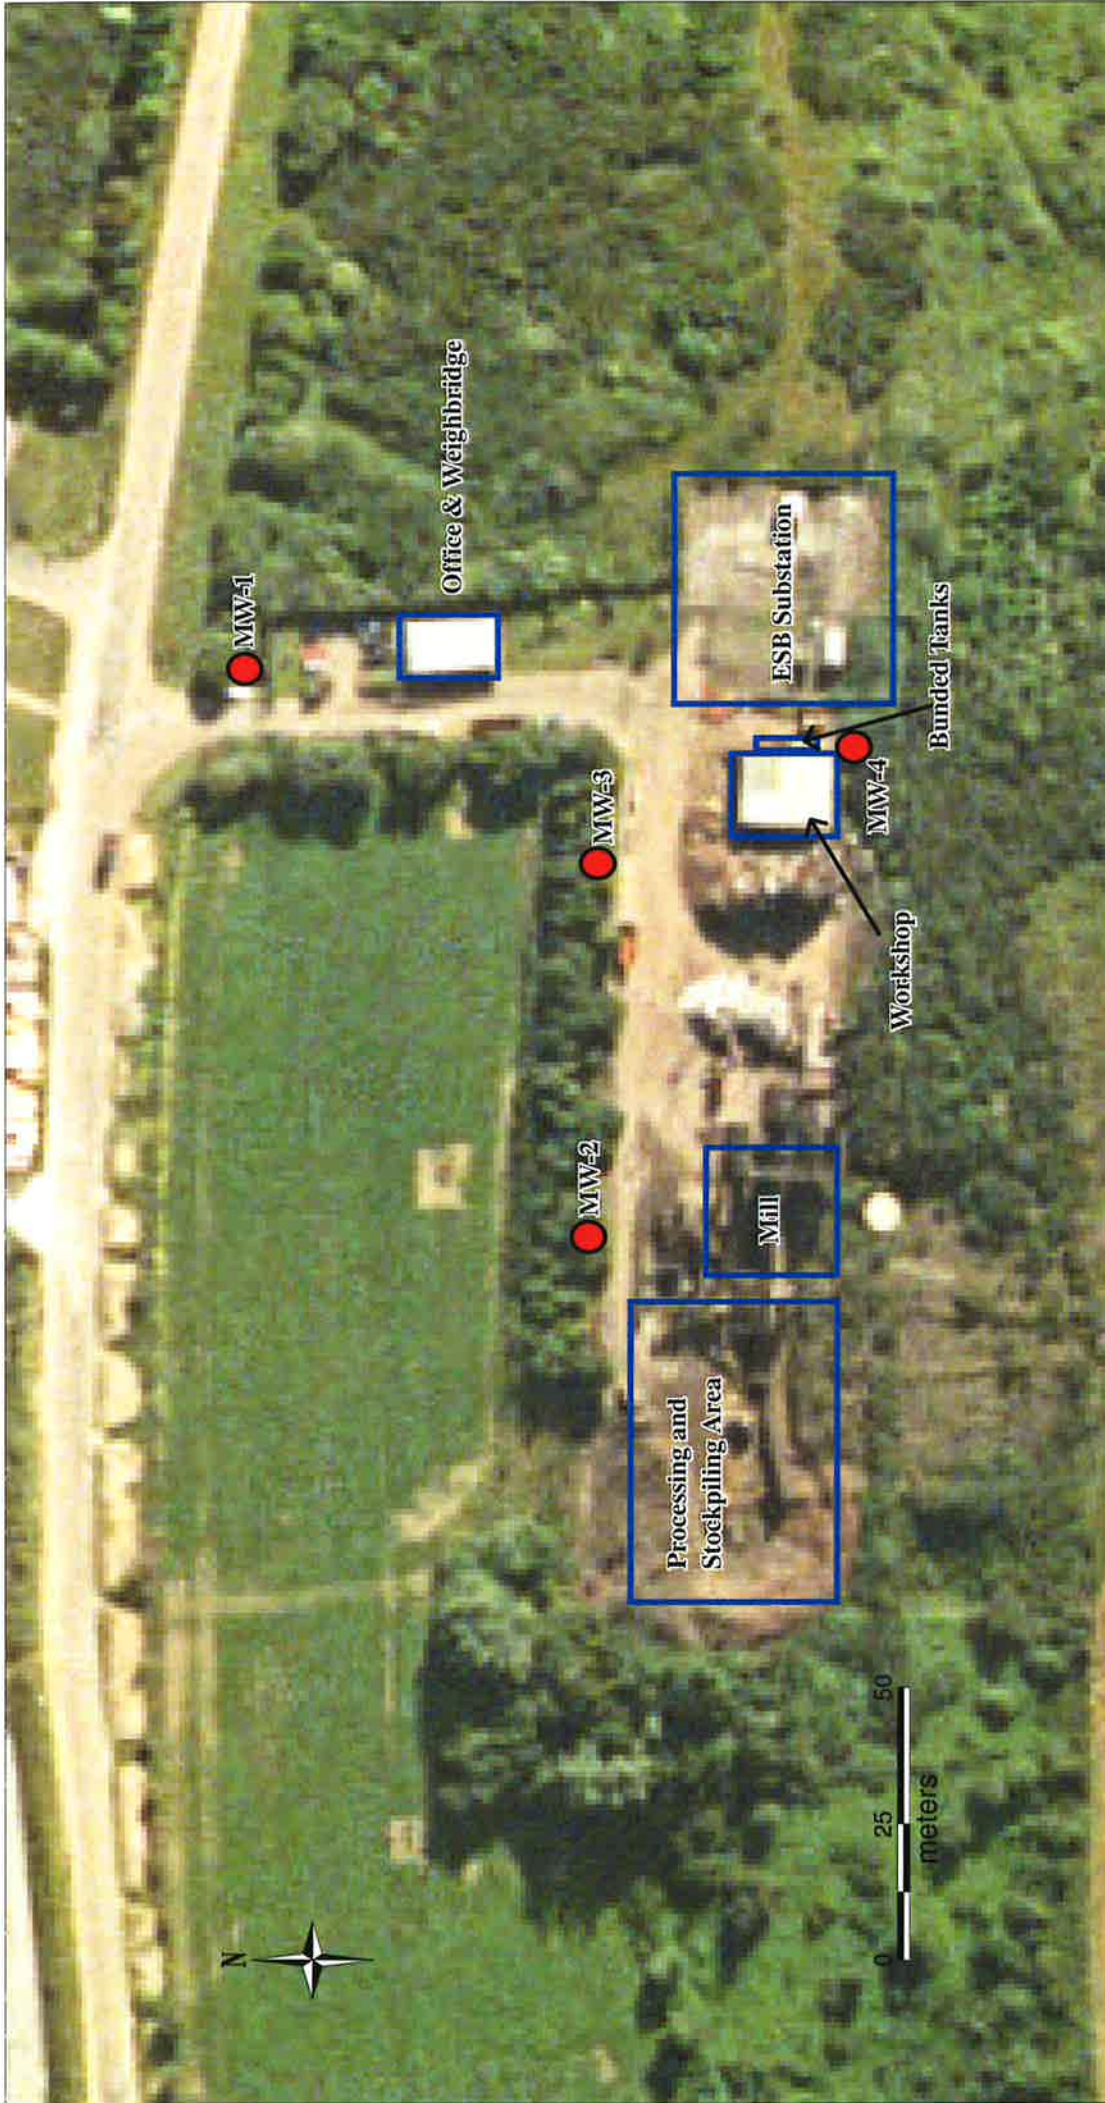
The site is accessed from the public road to the north. There is a weighbridge on the access road, with a site office to the east. The office houses administration, canteen, stores and toilets facilities. Sanitary wastewater discharges to a septic tank and percolation area located to the north of the building. The system was installed when the site was initially developed and Hammond Lane Metal Company informed OCM that it has always operated satisfactorily.

The access road slopes to the south towards the main yard area, which is located at a higher bench level cut into the hillside. The road is paved with tarmac, while the main operational area on site is concrete paved. The concrete is in generally good repair, however there are cracks and damaged areas along the northeast section of the access road. This damaged will be repaired as part of the proposed expansion of facility operations.

Storm water run-off from the site is collected in an ACCO type drain covered with a steel grid that runs along the northern site boundary. OCM inspected drain and the northern boundary with the adjoining agricultural land and did not identify any evidence of the overflow of oil contaminated run-off from the drain.

The drain connects to a settlement tank located to the east of access road and south of the offices. The settlement tank overflows to an oil interceptor located the west of the site access road. The water from the interceptor discharges to the local authority storm water sewer.

There are two fuel oil tanks in a concrete bund to the east of the garage. The first is a steel rectangular tank c1500l and the second is a polyethylene cylindrical tank of similar capacity. Both tanks appear to be in good repair. The bund is roofed and enclosed on three sides. At the time of the inspection in 2011, OCM noted the presence of a small amount of water in the bund, most likely from rainfall entering the open side to the enclosure. There were four 205l steel waste oil drums located on a drum storage pallet in this area.

Four monitoring wells (MW-1 to MW-4) were installed at the site between the 21st and 22nd July 2011. The well locations are shown on Figure 3.1. The well locations were selected by OCM.

MW-1 is located along the northern site boundary and immediately down hydraulic gradient of the oil interceptor and the septic tank. MW-2 and MW-3 are directly down hydraulic gradient of the main operational area, while MW-4 is along the southern site boundary and upgradient of the operational areas.

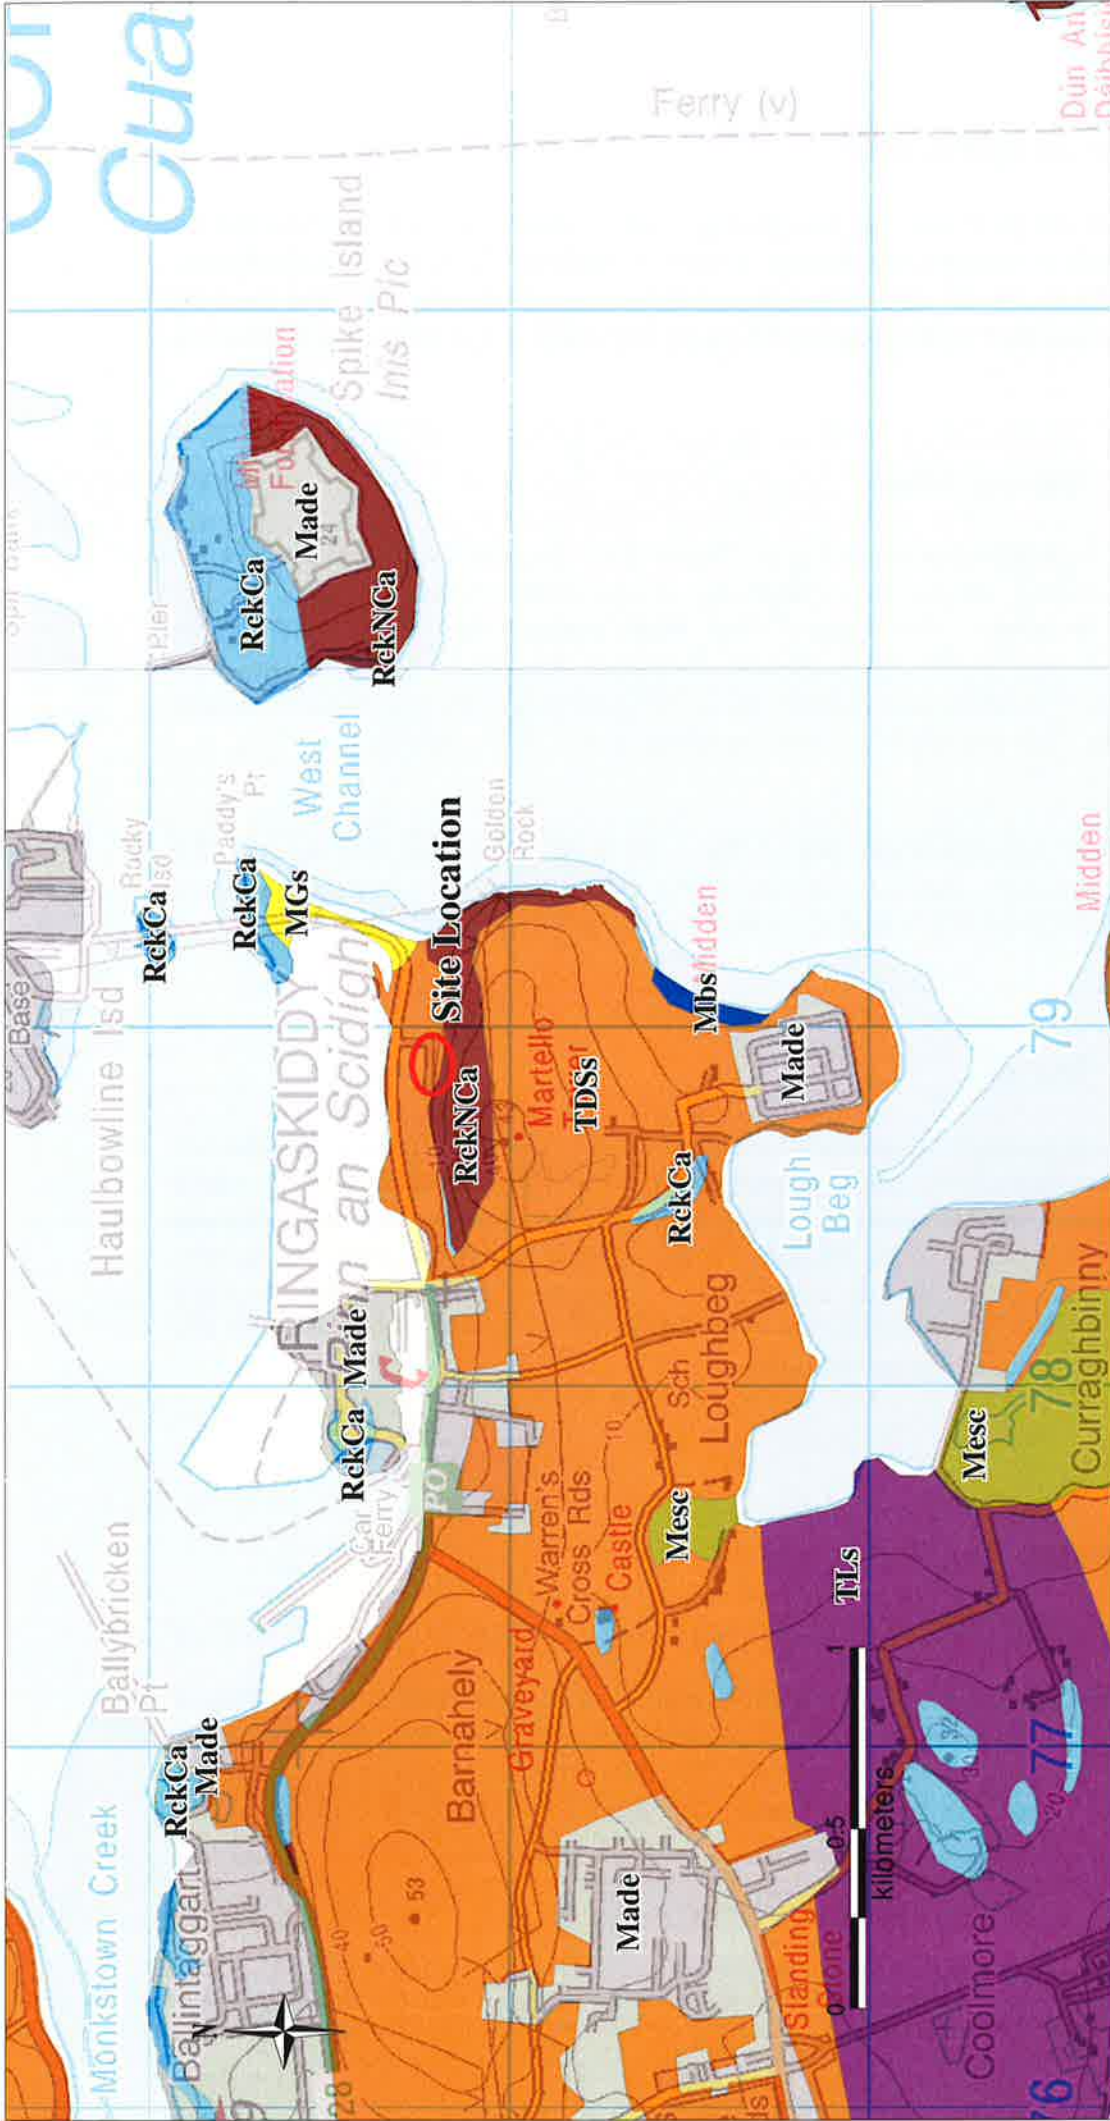
The subsoil distribution is shown on Figure 2.3. The site is underlain by 0.3 – 0.75m of gravelly fill partially comprising in-situ weathered and broken shale and sandstone bedrock. The Teagasc Soil Maps indicate the in-situ soils in the northern section of the site comprise Devonian Sandstone Till (TDSs). The southern section of the site is described as being underlain by non calcareous rock (**RckNCa**). This classification was confirmed by the 2011 investigation.

The depth of subsoils ranges from 2.7m in the north of the site to 0.3m near the southern boundary. Rock is exposed along the southern site boundary and also along the northwest site boundary, where the site is benched into the bedrock.

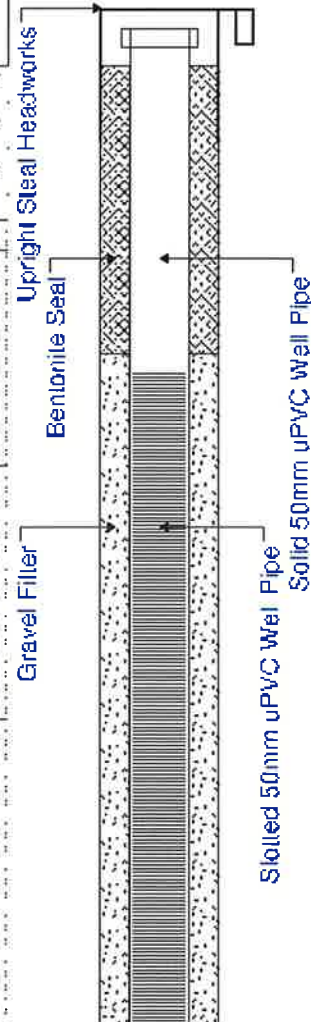
Borehole I.D. MW-2

Borehole Depth: 12.5m

Client: Hammond Lane Metal Co. SWL (m): 8.43m

Depth (m)	Lithology Description	Lithology	Well Construction Details
-1			
0	Ground Surface		
1	Fill Fill material comprising brown sandy slightly gravelly Clay.		
2	Rock Very broken green/grey fine grained Sandstone.		
3	Rock Competent green grey fine grained sandstone.		
4			
5			
6	Rock Very fine grained brown to red sandstone.		
7			
8			
9	Rock Grey fine grained sandstone.		
10	Water inflow at 9.5m.		
11			
12			
13			
14

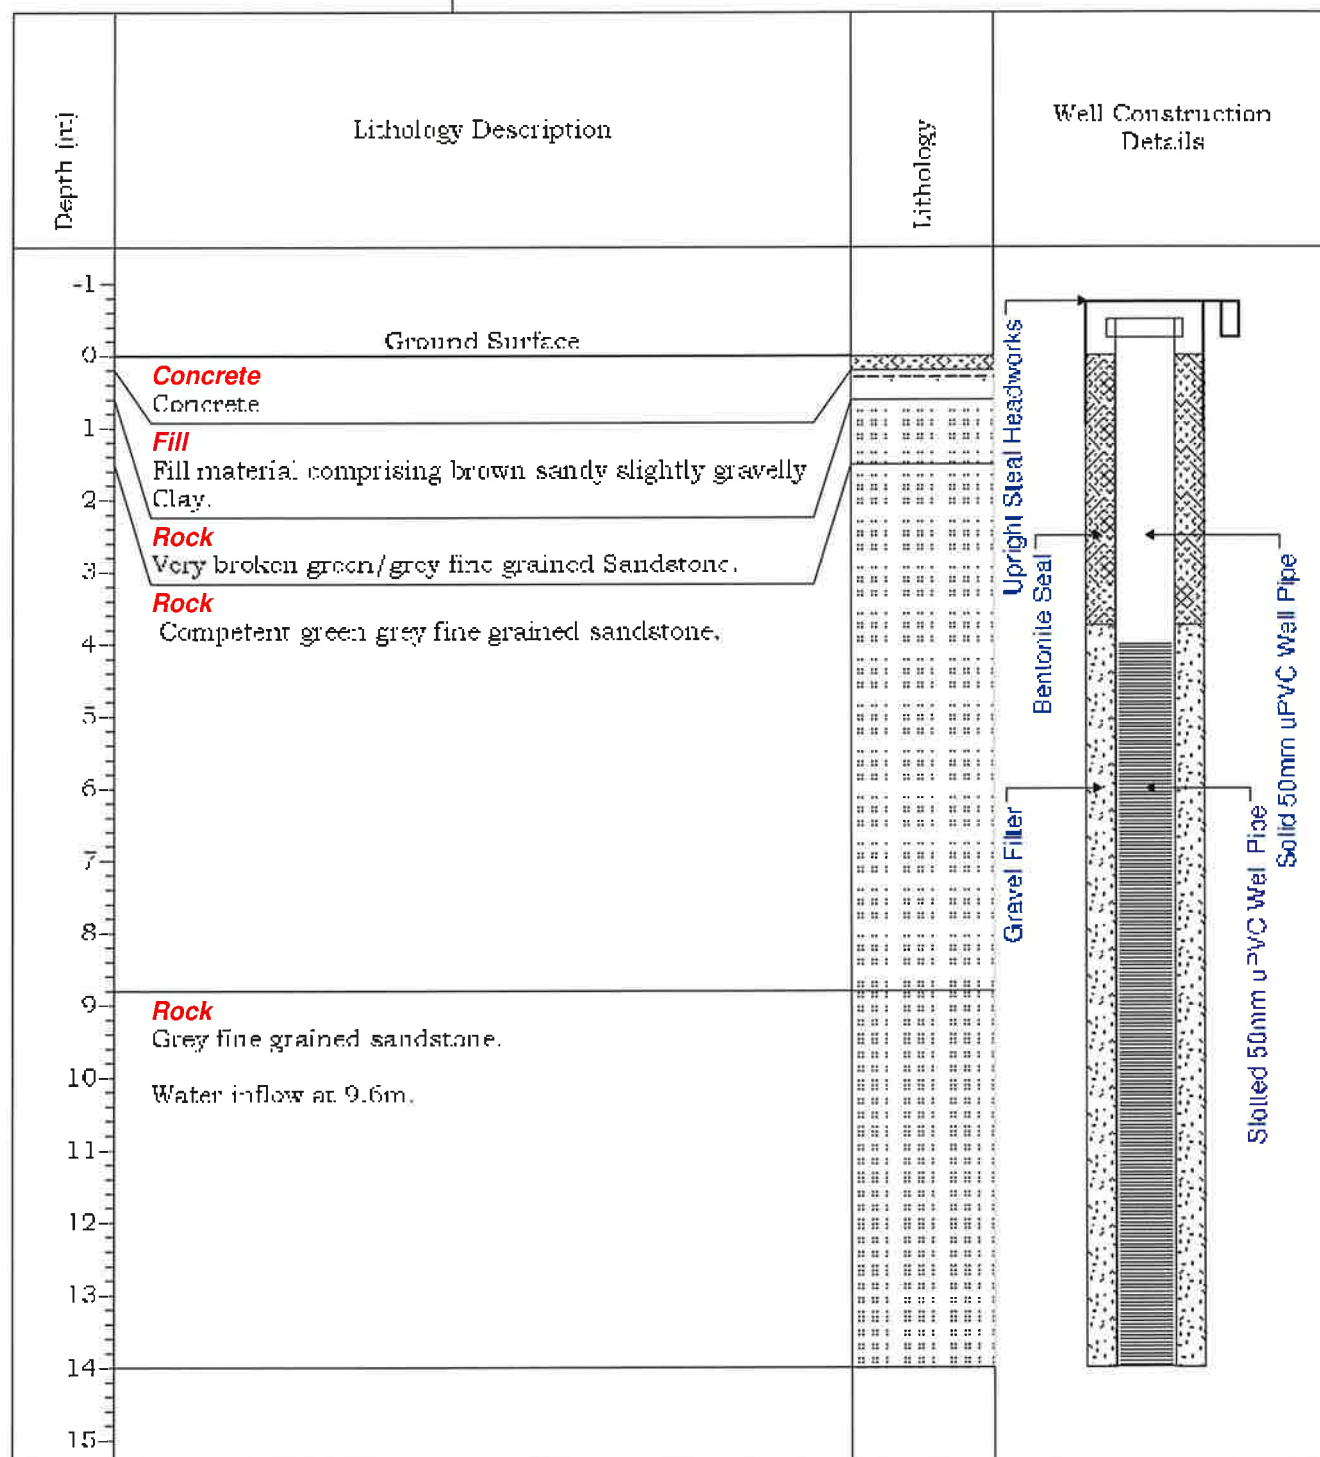
Borehole I.D. MW-3

Borehole Depth: 14m

SWL (m): 6.97m

Borehole Type: Monitoring Well

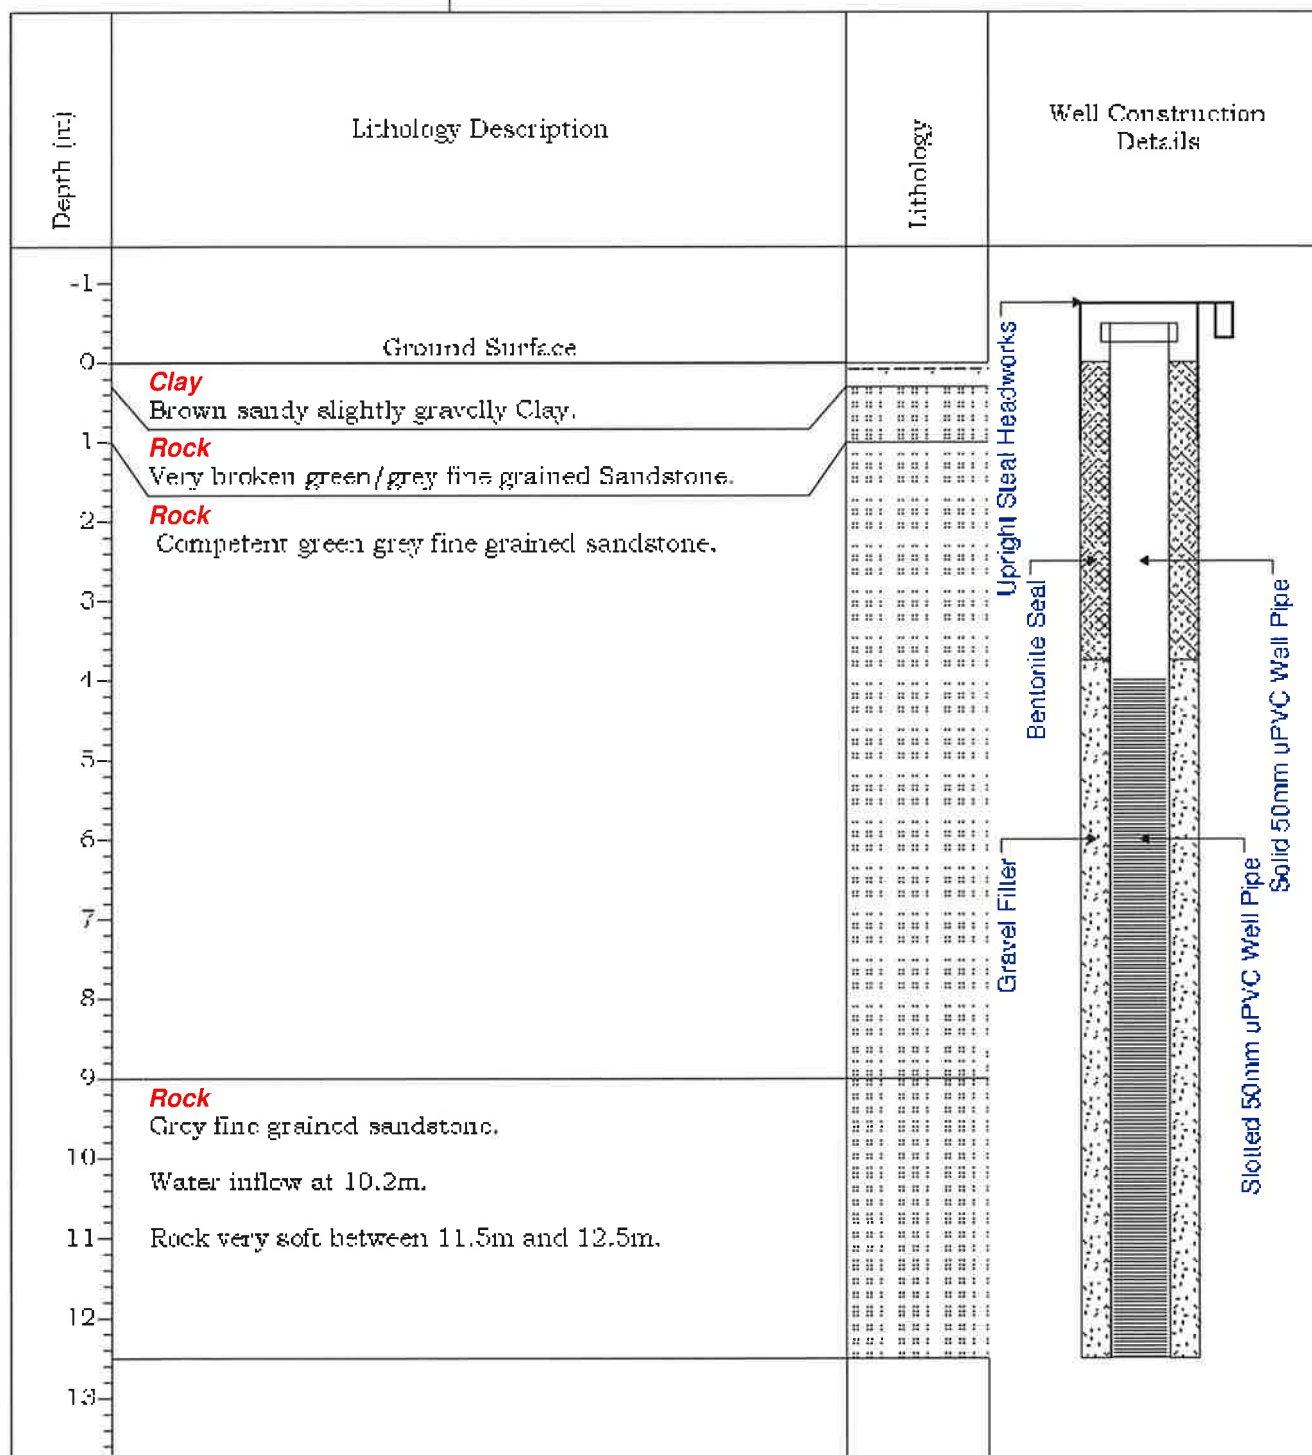
Borehole I.D. MW-4

Borehole Depth: 12.5m

Borehole Type: Monitoring Well
