# REMEDIAL ENVIRONMENTAL IMPACT ASSESSMENT REPORT (rEIAR)

For a quarry and associated processing plant and welfare facilities over a total site area of 81 hectares.

Clonmelsh & Garyhundon,  
Nurney,  
Co. Carlow

On behalf of  
Dan Morrissey Ireland Ltd. (In Receivership)

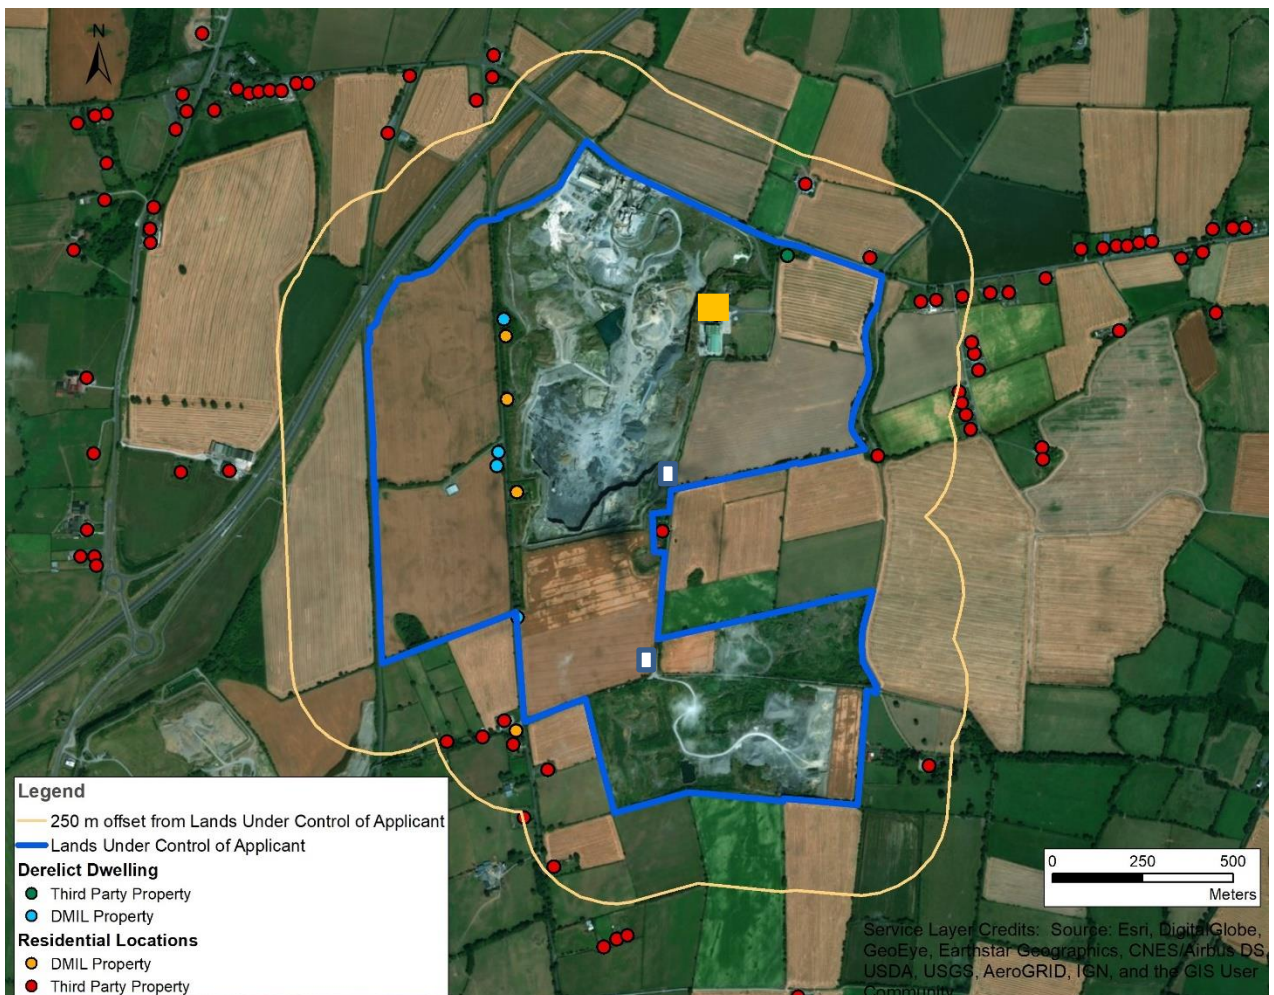
**Figure 4.2 Dwellings in the vicinity of the rEIAR site.**

- on the immediate western side of the Clonmelsh rEIAR that is in the ownership of a former DMIL manager and excluded from this rEIAR and the lands now in control of DMIL indicated thus ■ on figure 4.2; and
- another on the south eastern corner of the Clonmelsh rEIAR unit.

A review of the historic OSI map originating from the 1940s ahead of development indicates that 2 no. dwellings within the lands in the control of the developer and their ownership have been removed in the course of the development of the subject lands indicated thus ■ on figure 4.2. A review of aerial photography from 1995 indicates that the southern dwelling was removed pre-baseline by the northern post-baseline (1990)

Within the area controlled by the developer but excluded is an historic graveyard just south of ■ on figure 4.2. This is owned and maintained on behalf of visiting members of the public and is noted as recorded monument CW012-024003- at Chapter 11 of this rEiAR.

The quarrying land use has necessitated the removal of 2 no. dwellings (at figure 4.2) which is a direct, negative, permanent and slight.

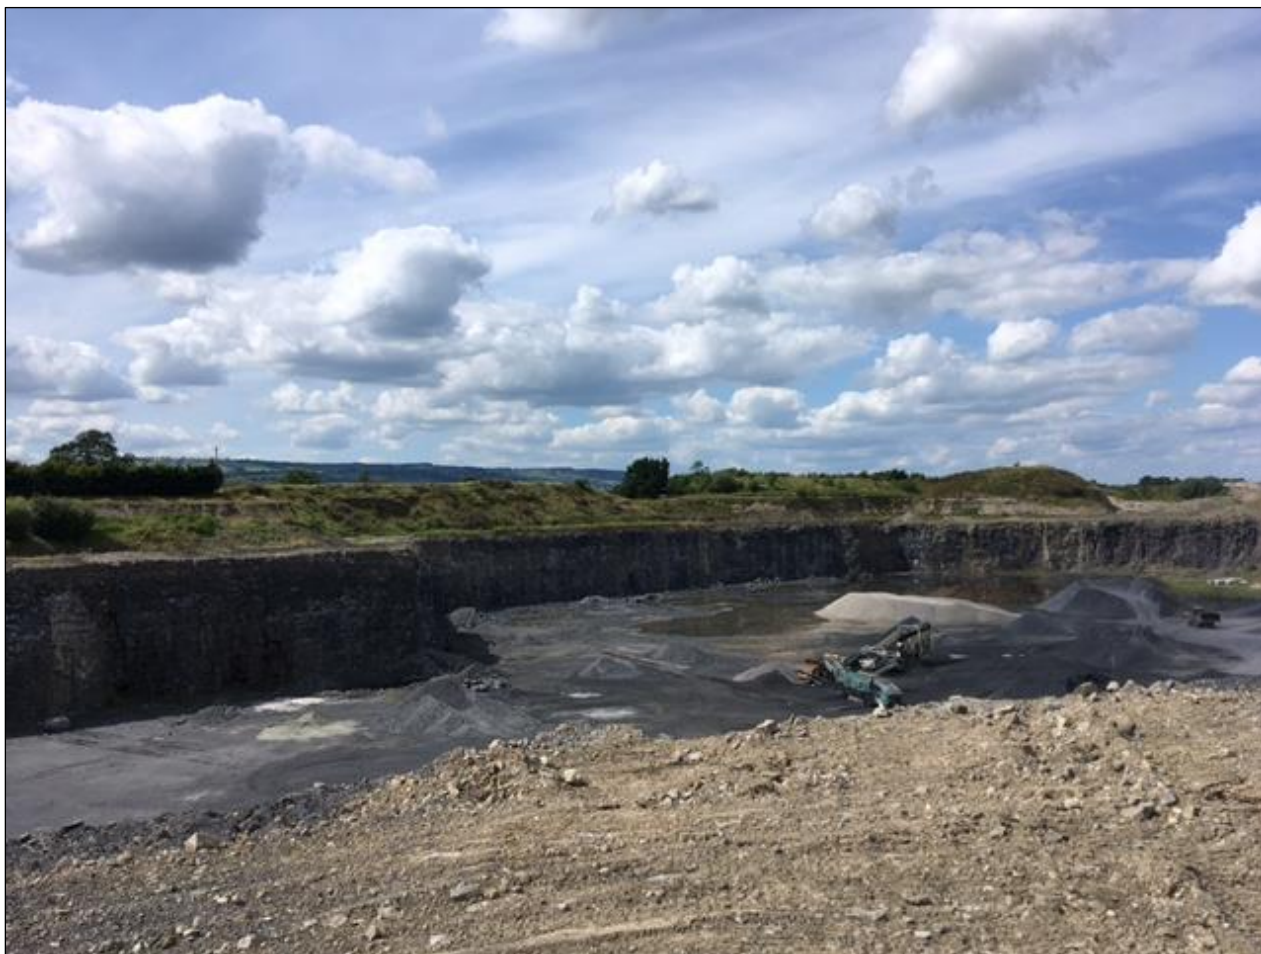
Figure 5.3: Active quarry, looking North Westerly

Whilst the vast majority of the active quarry footprint is sterile in terms of species presence and composition some peripheral development of flora was noted. The steep quarry faces preclude vehicular disturbance and pioneering species such as greater plantain *Plantago major* and pineappleweed *Matricaria discoidea* were recorded.

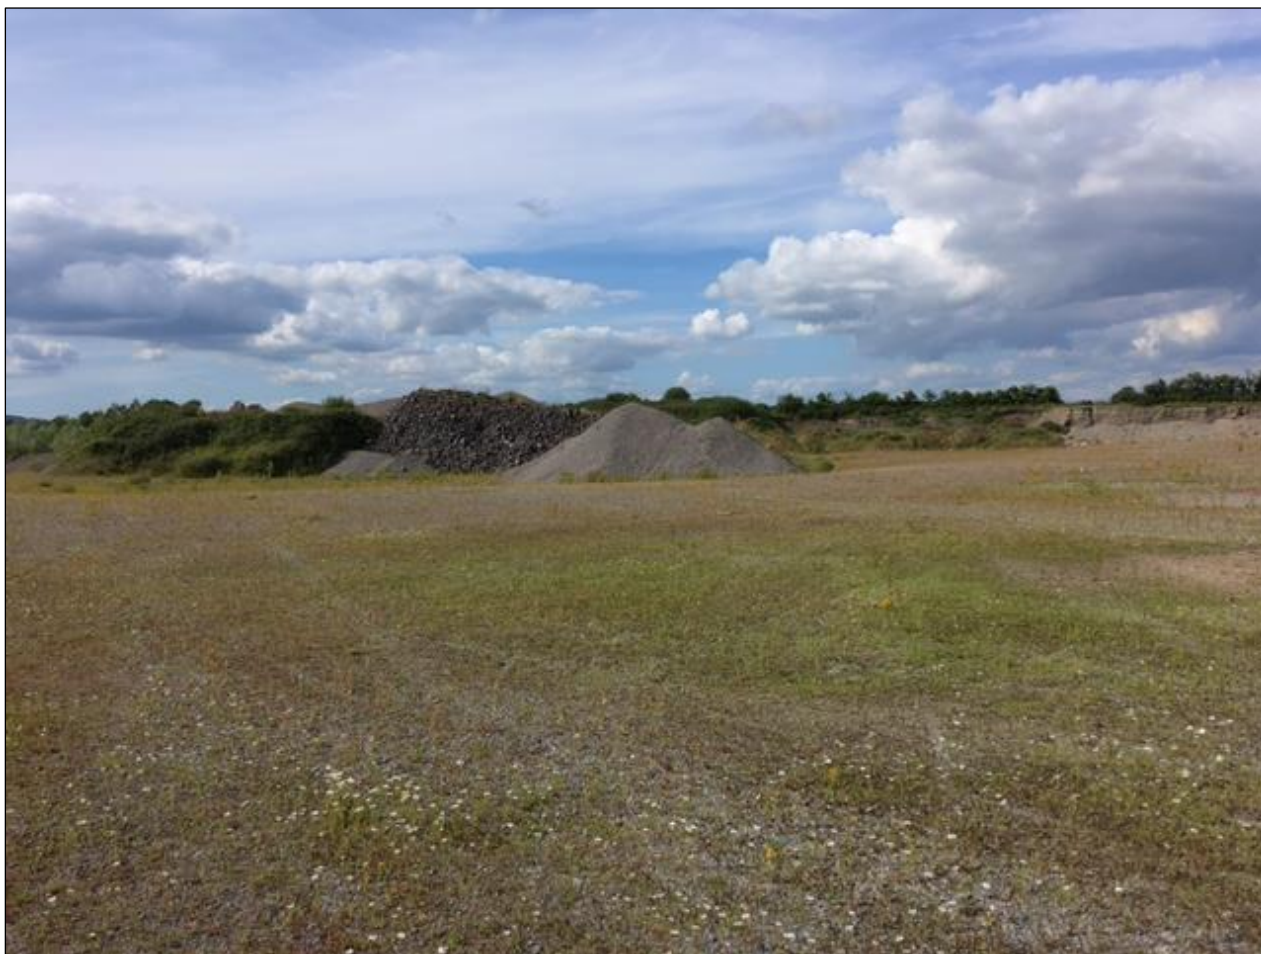
**Figure 5.4: Recolonising Bare Ground at the Garyhundon Site.**

Much of the Site that has historically been afforded anthropogenic disturbance has been left fallow for some years. The absence of regular vehicular traffic has allowed floral development. In many cases, the exposed sub-soils and nutrient poor strata have allowed a diverse flora to develop. Typical colonisers noted during the field assessment and by SLR (2010) included spear thistle *Cirsium vulgare*, hedge mustard *Sisymbrium officinale*, dyer's rocket *Reseda luteola*, rose-bay *Chamerion angustifolium* and white campion *Silene latifolia*. Additionally, other species such as scentless mayweed *Tripleurospermum inodorum* coltsfoot *Tussilago farfara* coltsfoot, ragwort *Senecio jacobaea* and beaked hawksbeard *Crepis vesicaria* were recorded or referenced.

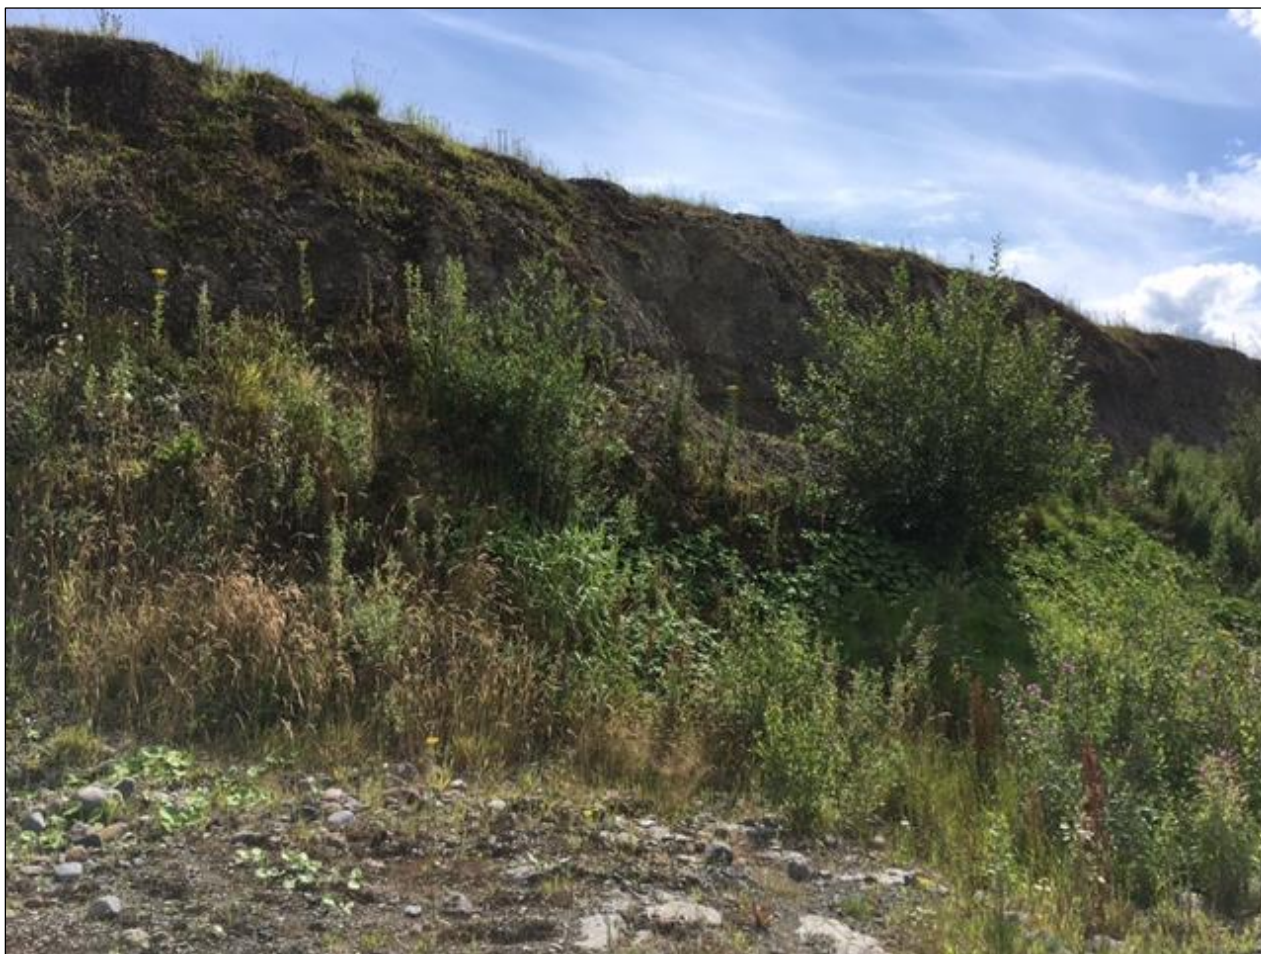
Figure 5.5: Scrub and pioneer plant succession on the Site periphery.

Scattered and dense scrub occurs frequently at hedge junctions on fallow ground throughout the Site. Species composition includes blackthorn *Prunus spinosa*, hawthorn *Crataegus monogyna*, brambles, gorse, willow *Salix* spp., cleavers *Galium aparine*, dog-rose *Rosa canina*. The scrub transitional habitat includes; gorse *Ulex europaeus*, brambles *Rubus fruticosus* agg, Yorkshire fog *Holcus lanatus*, cocksfoot *Dactylis glomerata*, creeping buttercup *Ranunculus repens* and creeping thistle *Cirsium arvense*.

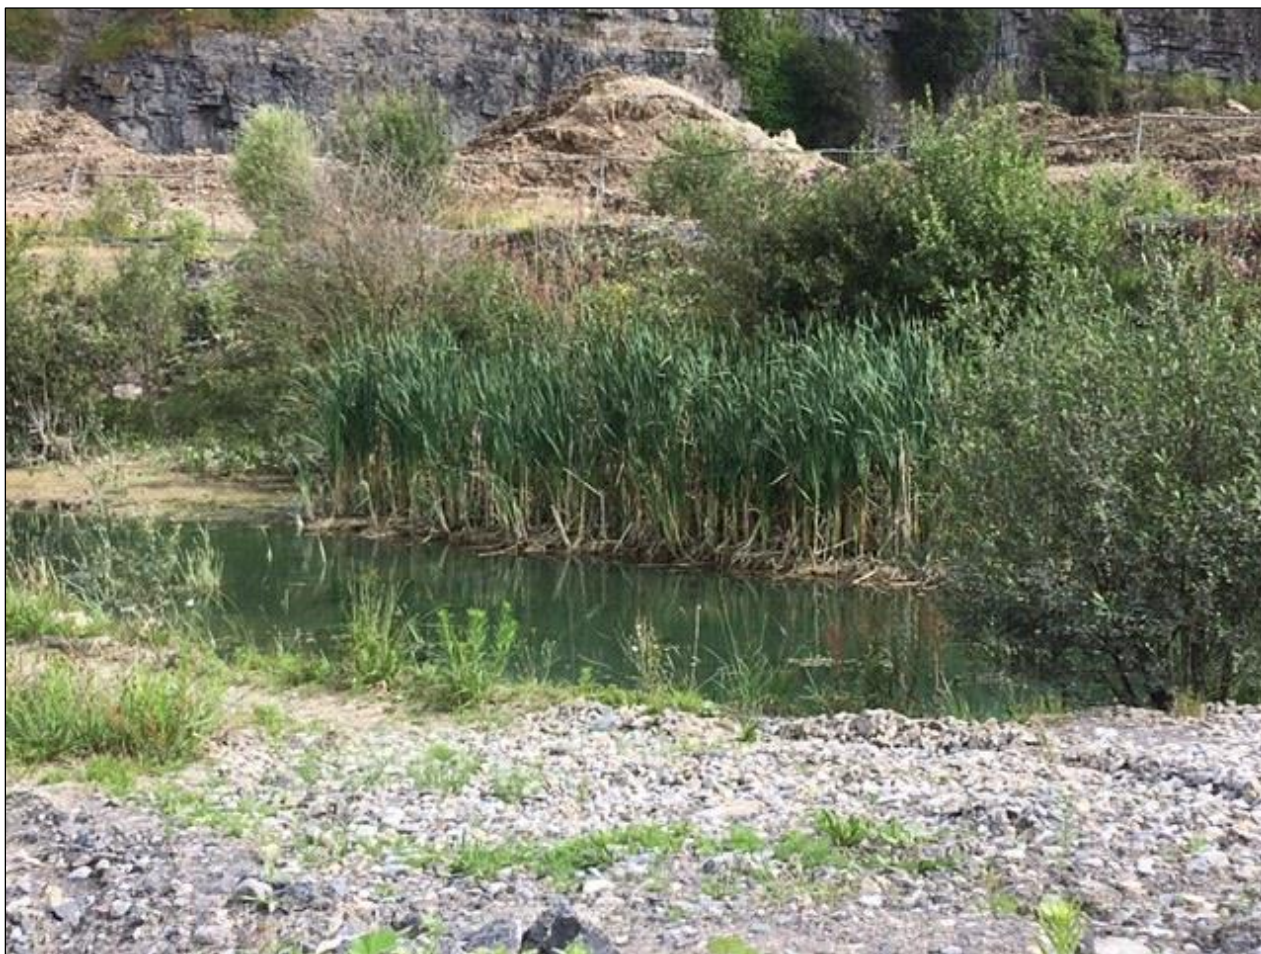
**Figure 5.6: Artificial Ponds within the Site**

Excavation of the Site over the decades has resulted in a number of standing water bodies as illustrated in Drawing 5.1. These ponds are likely to be ephemeral in nature and are also affected by pumping regimes in some circumstances in accordance with prevailing rainfall. Vegetation establishment within and adjacent to these features was apparent and aquatic species such as broad-leaved pondweed *Potamogeton natans*, stonewort *Chara* species and water plantain *Alisma plantago-aquatica* were recorded. In a marginal context, toad rush *Juncus bufonius*, self-heal *Prunella vulgaris* and hoary willowherb *Epilobium parviflorum* are abundant. The transitional zones between aquatic and terrestrial habitat were dominated by reedmace *Typha latifolia*, greater horsetail *Equisetum telmateia* hard rush *Juncus inflexus* and canary reed grass *Phalaris arundinacea*.

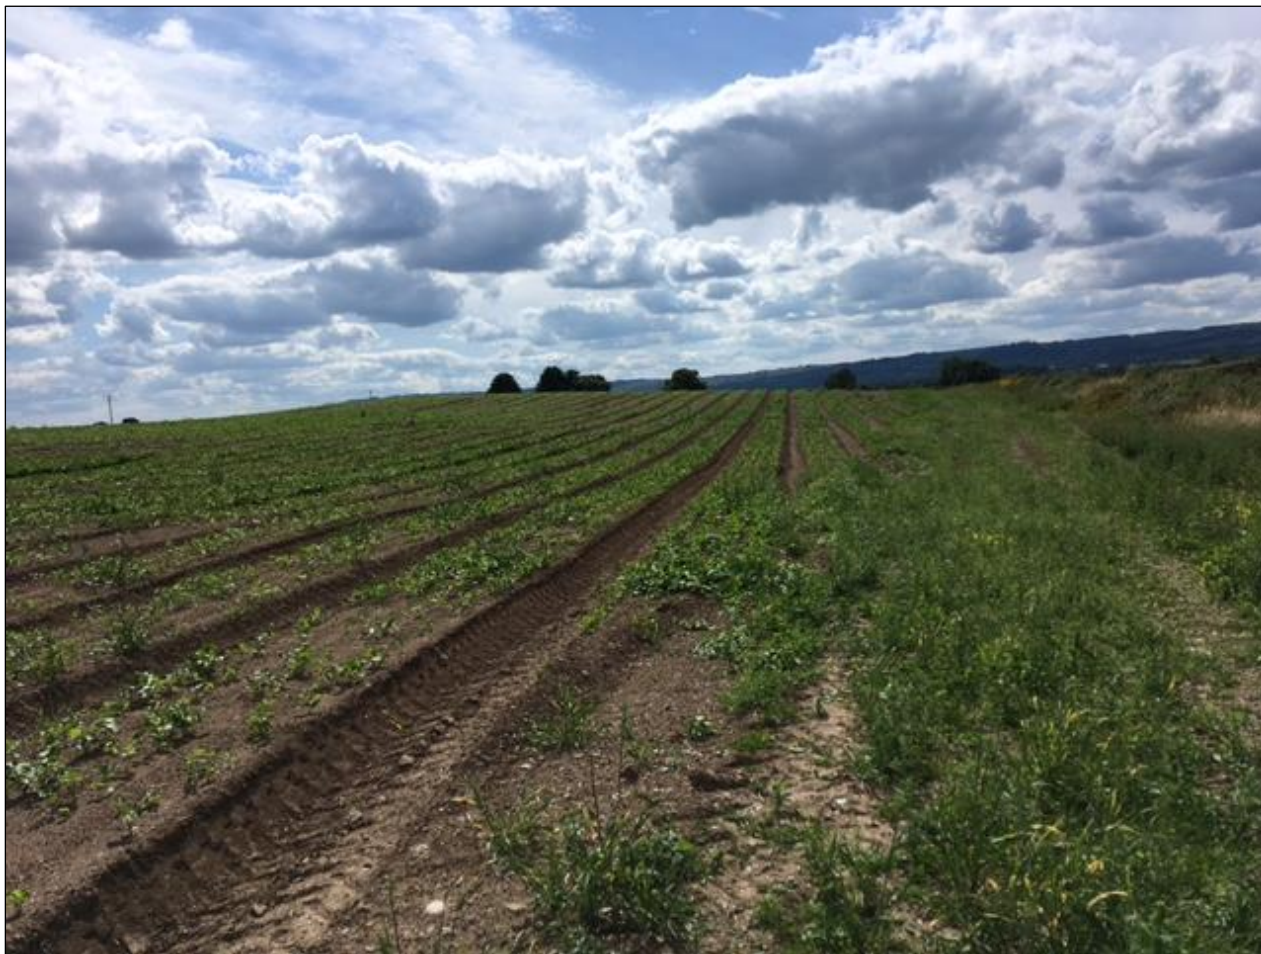
**Figure 5.7: Arable Habitat (carrots) situated between the Clonmelsh and Garyhundon Site**

Arable habitat is present on the Site periphery. This cropping regime, by definition, creates a monoculture of species-poor habitat of negligible biodiversity value. However, the arable field margins are considered to be of biodiversity interest. Species, considered to be weed flora in these margins include forget-me-not *Myosotis arvensis*, corn marigold *Chrysanthemum segetum*, field pansy *Viola arvensis* and fool's parsley *Aethusa cynapium* as recorded by SLR (2010).

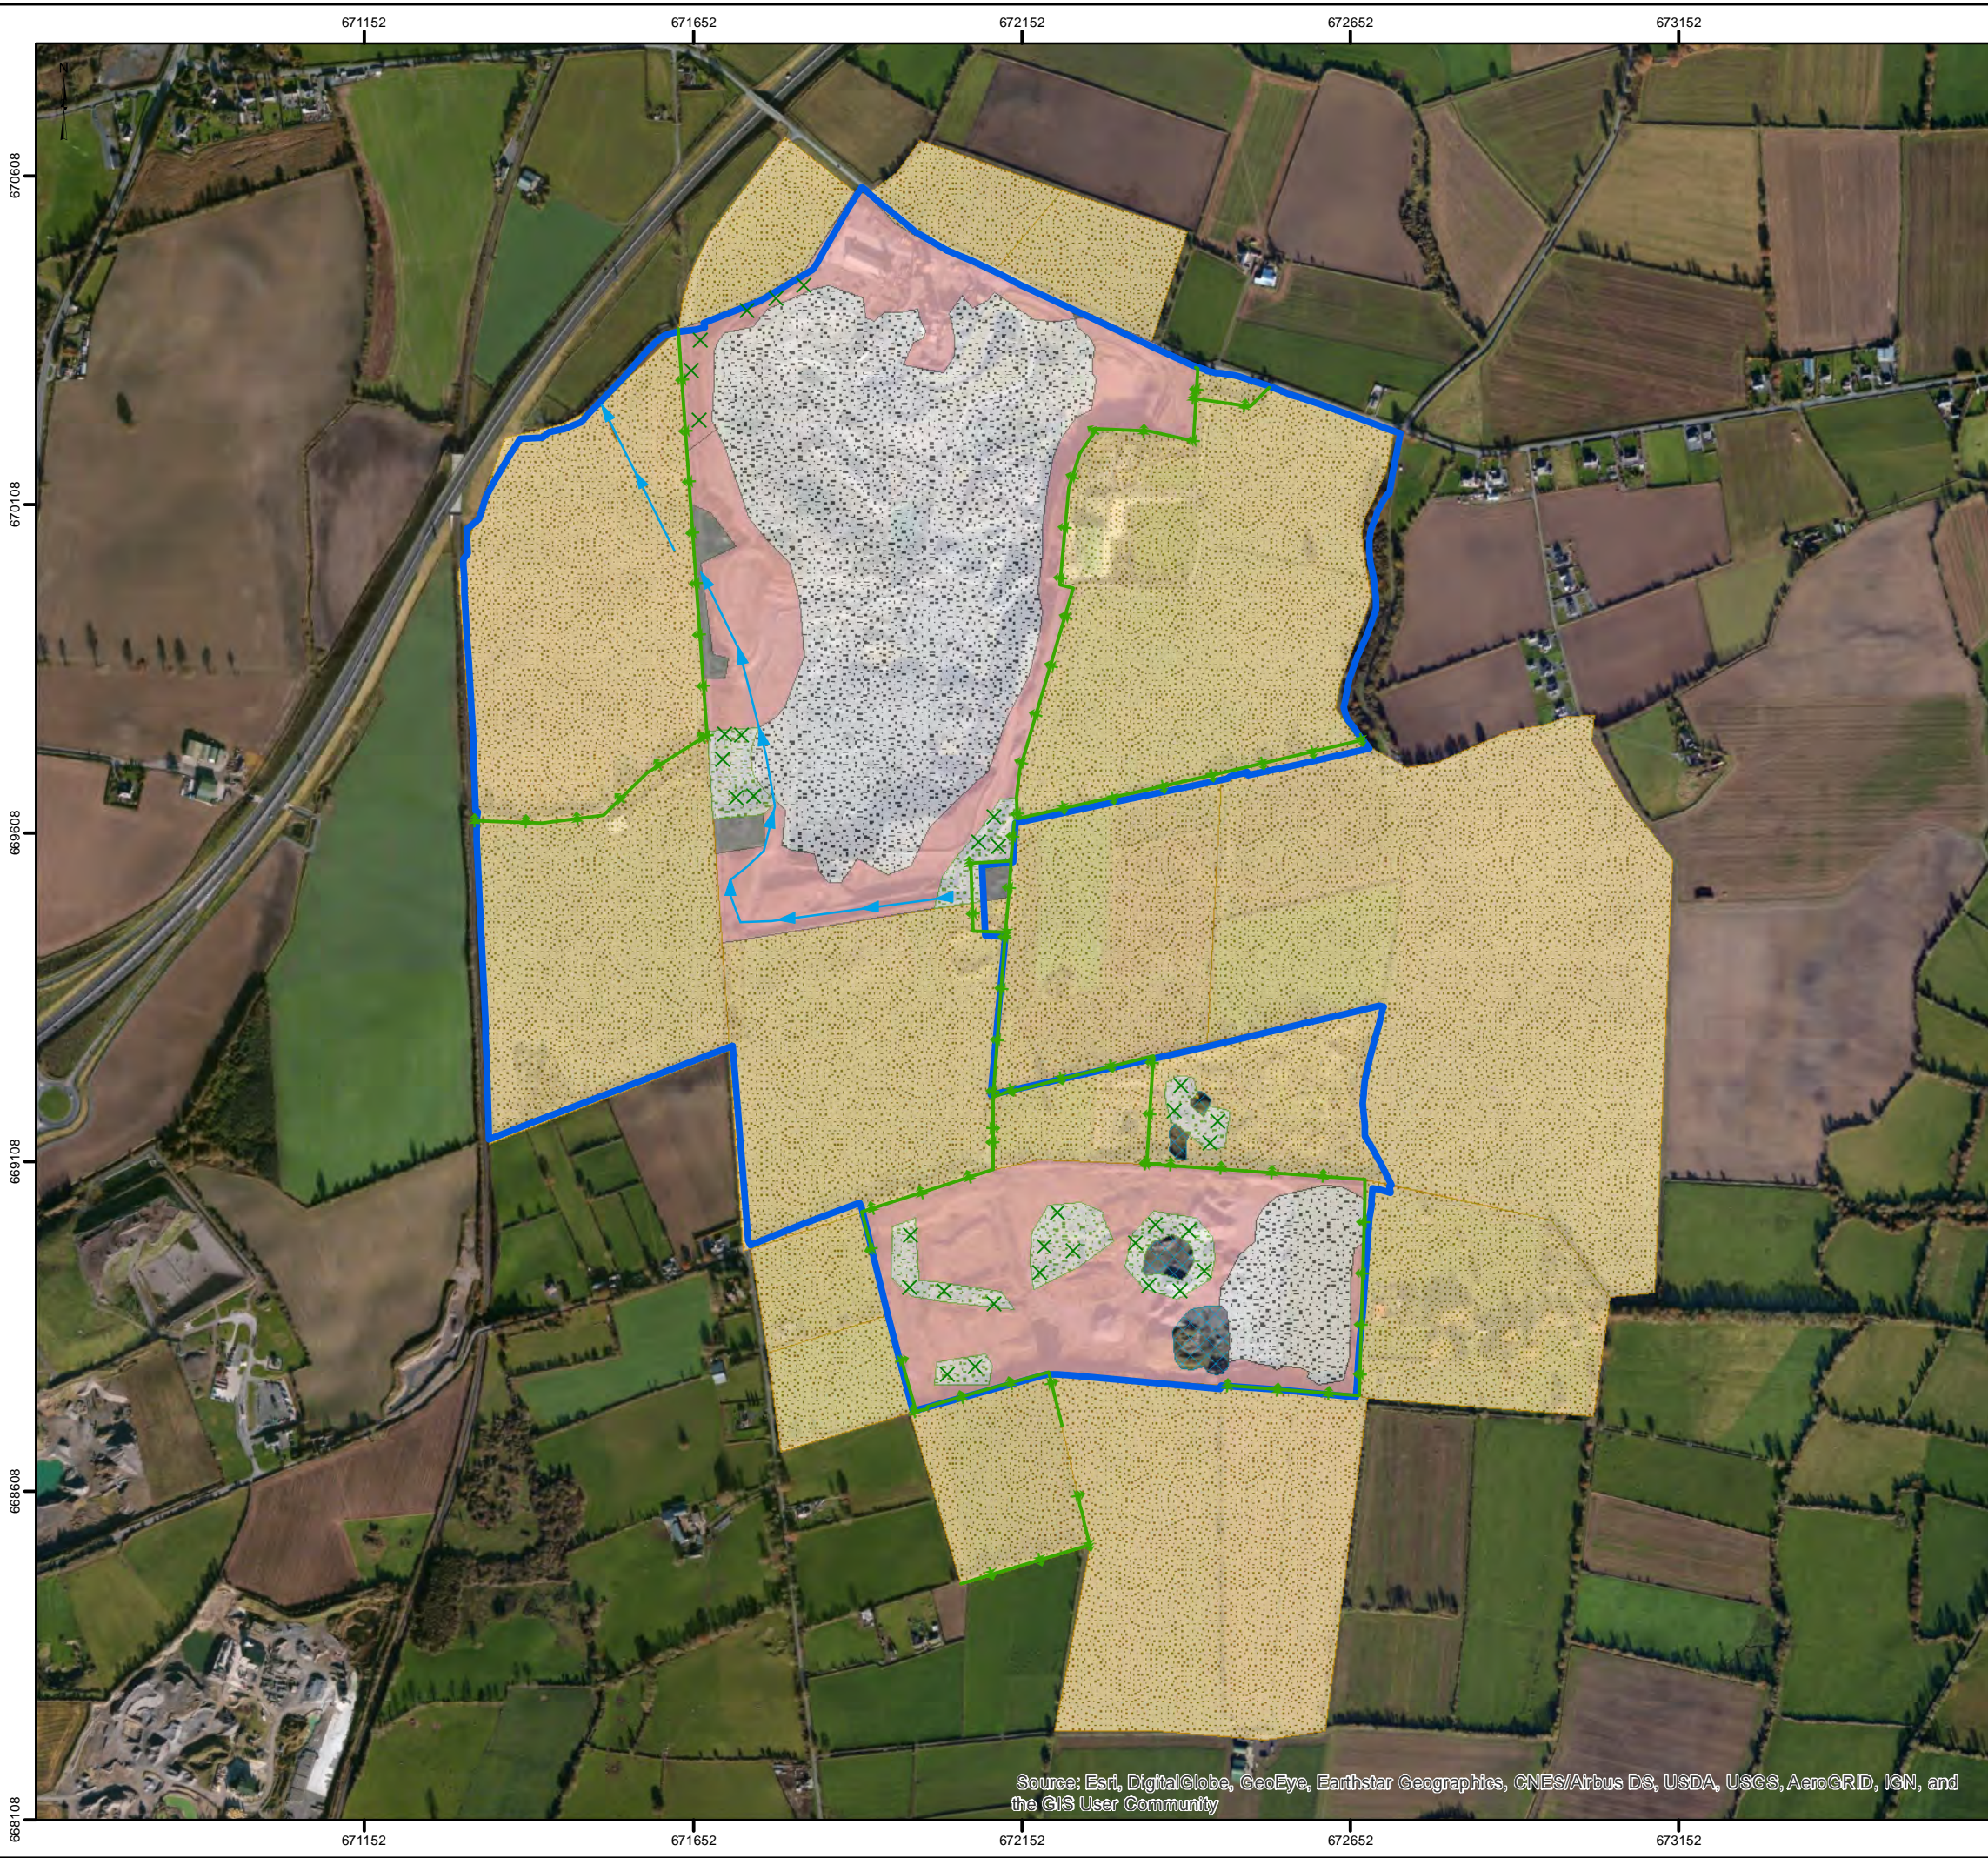
- LEGEND**
- Lands in Control of Applicant
  - Fossitt Habitat Classification**
  - ▶ FW4 Drainage Ditch
  - + WC1 Hedgerow
  - Building
  - BC1 Arable
  - ED3 Recolonising Bare Ground
  - ED4 Active Quarry
  - FL8 Artificial Pond
  - WS1 Scrub

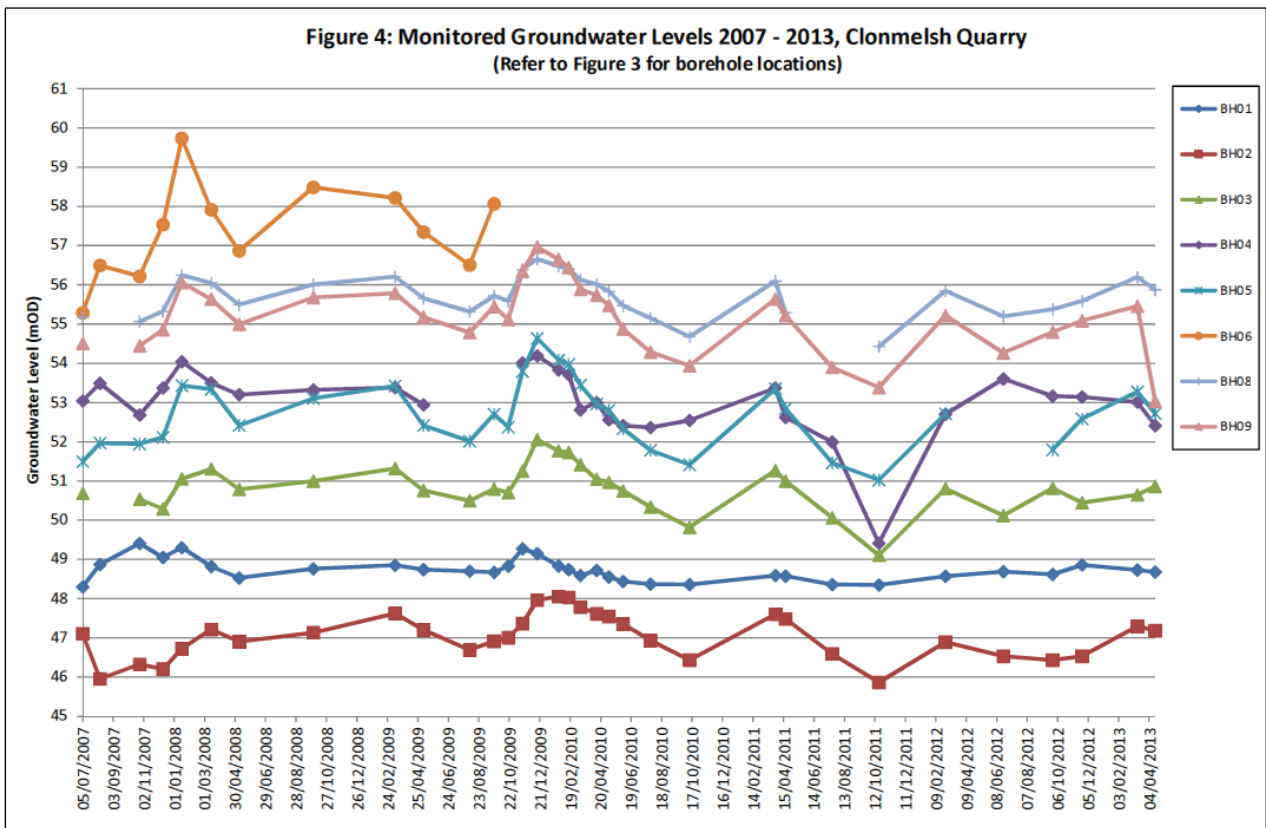
Figure 7.7: Hydrograph showing groundwater monitoring levels (2007 - 2013)

Groundwater levels for the 8 groundwater monitoring boreholes drilled in 2007 are presented in Figure 7.7. BH06 was destroyed by agricultural activity. The locations for the boreholes are shown on Figure 7.8.

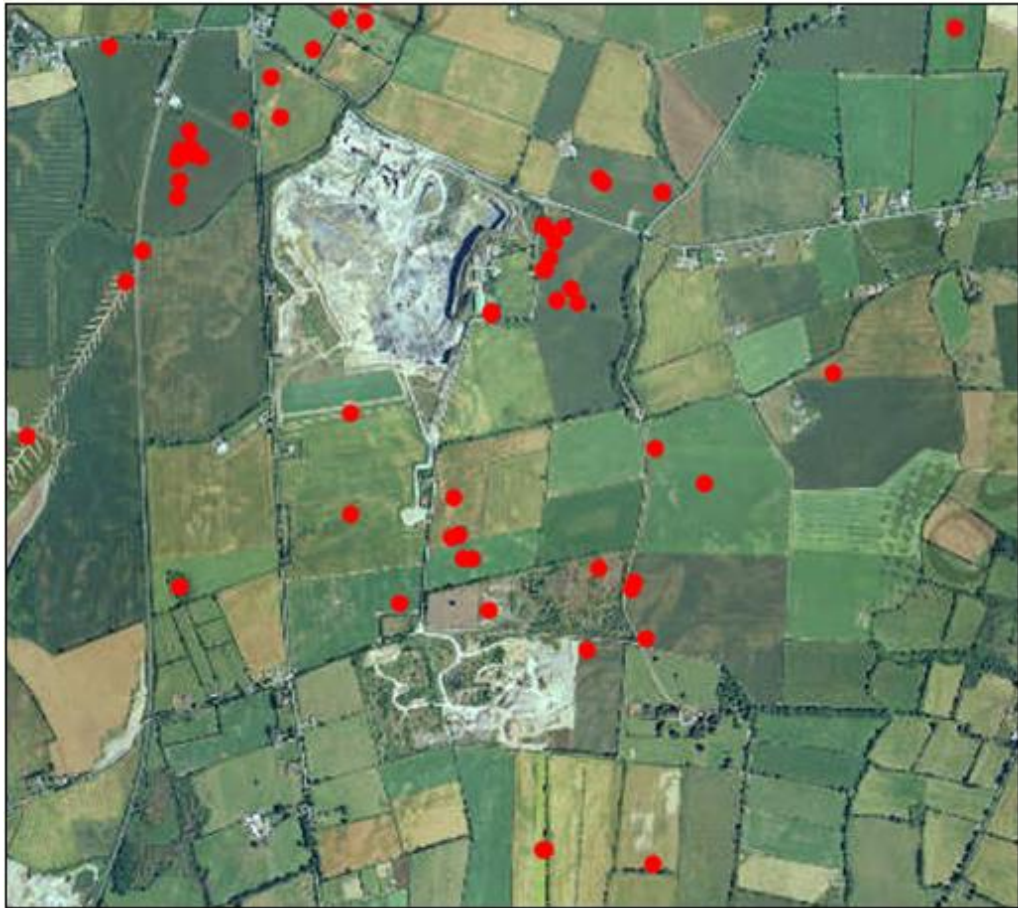
Figure 11.2 Extract from the RMP for the development with the existing quarry visible

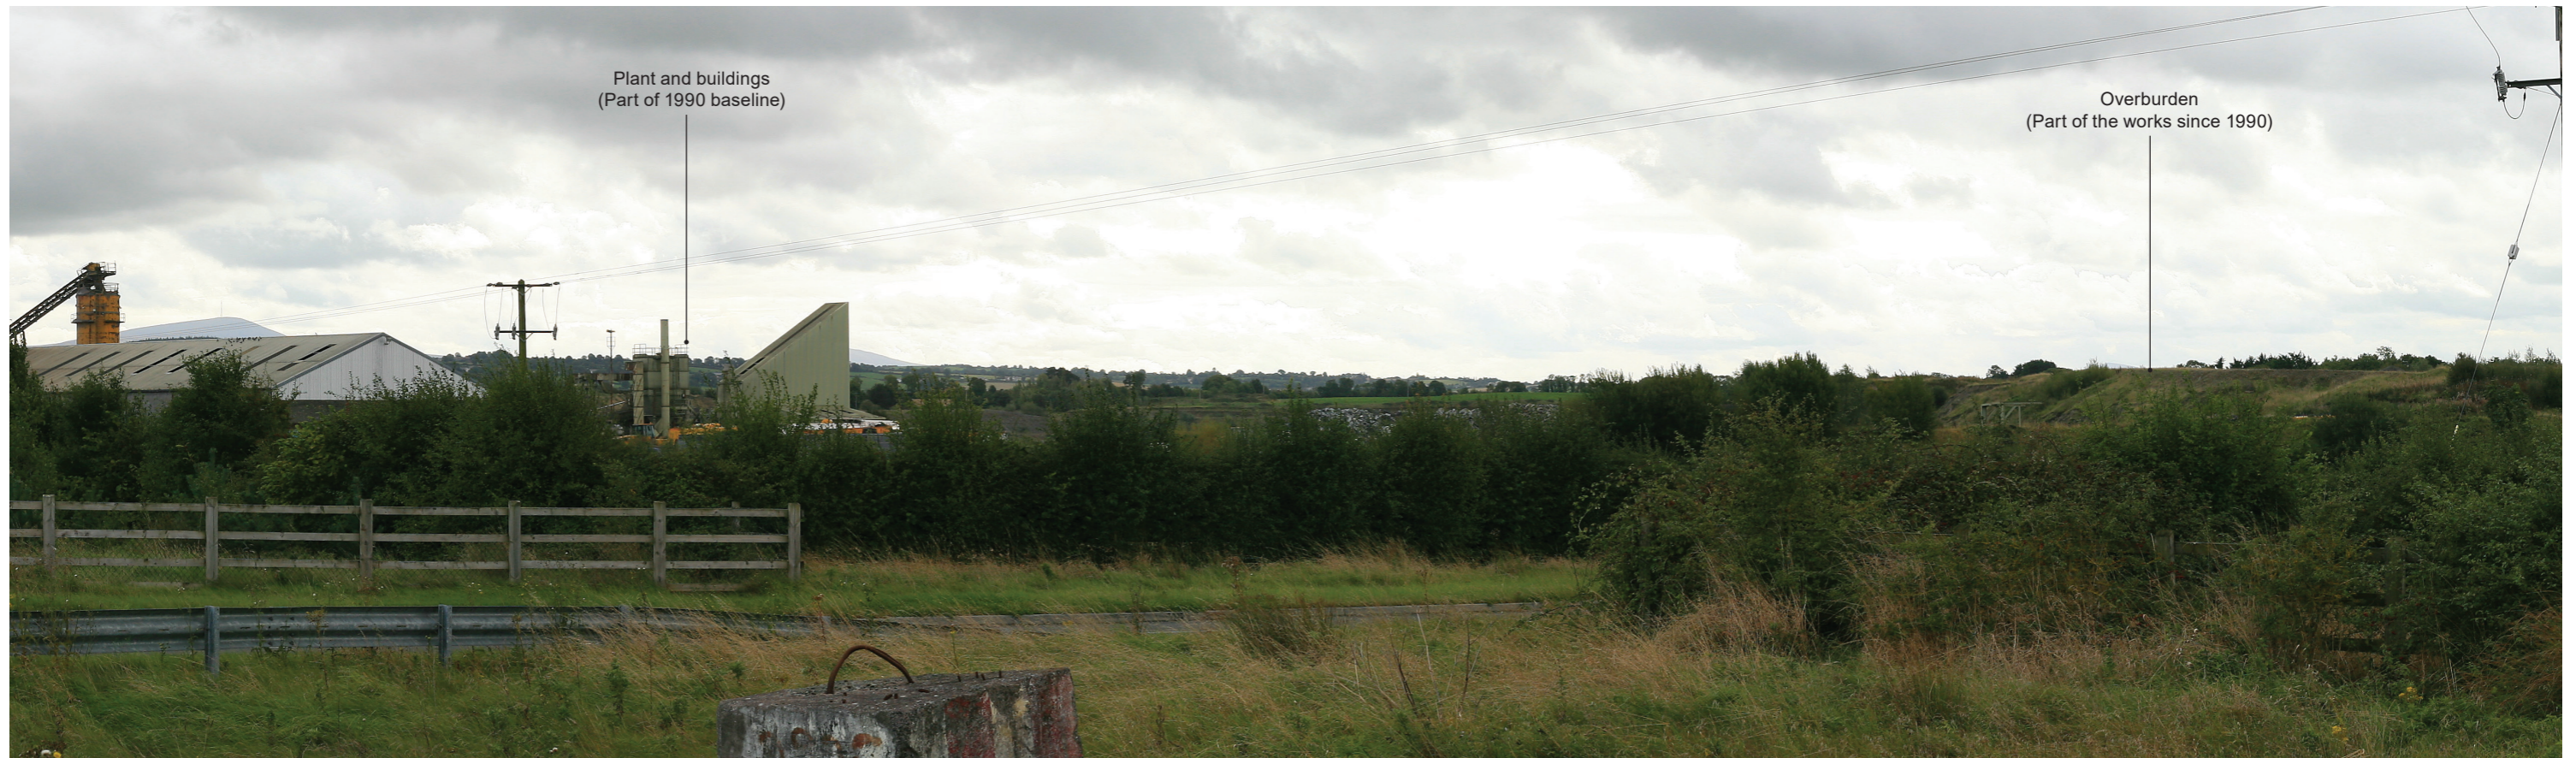
Plant and buildings  
(Part of 1990 baseline)

Overburden  
(Part of the works since 1990)

PHOTOGRAPH 1: VIEW FROM M9 OVERBRIDGE, NORTH OF CLONMELSH
