Chapter 14

Archaeology & Cultural Heritage

The proposed N5 Ballaghaderreen to Scramoge Road project comprises a Type 1 Single Carriageway 33.4km in length and passes through 46 townlands. A description of the proposed road development is provided in Chapter 4.

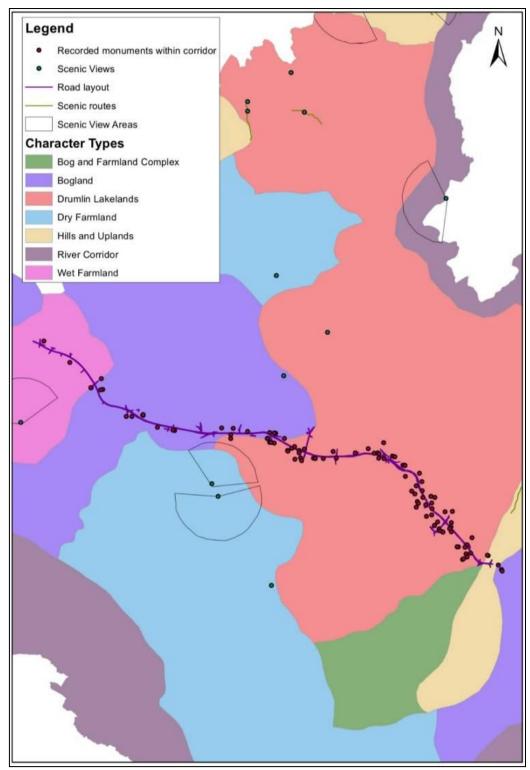
Plate 14.1 Character Type Areas and viewpoints (Mosart 2008) with the Proposed Route and Adjacent Recorded Monuments Shown

In the Roscommon Landscape Character Assessment report (2008), the rerouting of the existing N5 is seen as a change that could result in a fundamental alteration in the character of LCA 28. It has been determined that the existing N5 considerably detracts from the visitor experience of the publically accessible monuments within the Rathcroghan complex due to the intrusion of noise and traffic. If the existing traffic is diverted there is huge potential to significantly improve the quality of the Rathcroghan experience (Mosart 2008, 100).

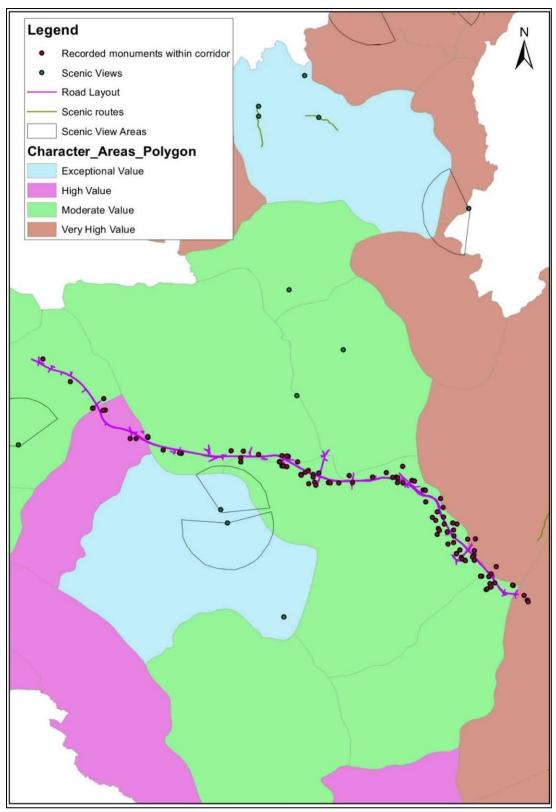
Plate 14.3 Character Value Areas and Viewpoints (Mosart 2008) with the Proposed Route and Adjacent Recorded Monuments Shown

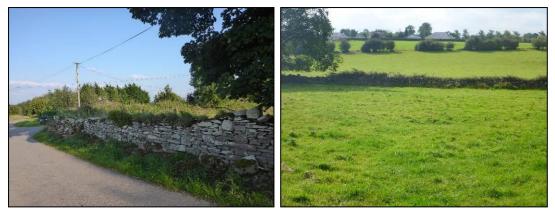
Plate 14.7 and 14.8 Roadside Stone Wall Ballaghcullia and Former Lands Associated with Strokestown Demesne, Killdalloge

The lands associated with former demesnes are often clearly defined by stone walls (mortared and unmortared) and this is the case with Frenchpark, Hermitage and Strokestown where long expanses of stone walls can be viewed along the existing roadside for example in townlands such as Cashel, Ballaghcullia and Killdaloge.

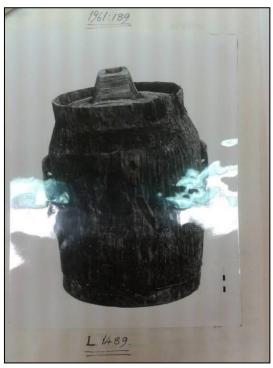
Plate 14.10 Photograph of Wooden Vessel Containing Bog Butter from Drummin Bog Courtesy NMI

According to the topographical files of the National Museum of Ireland, a wooden vessel containing bog butter (1943:288) was found in an unspecified bog in Mullen. In the same townland, a bronze triangular spearhead was also found (1941:351), but again in an unspecified location.

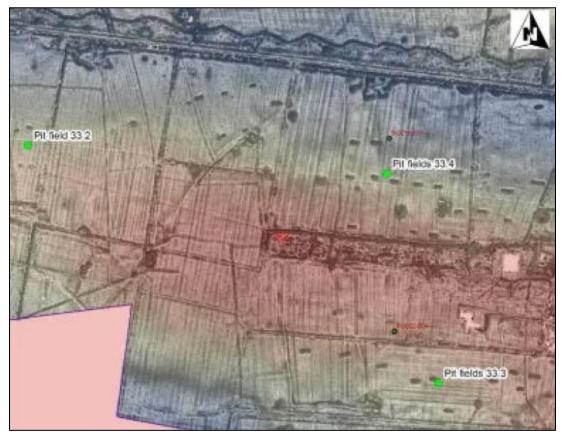
Plate 14.12 LiDAR Image of Pit fields at Kilvoy Townland (Davis 2015)

As part of the investigative work for this project a programme of geophysical survey has been carried out over a sample of the best preserved potential pit sites that will be traversed by the proposed road development. In addition to this metal detection, electrical resistivity imaging, topographical survey and targeted test trenching of the pits and the ground between them, soil sampling and an assessment by a consultant hydrogeologist took place in an attempt to gain a better understanding of these features. Following intensive investigation it is now thought that these potential sites could be a mixture of geological sites and manmade features . The results of the geophysical survey and test trenching are included in Section 14.4 of the report.

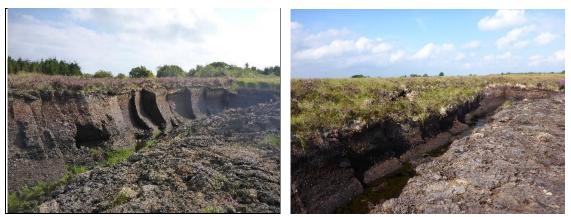
Plates 14.14 / 14.15 Peat Faces to the South of the Route at Ch. 11+500 and 12+250

The route does not pass any actively cut bog and any exposed peat faces or open cut drains that were inspected lay to the south of the proposed route and will not be affected by the development (Plates 14.14 and 14.15).

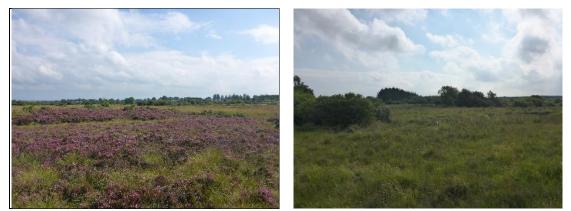
Plates 14.16 / 14.17 Reclaimed Bogland Along the Route at Ch. 12+250 and 10+950

There are no recorded monuments on this stretch of the proposed road development as it passes through the townlands of Mullen and Leggatinty. The area is shown as bogland on the 1st edition six-inch OS mapping. The character of the landscape has considerably changed since the mid-19th century with a greater number of enclosed fields and forestry plantations than was the case in the late 1830s when there was considerably more open land of a marshy or boggy nature as shown on the 1st edition six-inch OS. A large portion of the bog has also now been reclaimed (Plates 14.16 and 14.17) and used as rough grazing land.

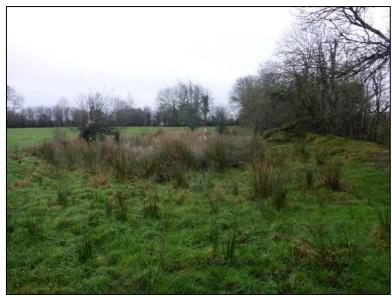
Plate 14.8 Wetland Area at Ch. 20+100

Within the landtake at Ch. 20+100 a number of drains meet forming a small semicircular wetland area to the north of an existing east-west bank and ditch boundary (this boundary is not on the 1st edition and only is shown on later revised OS editions). Two earthen banks approximately 2m apart protrude in a north-south direction from this boundary, acting as a channel for water and filling this natural wetland sump area. It is thought that the feature is a possible result of land reclamation practices in the area (Plate 14.8).

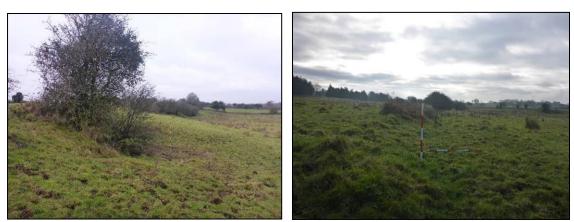
Plate 14.19 Possible Field Kiln

Plate 14.20 Possible Route Way/ Track

A quarried/pond area shown on the 1st edition map is now surrounded by trees and will be impacted by the proposed route. This possible quarry site presents as a large irregular area that appears to be cut into a northeast facing slope in the field. To the east there appears to be a level surface that acted as a former track that would have provided access to this feature. Further east along this possible route way is a smaller quarried area, possibly a field kiln (Plates 14.19 - 14.21). These kilns were once a common feature of the north Roscommon landscape and consisted of a free standing structure close to a quarry with a supply of limestone (Ganly 2009). A draw hole would be cut into the base of the kiln. A layer of sandstone was then pushed into the clay to give a heat resistant coating to the inside of the kiln. Many of these features had their steep sidewalls levelled to avoid injury to animals grazing the land.

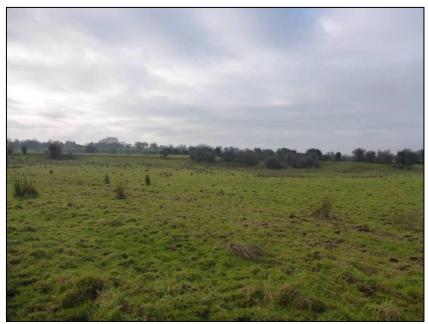
Plate 14.21 Photo Taken from Possible Former Track Overlooking the Quarry and Field Kiln Site (CHC 44A)

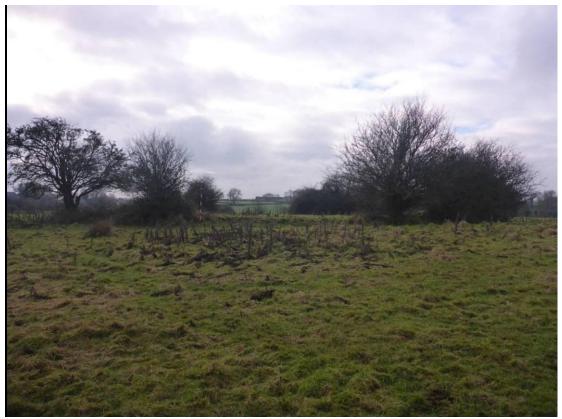
Plate 14.22 RO023-012 Ringfort (AH80) Located to the South of the Route

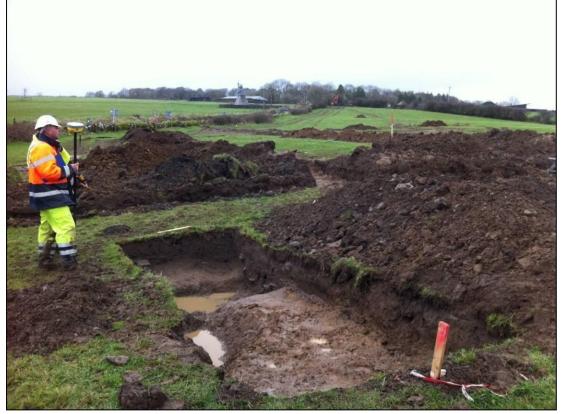
Plate 14.24 Test Excavation in Progress at Shankill

The results do not suggest the presence of an enclosing element associated with the adjacent church and graveyard site. Also no burials were recorded in any of the excavated trenches. The proposed junction upgrade works will result in the permanent removal of the newly identified below ground features and will therefore have a significant impact on these features. Preservation by record, i.e. full excavation would be the preferred mitigation measure (O'Connell 2016).

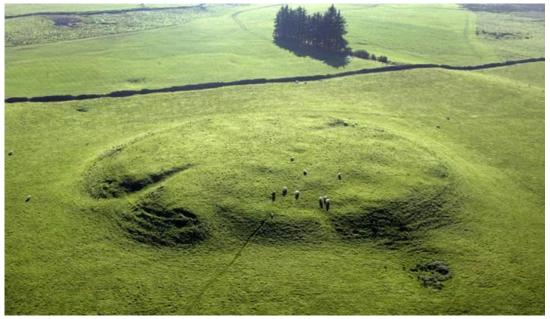
Rathcroghan Mound (RO022-057010-) (NMS)

The mound is just east of the centre of the ceremonial enclosure (RO022-057012-), and a number of other monuments that relate to the mound are within the ceremonial enclosure. The standing stone (RO022-057006-) is c. 100m to the northwest with a mound barrow (RO022-057007-) c. 40m to its southeast, and standing stone (RO022-057008-) is c. 100m to the north. Barrows (RO022-057013-) and (RO-022-057014-) are c. 70m to the east, and barrows (RO022-056015-; RO022-056016-) are c. 60m and c. 75m south southeast and southeast of the mound respectively.

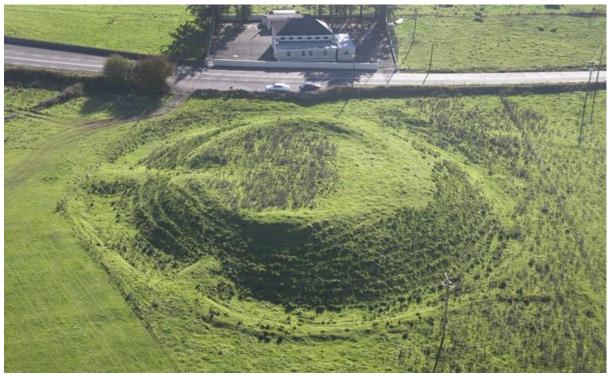
Rathmore (RO022-056017-) (NMS)

Geophysical survey revealed that it may be built around a slight natural rise, but it also recorded anomalies suggestive of two, or possibly three penannular structures that are probably hut-sites on the summit. The central one (ext. diam. c. 15m) appears to have a hearth and an east entrance, while that to the southwest appears to underlie the rath bank (Waddell et al. 2009, 66-79).

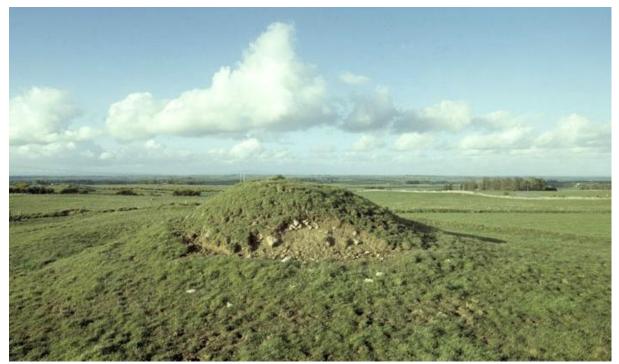
Caran Fort (RO022-056023) and Mound Barrow (RO022-056022) (NMS)

Two rectangular enclosures (dims. c. 15m x c. 8-16m) defined by slight scarps or banks are aligned north-south, and along a north northeast-south southwest field bank just to their west, the field system extends off to the north where it truncates Carran Fort (RO022-056023-) on the west side. A further curving northwest-southeast field bank is located just to the northeast of the rath, and a rectangular enclosure (RO022-056021-) (dims. c. 10m x c. 8m) which is defined by slight scarps and is located c. 100m west of the rath. Geophysical testing of Caran Fort regards the field system as pre-dating the rath, and anomalies immediately south of the rath raise the possibility of metal- working in the area (Waddell et al. 2009, 51-2).

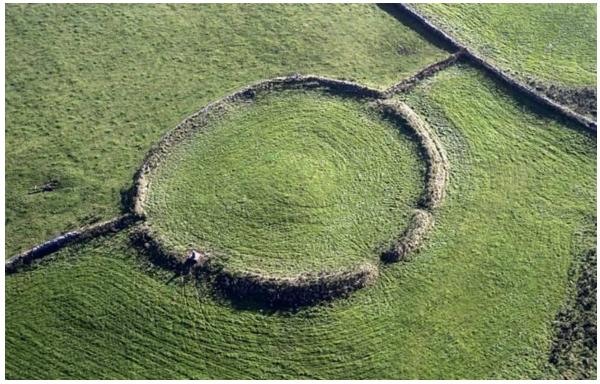
Ringfort (RO021-030) (NMS)

Description: This ringfort is located at the summit of a broad hill. It is a sub-circular grasscovered natural mound (dims. 27m east-west; 21m north-south; height 1-1.6m) within an enclosure (diam. 55m north-south; 54m east-west) defined by an earthen bank (Width 4.5-6.5m; int. height 0.9-1.1m; ext. height 1.3-1.8m). There is an entrance (Width 2.3m) at northwest but there is no visible fosse. Evidence of a fosse was recovered in a gradiometry survey conducted by Target Geophysics for M. Croghan in 2009 to the southwest and northeast but could not be recorded elsewhere because of interference from barbed wire fences. The survey also recovered slight evidence of a possible circular hut-site at the centre, with other possible features inside the bank at the north and the south. The bank is overlain by the remains of a stone wall to the east northeast-southwest, and there is a trig. station on the perimeter at the northeast of the site. Archaeological testing c. 200m to the west, and monitoring in the vicinity, failed to produce evidence of ancient activity (Dunne 1998).

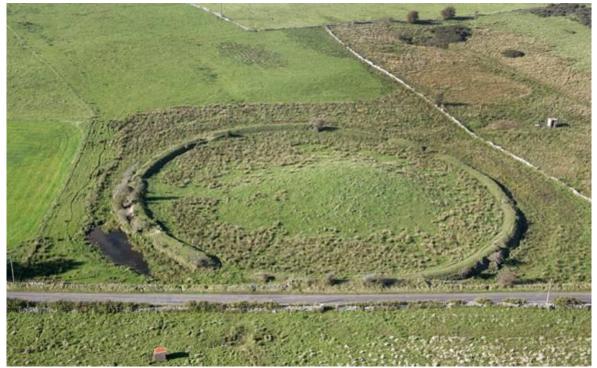
or activities, apart from what might be an episode of burning on the summit of the knoll (Waddell 2009, 58-66). Described as a possible ring-barrow (Herity 1983, 132; 1988, 131, Glenballythomas 3). (Knox 1911, 221; 1914, 13; Herity 1983, 132, Glenballythomas 3; Waddell 1983, 33-5; 1988, 8, No. 23).

Rathnadarve (RO022-057004) Aerial view (NMS)

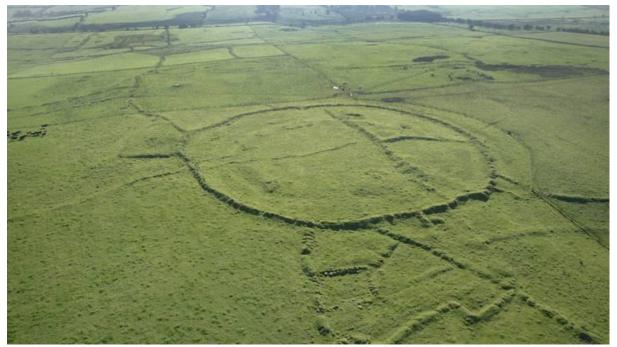
Relig na Riogh (RO022-057035) (NMS)

A rectangular enclosure or annexe (RO022-057038-) (dims. 27.5m NE-SW; 17.7m NW-SE) defined by scarps (H 0.3-0.8m) is situated on a slight height and attached to the outside of the outer enclosure at SE, but its perimeter at SW is overlain by a north-south field bank. There is a rectangular house site (RO022-057037-) (int. dims. 10.6m E-W; 4m N-S) on the perimeter of the inner enclosure at the west. Other house sites were investigated in 1913 (Waddell 1983, 26). The site is overlain by N-S and E-W field banks of the field system (RO022-057003-), and cashel (RO022-057039-) is c. 100m to the south. (Knox, 1914, 35-6; Herity 1983, 132, Glenballythomas 25; Waddell 1983, 29-31; 1988, 8-10, No. 13).

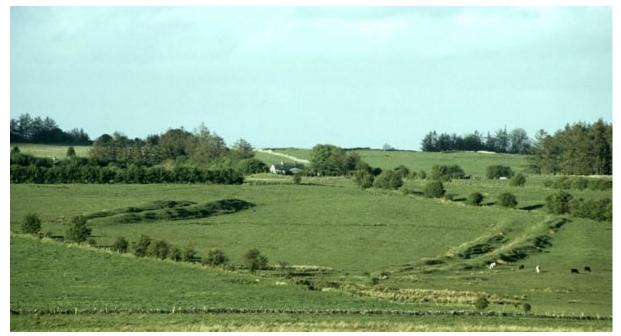
Mucklaghs (RO021-042015) (NMS)

Description: Towards the bottom of a gentle SW-facing slope. The name is derived from a local tradition that the linear features were made by a racing wild pig digging its tusks into the ground. The northern Mucklaghs are two parallel grass-covered earthen banks aligned ENE-WSW and curving slightly to the north at either end (L c. 100m). The north bank (Wth of base 11.2m; H 1.8m at S; H 2.8m at N) is flat-topped (Wth 2m) and separated by a berm (Wth 3.6m) in which a drain has been dug from the south bank (Wth of base 11.2m; H 2.2m at N; H 3.2m at south). The Southern Mucklaghs (RO021-042016-) are c. 70m to the south, and barrow (RO022-057027-) is c. 120m to the NE. Rather than being linear earthworks extending over the landscape, the two Mucklaghs may have been an attempt to create a large ceremonial enclosures (diam. c. 500m; c. 1km). (Knox 1914, 27-8; Herity 1983, 131; 1984, 138; Waddell 1983, 33; Waddell 1988,15; Waddell 2009, 89-90).

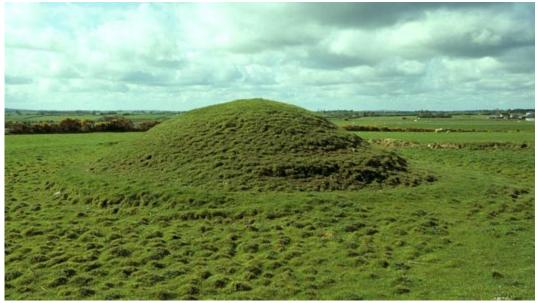
Carn Lamha (RO027-070) (NMS)

The monument is located on a rock-outcrop rise at the eastern end and at the highest point of the broad west northwest – east southeast Carnfree ridge and commands wide views to the north, east and south. It presents as a sub-circular grass-covered area with rock outcrop (dims. 85m E-W; 75.5m north-south) defined by low scarps (H 0.3m), with traces of a fosse (Width of top 4m; D 0.2m) at the north. The cairn (RO028-069001-) is located at the centre (approximately 12.50m in diameter and 1.40m in height). The road (RO028-062----) veers to the east to avoid the enclosure, which is partly quarried, especially at the east and overlain by north-south and east-west field walls. Limited geophysical survey failed to confirm its existence (Waddell et al. 2009, 119). Mound (RO028-251----) is just outside it at southeast. (Herity 1983,126-7). To the east of the inauguration mound along the broad ridge, in Carns townland is another mounded site that has been re-identified as Carn Lamha (RO027-070) (FitzPatrick 2004, 65).

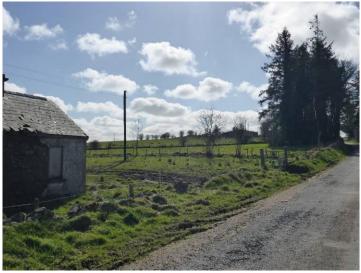
RO022-056006 Ring-barrow Grallagh

Other sites were considered for inclusion but were dismissed due to restricted views and/or interrupted view sheds for example the barrows at Grallagh (RO022-056006 and 007), now somewhat artificially enclosed, (see photograph below) or the ringfort at Ballyconboy (RO022-056001) where large forestry plantations are located directly north. Rathlough ringfort (RO022-006001) to the north of the key constraint area (Figure 14.26) in Clogher Beg was also examined but as it is located at the bottom of an east-west valley at the northern foot of the Rathcroghan plateau and has limited views to the north which are now interrupted by vegetation and agricultural buildings it was not included in the record.

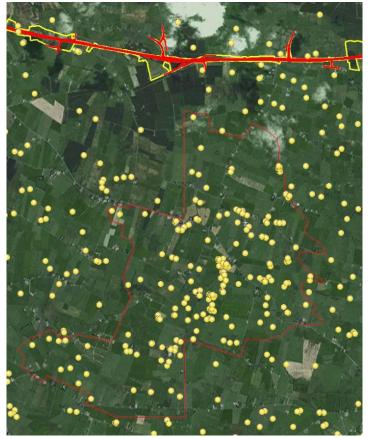
Plate showing the key constraint area for Rathcroghan, SMRs and the proposed road development

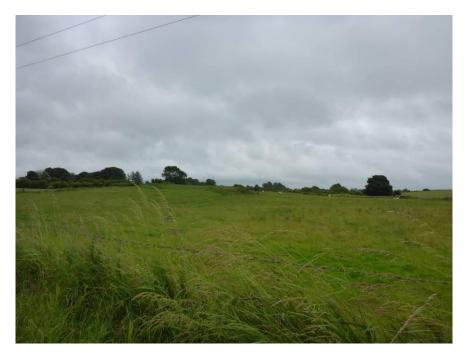
View from the southwest looking northwards towards a house and Rathlough ringfort site (RO022-006001/002) in Clogher Beg. The site is overgrown with vegetation and has been disturbed in the past with quarrying activity. It is located on a south-facing slope of an east-west valley at the northern foot of the Rathcroghan plateau. Views are restricted to the north.

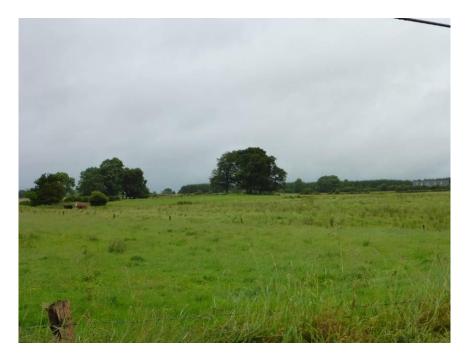
Taken from the southeast, view towards an enclosure (RO022-003). This enclosure is named as 'Crockaunagat' and is located on a south-facing slope within an east-west valley at the northern foot of the Rathcroghan plateau. The views to the north are limited from the site and restricted by vegetation.

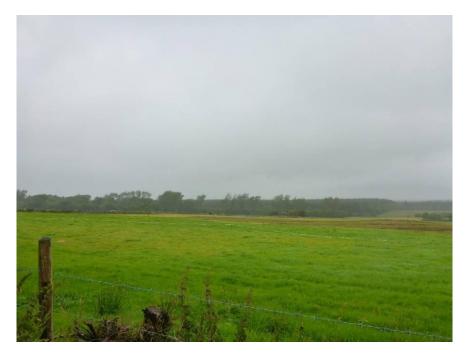
Taken from the south east in the direction of an enclosure site (RMP022-056001) in Ballyconboy. The site is located in a small field surrounded by mature hedgerow restricting views in all directions. Immediately to the north a forestry plantation is located.

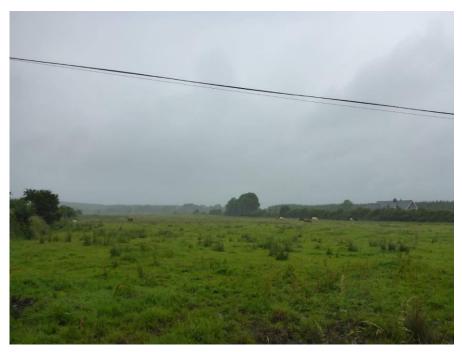
Taken from the southeast of the redundant record site (RO022-004) also identified by LiDAR survey as a pit field site in Kilvoy townland. The views to the north are restricted and a number of tree shelter belts occur between the proposed road development and this area.

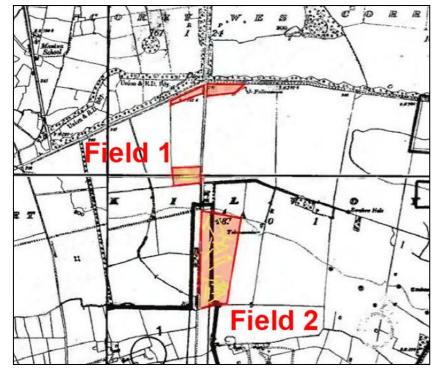
Plate 14.21: Map showing excavation areas opened under licence 09E0569

Testing was carried out in two areas, Fields 1 and 2 (Plate 14.21). Field 1 was located in the northern part of the proposed development. No geophysical survey was carried out in this area, as the land was waterlogged at the time of survey. During testing, three trenches were excavated and no archaeological features were identified. An elevated laneway links Field 1 to Field 2 to the south. This was a stone hard-core track that branches out into the forested areas to the east and west. Two derelict 19th-century stone buildings representing an old farmstead were located to the east of this elevated laneway.

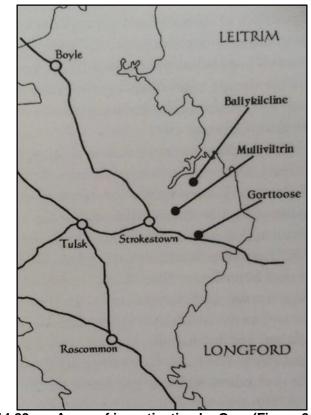
Plate 14.22 Areas of investigation by Oser (Figure 2.1, 2006)

Between 1996 and 2002, Charles E. Orser Jr. of the Anthropology Dept. of Illinois State University carried out a series of archaeological investigations focusing on the Famine period and attempted to broaden our understanding of early 19th rural tenant life in this part of the country. These excavations took place under licence numbers 96E0073, 97E0164 and 98E0267, in the townlands illustrated in Plate 14.27.
