Lackagh Tunnel Geotechnical and Hydrogeological Appraisal

Galway County Council

N6 Galway City Ring Road

Lackagh Tunnel: Geotechnical and
Hydrogeological Appraisal

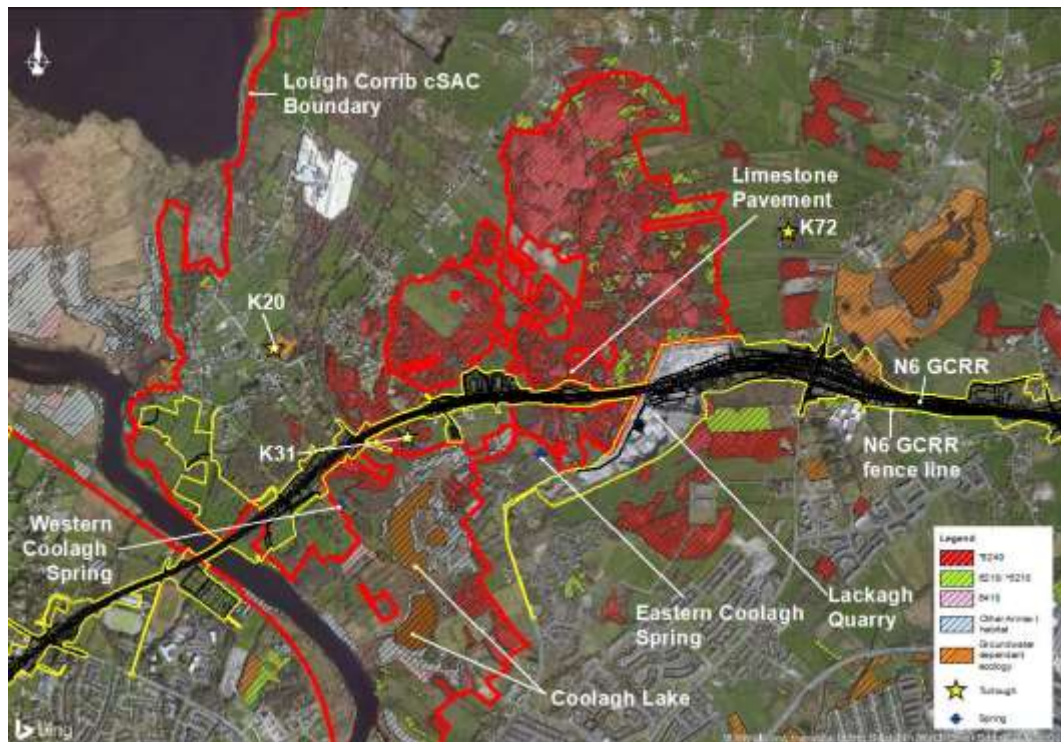
Figure 3.1: Limestone pavement and GWDTE adjacent to Lackagh Tunnel

The ecology in the area of the proposed tunnel sensitive to potential hydrogeological and geological direct and indirect impacts include Limestone pavement, Calcareous grassland and GWDTE (including Turloughs and Coolagh Lakes) - refer to **Figure 3.1**. Groundwater contributes to Coolagh Lakes, Lough Corrib, River Corrib and Galway Bay. GWDTE and Limestone pavement are sensitive to changes in hydrogeology but are dependent on different aspects of the water environment. Whilst, GWDTE is dependent on the groundwater table and its interaction with surface water, Limestone pavement habitat is dependent on exposed, free draining and unsaturated limestone with clints and grykes.

The karst survey undertaken for the constraints study for the proposed road development included a site walkover. The survey identified several karst features in the area including the Western Coolagh Springs, which discharges to Upper Coolagh Lake, as well as three Turloughs in the Menlough/Coolough area (Refer to **Figure 3.1**).

The upper lake receives flow from the Western Coolagh Spring and Eastern Coolagh Spring (Refer **Figure 3.1** for location of springs). It is noted that the Western Coolagh Spring is a karst spring whilst Eastern Coolagh Spring is not a karst spring because it sits on thick clay subsoil as evidenced by ground investigations (GI). There is a potential for seepage from the limestone aquifer through the clayey subsoil to the Eastern Coolagh Spring but due to the low permeability and thickness of the clayey subsoil, these potential seepages are of a very low flow rate. If present, seepages from the subsoil to the Eastern Coolagh Spring would represent a very small fraction of the groundwater contribution to Coolagh Lakes compared to the karst inflow at Western Coolagh Spring which provides the main groundwater contribution flow to Coolagh Lakes. The flow rate from the Western Coolagh Spring has been estimated to range from 0 to 100 l/s

Three Turloughs were identified in the Menlough area, with all three located outside the Lough Corrib cSAC (Refer to **Figure 3.1**). Turlough K31 lies immediately to the south of the proposed road development, Turlough K20 is located just to the north of Menlough Village and K72 is located north of Lackagh Quarry. The winter flooding of the turloughs is due to the seasonal groundwater rise. Although outside of the Lough Corrib cSAC, these turloughs are assessed in this report as there is the potential for indirect hydrogeological impacts on these features due to Lackagh Tunnel.

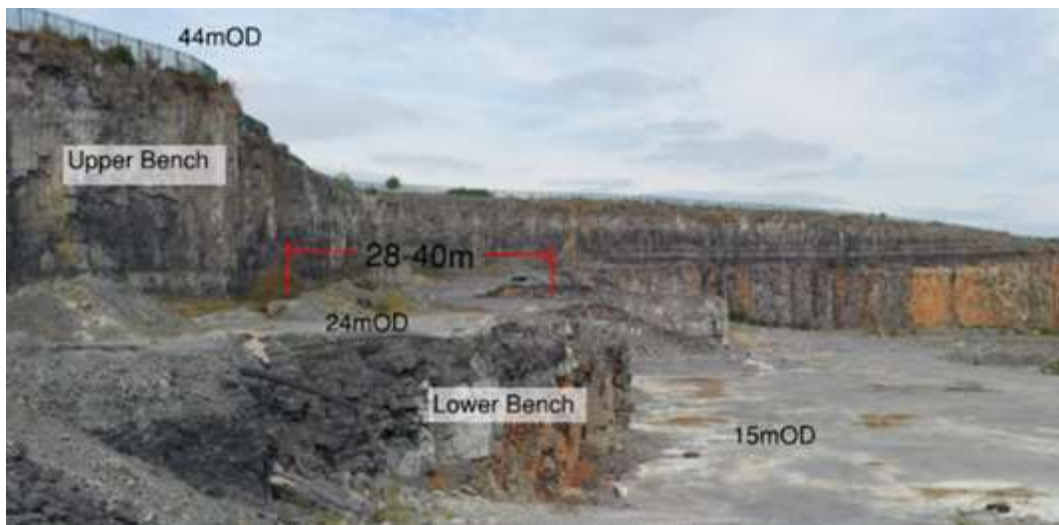
**Figure 3.3: Photograph of Lackagh Quarry in the vicinity of the tunnel portal**

The proposed eastern tunnel entry portal is located within the now inactive Lackagh Quarry, on the western quarry wall. The western quarry wall comprises of a lower and upper bench. The lower bench floor level is at +15mOD which rises steeply to +24mOD at the upper bench with a slope angle ranging from 75 degrees to sub-vertical in places with an uneven surface, (**Figure 3.2**). The distance between the top of the lower bench to the base of the upper bench ranges in width from 28m to 40m around the proposed tunnel portal area, (**Figure 3.3**). The upper bench ranges in height from 18m to 20m with a slope angle ranging from 70 degrees to sub-vertical. The maximum elevation of the quarry wall in this location is +44mOD.

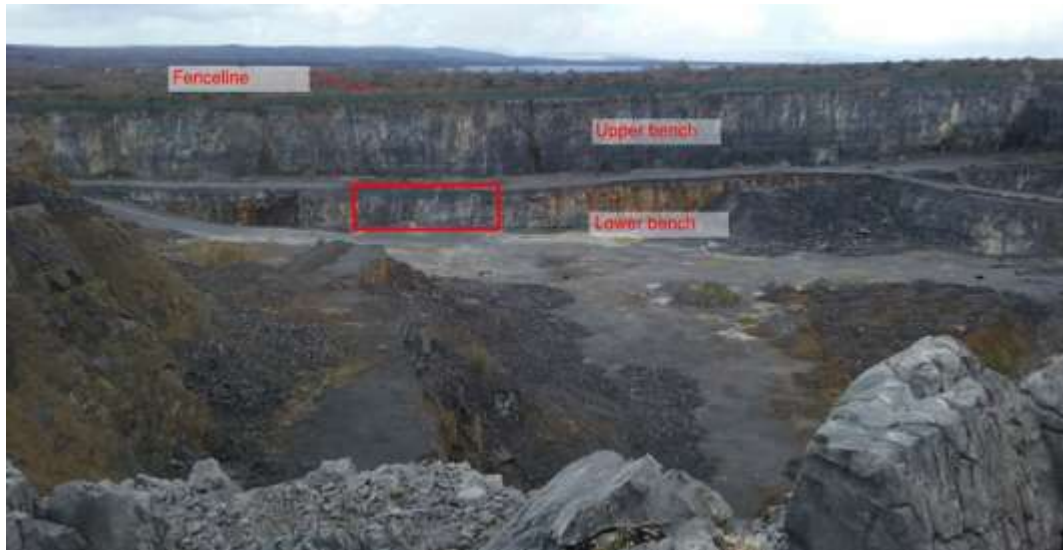
The quarry boundary is defined by a steel fence on a concrete plinth, which borders the Limestone pavement within the Lough Corrib cSAC. There is an average distance of approximately 1m between the edge of the fenceline plinth and the top of the upper quarry bench. **Figure 3.4** below shows a view of the western quarry wall from a distance, outlining the lower and upper bench and boundary fence.

Figure 3.4: Features of the eastern tunnel portal area, with extent of tunnel portal marked within red rectangle

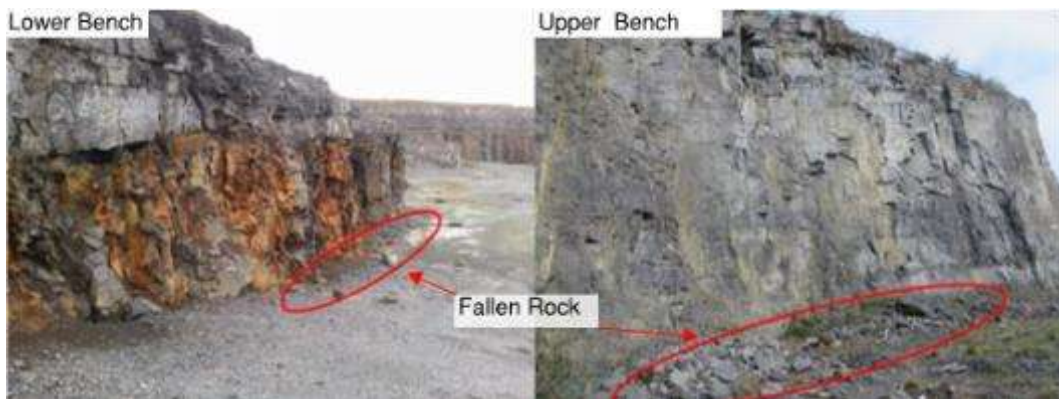
Some instability in the rock face is evident predominantly from blast damage during the operation of the quarry, with open discontinuities (joints and fractures), loose rock and the accumulation of debris resulting from spalling and failures present at the base of the lower and upper benches, see **Figure 3.5** below.

Figure 3.5: Face instability on the lower and upper bench

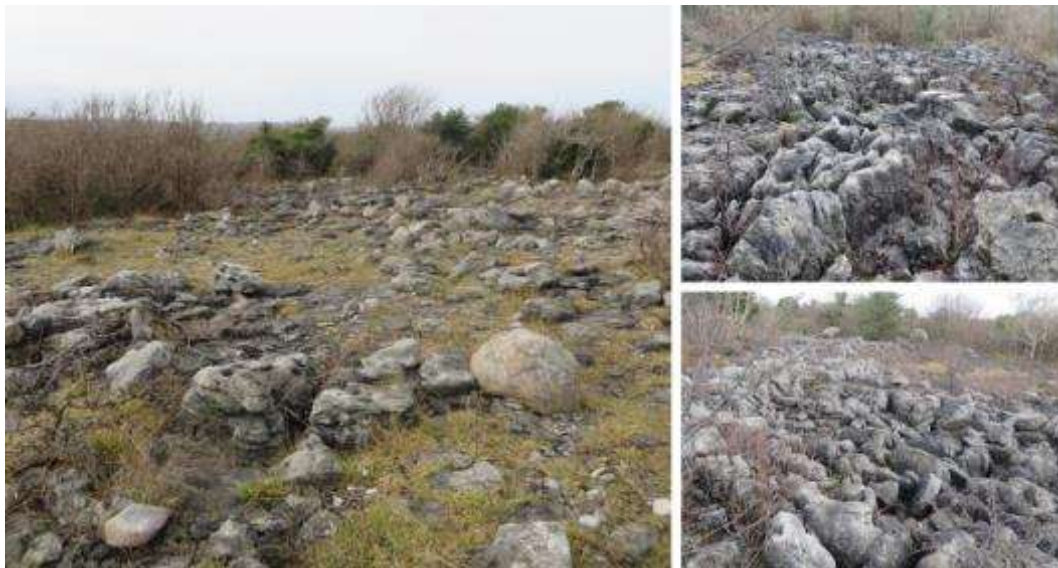
Figure 3.7: Photographs of Limestone pavement located in Section 2

Section 2 focuses on Lackagh Tunnel which overlaps with Sections 1 as the tunnel extends into Lackagh Quarry, **Figure 3.6**. The proposed tunnel lies beneath Limestone pavement within the Lough Corrib cSAC and beneath agricultural fields. The existing ground levels of the Limestone pavement, **Figure 3.7**, range from 36.4 to +40.5mOD along the alignment of the proposed road development, falling from east to west. The tunnel extends west beyond the Limestone pavement extents, in an area overlain by agricultural land where the ground level reduces to +30.7mOD in the west from +36.4mOD in the east.

Limestone pavement comprises of flat bare rock surfaces with limestone blocks (clints) separated by fissures (grykes). Clints and grykes are characteristic features of Limestone pavement and these features form by a combination of chemical and physical weathering from rainfall. As rainfall is mildly corrosive to limestone, chemical weathering is enhanced over other non-calcareous rock types and where soil or vegetation is present then rainfall can become more aggressive to limestone.

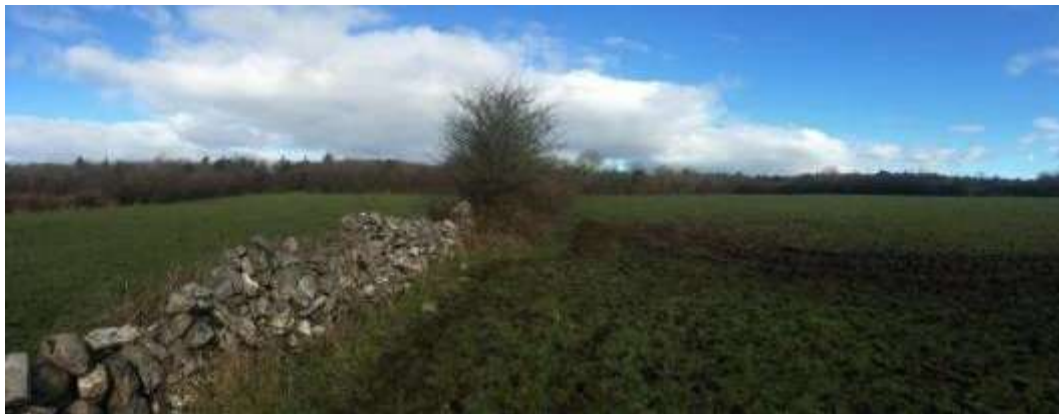
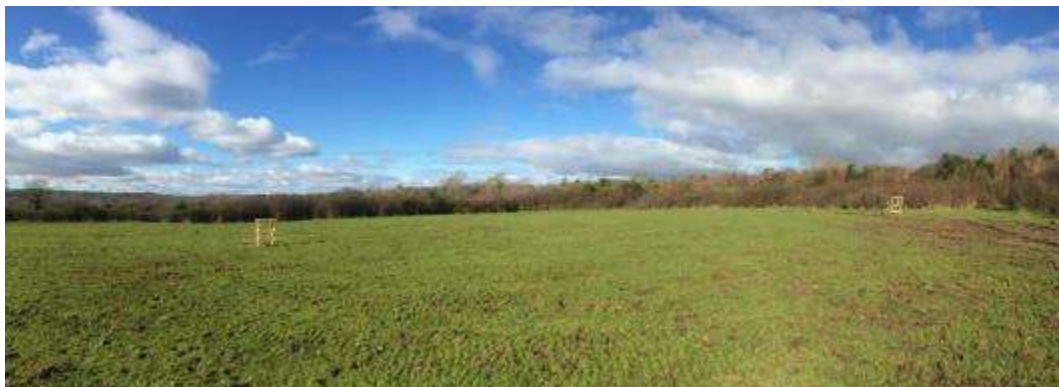
Figure 3.9: Photographs of the agricultural fields located in Section 3

Section 3 is bounded on the north and south by Lough Corrib cSAC and is located in an area made up of agricultural fields and stone boundary walls, **Figure 3.8**. The existing ground levels fall from east to west from +30.7 to +13.41mOD.

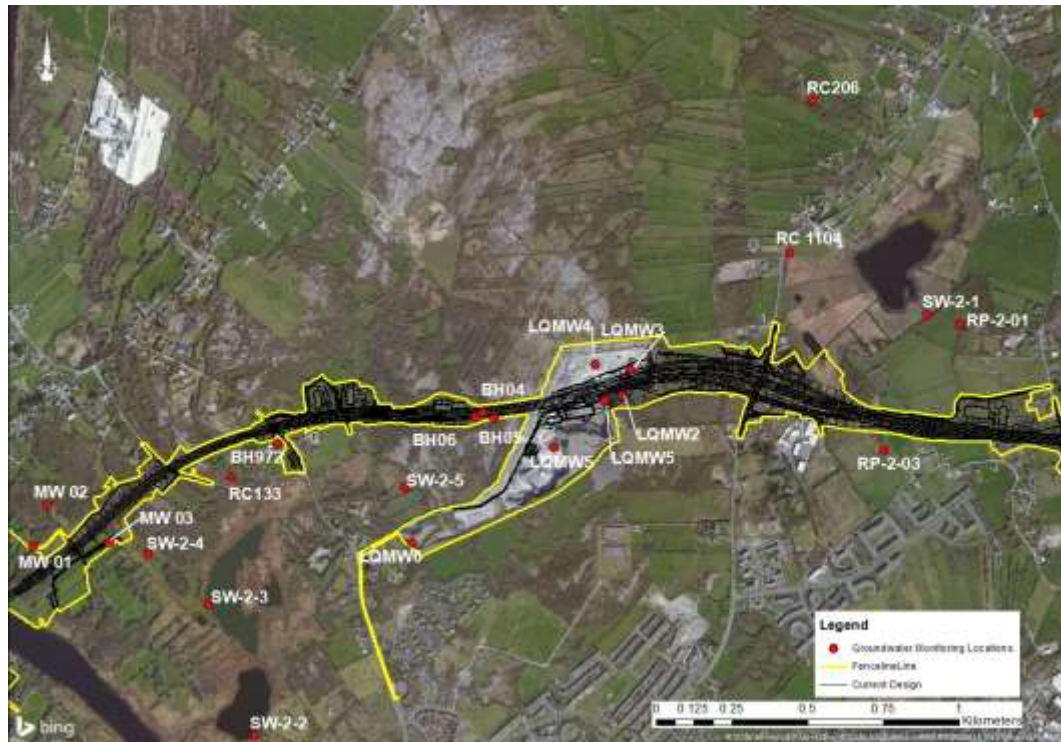
Figure 3.10: Groundwater and surface water monitoring locations along the proposed road development

Groundwater level data has been gathered between June 2015 and January 2017 from a number of monitoring boreholes in the area between Menlough, Lackagh Quarry and Ballindoooley Lough. These include monitoring boreholes as shown in **Figure 3.10** and **Table 3.1**. Based on this data the regional groundwater levels have been compiled and this allows the extents of groundwater bodies to be delineated as shown in **Figure 3.11**. The groundwater bodies are named based upon the original delineation of groundwater bodies by the GSI.

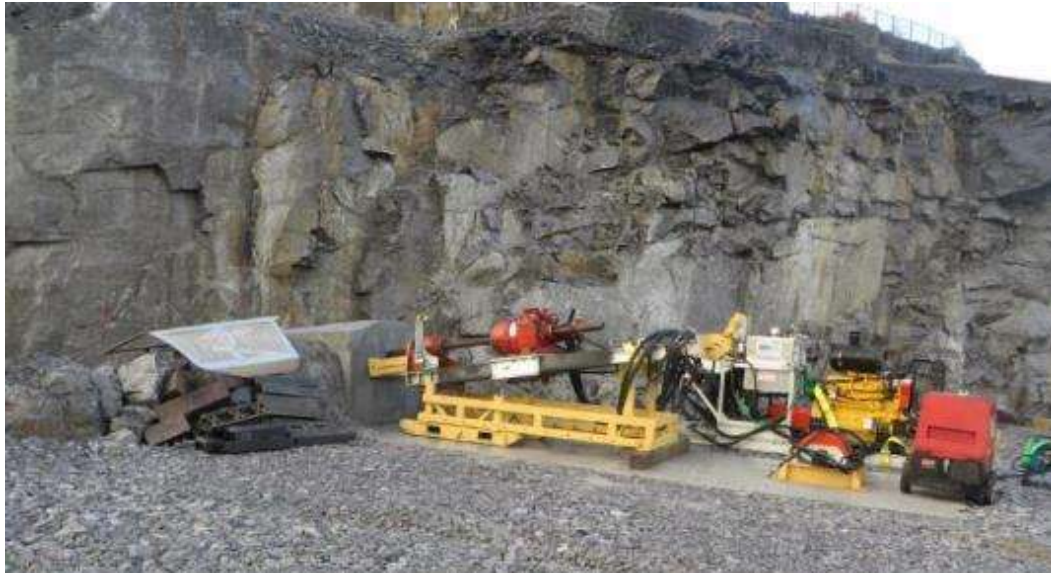
Figure 3.13: BH01 Horizontal borehole at the eastern tunnel portal

In total five boreholes (BH1, 3, 4, 5 and 6), were drilled both in Lackagh Quarry and in the adjacent fields west of the quarry (Refer to **Table 3.2** and **Figure 3.12**). One horizontal rotary core borehole (BH1) (**Figure 3.13**), was drilled at an inclination of $\sim 12^\circ$ off horizontal, through the western quarry face, at the location of the proposed eastern tunnel portal and four vertical rotary core boreholes were drilled in the fields adjacent to the quarry on the west, above the proposed tunnel alignment.

The stratigraphy of Section 1 and 2 was investigated by a 280m horizontal borehole (BH01) drilled sub-horizontally along at a 12° off horizontal incline along the alignment of the proposed road development, beginning at the eastern tunnel portal location. The ground conditions in Section 2 were also determined using vertical boreholes BH04 and BH05 which reached depths of 35m and 40m, respectively.

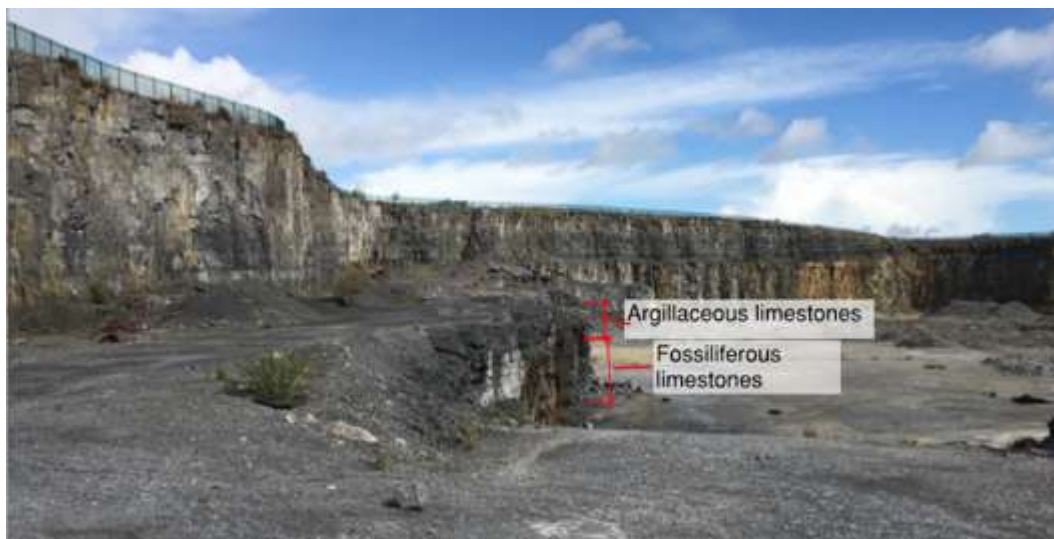
Ground conditions at the western face of Lackagh Quarry comprise a cyclical sequence of carboniferous limestones (see **Figure 3.14**). Each cycle is between 10m and 15m thick and is characterised by thinly bedded, dark mud-rich (argillaceous) limestones which pass upward into thicker bedded, paler non-argillaceous limestones. The darker limestone marks the beginning of the upper bench at the western face, and is generally considered to be stronger than the paler limestones.

Figure 3.14: Cyclical sequence of Limestones at Lackagh Quarry

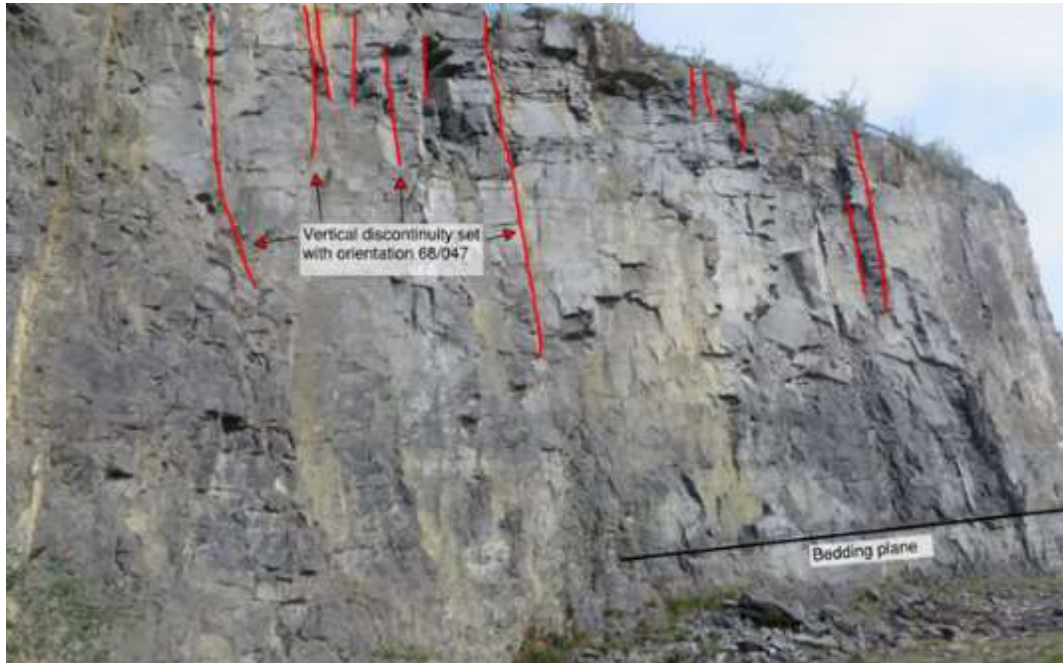
Figure 3.16: Exposed discontinuities on the upper bench

The vertical and horizontal discontinuities are visible on the exposed quarry face and are more evident in the upper bench wall, as the lower bench wall has been heavily affected by blast induced fractures.

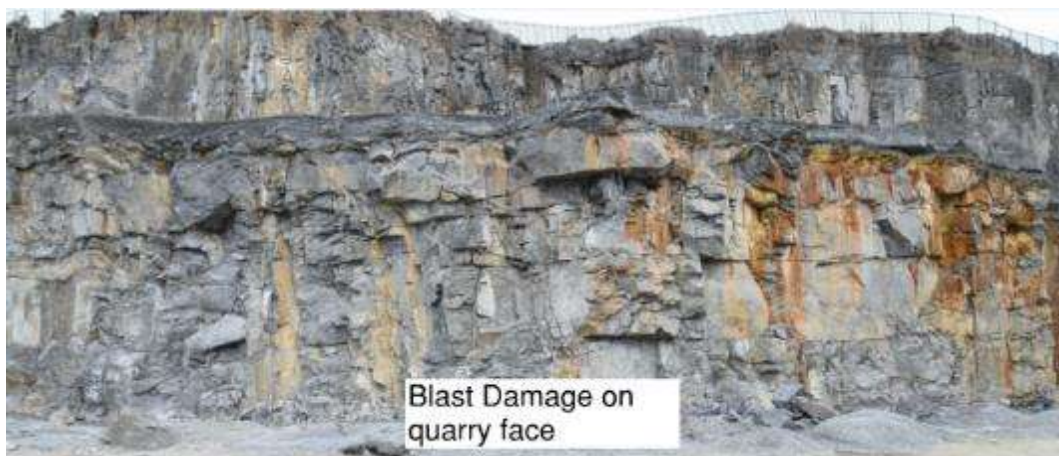
The western face has been left unprotected since the closure of the quarry in 2010 and has gradually deteriorated over time. Previous quarry workings have resulted in a heavily fractured rock face, both natural and blast induced (**Figure 3.17**), and unsafe overhangs and loose rock are present in the area of the proposed tunnel portal.

Figure 3.17: Blast damage on quarry face

Given the nature of the fracturing and the evidence of failures, the angle at which the current rock face stands is too steep in parts, suggesting that this unprotected face, if left in its present state will continue to erode and may potentially impact the overlying Limestone pavement if a deep seated slope failure was to occur.

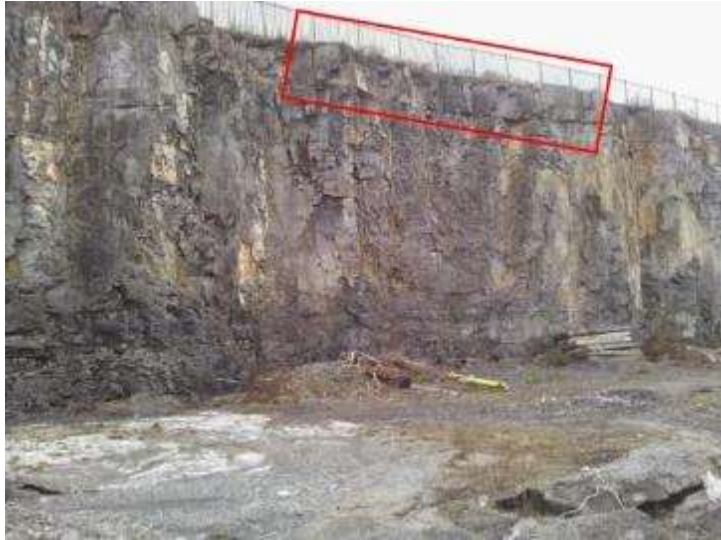
Following analysis of the site specific ground information and the discontinuity data, presented in **Table 3.4** in **Chapter 3**, it was determined that the failure most likely to occur within the rock mass and impact upon the structural integrity of the Limestone pavement is wedge failure and toppling. Wedge failures are seen in the upper section of the upper bench illustrated in **Figure 5.2** below.

Figure 5.2: Wedge failure in the upper bench

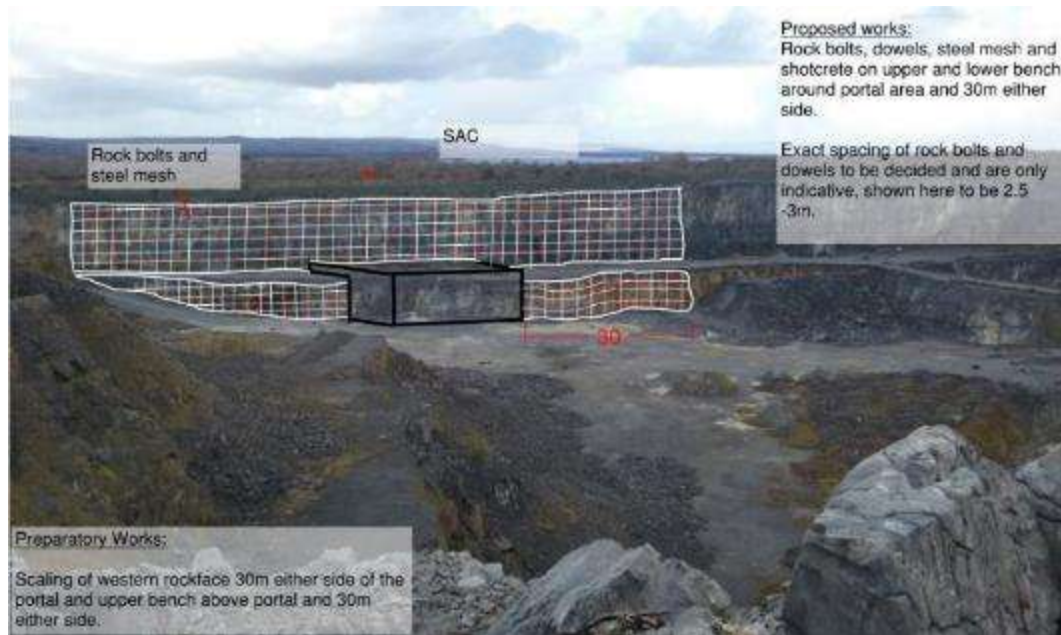
Figure 5.3: Extent of proposed works at tunnel eastern portal

It is proposed that works on the upper bench wall will consist of rock bolts and rock dowels with steel mesh and shotcrete. Works on the lower bench wall will consist of rock dowels and steel mesh with shotcrete. A composite support system of rock bolts, steel mesh and sprayed concrete will be used, **Figure 5.3**. These stability measures will be installed prior to excavation works on Section 2 commencing as per the Schedule of Commitments to ensure rock mass stability and no impact to the overlying Annex I habitats.

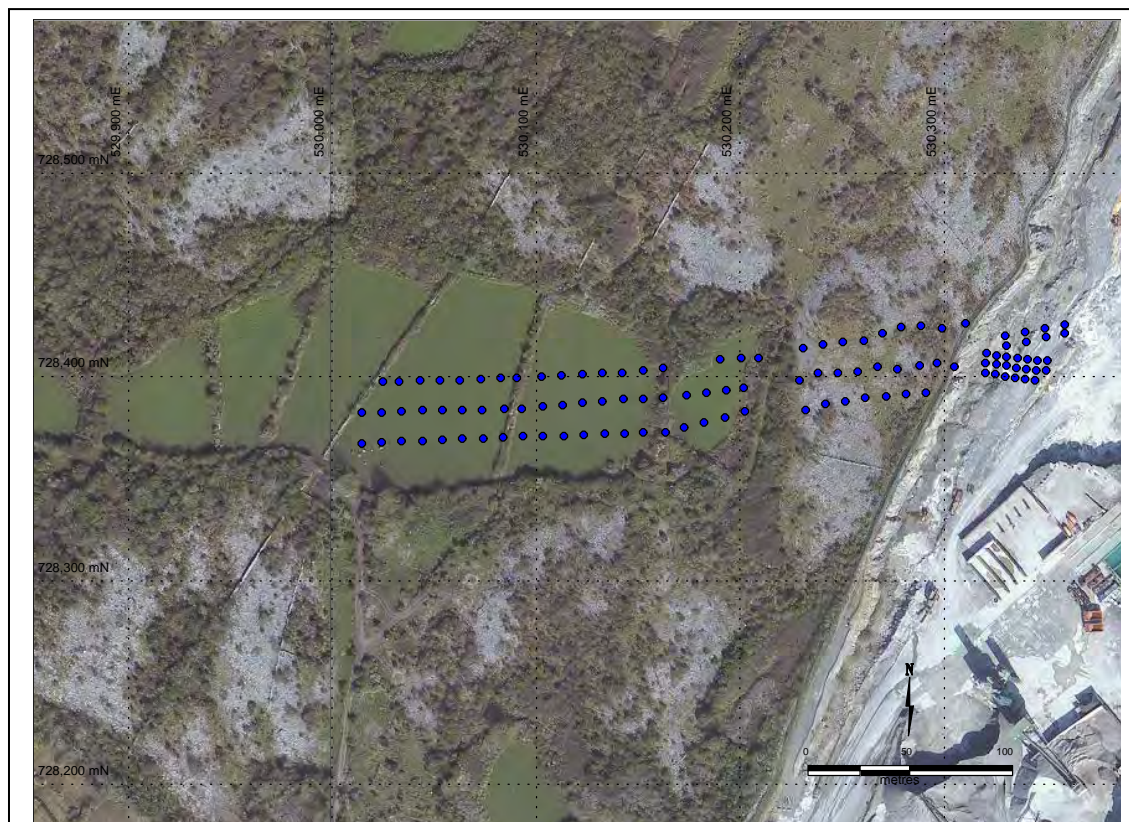
Figure 7: Microgravity Station Locations

Microgravity data was acquired with measured sites along the centre line and 15m either side of the proposed tunnel section. These lines were measured with nominal station spacing of 10m, with gaps where scrub hawthorn was too thick. Extra stations were measured within the quarry on the first bench at 5-10m intervals. Measurements were taken using a Lacoste & Romberg model G gravity meter. Instrument drift was monitored by returning to a locally established base station at hourly intervals.

Stations were topographically surveyed using a Trimble GeoExplorer 6000 RTK GPS system corrected through phone modem link for both the ERT and the gravity surveys. The drift corrected gravity data was corrected for elevation, latitude, and reduced to Bouguer 2.67g/cm^3 to allow for local average rock densities. It was then gridded and exported for display and interpretation in the MapInfo GIS system (Figure 7).

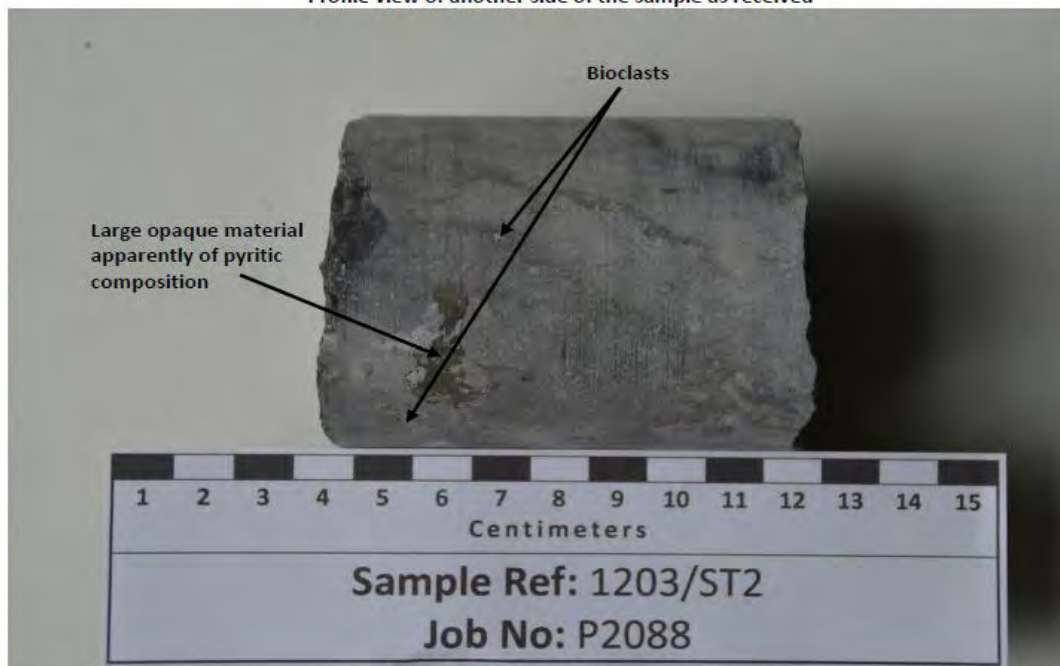
Profile view of another side of the sample as received

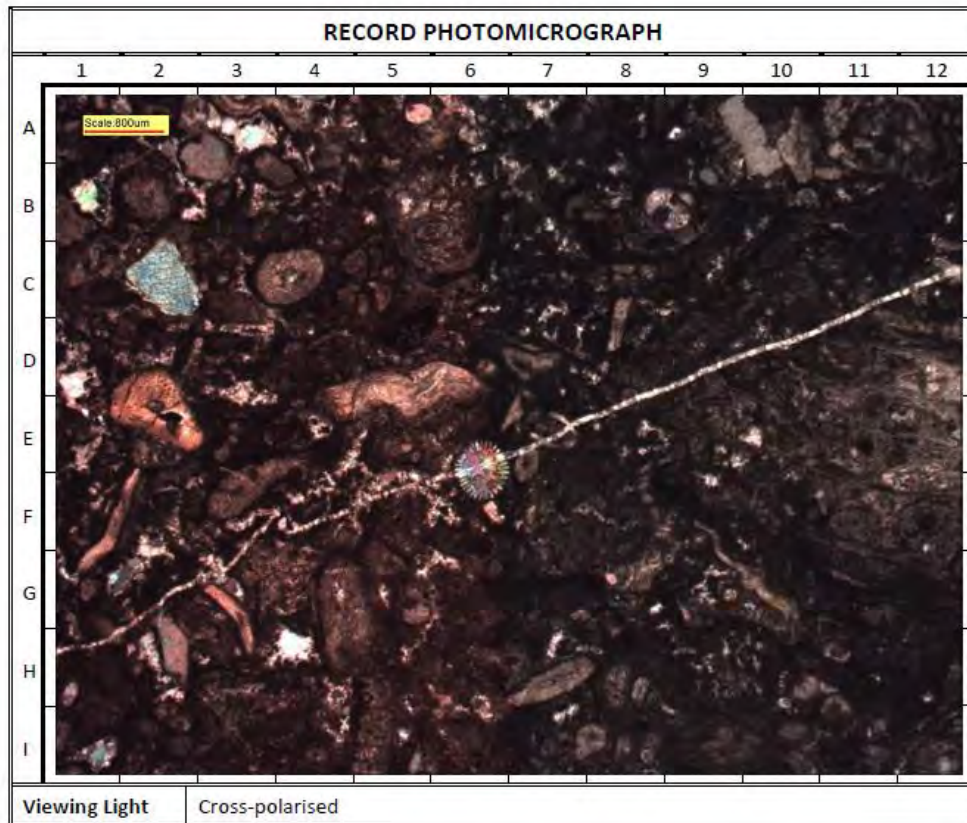
View of a section through a part-stained section of the sample, showing bioclasts (pink, pale ink, light brown, purple/green: A3, A11, B5, D5, E6 and E11) and calcite vein (light brown/pale pink/white: C12 to H1).

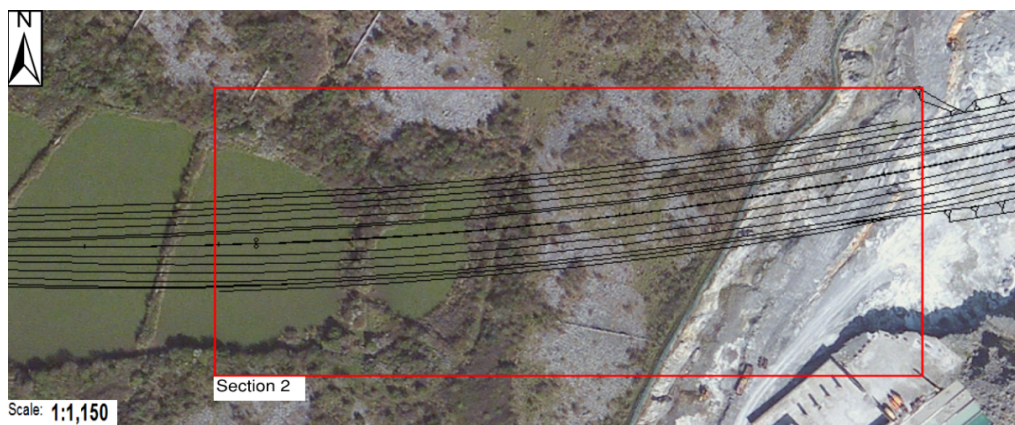
Figure D1(a) - Site overview of Lackagh Tunnel (Section 2)

Introduction: This calculation is prepared to determine the minimum separation between the twin bores tunnel bores for Lackagh Tunnel (Section 2) . The tunnel bores are expected to be approximately 16m wide through limestone bedrock. The bore separation is based on the Phase 3 Ground Investigation Contract 2 including laboratory test results.
