**N6 Galway City Transport Project**

**Phase 3 Ground Investigation**

**Contract No. 2 - Factual Report**

**R15/16**  
**N6 Galway City Transport Project - Phase 3 Ground Investigation**  
**Contract No. 2 - Factual Report**  
**Dave Blaney P.Geo**  
**May 2016**

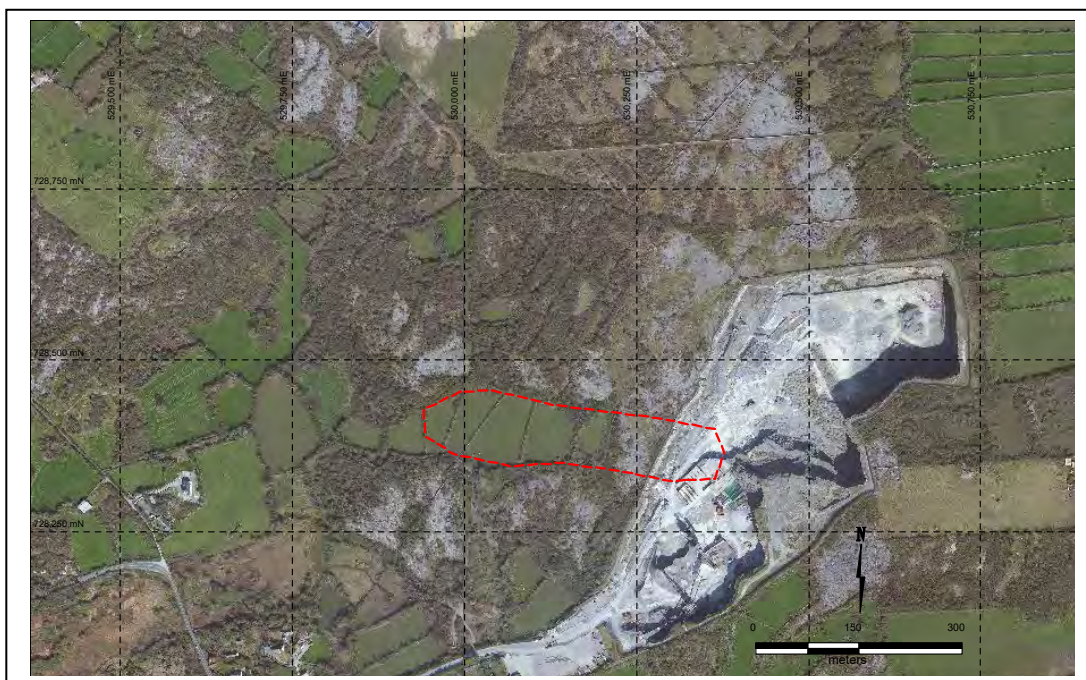
**Figure 2:** Site Area - Dashed Red Line

The site consists of a non-active quarry with associated derelict buildings, plant, structures and poor quality agricultural land used for the grazing of cattle (Figure 2).

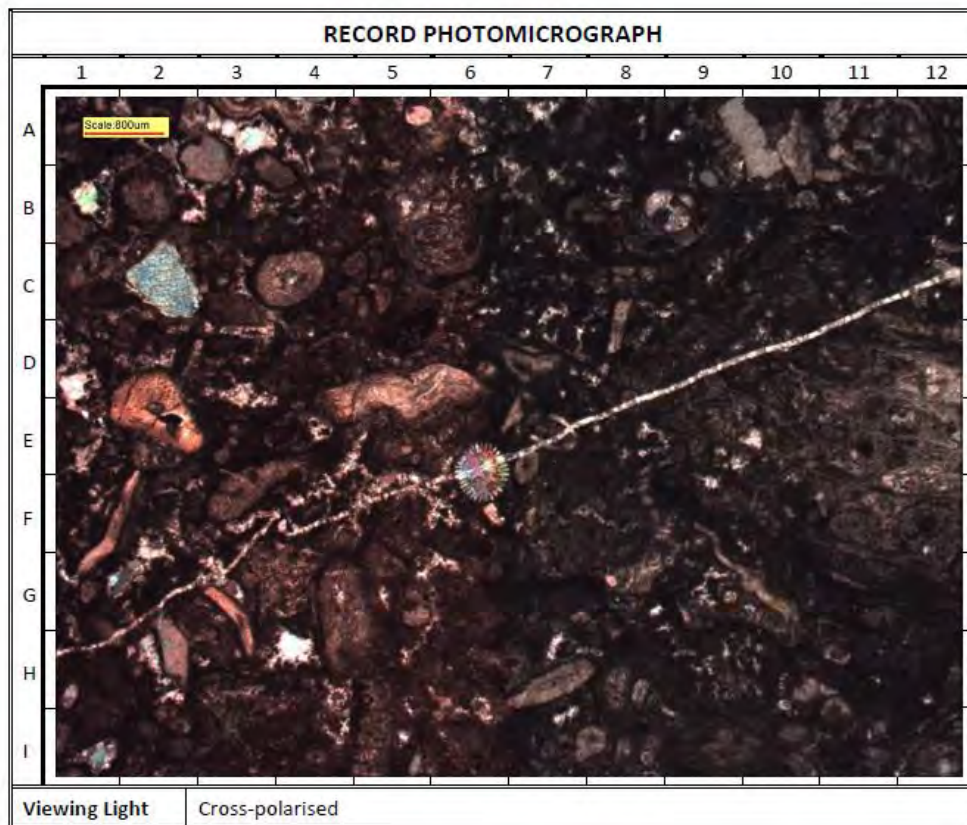
View of a section through a part-stained section of the sample, showing bioclasts (pink, pale pink, light brown, purple/green: A3, A11, B5, D5, E6 and E11) and calcite vein (light brown/pale pink/white: C12 to H1).

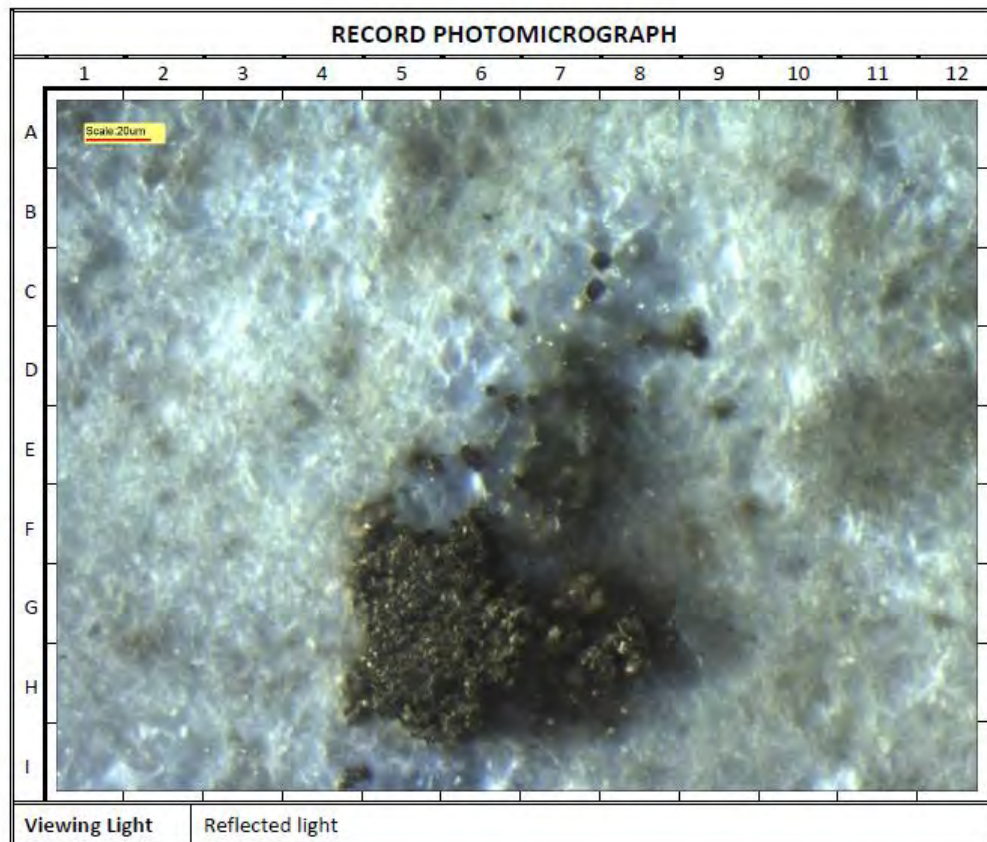
Closer view of the section through the sample, showing framboidal pyritic grains (brass colour: C7 and G5).

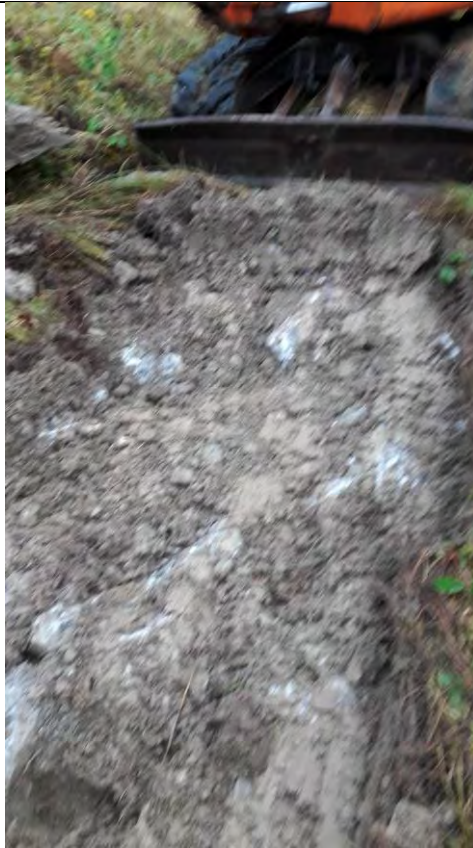
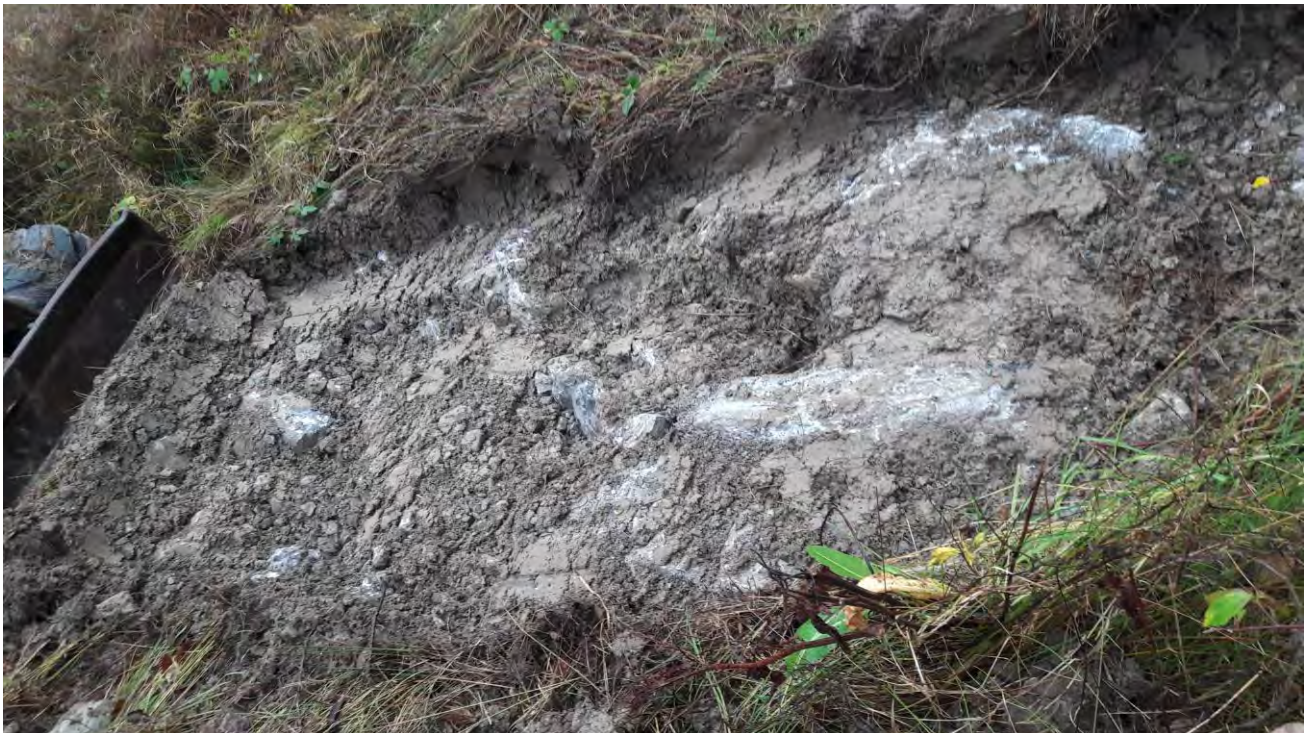
**Number: TP03-19**

Firm, light grey to light brown, slightly sandy gravelly SILT with high cobble content and medium boulder content. Sand is fine to coarse. Gravel is fine to coarse, angular to sub-angular, Limestone lithology. Cobbles are angular to sub-rounded, 63-200mm dia. Limestone lithology. Boulders are angular to sub-angular, 200-700mm dia. Limestone lithology.
							End of Pit at 0.25m
							1
							2
							3
							4
							5

<b>Stability:</b> Good.	<b>Groundwater:</b> None encountered.
<b>Plant:</b> 6t track machine.	
<b>Backfill:</b> Arisings.	
<b>Remarks:</b> Trial pit terminated at 0.25m bgl on bedrock.

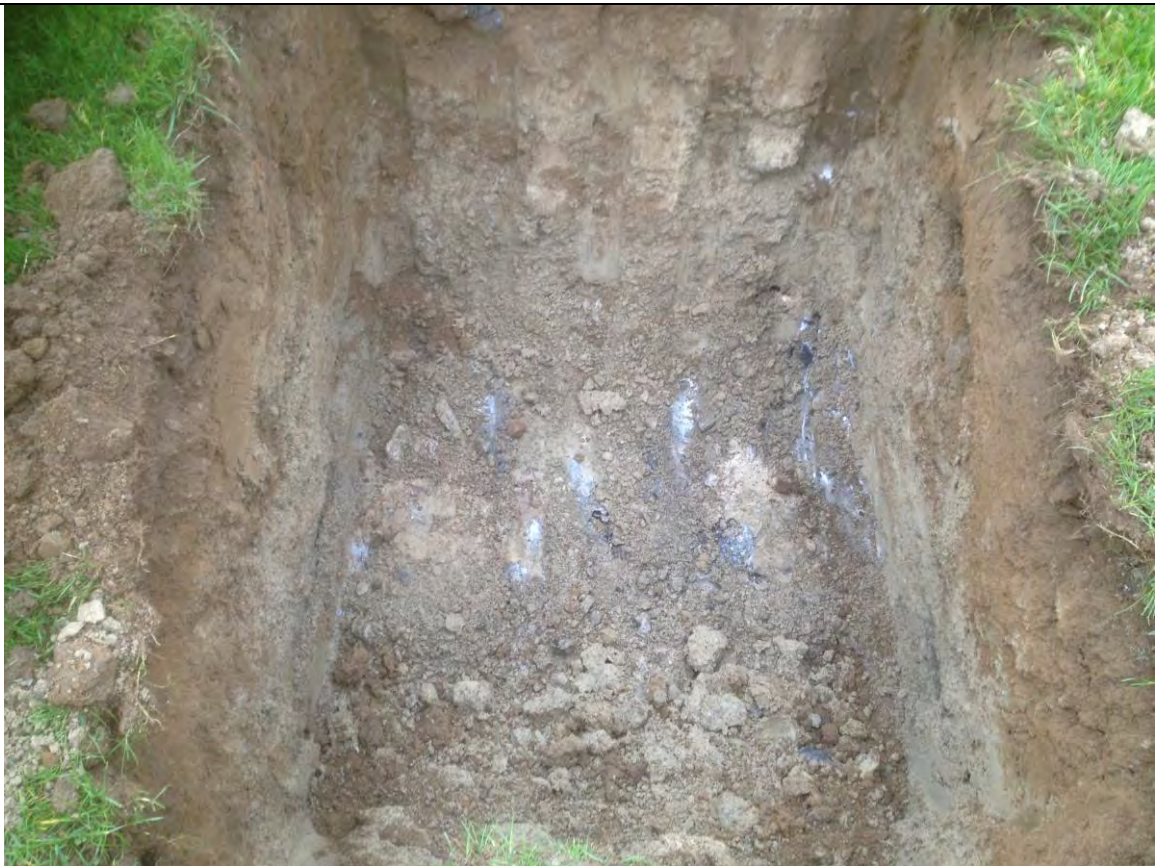
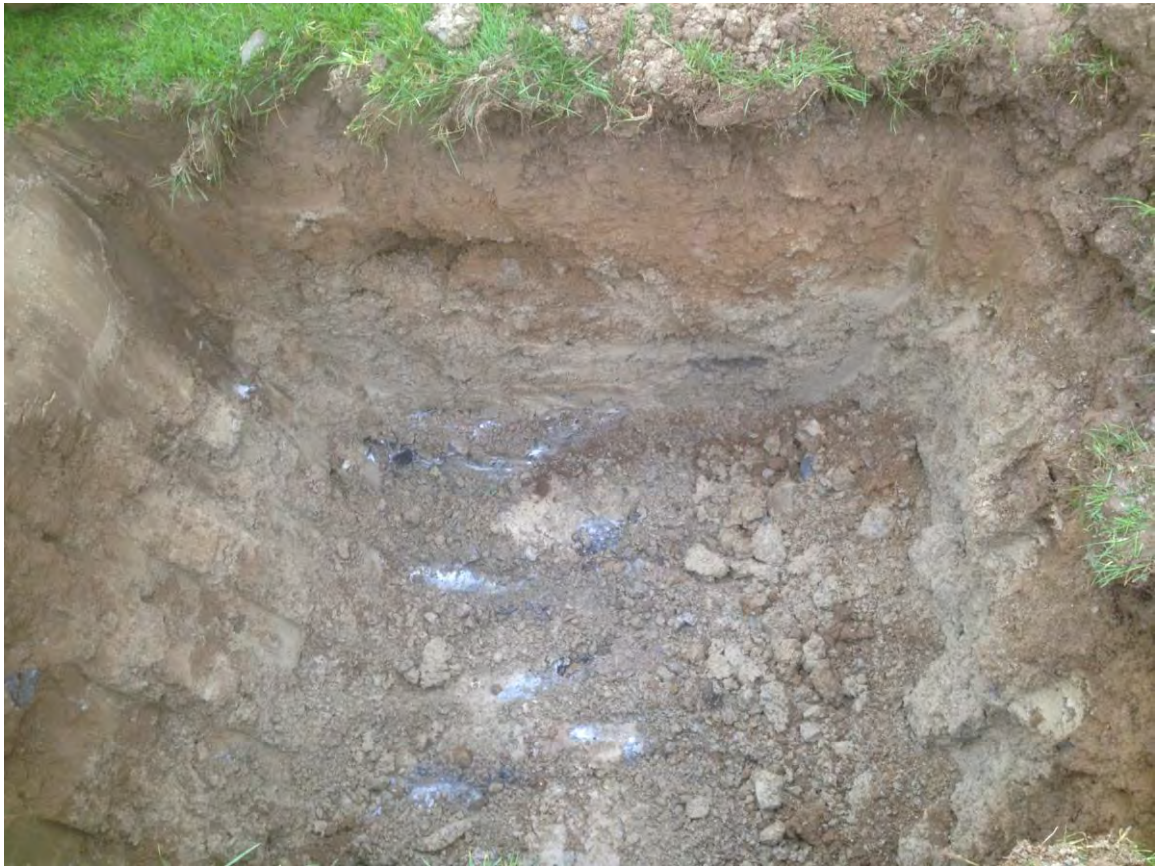
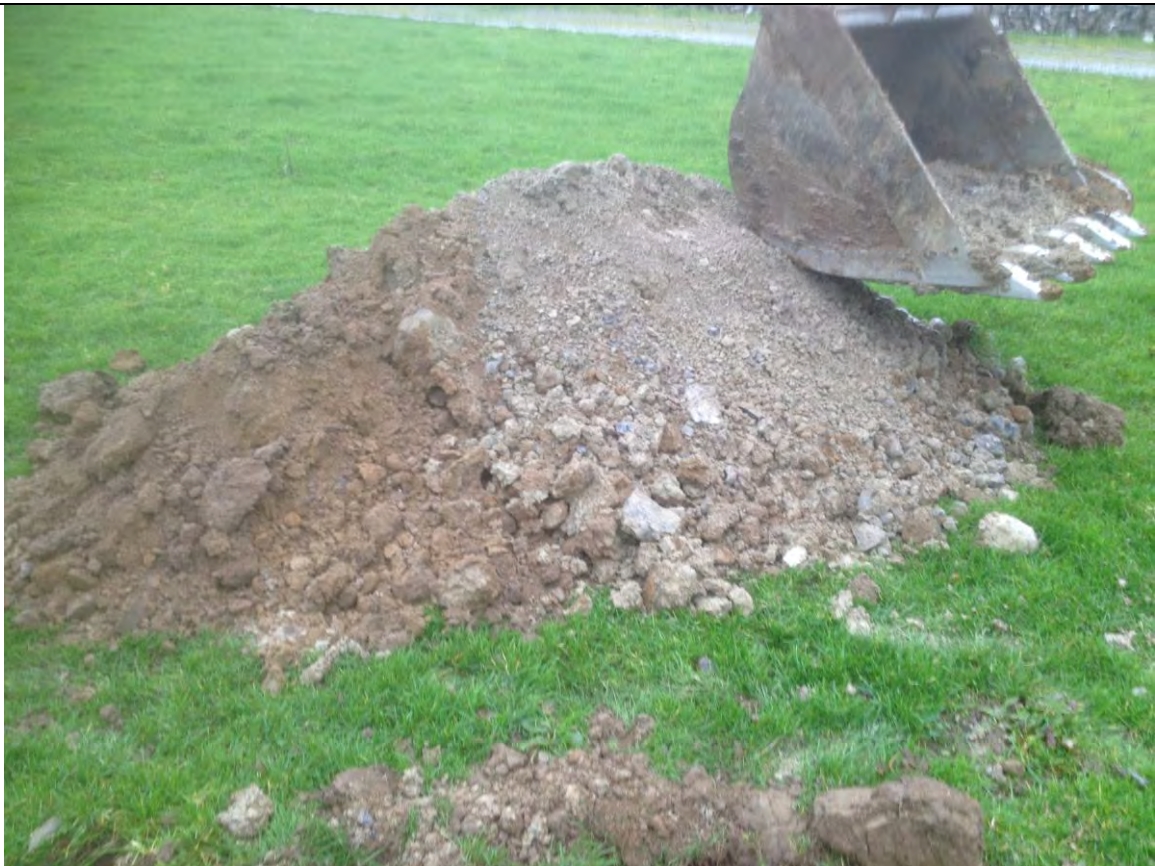
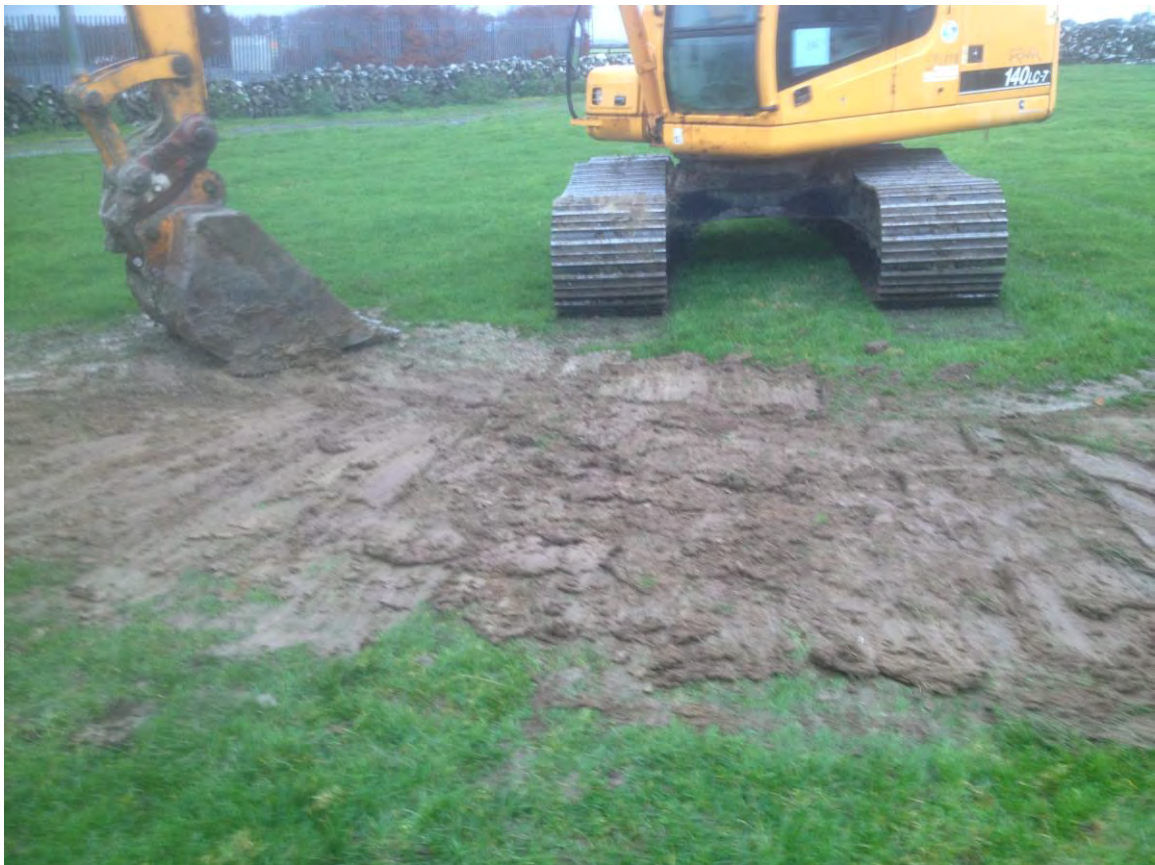
Number: TP03-52

Water Strike	Samples & In Situ Testing			Depth (m)	Level (m)	Legend	Stratum Description	
	Depth	Type	Results					
	0.20 - 0.50 0.20 - 0.50	B D		0.15	56.64		Topsoil.	
							Soft, light brown, slightly sandy gravelly SILT. Sand is fine to coarse.	
	0.50 - 1.20 0.50 - 1.20	B D		0.50	56.29		Soft to firm, slightly sandy gravelly CLAY with low cobble content. Sand is fine to coarse. Gravel is fine to coarse, sub-angular to sub-rounded. Cobbles are sub-rounded.	1
				1.25	55.54		End of Pit at 1.25m	2
								3
								4
								5

<b>Stability:</b> Moderate.	<b>Groundwater:</b> None encountered.
<b>Plant:</b> 14T track machine.	
<b>Backfill:</b> Arisings.	
<b>Remarks:</b> Trial pit terminated at 1.25m bgl, on bedrock.

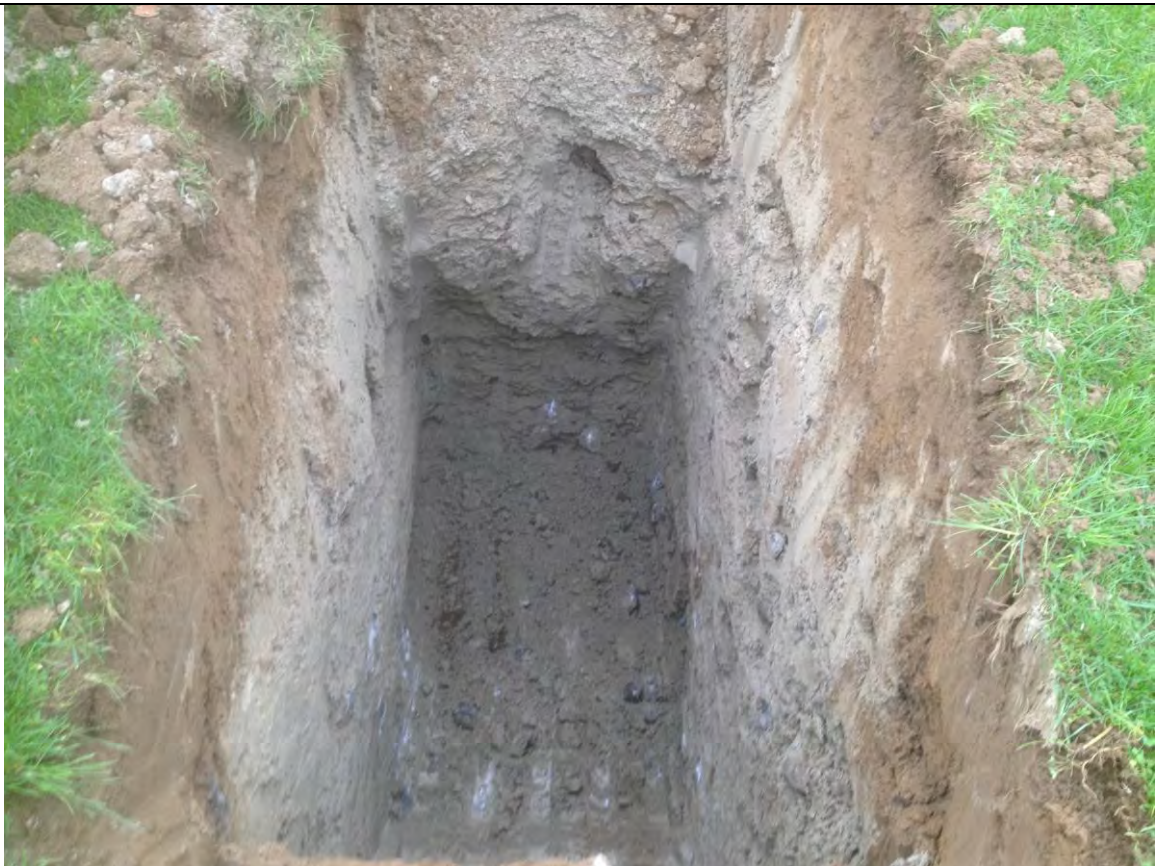
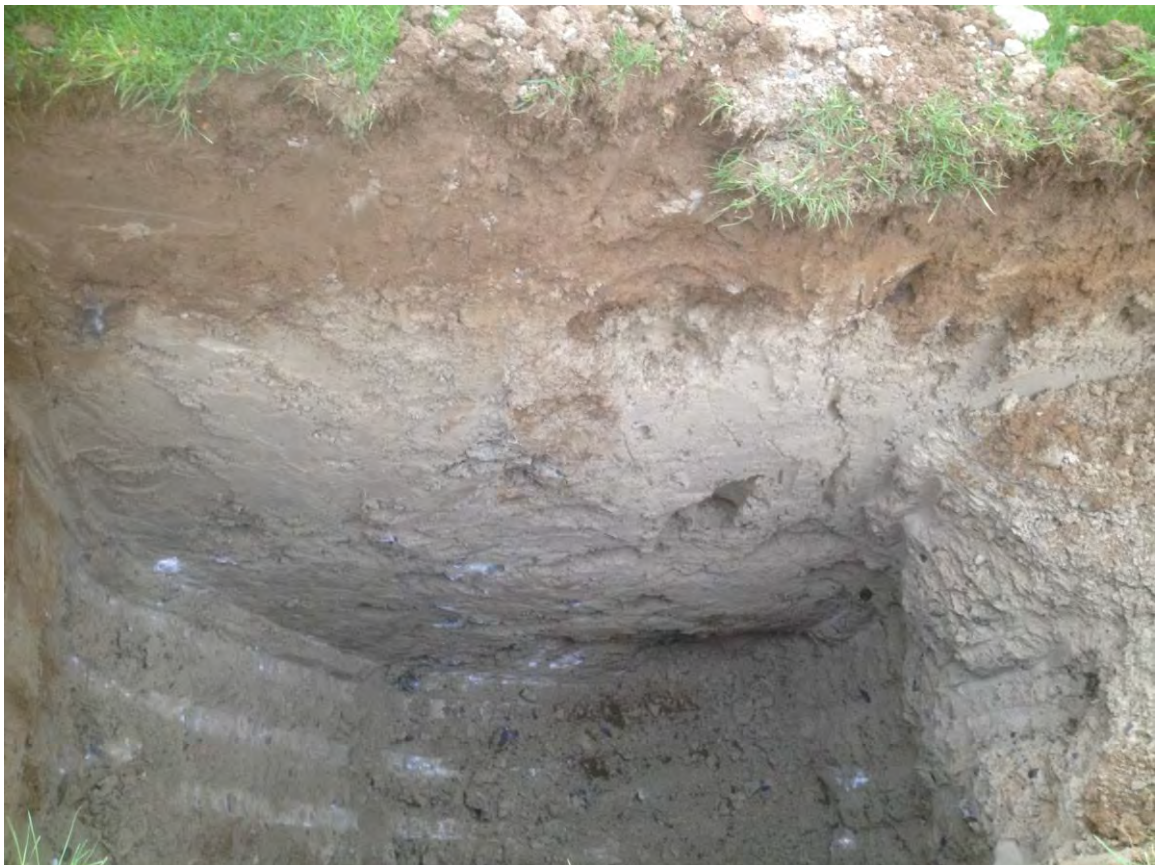
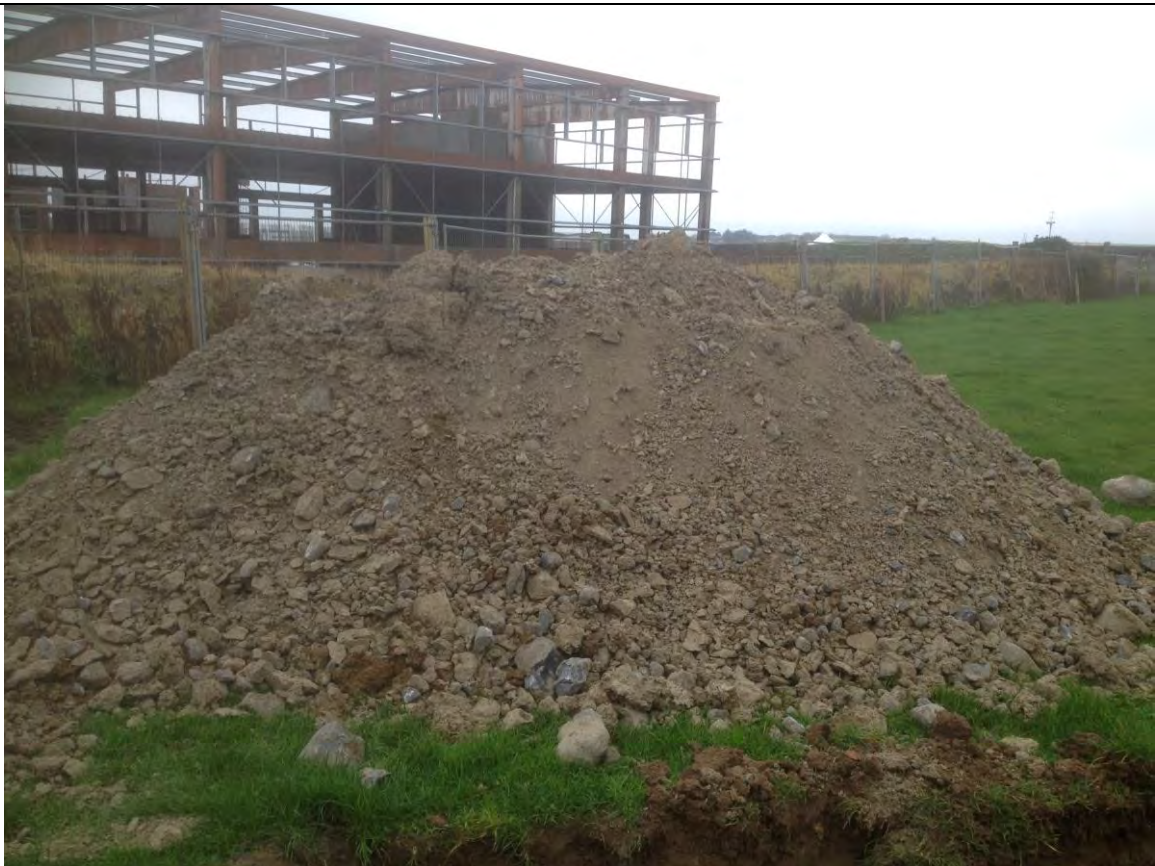
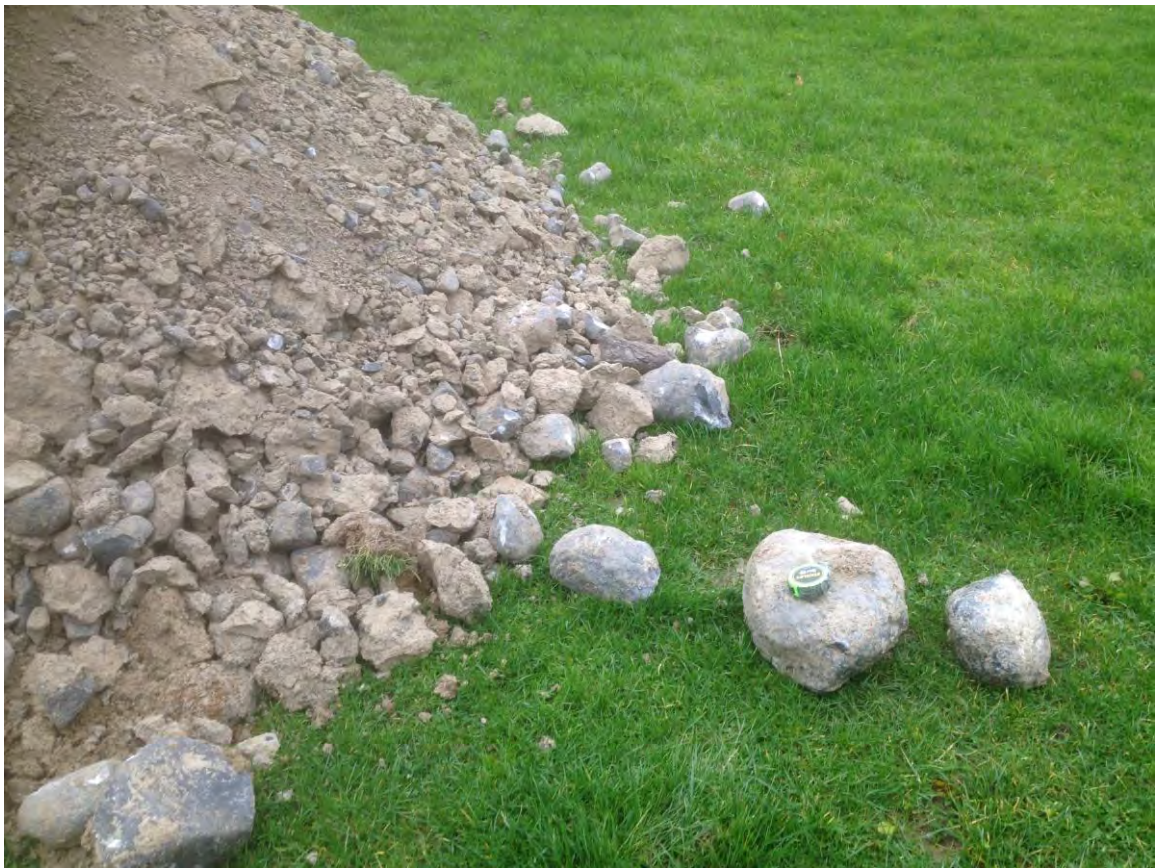
Number: TP03-53

**Stability:** Good.  
**Plant:** 14T track machine.  
**Backfill:** Arisings.  
**Remarks:** Trial pit terminated at 4.00m bgl. Difficult to excavate very stiff strata.

**Groundwater:** None encountered.

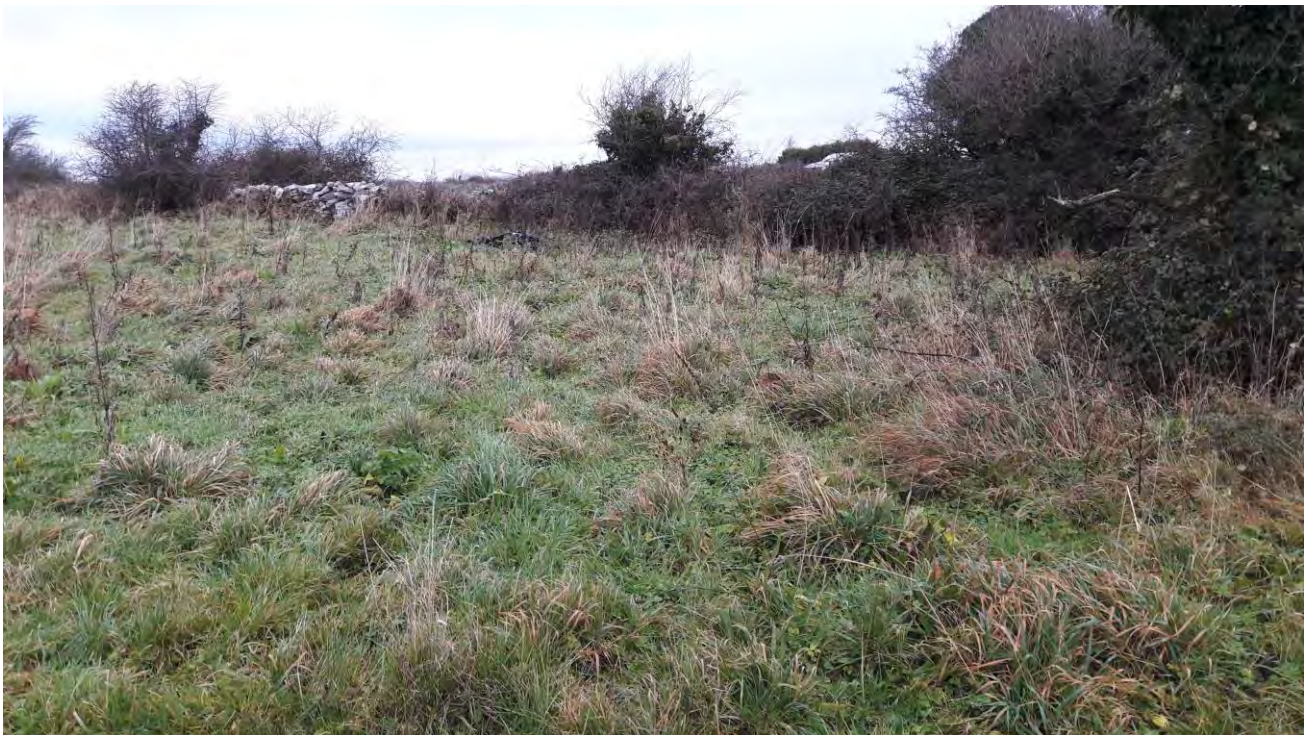
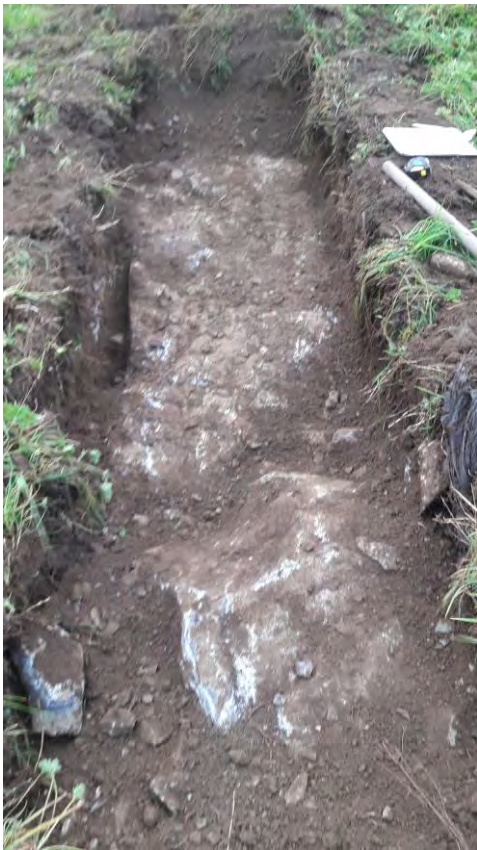
Number: SW03-03

See SW3/03 log for detailed soil strata details: slightly sandy gravelly SILT  
No groundwater was encountered, pit assumed saturated for third test.  
Infiltration rate calculated over actual fall.

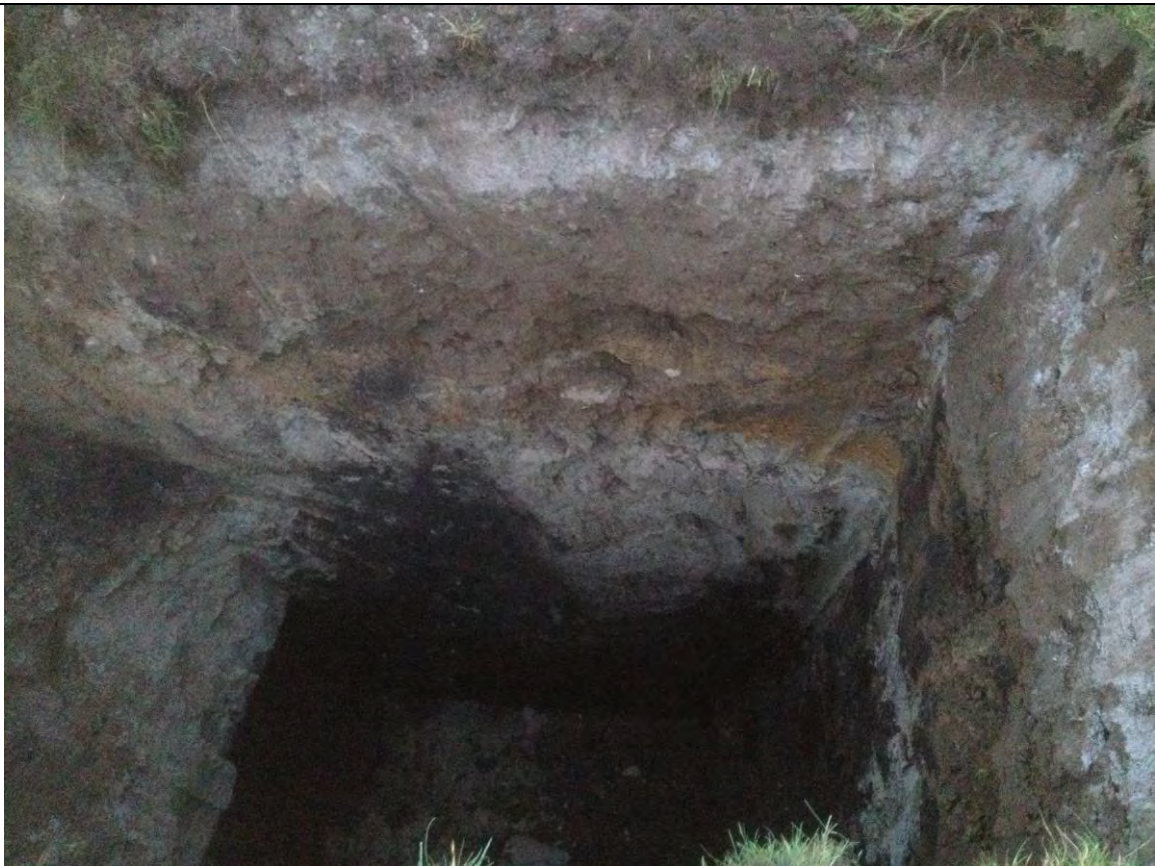
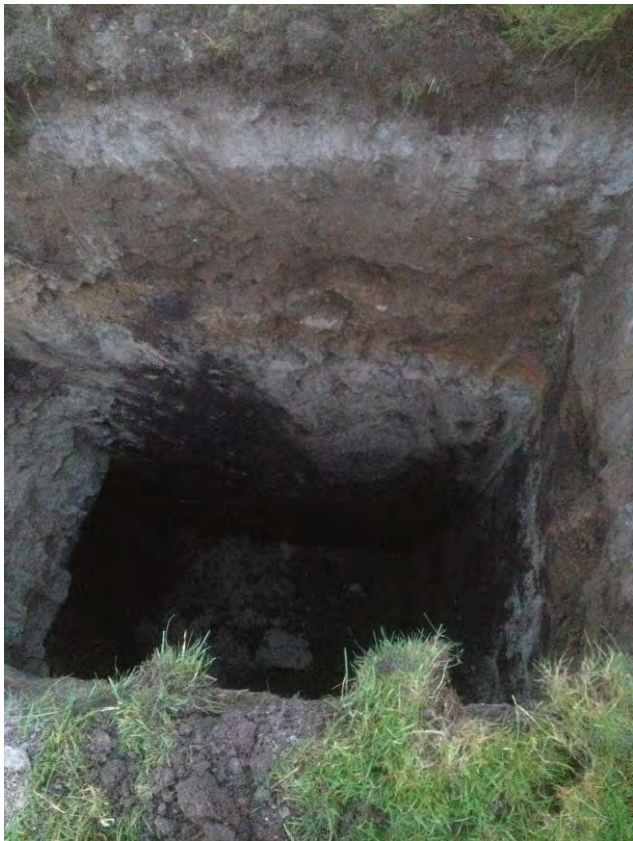
Number: SW03-14

Pit wall collapsed overnight.Final reading disregarded.

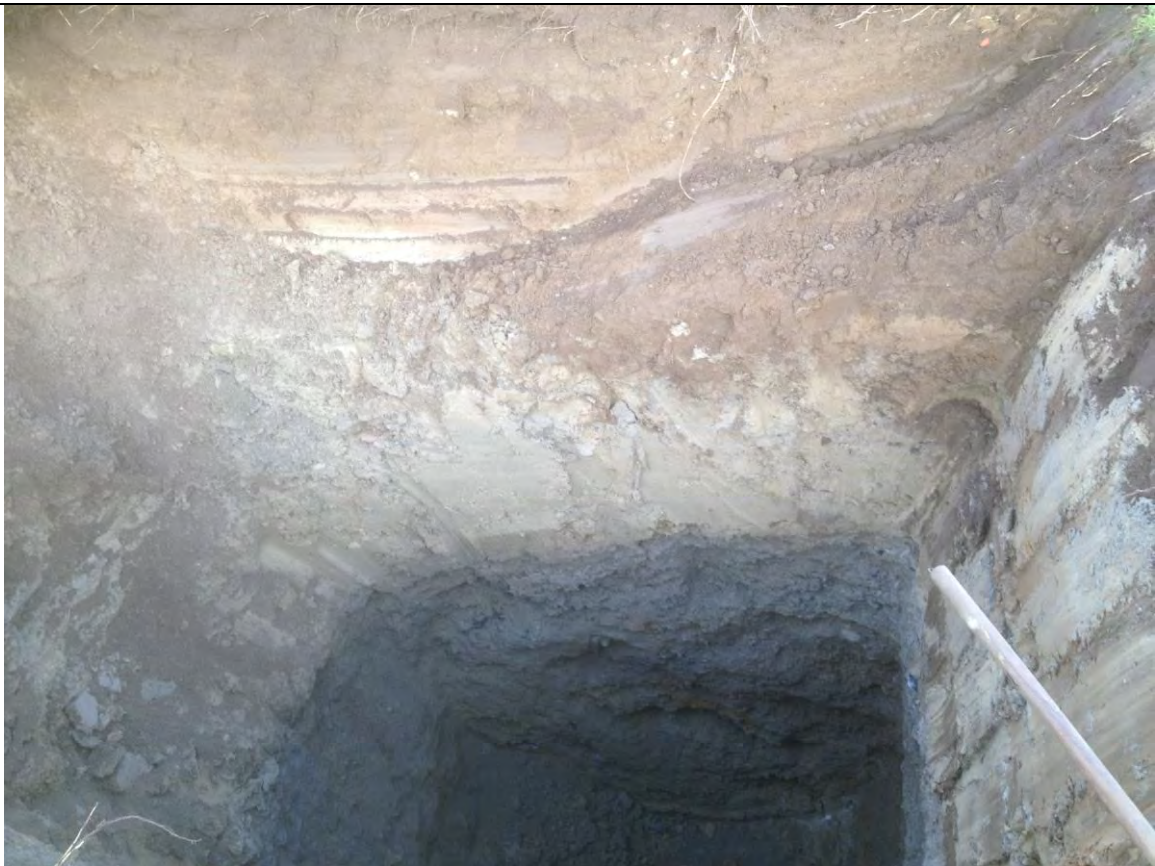
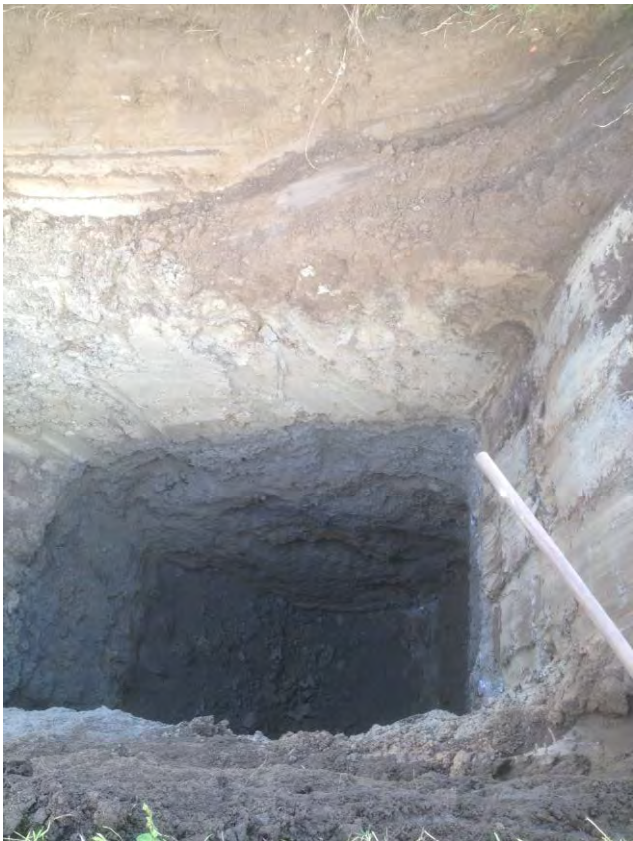
Number: SW03-16

Infiltration Coefficient *f* 1.743E-06 ms<sup>-1</sup>

No groundwater was encountered, pit assumed unsaturated.

Infiltration rate calculated over actual fall.

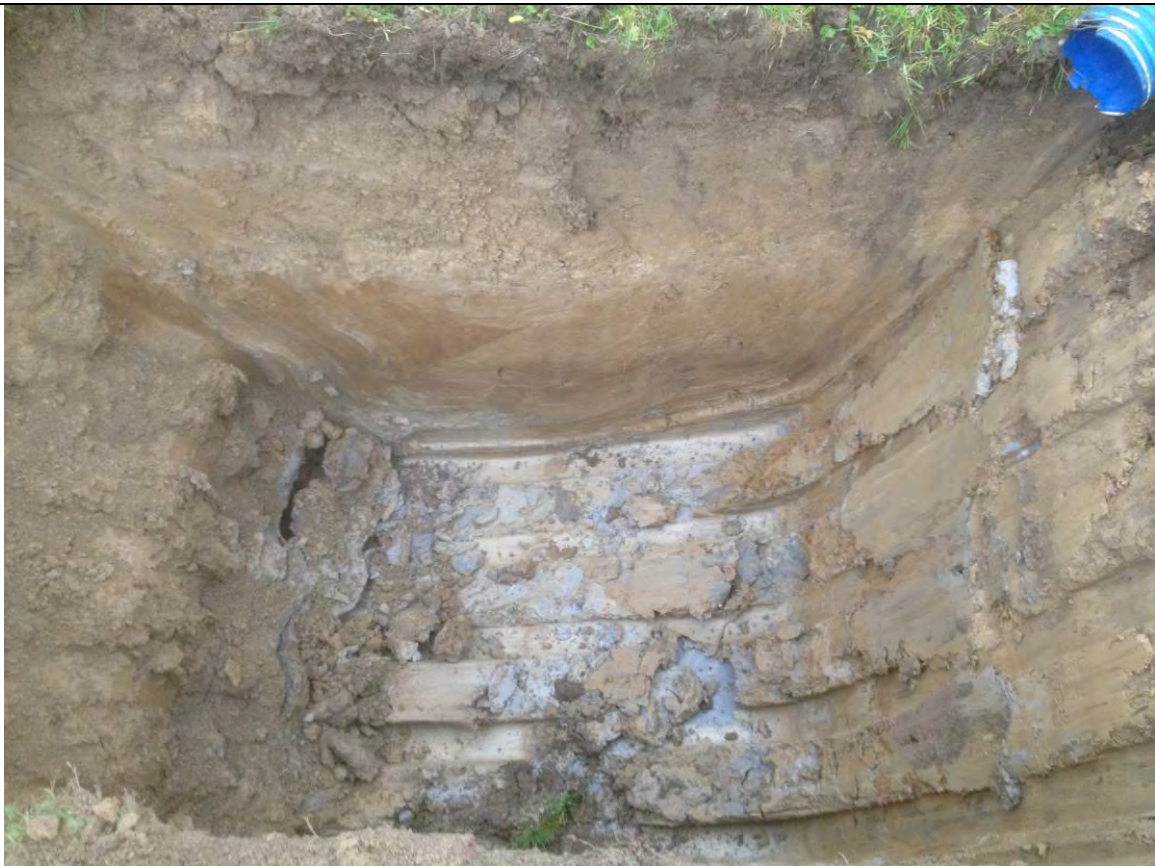
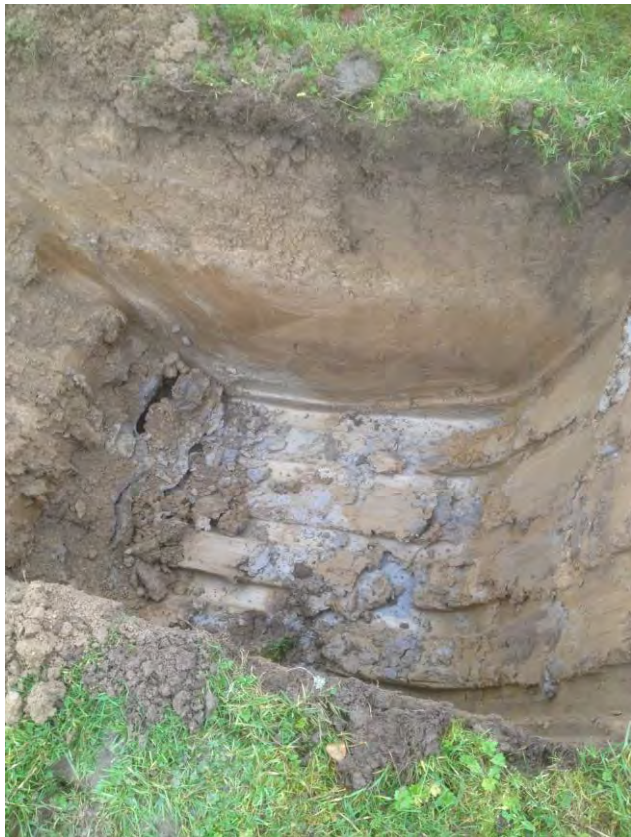
Number: SW03-17

No groundwater was encountered, pit assumed unsaturated.

Infiltration rate not applicable.

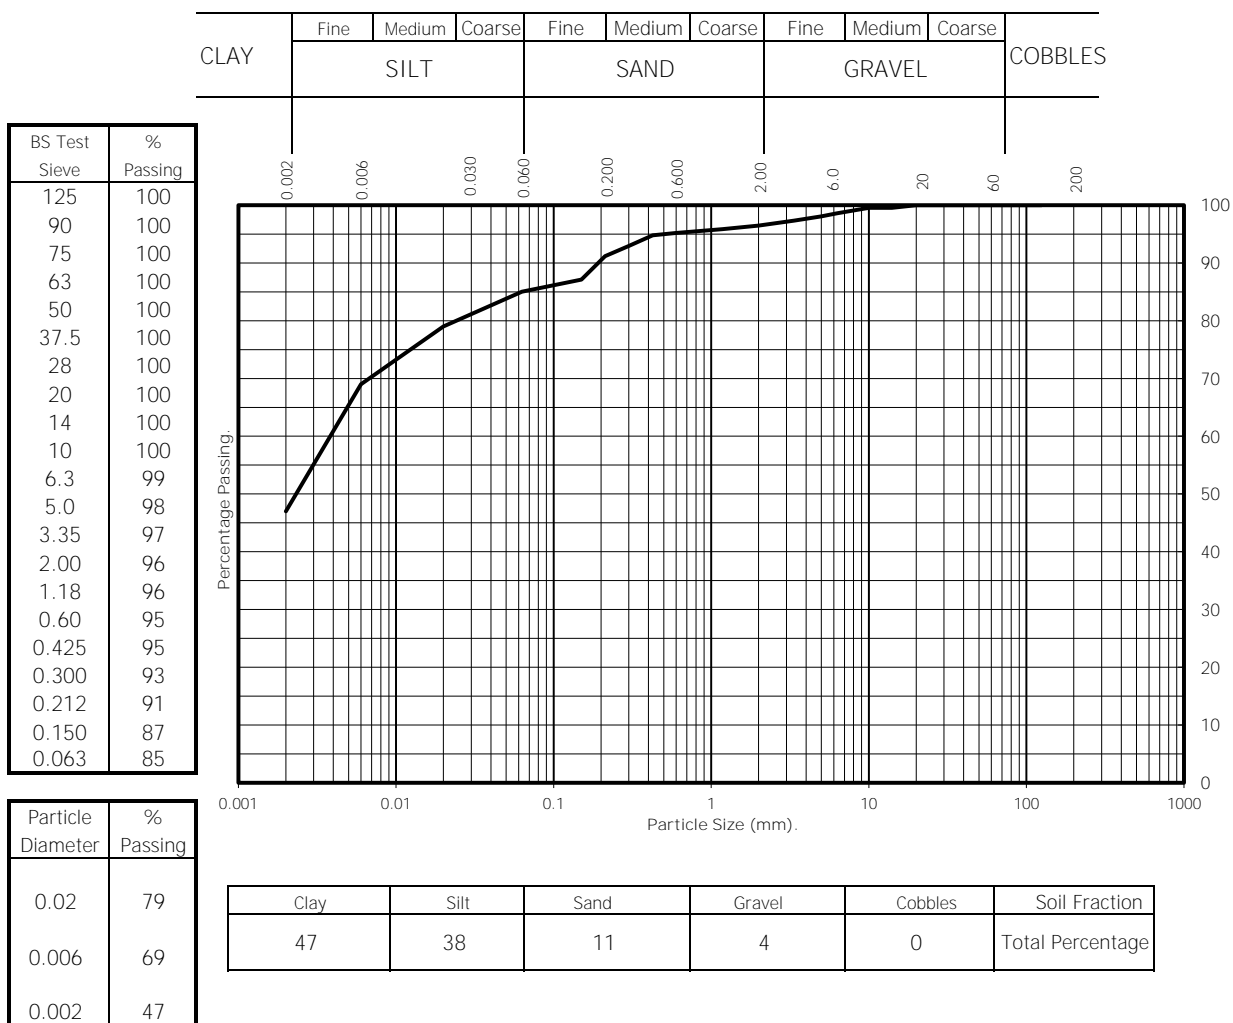
Sample Number: 2  
Depth from (m): 1.00  
Depth to (m): N/A  
Sample Type: B

Location: Galway GCT  
Description: Brown gravelly sandy fine to medium silty CLAY.

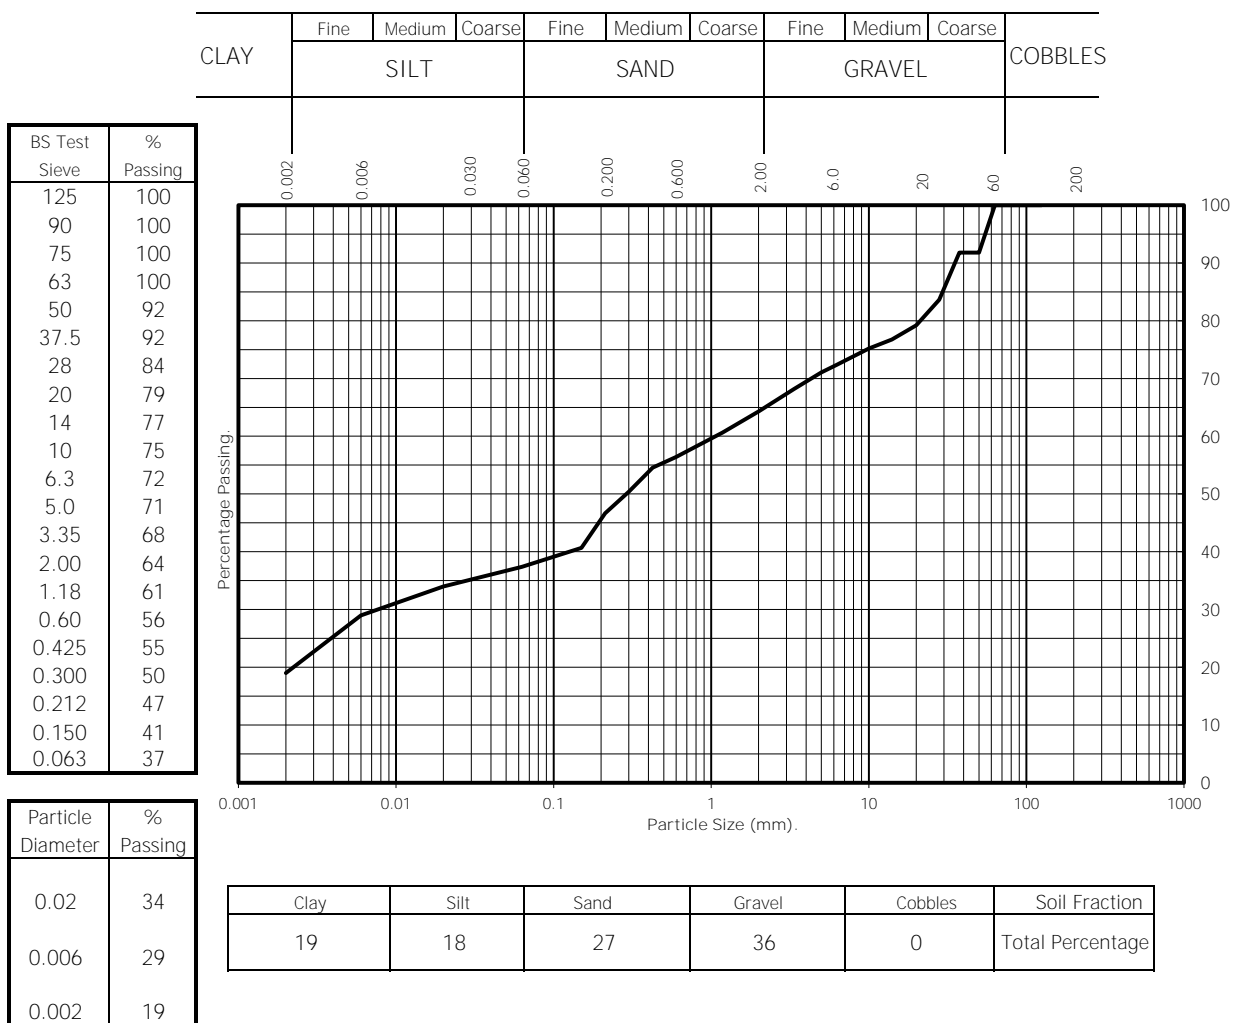
Sample Number: 1  
Depth from (m): 1.00  
Depth to (m): N/A  
Sample Type: B

Location: Galway GCT  
Description: Brown silty clayey sandy fine to coarse GRAVEL

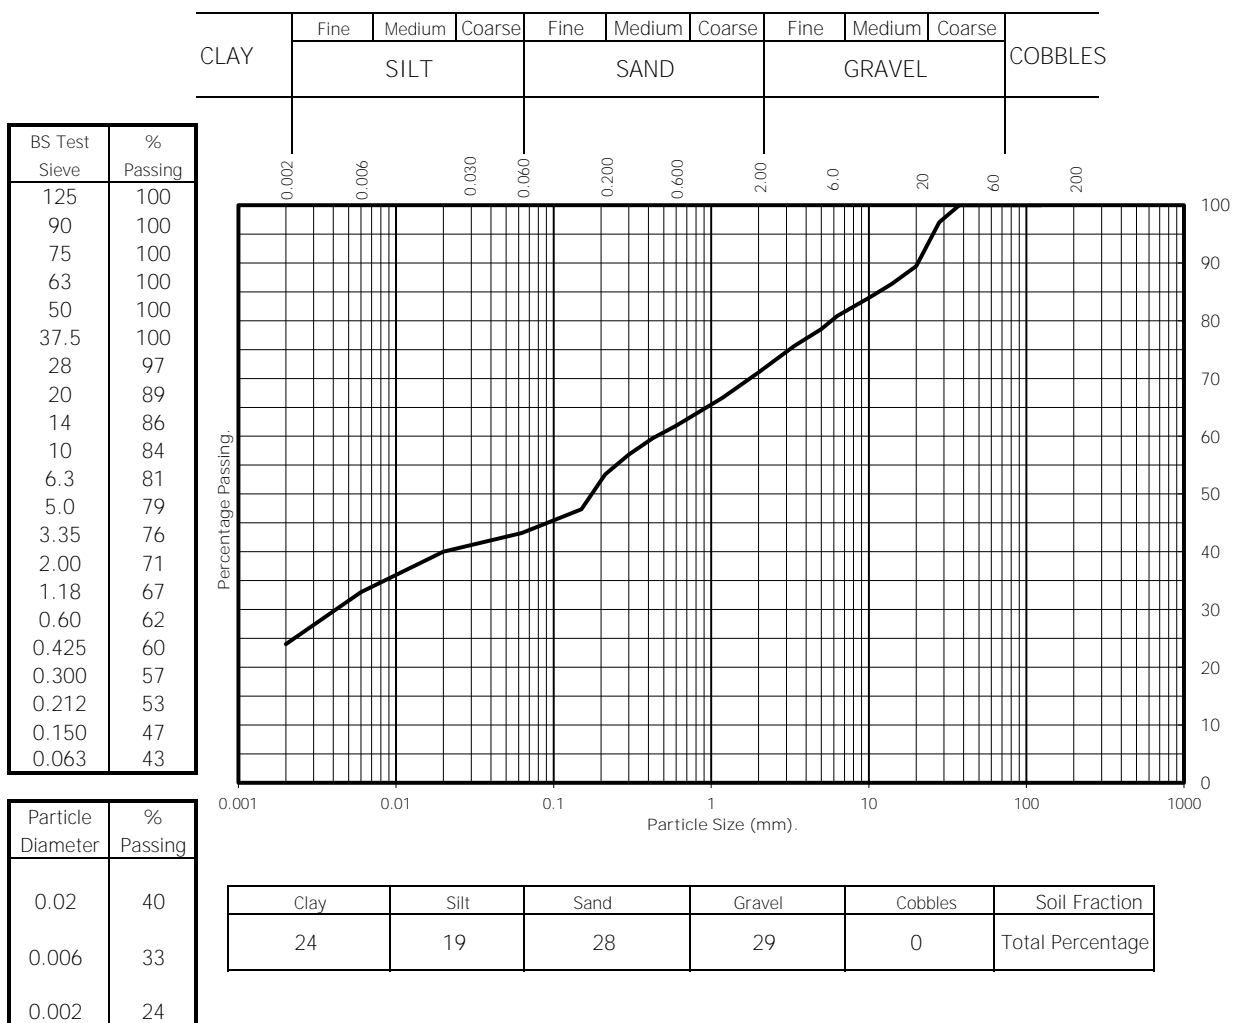
Sample Number: 2  
Depth from (m): 2.00  
Depth to (m): N/A  
Sample Type: B

Location: Galway GCT  
Description: Brown silty clayey sandy fine to coarse GRAVEL
