**N6 Galway City Transport Project**

**Phase 3 Ground Investigation**

**Contract No. 2 - Factual Report**

**R15/16**  
**N6 Galway City Transport Project - Phase 3 Ground Investigation**  
**Contract No. 2 - Factual Report**  
**Dave Blaney P.Geo**  
**May 2016**

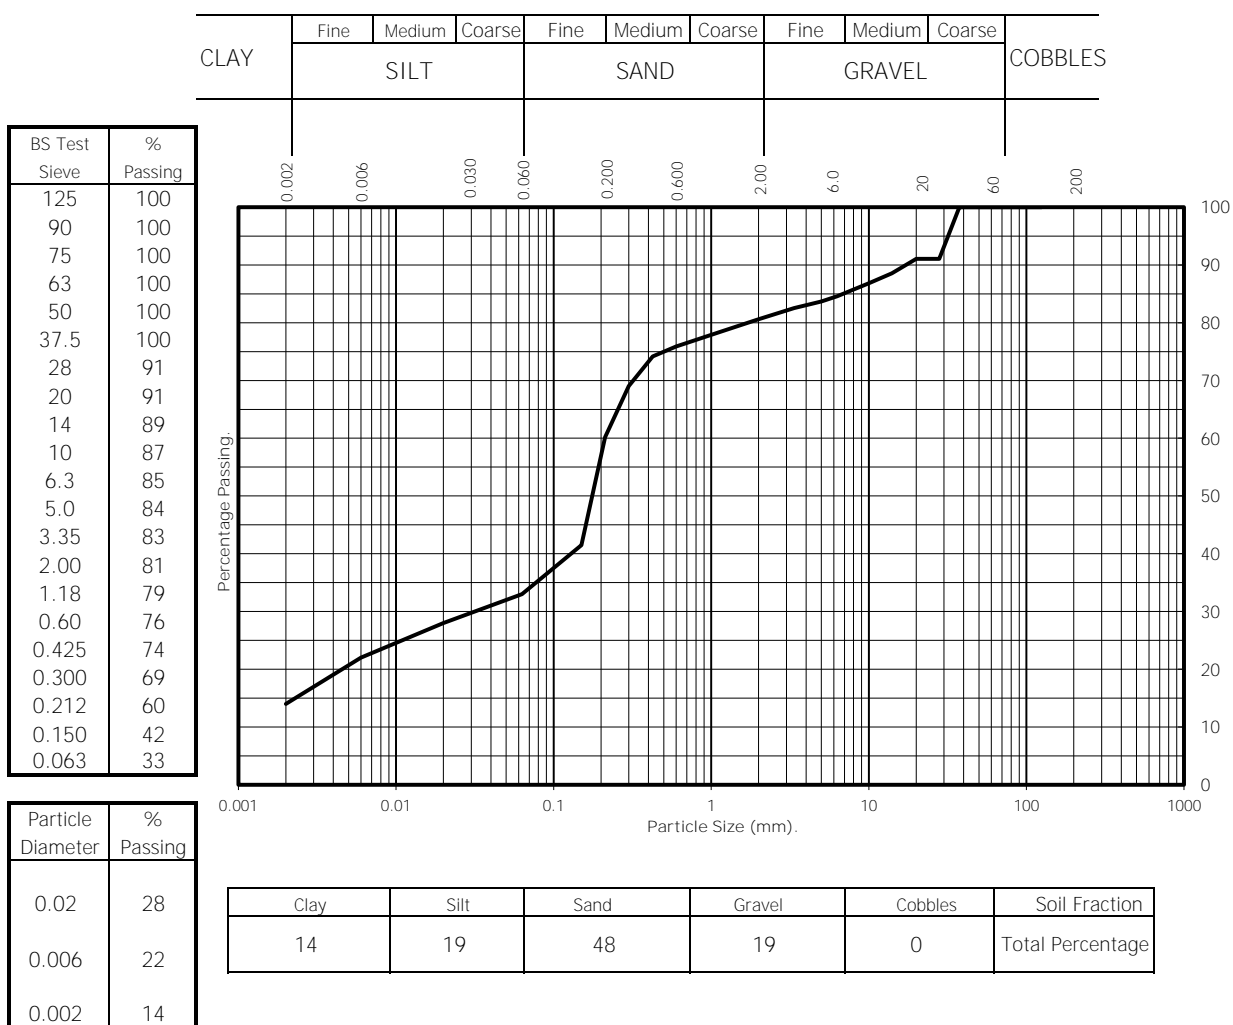
Sample Number: 1  
Depth from (m): 0.50  
Depth to (m): N/A  
Sample Type: B

Location: Galway GCT  
Description: Brown clayey silty fine to coarse gravelly SAND.

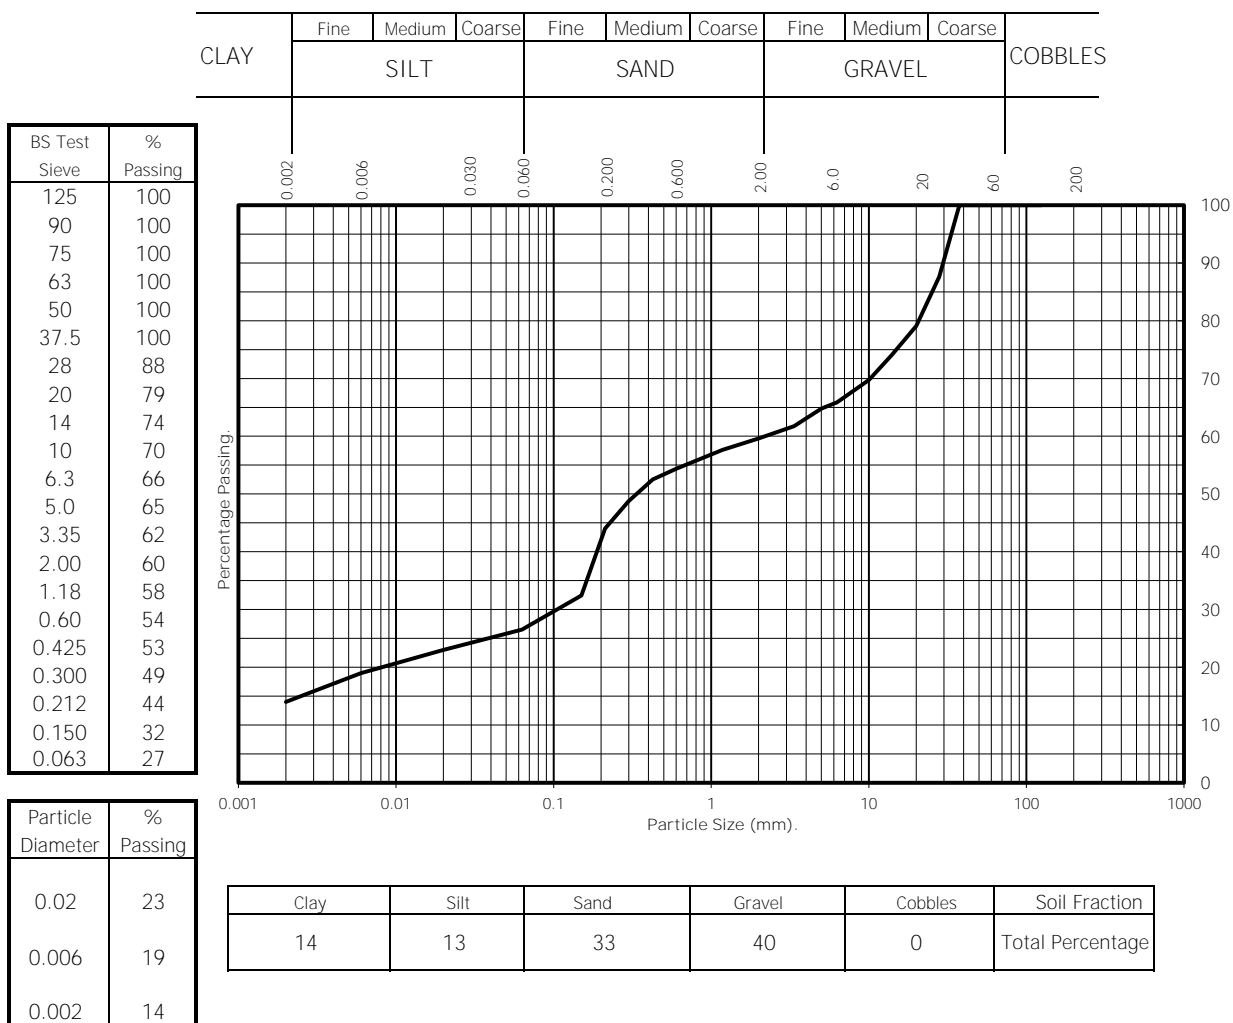
Sample Number: 5  
Depth from (m): 2.50  
Depth to (m): N/A  
Sample Type: B

Location: Galway GCT  
Description: Brown silty clayey sandy fine to coarse GRAVEL.

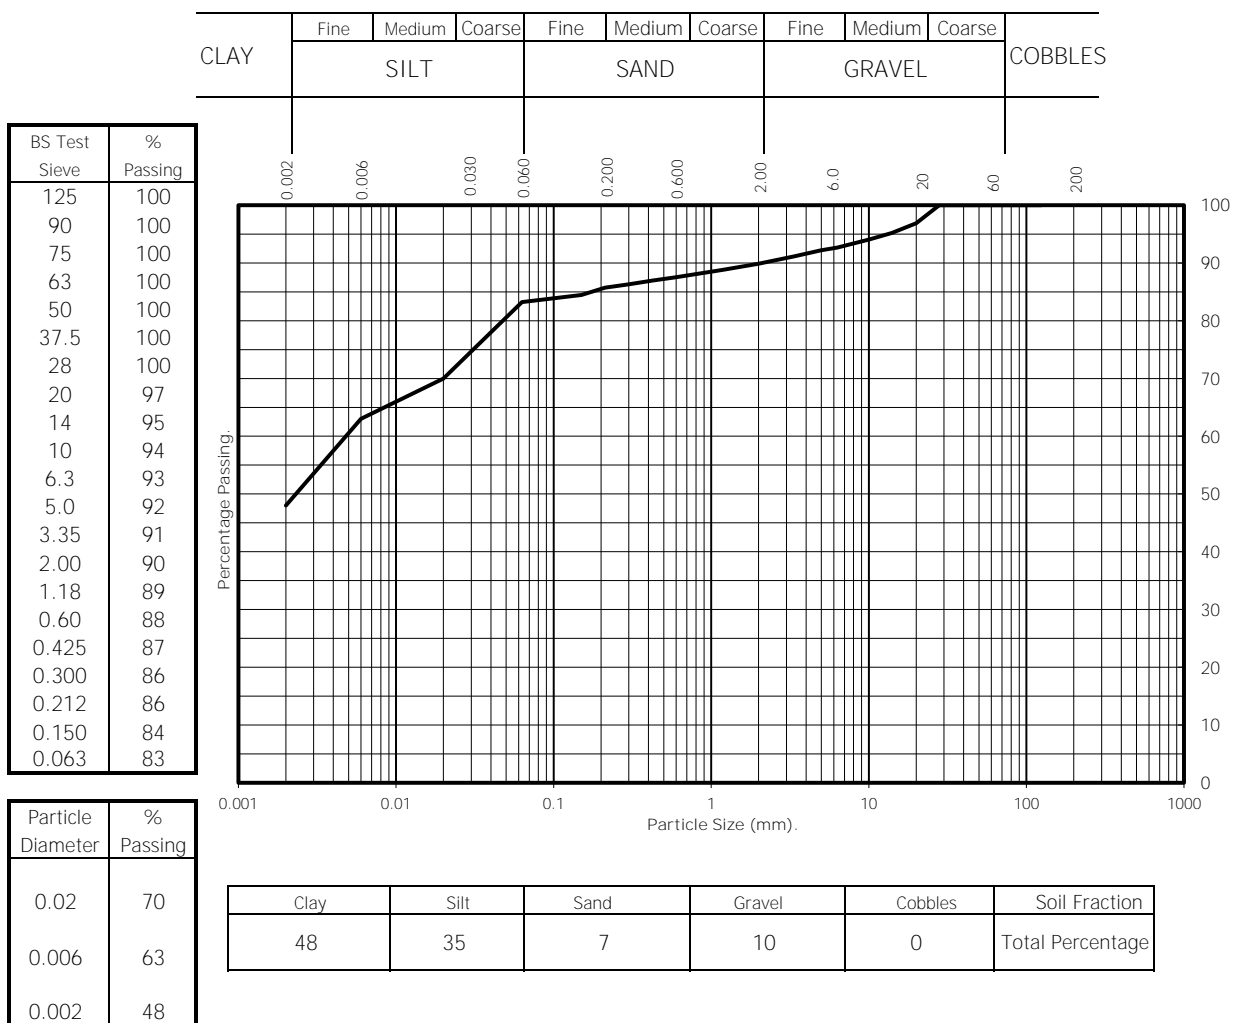
Sample Number: 7  
Depth from (m): 3.00  
Depth to (m): N/A  
Sample Type: B

Location: Galway GCT  
Description: Brown sandy fine to coarse gravelly silty CLAY.

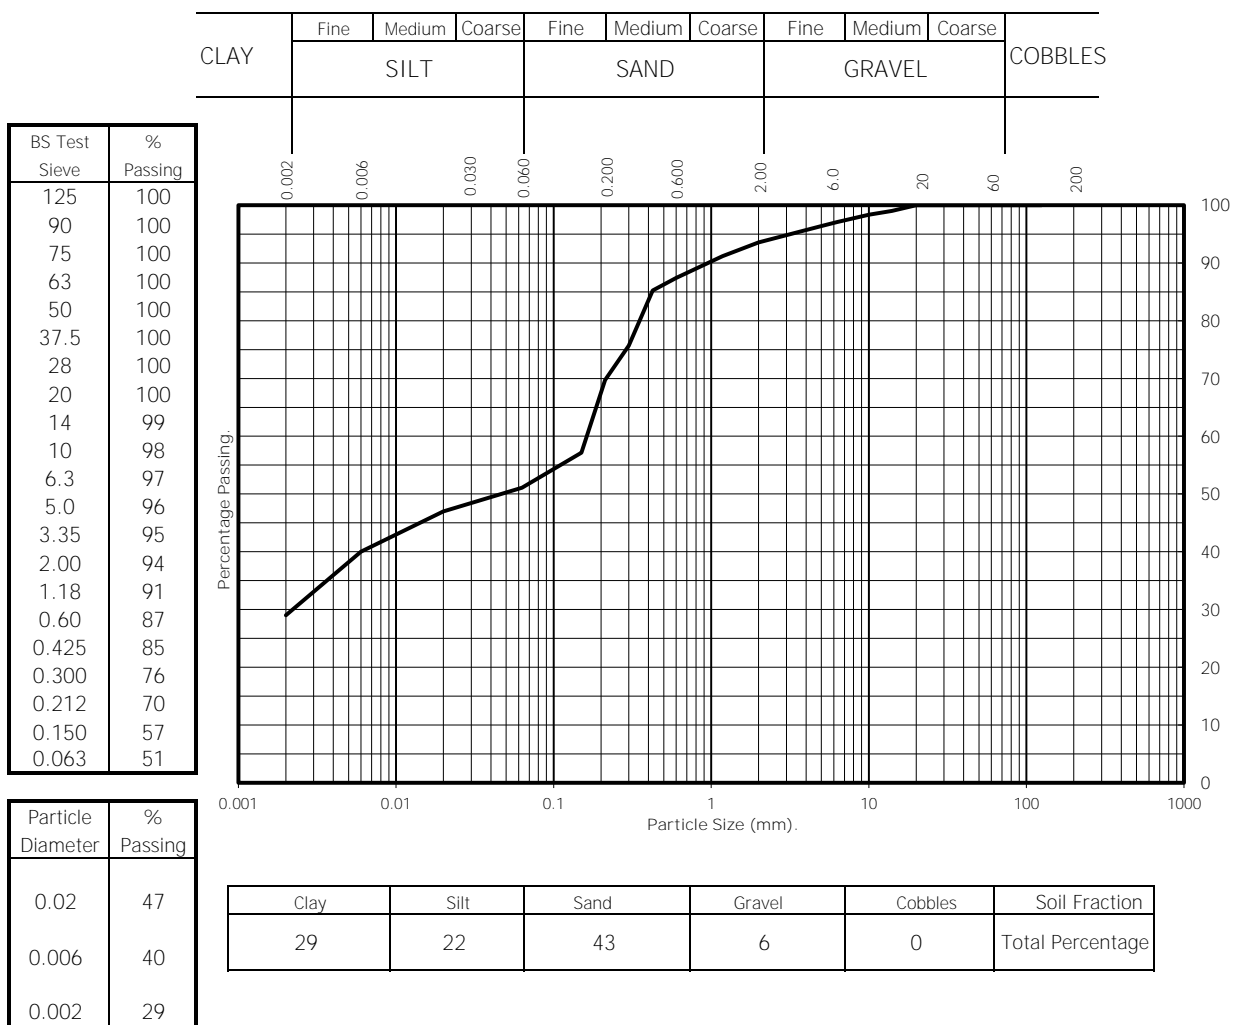
Location: Galway GCT

Description: Brown gravelly silty clayey fine SAND.

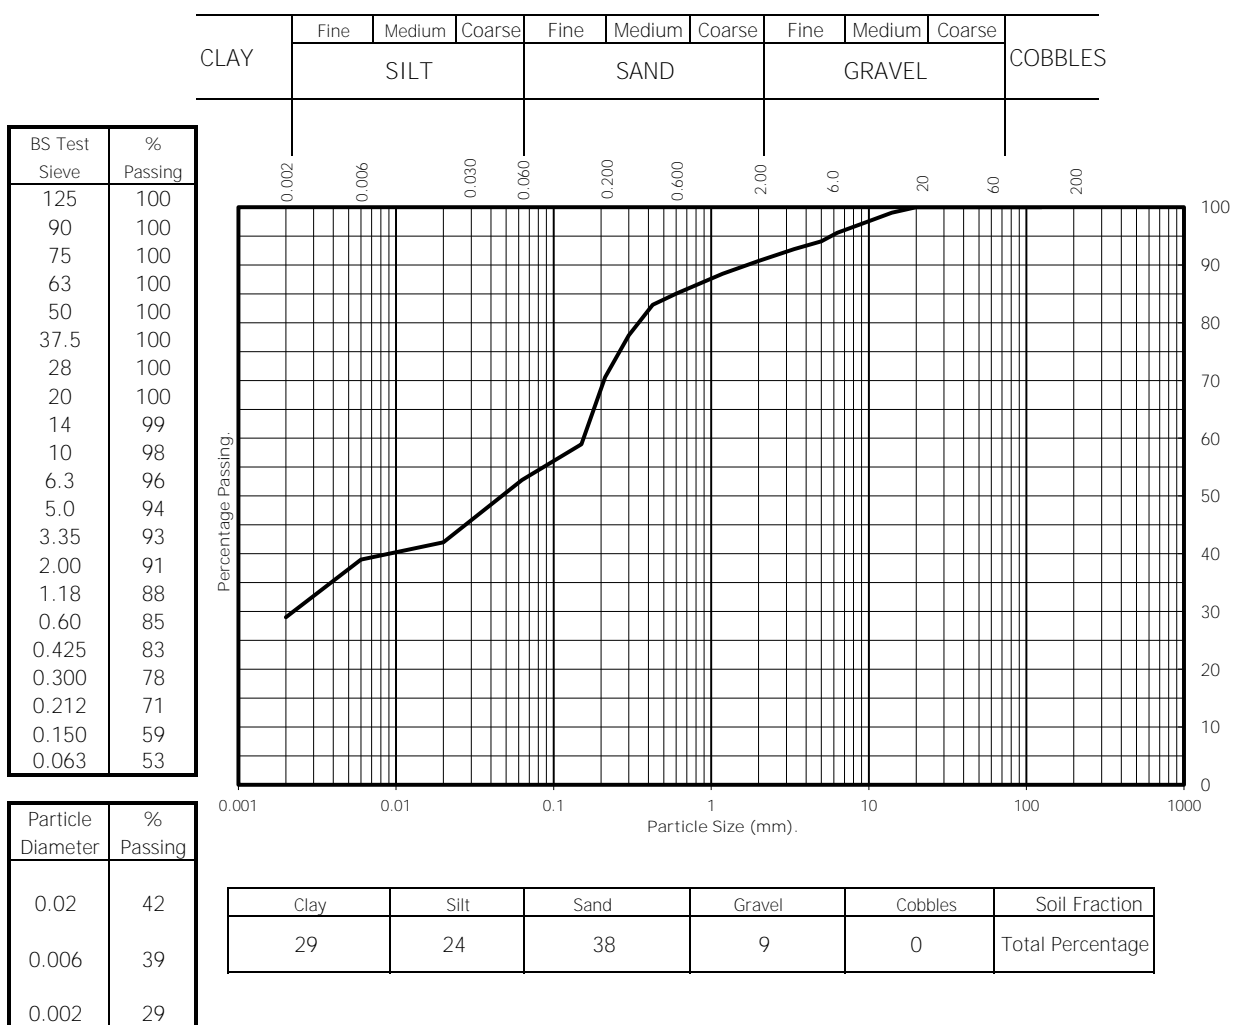
Location: Galway GCT

Description: Brown gravelly silty clayey fine to coarse SAND.

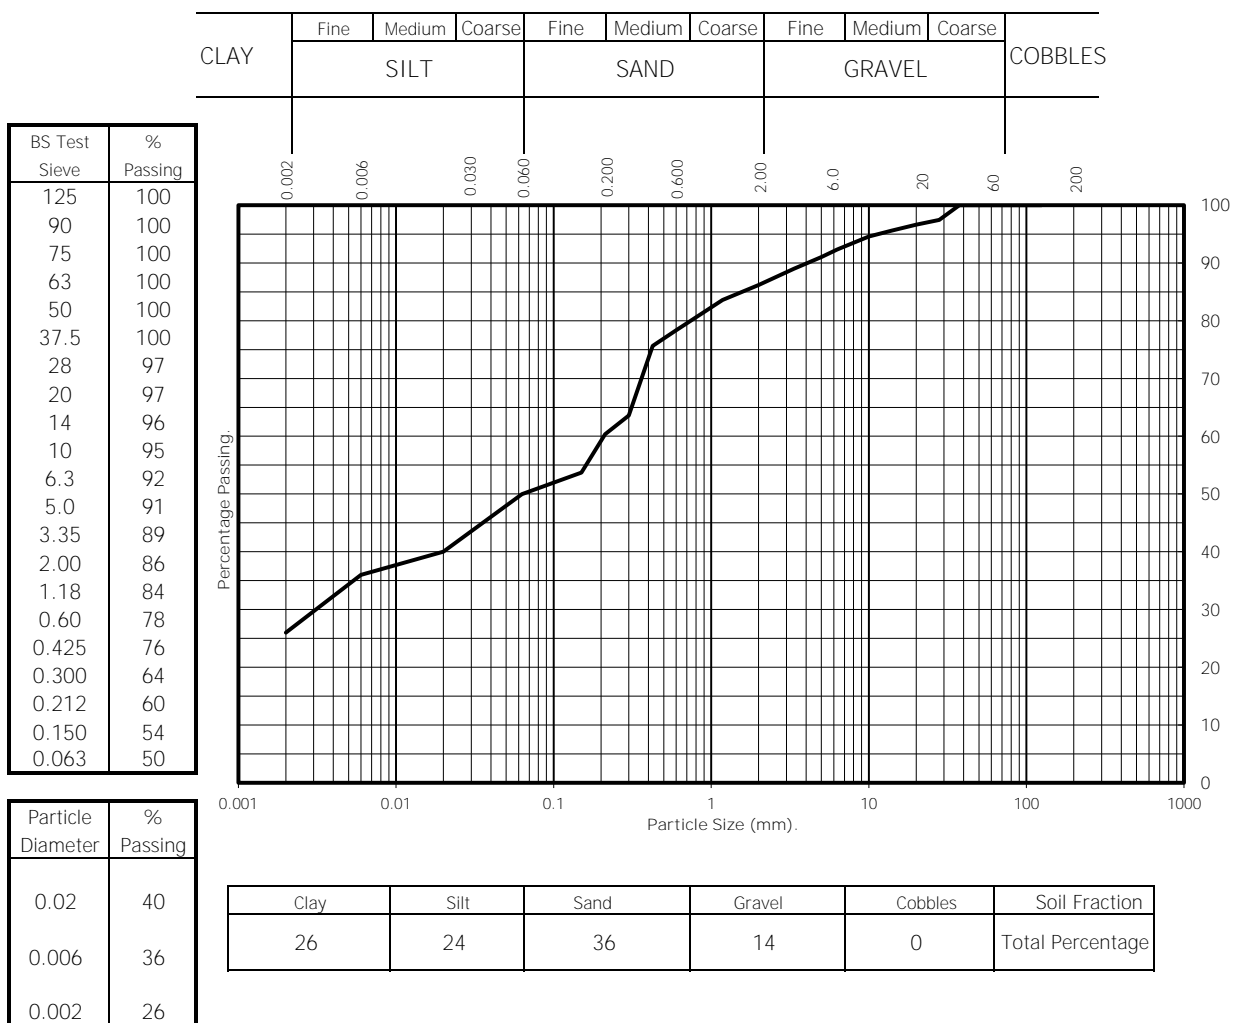
Location: Galway GCT

Description: Brown fine to coarse gravelly silty clayey SAND.

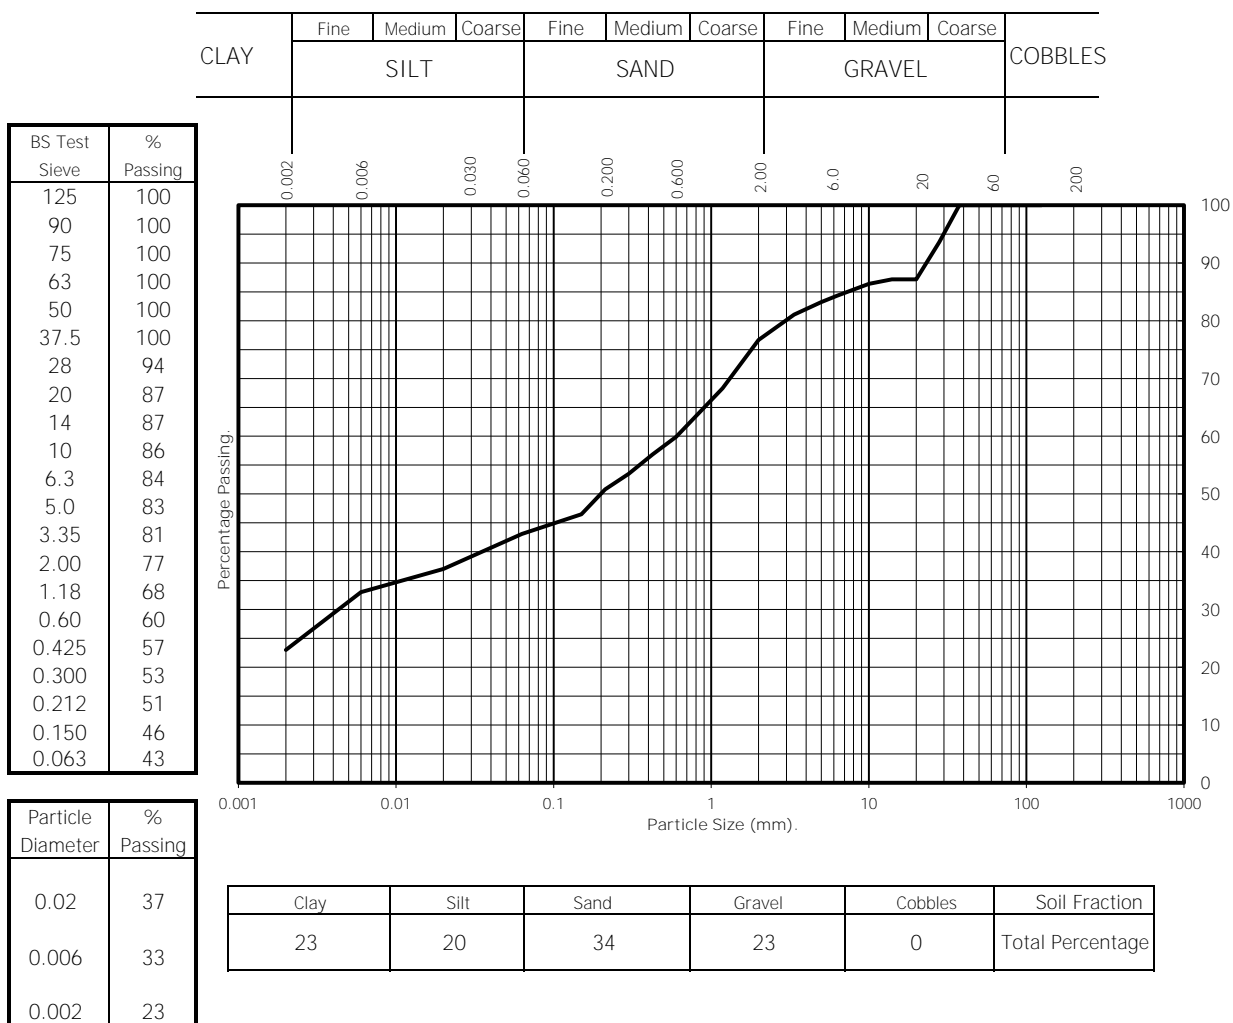
Sample Number: 3  
Depth from (m): 2.00  
Depth to (m): N/A  
Sample Type: B

Location: Galway GCT  
Description: Brown silty clayey fine to coarse gravelly SAND.

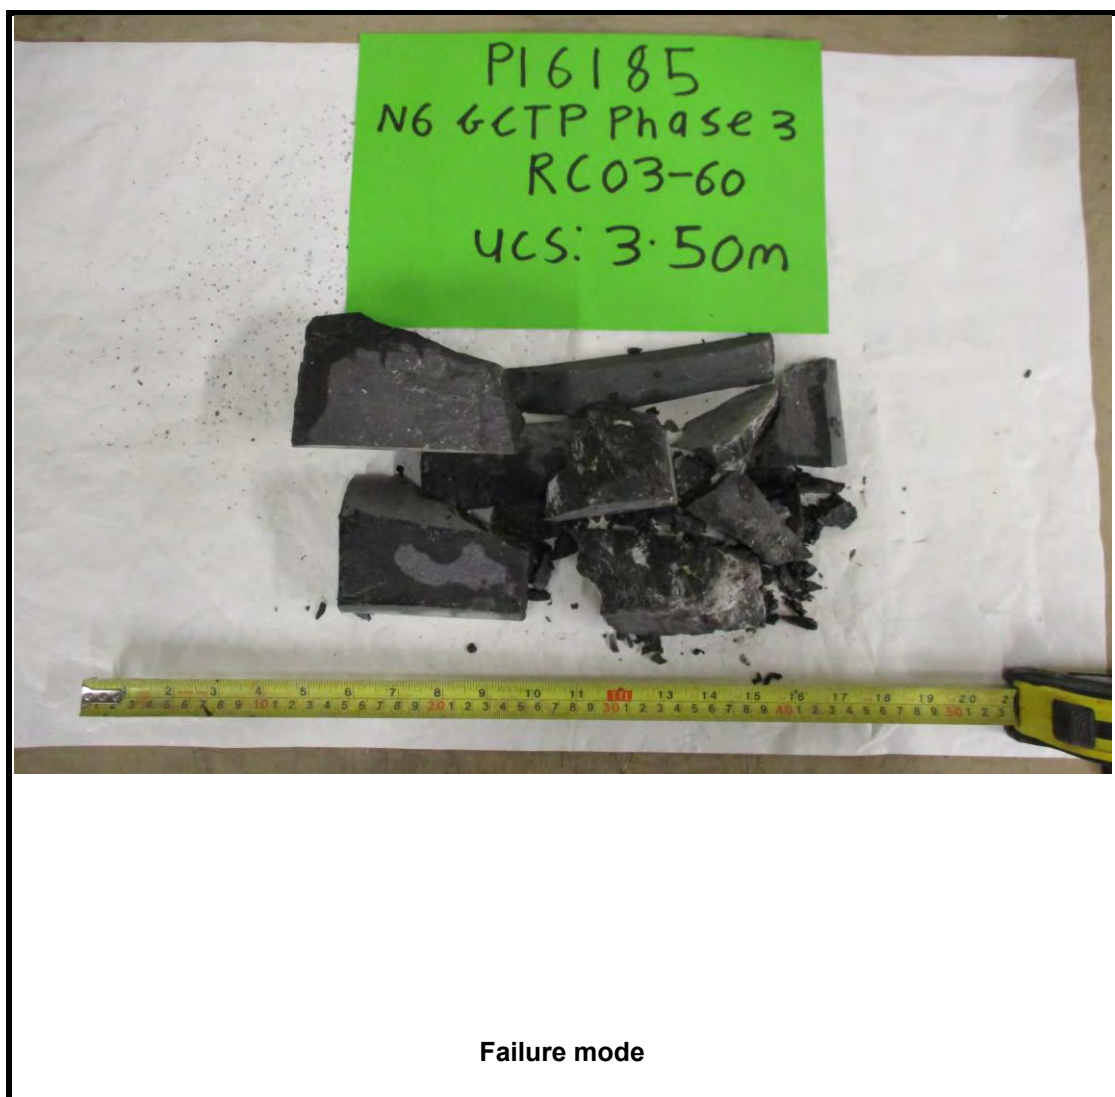
Job Name	N6 GCTP Phase 3
Job Number	P16185
Borehole:	RC03-60
Depth:	3.5 m
Rock Type	Limestone
Bulk Density	2.69 Mg/m <sup>3</sup>
Load at Failure, P	147.9 kN
Stress at Failure	25.41 MPa

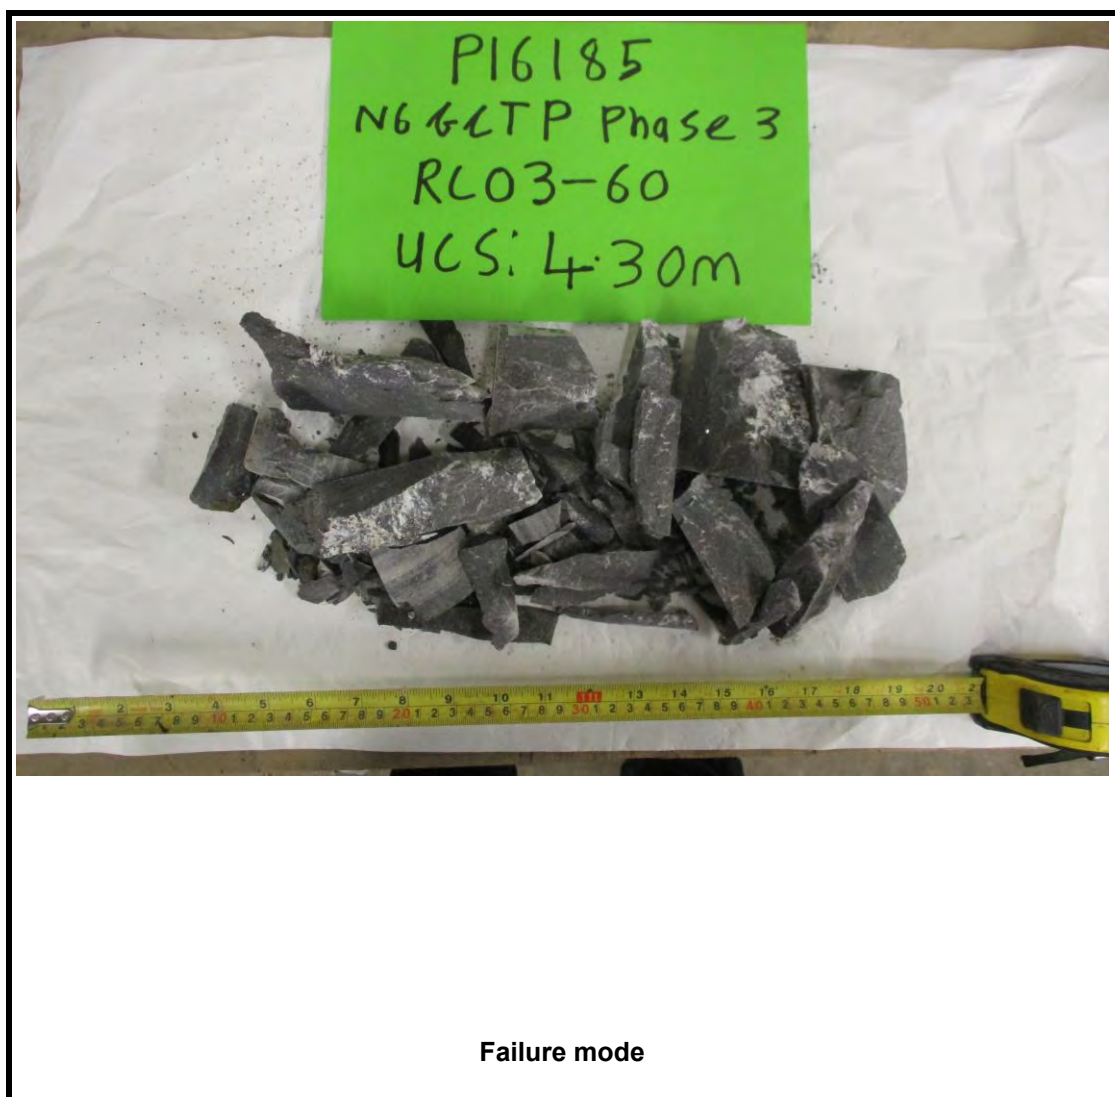
Job Name	N6 GCTP Phase 3
Job Number	P16185
Borehole:	RC03-60
Depth:	4.3 m
Rock Type	Limestone
Bulk Density	2.69 Mg/m <sup>3</sup>
Load at Failure, P	455.6 kN
Stress at Failure	78.41 MPa

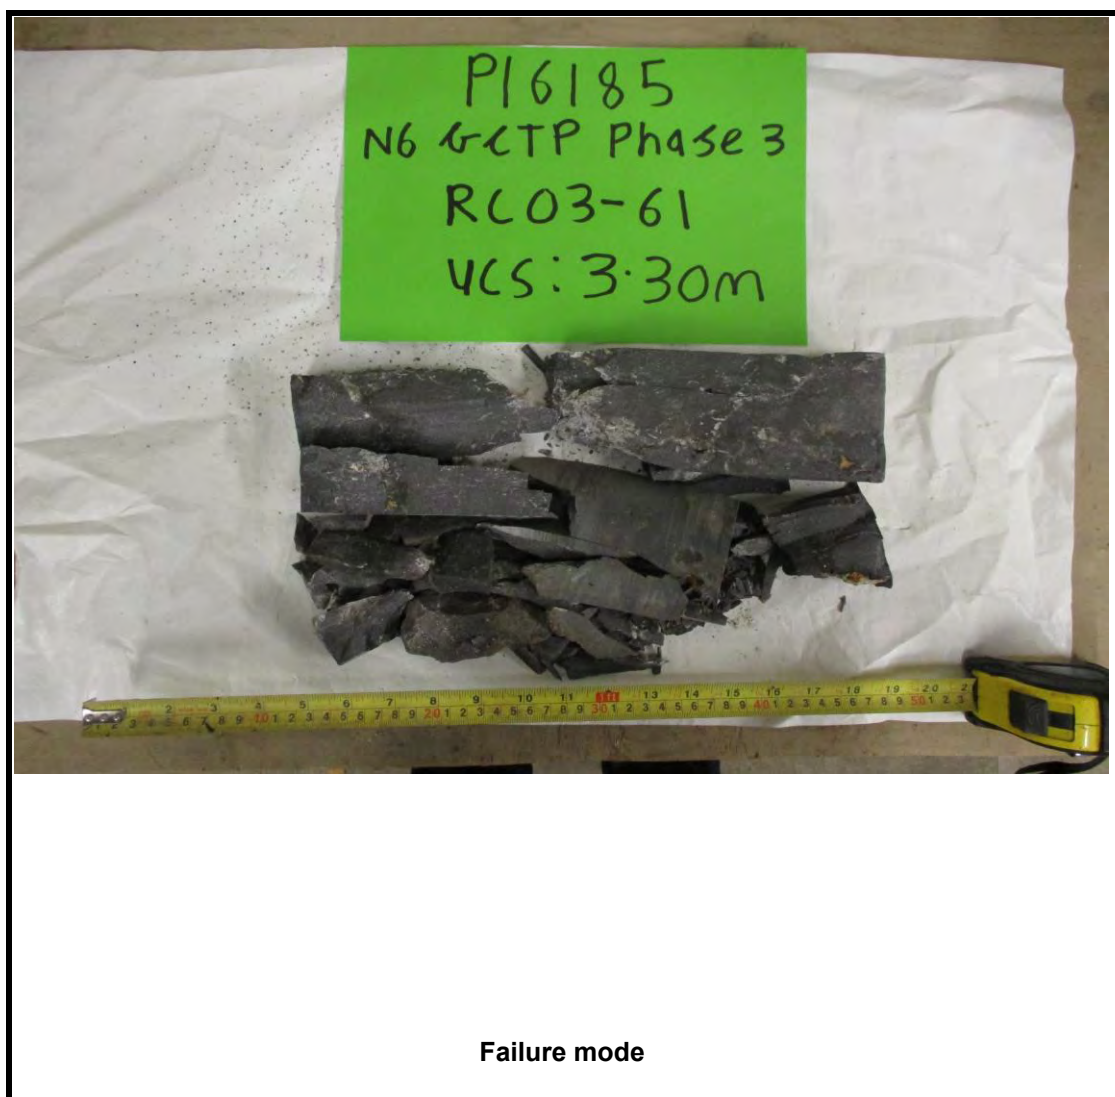
Job Name	N6 GCTP Phase 3
Job Number	P16185
Borehole:	RC03-61
Depth:	3.3 m
Rock Type	Limestone
Bulk Density	2.69 Mg/m <sup>3</sup>
Load at Failure, P	292.8 kN
Stress at Failure	50.41 MPa

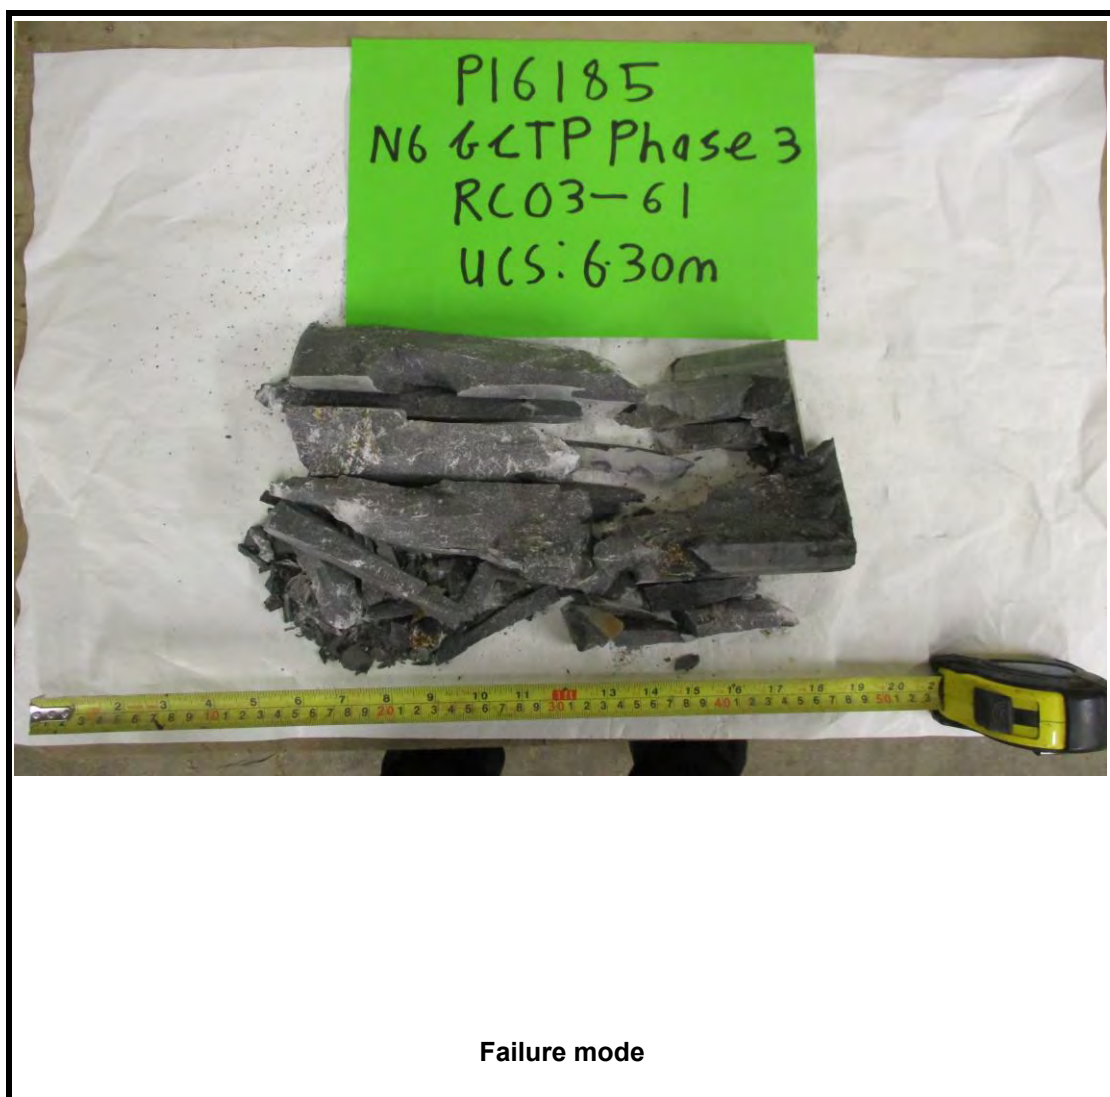
Job Name	N6 GCTP Phase 3
Job Number	P16185
Borehole:	RC03-61
Depth:	6.3 m
Rock Type	Limestone
Bulk Density	2.69 Mg/m <sup>3</sup>
Load at Failure, P	455 kN
Stress at Failure	78.36 MPa

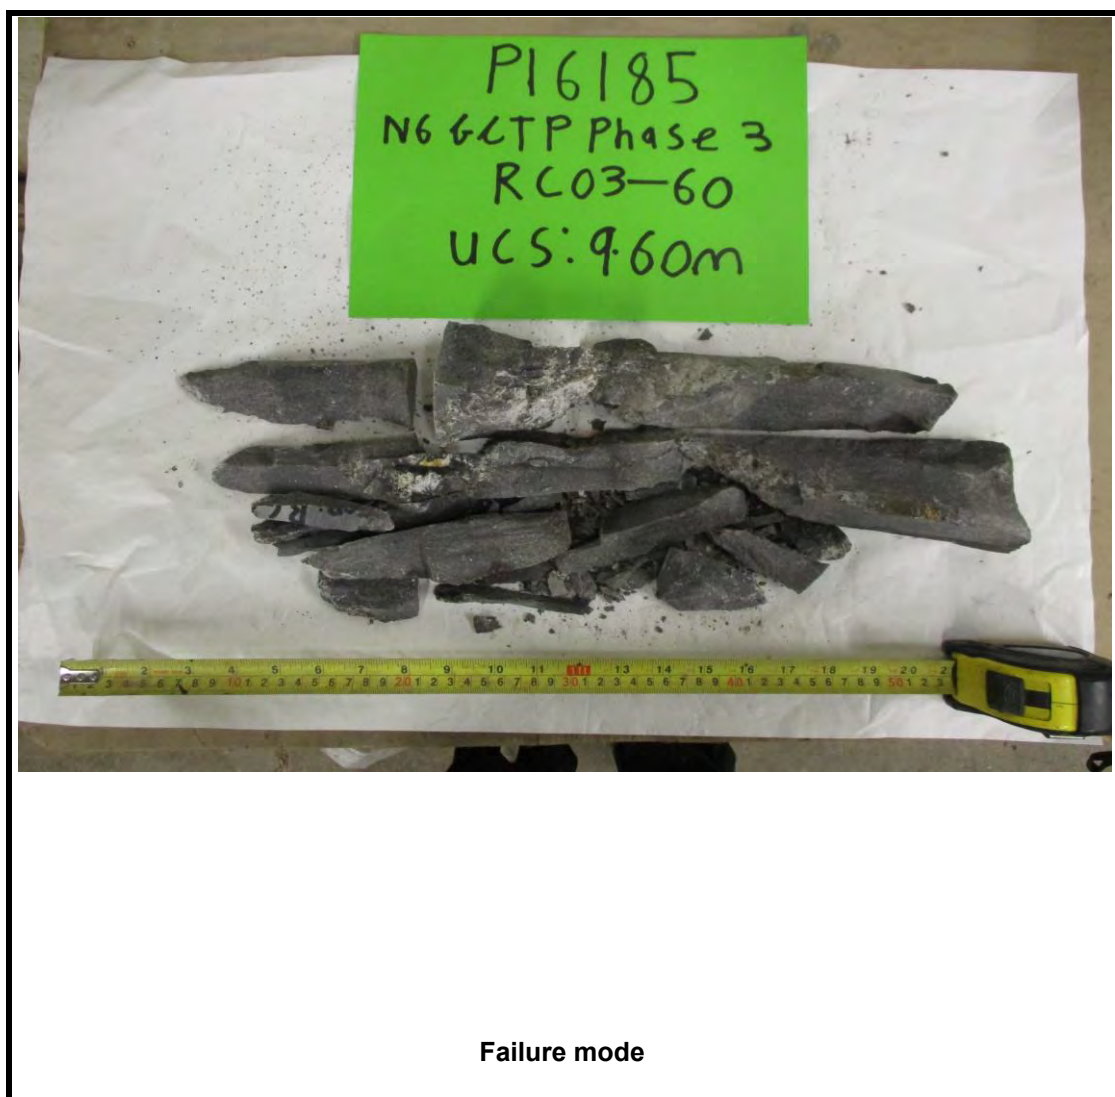
Job Name	N6 GCTP Phase 3
Job Number	P16185
Borehole:	RC03-60
Depth:	9.6 m
Rock Type	Limestone
Bulk Density	2.68 Mg/m <sup>3</sup>
Load at Failure, P	208.1 kN
Stress at Failure	35.1 MPa

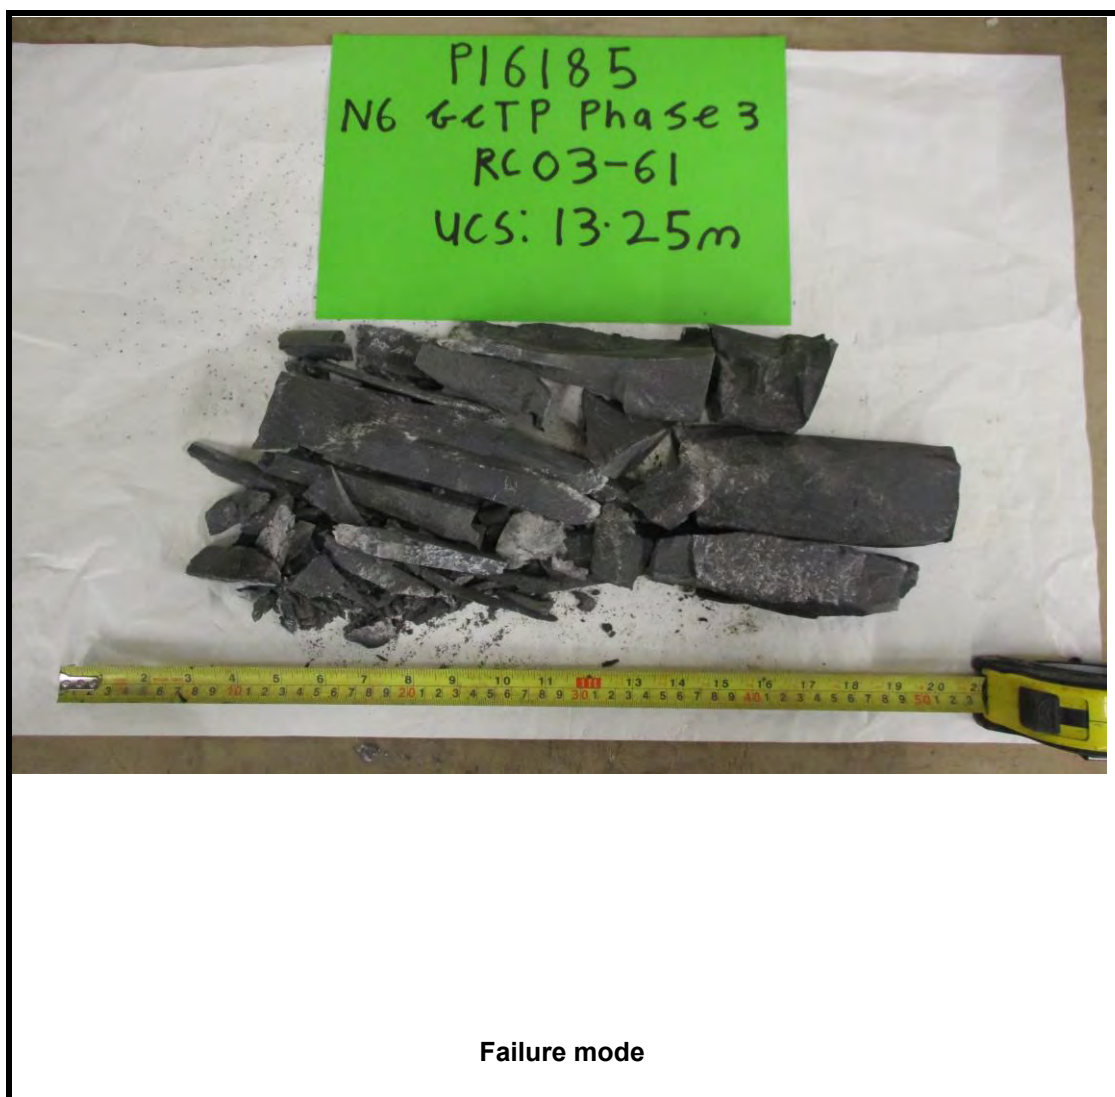
Job Name	N6 GCTP Phase 3
Job Number	P16185
Borehole:	RC03-61
Depth:	13.25 m
Rock Type	Limestone
Bulk Density	2.70 Mg/m <sup>3</sup>
Load at Failure, P	560.4 kN
Stress at Failure	96.51 MPa

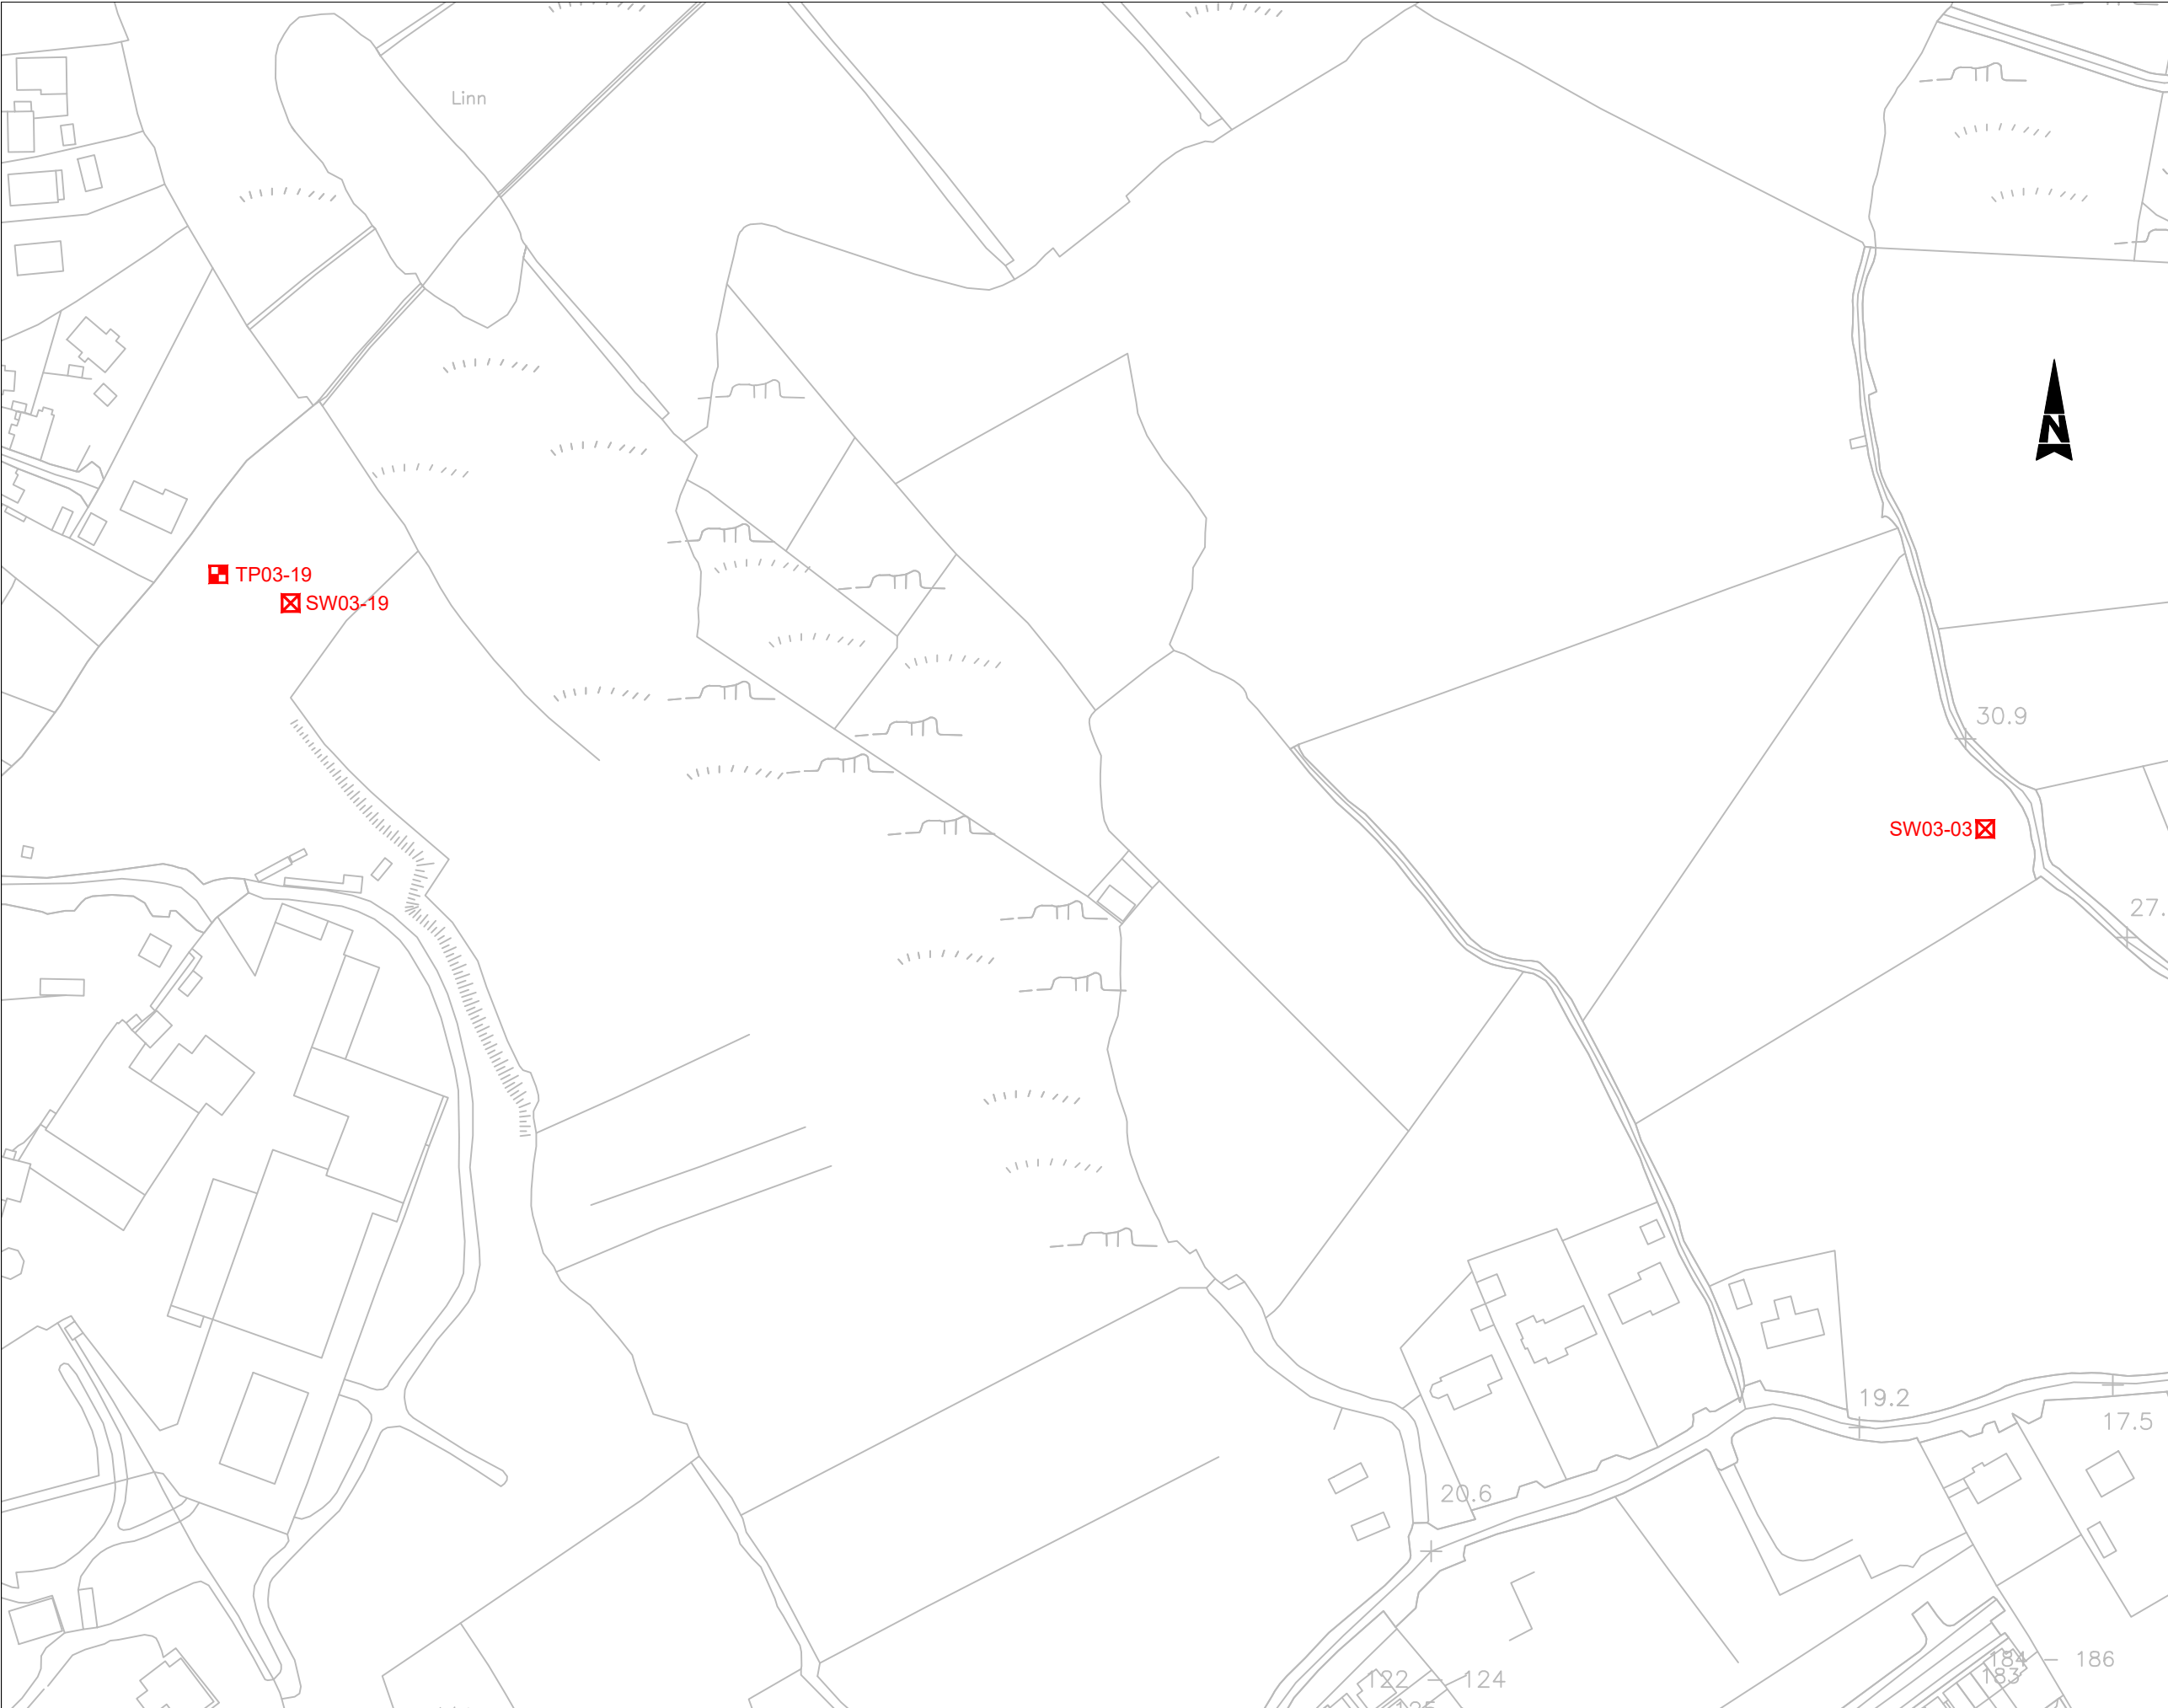
JOB NAME:	
Galway N6 GCTP Phase 3	
Sheet Title:	
EXPLORATORY LOCATION LAYOUT	
JOB NUMBER:	
P16185	
DRAWING NUMBER:	
P16185-SI-A	
DRAWN BY:	
Gary Curtin	
DATE:	
02/02/2017	
SCALE:	APPROVED:
1:20,000 ON A3	GH
REVISION:	
D01

- SW00** Denotes Slit Trench and Datum location
- TP00** Denotes Trial Pit location
- BH00** Denotes Borehole location
- RC00** Denotes Rotary Core location
