STRUCTURAL STRATEGY DOCUMENT

Parnell Square Cultural Quarter
Central Library

Georgian Buildings Structure Planning Strategies

Date: 13th June 2018

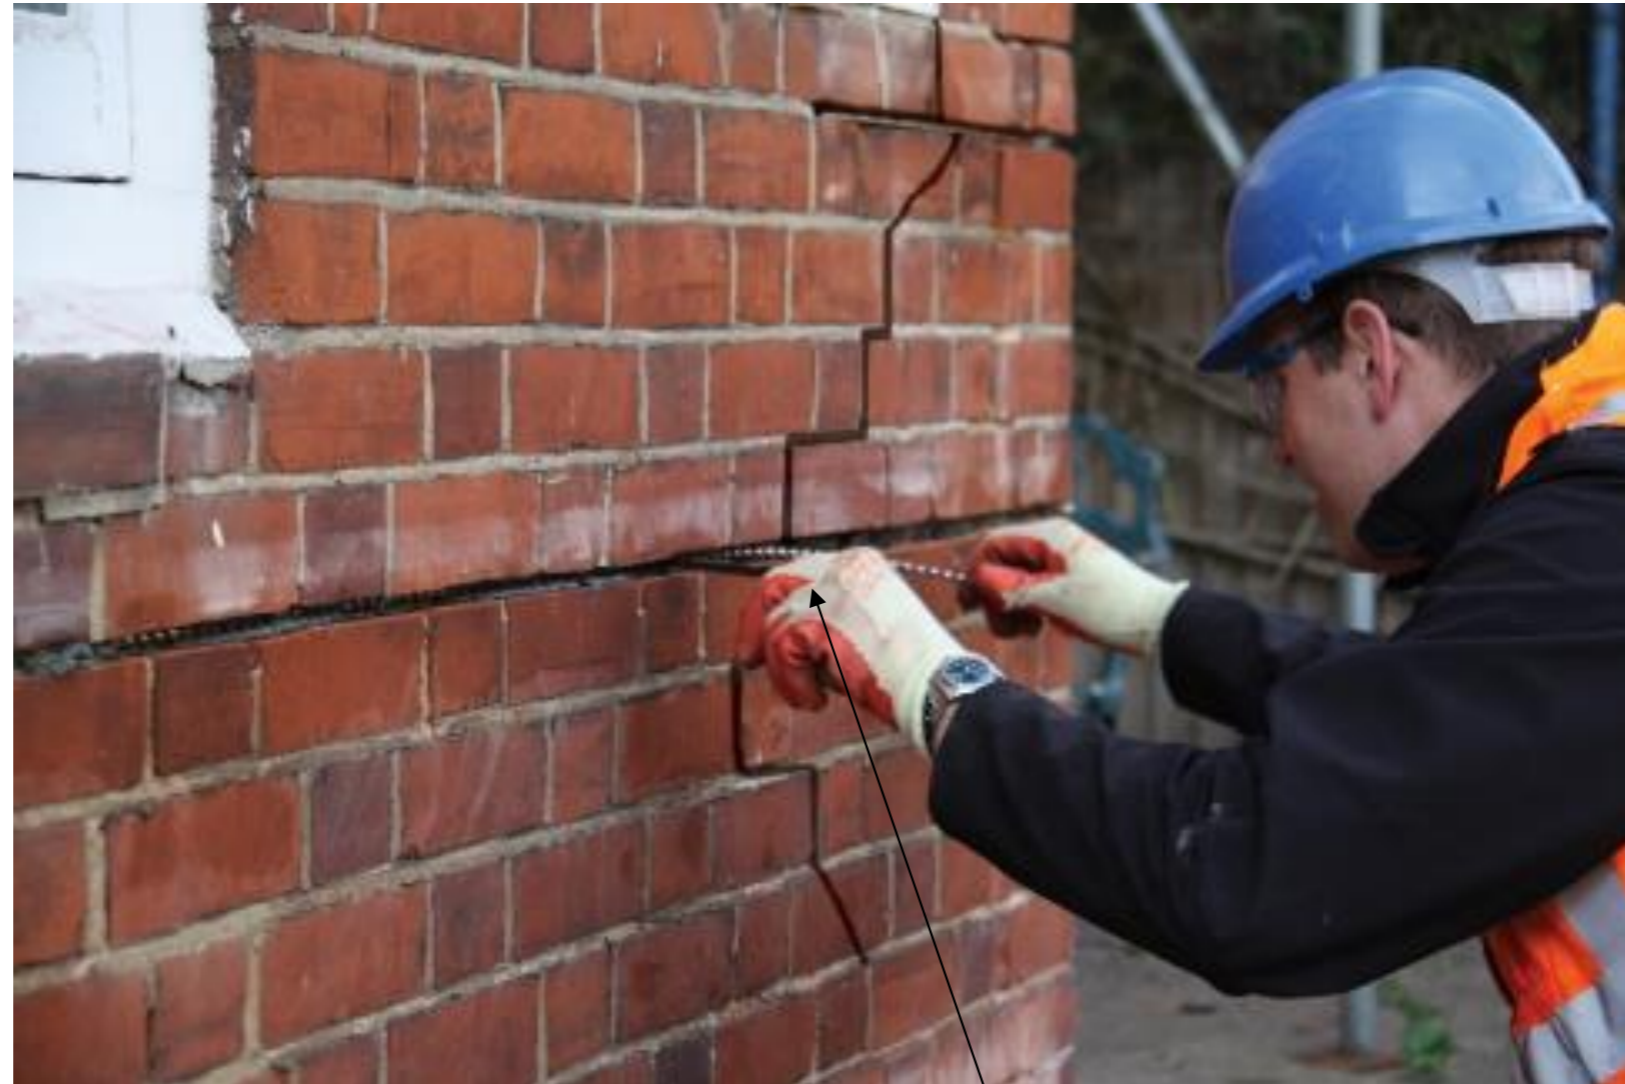
Helibar Installation

Masonry Stitching – All cross wall locations

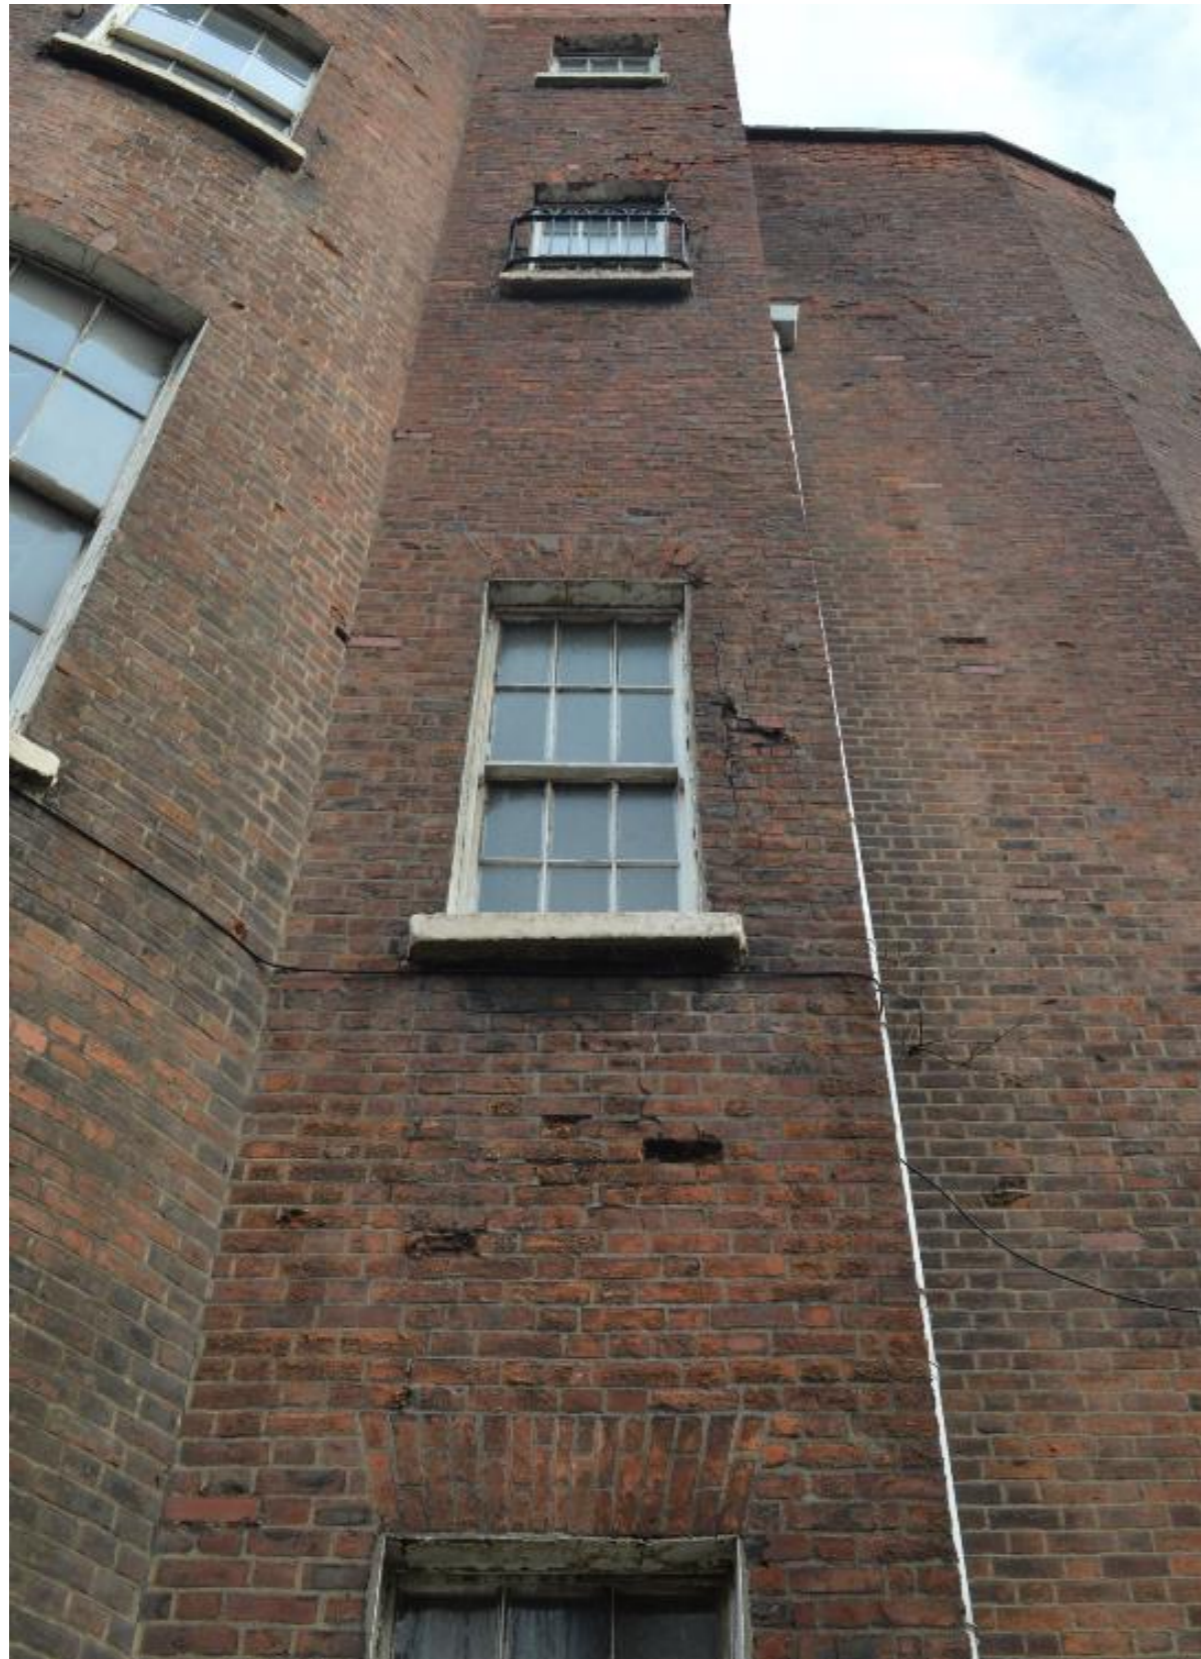
Façade Restoration/Replacement

Stone Window Heads No. 21/23

- Hammer Tap test of all brickwork to be undertaken to establish any hollow section of potential spalling material.
- Flat arches to be replaced with galvanised steel plate lintels.
- Brickwork façade to be washed and mechanical nylon brushed.

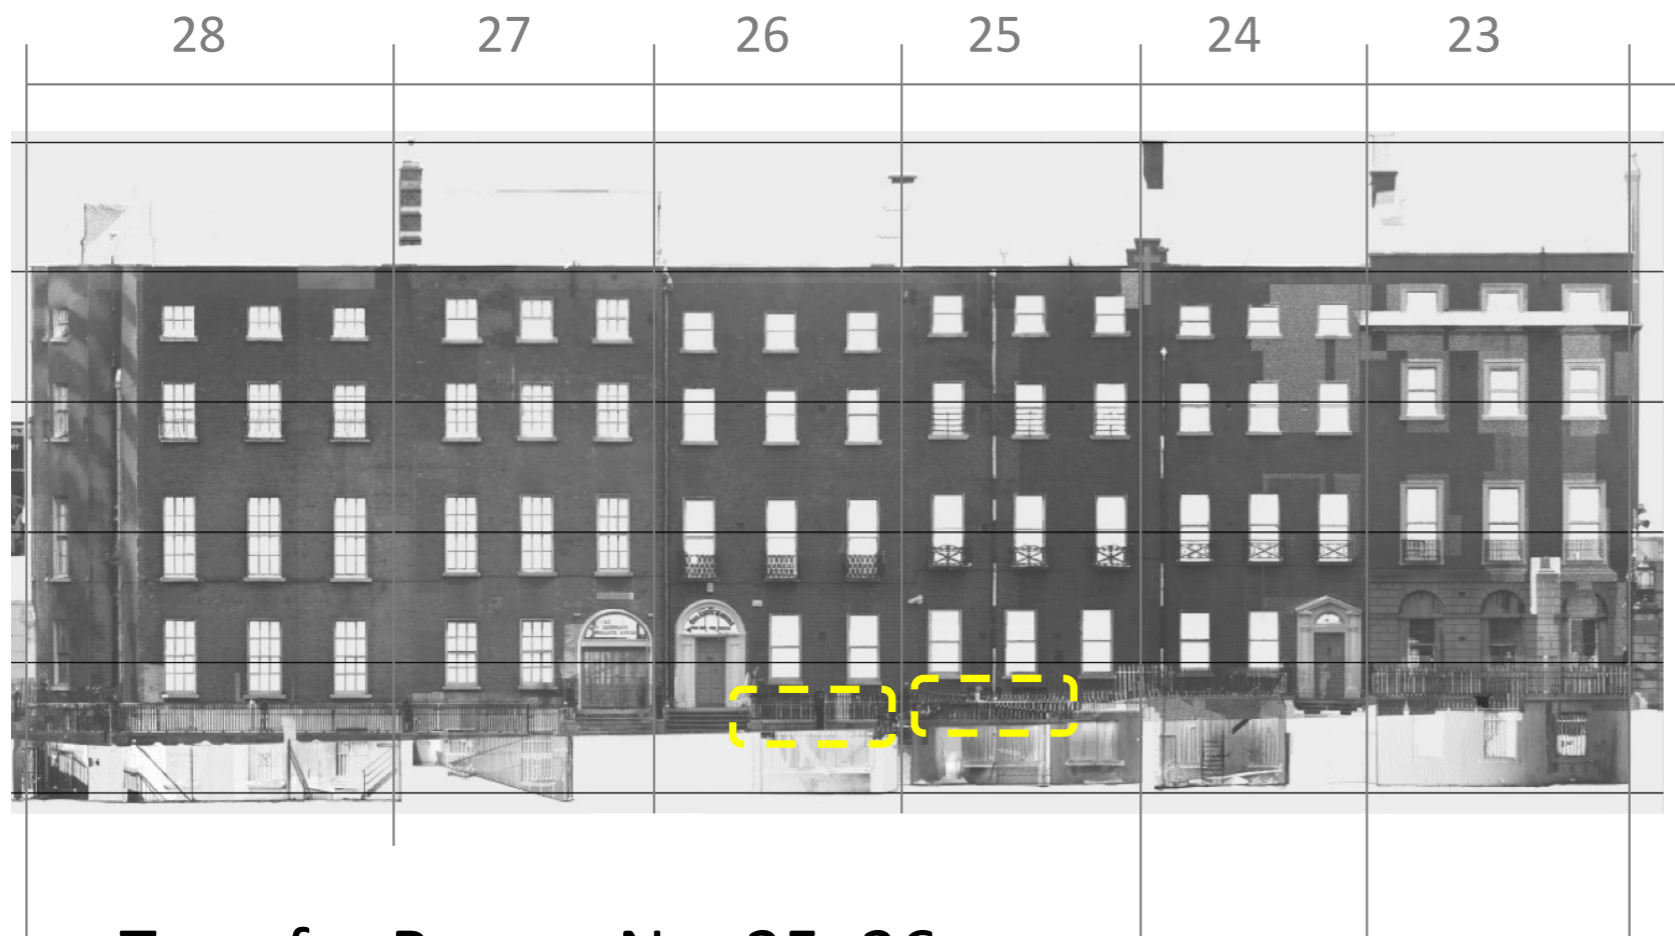
Transfer Beams No. 25, 26

- Existing Transfer Beams potentially supporting **4 stories/floors** above.

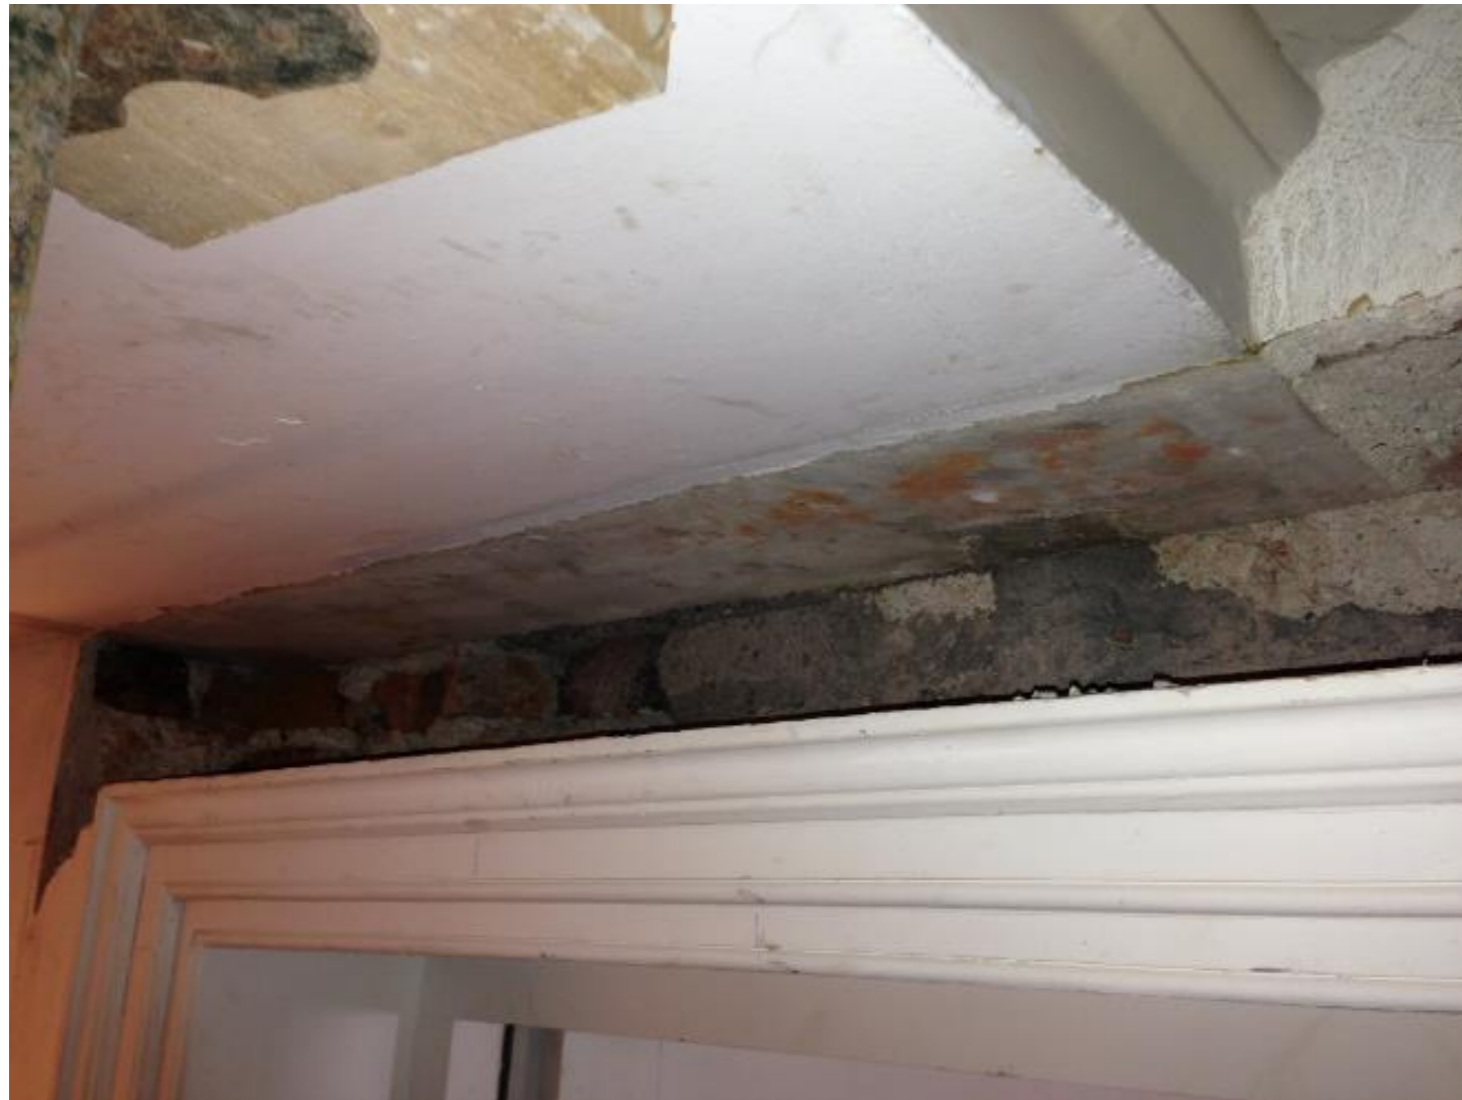
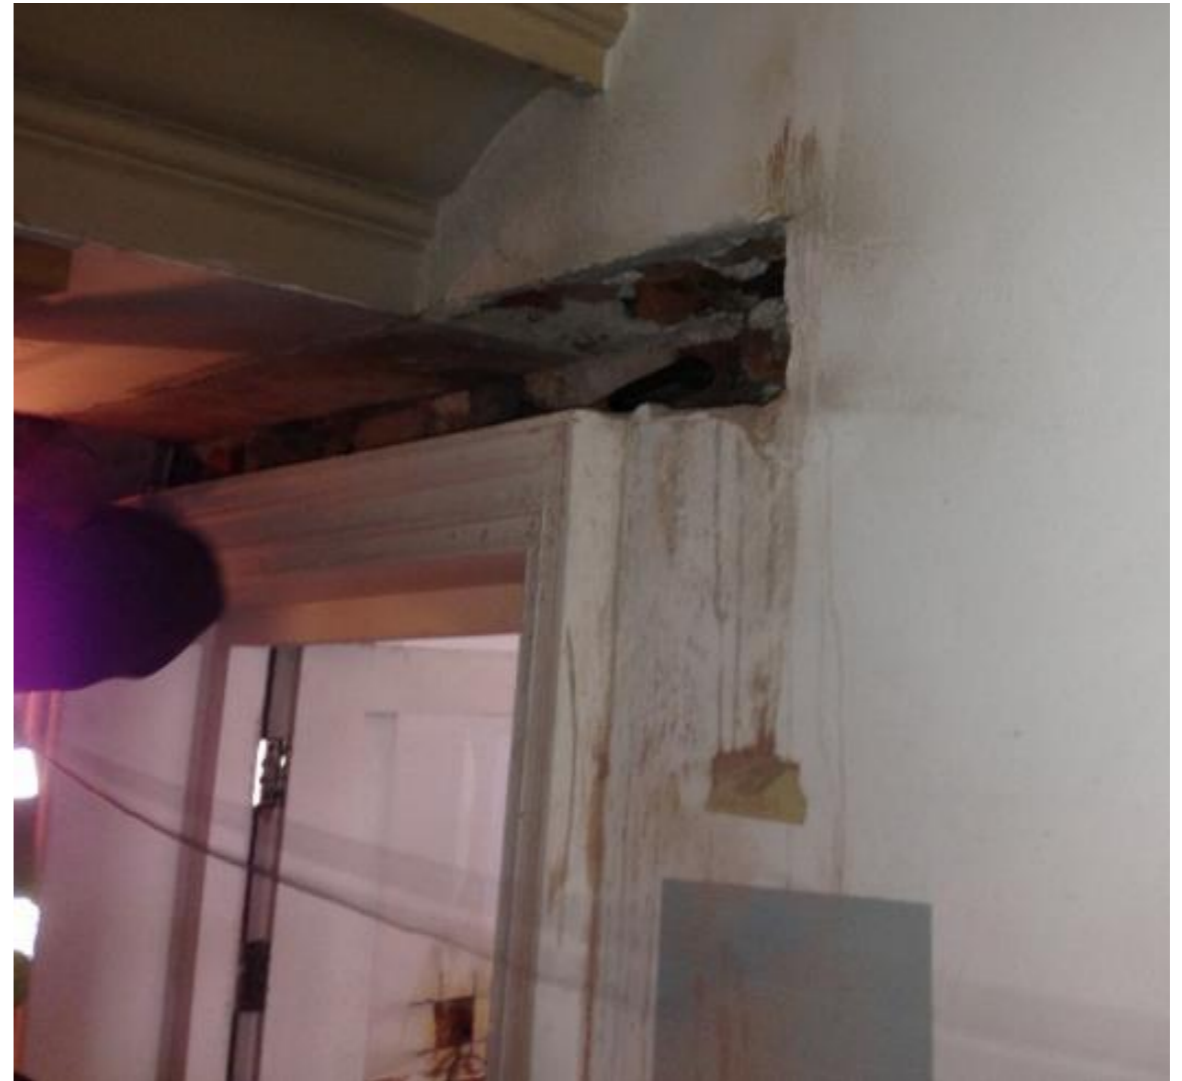
Replacement of Lintels

- Replacement of decayed lintels
(assume up to 80%)

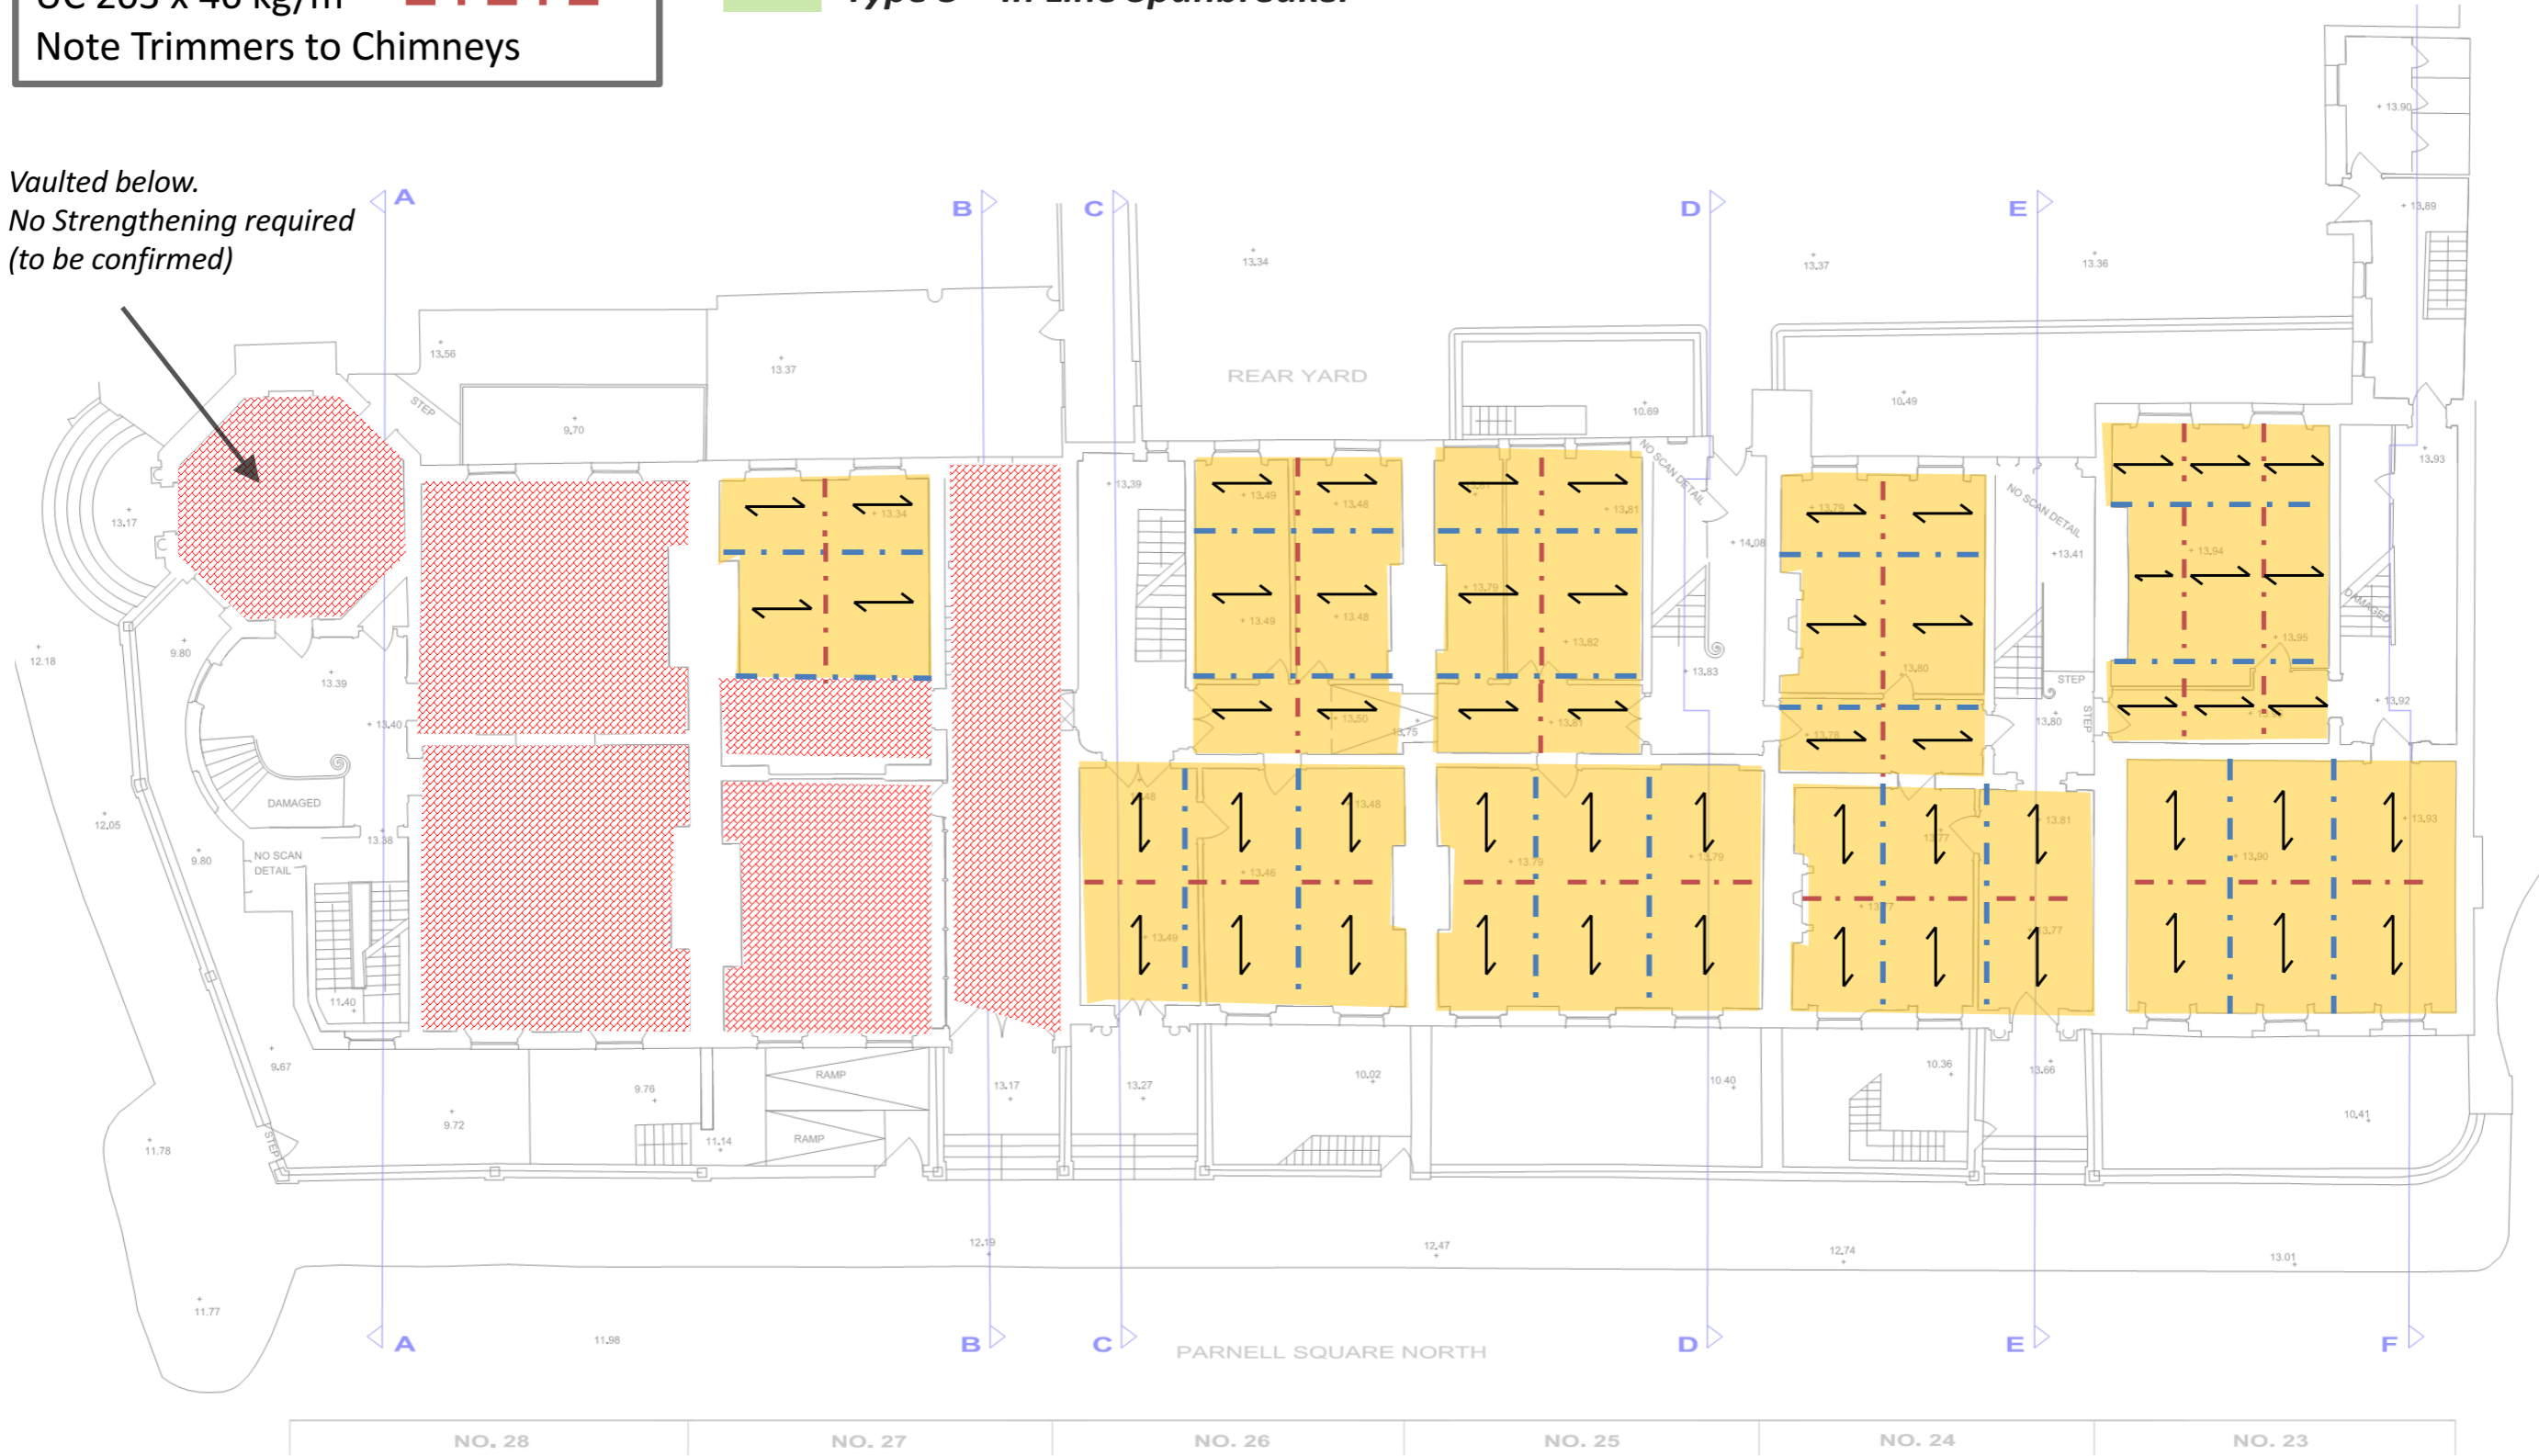
Ground Floor – Proposed Span Breaker Strengthening

Note:
Span directions and condition of timber in houses 27, 26 and 25 have been assumed based of investigative works to houses 28, 24 and 23.

*Vaulted below.
No Strengthening required
(to be confirmed)*

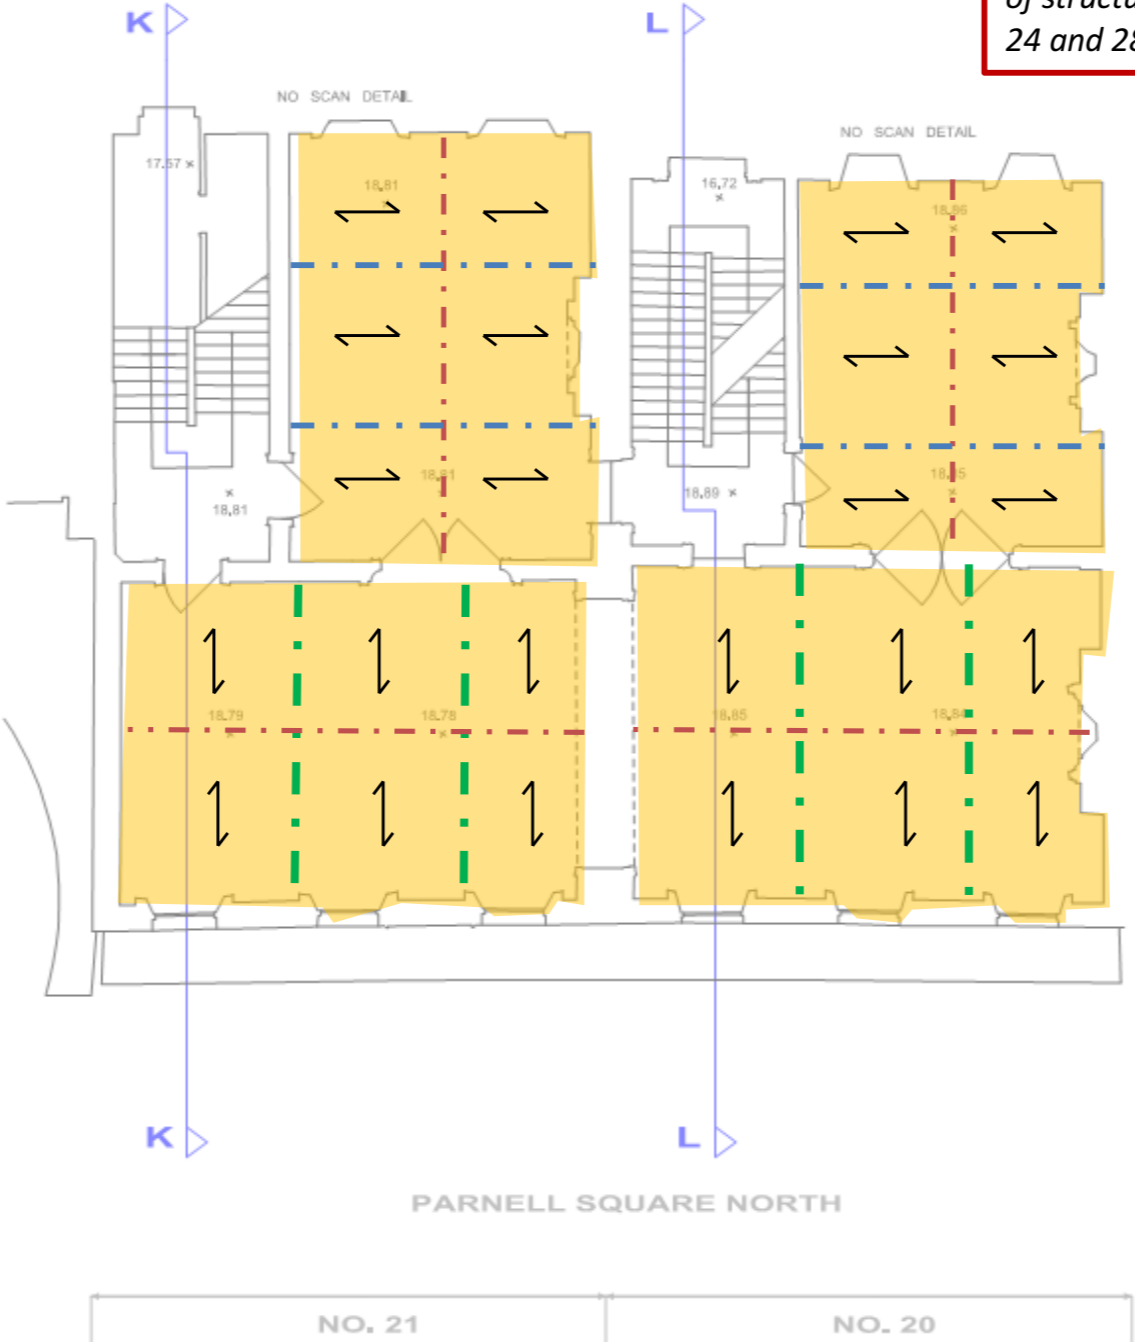
Level 1 & 3 Typical – Proposed Span Breakers (No. 20 & 21)

Note:
 Very **limited** investigative works carried out to Level 2 Joists **ONLY** for Houses 20 & 21. Condition of timber, span directions and depth of structural zone has been **assumed** based of findings in Houses 23, 24 and 28 and is subject to change.

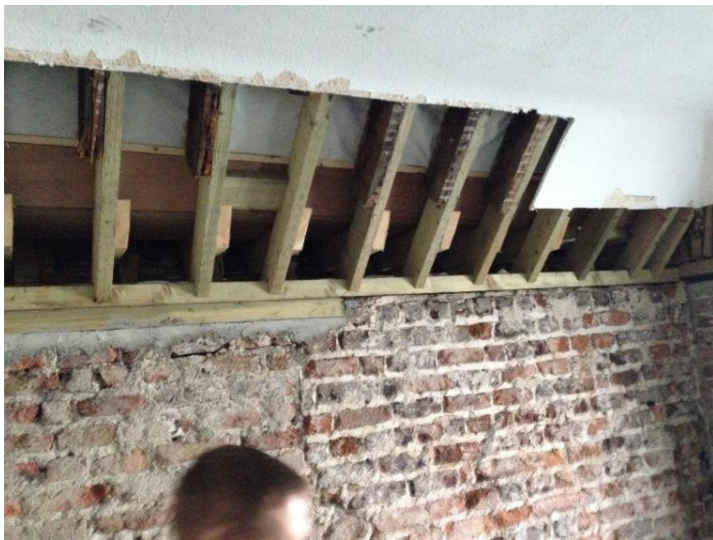
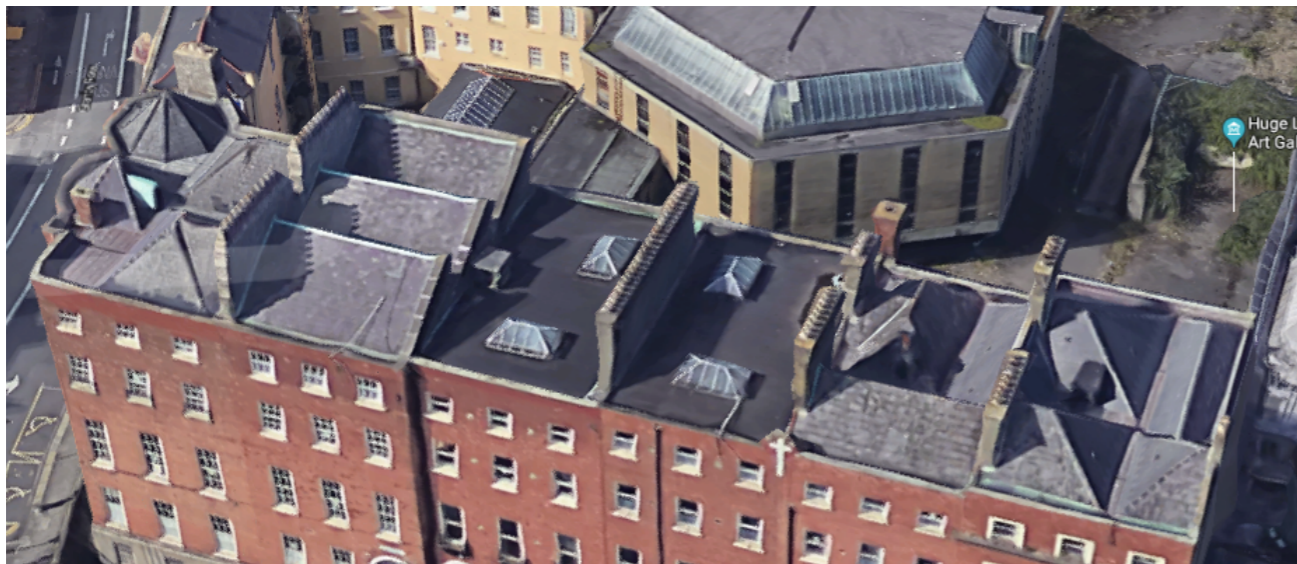
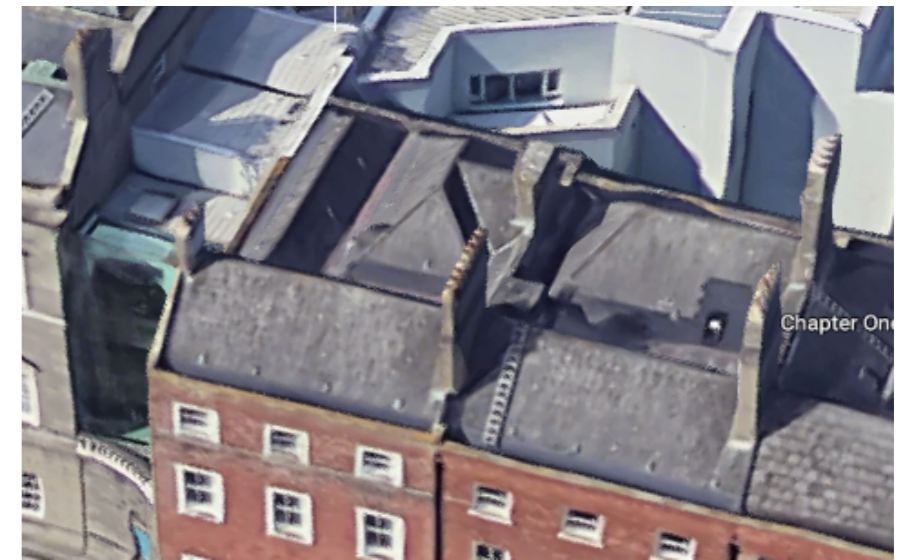
Upgrade of Existing Roofs 20,21, 23, 24 & 28

- 20% Rafter Replacement + 20% Rafter Splicing (page 35)
- 30% Rafter Replacement + 50% Rafter Splicing (page 35)
- 100% Roof Replacement
- To be removed as per scheme (see next section)

Note: Evaluation of timber roofs based off of limited opening up works. Contingency should be considered in costing.
