Peat Stability Risk Assessment

Timahoe North Solar Farm

Document No.: QS-000218-01-R460-002

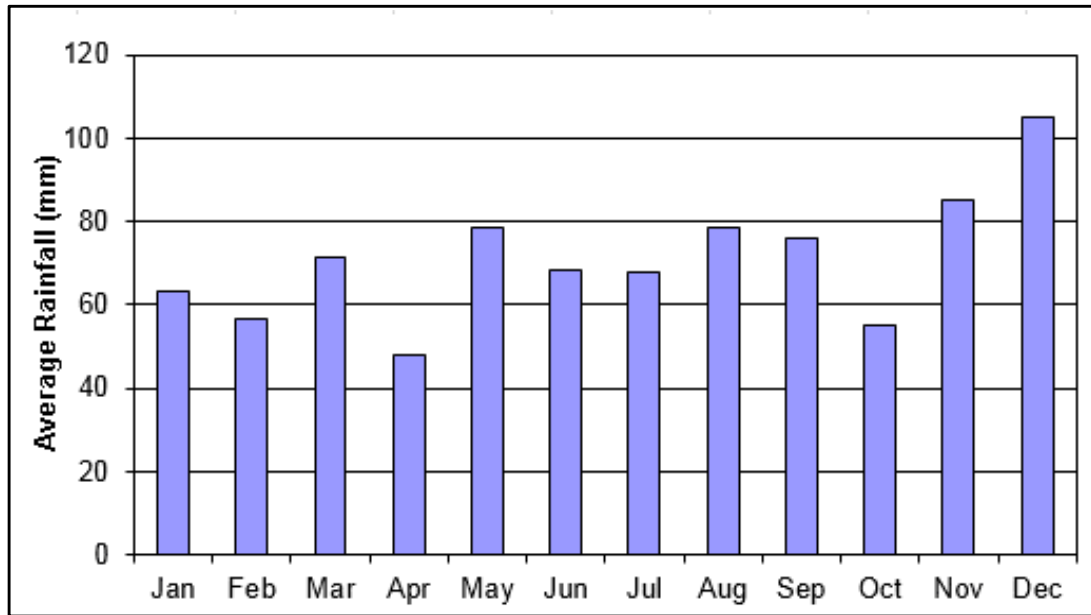
Figure 2-7 Mean monthly rainfall at Dunsany Observatory 2014 – 2017 (Met Éireann)

The nearest weather station to Timahoe North Solar Farm is at Dunsany Observatory. This weather station is located approximately 35 km north-east of the proposed solar farm. Given the proximity to the site it is expected that average rainfall would be similar at Timahoe North. The mean monthly rainfall at Dunsany Observatory is presented in Figure 2-7.

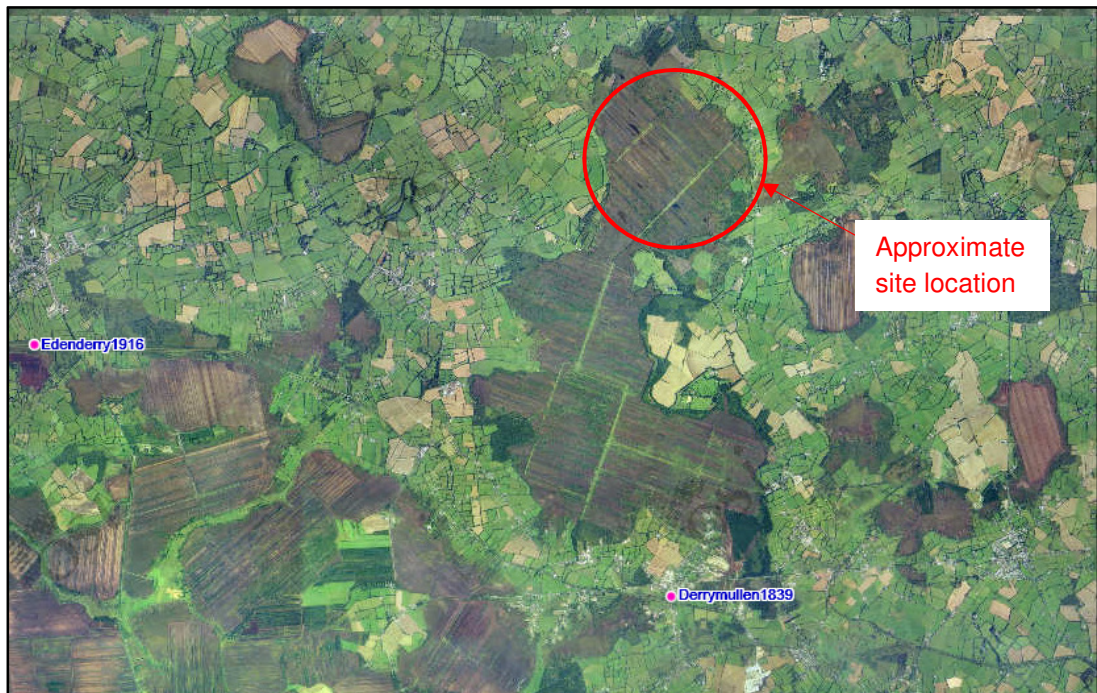
Figure 2-9 Landslide Susceptibility Map

Edenderry. Both locations are marked on the Landslide Susceptibility Map generated by GSI shown in Figure 2-9. The details provided for these landslides are:

- Derrymullen: The GSI database shows that a landslide occurred at Derrymullen, approximately 7.5 km south of the Drehid cluster boundary. This was a landslide that occurred in peat bog adjacent to the Grand Canal in 1839.
- Edenderry: The GSI database shows that a peat landslide took place approximately 13 km west of the proposed solar farm site in 1916 following a period of heavy rain and flooding. The 270 m long slide occurred on the north bank of the Grand Canal with no apparent impact. A breach occurred again in 1989.

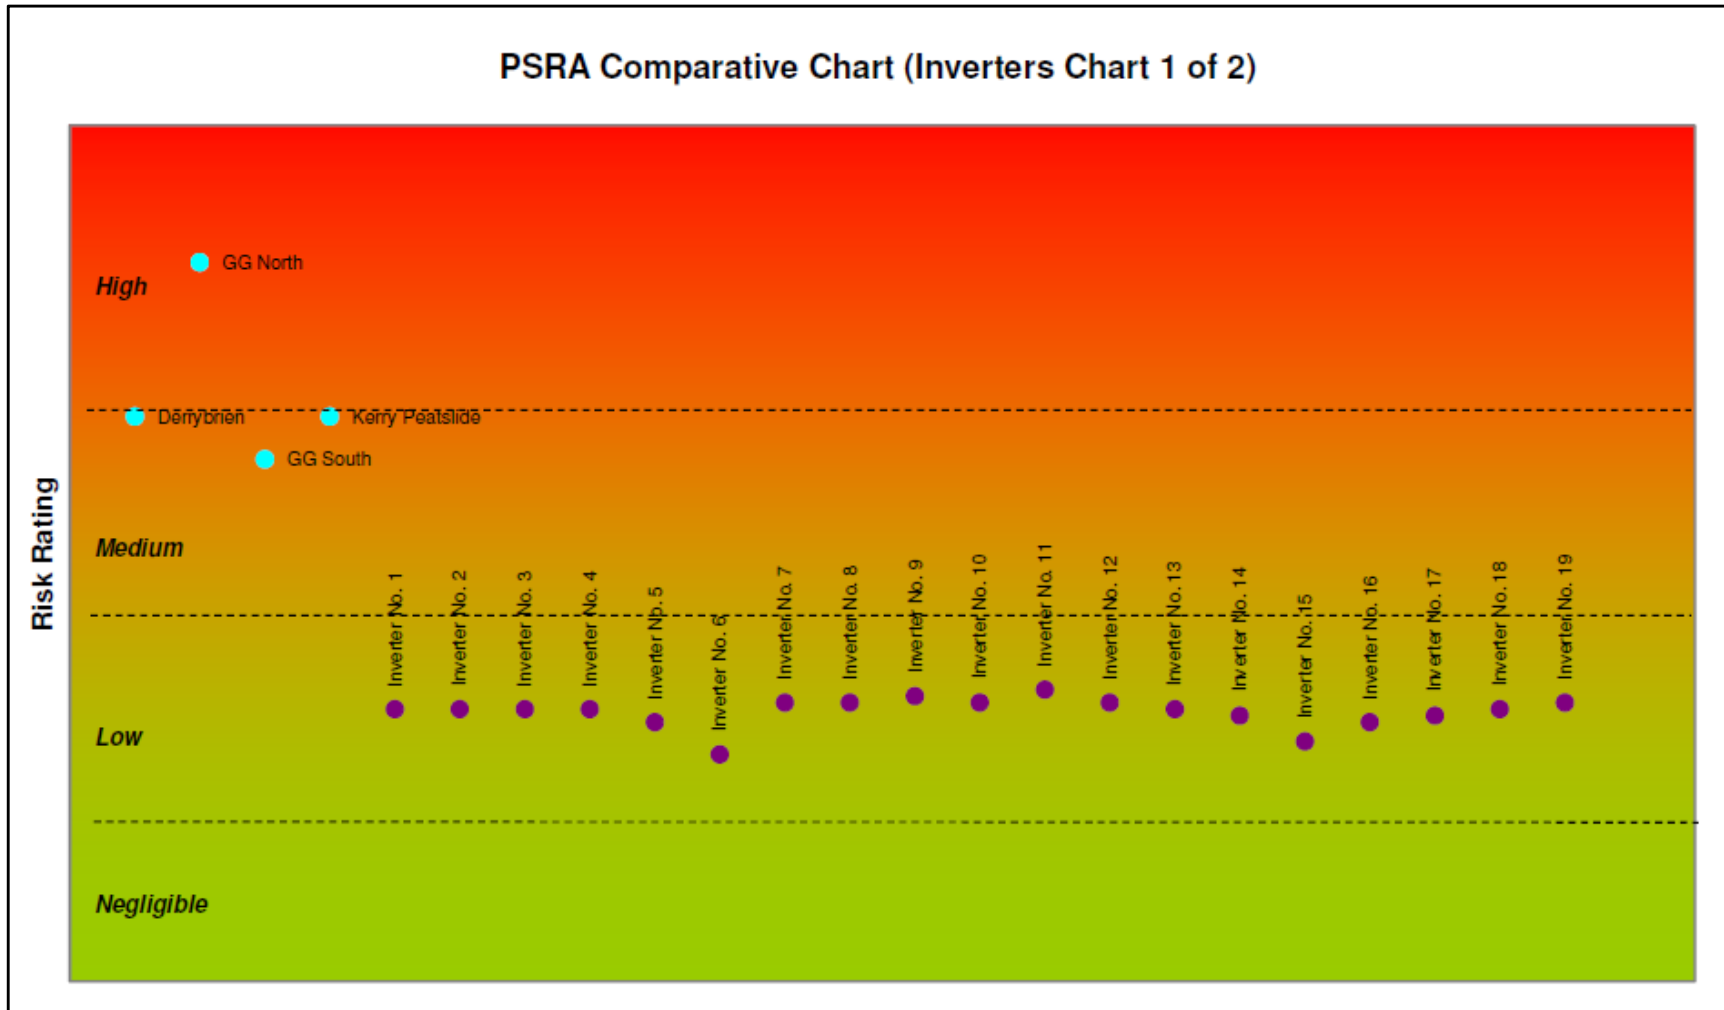
Figure 6-1 PSRA Comparative Chart – Inverters Chart 1 of 2

The PSRA results for the inverter locations are also presented graphically on Figure 6-1 and Figure 6-2. These graphs put the risk ratings for Timahoe North Solar Farm into context as the results are presented along with risk ratings for sites of known peat failures. Those sites are Derrybrien, Garvagh Glebe North, Garvagh Glebe South, which are ESB Wind Farms, and a peat slide that occurred in Kerry in 2008.

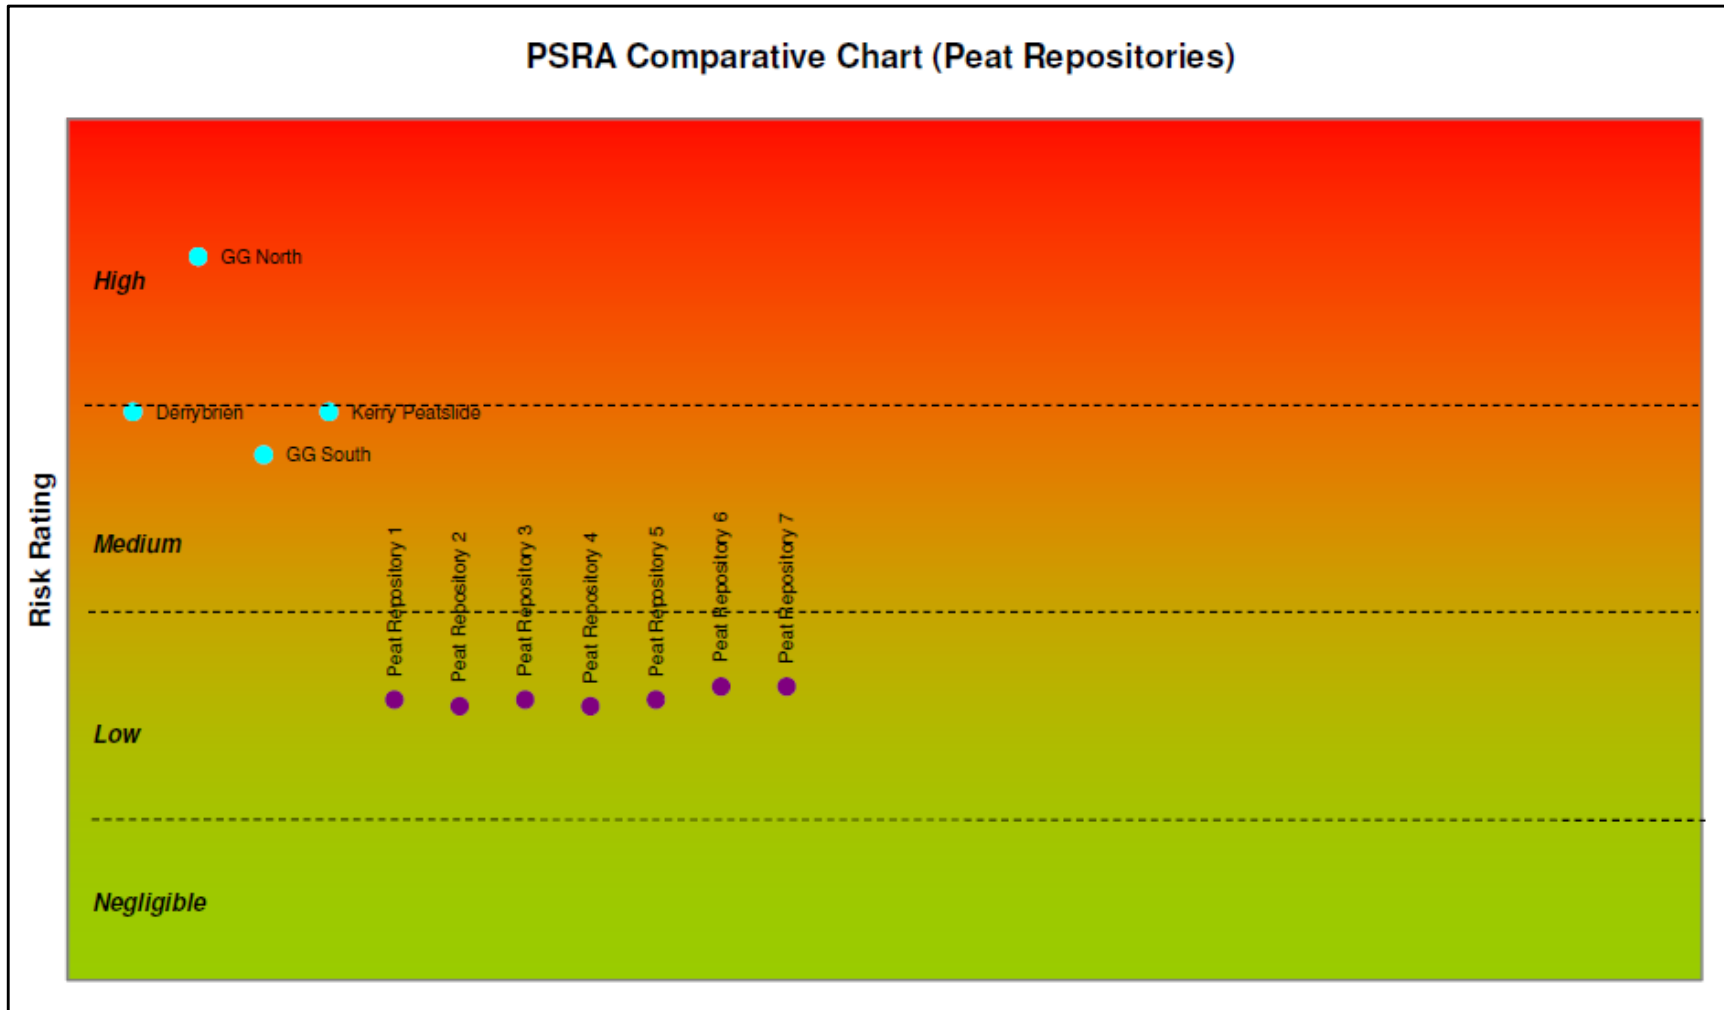
Figure 6-3 PSRA Comparative Chart – Peat Repositories

The PSRA results for the peat repository locations are also presented graphically on Figure 6-3. This graph put the risk ratings for Timahoe North Solar Farm into context as the results are presented along with risk ratings for sites of known peat failures. Those sites are Derrybrien, Garvagh Glebe North, Garvagh Glebe South, which are ESB Wind Farms, and a peat slide that occurred in Kerry in 2008.

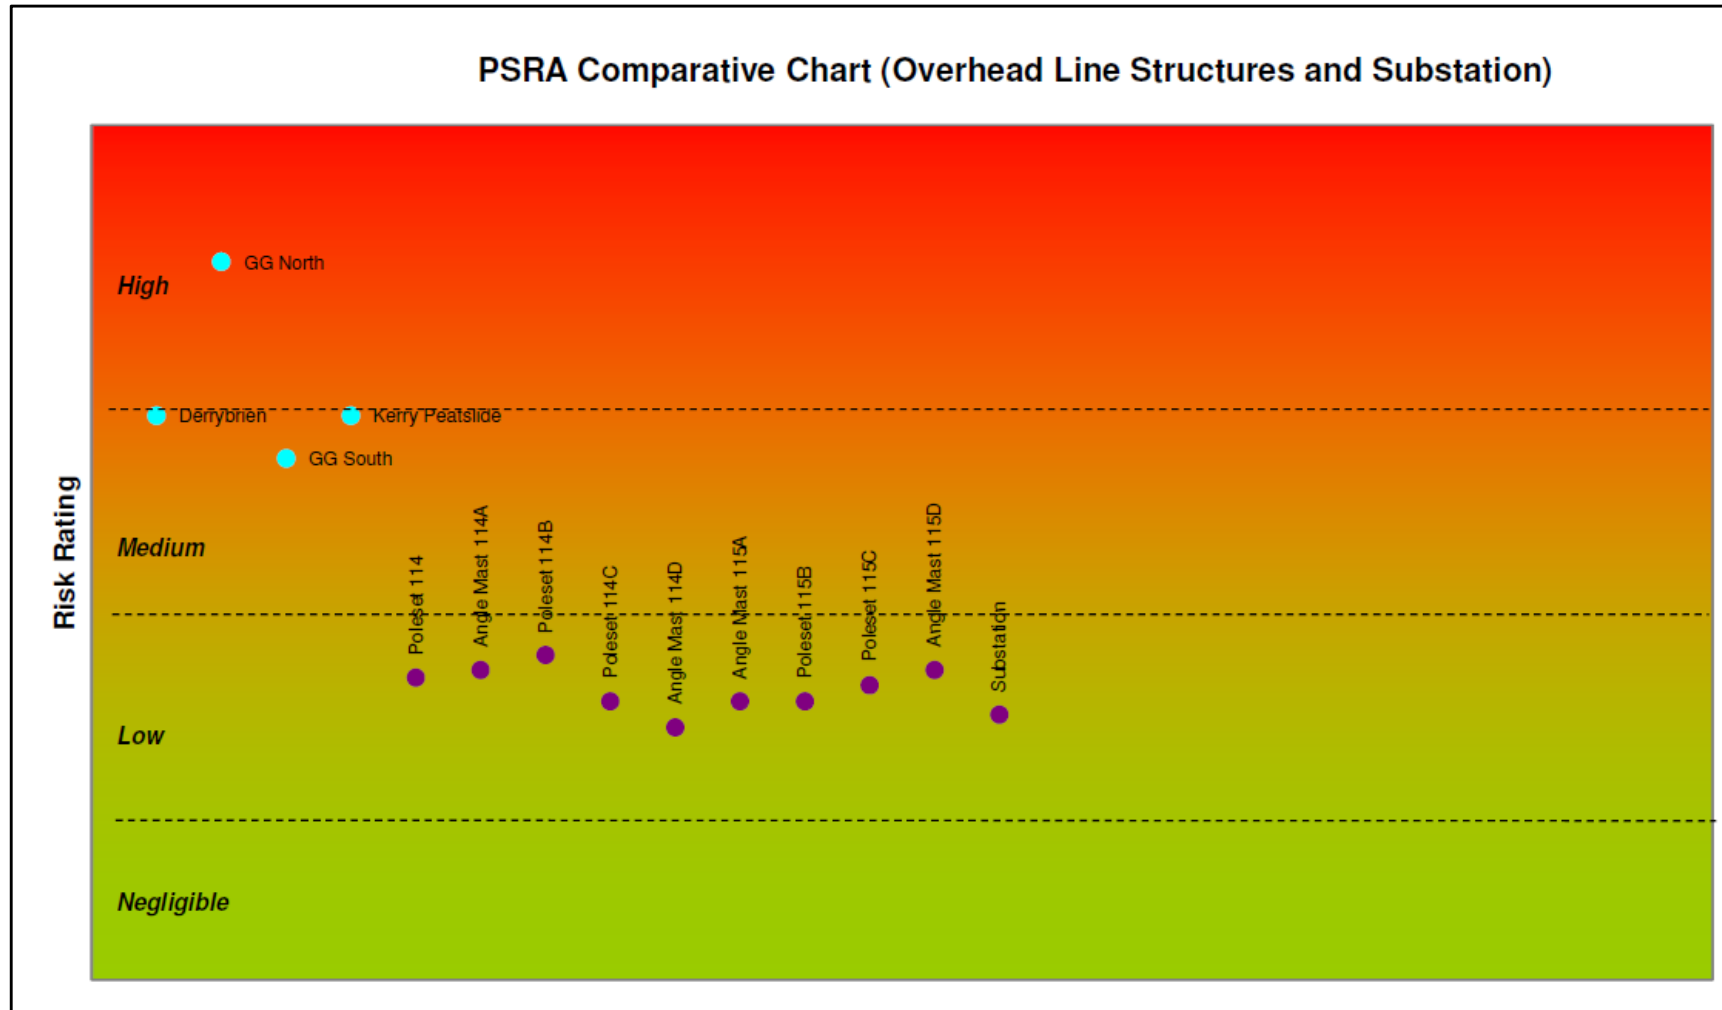
Figure 6-4 PSRA Comparative Chart – Overhead Line Structures and Substation

The PSRA results for the overhead line structure locations are also presented graphically on Figure 6-4. This graph put the risk ratings for Timahoe North Solar Farm into context as the results are presented along with risk ratings for sites of known peat failures. Those sites are Derrybrien, Garvagh Glebe North, Garvagh Glebe South, which are ESB Wind Farms, and a peat slide that occurred in Kerry in 2008.

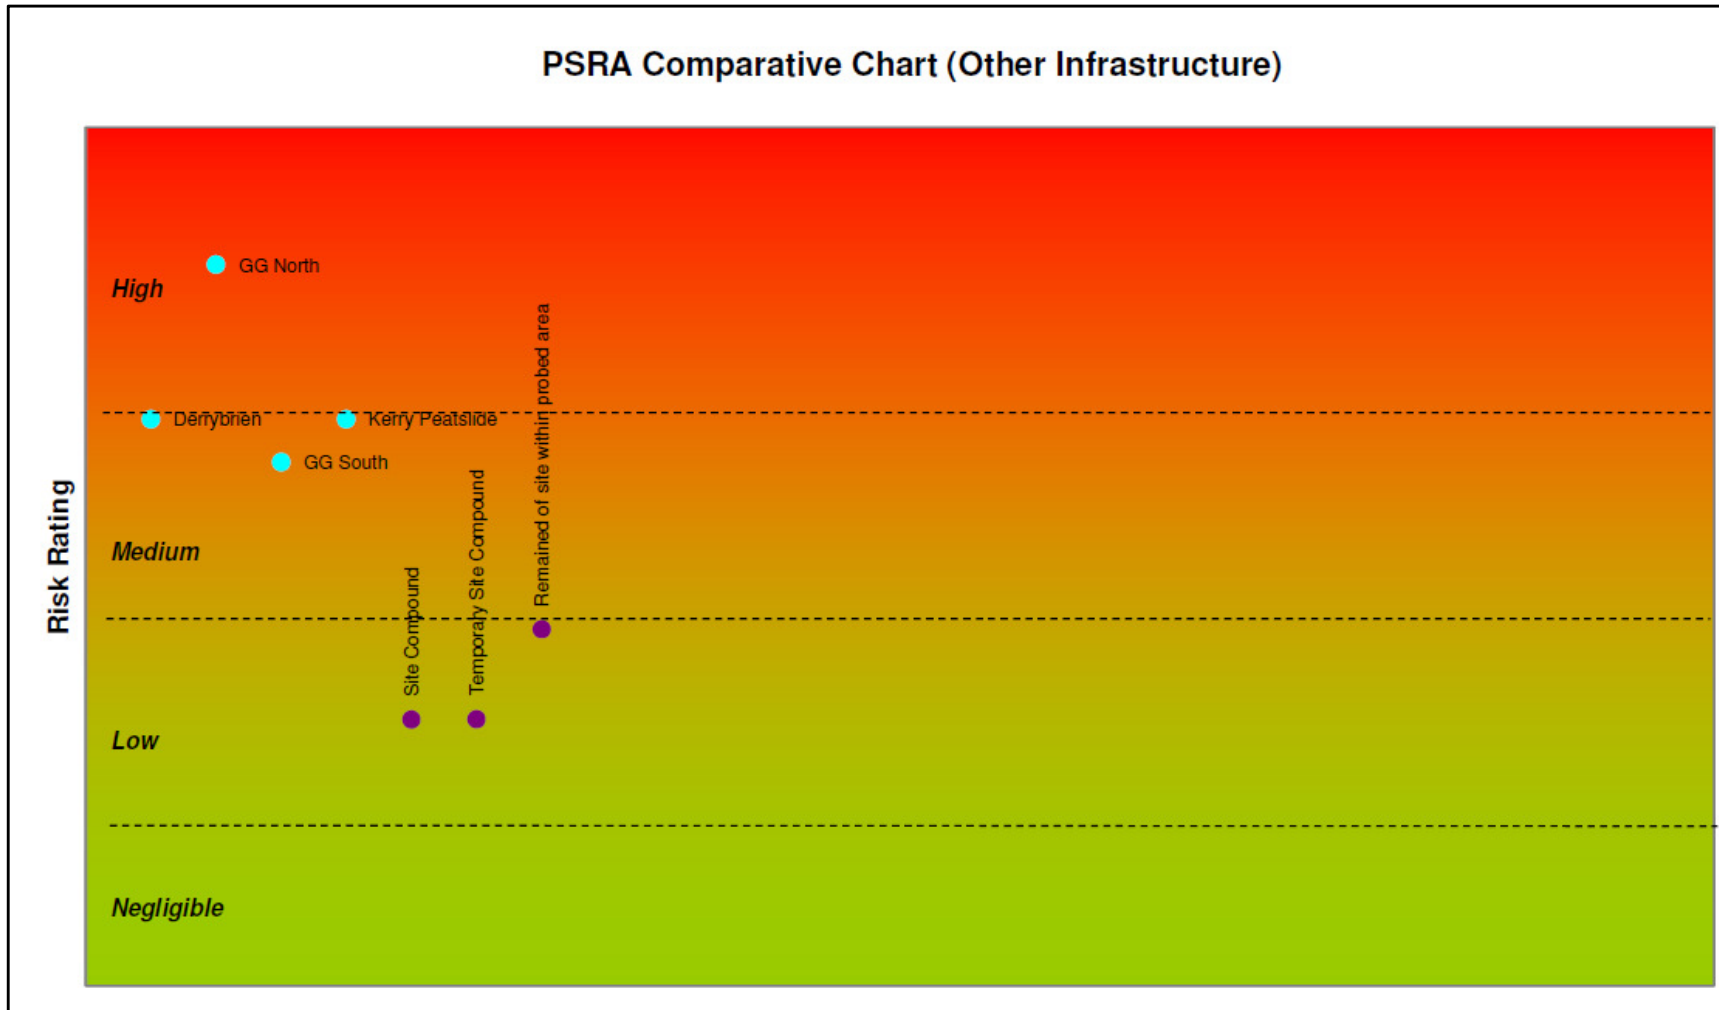
Figure 6-5 PSRA Comparative Chart – Other Infrastructure

The PSRA results for the peat repository locations are also presented graphically on Figure 6-5. This graph put the risk ratings for Timahoe North Solar Farm into context as the results are presented along with risk ratings for sites of known peat failures. Those sites are Derrybrien, Garvagh Glebe North, Garvagh Glebe South, which are ESB Wind Farms, and a peat slide that occurred in Kerry in 2008.

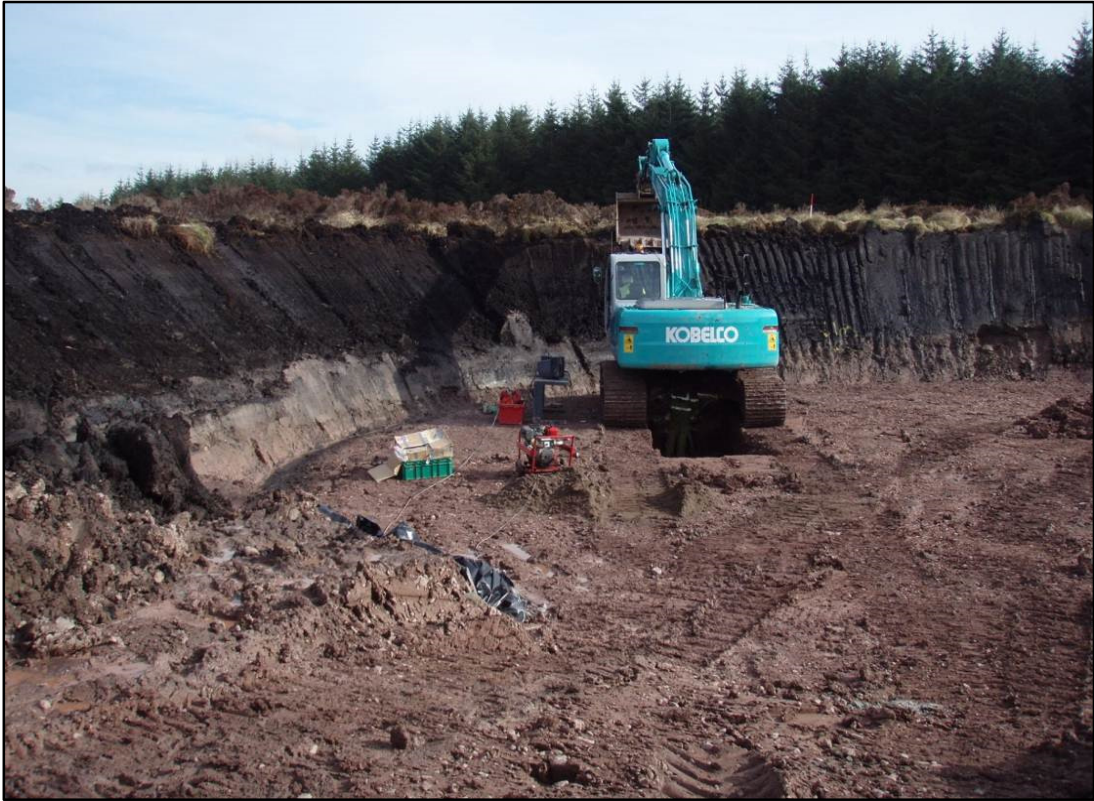
Figure 7-2 Excavation trimmed back to a stable temporary side slope

Figure 7-2 shows an excavation in peat up to about 2.5 – 3.0 m deep on a previous ESB Wind Farm site in Co. Tyrone where the peat conditions were very favourable and the sides were trimmed back to temporary slopes of about 1V:1H during construction.

Areas where it may be possible to trim back the side slopes of excavations are often indicated by stable trial pits in peat with little or no ingress of groundwater during excavation. Relatively high undrained shear strengths from a hand vane (> 10 kPa) would also indicate where the side slopes could be stable. It should be confirmed by inspection by a geotechnical engineer on site during excavation.

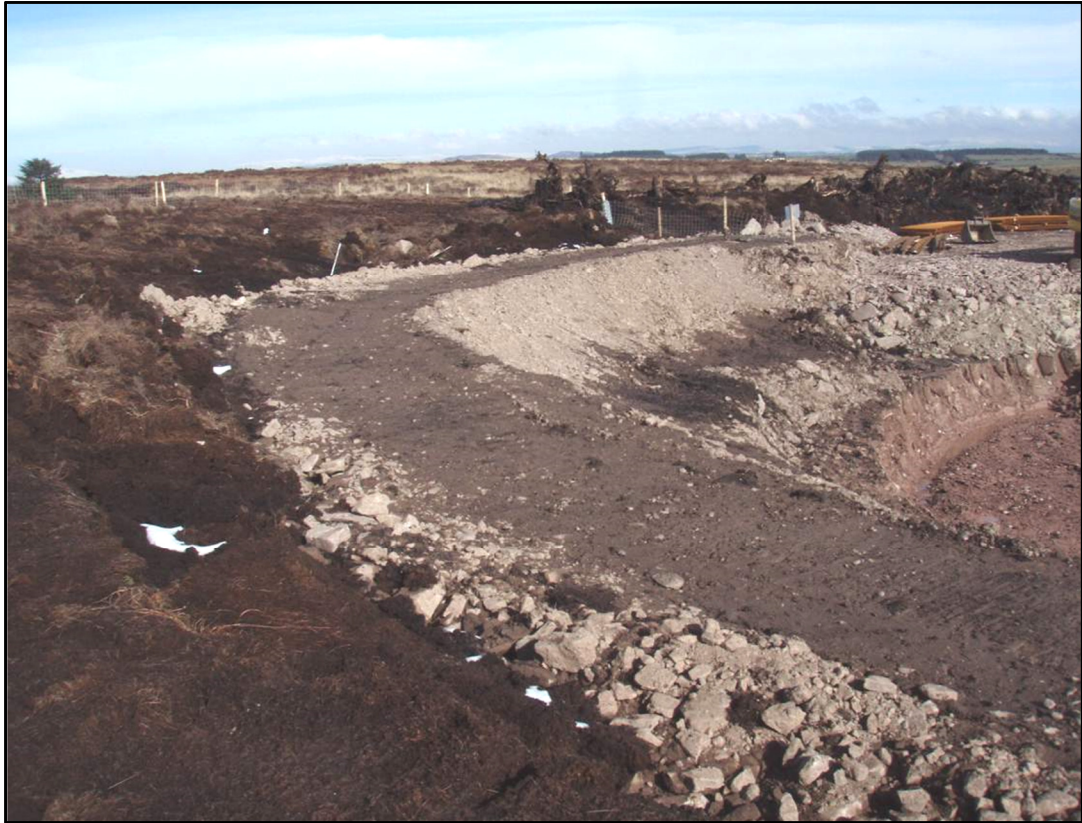
Figure 7-3 Rockfill berm around an area of deep peat on an existing ESB Wind Farm

Figure 7-3 shows an excavation in 4.5 m of very soft and weak peat where a rockfill berm was constructed around the perimeter of the excavation to support the peat.

mechanical excavator used to construct the berm. The inside face is subsequently trimmed back to a stable angle of repose at about 1V:1H.

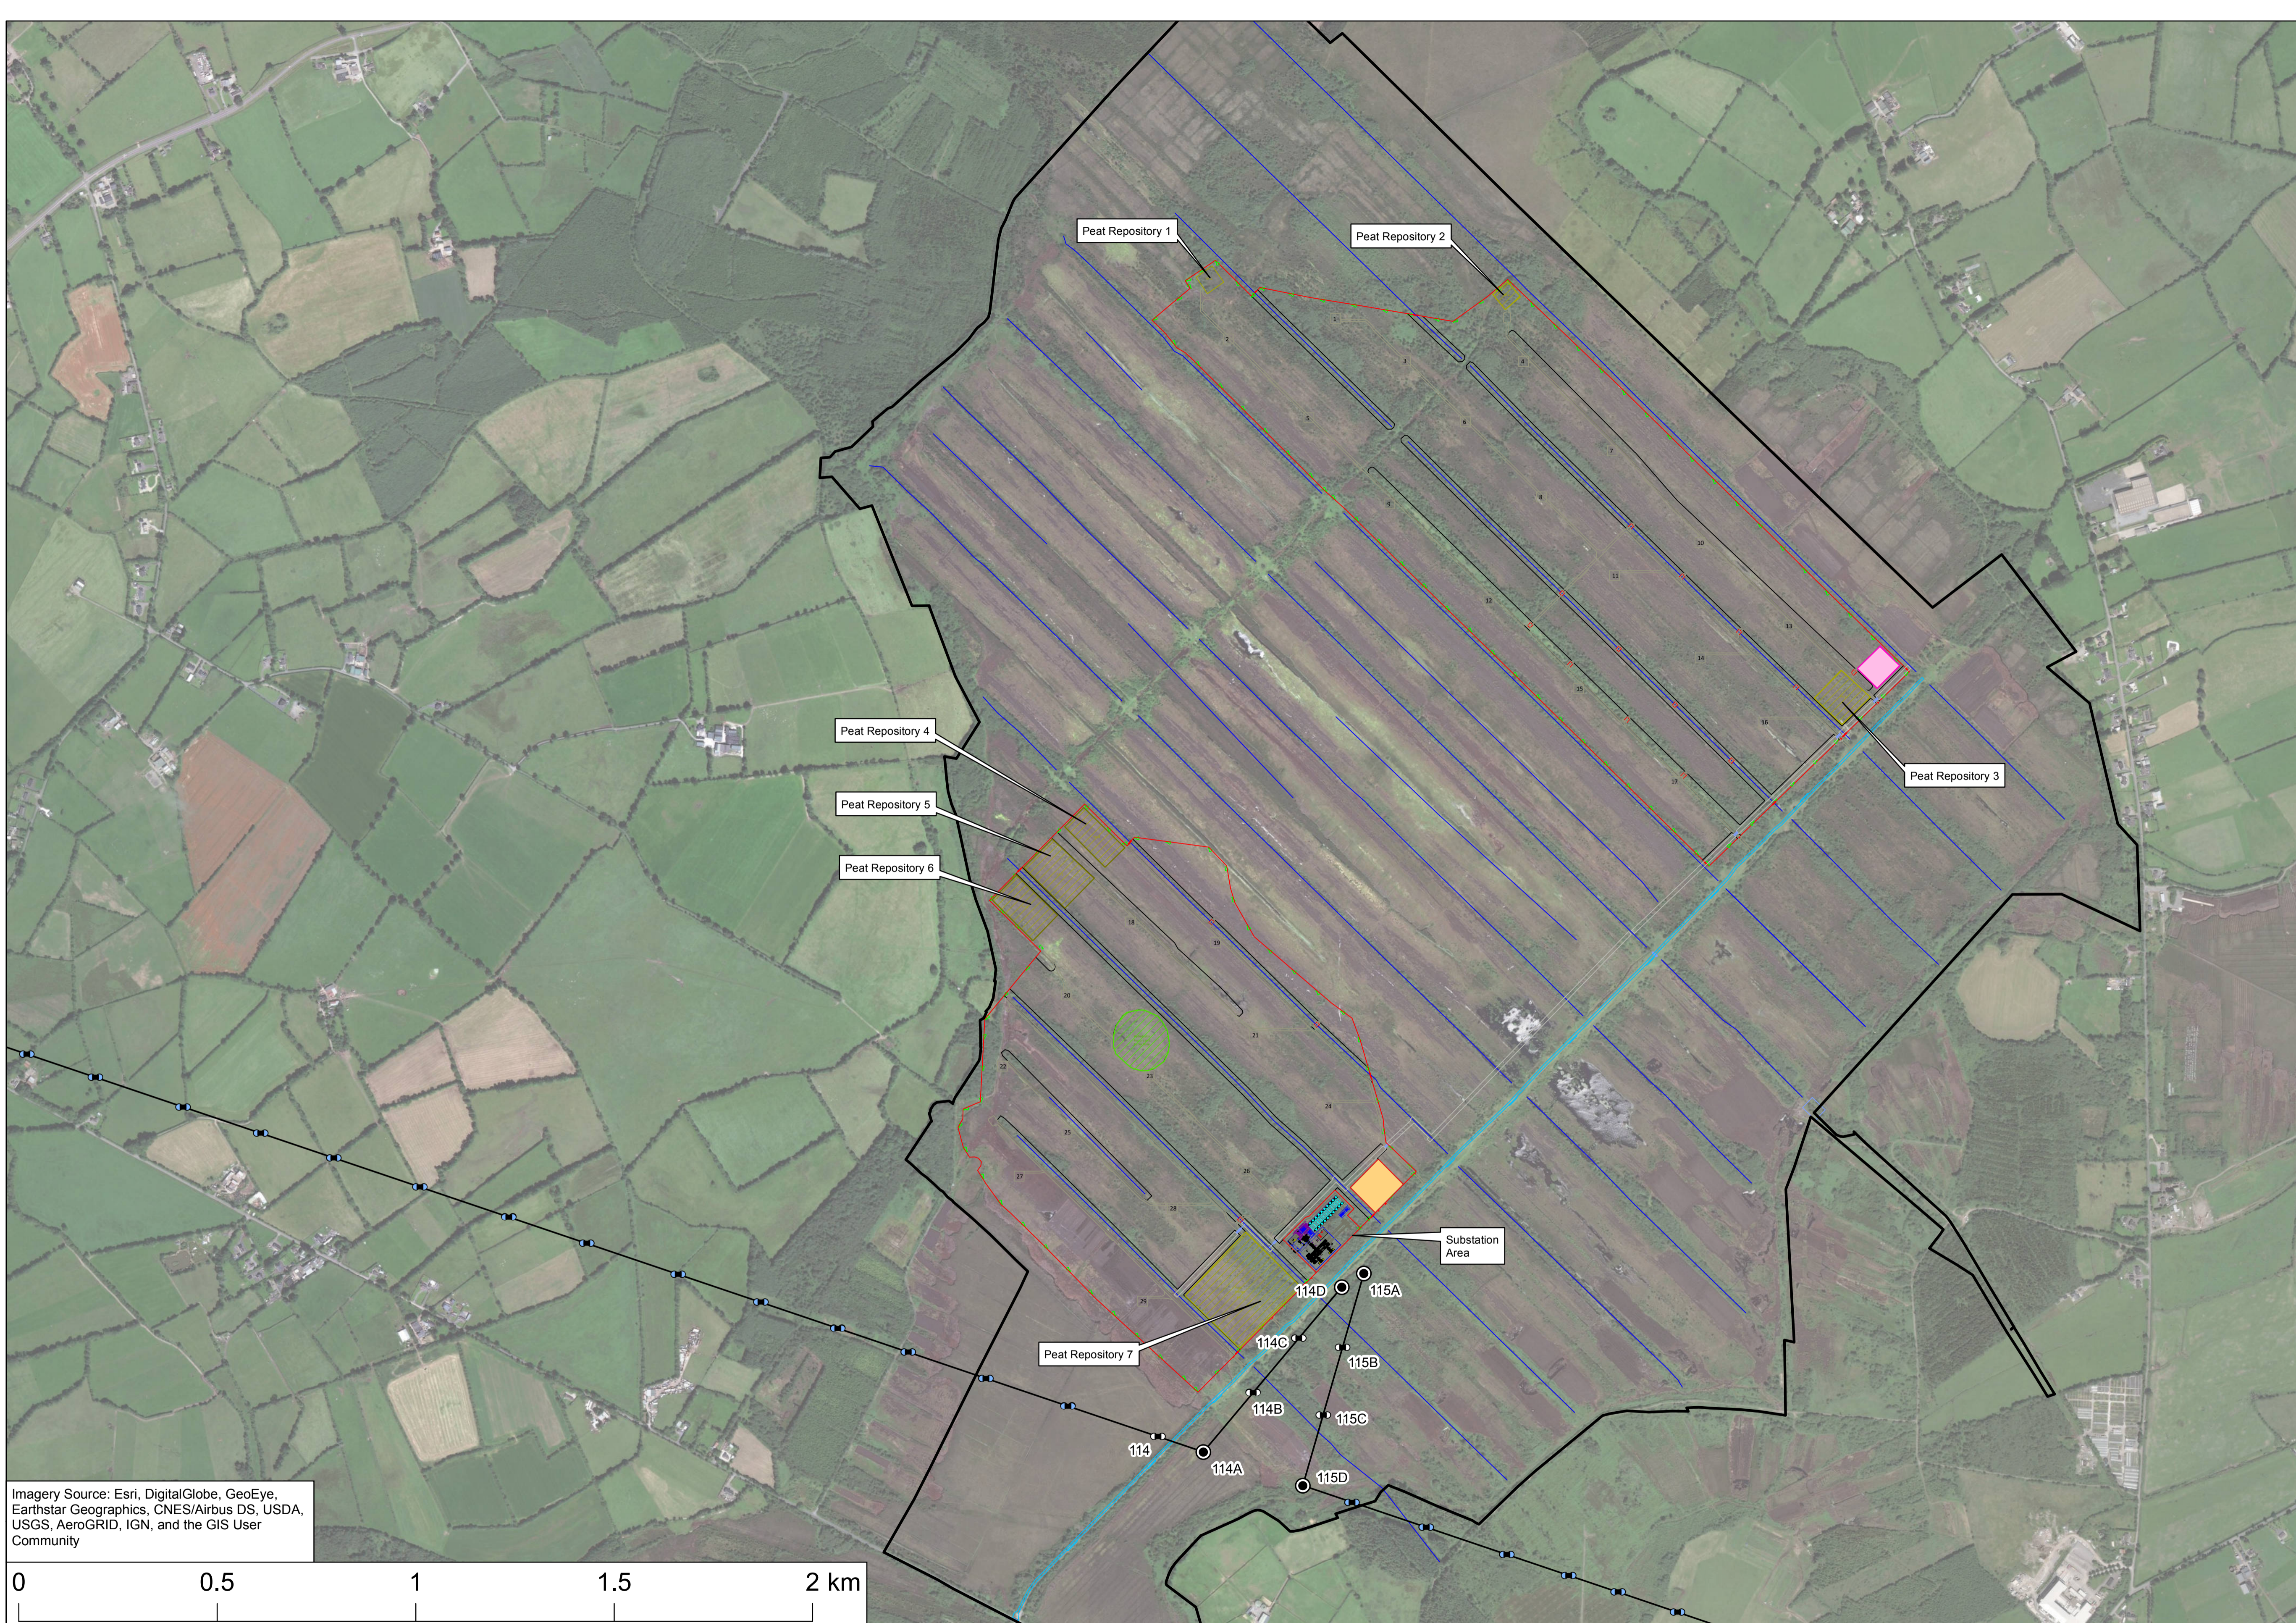
- Timahoe North Site Boundary
- Existing Structure
- New Intermediate Poleset
- New Angle Mast
- 110 kV Line
- EXISTING DRAINS
- PV TABLE
- EXISTING ACCESS ROAD TO BE UPGRADED
- NEW ACCESS ROADS
- BRIDGE OVER DRAIN WITH ACCESS ROAD
- INVERTER STATION WITH PAD AND LABELING (PAD SIZE: 25m x 25m)
- DEER FENCE (PROJECT BOUNDARIES)
- BRIDGING STRUCTURE OVER DRAIN FOR THE DEER FENCE CROSSING
- ACCESS GATES
- SHEEP FENCE (AROUND DRAINS)
- SUBSTATION FENCE
- TEMPORARY COMPOUND FENCE
- PEAT STORAGE AREA
- SUBSTATION AREA
- HYDROLOGICAL FEATURE AND BUFFER ZONE
- TEMPORARY COMPOUND AREA
- MAIN COMPOUND AREA
- CCTV CAMERA
- SWITCHBOARD (NORTH SIDE)

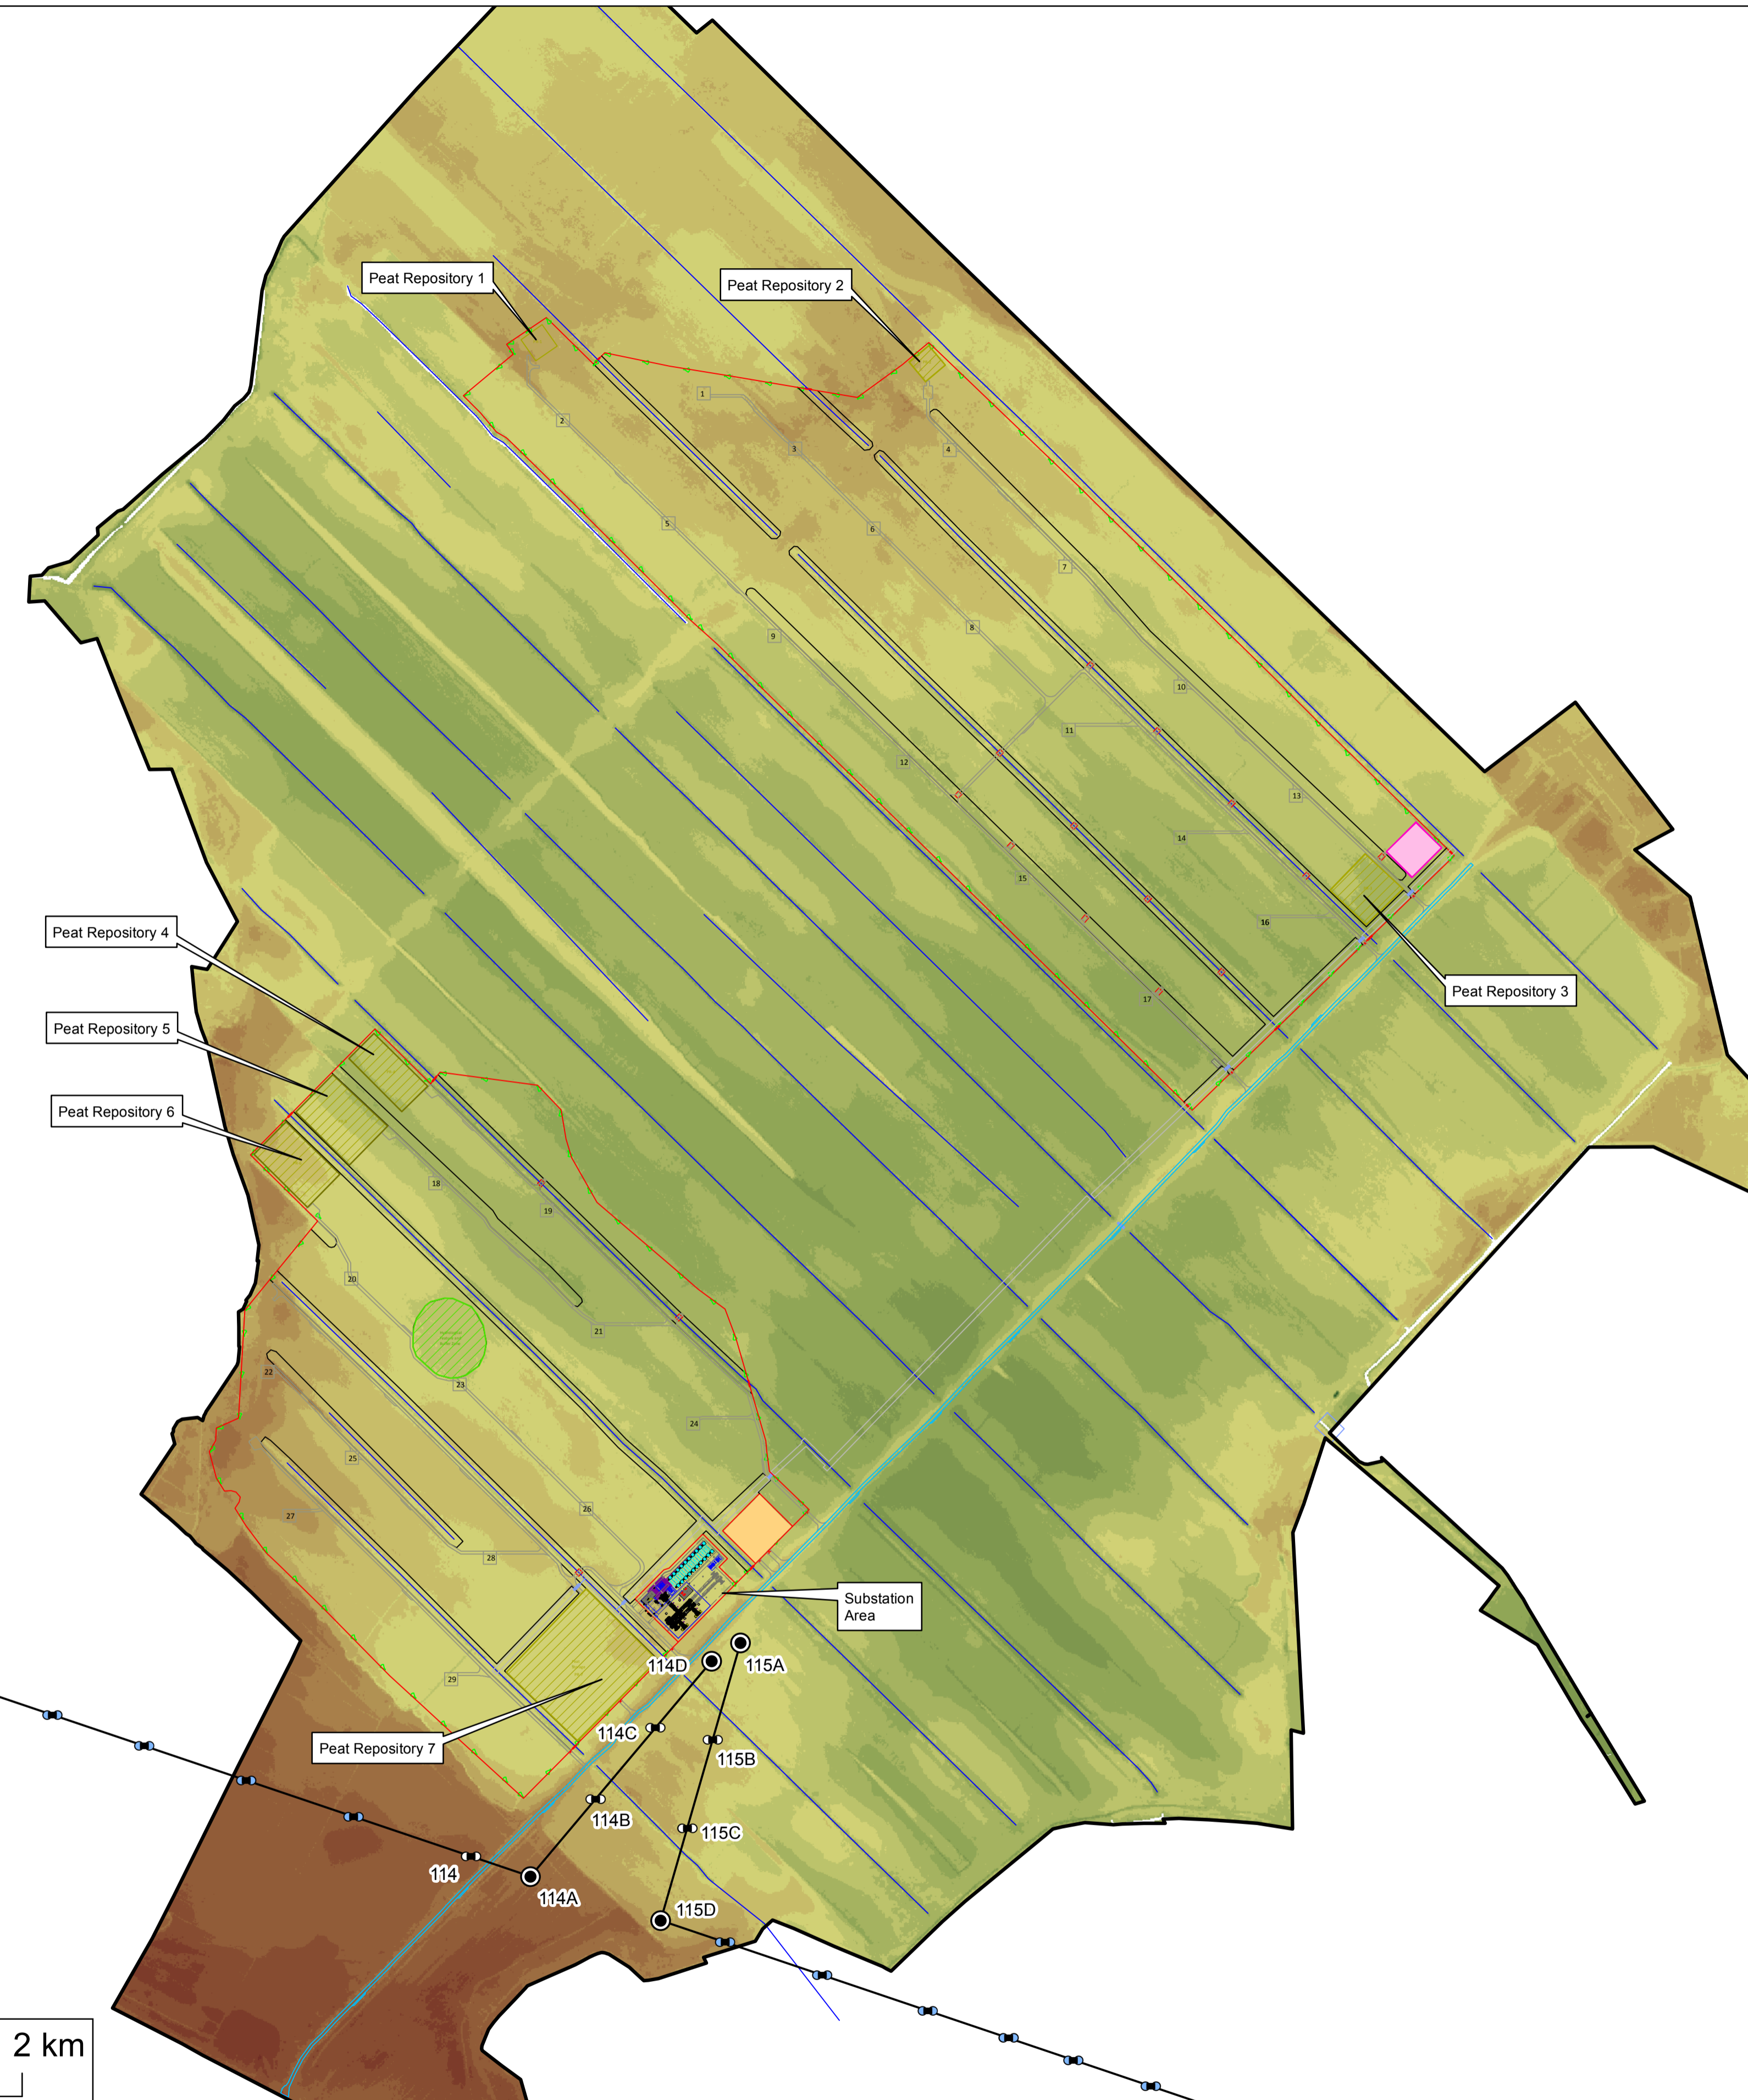
Peat Repository 1
Peat Repository 2
Peat Repository 3
Peat Repository 4
Peat Repository 5
Peat Repository 6
Peat Repository 7

Substation Area
114D 115A
114C 115B
114B 115C
114 114A 115D
