Title: **STAGE 1&2 ROAD SAFETY AUDIT**

Belgard Gardens, Residential Development, Tallaght.

Report reference: **0488R01**

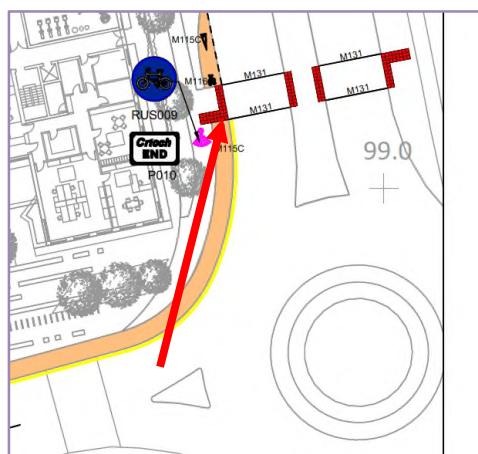
Drawing A557-OCSC-XX-XX-DR-C-1200 S3 rev P05

Proposed Toucan crossing on Belgard Road, North of the roundabout.

There is a risk that drivers of vehicular traffic turning left out of Belgard Square North at the roundabout on Belgard Road may not have adequate visibility to the proposed toucan crossing to the north of the roundabout and may have insufficient time to stop if a pedestrian or cyclist is crossing. This could lead to conflicts between vehicular traffic and vulnerable road users. In addition, vehicle speeds may be high on approach to the toucan crossing due to the straight and wide alignment of Belgard road and the geometry of the roundabout. Higher vehicle speeds lead to greater injury severity should collisions occur.

It is recommended that adequate visibility is provided to the crossing for left turning drivers from Belgard Square North. This includes the removal of any vegetation that could grow during summer months or due to lack of maintenance.

The signal heads for both the nearside and offside signals for northbound traffic should be easily seen by left turning traffic. (Note the position of signal heads have not been shown on the drawings provided)

It is recommended that the toucan crossing be raised similar to the uncontrolled crossing to the south of the roundabout to highlight its presence and provide traffic calming.

It is also recommended that a raised table is provided on Belgard Road North in advance of the roundabout to ensure slow entry and hence exit speeds from the roundabout.

3.1	Yes	No	<p>Measures 1, 2 and 3 are accepted. The raised crossing will be provided on the Belgard Road subject to detailed agreement with SDCC Roads Department.</p> <p>Measure 4 is not accepted. The scheme provides for very high quality landscaping along the northern side of Belgard Square North. It is the opinion of the Designer that this coupled with the active frontage of the Student Accommodation Entrance will sufficiently reduce speeds</p>	Yes

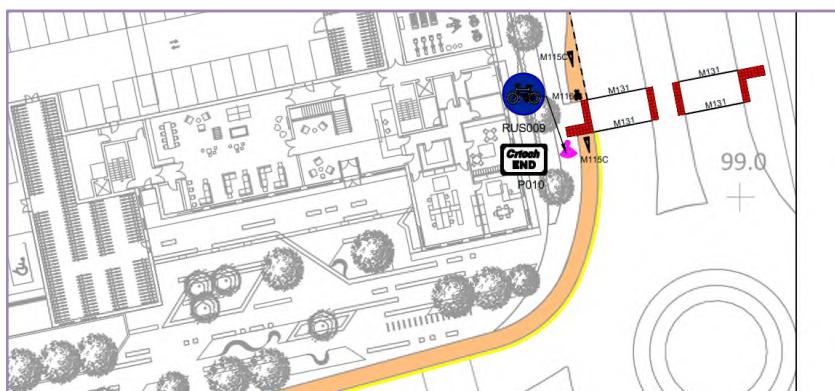
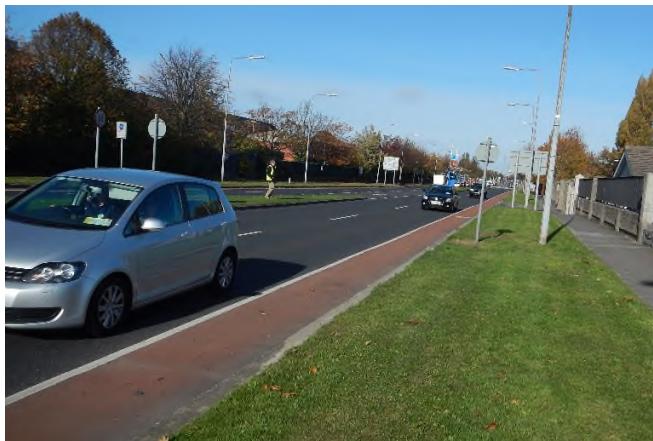
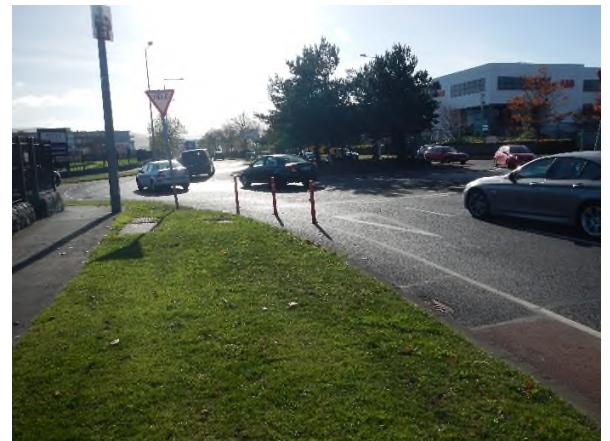
Drawing A557-OCSC-XX-XX-DR-C-1200 S3 rev P05

Proposed Toucan crossing on Belgard Road, North of the roundabout.

It is anticipated that there will be a high demand for cyclists using the proposed toucan crossing who will wish to travel from the new student accommodation to the ITT. There is a risk that the lack of connectivity with cycle facilities on either side of the toucan crossing will lead to collisions between cyclists and pedestrians. Cyclists will travel in both directions to take the shortest journey between the residential accommodation and the college.

It is recommended that two-way cycle facilities be provided from the ITT gates to the proposed crossing and that two-way facilities be provided from the crossing to the proposed development.

The Audit Team acknowledge that the land to the East of Belgard Road is not within the applicant's ownership.

3.2	Yes	Yes	The crossing will be connected to the existing cycle facilities on Belgard Road.	Yes
3.3	Yes	Yes		
3.4	No	No	Moving the landscape and bio-retention zone further away from the road could make the road feel wider. This could result in higher speeds within the development and lead to more serious collisions occurring. On this basis the designer would prefer to maintain the current landscaping zone in the cross-section.	Yes

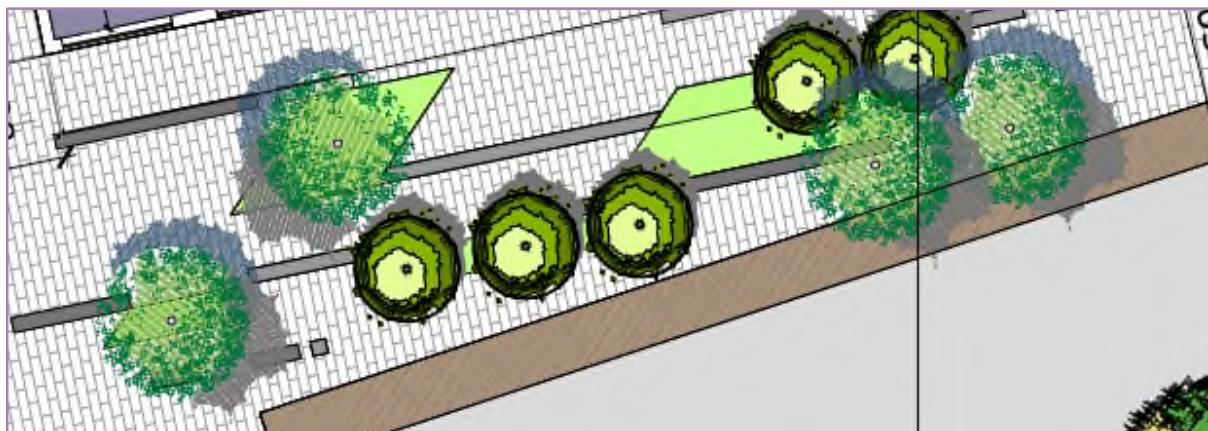
Drawing, Proposed Site Plan (O'Mahony Pike)

It is unclear if there is a clear route for blind or partially sighted pedestrians to navigate along the paved pedestrian space along Belgard Road North. A lack of space could lead to injury for such vulnerable road users if they collide with roadside furniture.

It is recommended that the paths for pedestrians along the northern side of Belgard North is easily navigated without obstruction and that it is of sufficient width.

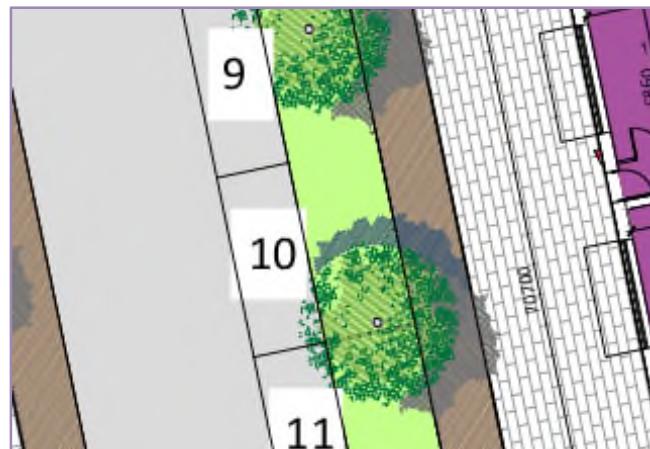
Drawing, Proposed Site Plan (O'Mahony Pike)

Internal Road, BL01, car parking.

It is proposed to have some parallel parking along the eastern side of internal road BL01. There is a grassed verge adjacent to the car parking spaces which could lead to slips and falls for pedestrians getting to/from their vehicles, especially in wet or icy conditions.

Provide a footpath to the rear of the parking spaces.

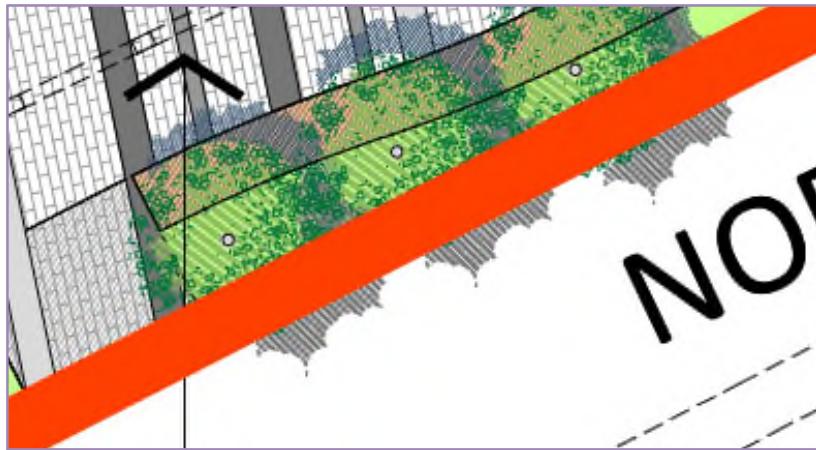
Drawing, Proposed Site Plan (O'Mahony Pike)

Trees along Belgard Square North.

It is proposed to have trees in the grass verge between the carriageway of Belgard Square North and the Cycle track. There is a risk that the canopy of the trees may overhang the cycle track and lead to potential injury for cyclists or may overhang the carriageway and be struck by passing vehicles including high sided vehicles (including buses)

It is recommended the trees of suitable girth and canopy are chose at these locations and if they cannot be accommodated that more suitable planting be provided.

3.5	Yes	Yes

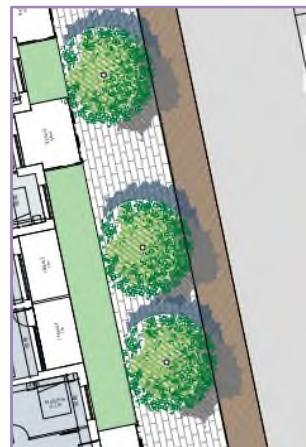
Drawing, Proposed Site Plan (O'Mahony Pike)

Internal Road, BL01, trees.

It is unclear if there will be sufficient width of footpath either side of the proposed trees to the West of internal road BL01 to allow mobility impaired pedestrians to pass (particularly wheelchair users and users with two walking sticks) Insufficient space could lead to pedestrians using the carriageway where they would be at greater risk of being struck by a passing vehicle.

It is recommended that appropriate width be provided for the mobility impaired, taking into consideration the tree pit dimensions and the mature girth of the trees.

Paragraph No. in Safety Audit Report	Problem accepted (yes/no)	Recommended measure accepted (yes/no)	Alternative measures (describe)	Alternative measures accepted by Auditors (Yes/No)
3.6	No	No	As a clarification, the footpath width in this location is 4.5m wide. Given a mature tree width of 0.3m-0.5m, this leaves 1.75m-2.1m either side of the trees.	Yes
3.7	Yes	Yes	The internal area of the development, after the dedicated cycle facilities becomes a "Home Zone" type area, this is denoted by the raised area and the use of the large cycle symbol M116 on the carriageway. This will result in lower speed for vehicles as they enter this shared surface and will result in increased safety for cyclists.	Yes

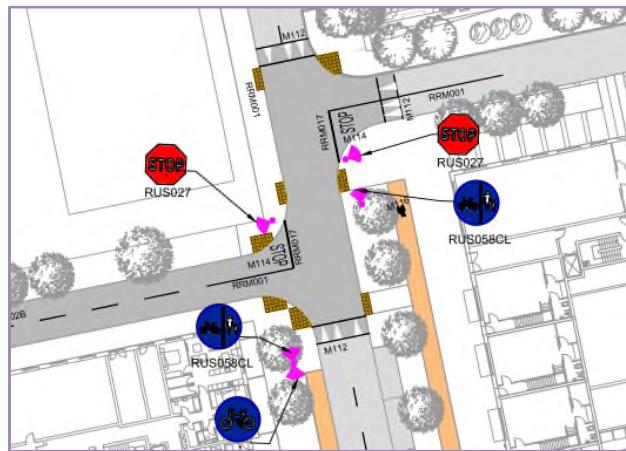
Drawing, Proposed Site Plan (O'Mahony Pike)

Internal Junction, BL01, BL02 & BL03

It is unclear how on-road cyclists on BL03 can access the cycle track along BL01 or how cyclists travelling along BL02 can access the cycle track along BL01 without conflicts with vehicles or pedestrians.

It is recommended that cyclists making manoeuvres in all directions have adequately wide cycle or shared facilities to avoid conflicts with other road users.
