Chapter 7:

Land and Soils

7.1 INTRODUCTION

The proposed development consists of a residential development comprising of 913 no. residential units, a neighbourhood centre, including 2 no. retail units, a café / restaurant unit, a primary healthcare / gym, a community facility and a childcare facility, all associated open space, a section of the Dunshaughlin Outer Relief Road, internal roads, cycle and pedestrian infrastructure, services and all other associated development on a site of c. 28.3 hectares.

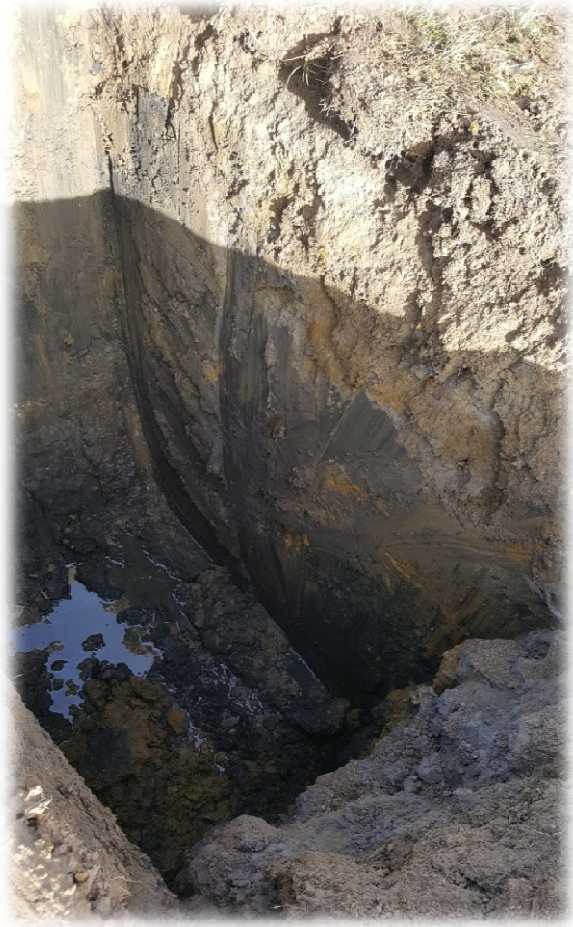
TRIAL PIT 1

Width: 1.7m		Length: 3.3m			1.2m (mottled to 0.35m BGL)
		Groundwater Depth:

Dims: 3.3m L x 1.7m W x 3.1m D
Date: 01/02/2018
Client: Rockture One Limited
Location: The Willows', Dunshaughlin, Co. Meath

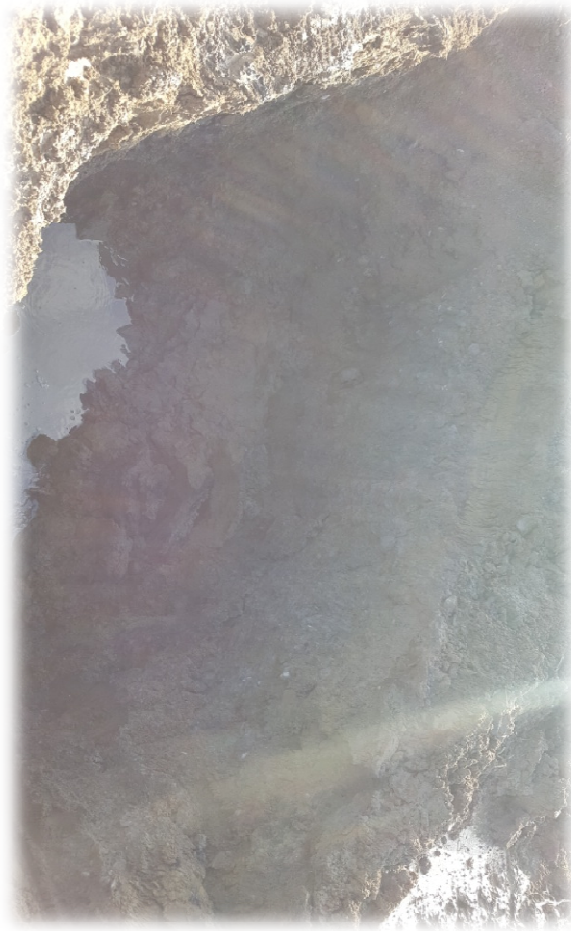
TRIAL PIT 2

2.6								
2.7								
2.8								
2.9								
3.0								
3.1								
3.2								
3.3								
Plan View (TP)		Remarks: Very wet side walls collapsing immediately following dig						
		Width: 2.1m				1.6m (mottled to 0.5m BGL)		
		Length: 4.2m				Groundwater Depth:

Dims: 4.2m L x 2.1m W x 2.8m D
Date: 01/02/2018
Client: Rockture One Limited
Location: The Willows', Dunshaughlin, Co. Meath

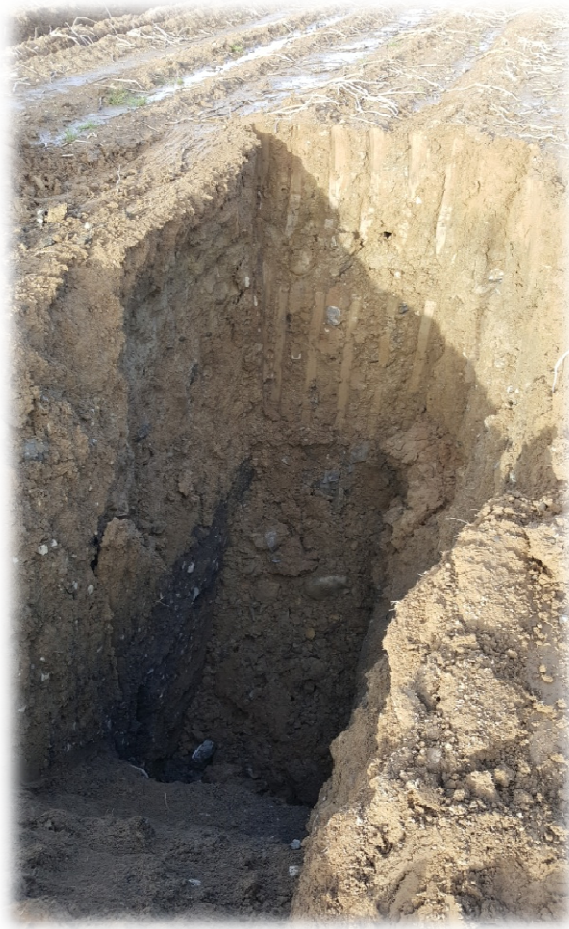
TRIAL PIT 3

3.5						
Plan View (TP)		Remarks: On the Northern slope away from sight. Higher ground content than TP 1, 2, 4, 5, 6					
		Width: 1.6m Length: 3.7m Groundwater Depth: 2.3m

Dims: 3.7m L x 1.6m W x 3.0m D
Date: 01/02/2018
Client: Rockture One Limited
Location: The Willows', Dunshaughlin, Co. Meath

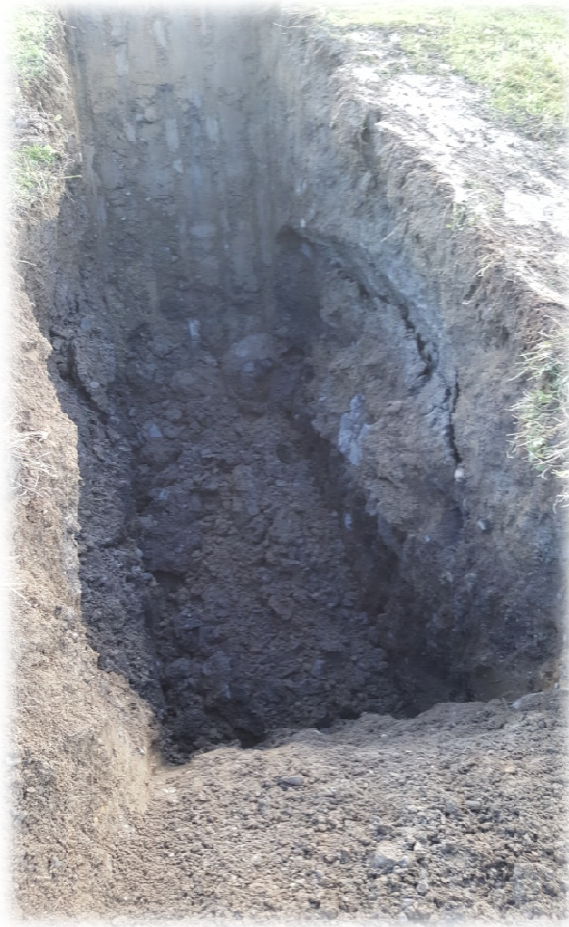
TRIAL PIT 4

Width: 2.0m		Length: 3.5m		Groundwater Depth: 1.5m (mottled to 0.7m BGL)	
		Groundwater Depth:

Dims: 3.5m L x 2.0m W x 2.8m D
Date: 01/02/2018
Client: Rockture One Limited
Location: The Willows', Dunshaughlin, Co. Meath

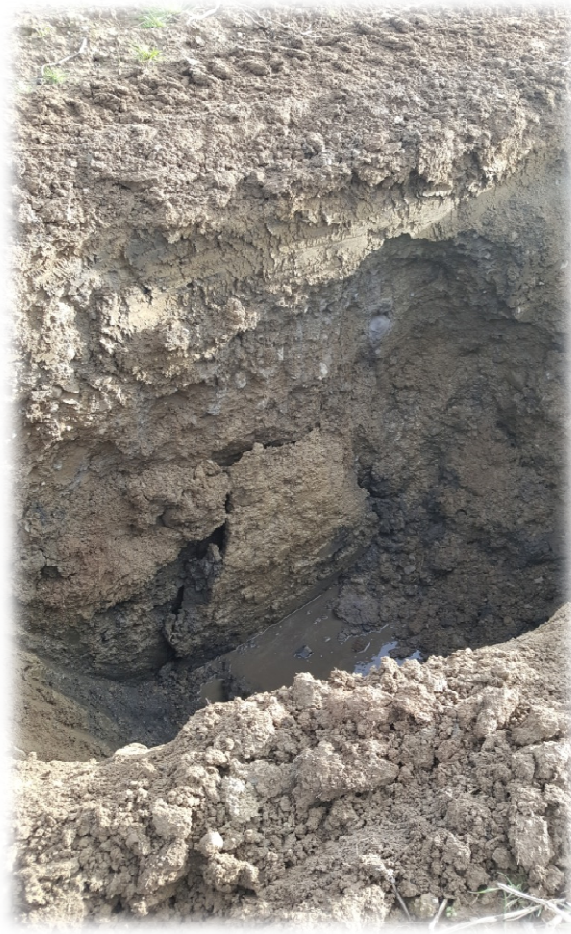
TRIAL PIT 5

Width: 1.4m		Length: 3.7m		1.7m (mottled to 0.6m BGL)	
		Groundwater Depth:

Dims: 3.7m L x 1.4m W x 2.8m D
Date: 01/02/2018
Client: Rockture One Limited
Location: The Willows', Dunshaughlin, Co. Meath

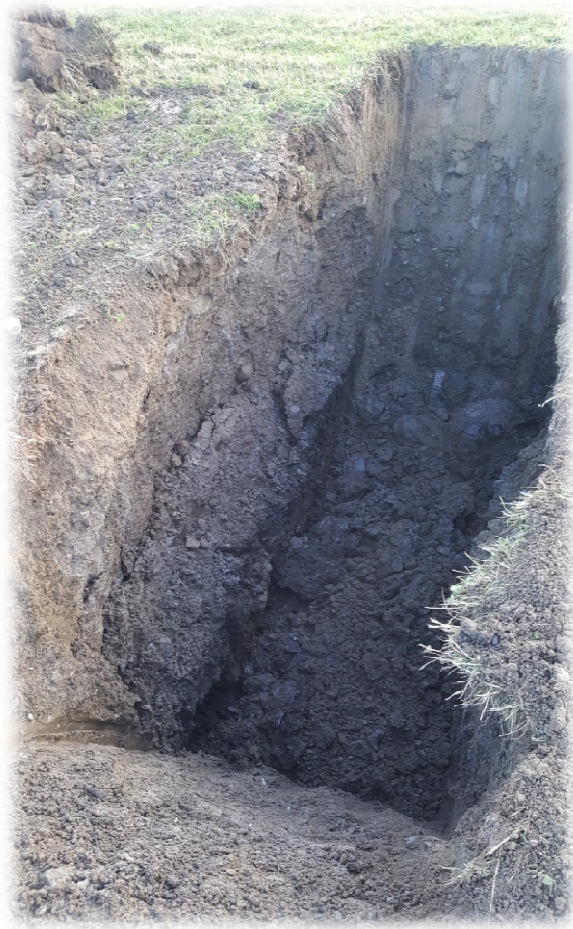
TRIAL PIT 6

Width: 1.5m		1.8m (mottled to 0.7m BGL)		
Length: 3.1m			Groundwater Depth:

Dims: 3.1m L x 1.5m W x 2.8m D
Date: 01/02/2018
Client: Rockture One Limited
Location: The Willows', Dunshaughlin, Co. Meath

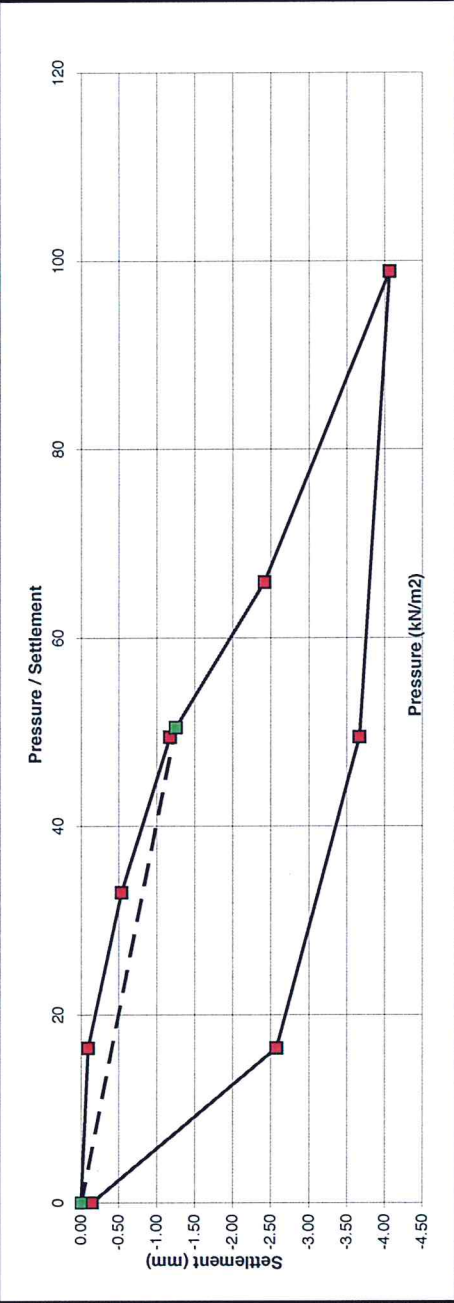
Contract The Willows Dunshaughlin	(natural soil, placed fill, sub-base)	
Test No. PB12 RELOAD	Loose brown gravelly sand	
Location Dunshaughlin		
Depth 0.50m		
Client Gem Construction	Sample Ref No. m bgl	
Plate Diameter: 450 mm	Depth	
Test Method BS 1377: Part 9: 1990 Test 4 - Incremental Loading Test		
Technician LD		
Authorised by A.S.		
Date 10-02-17

Gradient at 1,25 mm settlement intersection = 40
 Modulus of subgrade reaction = 26 MPa/m
 Correction factor applied = 0.64 as per HD 25-26/10

Equivalent CBR value in accordance with NRA HD25-26/10 2.7 %

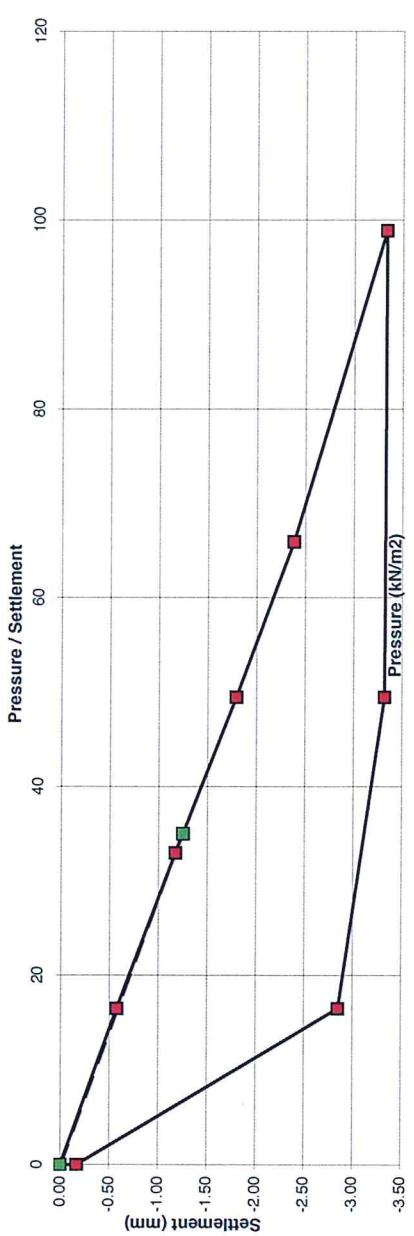
Test No. PBT3 reload	Location Dunshaughlin	Sample Ref No.	Depth m bgl
Depth 0.50m	Client Gorm Construction		
Plate Diameter: 450 mm	Test Method BS 1377: Part 9: 1990 Test4 - Incremental Loading Test		
Technician D	Authorised by D		
Date 10-02-17

Pressure (kN/m ²)	Settlement (mm)
0.00	0.00
0.50	-0.20
1.00	-0.50
1.50	-0.80
2.00	-1.20
2.50	-1.80
3.00	-2.50
3.50	-3.50

Gradient at 1.25 mm settlement intersection = 28

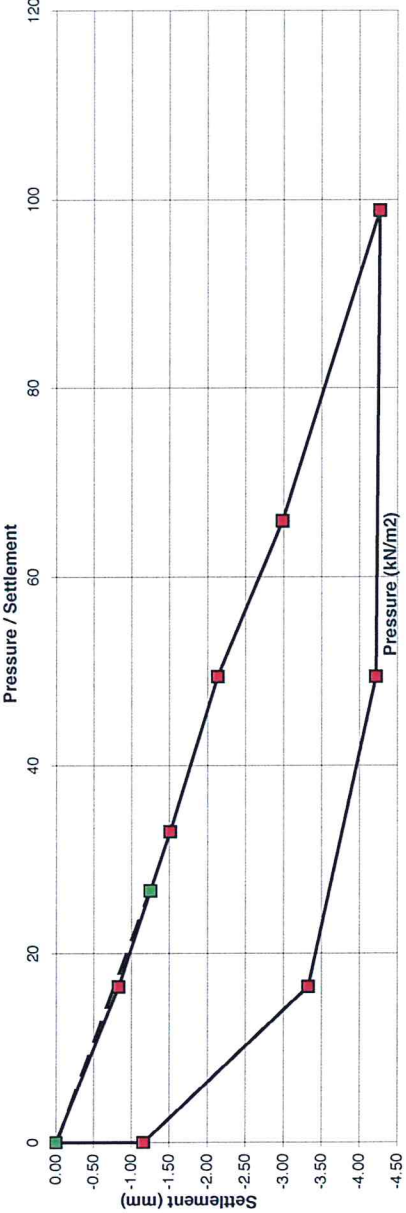
The graph plots Pressure / Settlement (kN/m²) on the x-axis (0 to 120) against Settlement (mm) on the y-axis (0 to -4.50). The curve shows a non-linear relationship, starting at (0,0) and reaching approximately (100, -4.50). A tangent line is drawn at 1.25 mm settlement, intersecting the x-axis at approximately 14 kN/m².

Settlement (mm)	Pressure (kN/m ²)
0.00	0.00
-0.50	1.00
-1.00	1.50
-1.50	2.50
-2.00	4.00
-3.00	8.00
-3.50	15.00
-4.00	30.00
-4.50	100.00

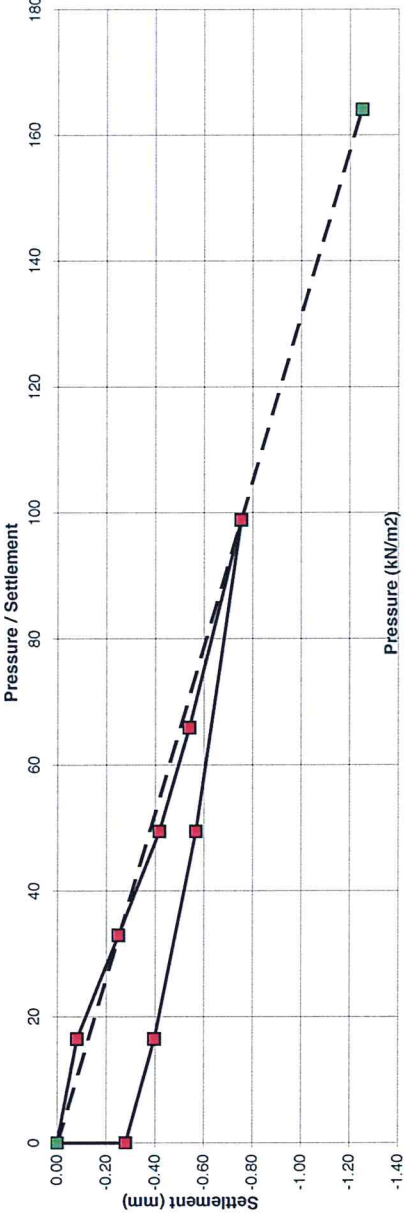
Test No. PBI's reload	Location Dunshaughlin	Description of soil under test (natural soil, placed fill, sub-base) Loose brown gravelly sand	
Depth 0.50m	Client Gem Construction	Sample Ref No. m bgl	
Plate Diameter: 450 mm	Test Method BS 1377: Part 9: 1990 Test 4 - Incremental Loading Test	Depth	
Technician LD	Authorised by AAS		
Date 10-02-17

The graph plots Settlement (mm) on the y-axis (0.00 to -1.40) against Pressure / Settlement (kN/m²) on the x-axis (0 to 180). A dashed line represents the test results, showing a non-linear relationship. A solid line represents the theoretical curve for a 1.25 mm settlement intersection.

Pressure (kN/m ²)	Settlement (mm)
0	0.00
10	-0.15
20	-0.25
30	-0.35
40	-0.45
50	-0.55
60	-0.65
70	-0.75
80	-0.85
90	-0.95
100	-1.05
160	-1.25

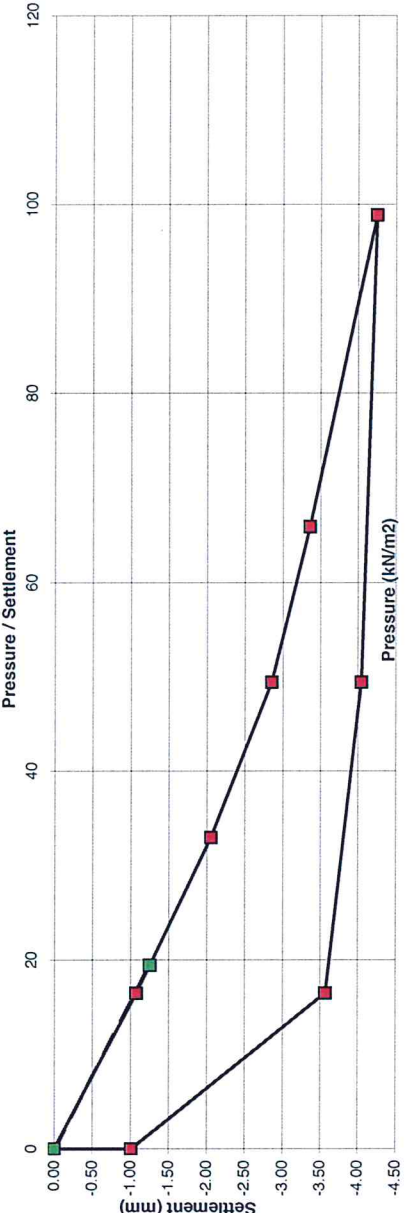
PLATE TEST REPORT SHEET (F3.1)		Applied Pressure/Settlement Curve	
Reference No. R779335 Contract The Willows Dunshaughlin Test No. PB16 Location Dunshaughlin Depth 0.50m Client Gem Construction Plate Diameter: 450 mm Test Method BS 1377 Part 9: 1990 Test 4 Incremental Loading Test Technician LD Authorised by Date 10-02-17	Description of soil under test (natural soil, placed fill, sub-base) Loose brown gravelly sand

<p>The graph plots Settlement (mm) on the y-axis (0 to -4.50) against Pressure / Settlement (kN/m²) on the x-axis (0 to 120). The curve shows a non-linear relationship, starting at (0,0) and passing through points approximately at (10, -1.0), (20, -1.5), (30, -2.0), (40, -2.5), (50, -3.0), (60, -3.5), (70, -4.0), and (80, -4.5). A tangent line is drawn at the 1.25 mm settlement point, intersecting the y-axis at 16 mm.</p>			
Gradient at 1.25 mm settlement intersection = 16 Modulus of subgrade reaction = 10 MPa/m Correction factor applied = 0.64 as per HD 25-26/10		Equivalent CBR value in accordance with NRA HD25-26/10 0.5 %

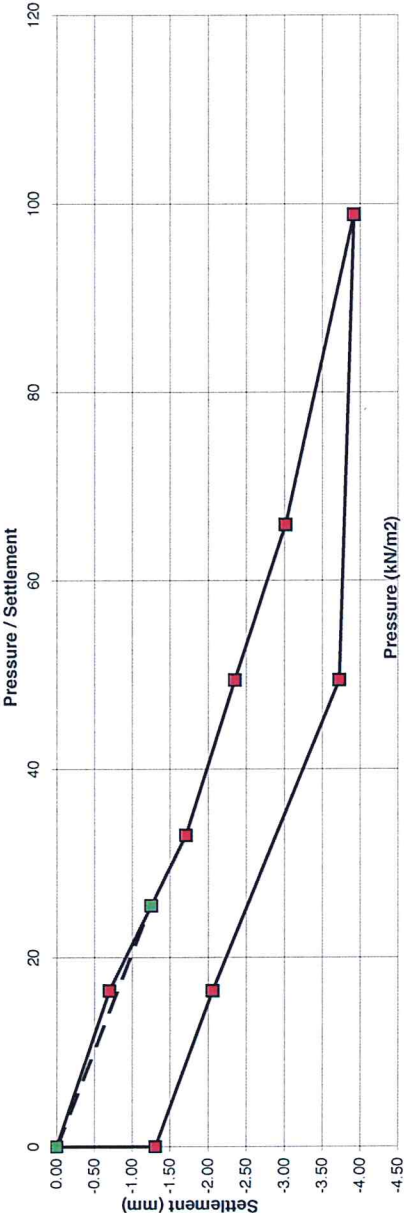
PLATE TEST REPORT SHEET (F3.1)		Applied Pressure/Settlement Curve	
Reference No. R77336 Contract The Willows Dunshaughlin Test No. PBT7 reload Location Dunshaughlin Depth 0.50m Client Gem Construction Plate Diameter: 450 mm Test Method BS:1377, Part 9, 1990 Test4 - Incremental Loading Test Technician LD Authorised by AAAS Date 09-02-17	Description of soil under test (natural soil, placed fill, sub-base) Loose brown gravelly sand

<p>The graph plots Settlement (mm) on the y-axis (0.00 to -4.50) against Pressure / Settlement on the x-axis (0 to 120). Two data series are shown: one with red square markers and one with green square markers. Both series show a linear relationship between pressure and settlement, with the green series having a steeper slope. The x-axis is labeled 'Pressure / Settlement' and the y-axis is labeled 'Settlement (mm)'. The pressure values for the red series are approximately 15, 35, 50, 65, 80, and 95 kN/m², corresponding to settlements of -0.5, -1.0, -1.5, -2.0, -2.5, and -3.0 mm. The pressure values for the green series are approximately 15, 35, 50, 65, 80, and 95 kN/m², corresponding to settlements of -0.5, -1.0, -1.5, -2.0, -2.5, and -3.0 mm.</p>

Gradient at 1.25 mm settlement intersection = 20 Modulus of subgrade reaction = 13 MPa/m Correction factor applied = 0.64 as per HD 25-26/10			
Equivalent CBR value in accordance with NRA HD25-26/10 0.8 %
