## i. Preface

THIS ENVIRONMENTAL IMPACT ASSESSMENT REPORT CONSISTS OF THE FOLLOWING DOCUMENTS:

This Environmental Impact Assessment Report (hereafter referred to as **EIAR**), has been prepared and coordinated by the TII National Roads Project Office of Sligo County Council, under the auspices of Transport Infrastructure Ireland. The following are the key bodies responsible for the project delivery. The qualifications and experience of the key team members is outlined in Chapter 1 of this EIAR (Volume 2 – Main Report).

# 1 Appendix 1.1; Chapter 1 (Main Report Reference);

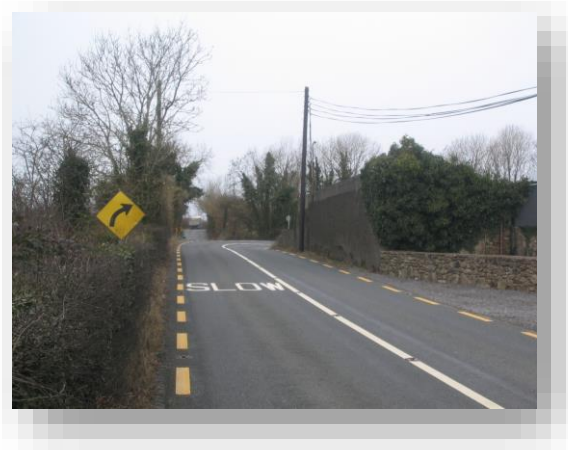
*Figure 2-3: Junction with Drum Road (L-3406-0)*

The grossly deficient horizontal nature of the existing alignment at the N16’s connection point with the L-3406-0 (See Figure 2-3), by its nature, presents an opportune Tie-In point for a roundabout. The

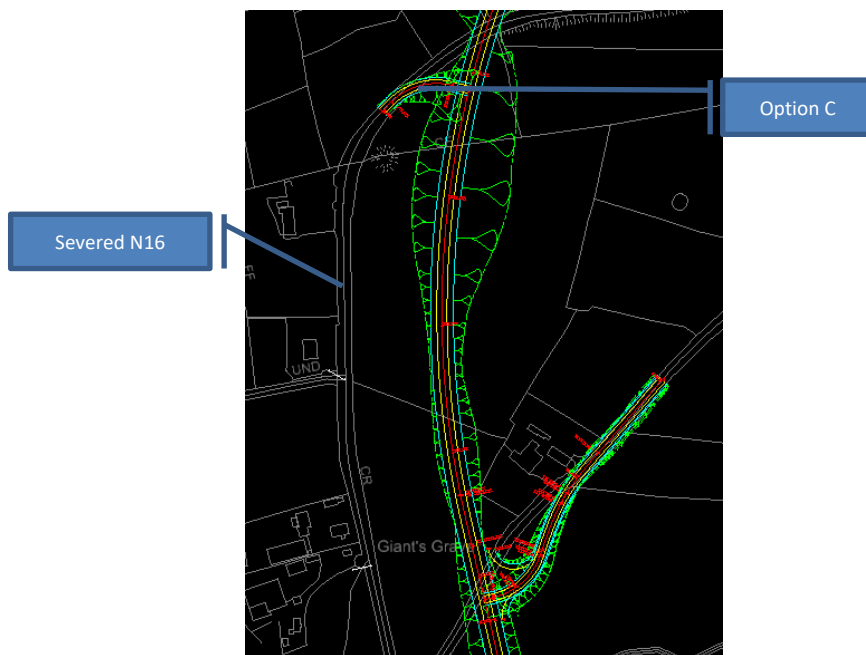
Figure 2-9: Option C: Simple T Junction direct connection at Lugatober

This connection measures approximately 70m in length and is outlined in *Figure 2-9*.

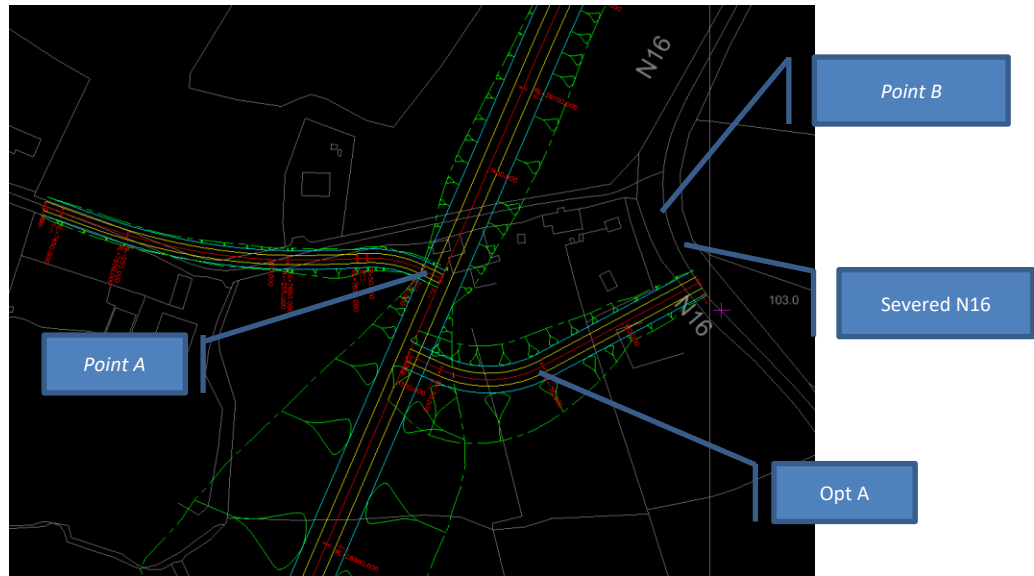
Figure 2-11: Option A: Simple T Junction at Lugatober (EAST) – Ch. 1,315m

The design solution which is outlined in *Figure 2-11* passes through a low lying topographical depression requiring a fill section of circa 4m to 5m in height.

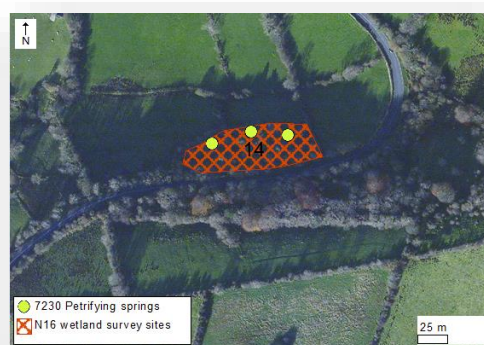
Figure 2-13: Location of petrifying springs at West of Castlegal (Lugatober)

interfered with and that the Petrifying Springs described below in Figure 2-13 will not be directly impacted upon.

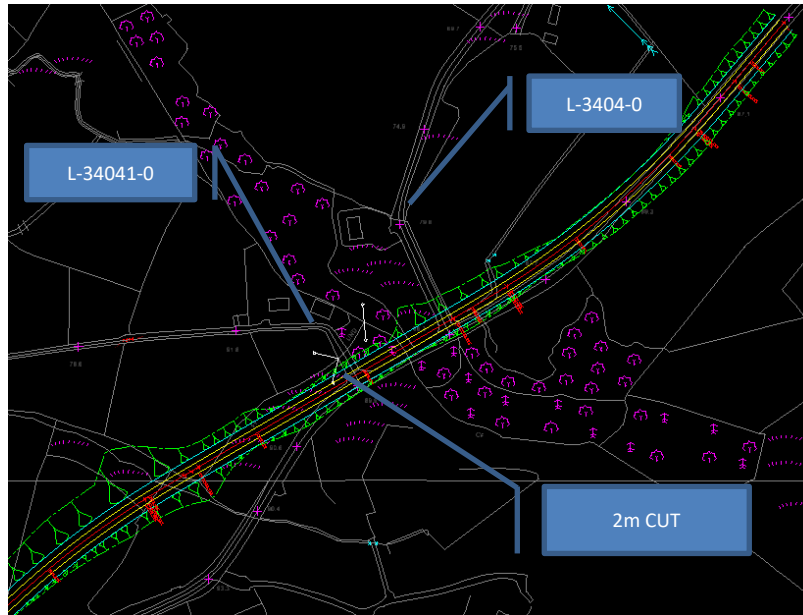
Figure 2-14: N16 Mainline Option 001 – Collinsford/Lugnagall – Horizontal Geometry

This design arrangement is outlined in *Figure 2-14* (Horizontal Plan) and *Figure 2-15* (Vertical Profile). A Vertical Hog curve placed within a straight section to the south of a 720m radius Horizontal Curve, results in a Cut of circa 2.2m (excluding road construction) through a hill area located at circa Ch. 2,100m. This design arrangement is largely controlled by the vertical requirement to tie into the existing network to the north.

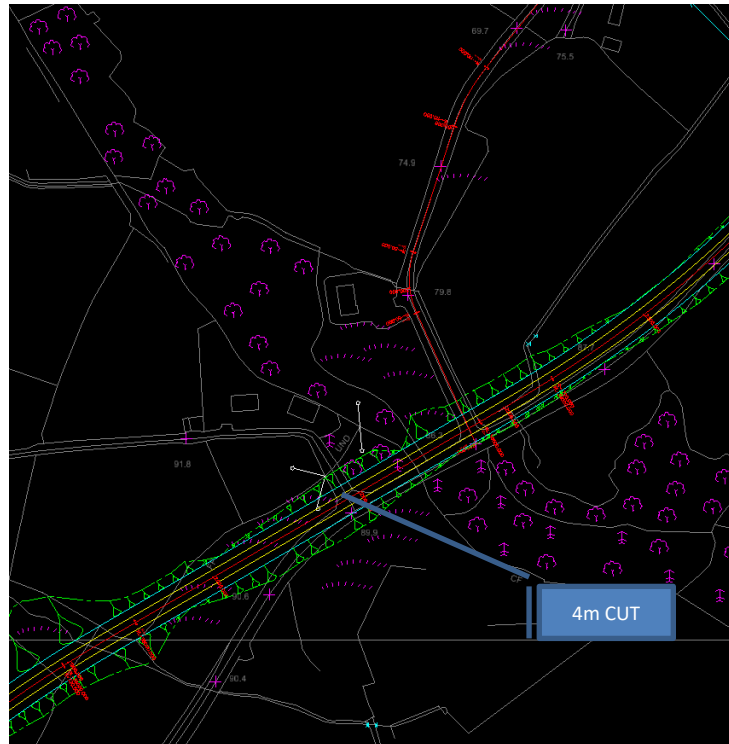
*Figure 2-18: N16 Mainline Option 003 – Collinsford/Lugnaqall – Horizontal Geometry*

This design arrangement is outlined in *Figure 2-18* and *Figure 2-19*. A Vertical Hog curve to Desirable Minimum standards placed within the 720m radius Horizontal Curve to the north, results in a Cut of circa 4m (excluding road construction) through a hill area located at circa Ch. 2,100m. This design arrangement is largely controlled by the vertical requirement to tie into the existing network to the north.

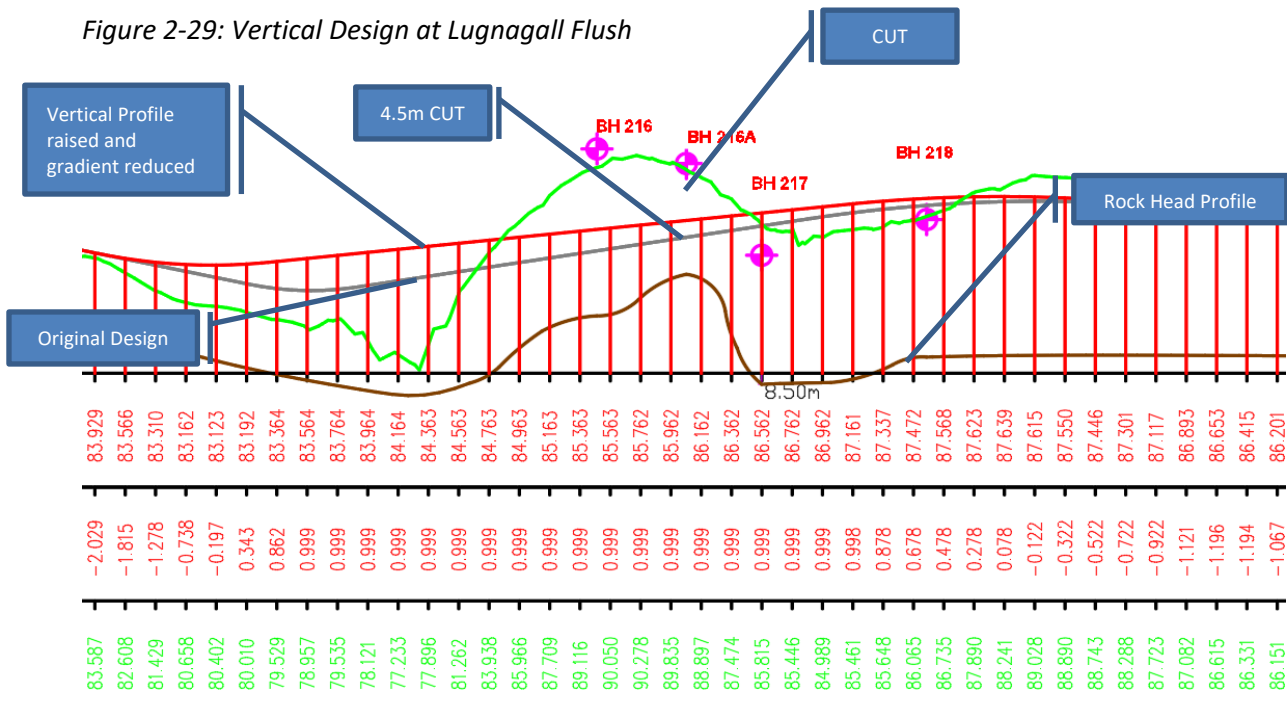
Figure 2-29: Vertical Design at Lugnagall Flush

JA 06 Opt E (VA 02)	2	Moderately Negative	No direct impact on Lugnagall Flush, or Crockauns/Kellyogyboy Bogs Biodiversity Sites.  VA 02 is circa 5.5m deep at the Cut Section. Based on observed ground water levels, there is some potential for this option to impact upon the hydrogeological regime table.

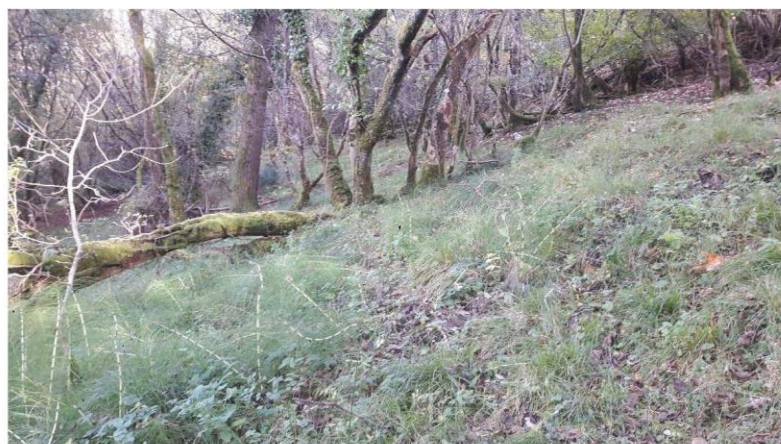
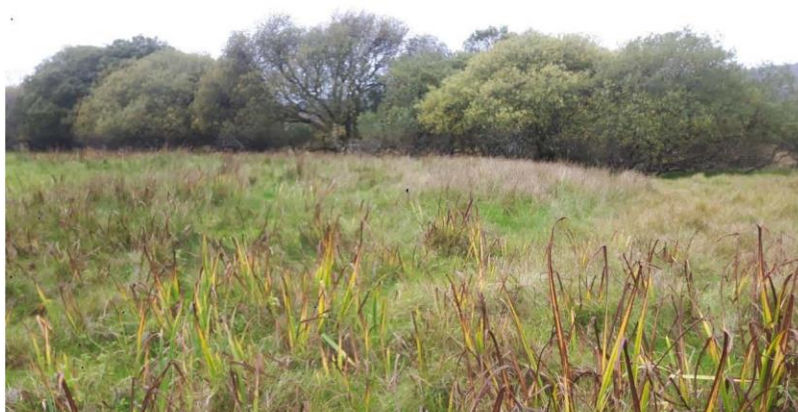
(Above) Spring in woodland, west of Castlegal  
(Below) Flush in grassland west of Lugatober

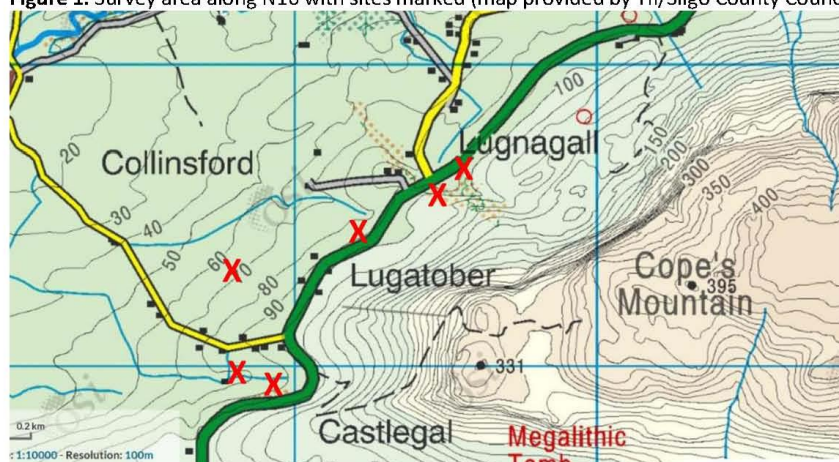
Figure 1. Survey area along N16 with sites marked (map provided by TII/Sligo County Council).

The survey area runs from near a bad bend in the road west of Castlegal townland, north along the N16 corridor to Lugnagall townland. Survey locations are marked approximately on Figure 1. Castlegal townland is approximately 7km NNE of Sligo town. The entire stretch sits with the 10 km square: G74.

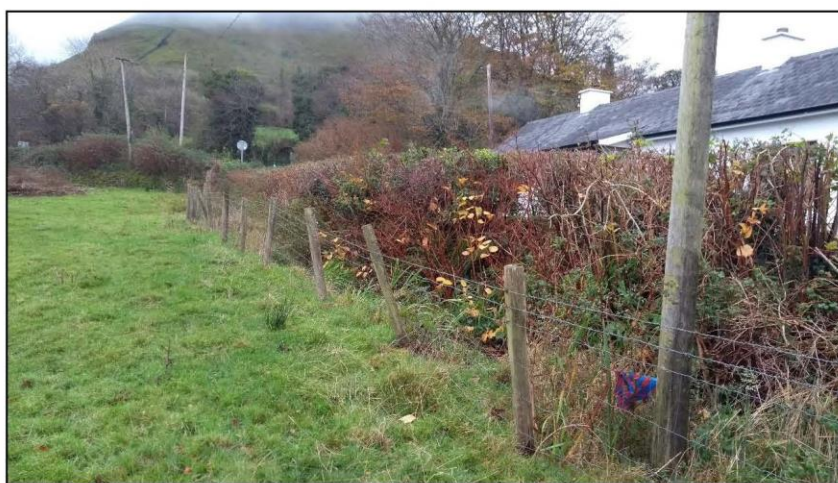
Plate 3.1. Linear stand of Knotweed growing in association with residential hedge as shown on Figure 3.1

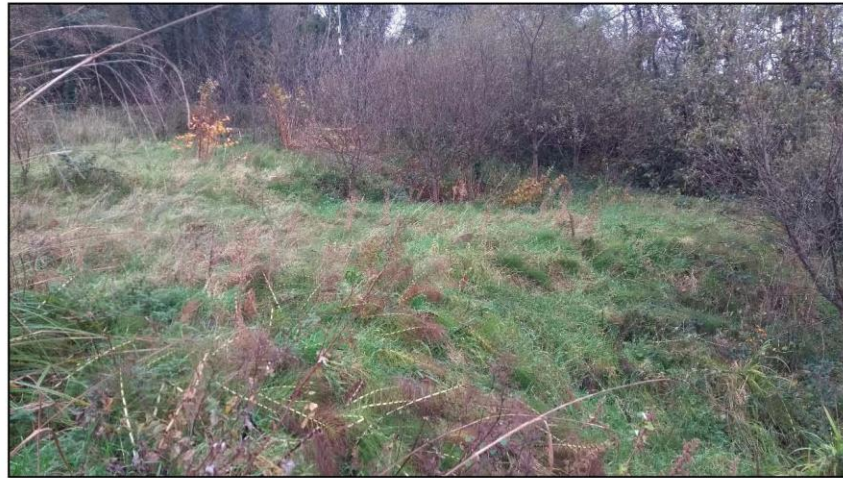
Plate 3.2. Individual stands of Knotweed growing within field as shown in Figure 3.1 (seen as yellow leaved plants as per October 2017).

A second infestation was recorded in the townland of Lugnagall (Grid Ref 572380, 841629). The infestation consisted of two small stands which measures approximately 2m x 2m (Plate 3.2 and Figure 3.2).

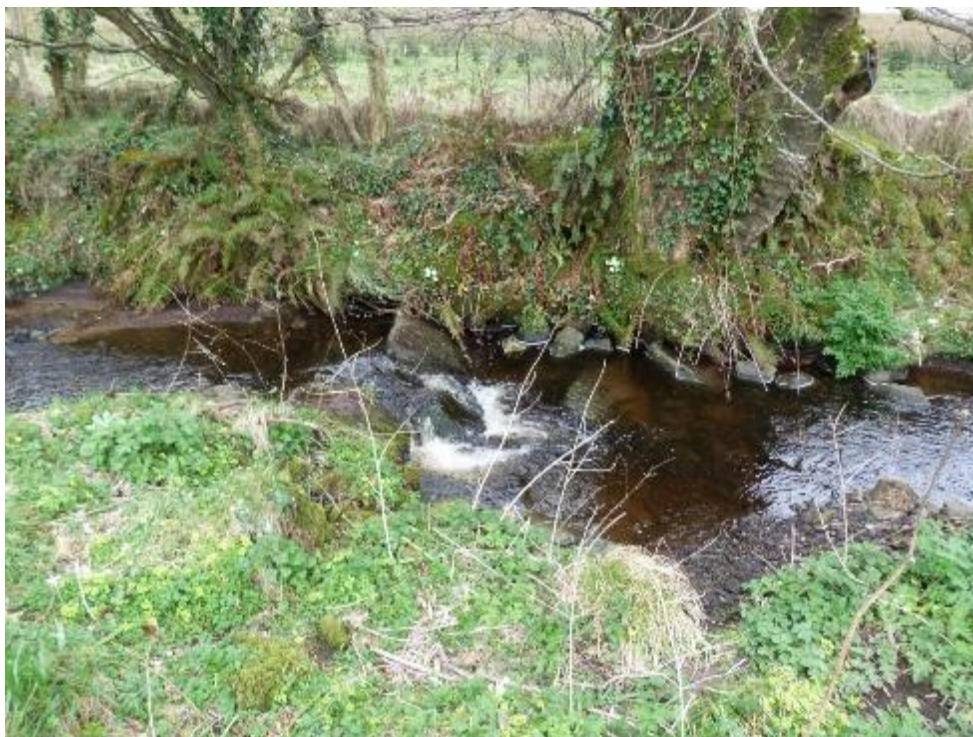
Plate 14-1 Field 3 river looking south (AAP 07/TB 06)

ID No.	AAP 07 (see Plate 14-1)
Legal Status	N/A
Reference number	N/A
Townland	Drumkilsellagh/Castlegal
Site Type	River
ITM	571775, 840335
Description	Narrow and shallow river, it is c. 1m wide and set within a deep cut/ravine. There is a lot of stone visible in the base of the channel and there are a number of stone steps in the channel. Each bank is lined by mature trees. The river forms the townland boundary between Drumkilsellagh and Castlegal (TB 06).
Sources	Aerial photography
Distance to CPO	0
Perceived Significance	Regional
Type of impact	Direct
Significance and quality of Impact	Moderate, negative
Mitigation measures	A wade survey, photographic survey and written record of the impacted section of the stream will be undertaken prior to development.
Impact after mitigation	Positive residual impact, any archaeological features will be recorded prior to construction. If required site will be notified to the Archaeological Survey of Ireland (DCHG) for inclusion in the SMR.

ID No.	TB 06 (see Plate 14-1)
Legal Status	N/A
Reference number	N/A
Townland	Drumkilsellagh/Castlegal
Site Type	Townland boundary
ITM	571775, 840335
Description	Townland boundary between Drumkilsellagh and Castlegal, comprising shallow and narrow river (AAP 07), it is c. 1m wide and set within a deep cut/ravine. There is a lot of stone visible in the base of the channel and there are a number of stone steps in the channel. Each bank is lined by mature trees.
Sources	Aerial photography
Distance to CPO	0
Perceived Significance	Local
Type of impact	Direct
Significance and quality of Impact	Moderate, negative
Mitigation measures	A wade survey, photographic survey and written record of the impacted section of the townland boundary will be undertaken prior to development.
Impact after mitigation	Positive residual impact, any archaeological features will be recorded prior to construction. If required site will be notified to the Archaeological Survey of Ireland (DCHG) for inclusion in the SMR.

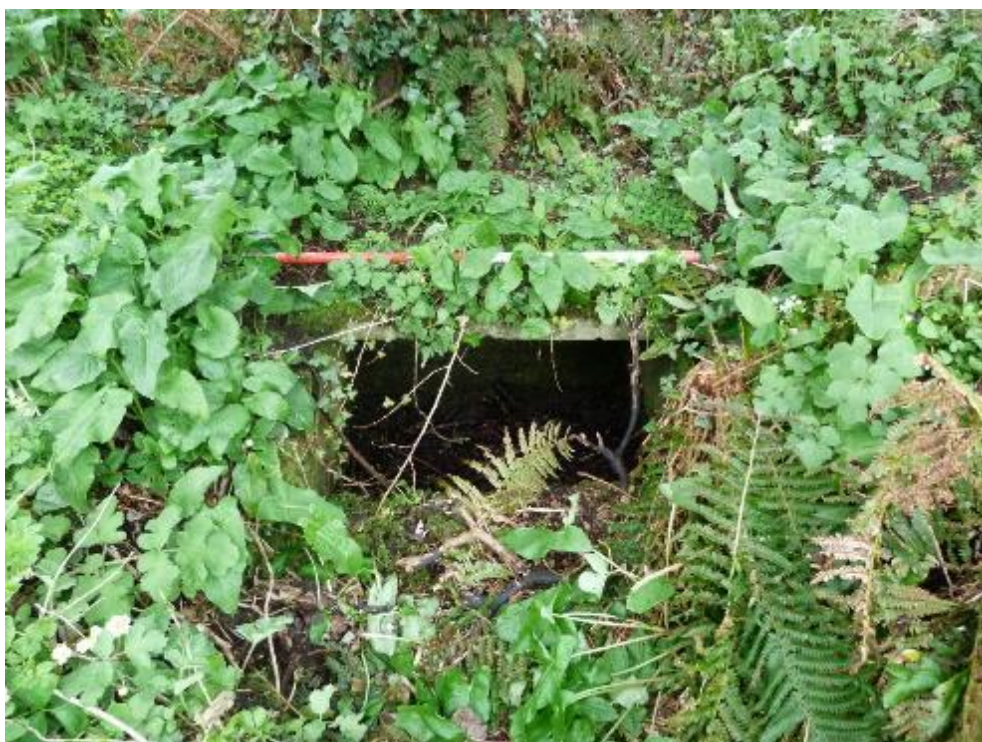
Plate 14-2 Field 3 well marked on 25" OS map (CHC 85)

ID No.	CHC 85 (see <i>Plate 14-2</i> )
Legal Status	N/A
Reference number	N/A
Townland	Castlegal
Site Type	Well
ITM	571745, 840358
Description	A well, marked on the 25" Ordnance Survey map, was located along the north bank of the river. Concrete slabs for the west, south and east sides and there is a concrete slab covering the top of the well. It is 0.95m wide.
Sources	Field survey
Distance to CPO	0
Perceived Significance	Local
Type of impact	Direct
Significance and quality of Impact	Moderate, negative
Mitigation measures	The area within the CPO will be subject to targeted test excavation prior to development. Further mitigation including archaeological excavation may be required.
Impact after mitigation	Positive residual impact, any archaeological features will be recorded prior to construction. If required site will be notified to the Archaeological Survey of Ireland (DCHG) for inclusion in the SMR.

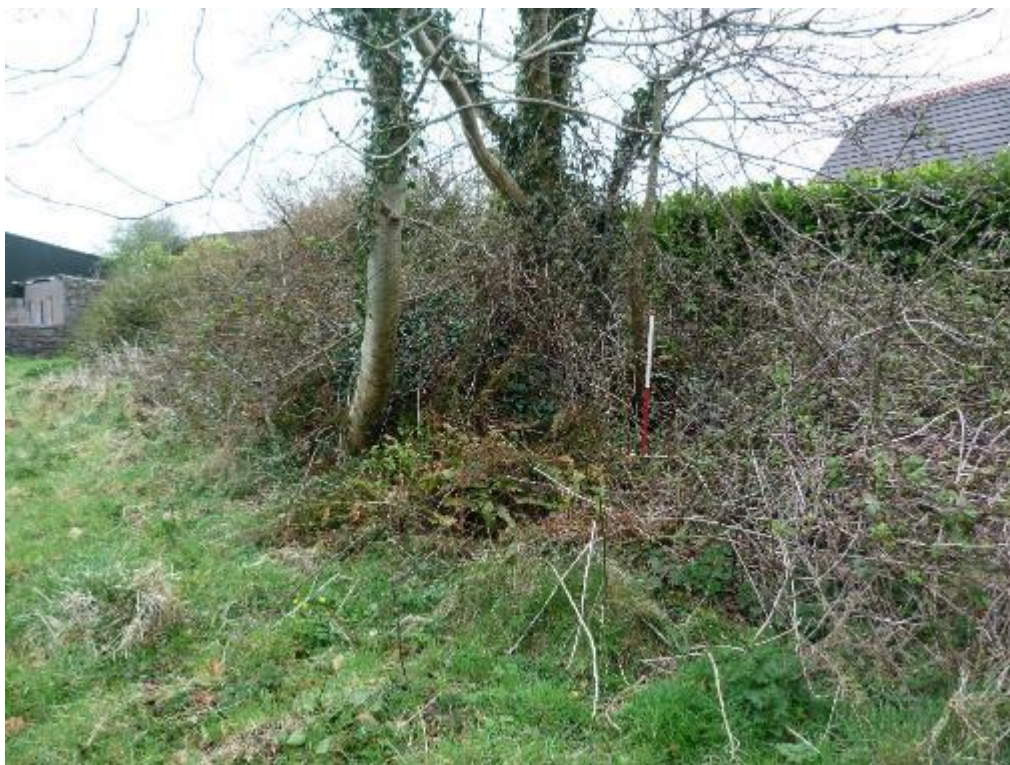
*Plate 14-5 Field 6 wedge tomb, Drum East (CHC 1 - RMP SL009-028)*

ID No.	CHC 01 (see Plate 14-5)
Legal Status	RMP
Reference number	SL009-028
Townland	Drum East
Site Type	Megalithic tomb - wedge tomb
ITM	571651, 840453
Description	<p>Description from RMP, site is currently completely overgrown.</p> <p>This monument was first shown on the 1913 edition of the OS 6-inch map. It lies about 5km to the northeast of Sligo town and is situated immediately to the west of the Sligo-Manorhamilton road. The monument is on flat pasture at the foot of Castlegal Mountain.</p> <p>The tomb is ruined but retains a single roofstone. It consists of a long, apparently wedge-shaped gallery flanked at either side by the remains of outer-walling. A single façade stone adjoins the north side of the gallery. The structure is incorporated on a low mound measuring about 11m east-west and 6m north-south.</p> <p>The gallery is 8.15m long and narrows from 1.30m wide near the middle to 1m near the back. The north side is represented by four stones. That next to the façade measures 1.40m by 35cm by 1m high and the small side stone east of this, 45cm by 15cm by 10cm high. This third side stone leans heavily inwards. It measures 2.20m by 45cm and if erect would be 85cm high. The last side stone here is 35cm by 25cm and 10cm high. The stone marking the east of the gallery measures 80cm by 50cm by 30cm high. Beyond this is a prostrate stone 1.70m in maximum dimension. The five stones representing the south side of the gallery are 45cm to 60cm high. That at the west leans heavily inwards under the roofstone. This measures 2.55m by 2.15m by 40cm thick.</p> <p>The outer-walling at the north is represented by a line of three stones. That at the west measures 95cm by 15cm by 30cm high and the stone next to this 90cm by 25cm by 65cm high. The third stone appears to be the stump of an orthostat and is 30cm by 5cm by 5cm high. The three surviving outer-wall stones at the south are largely concealed by the roots of a tree. The tallest protrudes 40cm above the roots. The façade stone measures 1.20m by 30cm by 1m high. The prostrate stone beside it is 1.70m in maximum dimension.</p>

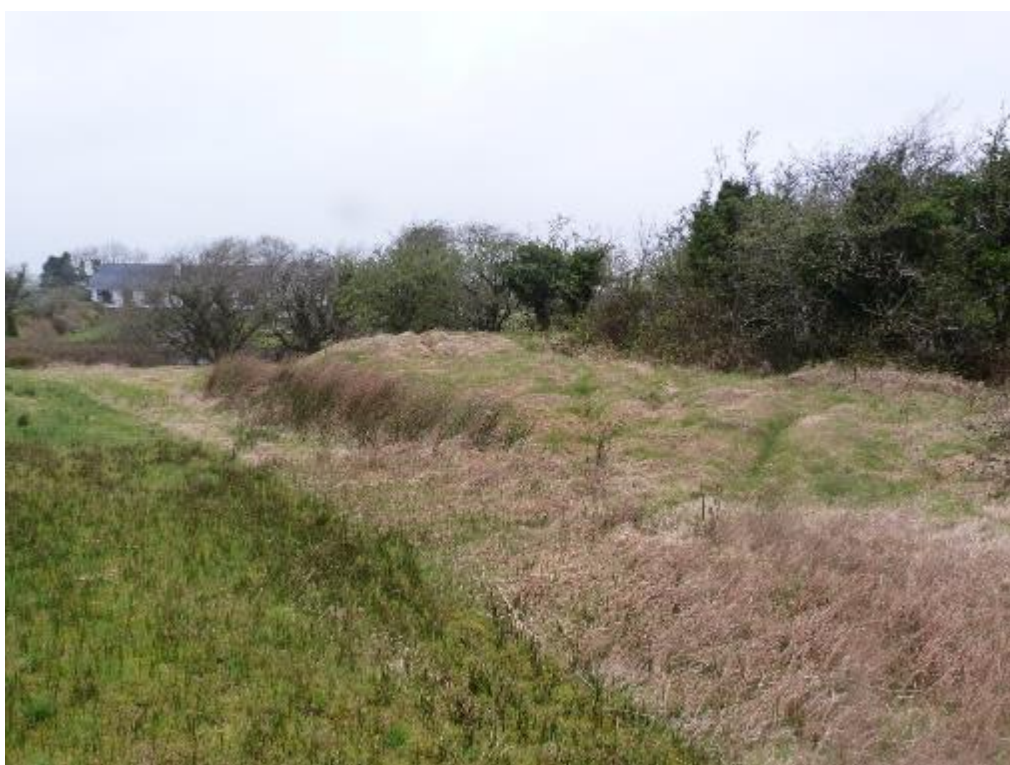
*Plate 14-6 Field 7 Ringfort from southeast (CHC 11 - RMP SL009-026)*

ID No.	CHC 11 (see Plate 14-6 and Plate 14-7)
Legal Status	RMP
Reference number	SL009-026
Townland	Castlegal/Lugatober
Site Type	Ringfort - rath
ITM	571681, 840765
Description	Situated on a slight NW-facing slope in gently undulating pasture. Circular raised area (diam. 15m) enclosed by a bank of earth (Wth 6.4m; int. H 0.4m). There is no fosse visible at ground level. The bank encloses the site W-S. From S-SW the bank has been removed by a small quarry. From SW-W the edge of the site is defined by an irregular scarp. The original entrance is not recognisable. An ENE-WSW orientated field boundary bank with a drain crosses the interior to N of centre cutting through the bank at W and at NE. The interior to the S of this boundary is heavily disturbed by quarrying.
Sources	RMP
Distance to CPO	0
Perceived Significance	National
Type of impact	Direct
Significance and quality of Impact	Moderate, negative
Mitigation measures	Part of the monument is included in the CPO for severance reasons however it will be excluded from the LMA for construction and thus preserved in situ. The area within the CPO will be subject to geophysical survey. Any archaeology discovered within the LMA will be subject to targeted test excavation prior to development. Further mitigation including archaeological excavation may be required.

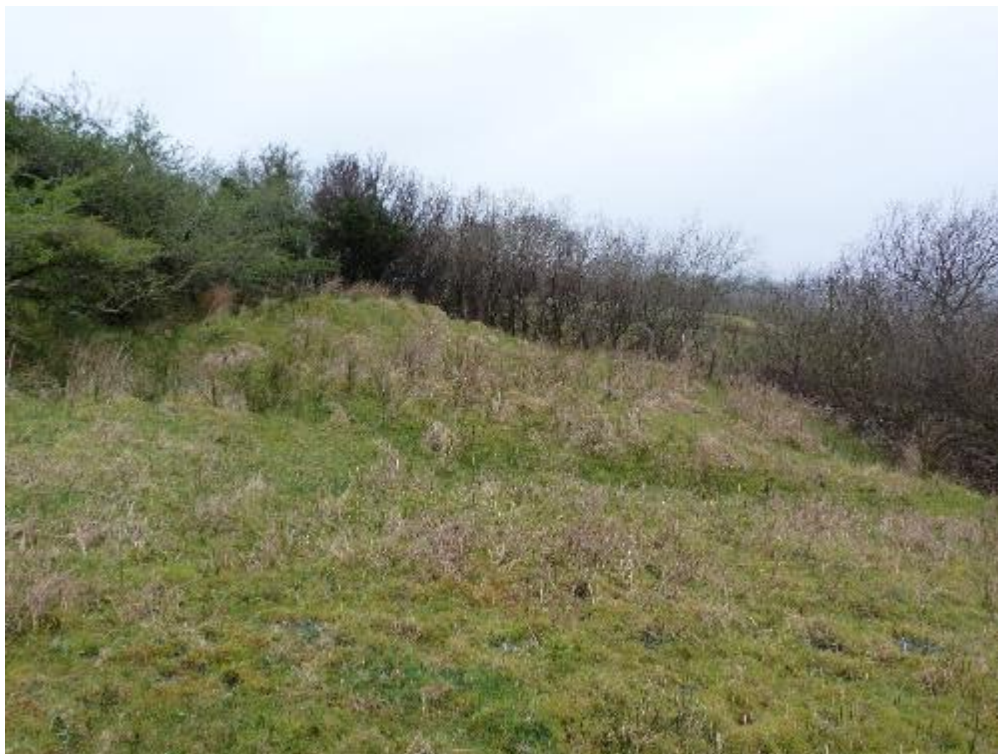
*Plate 14-7 Field 8, ringfort from northeast (CHC 11 - RMP SL009-026)*

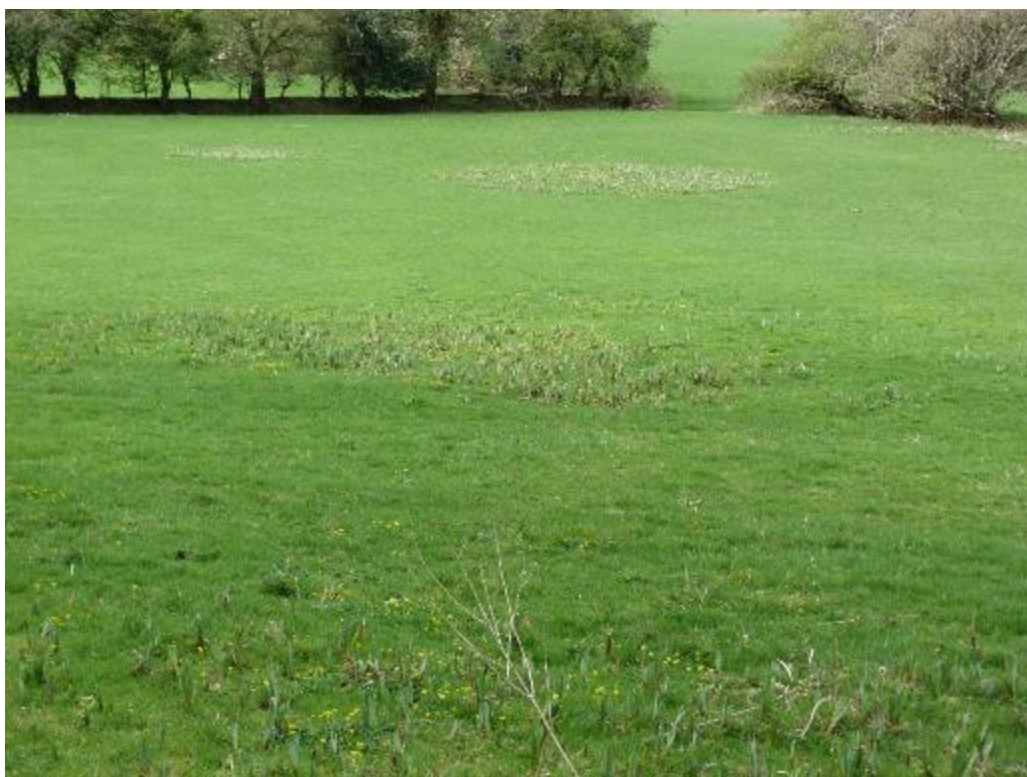
*Plate 14-12 Field 15, areas of wetter ground (AAP 19)*

ID No.	AAP 19 (see Plate 14-12)
Legal Status	N/A
Reference number	N/A
Townland	Lugatober
Site Type	AAP (Area of wet rushy ground
ITM	571982, 841386
Description	Three roughly circular areas of wetter, rushy ground within Field 15.
Sources	Aerial photography, field survey.
Distance to CPO	0
Perceived Significance	Local
Type of impact	Direct
Significance and quality of Impact	Moderate, negative
Mitigation measures	The area within the CPO will be subject to targeted test excavation prior to development. Further mitigation including archaeological excavation may be required.
Impact after mitigation	Positive residual impact, any archaeological features will be recorded prior to construction. If required site will be notified to the Archaeological Survey of Ireland (DCHG) for inclusion in the SMR.

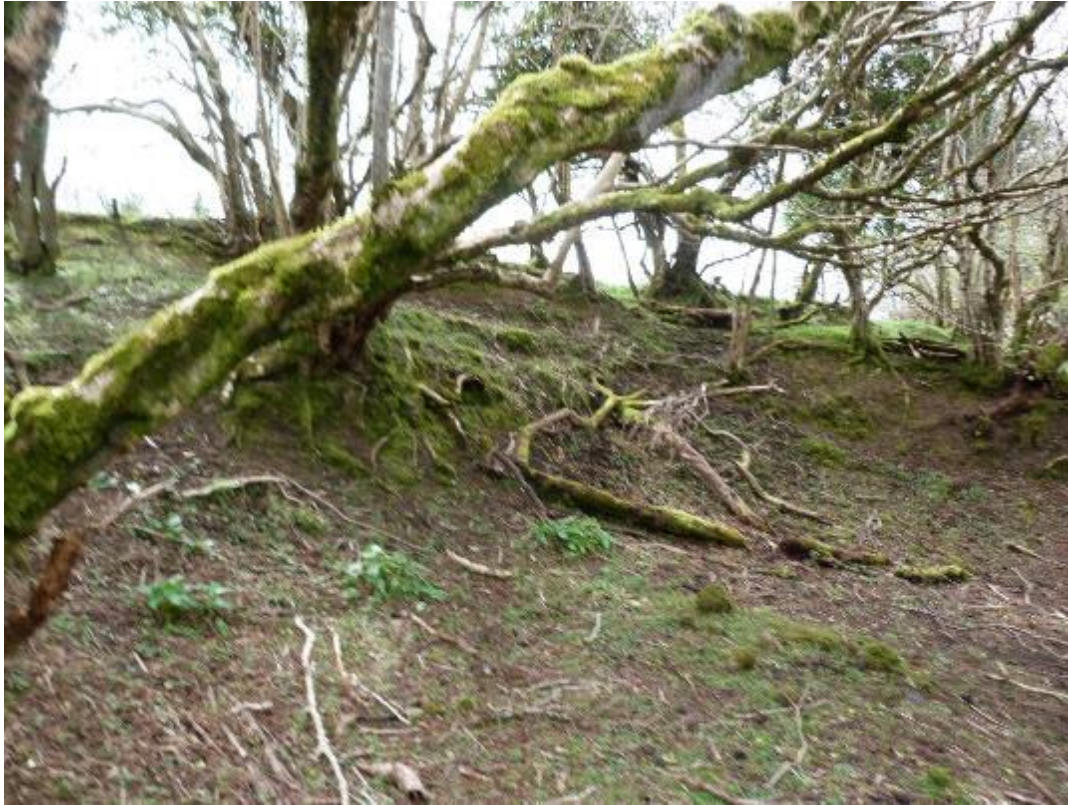
*Plate 14-13 Field 17, possible quarry (AAP 20)*

ID No.	AAP 12 (see Plate 14-13)
Legal Status	N/A
Reference number	N/A
Townland	Lugatober
Site Type	Quarry
ITM	571982, 841386
Description	Evidence of historic quarrying comprising scarped area with pile of limestone to centre, mature trees growing within the quarried area and on the edge of the scarped area. While this feature is not indicated on the 1 <sup>st</sup> or later edition Ordnance Survey maps, the Ordnance Survey Name Books record a quarry in the southern part of the townland of Collinsford and the northern part of the townland of Lugatober which may correspond with this location.
Sources	Aerial photography, field survey.
Distance to CPO	0
Perceived Significance	Local
Type of impact	Direct
Significance and quality of Impact	Moderate, negative
Mitigation measures	The area within the CPO will be subject to targeted test excavation prior to development. Further mitigation including archaeological excavation may be required.

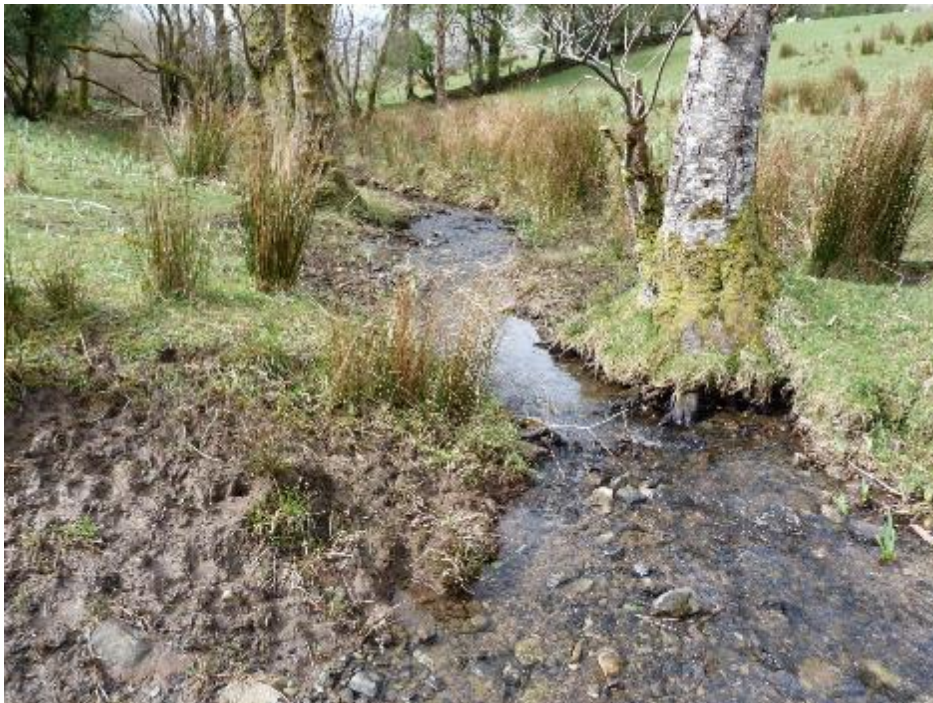
*Plate 14-14 Field 17 - Field 18, stream (AAP 16 - TB 09)*

ID No.	AAP 16 (see Plate 14-14)
--------	--------------------------

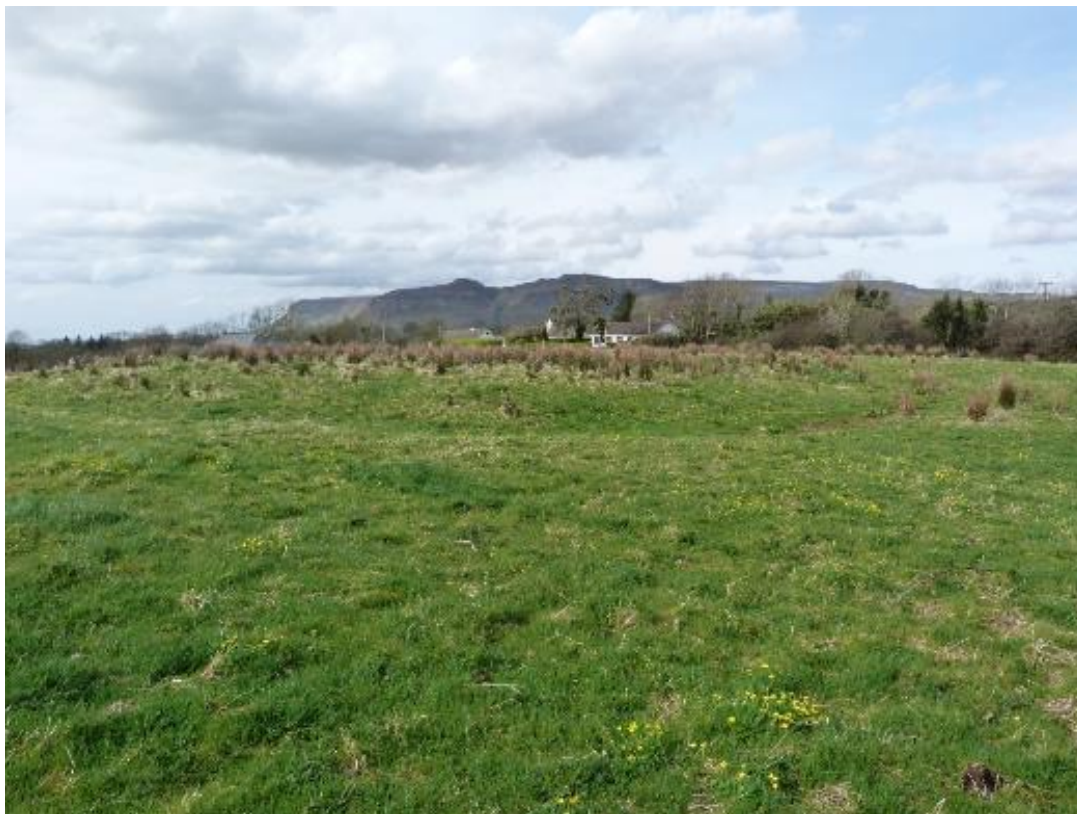
*Plate 14-19 Field 27, ringfort from south (CHC 12 - RMP SL009-035)*

ID No.	CHC 12 (see Plate 14-19 and Plate 14-20)
Legal Status	RMP
Reference number	SL009-035
Townland	Doonally
Site Type	Ringfort - rath
ITM	571607, 839729
Description	On a level summit of a slight rise in gently undulating pasture. Slightly raised circular area (diam. 22m) enclosed by a low broad bank of earth (Wth 5m; int. H 0.3m) with an external fosse (Wth 2.6m; D 0.3m). Both the bank and the fosse enclose the entire site having a consistent profile along the entire circuit. A break (Wth 2.3m) in the bank with a causeway across the fosse at SE marks the position of the original entrance.
Sources	RMP
Distance to CPO	12
Perceived Significance	National
Type of impact	Indirect
Significance and quality of Impact	Moderate, negative impact on setting of monument.

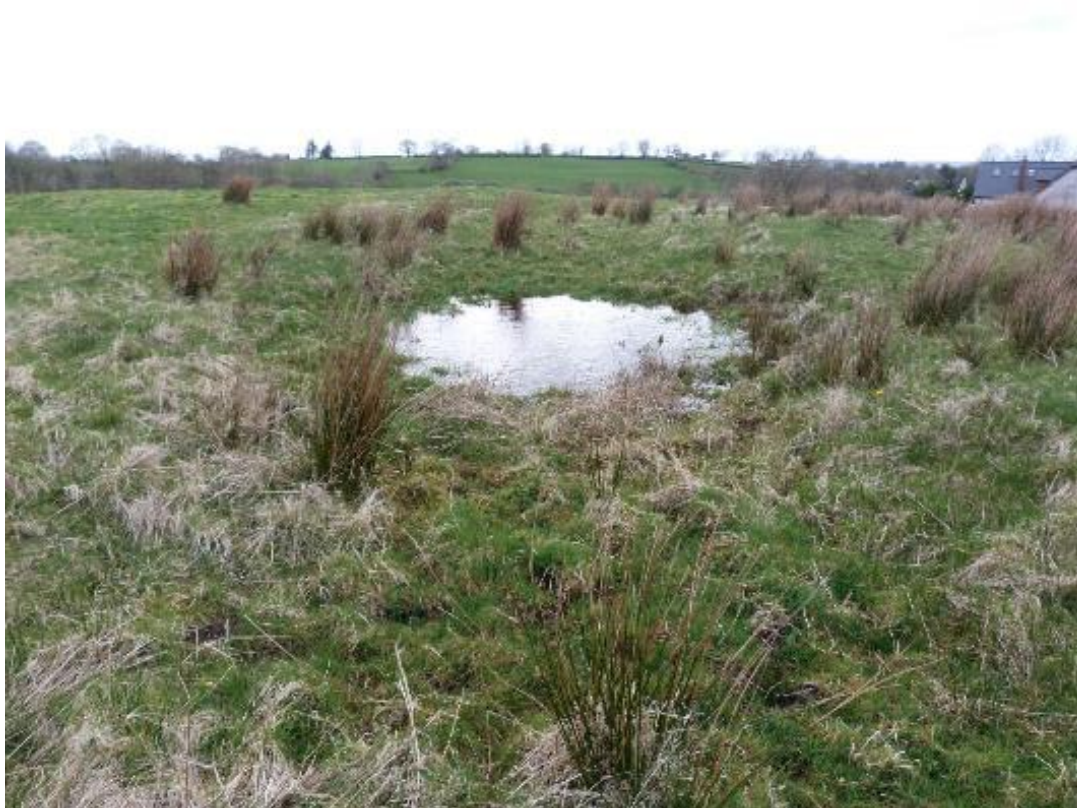
*Plate 14-20 Waterfilled depression to north of ringfort (CHC 12 - RMP SL009-035)*

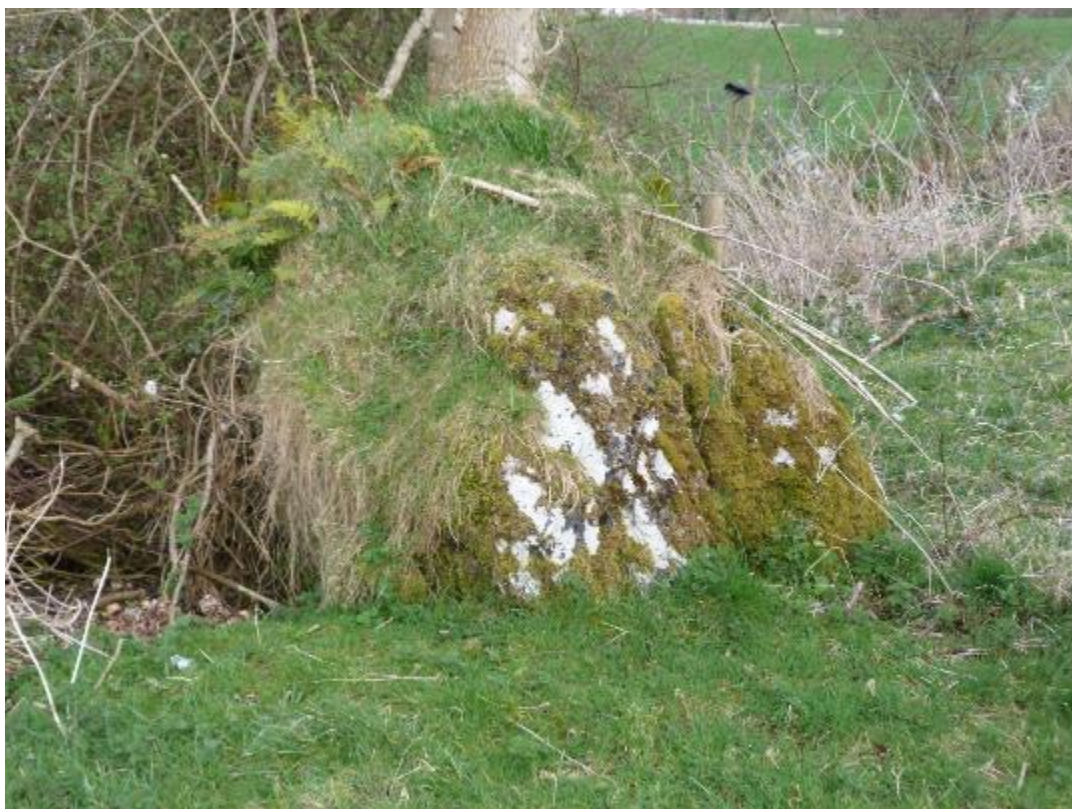
*Plate 14-21 Possible mass rock (CHC 84)*

ID No.	CHC 84 (see Plate 14-21)
Legal Status	N/A
Reference number	N/A
Townland	Doonally
Site Type	Mass rock, possible current site of.
ITM	571750, 839644
Description	Large earthbound limestone boulder, possibly not in original location. Local landowner indicated that the boulder was known locally as a mass rock. May originally have been located further to the west within a copse of trees or trees ring. Not indicated on 1 <sup>st</sup> ed. OS map.
Sources	Pers. Comm. local landowner (E. Collis)
Distance to CPO	0
Perceived Significance	Local
