## **Appendix 12-2      Tree Survey**

TREE SURVEY

Glenamuck Distributor Road Scheme,  
Co Dublin.

December 2018

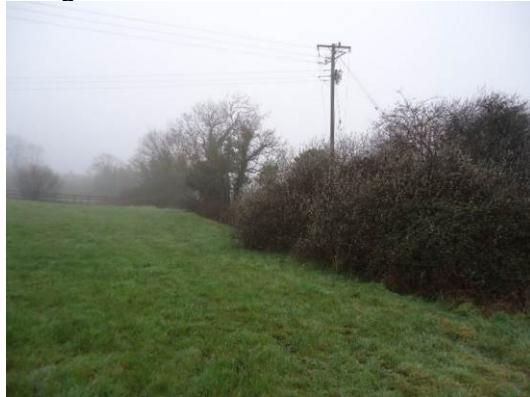
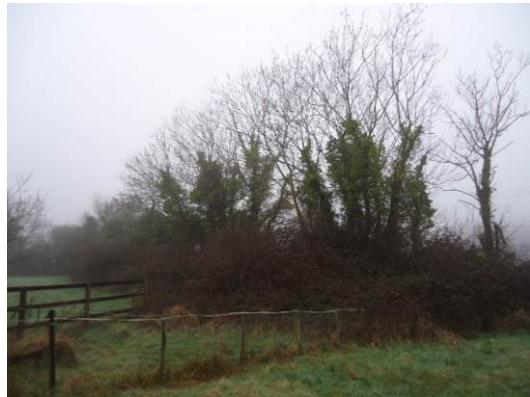
Hedgerow 2 – a portion of (approx. 45 linear metres) of this hedgerow will require to be removed to facilitate the passage of the proposed road, it is of moderate value with no trees of high value.

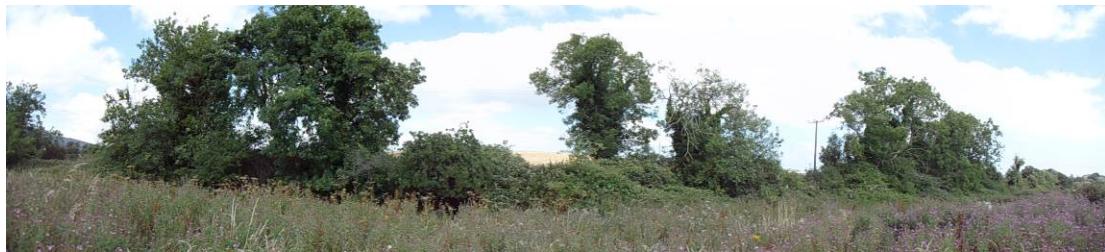
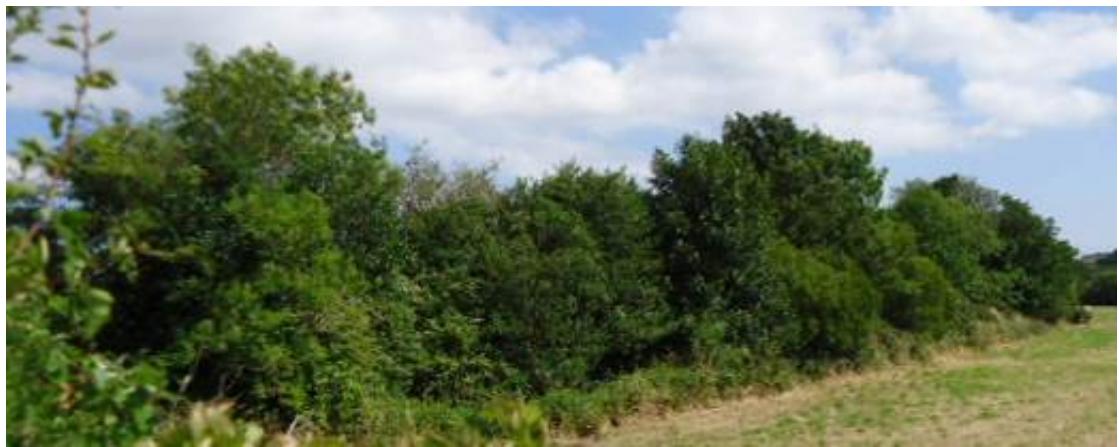
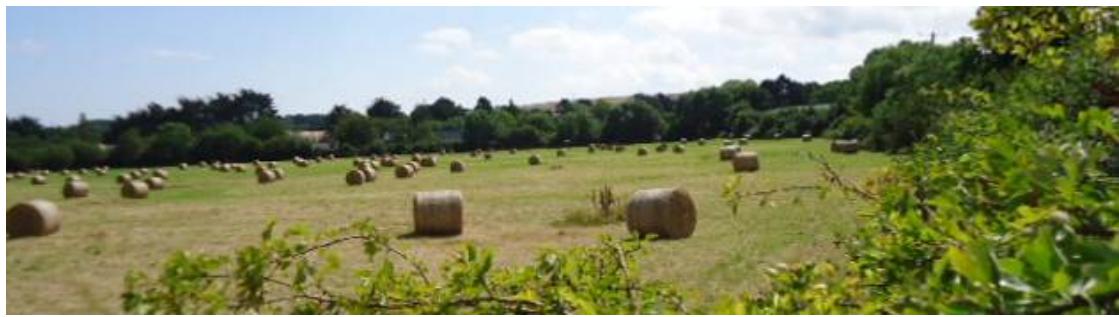
Hedgerow 3 (typical section – western end).

Hedgerow 3 (typical section – middle).

Hedgerow 3 (spur to south).

Hedgerow 3 – a side section/spur (approx. 100 linear metres) of this hedgerow will require to be removed to facilitate the passage of the proposed road and attenuation area, it is of moderate value with no trees of high value.

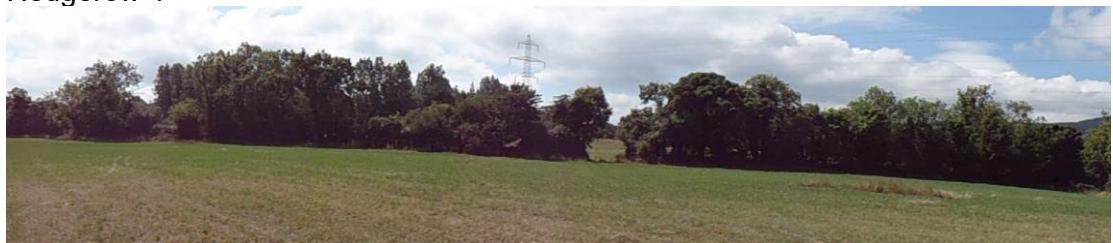
Hedgerow 5 – two portions of (approx. 65 & 80 linear metres) of this hedgerow will require to be removed to facilitate the passage of the proposed road, it is of moderate value with no trees of high value.

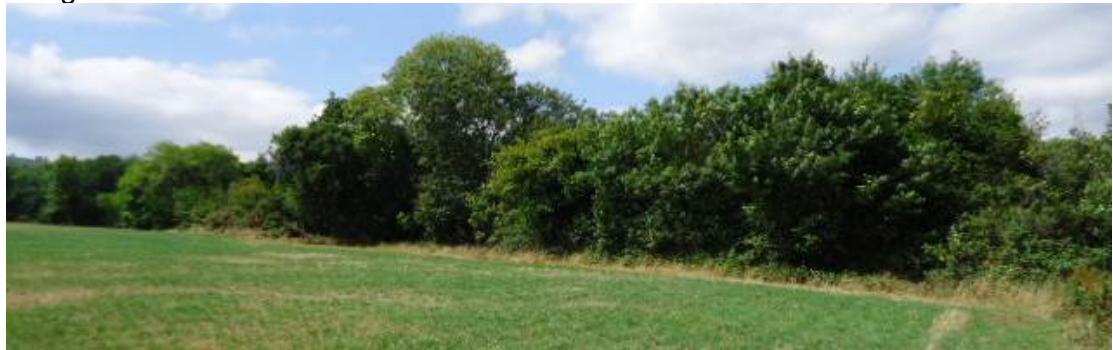
Hedgerow 6 – a portion of (approx. 60 linear metres) of this hedgerow will require to be removed to facilitate the passage of the proposed road, it is of moderate value with no trees of high value.

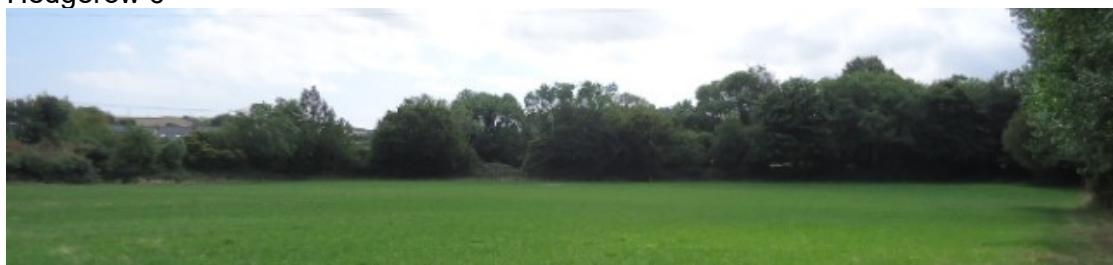
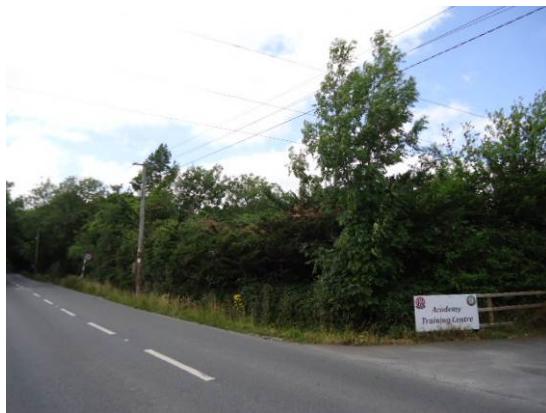
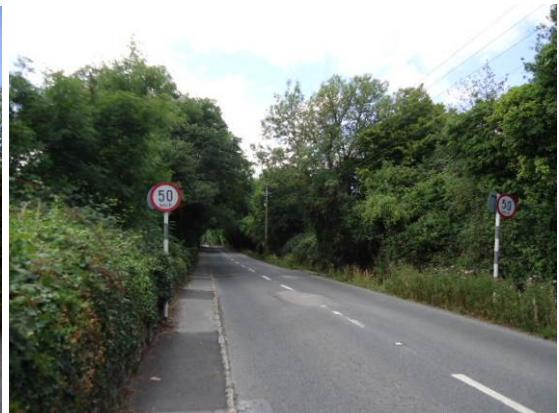
Hedgerow 7 (Right hand side of road)

Hedgerow 7 – most of this hedgerow will require to be removed to facilitate the passage of the proposed road, it is of moderate value, (though the northern most portion consists of low value Leylandii species), with no trees of high value.

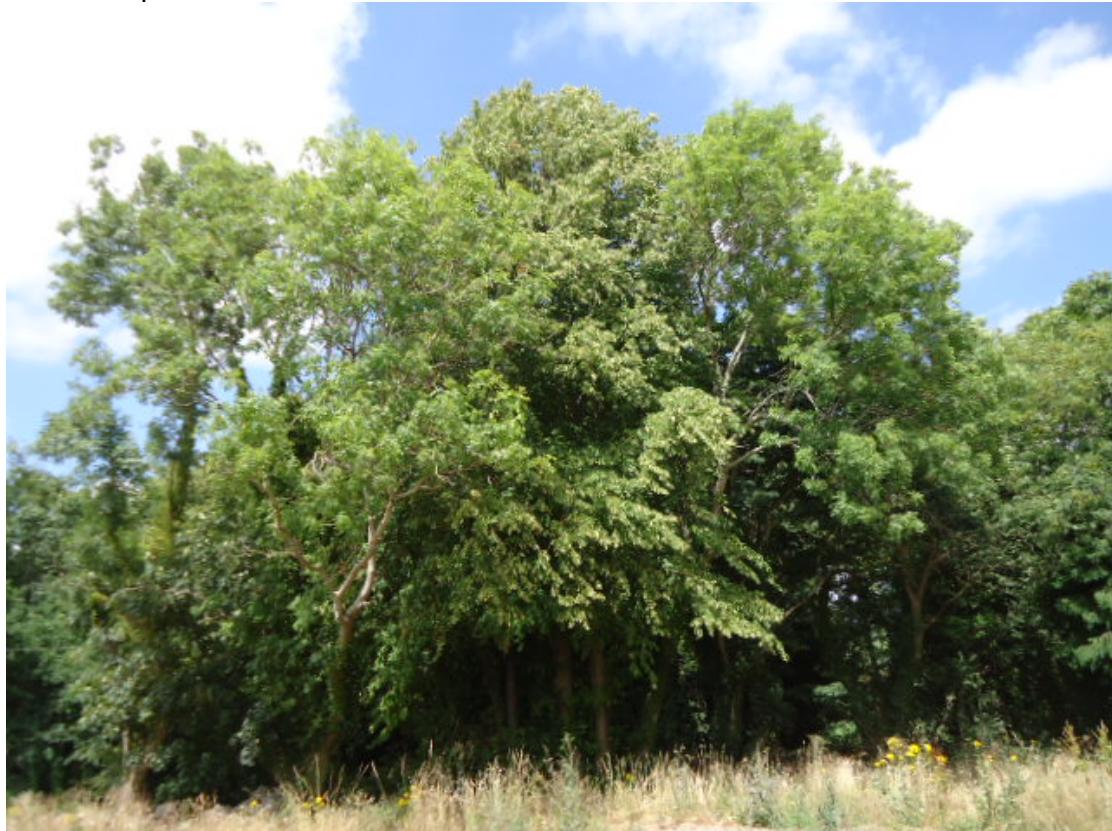
Tree Group 2 – all of this tree group is in direct conflict with the proposed road / roundabout alignment and will require to be removed. It is of moderate value.

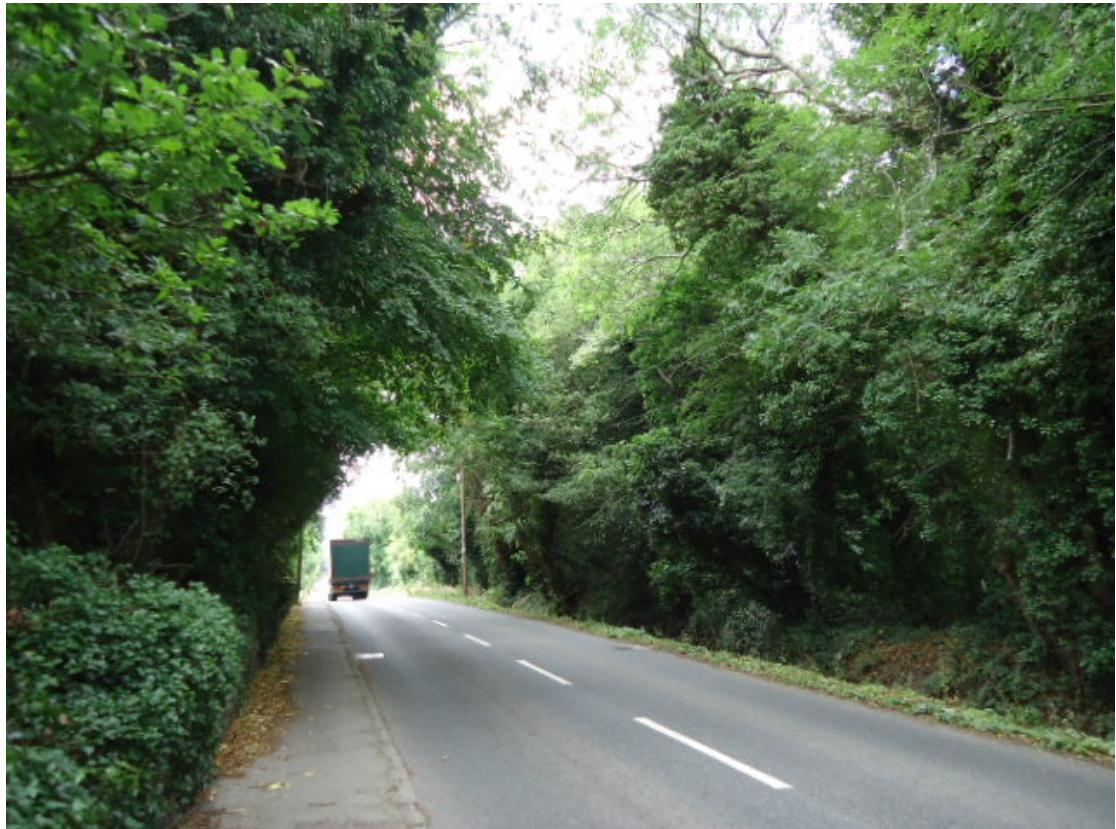
Hedgerow 7&8 (right) TG2 (left)

Hedgerow 8 – the entirety of this hedgerow will require to be removed to facilitate the passage of the proposed road and associated earthworks, it is of moderate value, with no trees of high value.

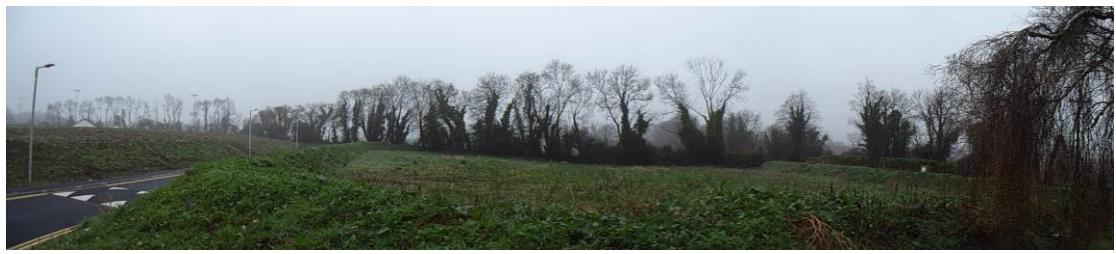
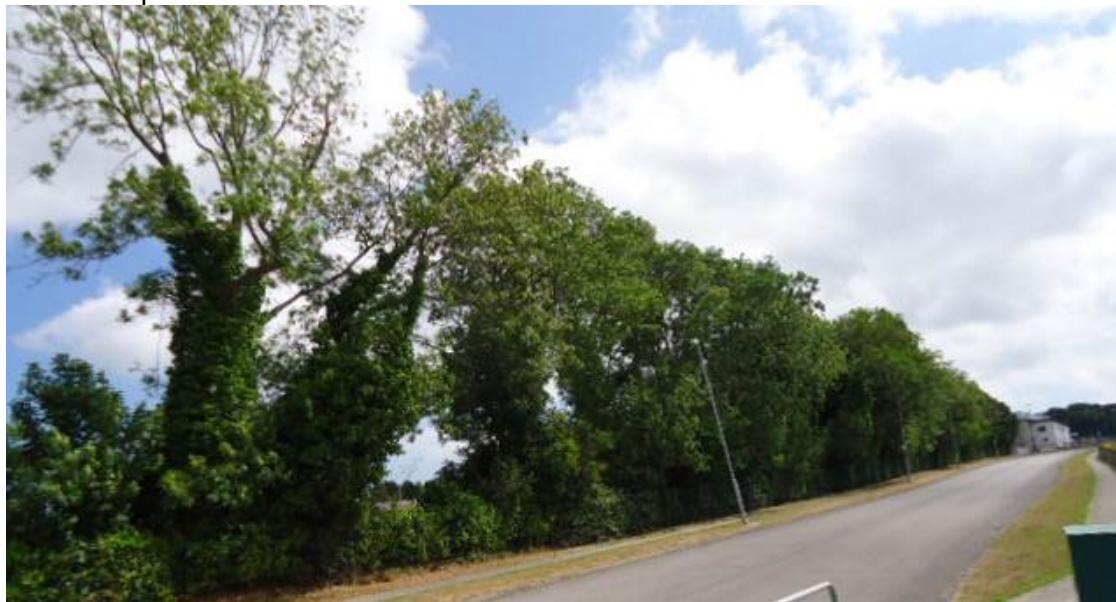
Tree Group 3 – most of this tree group (approx. 145 linear metres) is in direct conflict with the proposed road alignment / pond location and will require to be removed. The group is cumulatively of high value, composed of moderate value individual trees.

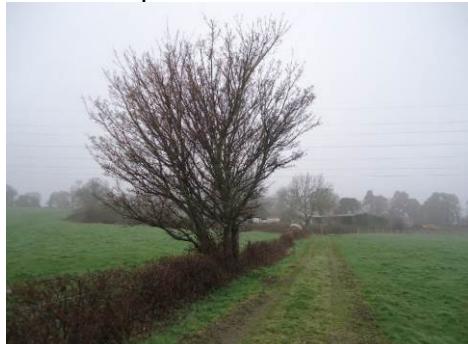
Hedgerow 9 – a portion of (approx. 30 linear metres) of this hedgerow will require to be removed to facilitate the passage of the proposed road, it is of low value with no trees of high value.

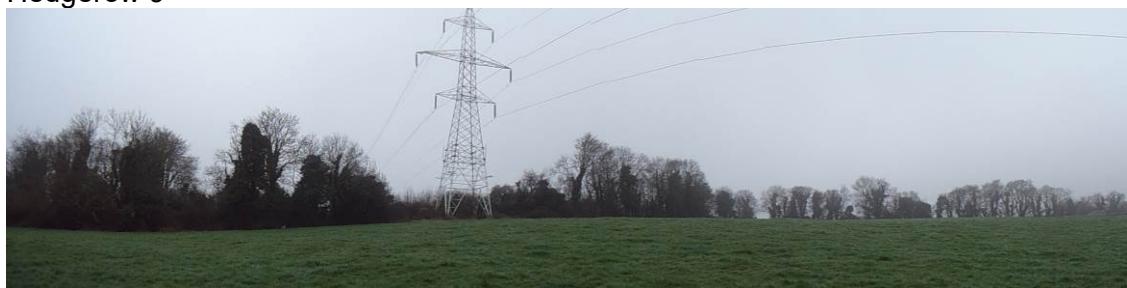
Tree Group 4 – the western most portion (approx. 30 linear metres) of this tree group is in direct conflict with the proposed road alignment and will require to be removed. It is of moderate value.

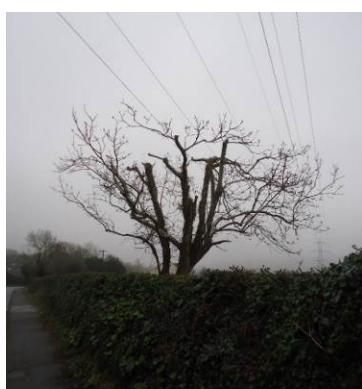
C Class (Low Value) T451/ T463

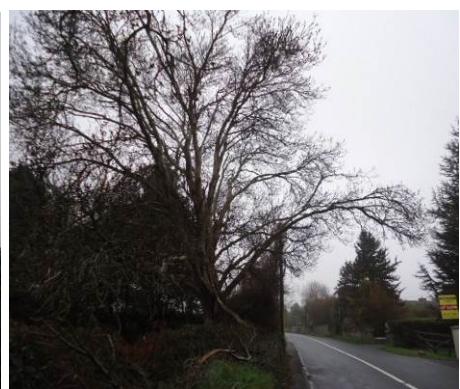
B Class (Moderate Value) T448 / T449 / T450 / T452 / T453 / T454 / T464

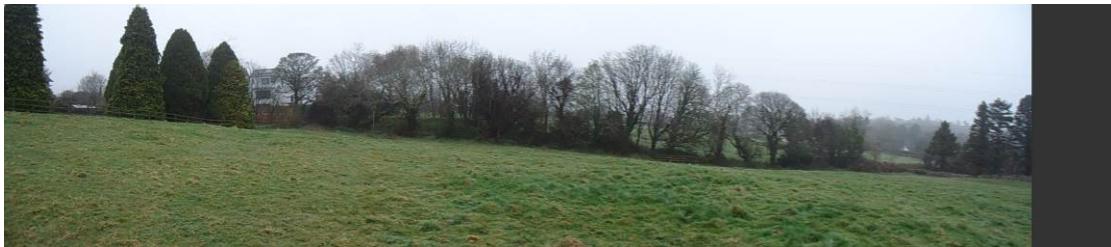
Tree Group 5 – a portion of this tree group (approx. 20 linear metres in the center) is in direct conflict with the proposed road alignment and will require to be removed. It is collectively of high value composed of moderate value individual trees.

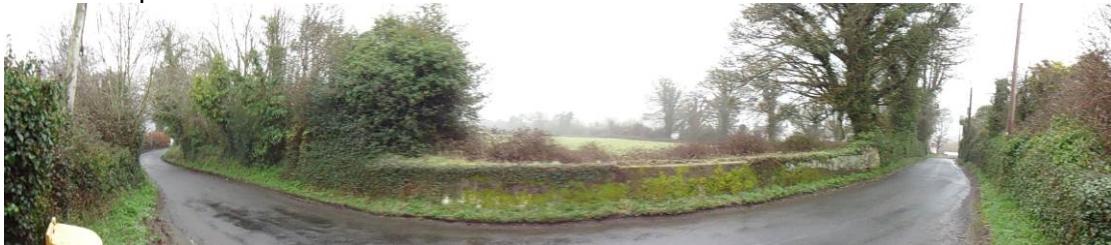
Tree Group 6 (left) / T461 (right)

Tree Group 6 – all of this small tree group is in direct conflict with the proposed road alignment and will require to be removed. It is of moderate value.

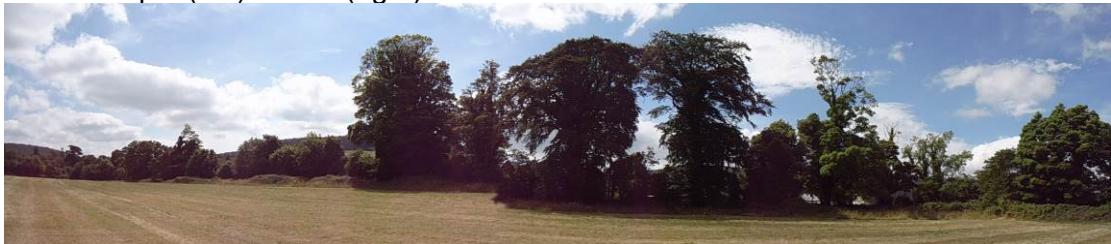
Tree Group 7 – a portion of this tree group (approx. 135 linear metres) is in direct conflict with the proposed road alignment and will require to be removed. It is cumulatively of high value composed of a mix of moderate and high value trees, however the portion in conflict contains only two high class individual trees.

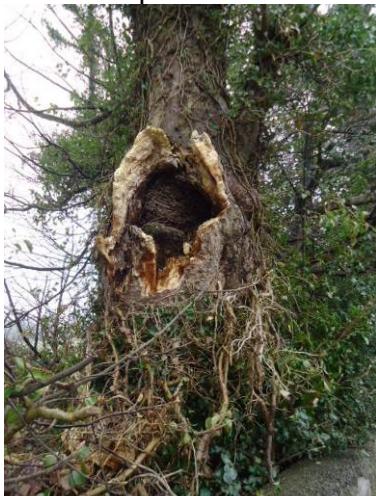
3.2 Category 'U' trees are recommended for immediate removal (felling) on general management grounds, irrespective of site development. One tree (T443, part of Tree Group 7) is assigned to category 'U'.

442	Acer pseudoplatanus	23	7/7/7/7	1100	13.20	4m all	MA	40+	Good	Fair	Remove Ivy	A1	heavily obscured
443	Acer pseudoplatanus	13	3/3/3/3	1100	13.20	3m e	MA	10<	Poor	Poor	Fell or monolith	U	large decay cavity
444	Fagus sylvatica	24	7/7/7/7	1100	13.20	3m all	MA	40+	Good	Fair	Remove Ivy & Crown Clean	A1	heavily obscured
445	Fagus sylvatica	24	8/8/8/8	1200	14.40	3m all	MA	40+	Good	Fair	Remove Ivy & Crown Clean	A1	heavily obscured
446	Acer pseudoplatanus	16	5/5/5/5	900	10.80	2m all	MA	40+	Good	Fair	Remove Ivy & Crown Clean	B1	heavily obscured
447	Acer pseudoplatanus	20	6/6/6/6	1100	13.20	2m all	MA	40+	Good	Fair	Remove Ivy & Crown Clean	A1	heavily obscured
448	Acer pseudoplatanus	18	5/5/7/5	950	11.40	3m all	MA	40+	Fair	Fair	Remove Ivy & Crown Clean	B1	fungus bracket 6m north
449	Acer pseudoplatanus	15	5/5/5/5	1000	12.00	2m all	MA	40+	Good	Fair	Remove Ivy & Crown Clean	B1	heavily obscured
450	Acer pseudoplatanus	15	6/6/7/5	900	10.80	3m all	MA	40+	Good	Fair	Remove Ivy & Crown Clean	B1	heavily obscured

3.5 T443 is a U Class tree which will require to be removed or reduced to a safe height and left as a monolith to decay safely offering important habitat value.

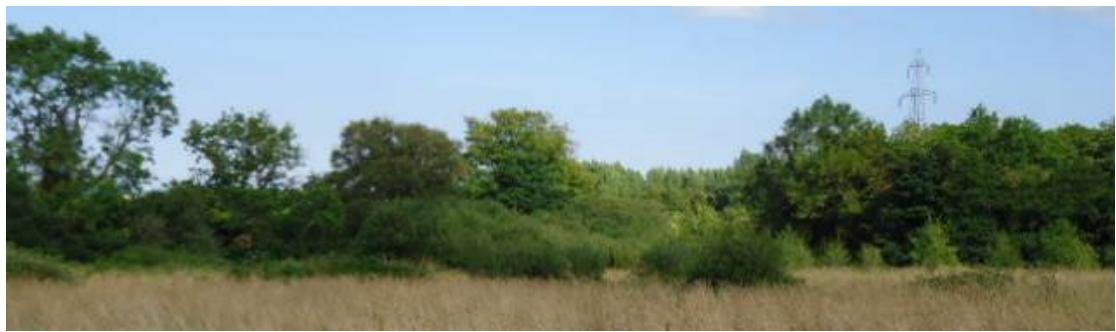
Tree Group 8 – a 40m wide corridor representing approximately half of this tree group is in direct conflict with the proposed road alignment and will require to be removed. This group is largely composed of scrub with occasional trees and it is of moderate value.

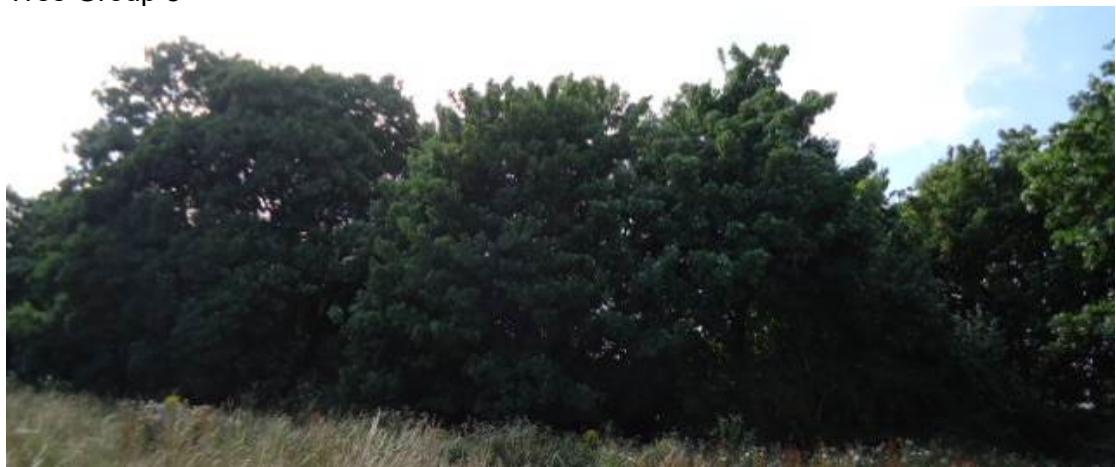
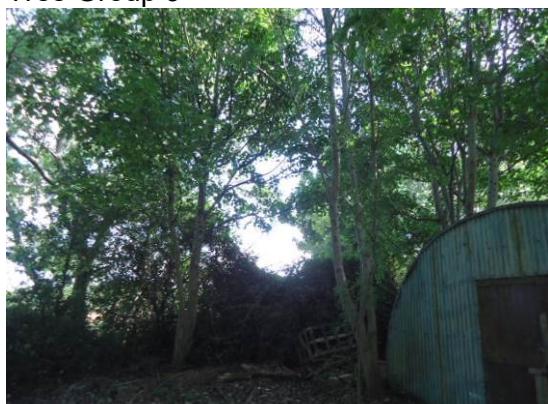
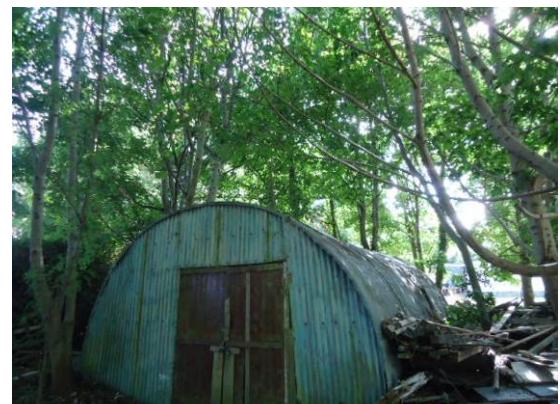
Tree Group 9 – a 35m wide corridor representing approximately a third of this tree group is in direct conflict with the proposed road alignment and will require to be removed. This group is of moderate value.

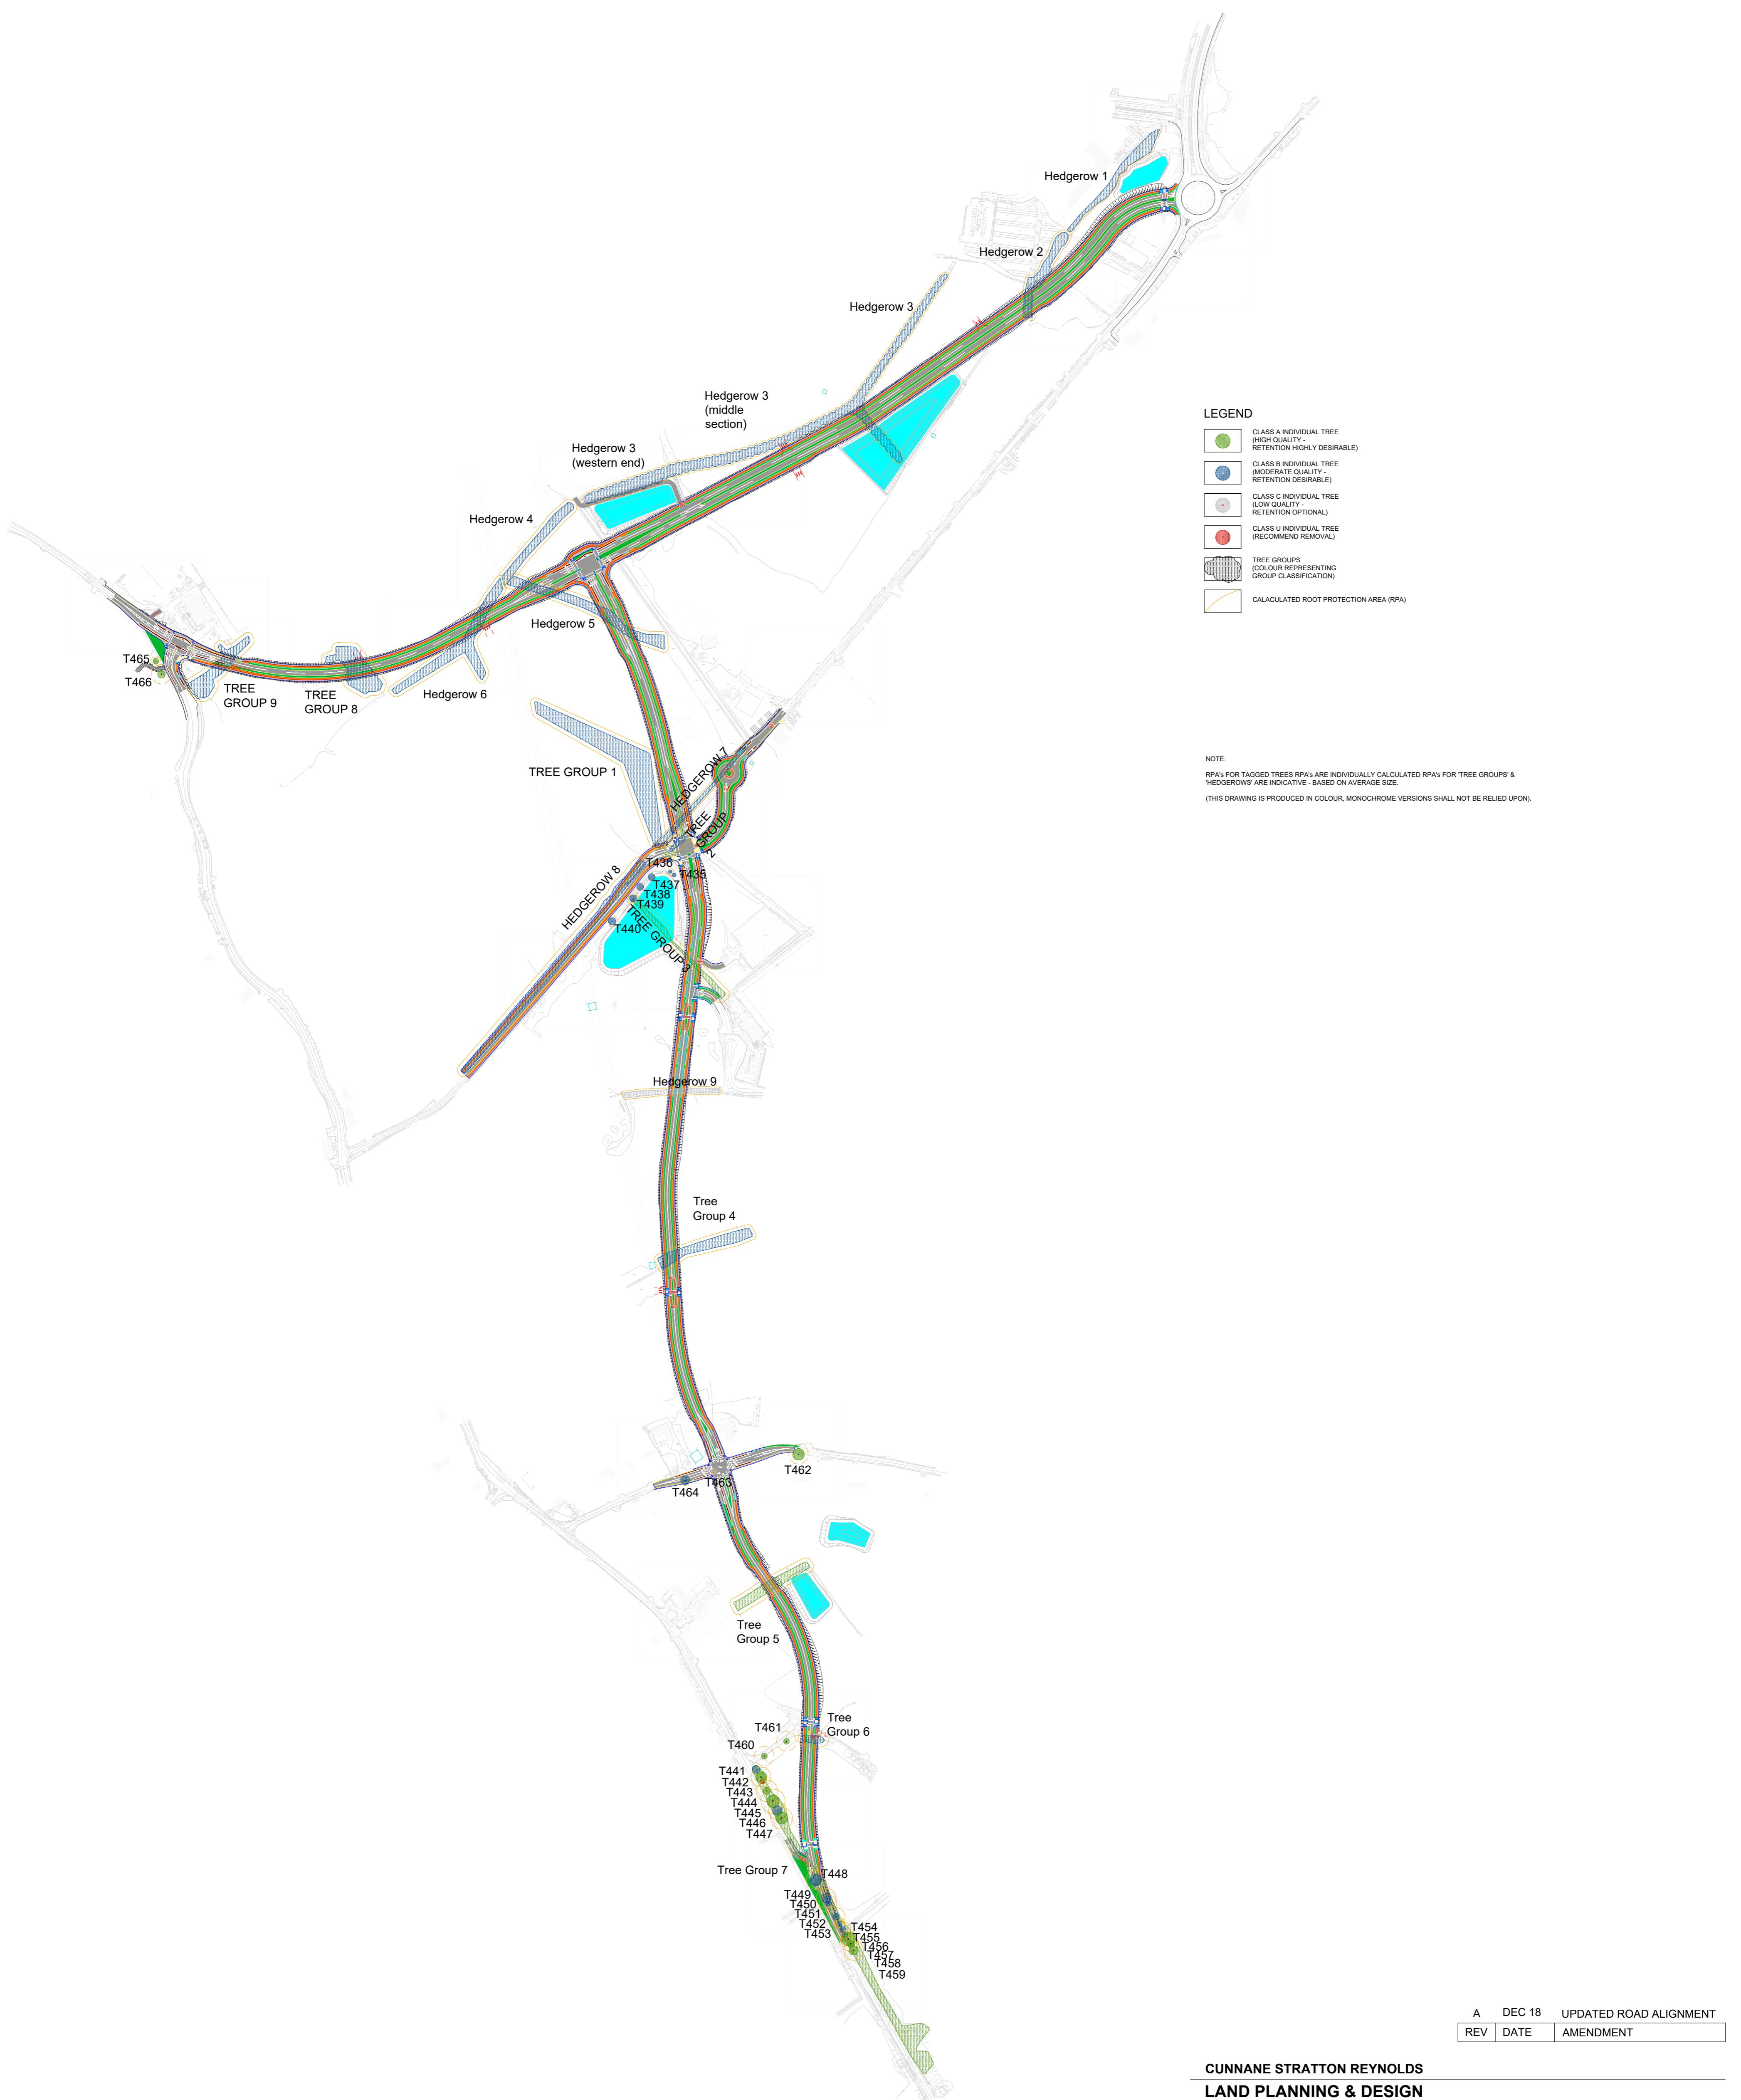
PROJECT: <b>GLENAMUCK DISTRICT DISTRIBUTOR ROAD SCHEME, CO. DUBLIN.</b>	DATE: <b>DECEMBER 2018</b>
SCALE: <b>1:4000 @ A1</b>	
DRAWN: CHECKED: <b>TREE CONSTRAINTS</b>	INIT KM
DRAWING NO: <b>18234-T-102</b>

3.4 Cognisance must also be given to indirect impacts - in particular care must be taken to ensure the proposed development and ancillary works do not represent an unacceptable conflict with the 'Root Protection Area' of the existing trees / hedgerows - as illustrated in Constraints Dwg No 18234/T/102.

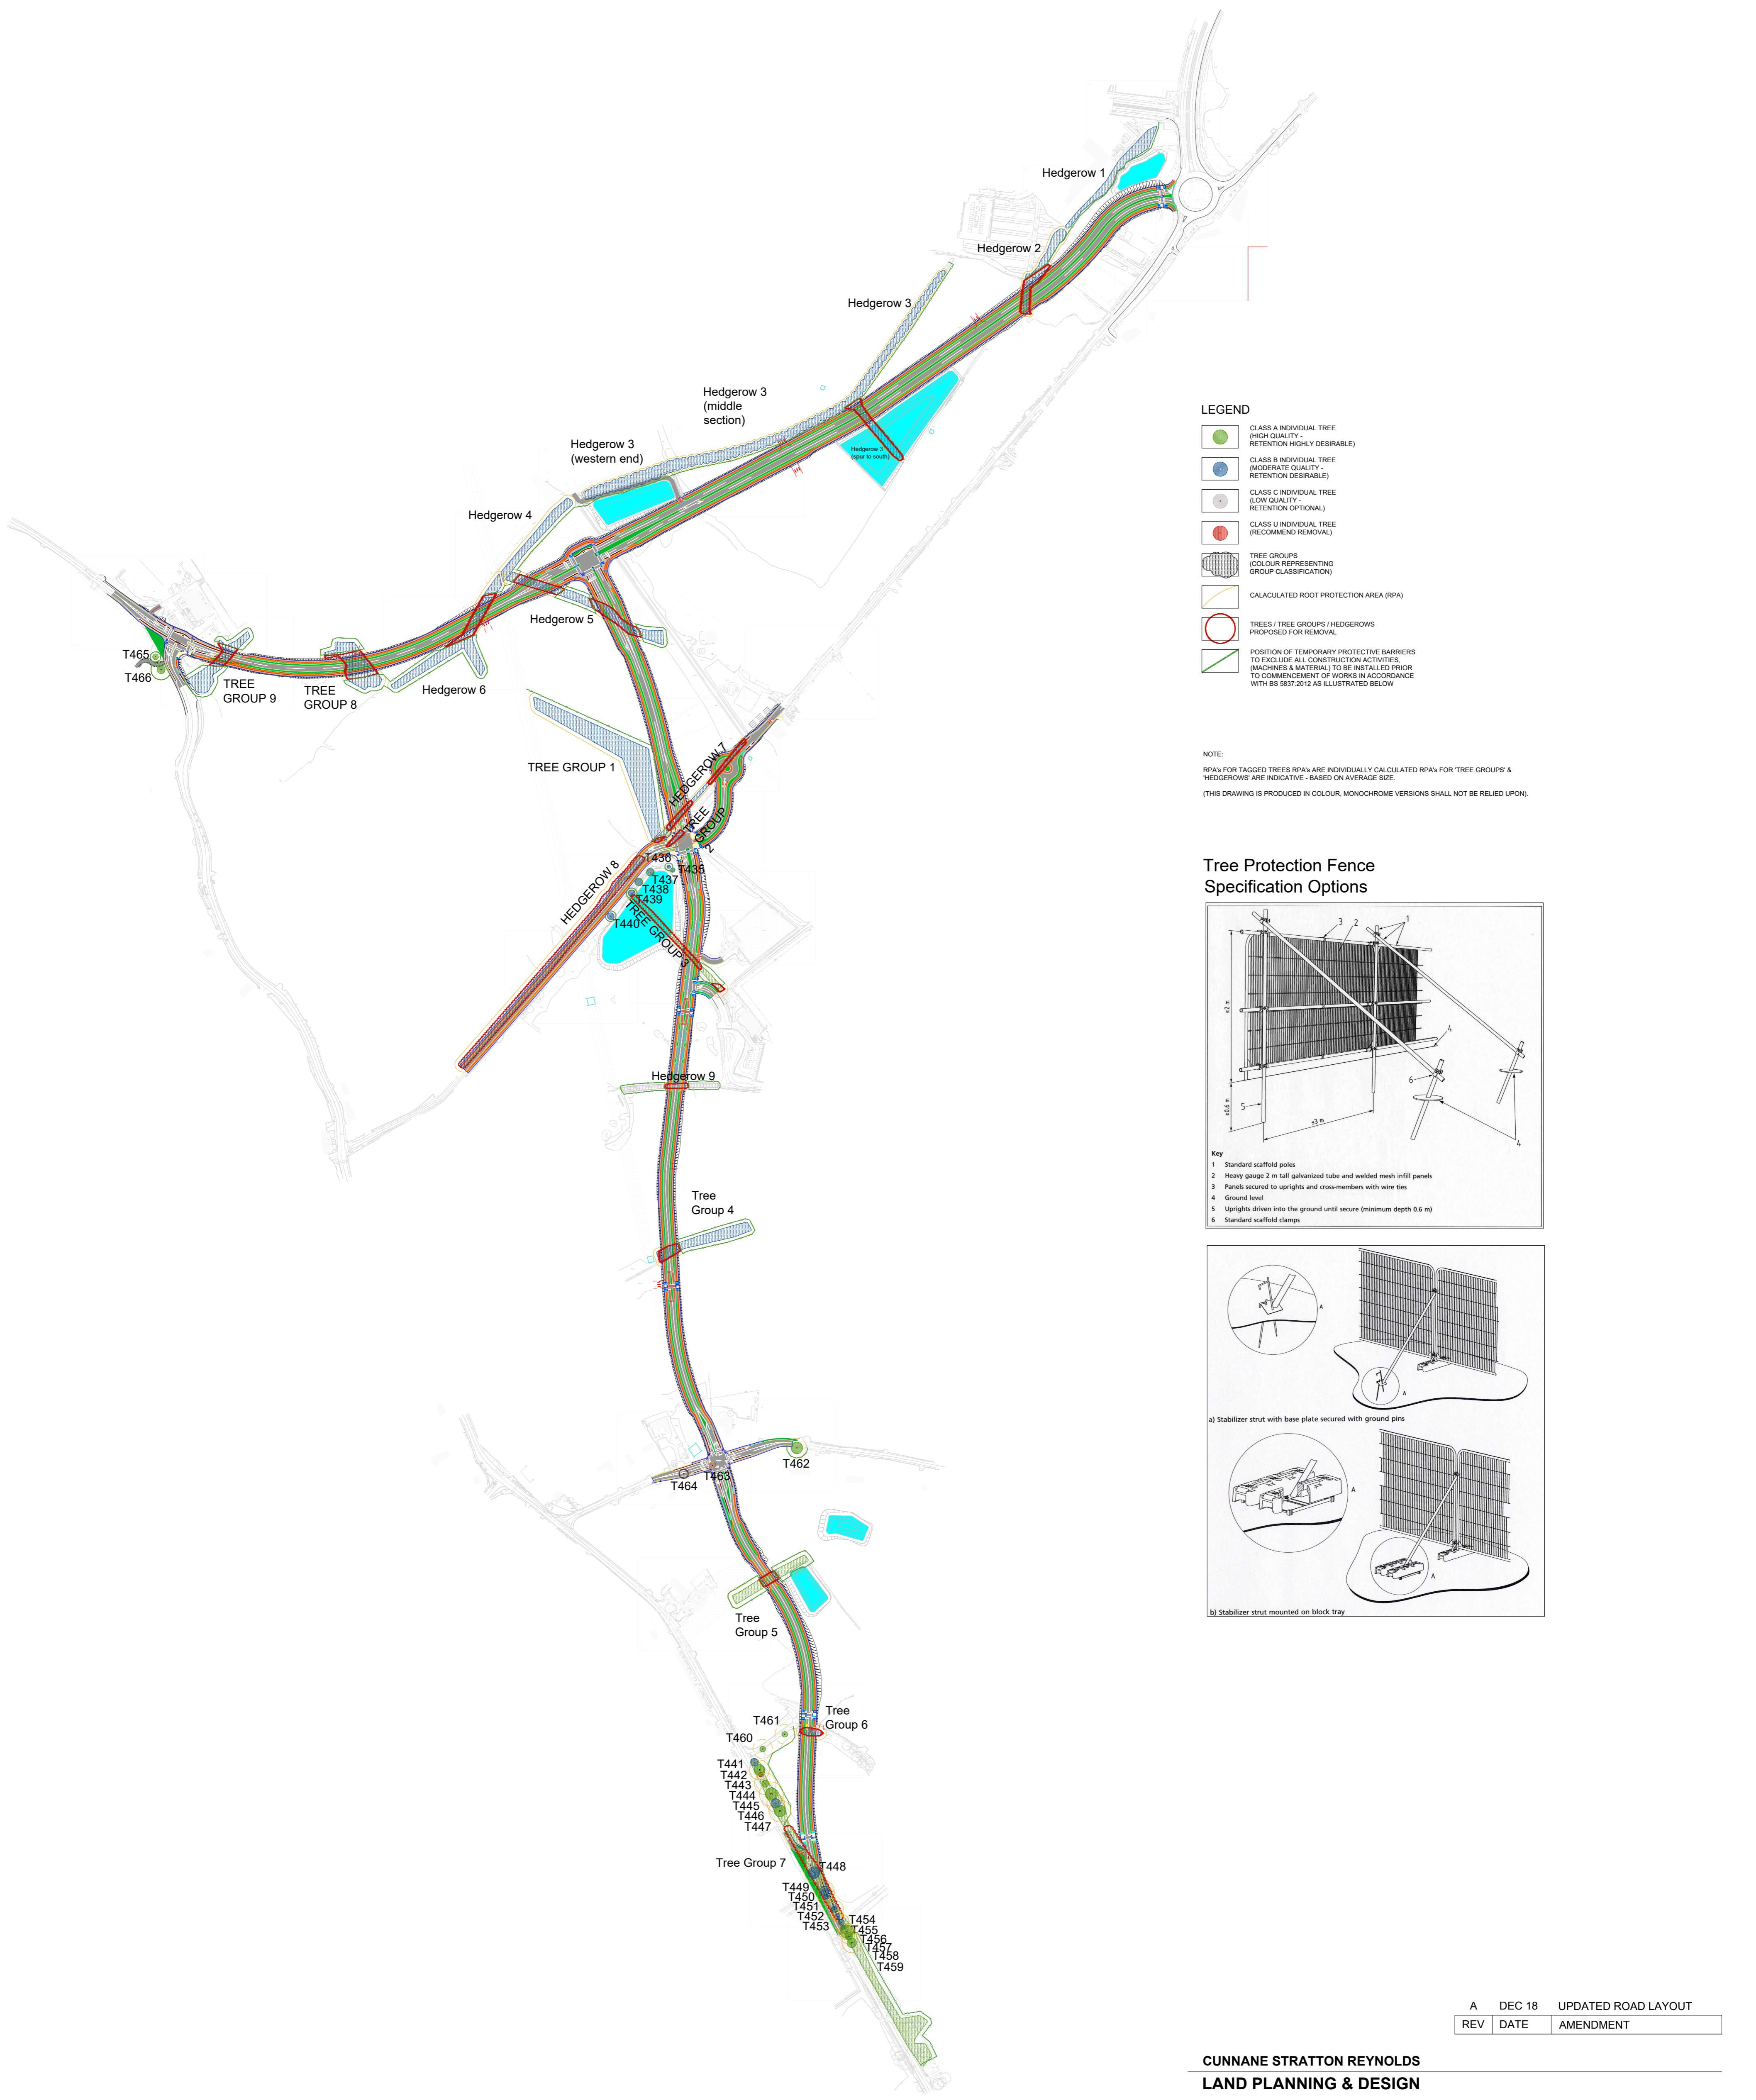
3.8 Tree Protection Areas (TPAs) are proposed, as indicated on accompanying Tree Protection Plan (Dwg No 18234\_T\_103). Protective fence line locations and details for these areas are also indicated on the plan.

Subject to the required permissions removal / felling works as specified on Dwg No No18234\_T\_103, should be performed prior to project commencement, by reputable contractors in accordance with BS 3998:2010 and current best practice. Removal of scrub vegetation and ivy clearance should preferably be performed in winter outside of the bird nesting season. Tree felling should be preceded by a competent assessment as to the presence of any protected wildlife species, where required specialist advice should be sought if necessary.

Following above permitted, priority tree works, protective fencing (barriers) should be erected in the positions and alignments as indicated on the Tree Protection Plan (Dwg No No18234\_T\_103). Fencing should be in accordance with BS 5837:2012 unless otherwise agreed with the planning authority. Commencement of development should not be permitted without adequate protective fencing being in place. This fencing, enclosing the minimum tree protection areas indicated, must be installed prior to any plant, vehicle or machinery access on site. Fencing should be signed 'Tree Protection Area – No Construction Access'. Fencing is not to be taken down or re-positioned without written approval of the project Arborist. No excavation, plant or vehicle movement, materials handling or soil storage is to be permitted within the fenced tree protection areas indicated on plan.
