Opera Site, Limerick.

EXISTING HISTORIC BUILDINGS - OVERVIEW

21 SUNDAYS WELL ROAD, CORK

June 2018 (Initially surveyed February 2017)

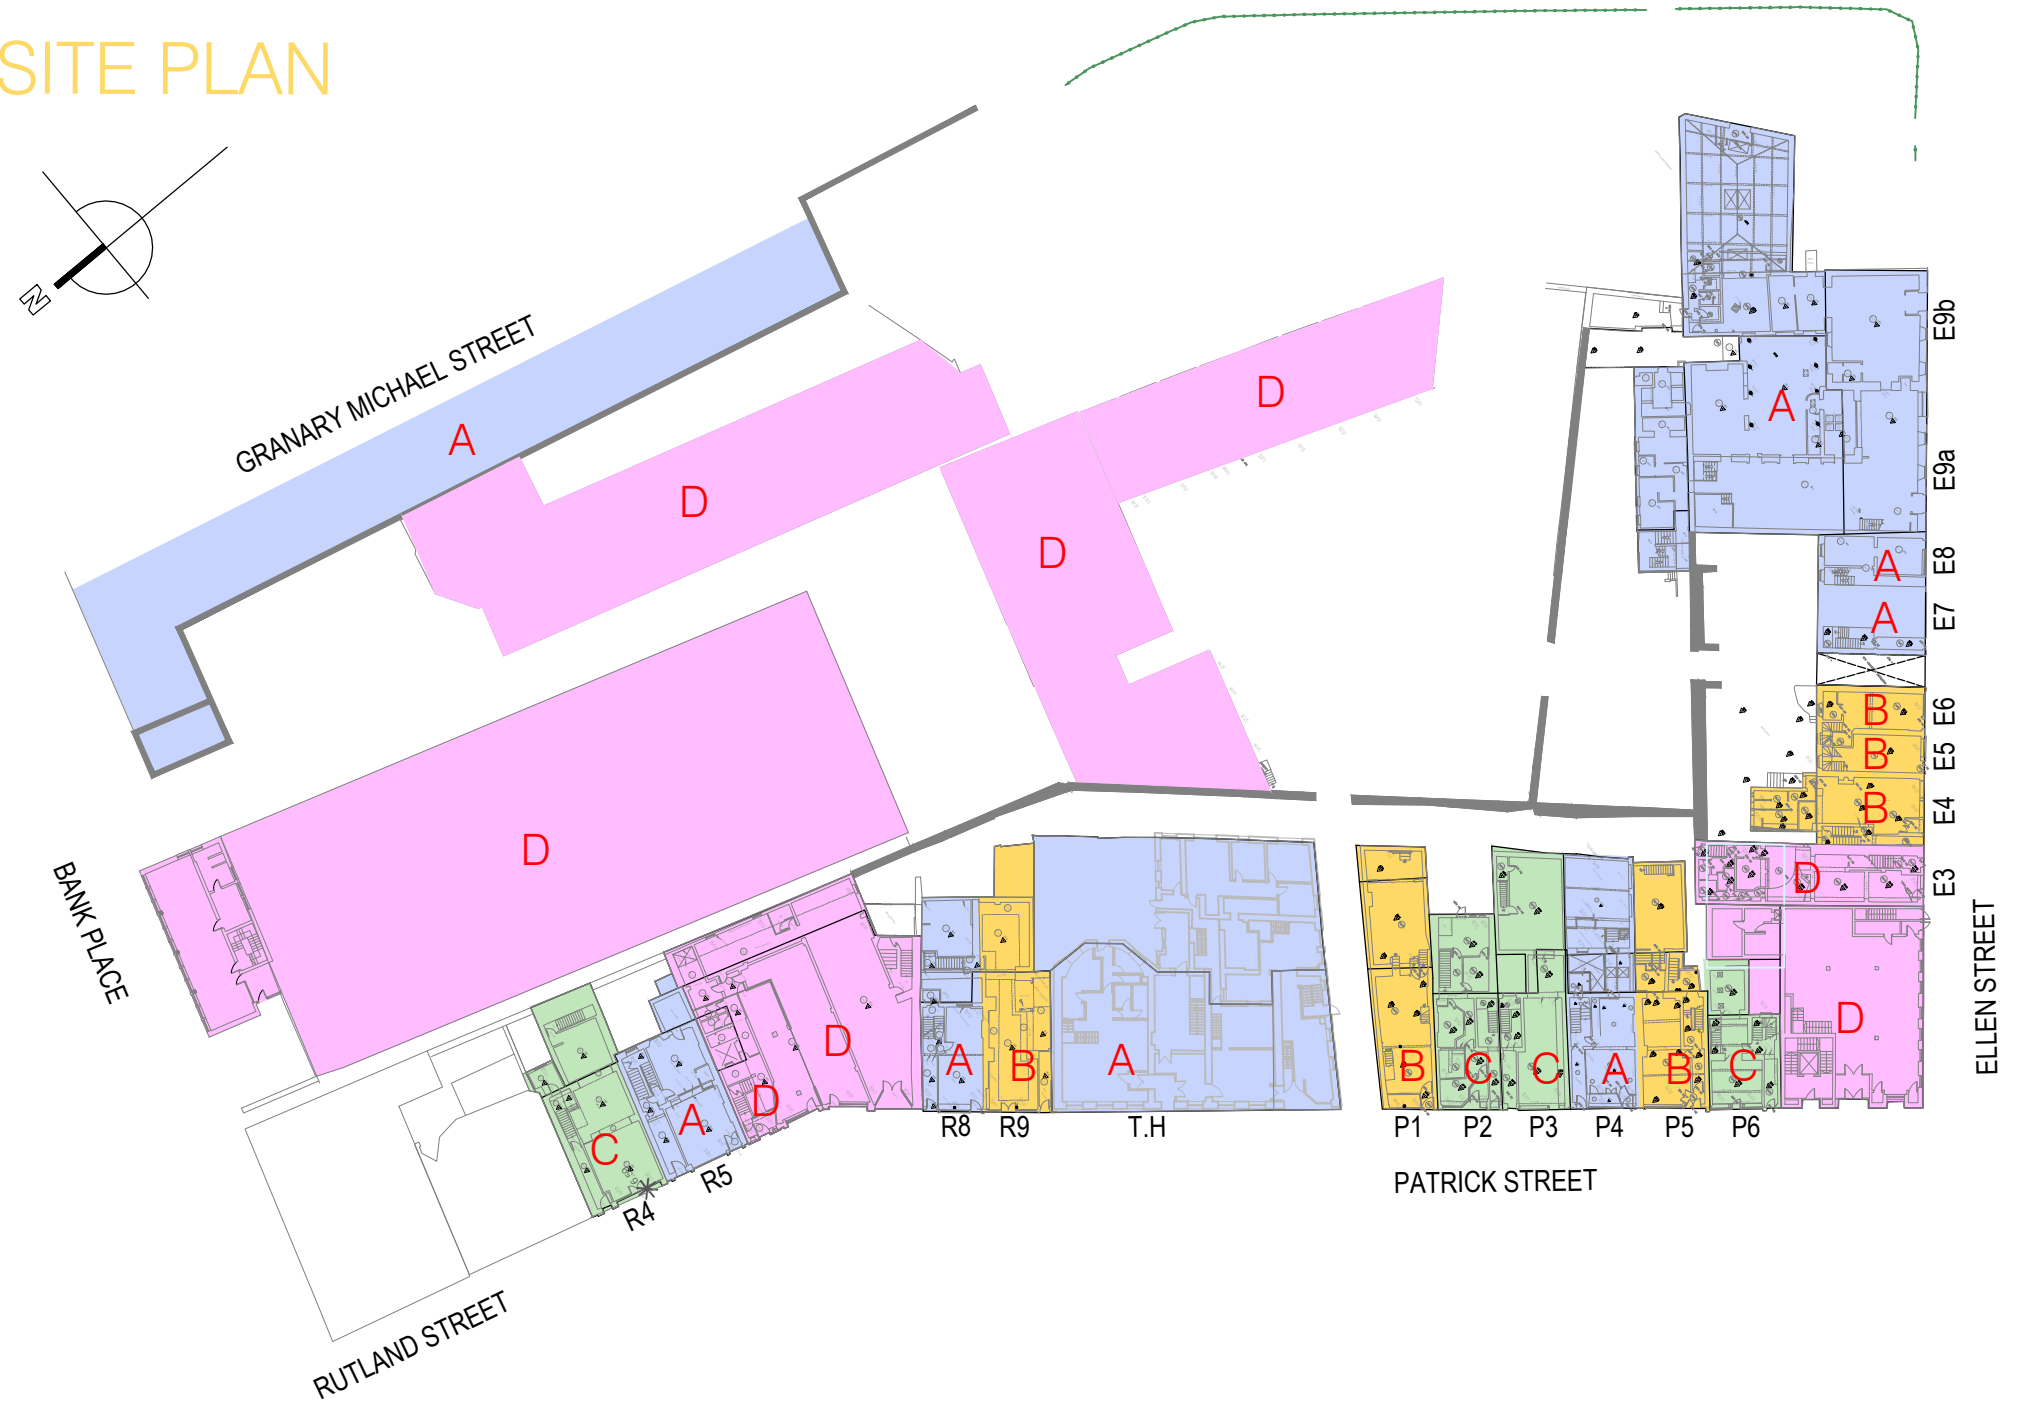
SITE PLAN

CONSERVATION CATEGORIES

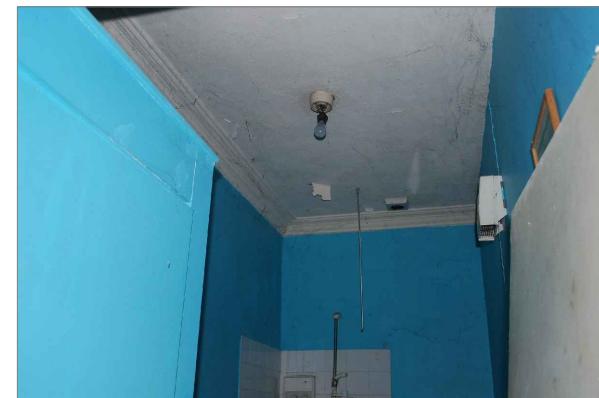
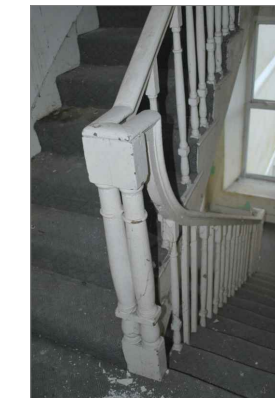
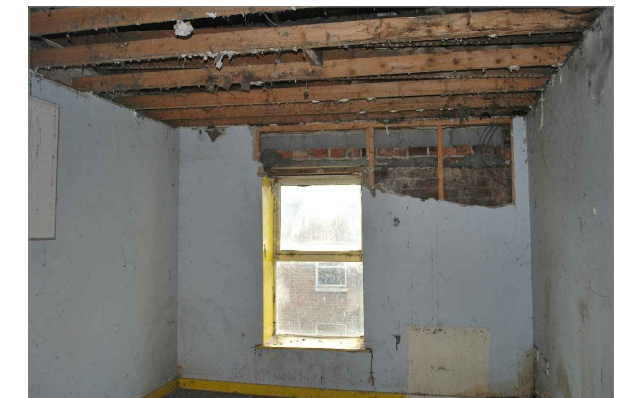
Address	Building Description	RPS	NIAH Candidate Protected Structure	Previous Planning Decision	Conservation Category	Assessment of Significance	Condition Issues/LCC Remedial Works/ Feb. 2017 Survey Notes
4 Ellen St	E. 19th C, No. 4 Ellen Street is a terraced two-bay four-storey over basement house having a modern shopfront inserted to the ground floor. The front elevation is of exposed Flemish bond brick with the rear elevation of rubble stone construction having brick to the window openings.	N/A	N/A	P08/173 PL 30.231180	B	This building retains its original roof trusses. Staircase is modern to lower floors, original stair intact to upper floors. Plan form is retained. Remains of a substantial building can be seen to the rear of this terrace of houses on Ellen Street. This can be seen to have been a large stone building, having brick to the openings.	Covered by Punch's Conservation Issues Report. LCC remedial works carried out. Floors reinforced. Parapet rebuilt.

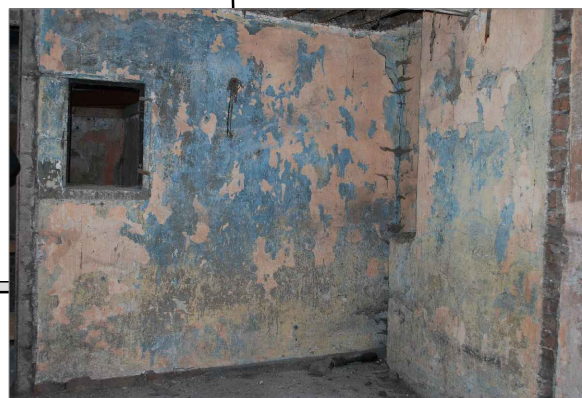
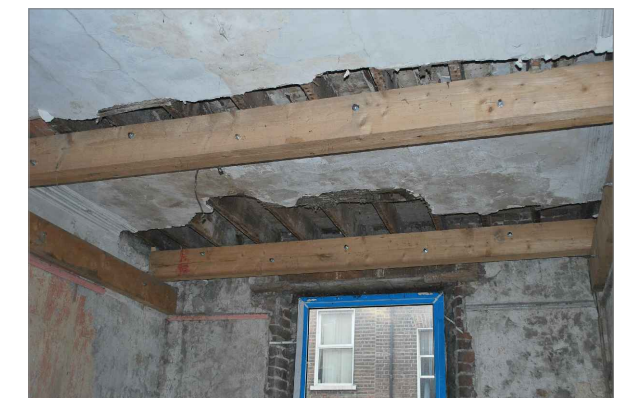
<p>E. 19th C, No. 5 Ellen Street is a terraced single bay four-storey over basement house having a small modern shopfront inserted to the ground floor. The front elevation is of exposed Flemish bond brick with the rear elevation of rubble stone construction having brick to the window openings.</p>	N/A	N/A	P08/173 PL 30.231180	B	<p>The building appears to comprise half of a larger, two bay building which was subdivided. The building is in poor condition but retains early features and finishes, including a staircase.</p> <p>The rear elevation forms a complete elevation with the adjoining terraced buildings on Ellen Street, without singular yards or other divisions between the properties.</p>	<p>Covered by Punch's Conservation Issues Report.</p> <p>LCC remedial works carried out. Floors reinforced allowing access throughout. Parapet rebuilt. Original roof lost – metal profile roof.</p>

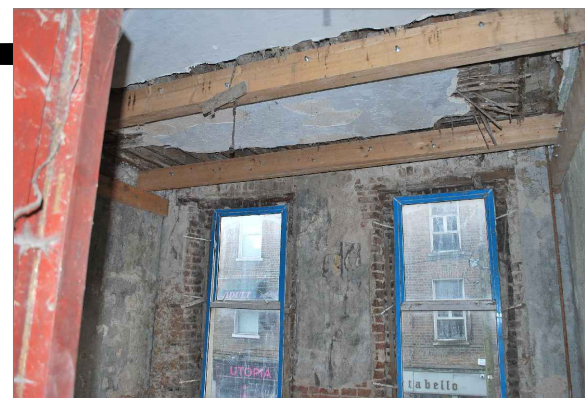
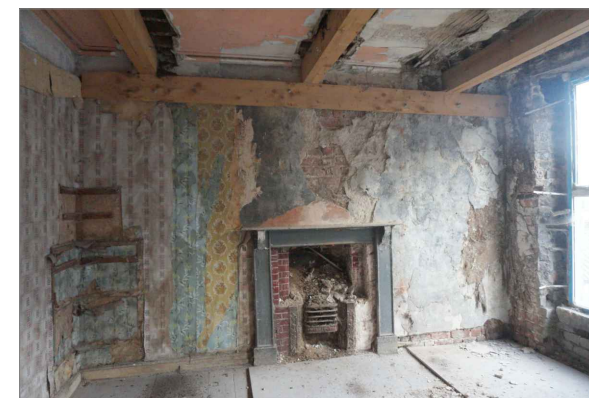
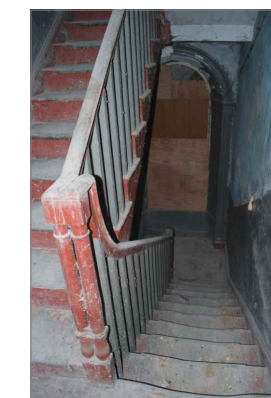
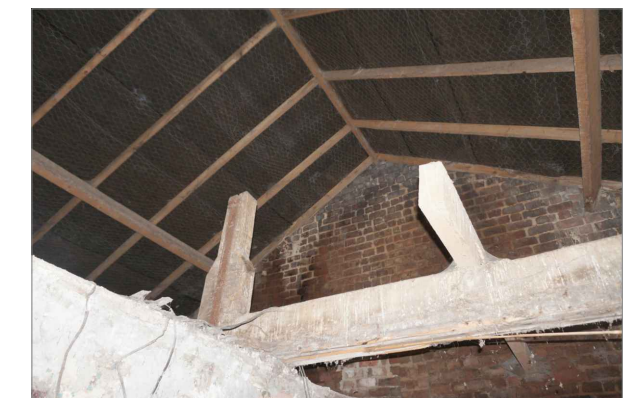
<p>No. 8 Ellen Street is a terraced two-bay four-storey over basement house having a shopfront inserted to the ground floor, probably in the later 19th century. The front elevation is of exposed Flemish bond brick with the rear elevation of rubble stone construction having brick to the window openings.</p> <p>Rear as to Ellen St. 5-7</p>	N/A	N/A	Whole building conserved and repaired. Laid out so as to open onto the street (in addition to any connection to into the new development)	A	<p>The rear elevation forms a complete elevation with the adjoining terraced buildings on Ellen Street, without singular yards or other divisions between the properties.</p> <p>The interior of this building retains the majority of its original features, including the staircase, doors, fireplaces, cornices, timber floors, etc.</p>	<p>Covered by Punch's Conservation Issues Report.</p> <p>LCC remedial works carried out. Floors reinforced allowing access throughout. Parapet rebuilt. Original roof lost - metal profile roof. Deterioration halted by these works.</p>

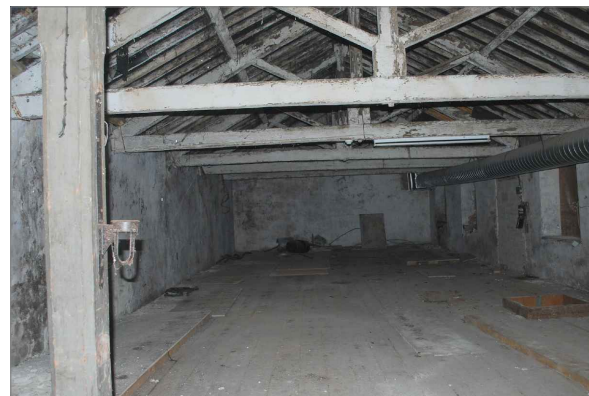
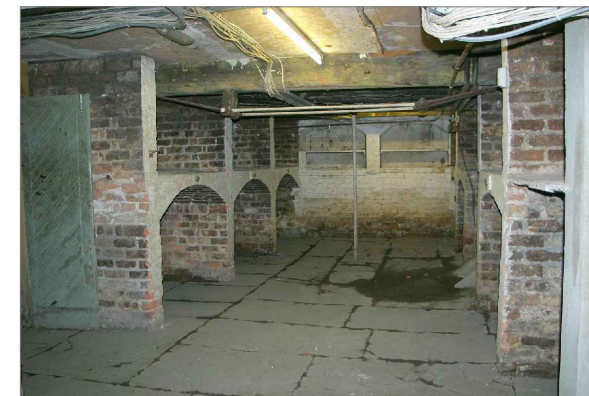
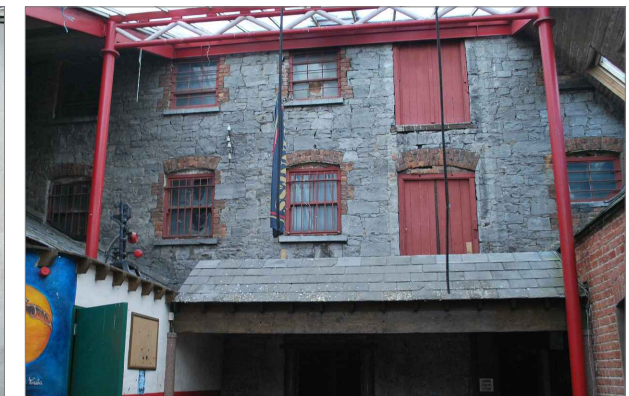
<p>The building found at 9 and 9a Ellen Street originally comprised the complex of buildings which formed John Quinn and Co.'s Wholesale Grocers and Wine Stores which was established in the late 19th century.</p> <p>Upper floors of thick timber boards supported on cast iron columns. Stone flags and brick wine vaults to basement.</p>	N/A	Reg. No. 21513018 Candidate Protected Structure	P08/173 PL 30.231180	A	<p>This complex of buildings is likely to incorporate an earlier structure (predating John Quinn's) dating from the late 18th or early 19th century.</p> <p>Basement extends along Ellen St under pavement across Nos. 7 & 8, extending in to the front area of these basements.</p>	<p>Covered by Punch's Conservation Issues Report.</p> <p>No LCC remedial works carried out. Structural condition of the building generally good. Small area of water ingress visible at upper level, party wall with No. 8. Upper floors retain post and truss structure and original floor boards. Cellar also intact.</p>

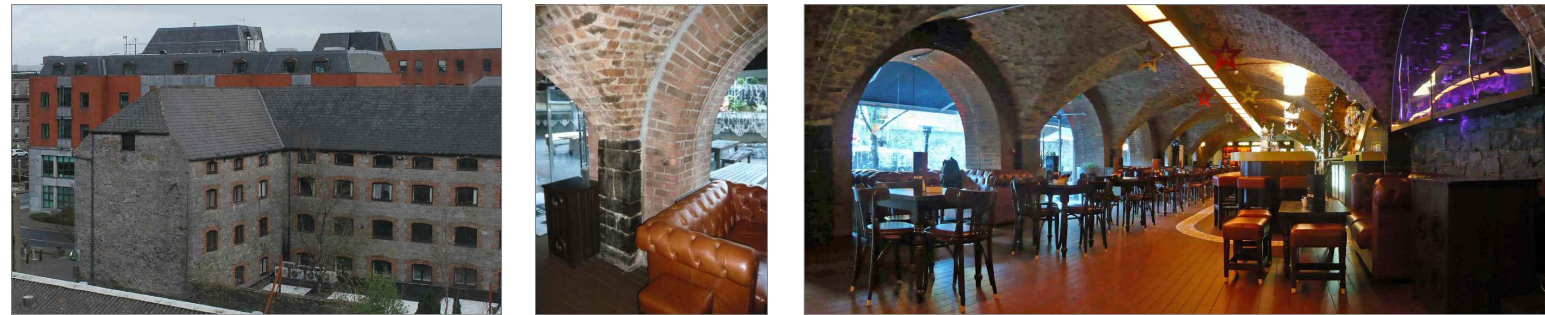
GRANARY MICHAEL STREET

The granary building is one of the earliest known multiple storey warehouses to be built in Limerick. The ground on which the building was constructed was bought by Philip Roche in 1787. The interior of the granary was almost completely gutted during the 1980s conversion, with all floors, supporting piers or columns, stairs etc. removed. The only internal element to be retained was the brick vaulting to the basement/lower ground floor.	RPS 272 Gate piers and iron gates within curtilage.	Reg. No. 21513017 Limestone gate piers and decorative gates included on NIAH listing.	Full retention with visual separation between historic building and new development	A	No internal fabric of architectural significance known to survive, with the exception of the ground floor vaulted ceiling.	Punch's Conservation Issues Report does not include this building. LCC remedial works not carried out to this building.
