# REMEDIAL ENVIRONMENTAL IMPACT ASSESSMENT REPORT

SUBSTITUTE CONSENT APPLICATION FOR AN EXISTING  
SAND AND GRAVEL PIT AT  
ROSCAT, TULLOW,  
CO. CARLOW

Earth Science Partnership Ire. Ltd  
Tonranny  
Westport  
Co. Mayo  
April 2019

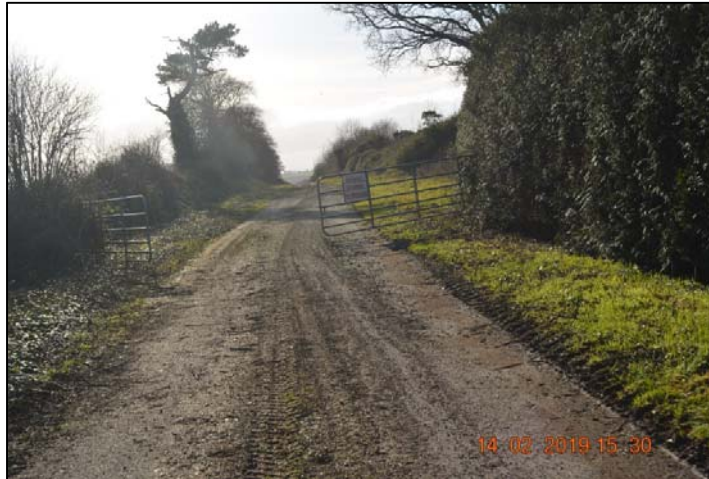
**Plate 6.1: The access track (BL3) to the application area.**

The paved access track (BL3) runs from the main entrance to the site coming from the N81 road and along the south-eastern boundary of the application area (Plate 6-1). As with the adjacent arable field, the track is bordered on both sides by mature hedgerows and treelines.

**Evaluation:** The access track, which is categorized as BL3 is considered to be of low ecological value and as such is evaluated as being of Local Importance (Lower Value).

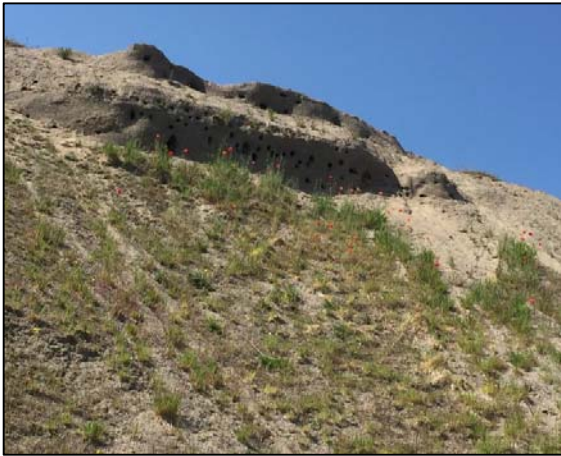
**Plate 6.3:** Sparsely vegetated sand stockpile containing a breeding Sand Martin colony.

There are a number of stockpiles of exposed sand and gravel within the worked area of the application site. A breeding Sand Martin (*Riparia riparia*) colony exists in the largest stockpile, which is located in the southwest of the worked area (Plate 6-2). There were approximately 50 nest entrances recorded within the colony.

**Evaluation:** Given that presence of a breeding colony of Sand Martin within this habitat, onsite exposed sand, gravel and till is considered to be of Local Importance (Higher Value).

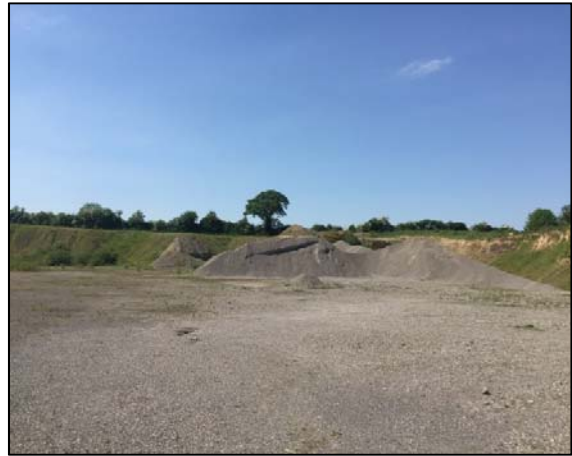
**Plate 6.2:** One of a number of sand/gravel stockpiles within the worked area of the application site.

Some of these stockpiles have become sparsely vegetated with various recolonising species such as Colt's Foot (*Tussilago farfara*), Scutch Grass (*Elymus repens*), Common Poppy (*Papaver rhoeas*) and Creeping Buttercup (*Ranunculus repens*) (Plate 6-3).

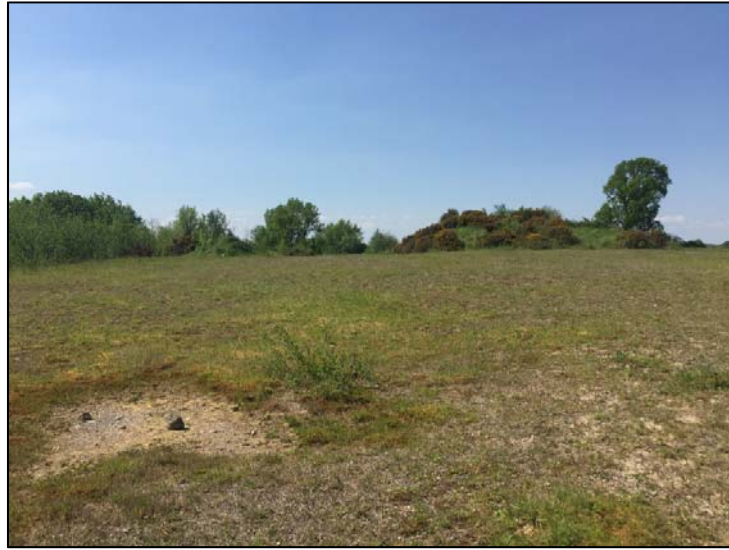
**Plate 6.4:** Recolonising bare ground in the south-western section of the worked area of the application site.

There are a number of areas of recolonising bare ground throughout the worked section of the application area. These mainly occur along the boundaries of the worked area where sand and gravel have been extracted and the exposed faces have been left to recolonise. The largest area of this habitat is located in the south-eastern section of the worked section where overburden from the original pit was placed and levelled (Plate 6-4). The recolonization is patchy and the sward is low suggesting that the sandy substrate is not particularly fertile. Typical colonising species occur such as Greater Plantain (*Plantago major*), Knotgrass (*Polygonum aviculare*), Pineappleweed (*Matricaria discoidea*) and Shepherd's-purse (*Capsella bursa-pastoris*). Grasses are usually also present but should not dominate.

**Evaluation:** Given its low species diversity and tight sward, recolonising bare ground is considered to be of Local Importance (Lower Value).

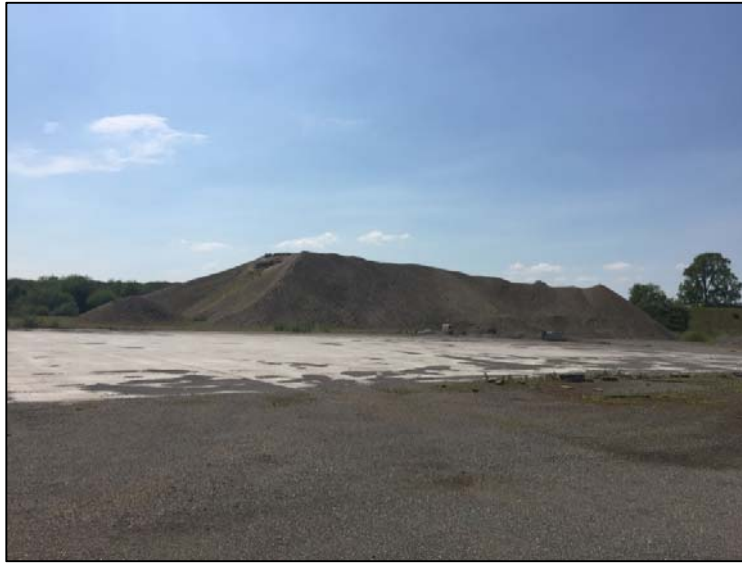
**Plate 6.5:** The central area of the worked sand and gravel pit within the south-western half of the application area which can be categorised as ED4 owing to the lack of colonisation of plants.

This habitat is the second most dominant habitat within the application area (Plate 6-5). Sand and gravel were extracted from this area in the past; however, the area has not been worked on an ongoing basis since approximately 2008. Nonetheless, the substrate of compacted gravel has only been colonised very sparsely by typical colonisers and weed plants such as Greater Plantain (*Plantago major*), Knotgrass (*Polygonum aviculare*), Pineappleweed (*Matricaria discoidea*) and Shepherd's-purse (*Capsella bursa-pastoris*).

**Evaluation:** Given its lack of recolonization this area of the sand and gravel pit is considered to be of Local Importance (Lower Value).

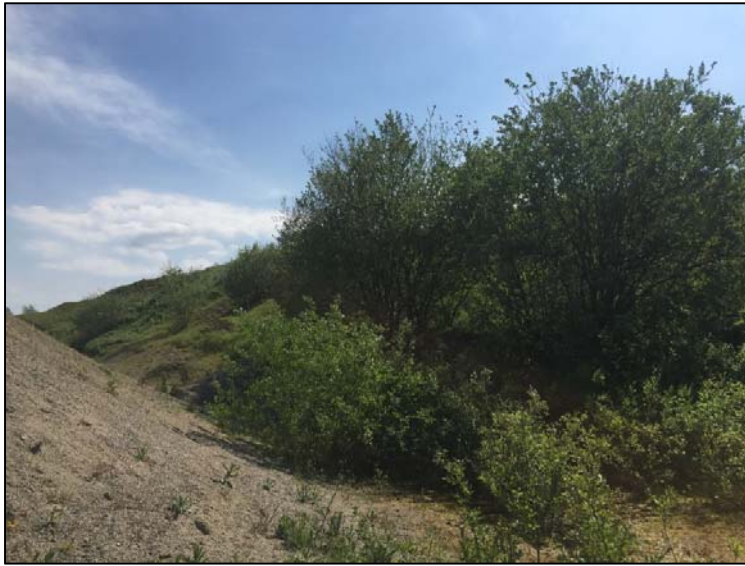
**Plate 6.6:** Patches of scrub occur primarily in the southern section of the worked area of the site.

Pockets of scrub habitat occur at various locations within the worked area of the application site primarily in the southwest of the site along the boundary and on an area of overburden also in that area (Plate 6-6). The species composition of the scrub habitat is primarily willow (*Salix spp.*) and gorse (*Ulex europaeus*). This habitat is of benefit to breeding birds for nesting and foraging purposes.

**Evaluation:** Although a higher value semi-natural habitat, given the absence of heath and calcareous grassland, there is no potential correspondence with the EU Annex I habitat *Juniperus communis* formations on heaths or calcareous grasslands [5130]. Given its foraging and nesting potential for general breeding bird species, scrub habitat is considered to be of Local Importance (Higher Value).

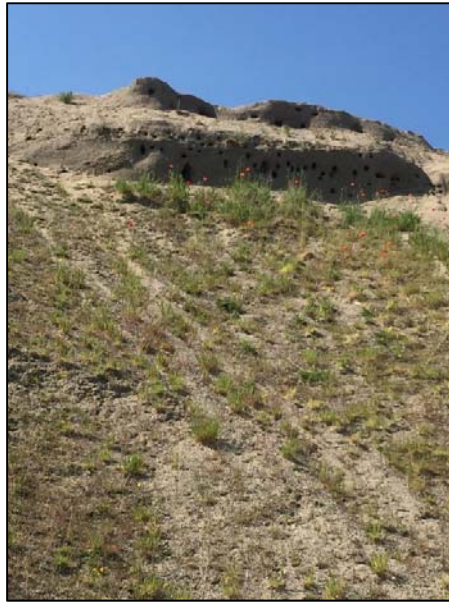
**Plate 6.7:** Breeding Sand Martins nesting in a stockpile of sand onsite.

The site survey recorded the presence of a number of bird species. All were common countryside species. The presence of pockets of scrub and hedgerows makes for suitable nesting and roosting sites for a range of these species. A total of 10 species were recorded in the Substitute Consent application area (Table 6-12). No species cited as Red-listed under the Birds of Conservation Concern in Ireland (Colhoun and Cummins, 2014) were recorded during the walk-over survey. A colony breeding Sand Martin (*Riparia riparia*) was also recorded nesting in an onsite stockpile of sand (Plate 6-7). There were approximately 50 nest entrances recorded within the colony. This is an Amber-listed species (Colhoun and Cummins, 2014).

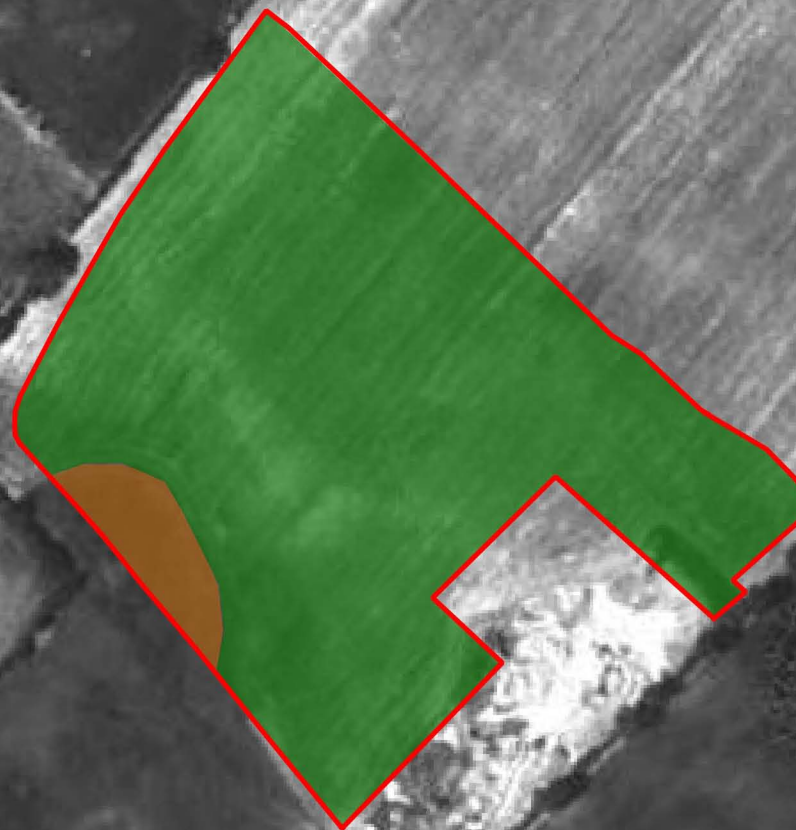
Figure: 6.5

As also illustrated in Figure 6.5, there was a relatively small area of what is assumed to be wet grassland in the middle of the western boundary of the Substitute Consent area. From the assessment of aerial imagery taken in 1995, this habitat appears to be an extension of the adjacent Ardristan fen (Figure 6.5). As the aerial imagery from 1995 is in black and white, this cannot be fully confirmed, however, given the shallow, well-drained mineral soils with alkaline signature beneath the majority of the site and that there also appeared to be drainage along western boundary of the site, it is likely that this habitat was not fen but indeed, wet grassland.

Ardristan Fen pNHA was an area that was permanently or seasonably saturated and supported flora and fauna tuned to these hydrological conditions and its historical condition prior to the extraction of the Substitute Consent area are shown in Figure 6.7. The aerial photography from 1995, as shown in Figure 6.5, illustrates that there were a number of established farm tracks crossing the fen. These tracks were most likely for agricultural use and would have substantially altered the hydrological regime of the fen resulting in a loss of water dependant botanical species.

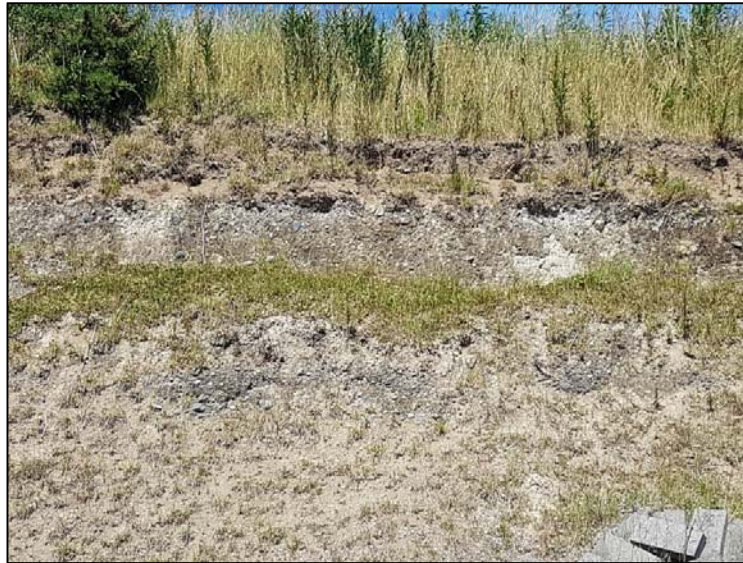
Multiple exposures of sub-vertical sand and gravel faces of up to 7 m, generally along the northern extents of the worked out area reveal the nature of targeted material. A typical exposure exhibits rounded to sub-rounded intermixed limestone gravels and cobbles, up to 100 mm in diameter. On the whole, material is generally poorly sorted but interbedded in places with (i) lenses of well-sorted coarse-grained sands and (ii) rounded gravels and cobbles (<50 mm) in a coarse sand matrix. The multiple layering doesn't necessarily follow surface topography when considered in 3 dimensions and this is attributed to the chaotic environment under which this material was deposited. A typical example of the exposed pit face (northern quarry boundary) is shown in Plate 7.1.

**Plate 7-1:** View of exposed pit face in northern portion of site.

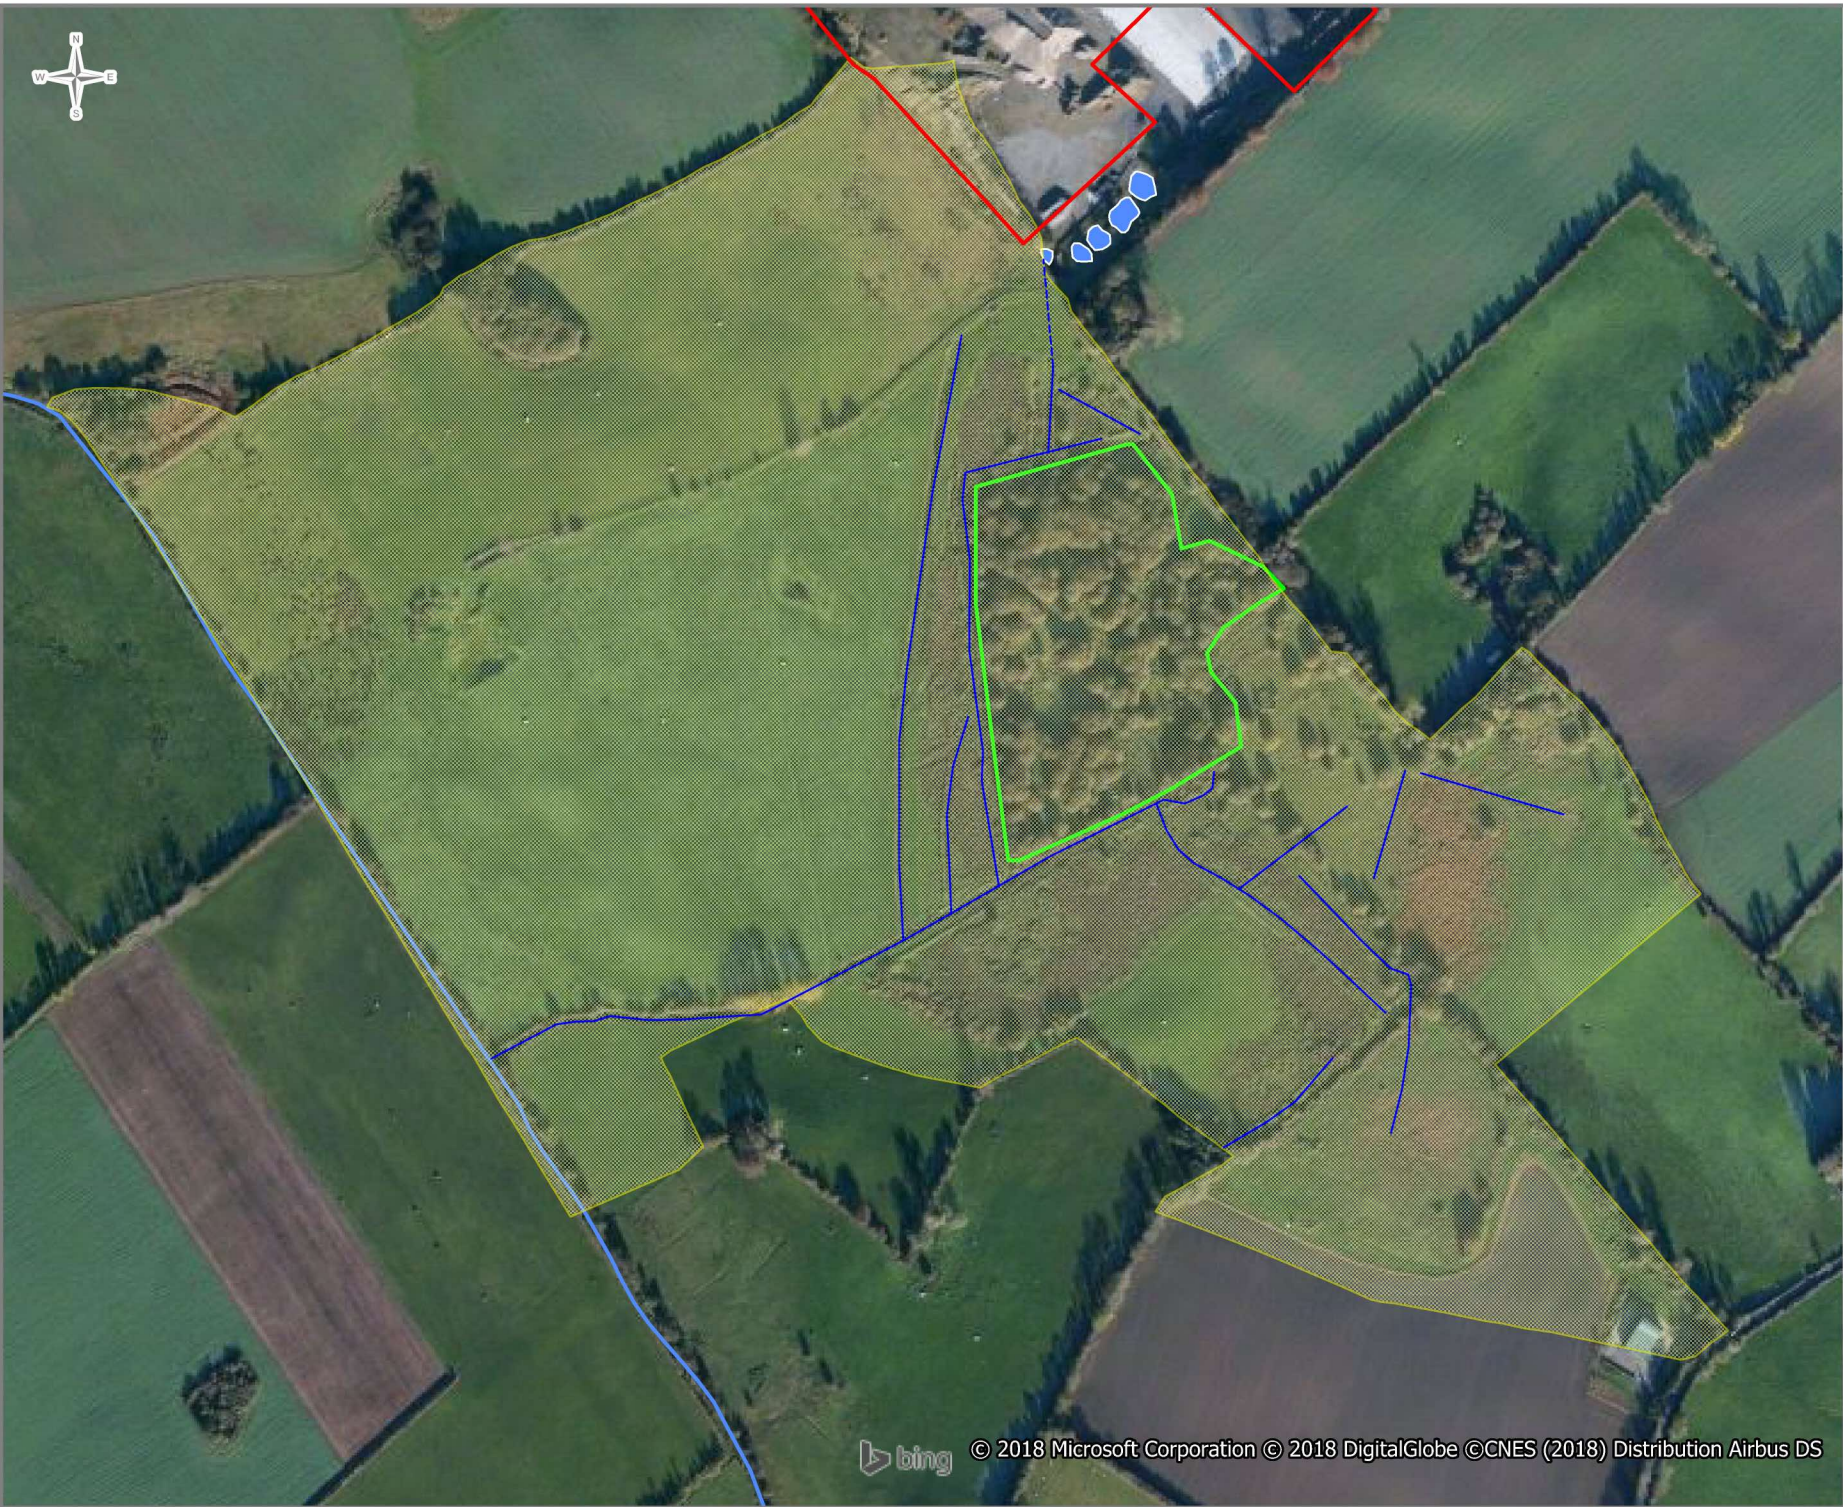
Fig. 8.4:	Surface Water & Groundwater Catchment
Date:	September 2018
Author:	C. O'Reilly
Scale:	1 : 20 000
Client:	Earth Science Partnership
No.:	1679
Project:	rEIAR Section: Water
Location:	Roscat, Tullow, Co. Carlow

The site lies within the surface water catchment of the Roscat Stream, which flows in a southeast to northwest direction, passing the site 520 m to the southwest. The stream has a catchment of 5.9 km<sup>2</sup> as it passes adjacent to the site (see Figure 8.4). The stream rises approximately 2 km southeast of the site in a topographical depression at Aghade. It outfalls to the Burren River just north of Rathtoe, which subsequently enters the River Barrow at Carlow Town.

The estimated area contributing groundwater to the fen (NPWS extents) based on topographical divides and inferred groundwater flow direction is shown in Figure 8.4. In this scenario the application site is upgradient of the fen.

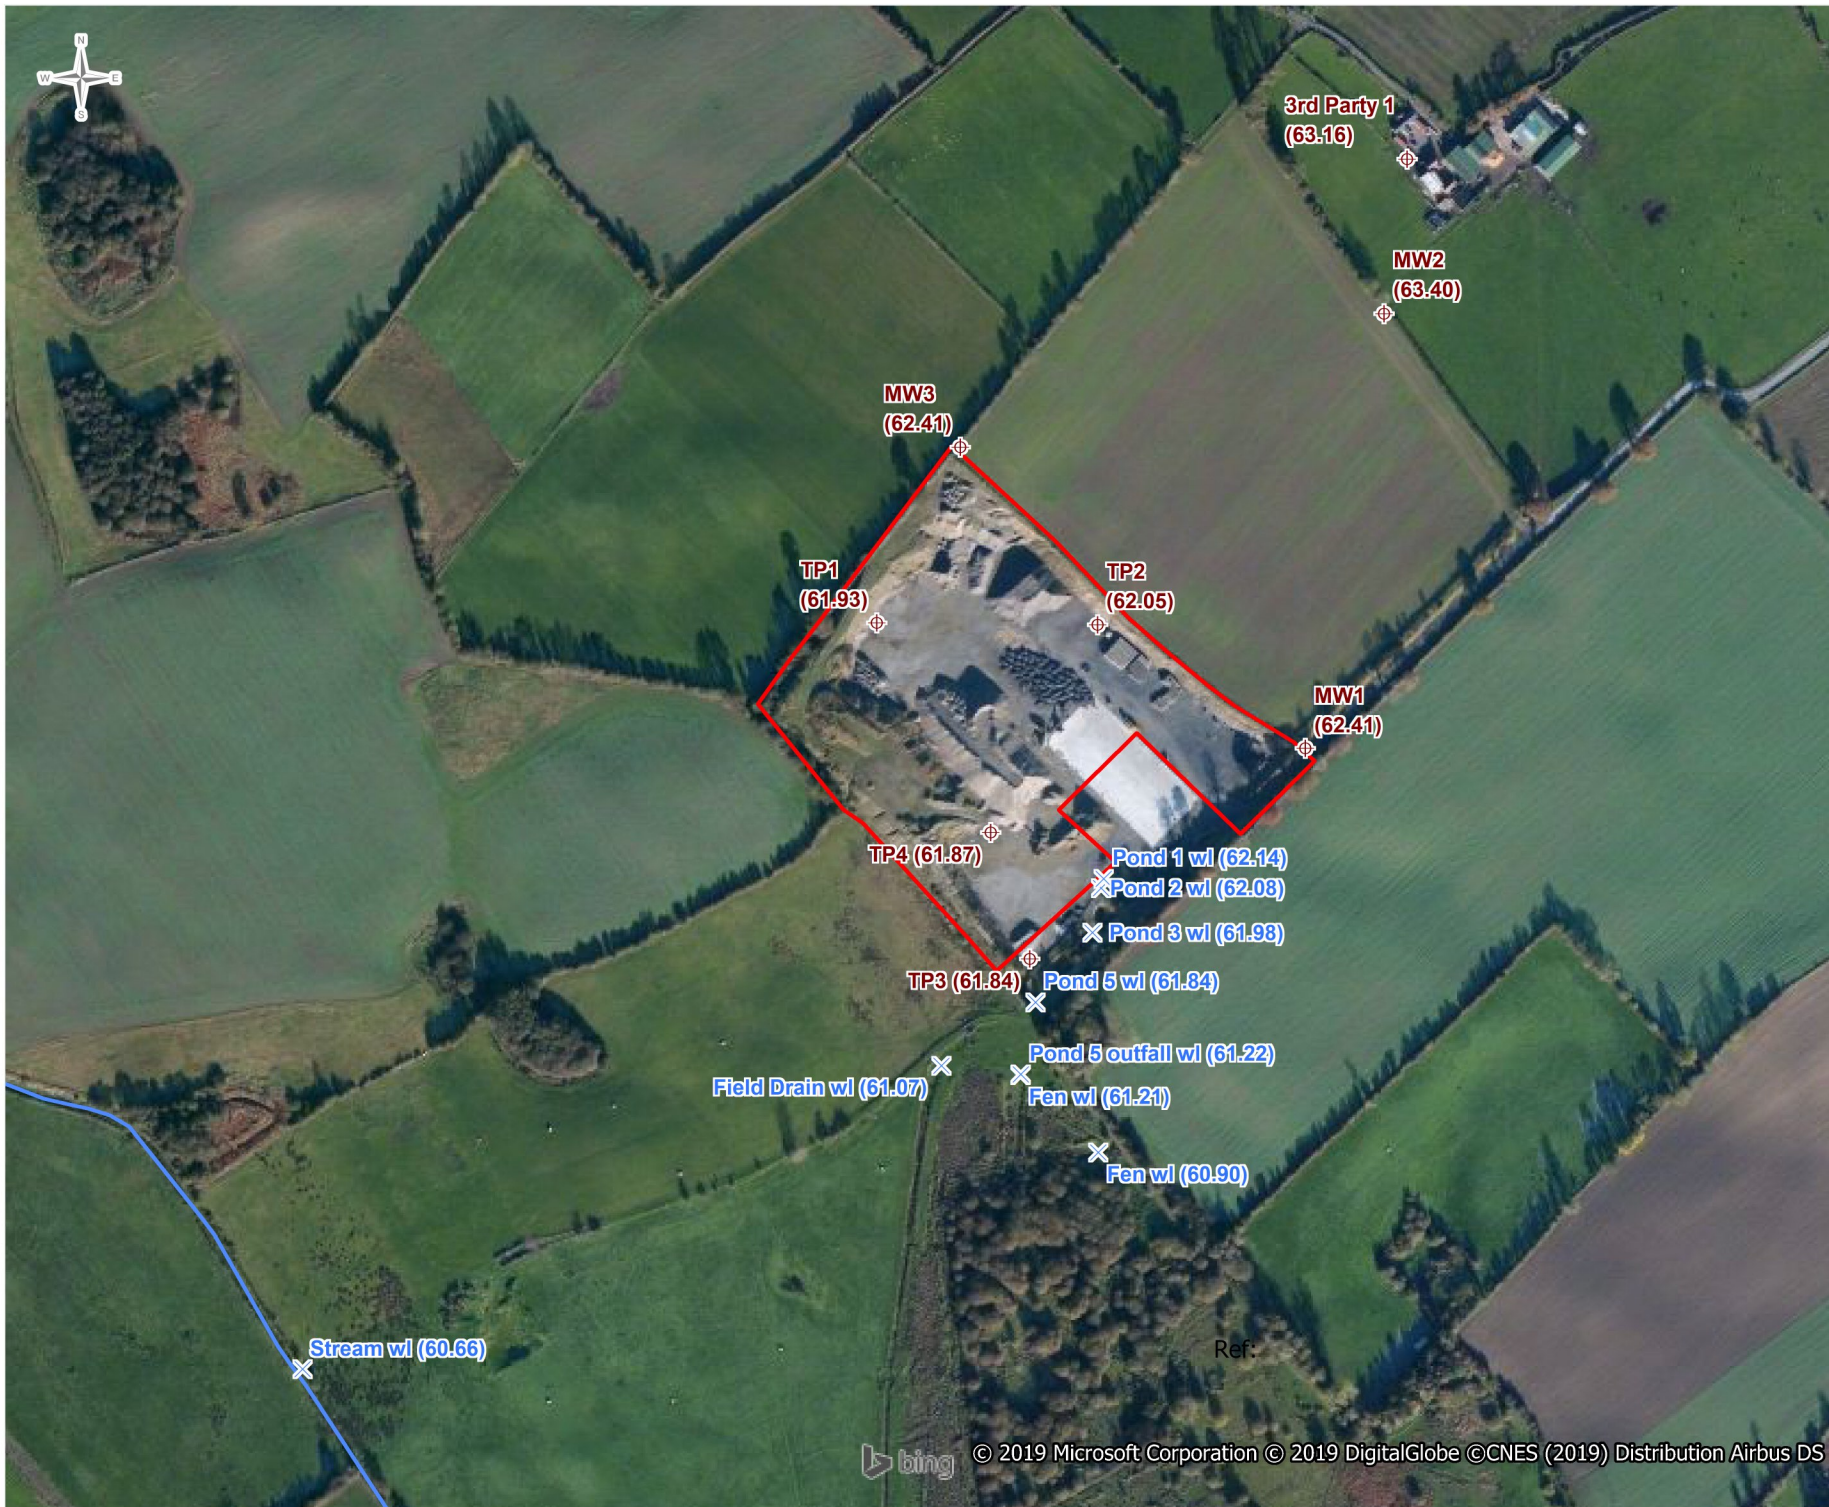
Fig. 8.5: Groundwater and Surface Water Levels Map

Table 8.4 shows that there is negligible difference between groundwater levels when comparing summer to winter groundwater regimes. Groundwater levels surveyed during Summer 2018 are illustrated in Figure 8.5. Surface water levels are also shown in Figure 8.5 and it can be seen that surface and groundwater appear to be broadly in continuum.

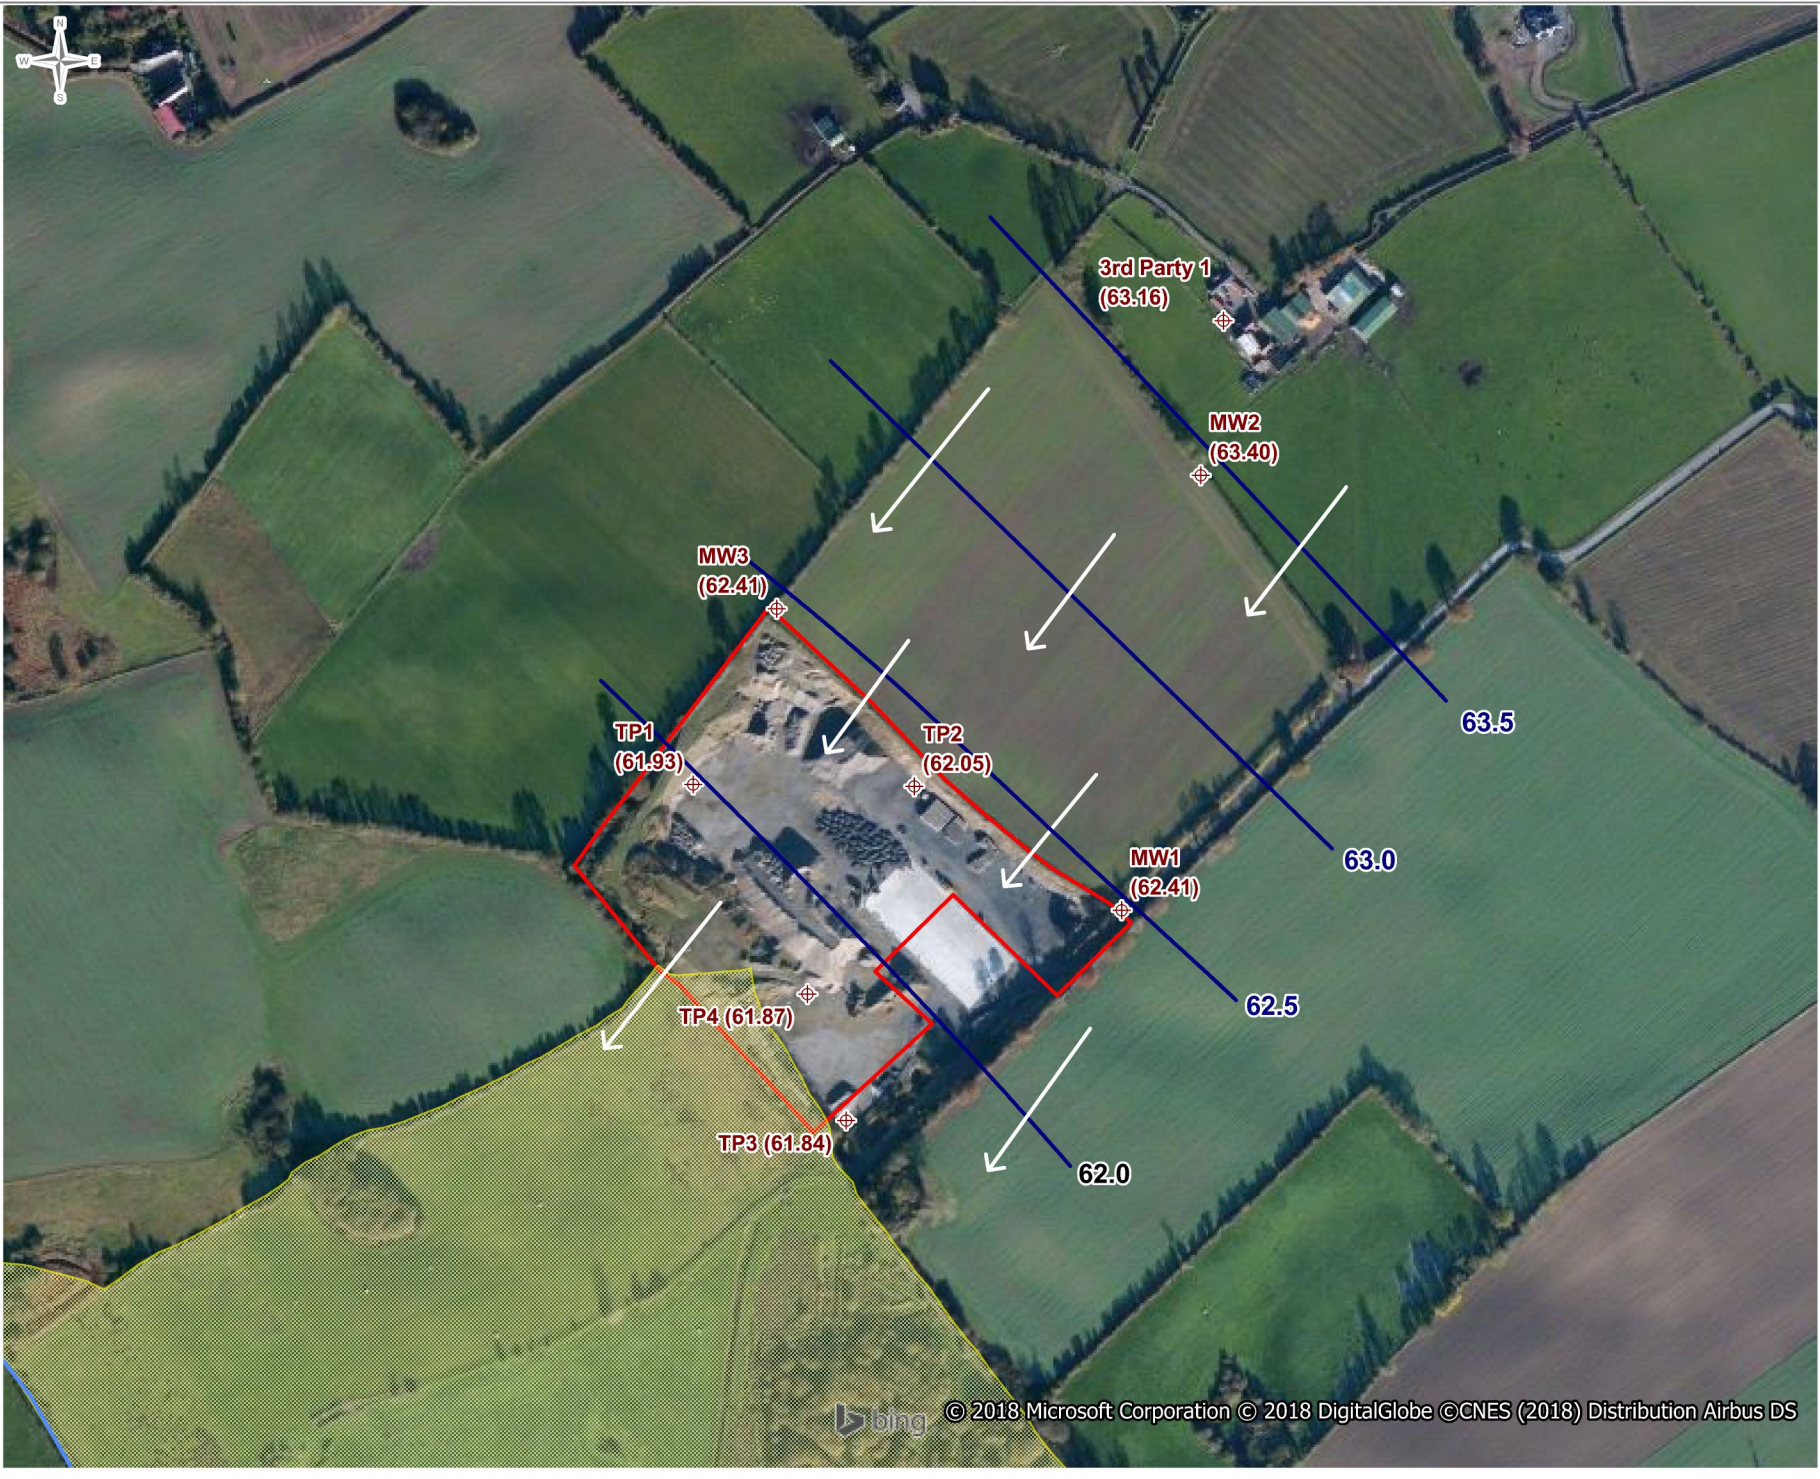
- Legend:
- Application Boundary
  - NPWS Ardristan Fen Extents
  - ⊕ Groundwater Level Monitoring Point, GW Elevation, mOD Malin 27/06/18
  - Groundwater Elevation Contour
  - Inferred Groundwater Flow Direction

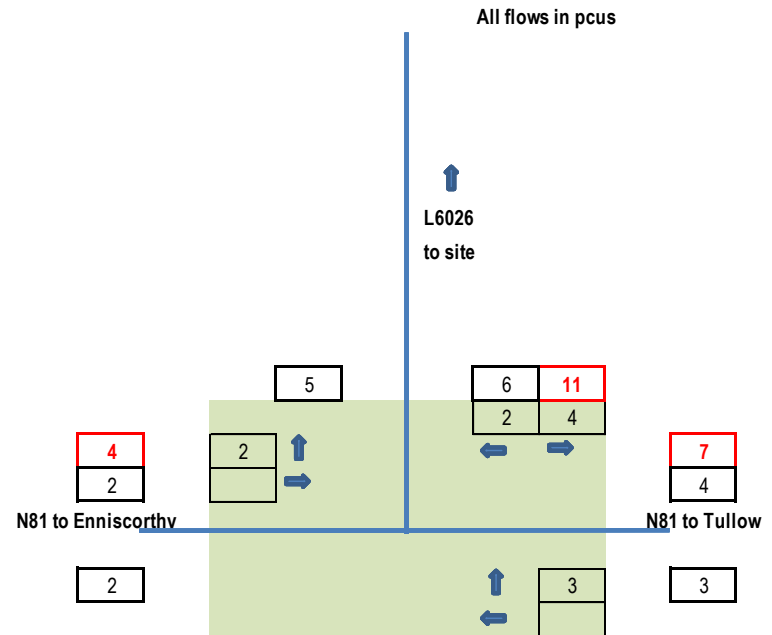
Figure 12.6 Development generated traffic flows, AM & PM peak hours

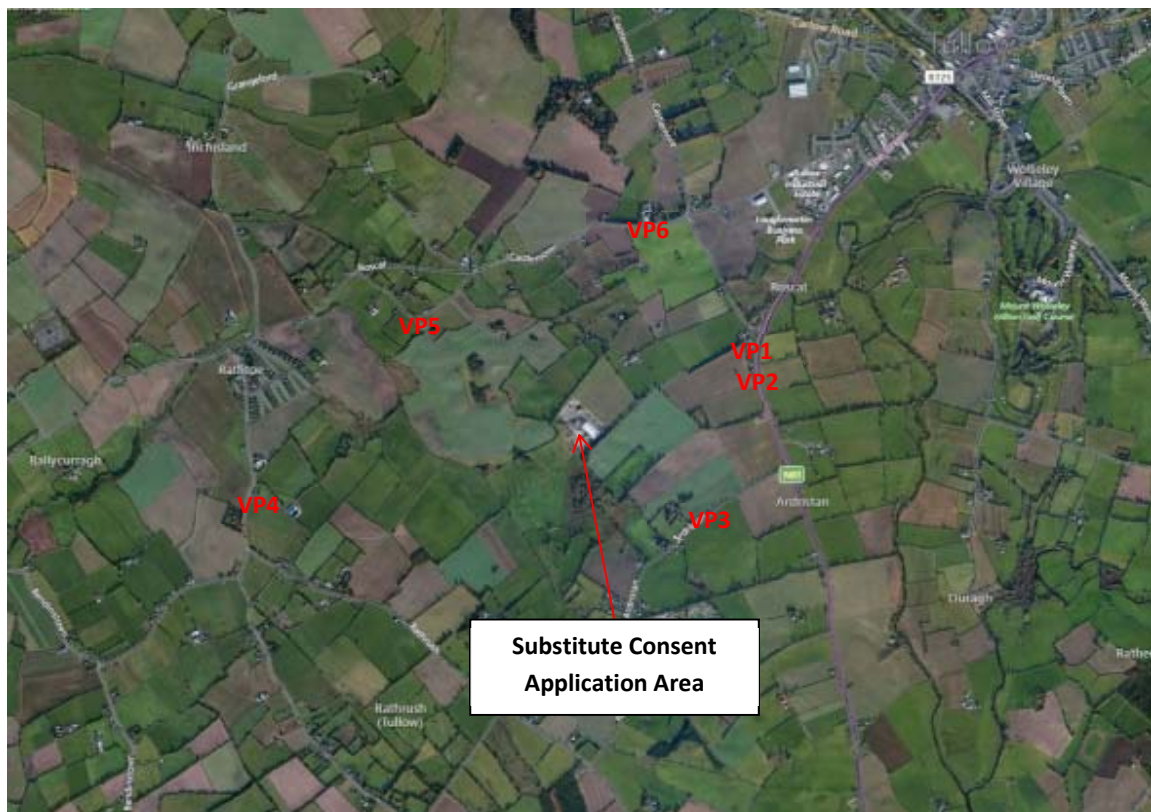
**Plate 13-3:** Visual impact assessment vantage points surrounding Kilcarrig's Sand and Gravel Pit at Roscat, Tullow, Co. Carlow.

The vantage points were chosen to give a representative sample of views of the existing development within the landscape. A total of 6 vantage points (VPs) were identified surrounding all boundaries of the Substitute Consent application area. All VPs are illustrated on Plate 13-3. Each vantage point is detailed below (Plates 13-4 – 13-9) with a brief description of the view from each location.

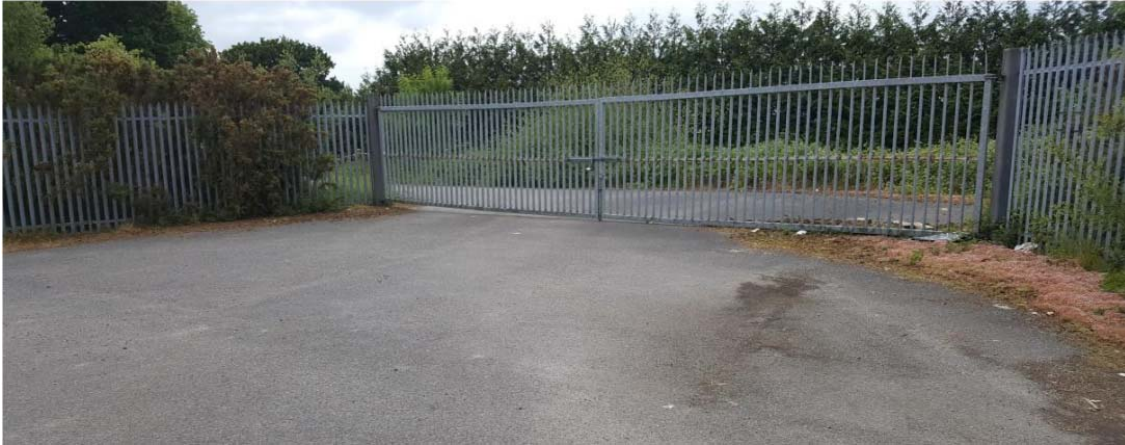
**Plate 13-4:** Vantage Point 1 – Westward view of the main entrance to the Substitute Consent application area.

Plate 13-4 shows the view from VP1 at the main site entrance. A vegetated berm is visible on the lefthand side of the image with a line of native trees planted as screening along this section of the access road immediately inside the boundaries of the site. The Substitute Consent application area is not visible from this location.

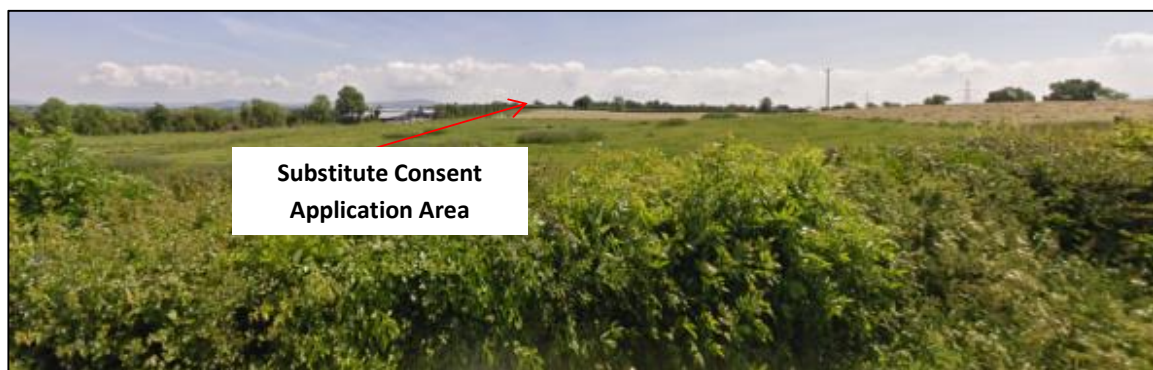
**Plate 13-7:** Vantage Point 4 – Eastward view from the local road L7113 approximately 1.8km to the west of the Substitute Consent application area.

Vantage Point 4 is approximately 1.8km to the west of the Substitute Consent application area along the local road L7113 to the south of the village of Rathoe (Plate 13-7). As with the other VPs, as a result of the flat topography and natural screen of mature deciduous trees, the Substitute Consent application area is not visible from this location.
