Strategic Housing Development Castletreasure

Flood Risk Assessment

April 2019

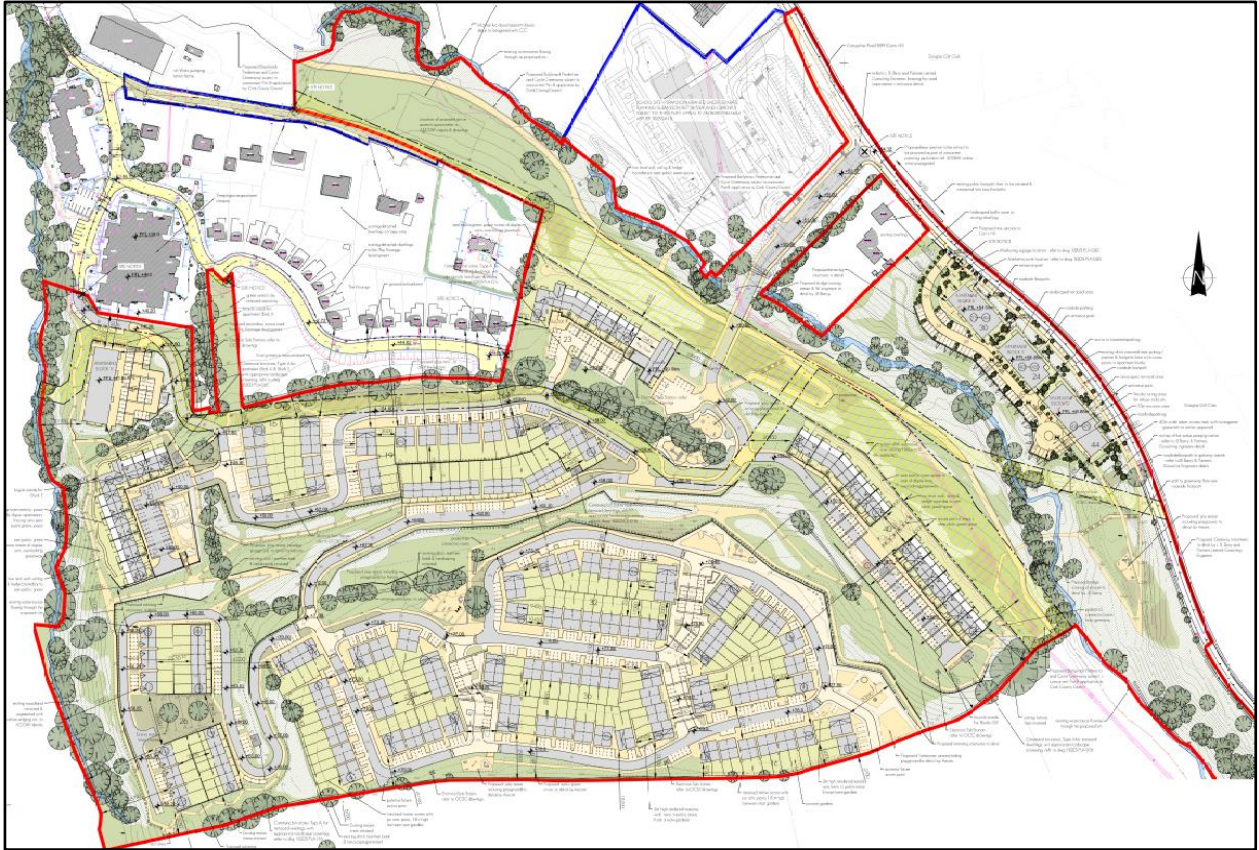
Figure 1-2: Proposed Development at Castletreasure

The proposed residential development consists of 472 no. dwelling houses and associated ancillary site works as shown in Figure 1.2 below.

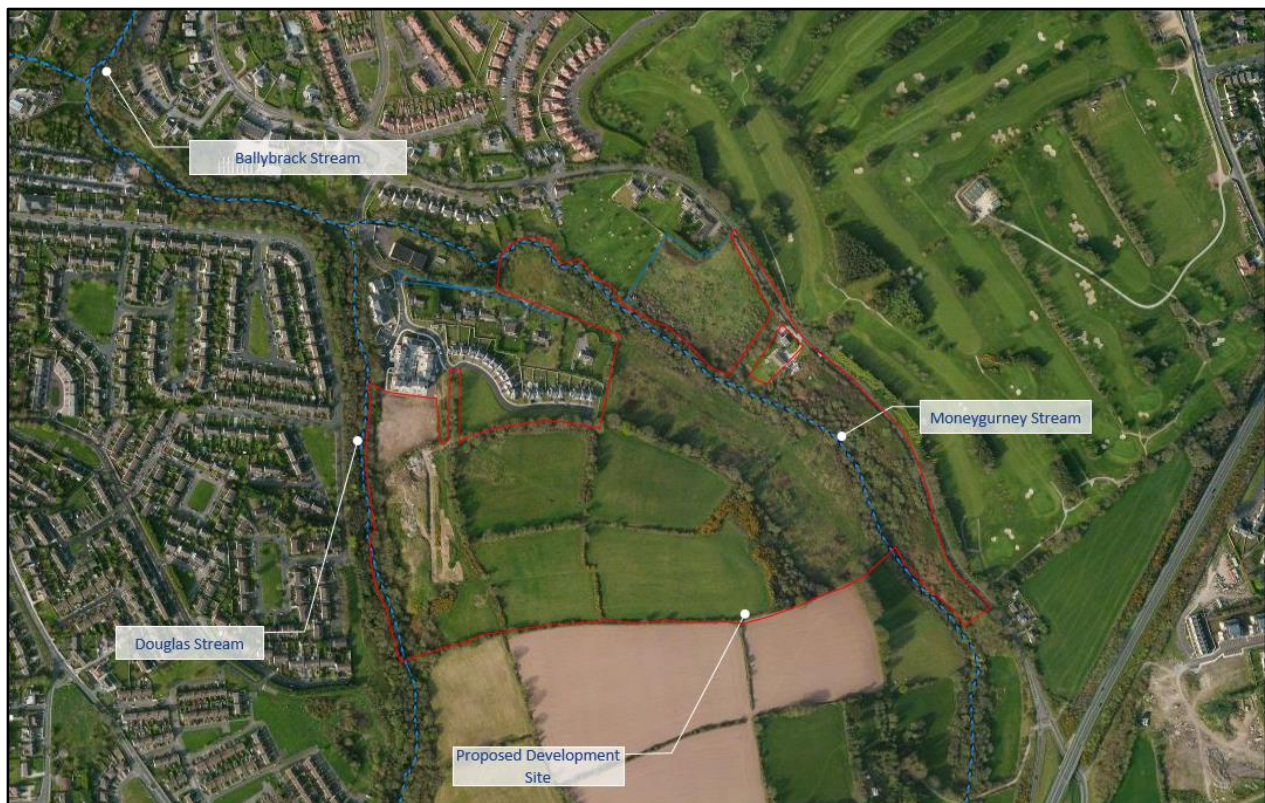
Figure 3-1: Hydrological Features of the Area (Source: www.epa.ie, annotation by J.B. Barry & Partners)

The main hydrological features of the area are the Douglas and Moneygurney Streams which flow in a northerly direction through the site. The Moneygurney Stream flows in a north westerly direction through the site and forms a portion of the northern boundary of the site. The Douglas Stream flows in a northern direction along the western boundary of the site. The Douglas and Moneygurney Streams meet just downstream of the north western corner of the site to form the Ballybrack Stream (also referred to as the Douglas River and Donnybrook River). The Ballybrack Stream flows north through Douglas village before it is culverted under Douglas Shopping Centre and joins the tidally influenced Tramore River to the north of Douglas. The Ballybrack Stream is currently subject to flood alleviation works under the Douglas Flood Relief Scheme. Therefore, the importance of not increasing the flow in the Ballybrack Stream due to increased surface runoff arising from the proposed development is noted and measures to assure this are presented in this report. Figure 3-1 below illustrates the main hydrological features associated with the site.

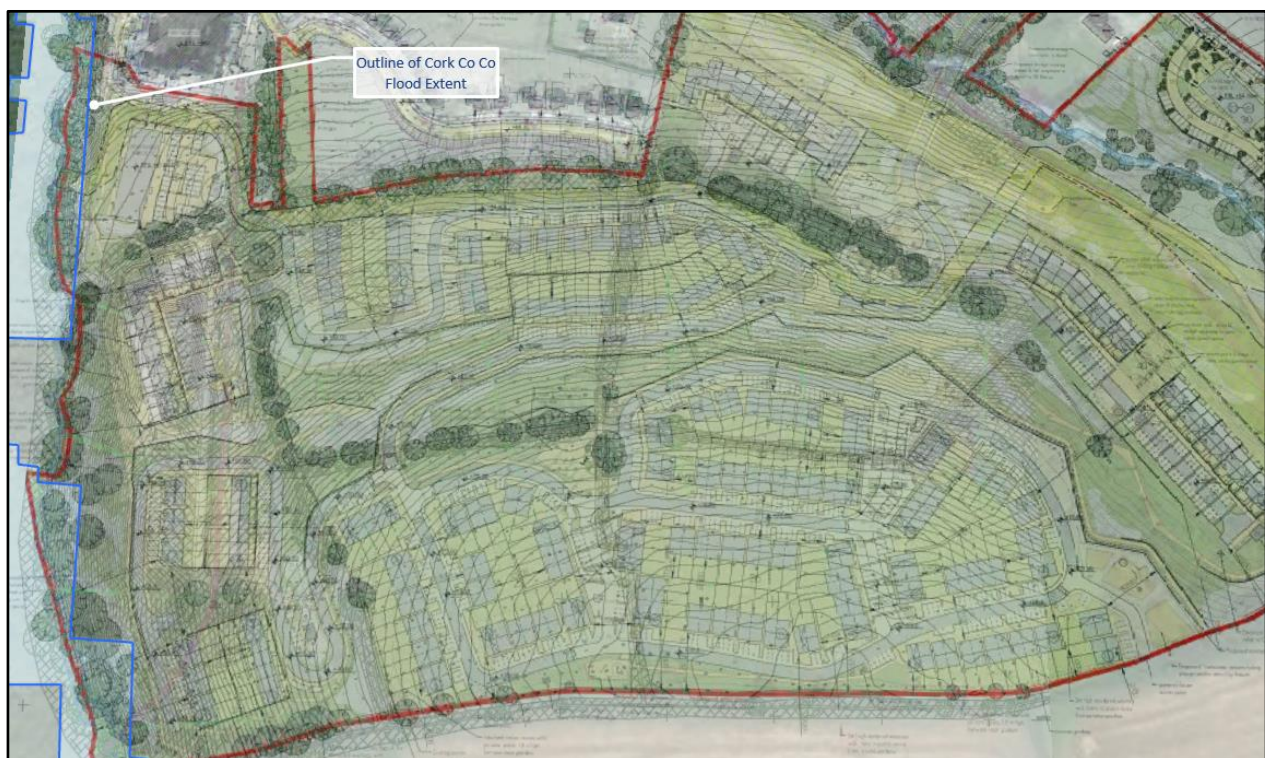
Figure 4-4: Overlay of Fluvial Flood Extent Map and Proposed Development Layout and Topography

As discussed above, a small portion of the site of the proposed development lies within the 1% AEP fluvial flood extent. However, all residential dwellings will be constructed in areas that are not vulnerable to flooding. Only a small number of houses along the western boundary of the site are located close to the area of possible fluvial flooding from the Douglas Stream.

The Ballincollig Carrigaline Municipal District Local Area Plan flood map is believed to be the most accurate flood study undertaken in the area. The LAP states that the 2011 flood zone mapping has been updated to take account of information that has become available in the CFRAM Study and other flood schemes undertaken by the OPW. As such, the fluvial flood extent map as shown in Figure 3-6 has been extrapolated and superimposed onto the results of a topographical survey of the proposed development site. An extract of this is shown in Figure 4-4 below. Observation of Figure 4-4 demonstrates that the extreme fluvial flood event extends to a level of approximately **+40.5mOD**. The proposed site layout was also superimposed onto the flood extent map and this demonstrated that all residential development will be located outside of the 0.1% AEP fluvial flood extent. Therefore there will be no discernible increase in flood risk elsewhere as there will be no decrease in the volume of the existing floodplain storage. With this, it is considered that the proposed development satisfies sub-criterion 2(i) of the Justification Test.

According to the FRM Guidelines, the minimum floor level for a new development should be set above the 1% AEP fluvial flood level and should include an allowance for climate change and freeboard. It is recommended to construct the finished floor level (FFL) of the residential dwellings in the vicinity of the fluvial flood extent at a level greater than the 0.1% AEP flood level with an allowance for freeboard and climate change. A conservative freeboard of 0.6m is recommended to account for any uncertainty in the flood maps and an allowance of 0.3m is recommended for the effects of climate change. This results in a recommend minimum FFL of the development as **+41.4mOD** (40.5mOD + 0.6m + 0.3m). This FFL is not only above the 1% AEP flood level in accordance with the FRM Guidelines but is also above the 0.1%

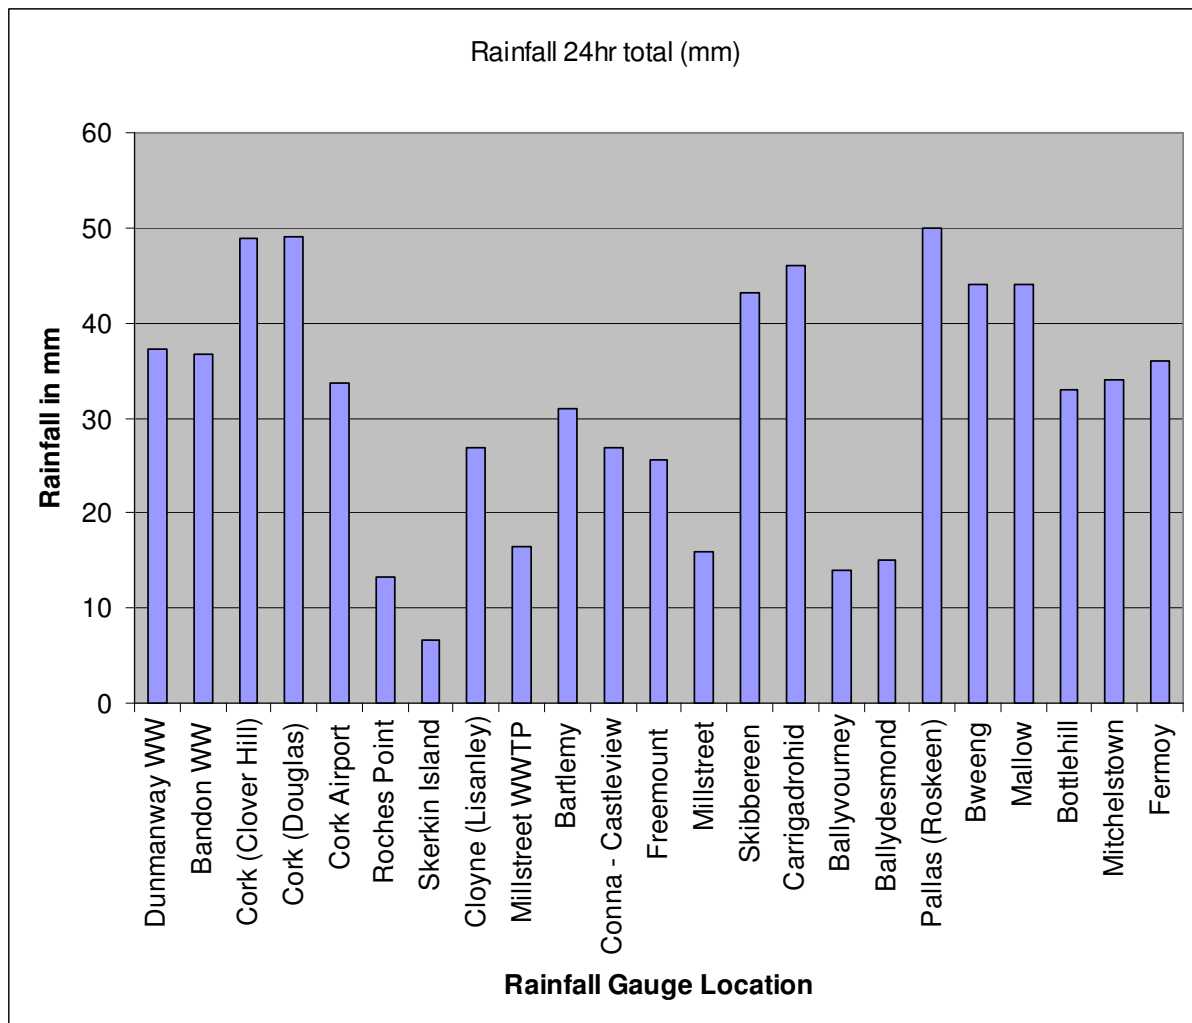
FIGURE 1 – RAINFALL 28/6/2012

Using the information gathered to date, a graphical representation of the daily (24hour) rainfall totals for Thursday 28th is as follows:

This shows quite clearly that rainfall amounts varied throughout the county on the day in question.

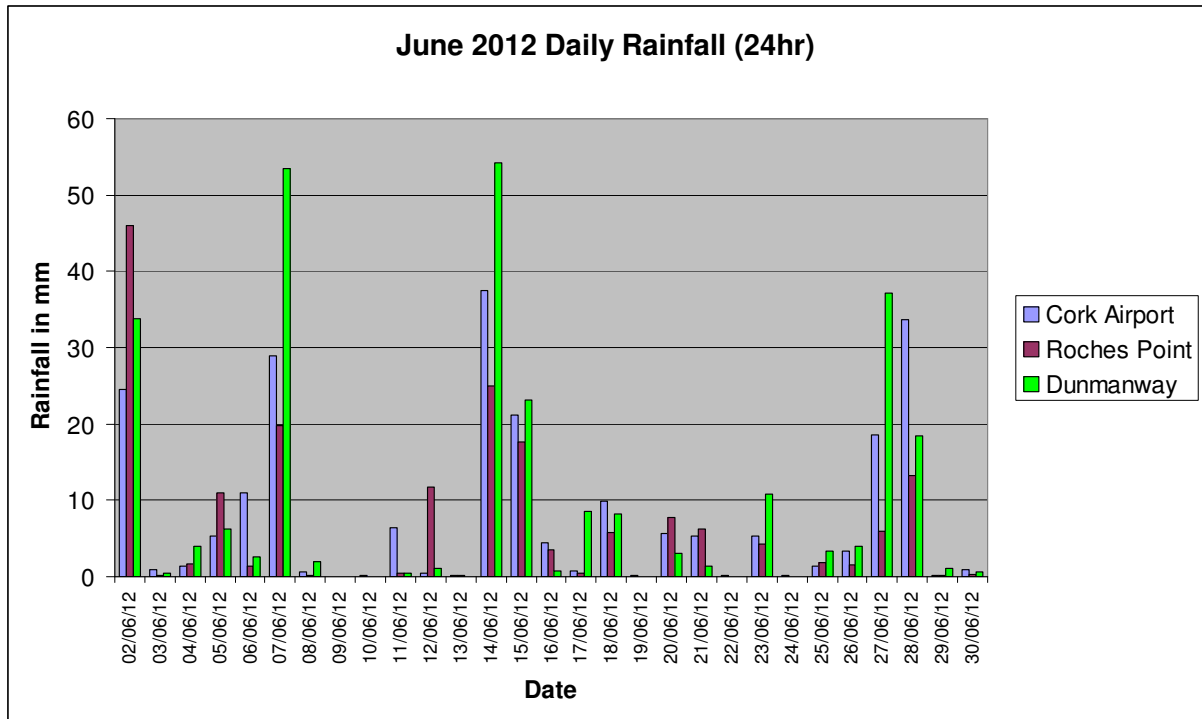
FIGURE 2 – RAINFALL CORK REGION JUNE 2012

To give an indication of the June 2012 rainfall in the Cork region, the following chart shows the daily totals for the rain gauges at Dunmanway, Cork Airport and at Roches Point:

As noted above the higher rainfall events earlier in the month did not cause significant flooding.

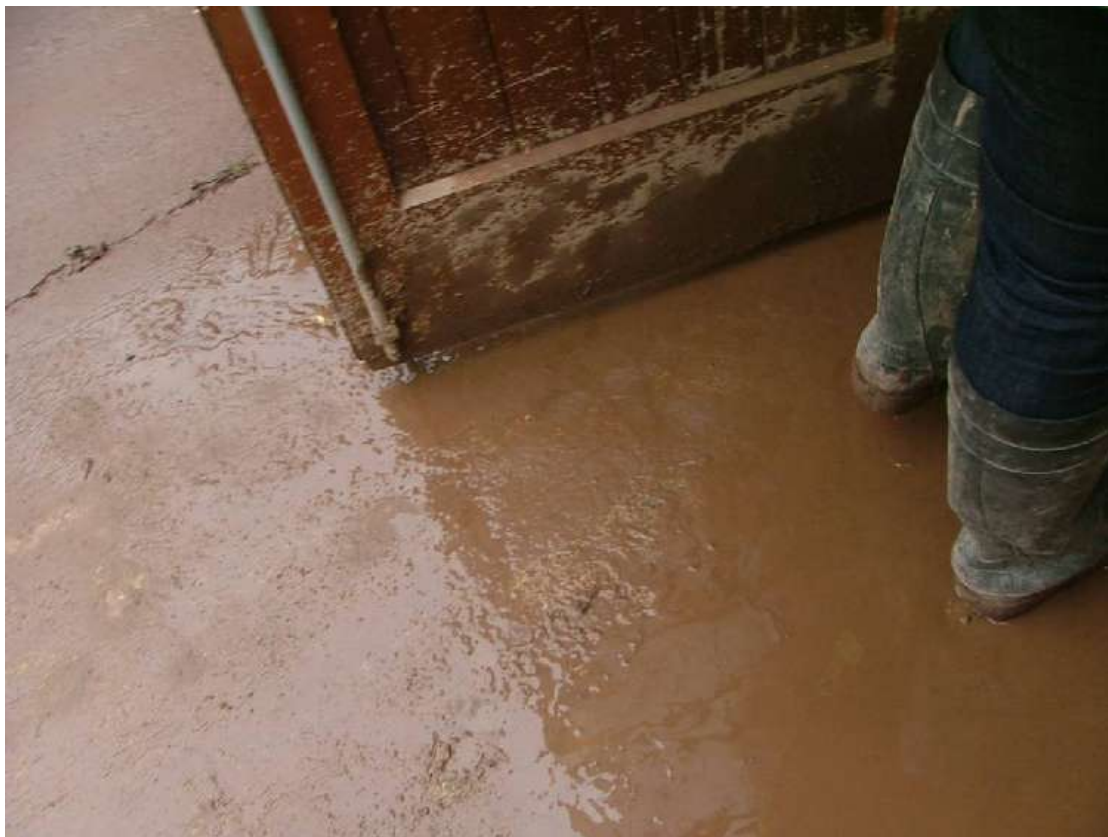
Meeting Hall - Church Road - Wall Knocked

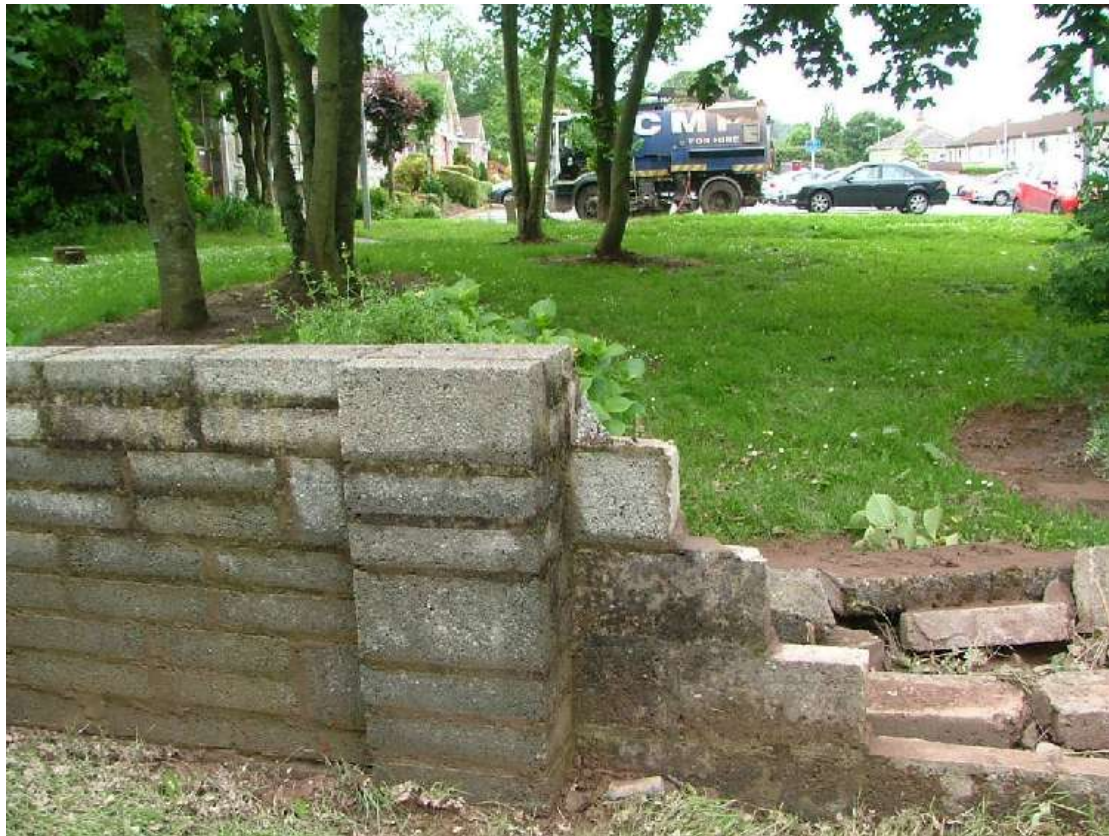
Meeting Hall - Church Road - Wall Knocked

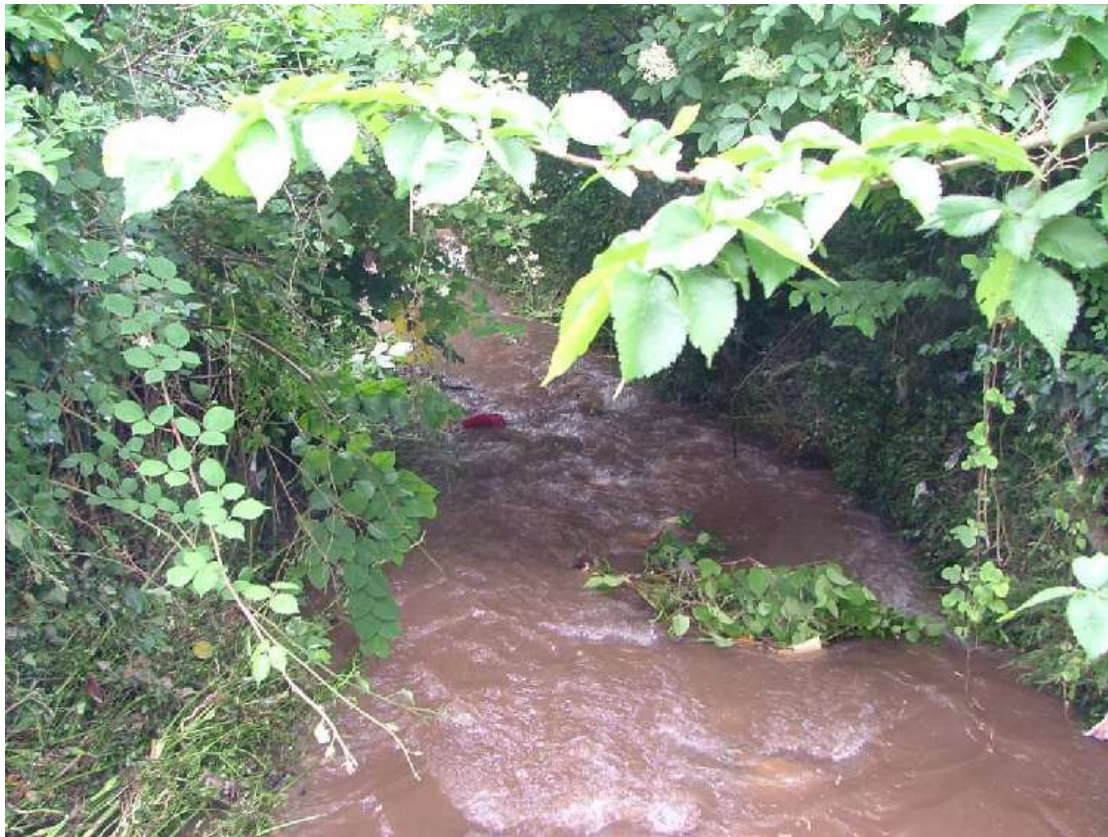
Residential Property – Behind Meeting Hall – Church Road – Bridge Blocked

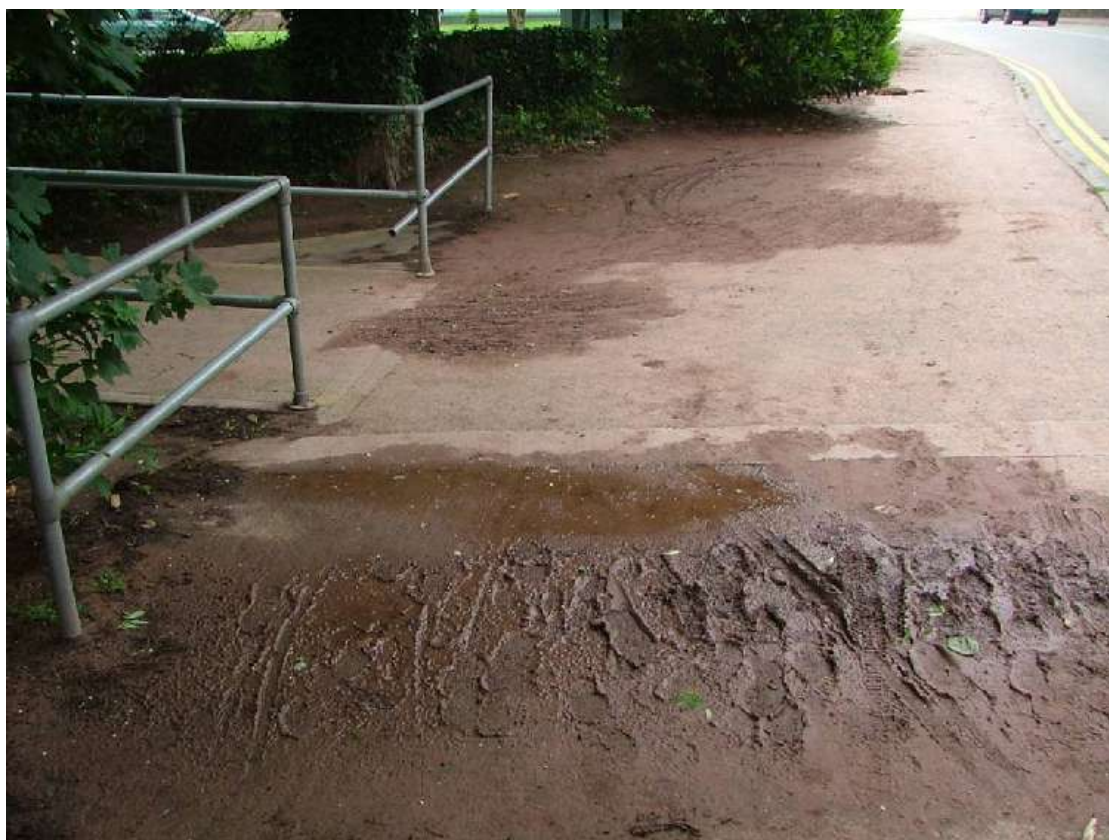
Residential Property – Behind Meeting Hall – Church Road – Bridge Blocked
