Appendix 14.2

Quality Audit

Proposed RB Central Apartments Development, Sandyford, Dublin 18

CST GROUP Chartered Consulting Engineers
1, O'Connell St, Sligo, F91 W7YV

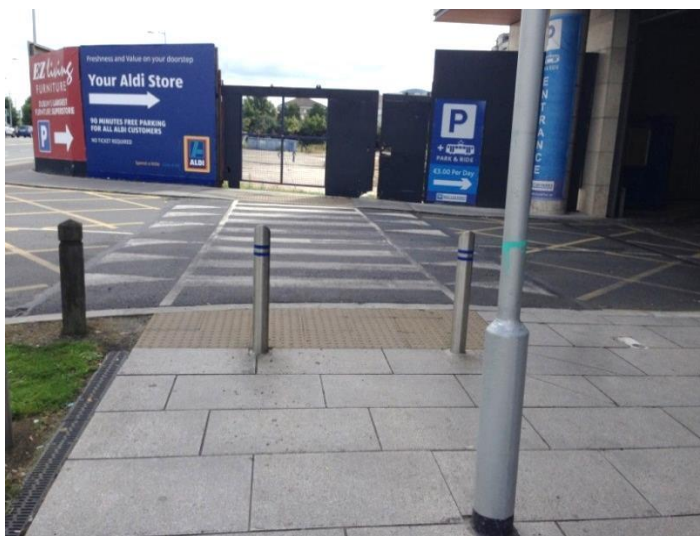
3.1.1 Pedestrian Crossing – Blackthorn Drive Entrance

Issue: The existing pedestrian crossing at the existing entrance has zebra crossing markings in conjunction with tactile paving. The tactile paving is not the correct colour and no belisha beacons are provided which is normally required for such crossings in public places.

Hazard: Partially sighted pedestrians may be confused as to their priority for the crossing.

Recommendation: Remove the zebra crossing markings to ensure pedestrians do not incorrectly assume right of way to crossing. The lines surrounding the bar markings can remain.

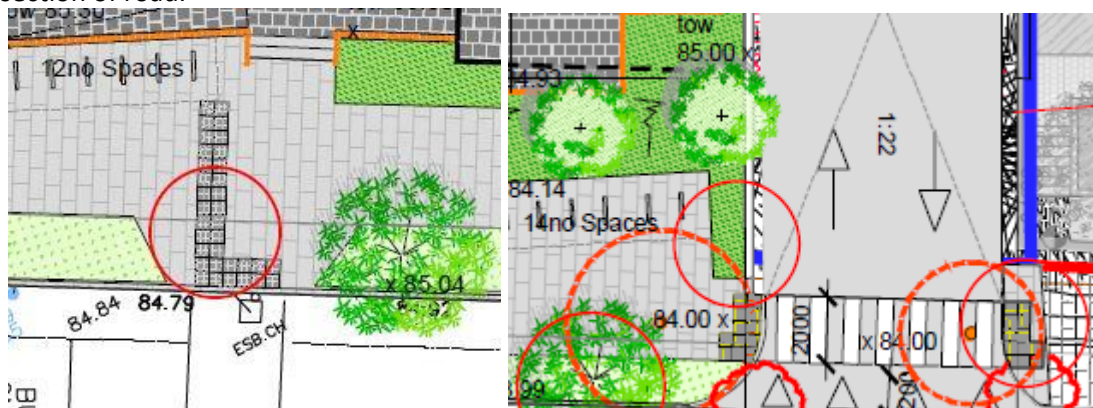
3.1.2 Tactile Paving for Crossings – Carmanhall Road

Issue: The landscaping drawing indicates incorrect colour and layouts to pedestrian crossings on this section of road.

Hazard: Partially sighted pedestrians may be confused by the priority of the crossings leading to an accident.

Recommendation: Tactile paving layout/colour should be to best practice

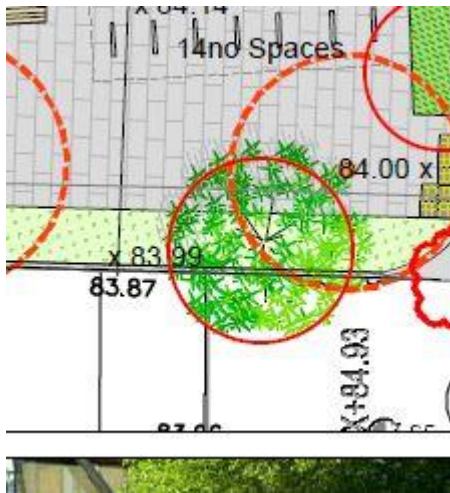
3.1.3 Carmanhall Road – Car Park Exit – adjacent Landscaping

Issue: semi mature tree inside visibility splay for basement exit – girth will increase with growth impeding visibility to right.

Recommendation: Ensure that landscaping does not encroach into visibility splays

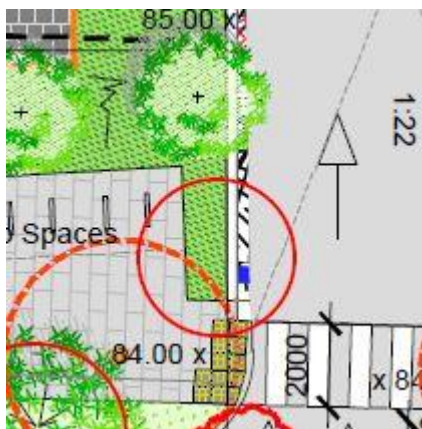
3.1.4 Carmanhall Road - Car Park Ramp Adjacent Retaining wall/Landscaping

Issue: Planting and retaining wall adjacent to ramp potentially impeding visibility of pedestrians on path

Hazard: Exiting vehicles may collide with crossing pedestrians.

Recommendation: ensure low level planting provided and/or low upstand to wall to ensure that both horizontal and vertical visibility splays are accommodated.

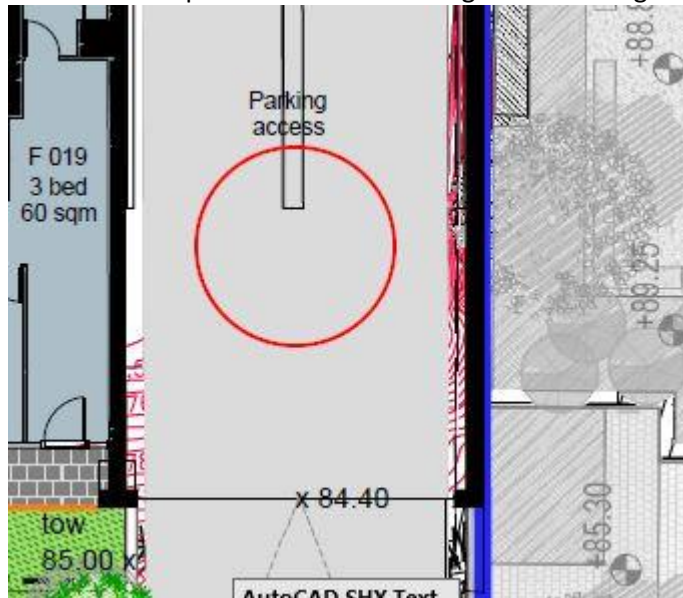
3.1.5 Carmanhall Road – Car Park Access Ramp – splitter island

Issue: There is potential for drivers to go down wrong side of ramp, or over run same.

Recommendation: Provide appropriate retroreflective/signage to highlight hazard.

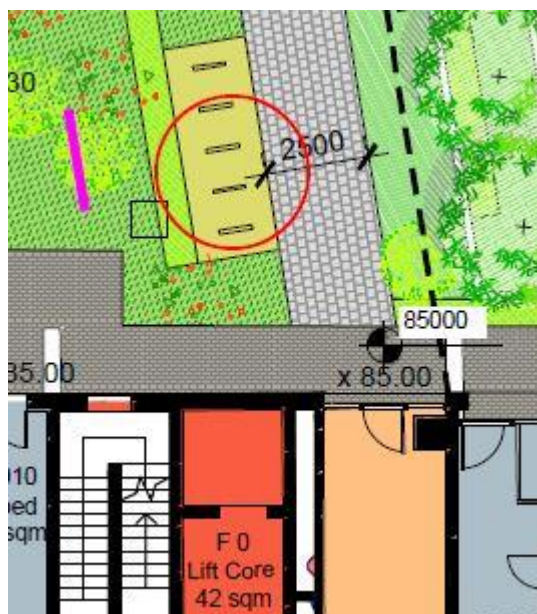
3.1.6 Courtyard Cycle Stands

Issue: Finish at cycle stands is called up as compacted gravel. This is likely to erode over time leading to ponding/trip hazards.

Recommendation: Use robust paving finish

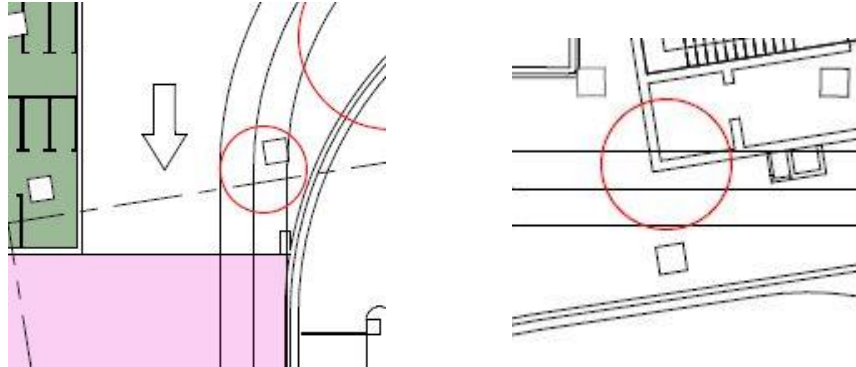
3.1.7 Columns and Core Walls on Cycle Track

Issue: Structural elements encroach into cycle access routes.

Recommendation: Relocate/remove elements to ensure cycle routes are unimpeded. Cyclists should also be advised to dismount where headroom within the basement is less than 2.40m.

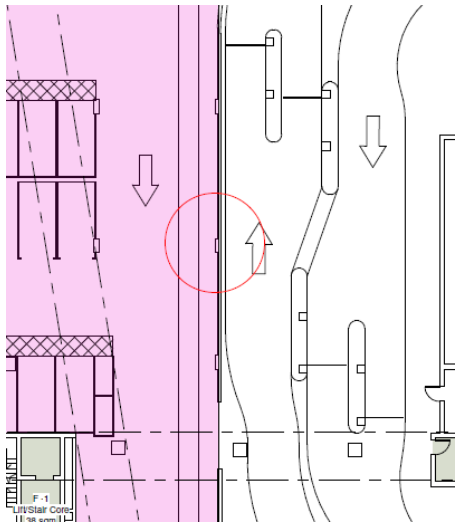
3.1.8 Walls adjacent Cycle Track

Issue: Structural walls located in close proximity to cycle access routes.

Recommendation: Offset cycle track to ensure there are not hazards adjacent, but also ensuring sufficient space for vehicles to pass. Checks should also be made for vertical clearances – and where insufficient cyclists should also be advised to dismount where headroom within the basement is less than 2.40m.

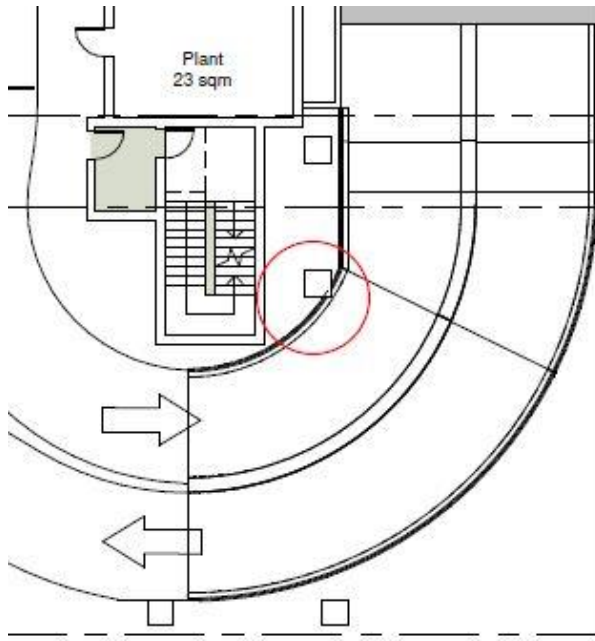
3.1.9 Car Park Access Ramp

Issue: A column encroaches into ramp rubbing strip which is likely to be hazardous to approaching traffic.

Recommendation: ensure columns are located outside rubbing strips

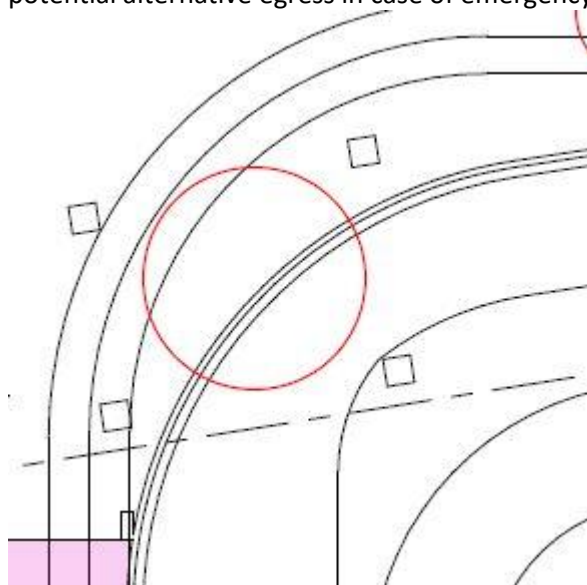
3.1.10 Demarcation between Car Park Access Ramps

Issue: A solid separation between accesses to Carmanhall Road and Blackthorn Drive which prevents potential alternative egress in case of emergency.

Recommendation: provide removable/openable section in wall.

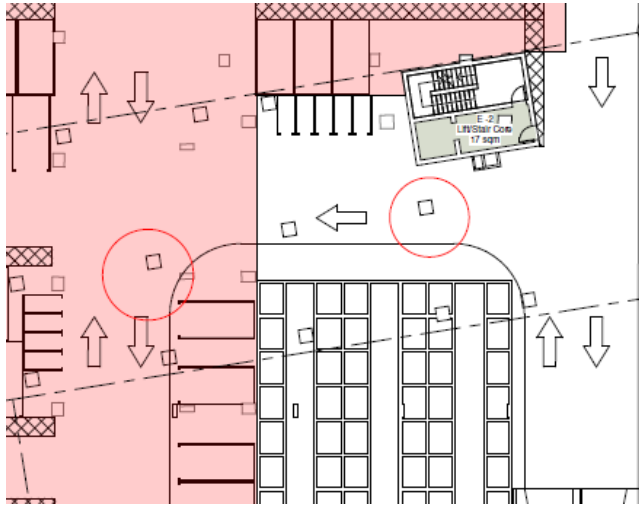
3.1.11 Columns on Car Park access Routes

Issue: Columns obstructing car access routes

Recommendation: relocate or remove columns to ensure that access widths comply with IStructE Multi storey car park guidelines.

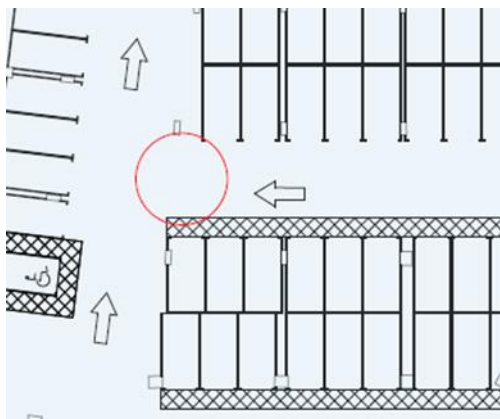
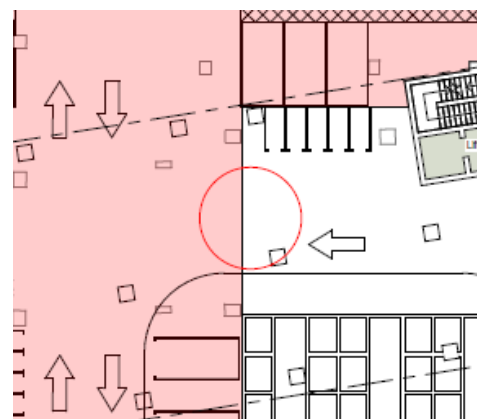
3.1.12 Car Park – Vehicle routing

Issue: There is no instruction to drivers of no entry to one way aisles where they are one way.

Recommendation: ensure 'no entry' markings and overhead signs are provided to aid wayfinding.
