**Residential Development,  
Capdoo,  
Clane,  
Co. Kildare**

**Site Specific Flood Risk Assessment**

**May 2019**

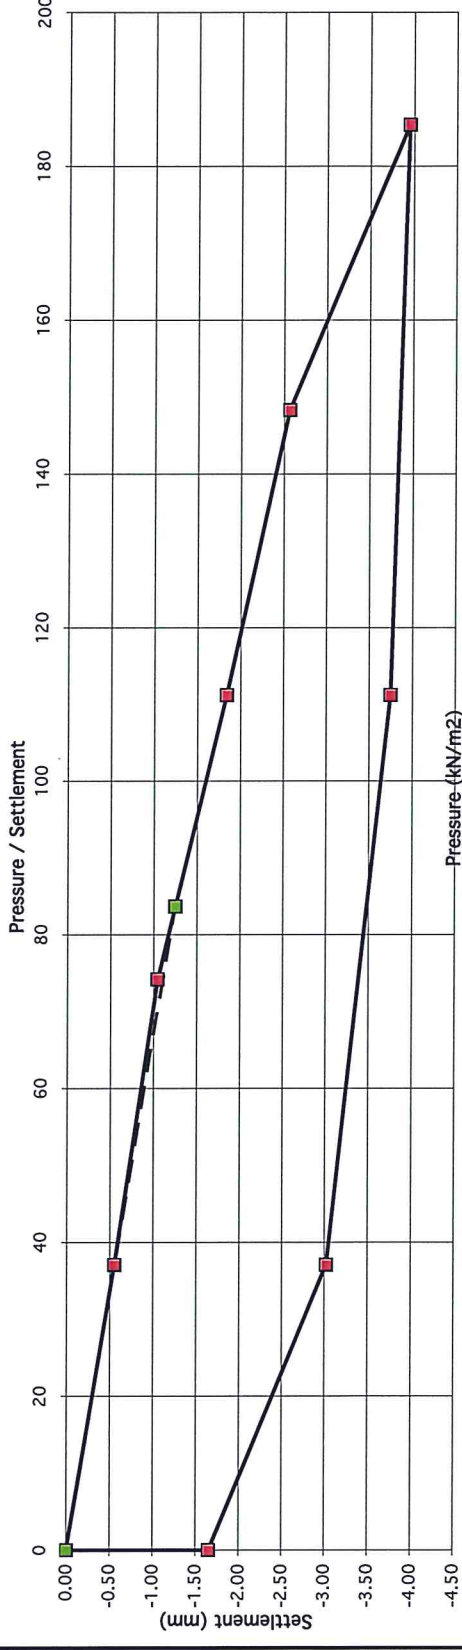
<p>The graph plots Settlement (mm) on the y-axis (0 to -4.50) against Pressure / Settlement (kN/m<sup>2</sup>) on the x-axis (0 to 200). The curve shows a non-linear relationship, starting at (0,0) and reaching approximately (185, -4.00). A tangent line is drawn at the 1.25 mm settlement point, intersecting the y-axis at -3.1 MPa/m.</p>

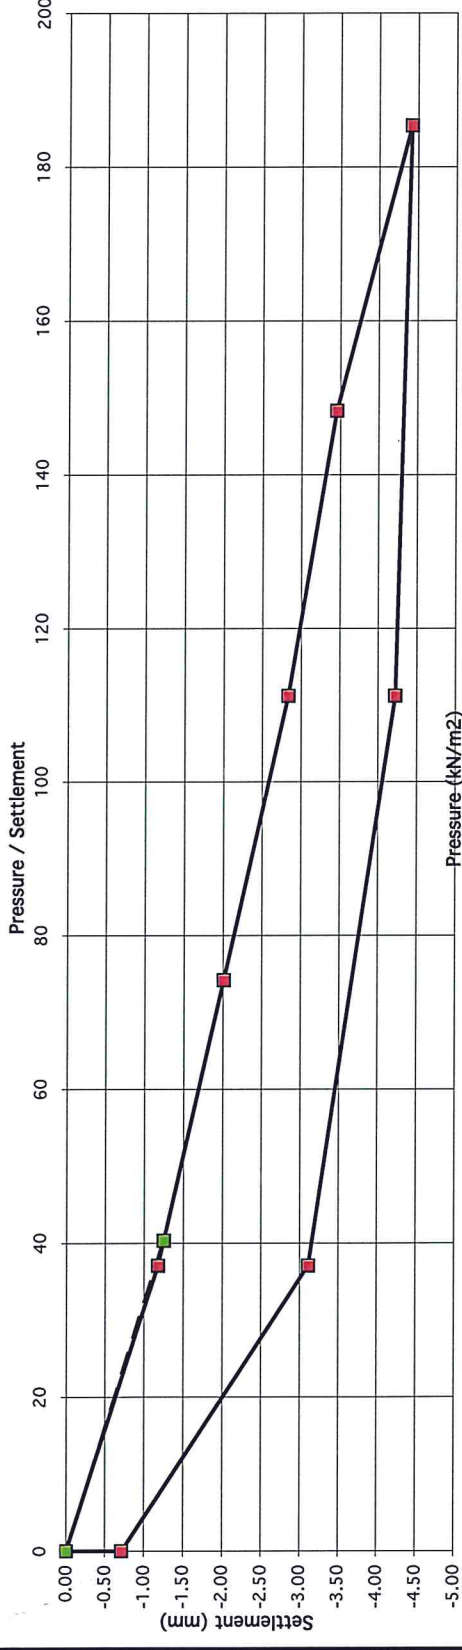
<p>The graph plots Settlement (mm) on the y-axis (0 to -5.00) against Pressure / Settlement (kN/m<sup>2</sup>) on the x-axis (0 to 200). The curve shows a non-linear relationship, starting at (0,0) and reaching approximately (185, -4.50). Key data points are marked with red squares.</p>

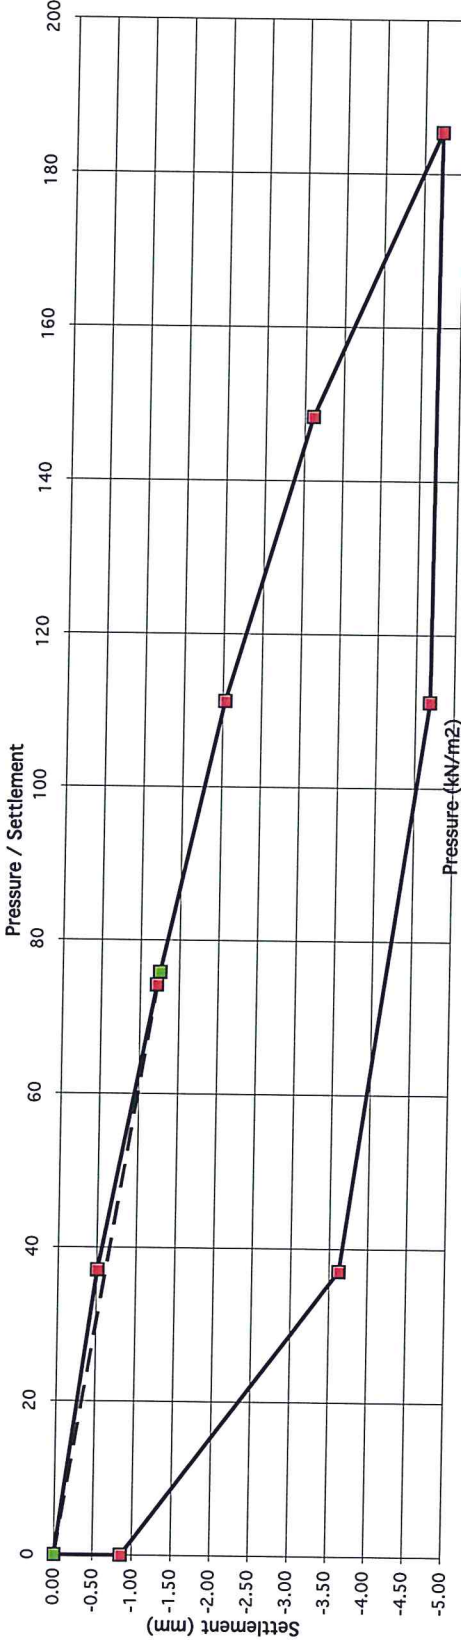
Gradient at 1.25 mm settlement intersection = 61 Modulus of subgrade reaction = 28 MPa/m Correction factor applied = 0.46 as per HD 25-26/10		Equivalent CBR value in accordance with NRA HD25-26/10 3.1 %

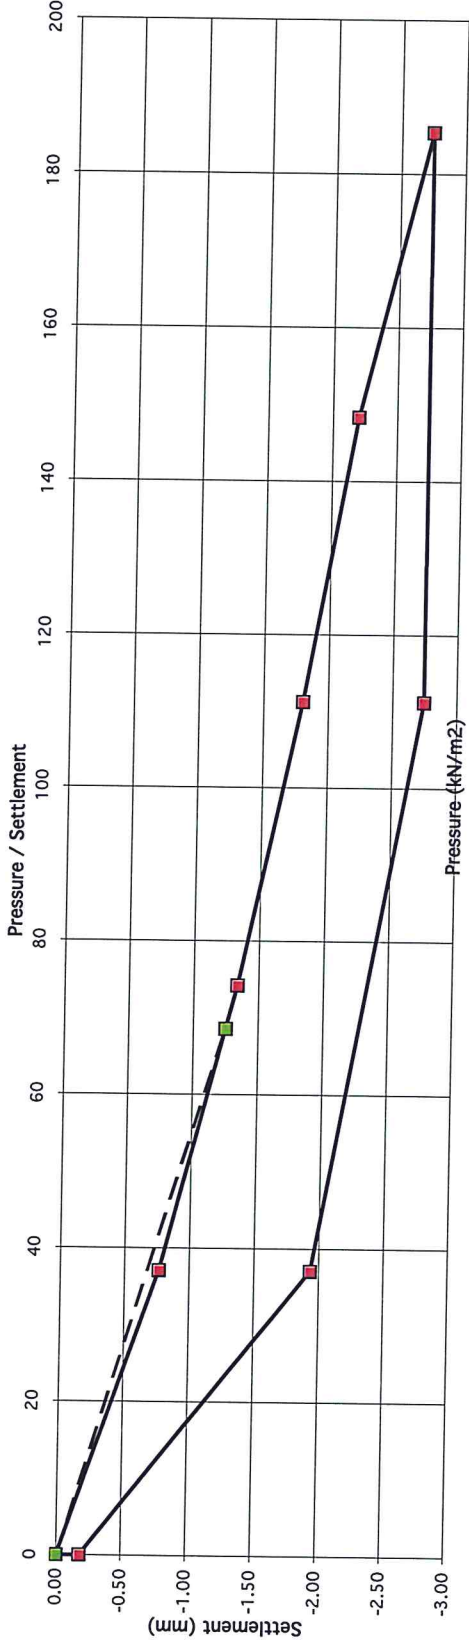
<p style="text-align: center;">Pressure / Settlement</p> <p style="text-align: center;">Settlement (mm)</p> <p style="text-align: center;">Pressure (kN/m<sup>2</sup>)</p>	
Technician L. Daniels	Authorised by L. Daniels		
Date 19-06-17			
Gradient at 1.25 mm settlement intersection = 55 Modulus of subgrade reaction = 25 MPa/m Correction factor applied = 0.46 as per HD 25-26/10		Equivalent CBR value in accordance with NRA HD25-26/10 2.6 %

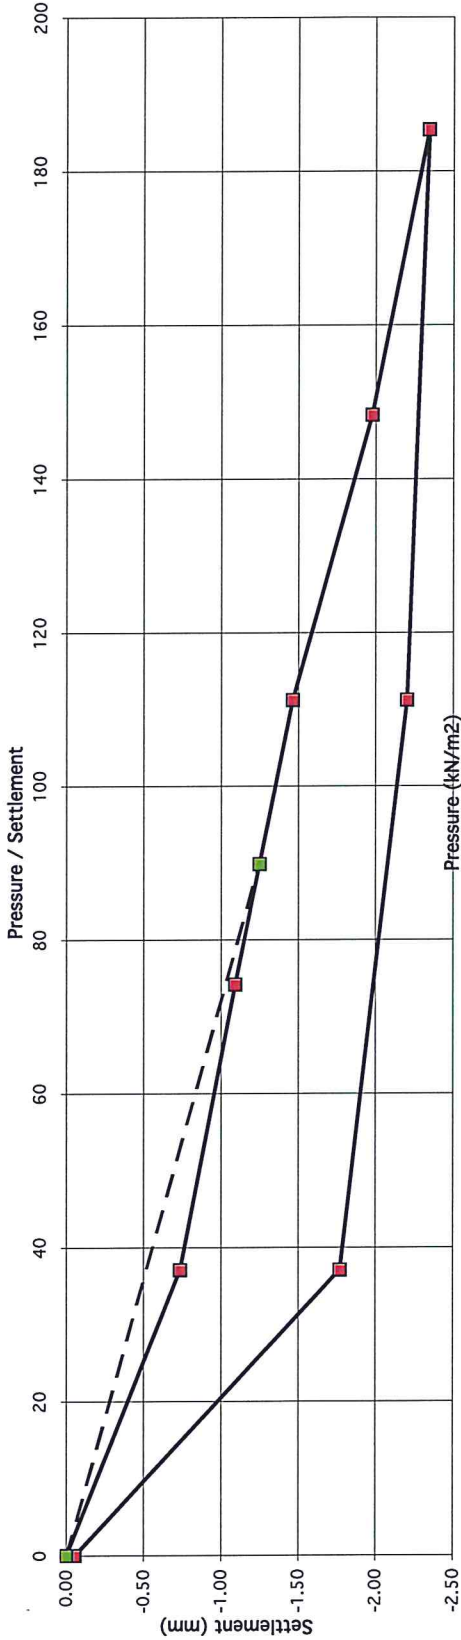
Gradient at 1.25 mm settlement intersection = 72 Modulus of subgrade reaction = 33 MPa/m Correction factor applied = 0.46 as per HD 25-26/10			
Equivalent CBR value in accordance with NRA HD25-26/10 4.1 %

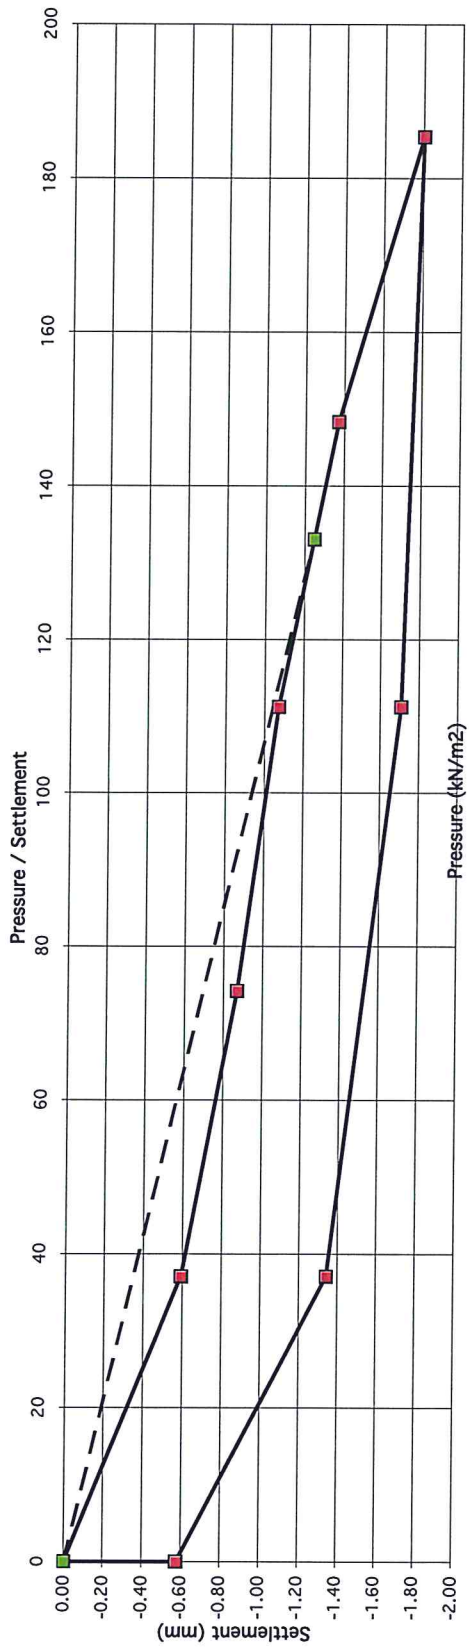
<p>The graph plots Settlement (mm) on the y-axis (0 to -2.00) against Pressure / Settlement (kN/m²) on the x-axis (0 to 200). A dashed line represents the theoretical curve, and a solid line with square markers represents the experimental data. The data points are approximately: (0, 0), (37, -0.60), (74, -0.80), (111, -1.00), (148, -1.20), (185, -1.40), (222, -1.60), (259, -1.80).</p>			
Gradient at 1.25 mm settlement intersection = 106 Modulus of subgrade reaction = 49 MPa/m Correction factor applied = 0.46 as per HD 25-26/10		Equivalent CBR value in accordance with NRA HD25-26/10 8.1 %

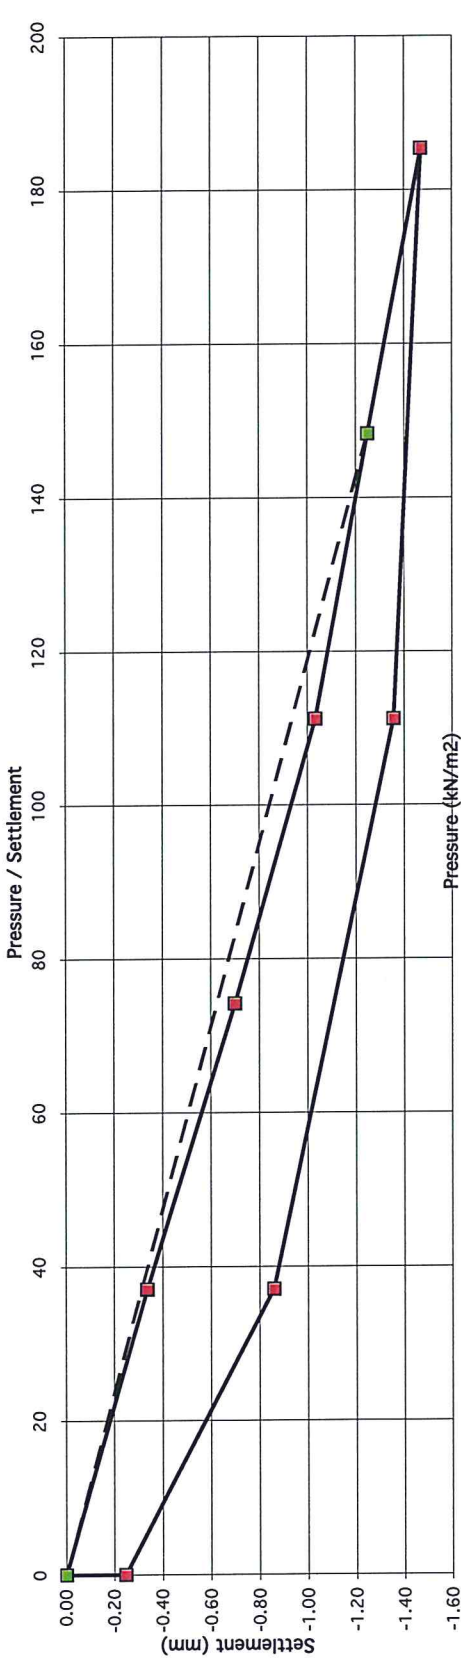
<p>The graph plots Settlement (mm) on the y-axis (0 to -1.60) against Pressure (kN/m<sup>2</sup>) on the x-axis (0 to 200). A solid line shows the test data points, and a dashed line shows the theoretical curve. The data points are approximately: (0, 0), (10, -0.20), (30, -0.40), (70, -0.60), (100, -0.80), (110, -1.00), (140, -1.20), (180, -1.40).</p>			
Gradient at 1.25 mm settlement intersection = 119 Modulus of subgrade reaction = 54 MPa/m Correction factor applied = 0.46 as per HD 25-26/10		Equivalent CBR value in accordance with NRA HD25-26/10 9.8 %

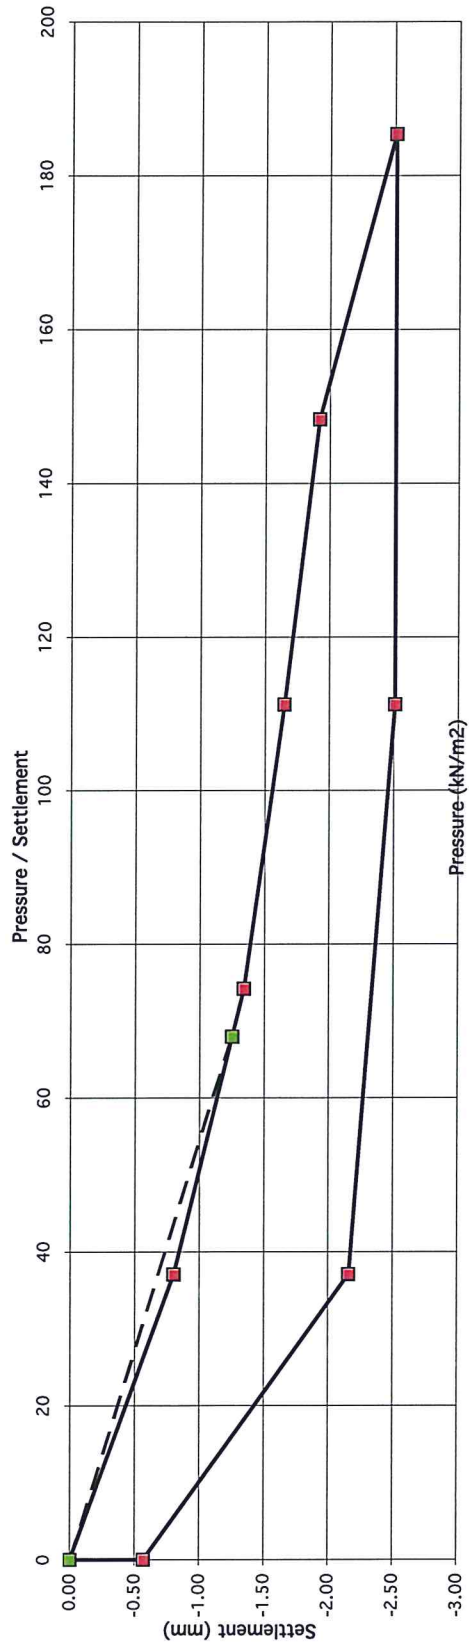
<p>The graph plots Settlement (mm) on the y-axis (0 to -3.00) against Pressure / Settlement (kN/m<sup>2</sup>) on the x-axis (0 to 200). A solid line with red square markers shows the test data points, and a dashed line shows the theoretical curve. The data points are approximately: (0, 0), (25, -0.5), (35, -1.0), (70, -1.5), (110, -2.0), (150, -2.5), (185, -3.0).</p>			
Gradient at 1.25 mm settlement intersection = 54 Modulus of subgrade reaction = 25 MPa/m Correction factor applied = 0.46 as per HD 25-26/10		Equivalent CBR value in accordance with NRA HD25-26/10 2.5 %

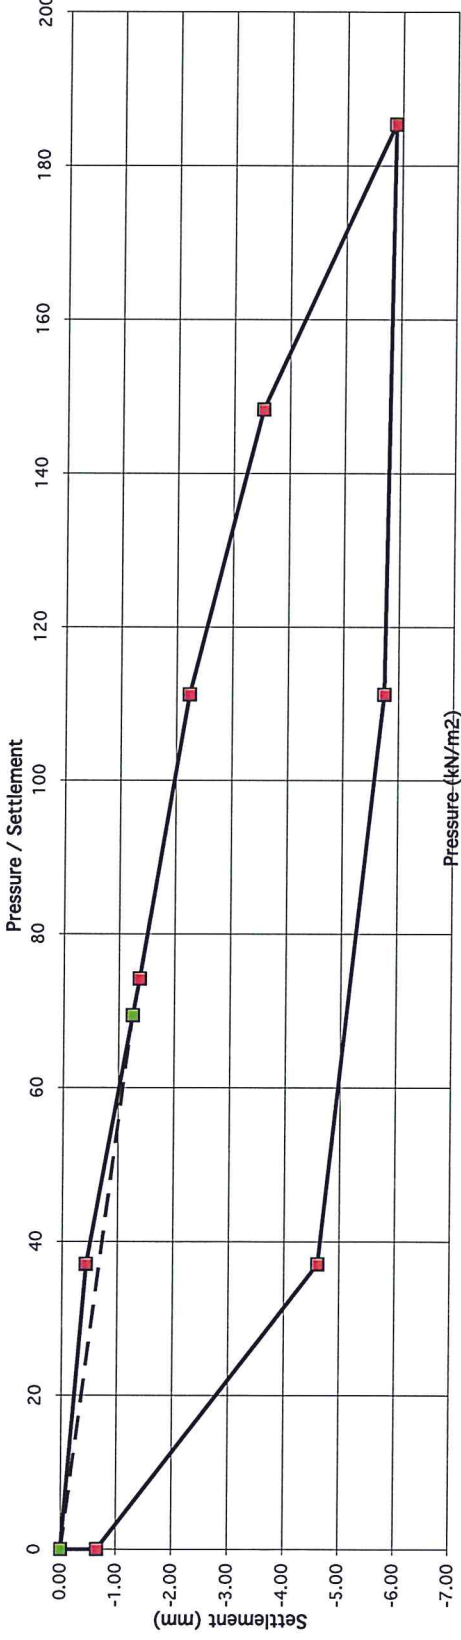
<p>The graph plots Settlement (mm) on the y-axis (0 to -7.00) against Pressure (kN/m<sup>2</sup>) on the x-axis (0 to 200). A solid line with red square markers shows the test data points, and a dashed line shows the theoretical curve. The data points are approximately: (0, 0), (35, -0.5), (70, -1.0), (110, -1.5), (145, -2.0), (185, -2.5).</p>			
Gradient at 1.25 mm settlement intersection = 56 Modulus of subgrade reaction = 25 MPa/m Correction factor applied = 0.46 as per HD 25-26/10
