REMEDIAL ENVIRONMENTAL IMPACT ASSESSMENT REPORT

SUBSTITUTE CONSENT APPLICATION FOR A
SAND AND GRAVEL PIT AT
CLONFINLOUGH,
CO. OFFALY.

**Dermot Nally Stone Ltd.
Lowerwarren,
Baylin
Athlone
Co. Westmeath**

**Earth Science Partnership Ire. Ltd
Tonranny
Westport
Co. Mayo
July 2019**

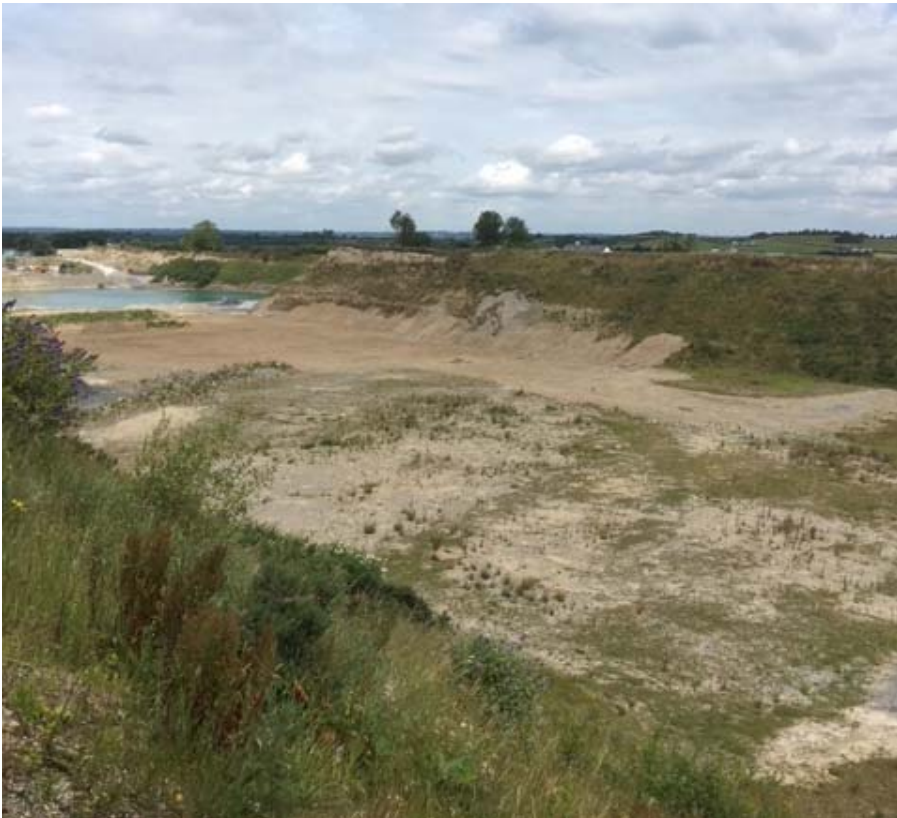
Plate 6.1 View of the site from the southern boundary

Plate 6.1 shows a view of the pit from the south east. As seen in Plate 6.1 a significant area of the pit has been landscape and restored. The applicant is proposing to continue these works in the remaining areas of the pit.

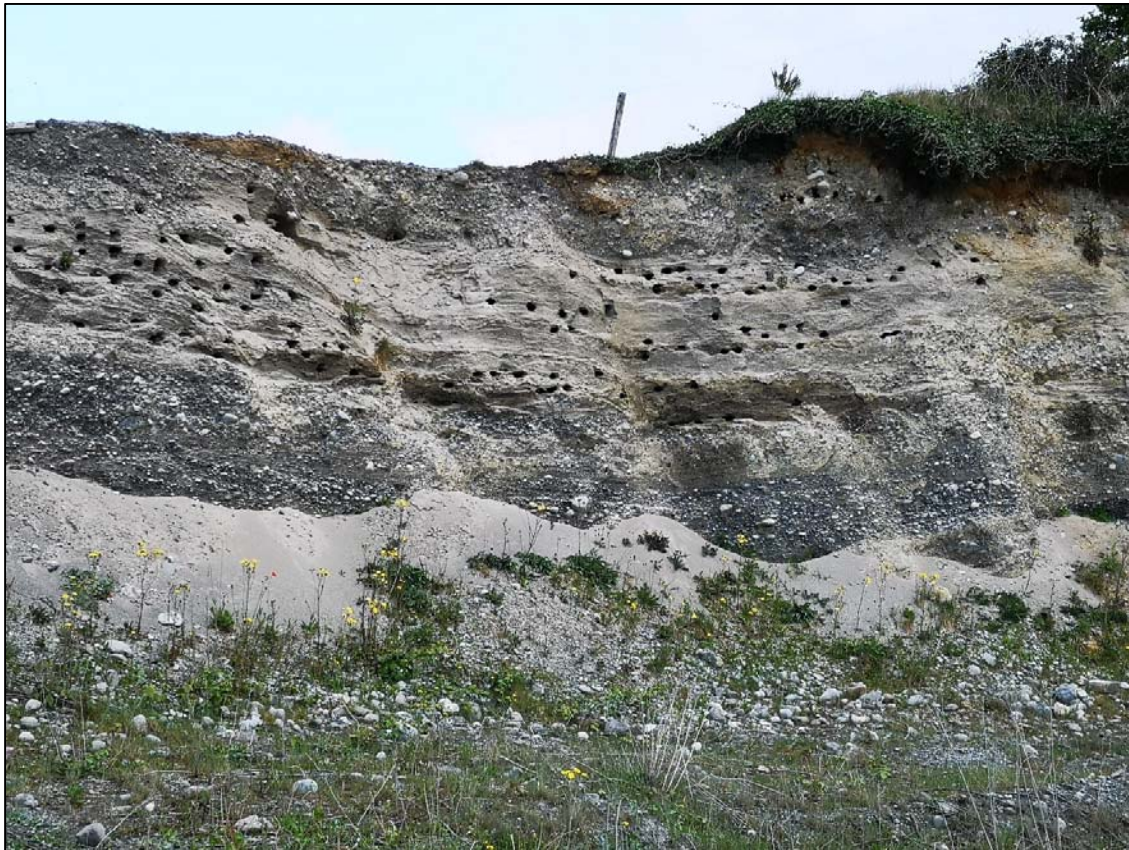
Plate 6.4 Sand martin colony near the site entrance onto the R444.

Birds noted during the site survey include starling *Sturnus vulgaris*, blackbird *Turdus merula*, wren *Troglodytes troglodytes*, barn swallow *Hirundo rustica*, hooded crow *Corvus cornix*, magpie *Pica pica*, jackdaw *Coloeus monedula* and sand martin *Riparia riparia*. There is a sand martin colony in a cliff face along the northern boundary of the site. Despite proximity to both the pit access road and the R444, the birds have adapted to the disturbance and on the day of the site survey, numbered approximately 25 nesting birds. Sand martin burrows were evident in other sections of the site on suitably vertical cliff faces. A kestrel *Falco tinnunculus* was observed hovering over grasslands to the immediate east of the site.

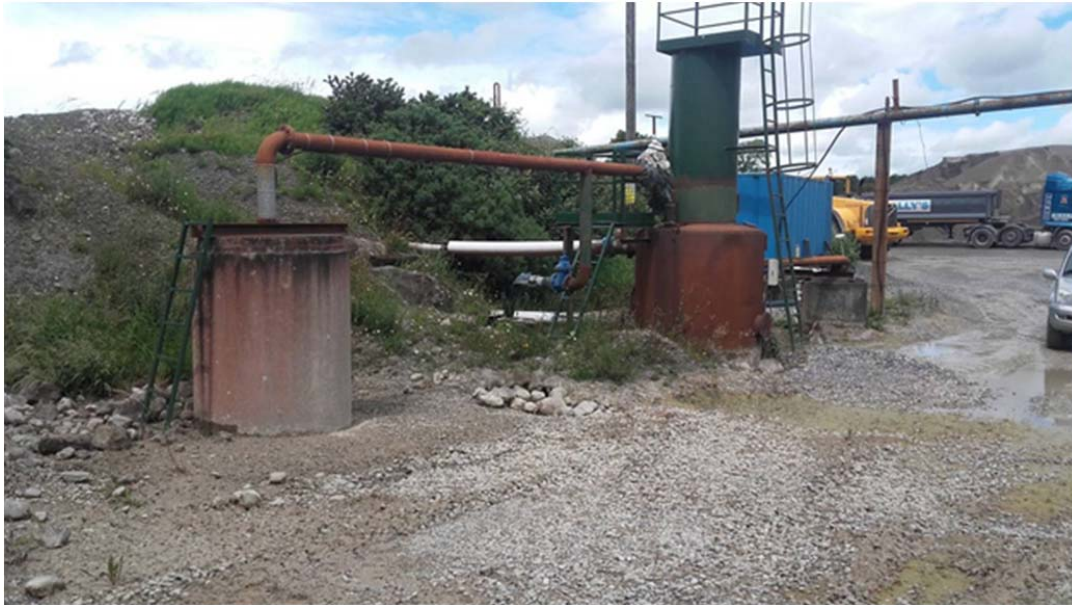
Figure 8-3: Photograph of washing plant wells / sumps

The aggregate processing and washing plant was located on the lower lying southern section of the site and comprises a standard sorting and grading system. Water for topping up the closed loop washing system was sourced from two shallow wells (sumps) which are located immediately to the west of the processing facility. The sumps are constructed of 1000 – 1,300mm diameter concrete pipes and extend approximately 3m below the local ground level (to ~44.3m OD).

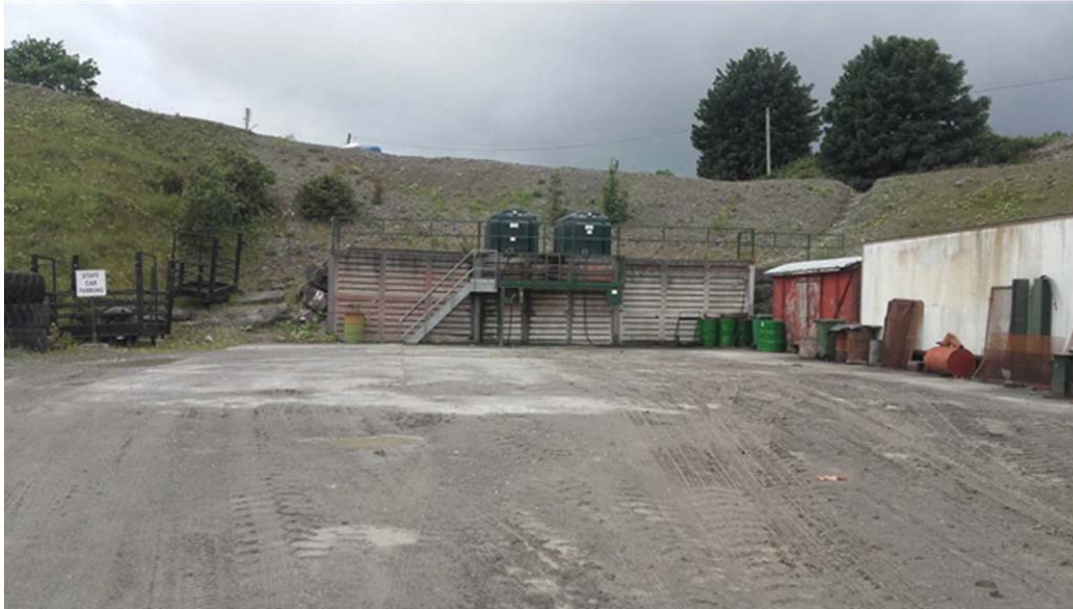
Figure 8-4: Above Ground Fuel storage and Refuelling Area

On the north-western section of the site (close to the site entrance) there was plant maintenance area along with a refuelling area (refer to Figure 8.4 below).

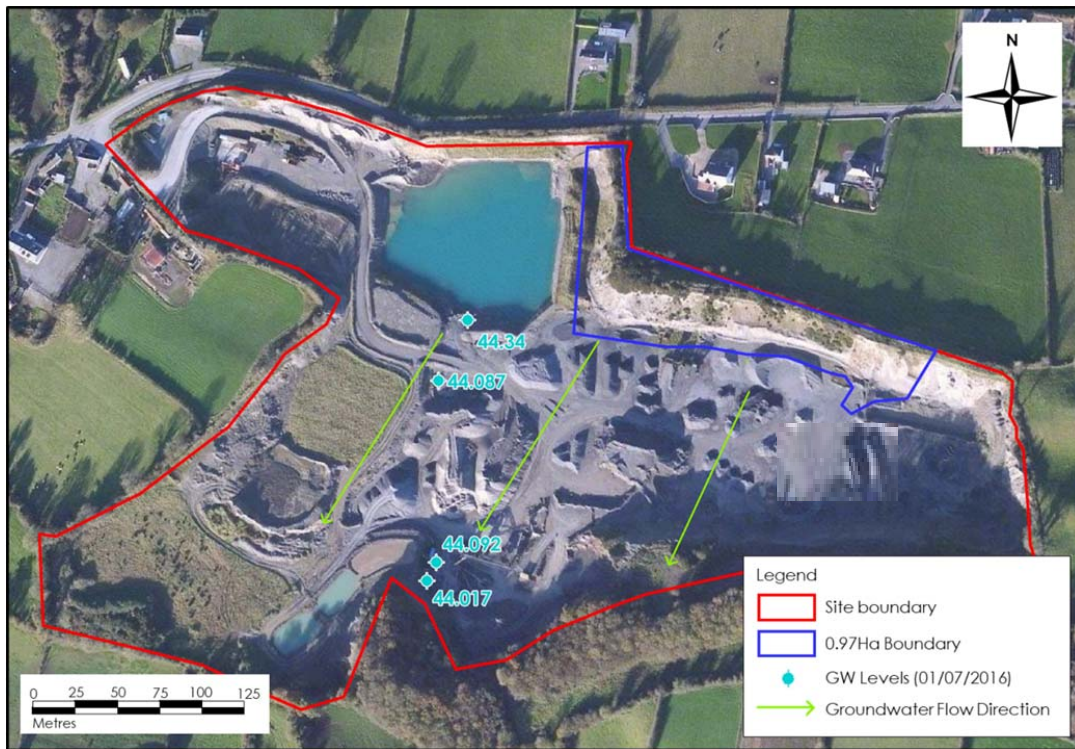
Figure 8-11: Local Groundwater Flow Direction Map

These water levels would suggest that the overall groundwater flow direction below the pit has generally been in a south / southwesterly direction. This is also consistent with the overall topography of the pit floor where the lowest lying area is at the southwestern section of the site in the area of the washing and processing plant. The abstraction of groundwater was also possibly having an influence on pit groundwater levels, but given the relatively small volumes being pumped and the low observed drawdown levels (0.1 – 0.2m) this is unlikely to be significant on a broader scale. The groundwater flow direction is also consistent with the local surface water catchment mapping which shows that the majority of the site exists within the Gowlan River surface water catchment which exits to the southwest of the site.

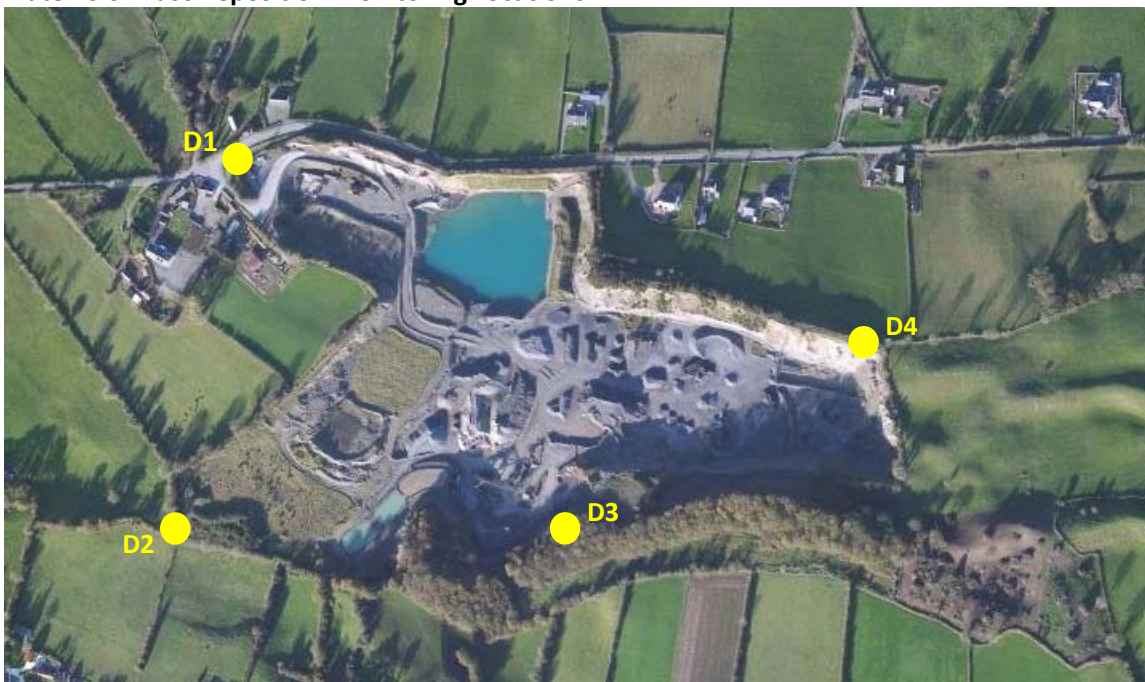
Plate 10.3: Dust Deposition Monitoring Locations

Dust monitoring was conducted on two occasions between the 14th July 2008 and 30th October 2008 using the the Bergerhoff method. Locations of monitoring are detailed on Plate 10.3 and tabulate in Table 10.5.

Date Out	Date In	Limit	D1	D2	D3	D4
14/7/08	22/8/08	350	32	190	NR	64.7
22/8/08	30/10/08	350	74	28.6	NR	37.3

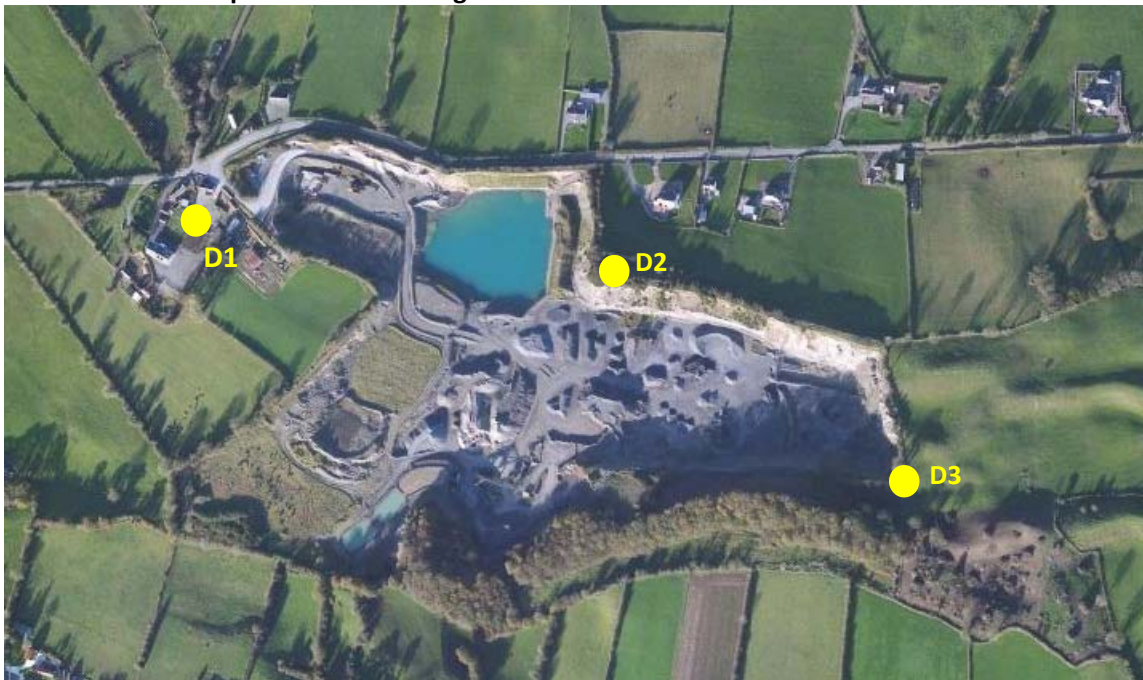
Plate 10.4: Dust Deposition Monitoring Locations

Two further rounds of monitoring were undertaken in 2015 and 2016 at three locations as shown on Plate 10.4 below with results of monitoring are detailed on Table 10.6. Results of dust deposition monitoring were all below the recommended guideline value of 350 mg/m²/day during both monitoring periods.

Date Out	Date In	Days	Limit	D1	D2	D3
29/10/15	26/11/15	28	350	150.4	71.2	175.1
26/01/16	24/02/16	29	350	128.4	102.4	92.3

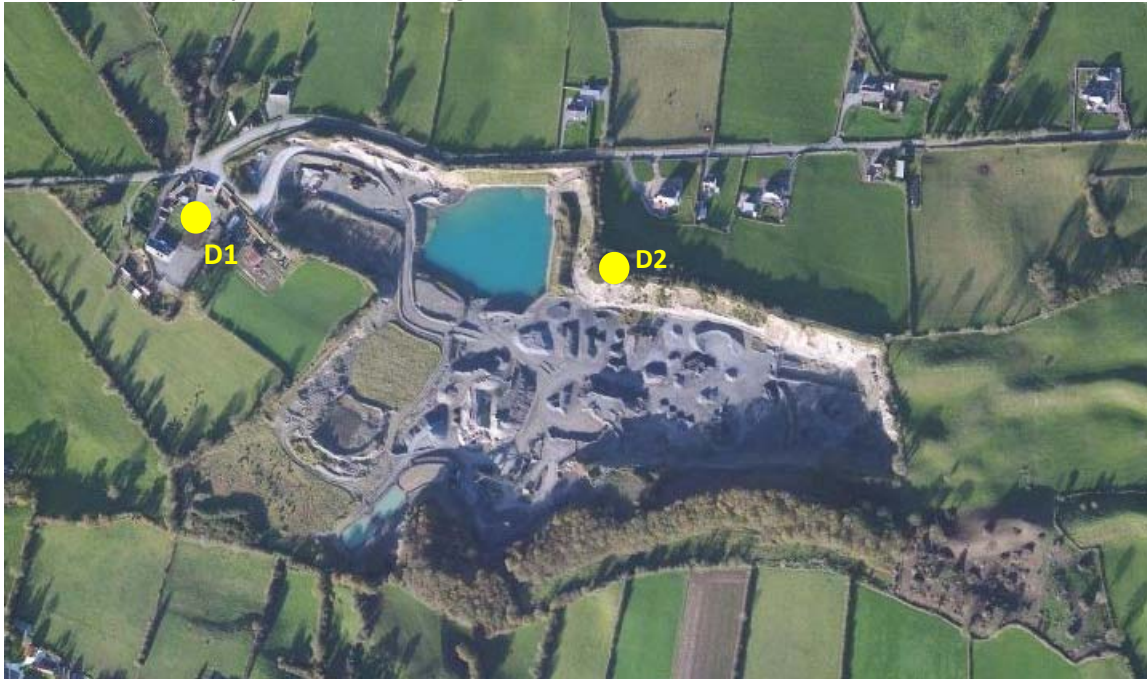
Plate 10.5: Dust Deposition Monitoring Locations

A round of monitoring was undertaken in 2019 at two locations as shown on Plate 10.5 below with results of monitoring detailed on Table 10.7. Results of dust deposition monitoring were all below the recommended guideline value of 350 mg/m²/day during the monitoring period.

Date Out	Date In	Days	Limit	D1	D2
26/03/19	24/04/19	29	350	309	34

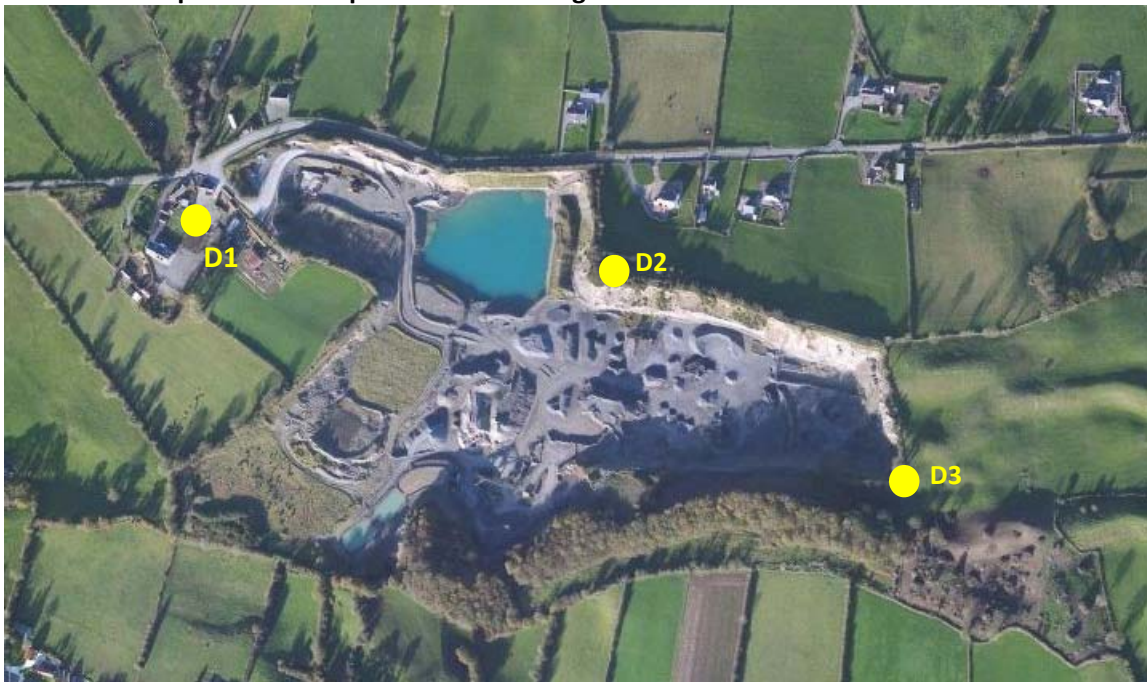
Plate 10.6: Proposed Dust Deposition Monitoring Locations

To ensure that the existing development is not impacting on air quality, dust deposition monitoring will be undertaken during the landscape and restoration phase of the development at the locations shown on Plate 10.6.

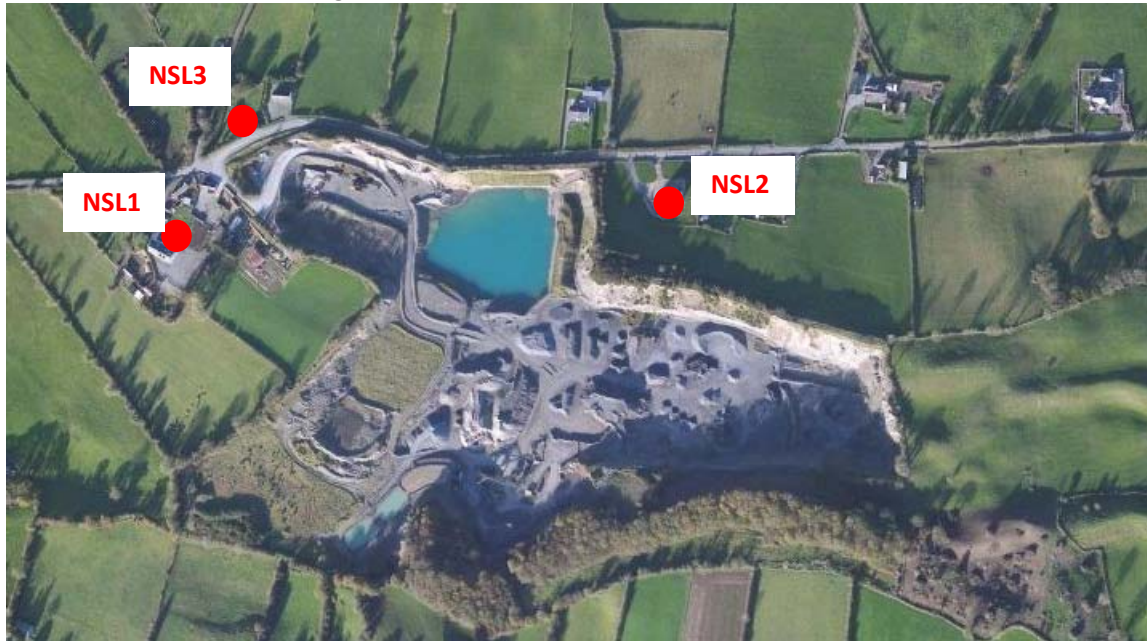
Plate 11.3: Noise Monitoring Locations October 2015

Noise monitoring was undertaken at three locations at 60 minute intervals on 29th October 2015 by BHP Laboratories Ltd. The results of noise monitoring are detailed in Table 11.2 with locations of monitoring illustrated on Plate 11.3.

Results of noise monitoring were all below the recommended noise level of 55 dB(A). As detailed in Table 11.2, activities being undertaken at the sand and gravel pit were slightly audible at noise monitoring locations. However, noise levels associated with pit activity were well below the LAeq level of 55dB as conditioned on the pit.

Time	L _{AEQ} dB	L _{A10} dB	L _{A90} dB	Wind m/s	Notes
NSL 1	08.08- 09.08hrs	46	49	36	0	The quarry is audible at 32-40dB and occasionally up to 43dB (a track machine is working nearby). The screener came on about 20 minutes into the run and was operating at 45-51dB. Occasional cars on the entrance road are at 43dB and one tractor coming in to load went by on the entrance road at 55-59dB. Cattle and birdsong are occasionally up to 44dB. Occasional traffic on the regional road is at 47-48dB.
NSL 2	09.17- 10.17hrs	44	45	37	0	The quarry (screener) is audible at 39-42dB, occasionally down to 36dB and up to 45dB depending on the rock load. Traffic on the regional road adjacent is occasional and up to 55-59dB.
NSL 3	07:24 – 07:39 hrs	40	44	27	0	The quarry is just audible at 34-36dB as machinery starting up at 7.30am. Occasional traffic on the regional road is up to 51-55dB. Birdsng is frequently up to 45dB.

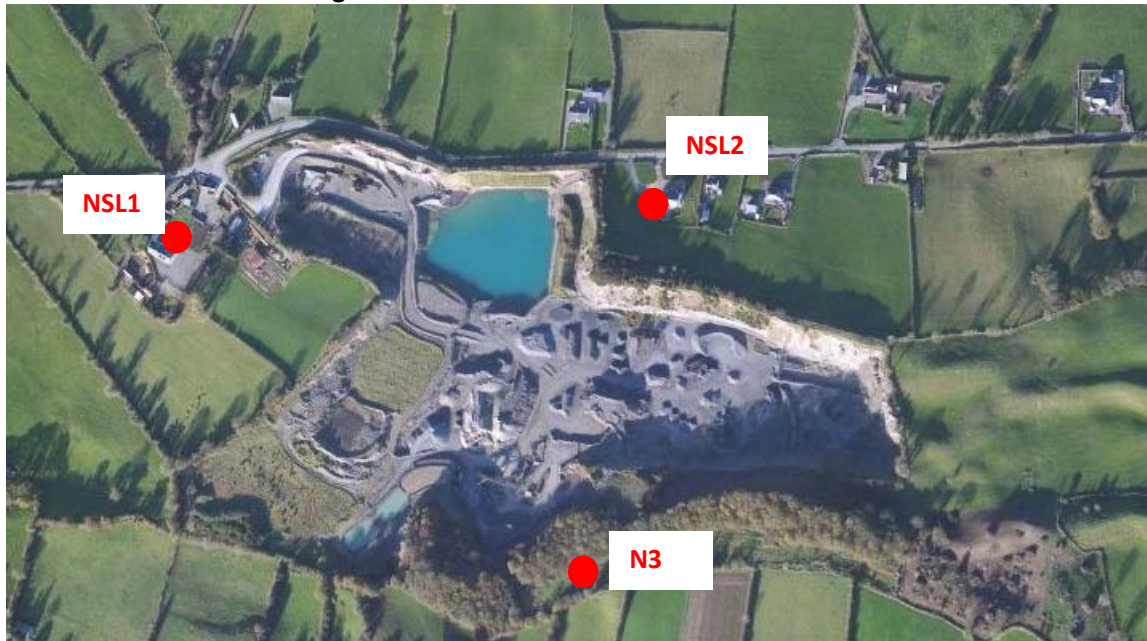
Plate 11.4: Noise Monitoring Locations

Monitoring of noise levels will continue at 3 locations as shown on Plate 11.5 on an annual basis during landscape and restoration to ensure that noise levels are below the recommended guideline values.

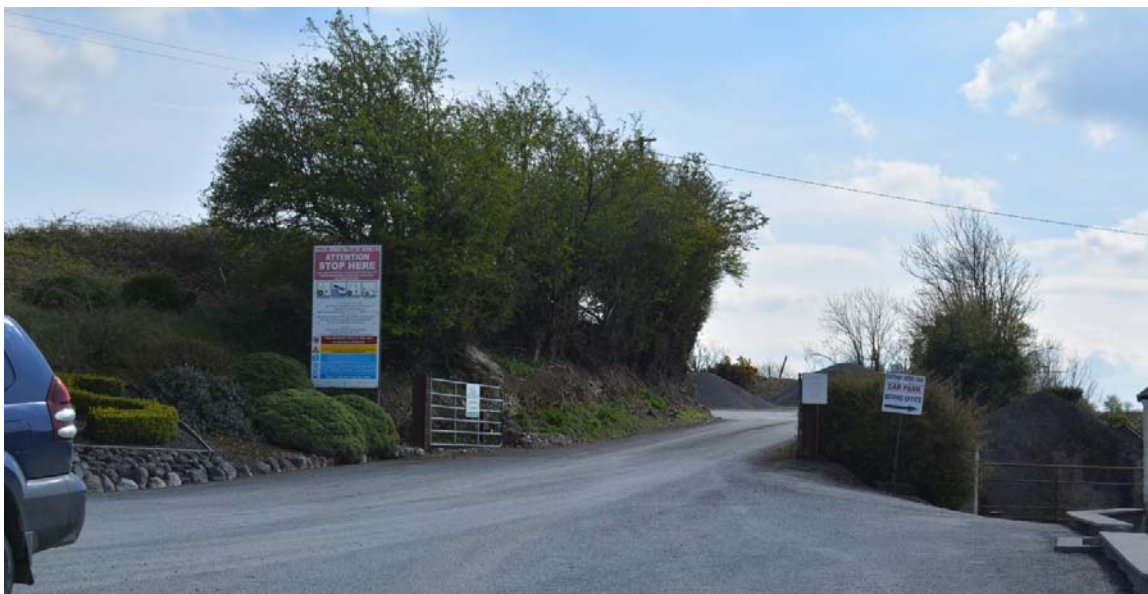
Plate 12.2: Site Entrance

The pit is accessed via a simple direct access off the R444 regional road. The access consists of a gated entrance which was closed and locked outside operation hours. Plate 12.2 details a photo of the pit entrance.

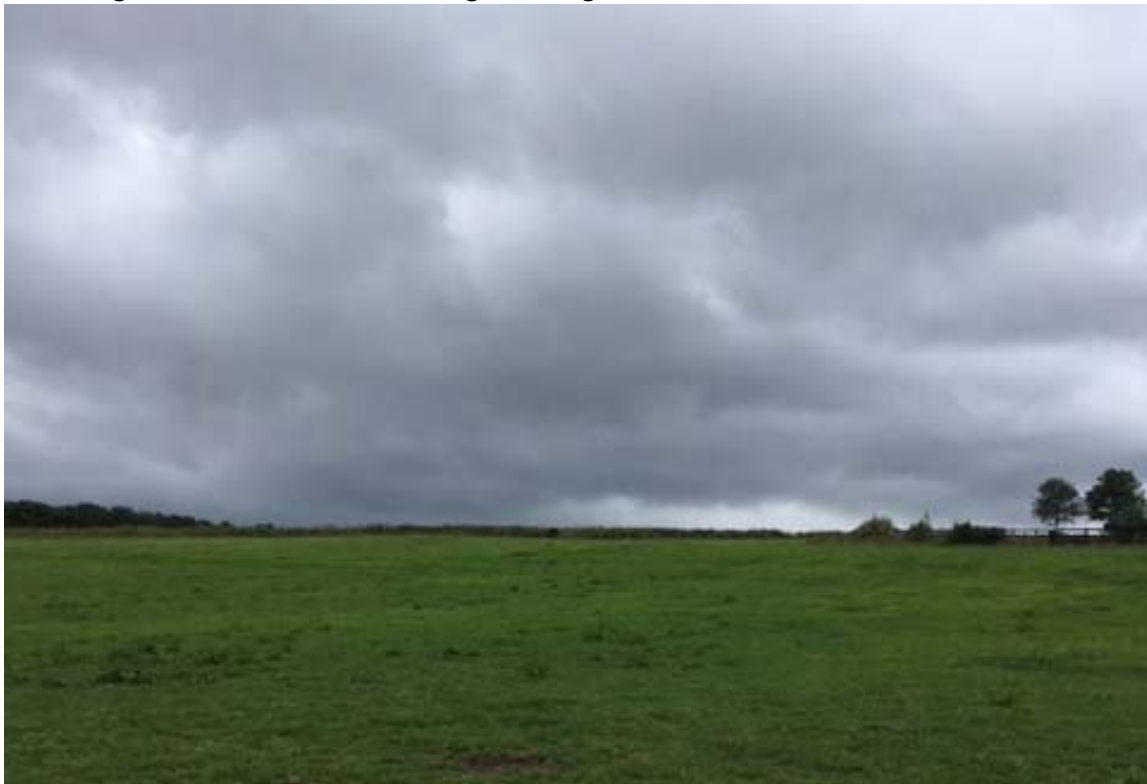
Vantage Point 1 – North of site along R444 Regional Road

Vantage Point 1 shows a view from the north of the pit from the R444. As seen from the photo, the land rises towards the boundary of the gravel pit. The trees present on the esker at the southern boundary of the pit are visible to the left of the photo. However, the pit is not visible.

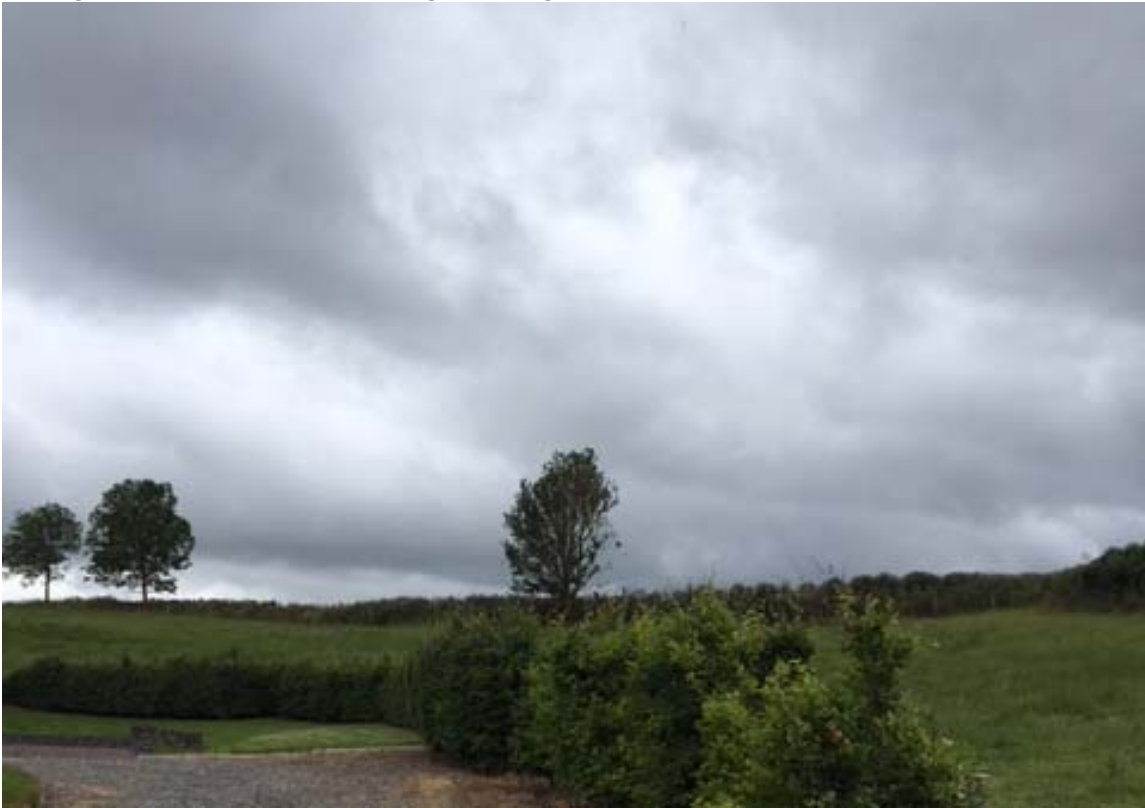
Vantage Point 2 – North of site along R444 Regional Road

Vantage Point 2 shows a view from the north of the pit further east along the R444 road. The existing vegetation left in place along the boundary fence aids in screening the pit.

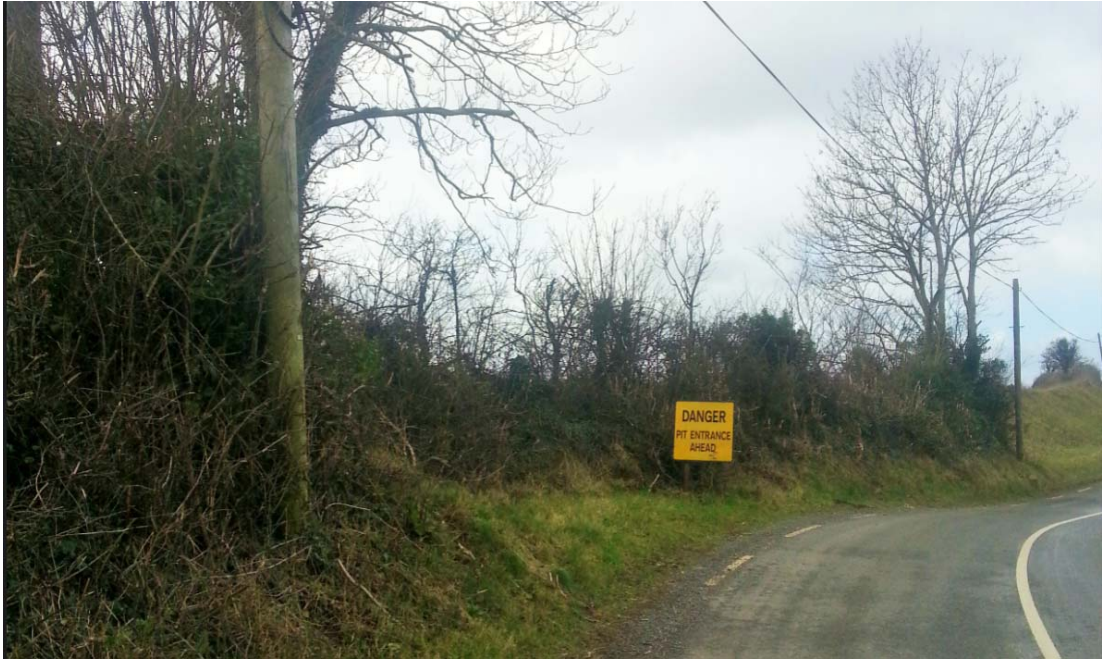
Vantage Point 3 – North of site along R444 Regional Road

Vantage Point 3 shows a view from the north of the pit further east along the R444 road. As seen from the photo, existing vegetation aids in screening the site from public view.

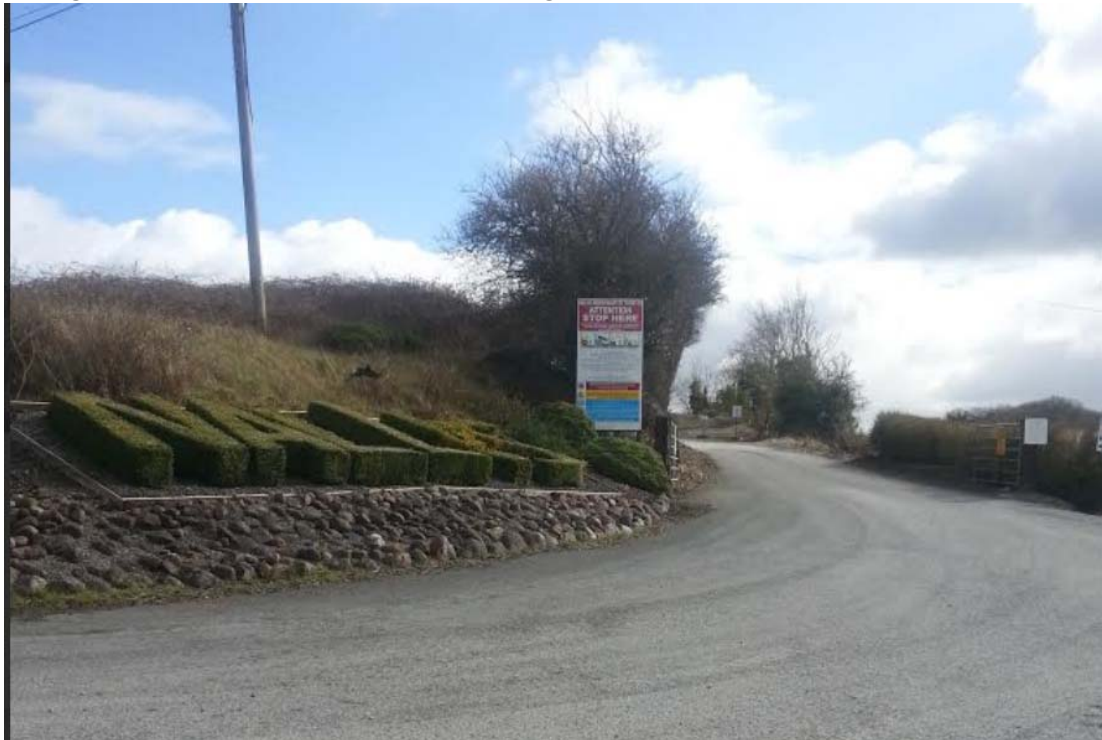
Vantage Point 4 – Entrance to site off R444 Regional Road

Vantage Point 4 shows a view of the entrance to the pit which is well landscaped. The pit is well screened at the entrance due to the alignment of the entrance road to the site.

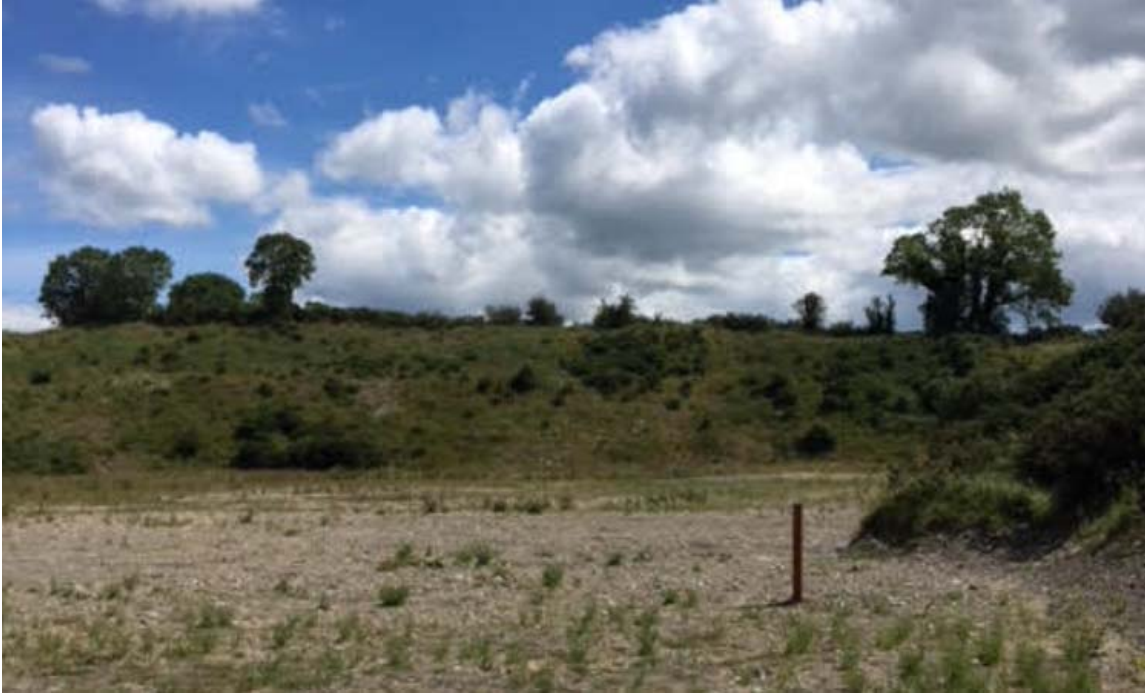
Plate 13.5: Restored Side Slopes Eastern Boundary

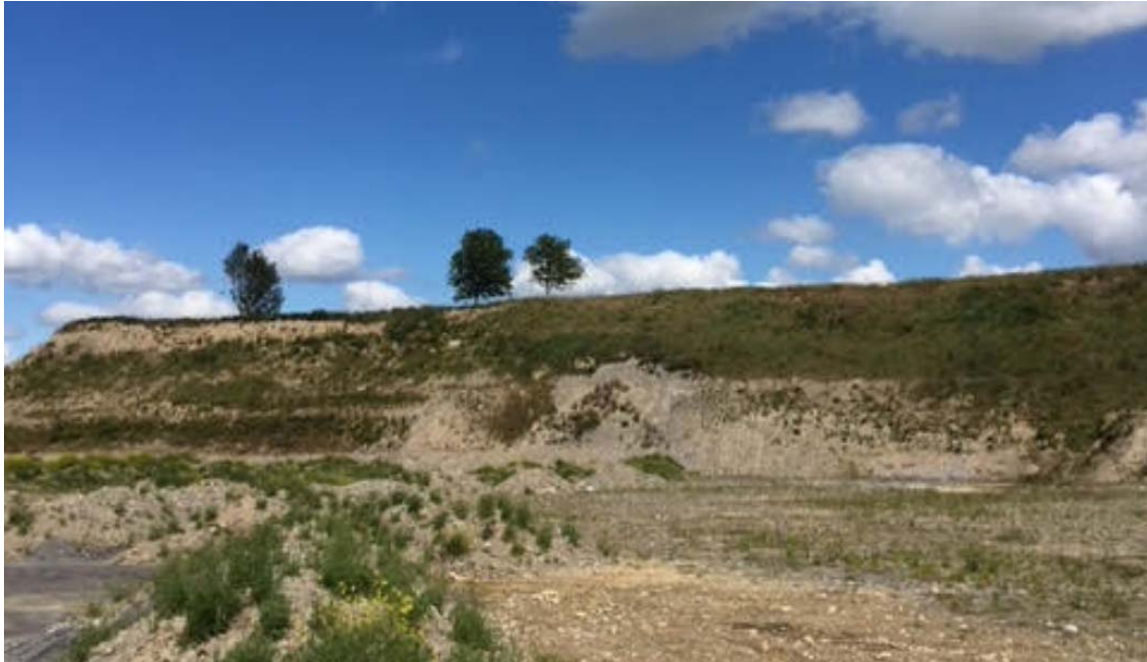
Plate 13.7: Restored Side Slopes North Eastern Boundary
