Kilcarbery - Grange Preliminary Masterplan

APPENDIX 2. Reports

Strategic Flood Risk Assessment

Updated Strategic Environmental Assessment Screening Report-Kilcarbery Grange Updated Masterplan

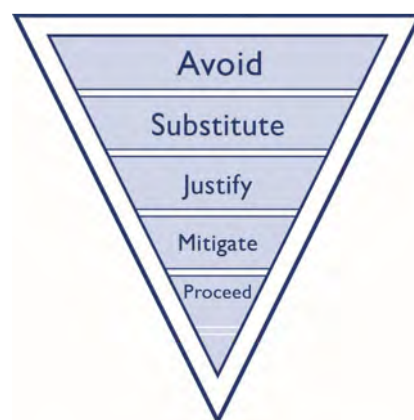
Figure 3.1 Sequential approach principles in Flood Risk Management

The Guidelines recommend using a sequential approach to planning to ensure the core objectives (as described in Section 3.1) are implemented. Development should be avoided in areas at risk of flooding, where this is not possible, a land use that is less vulnerable to flooding should be considered. If the proposed land use cannot be avoided or substituted a Justification Test must be applied and appropriate sustainable flood risk management proposals should be incorporated into the development proposal. Figure 3.1 shows the sequential approach principles in flood risk management. Table 3.2 outlines recommendations from the Guidelines for the types of development that would be appropriate to each flood zone and those that would be required to meet the Justification Test.

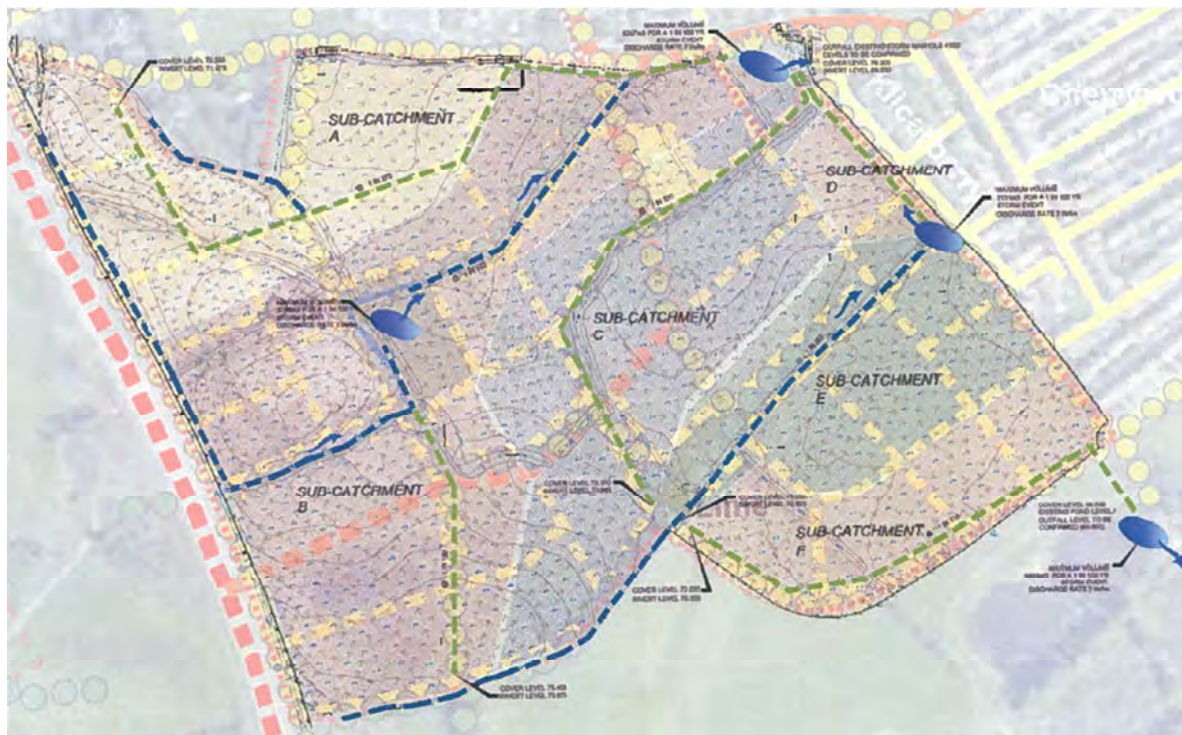
Figure 4.4 Proposed surface water drainage layout

The Masterplan outline drainage is shown in Figure 4.4 below. It includes a combination of above ground /below ground drainage channels and attenuation ponds. The outline drainage in principle follows the natural drainage path to outfalls in the north east and south east of the development site. The existing drainage ditches will need to be regraded in places to ensure the surface water runoff can discharge to the proposed outfall points.

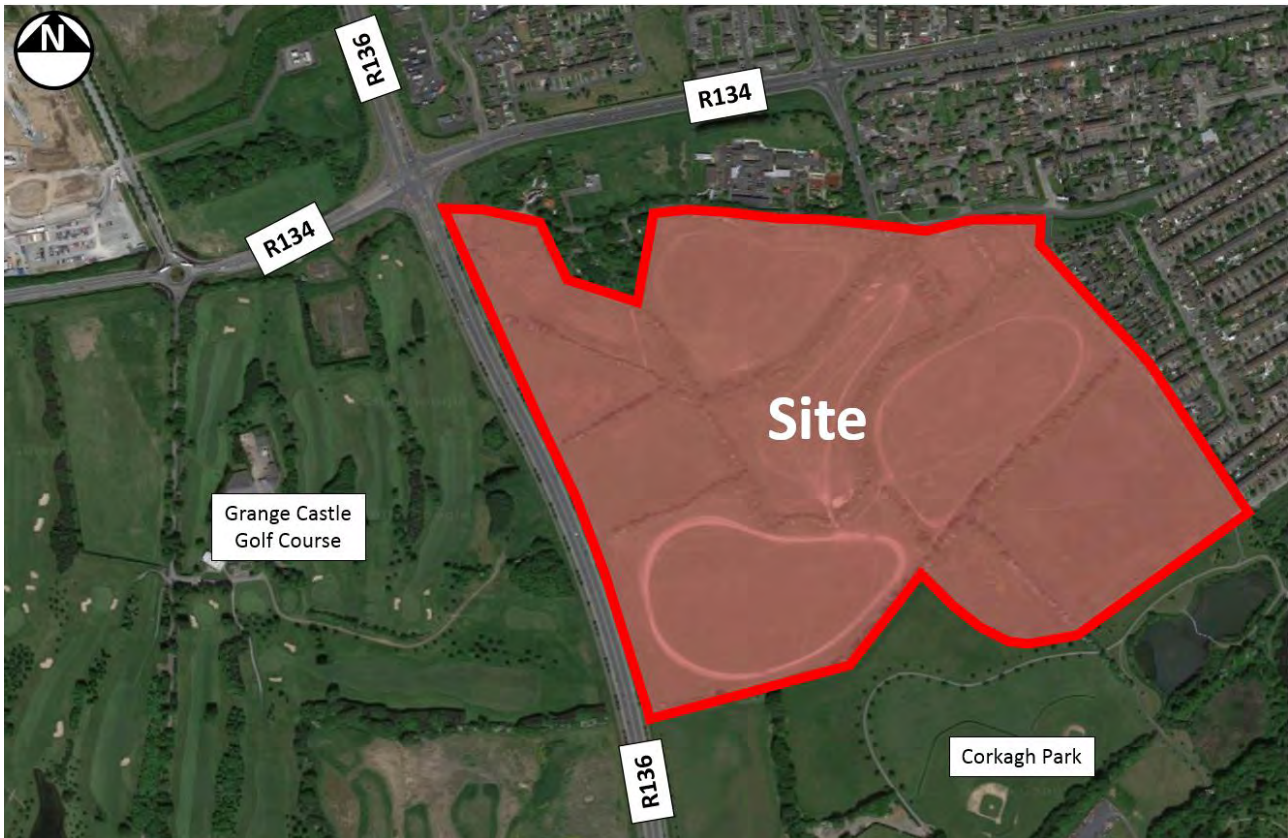
Figure 3-1 Site Location

3.1. The proposed development site is located to the south east of intersection of the R134 and the R136, north of Corkagh Park. The approximate site boundary is illustrated in Figure 3-1 below.

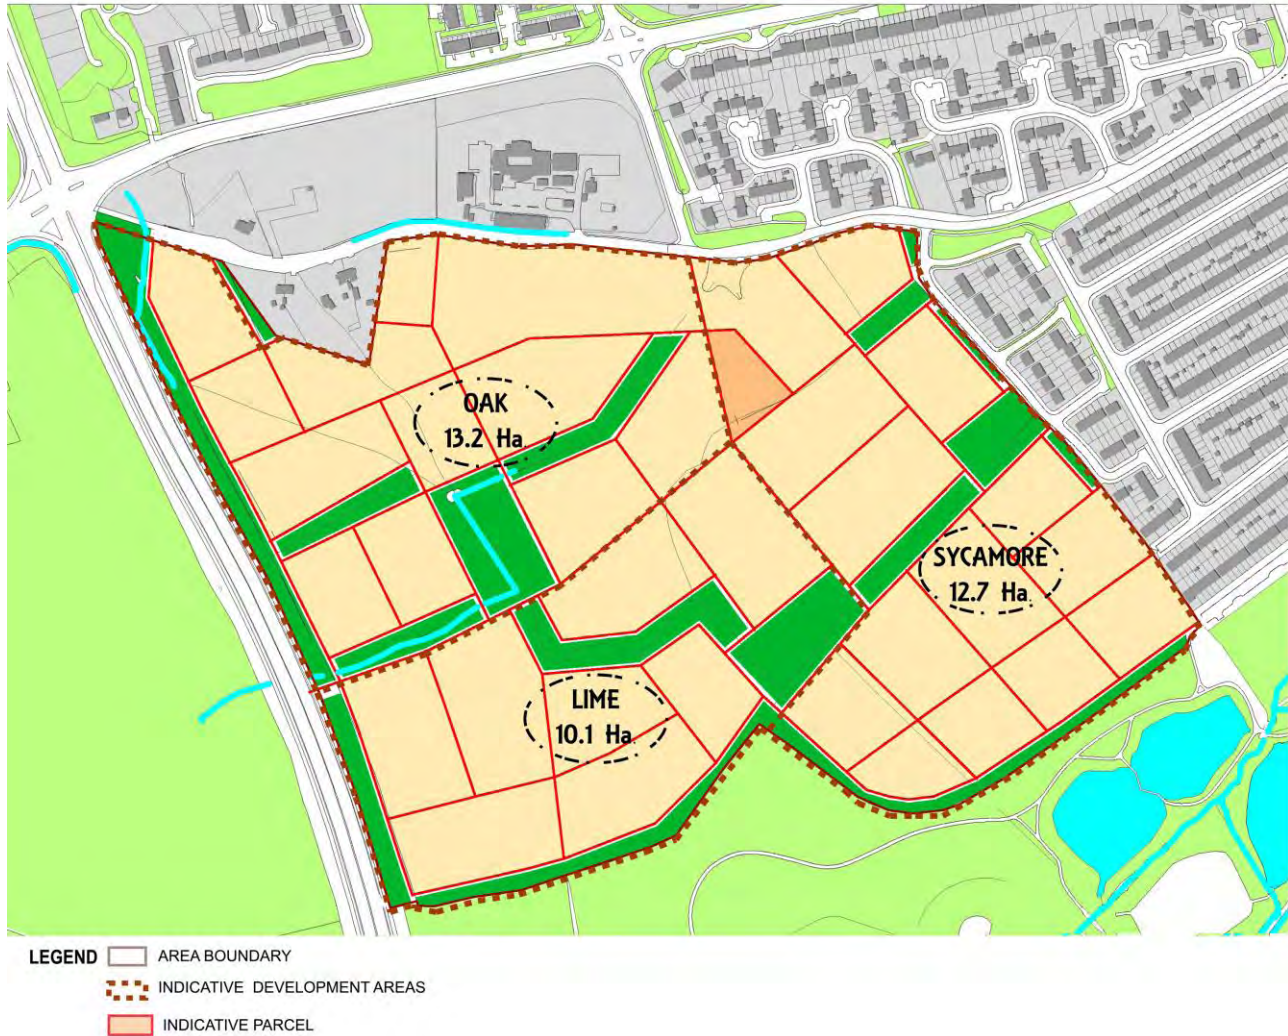
Figure 3-4 Development Areas

- 3.5. The proposed development will consist of circa 1000 residential units, 100 of which are accommodated in 3.14 hectare PPP site being developed by the NTMA. The remaining residential units are accommodated within 29.45 hectares.
- 3.6. The commercial space within the development will be a maximum of 2,000 sq.m GFA
- 3.7. The overall development is further broken down into 3 distinct development areas; Oak, Lime and Sycamore, as shown in the figure following.

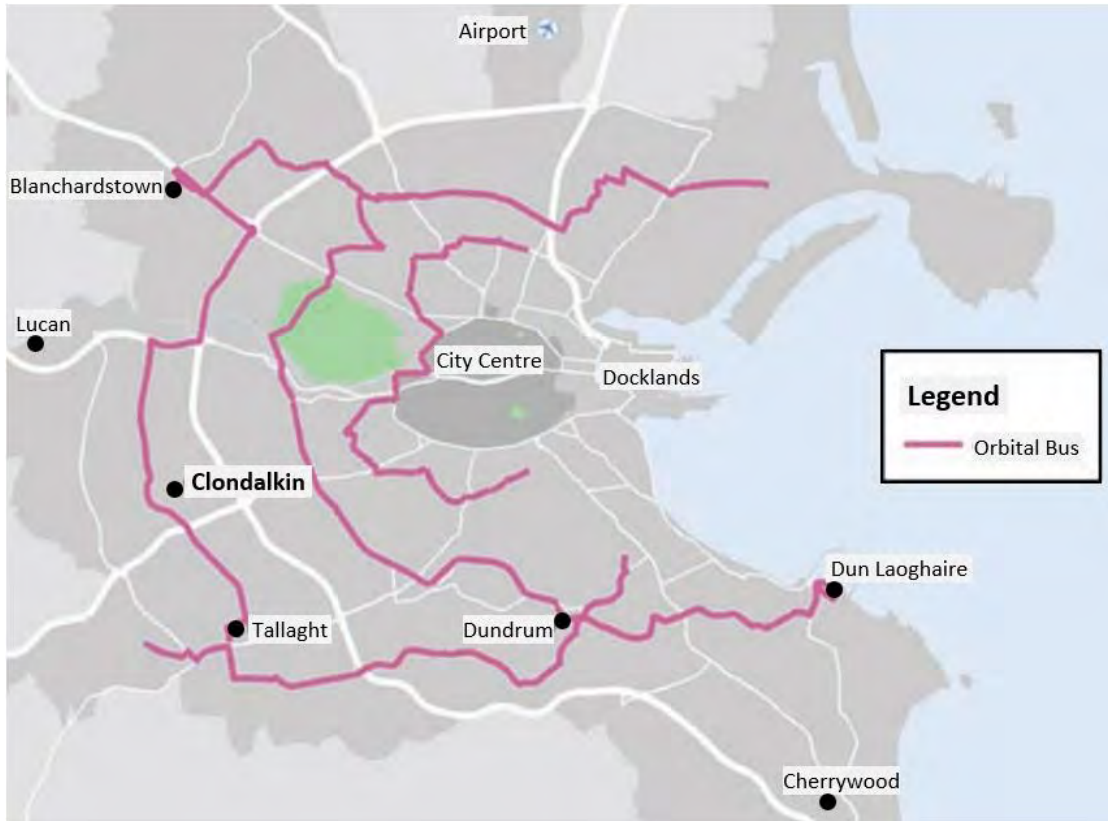
Figure 3-6 2035 Core Bus Network - Orbital Corridors

- 3.20. The Transport Strategy for the Greater Dublin Area 2016 – 2035 proposes a number of bus orbital routes which will comprise an important element of the Core Bus Network, ensuring that more trips within the Metropolitan Area can be undertaken by public transport in a convenient and efficient manner.
- 3.21. Clondalkin lies on the proposed Tallaght to Blanchardstown route which may be located on the R136.

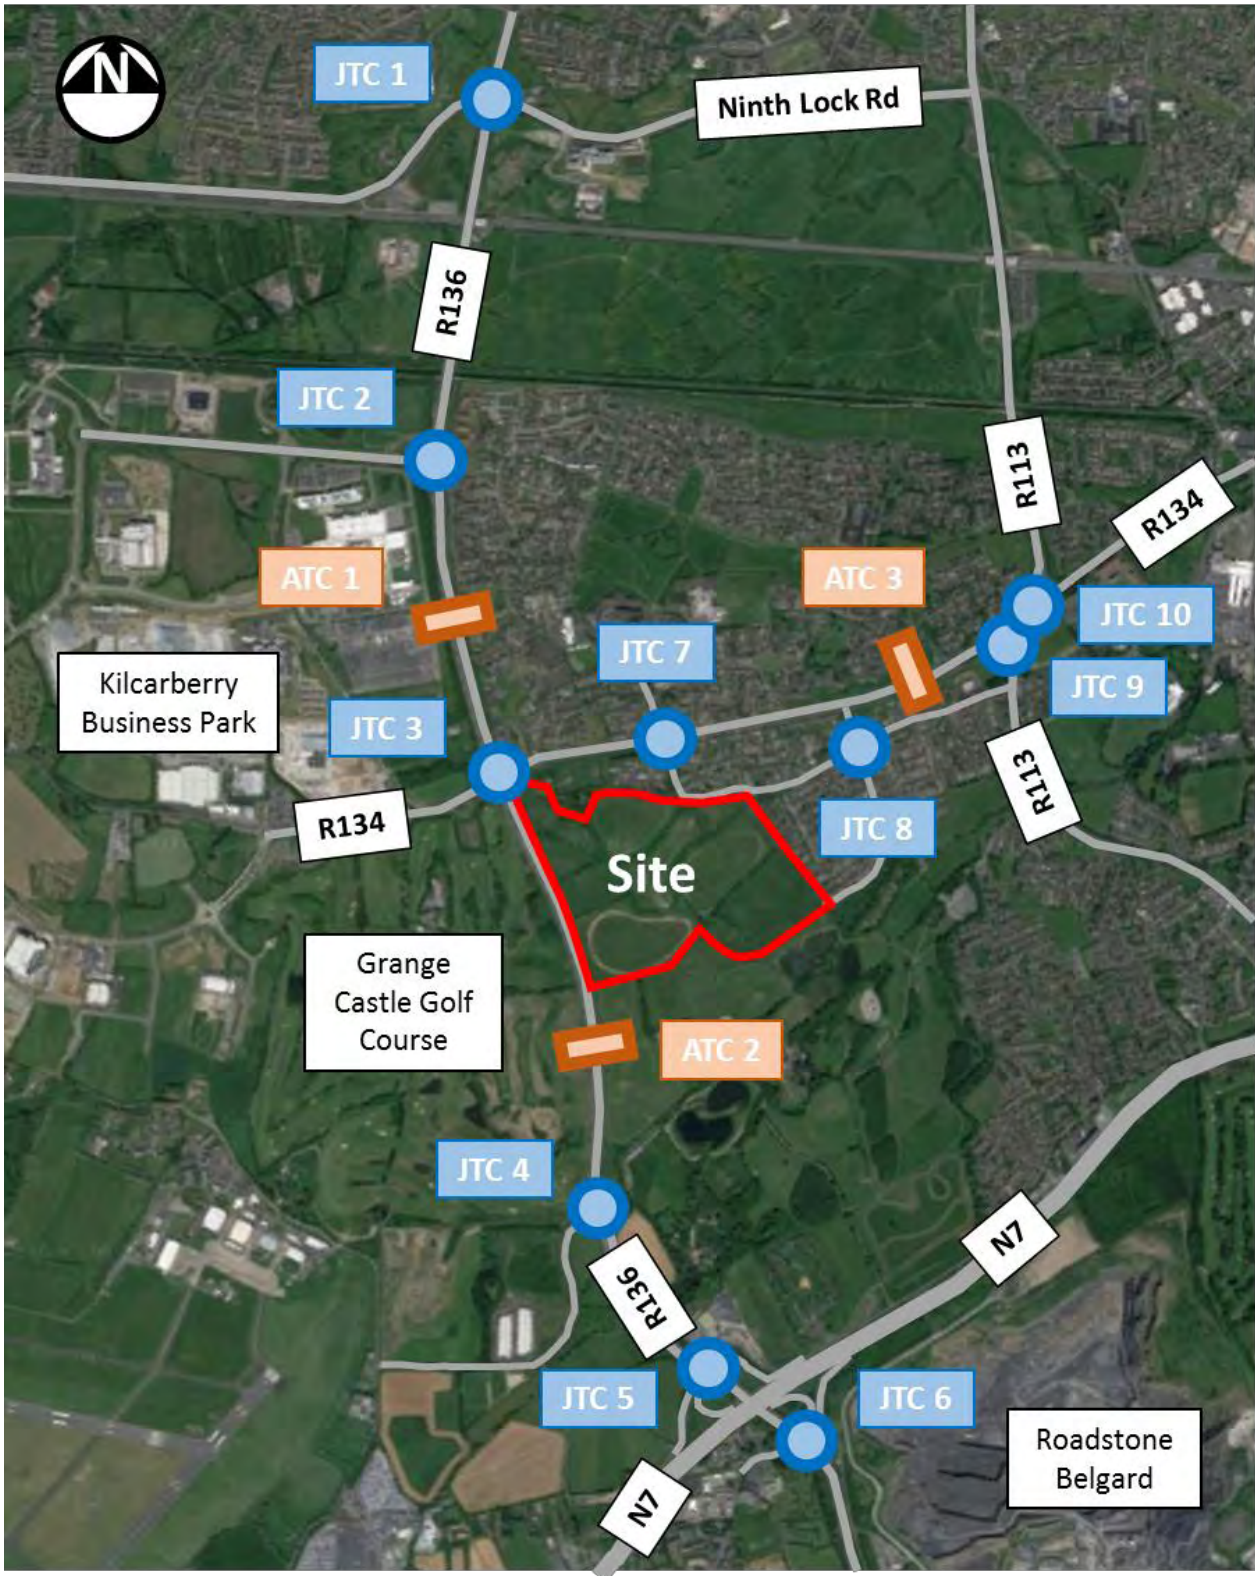
Figure 3-8 Proposed Traffic Survey Locations

- 3.38. Atkins has undertaken a review of the local road network and proposed development plans and the scope of traffic impact assessments for previous planning applications on the site. Following this a number of links and junctions have been identified, as a minimum, for assessment within the TTA. As such traffic surveys are proposed for the following locations as illustrated in Figure 3-8 and listed in Table 3.4

Junction Turning Counts (JTC)	Automatic Traffic Counts (ATC)
JTC 1: R136 / Ninth Lock Road	ATC 1: R136 (North)
JTC 2: R136 / Grange Castle Business Park	ATC: 2 R136 (South)
JTC 3: R136 / R134	ATC 3: R134
JTC 4: R136 / Kingswood Business Park	
JTC 5: R136 / N7 (North)	
JTC 6: R136 / N7 (South)	
JTC 7: R134 / Cherrywood Park	
JTC 8: Old Nangor Rd / Cherrywood Crescent	
JTC 9: R134 / R113	
JTC 10: R134 / R113

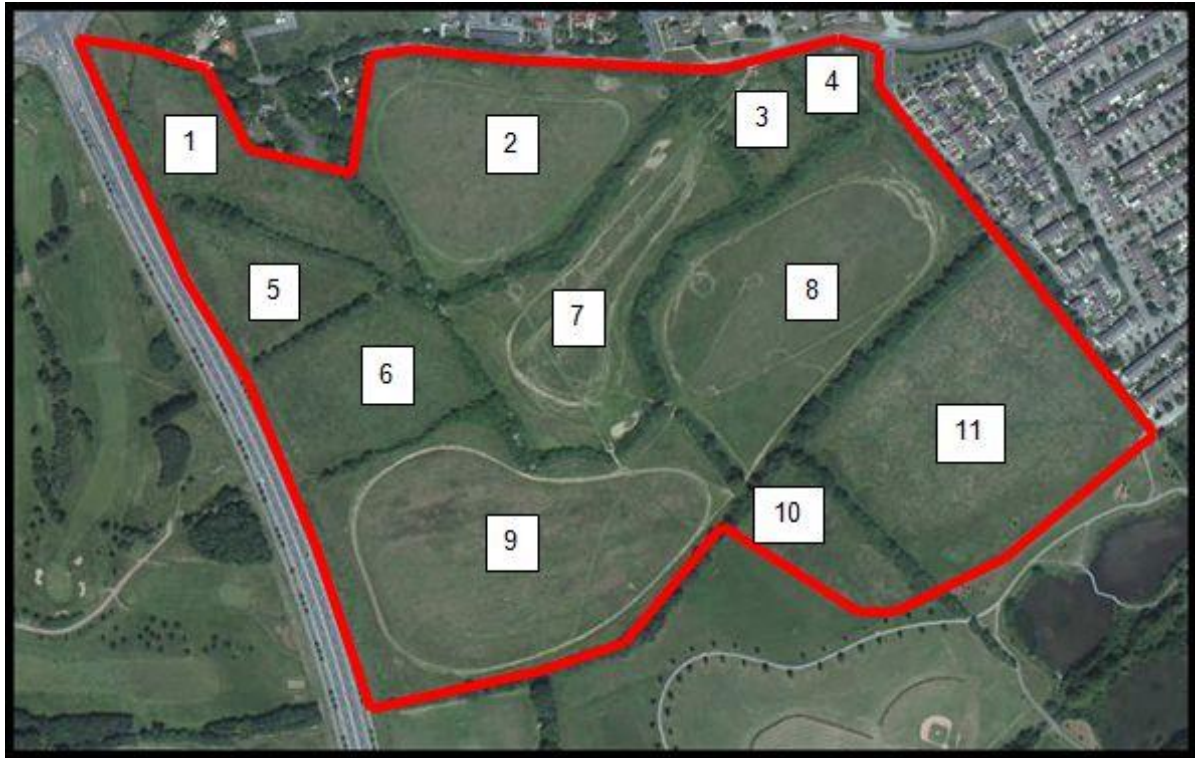
Figure 8: Location of Fields 1 – 11 from the walkover survey

Field 11 is a large open flat field located in the south east corner of the proposed land take. It has short to calf-length grass and is generally dry underfoot and with poor views in all directions.

No archaeological features or artefacts were revealed within any areas of proposed land take as a result of carrying out the walkover survey.

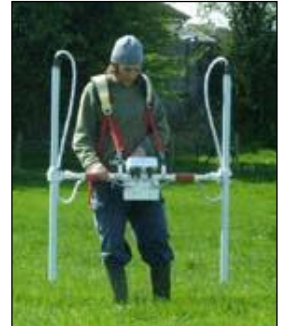
Bartington GRAD 601-2

The Bartington Grad 601-2 instrument is a specifically designed gradiometer for use in archaeological prospection. The gradiometer operates with a dual sensor capacity making survey very fast and effective. The sensors have a separation of 1m allowing greater sensitivity.

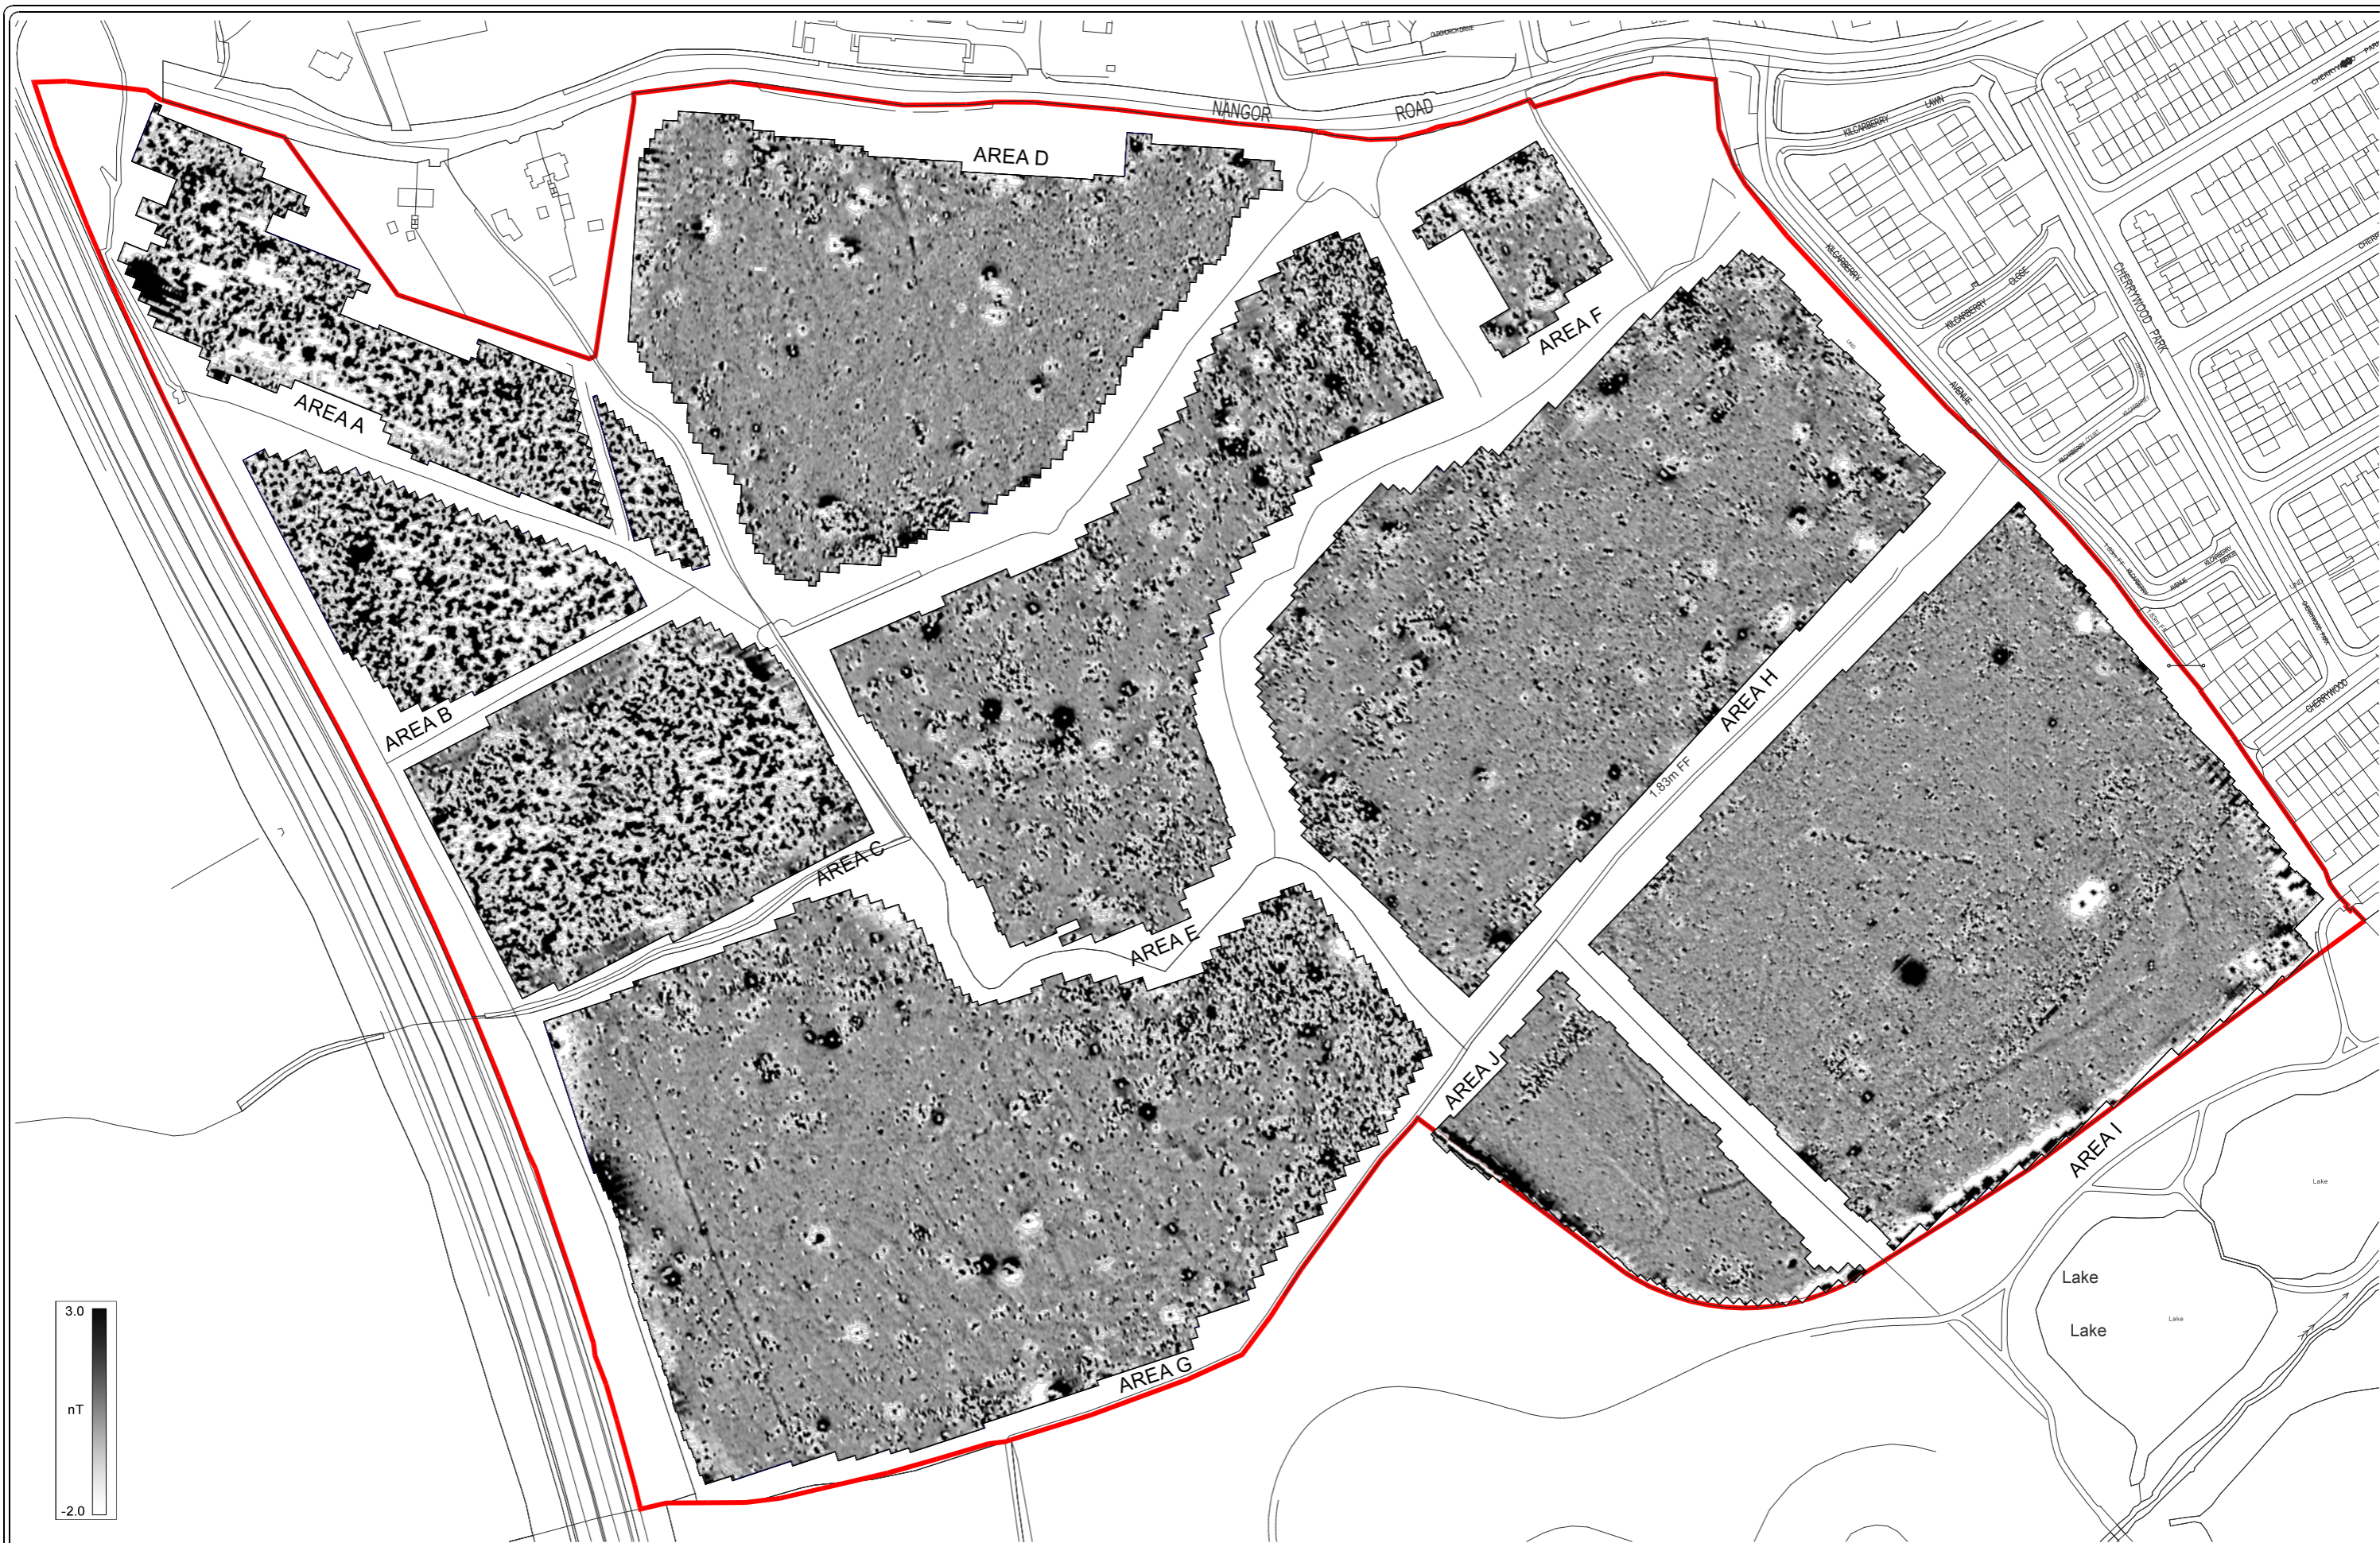
Scale @ A3: 1:2,500
Figure: 2
Licence No's.: 17R0016
Issue Date: 02.05.2017

Figure	Description	Paper Size	Scale
Figure 1	Site & Survey Location Diagram	A3	1:4,000
Figure 2	Summary greyscale image	A3	1:2,500
Figure 3	Summary interpretation diagram	A3	1:2,500

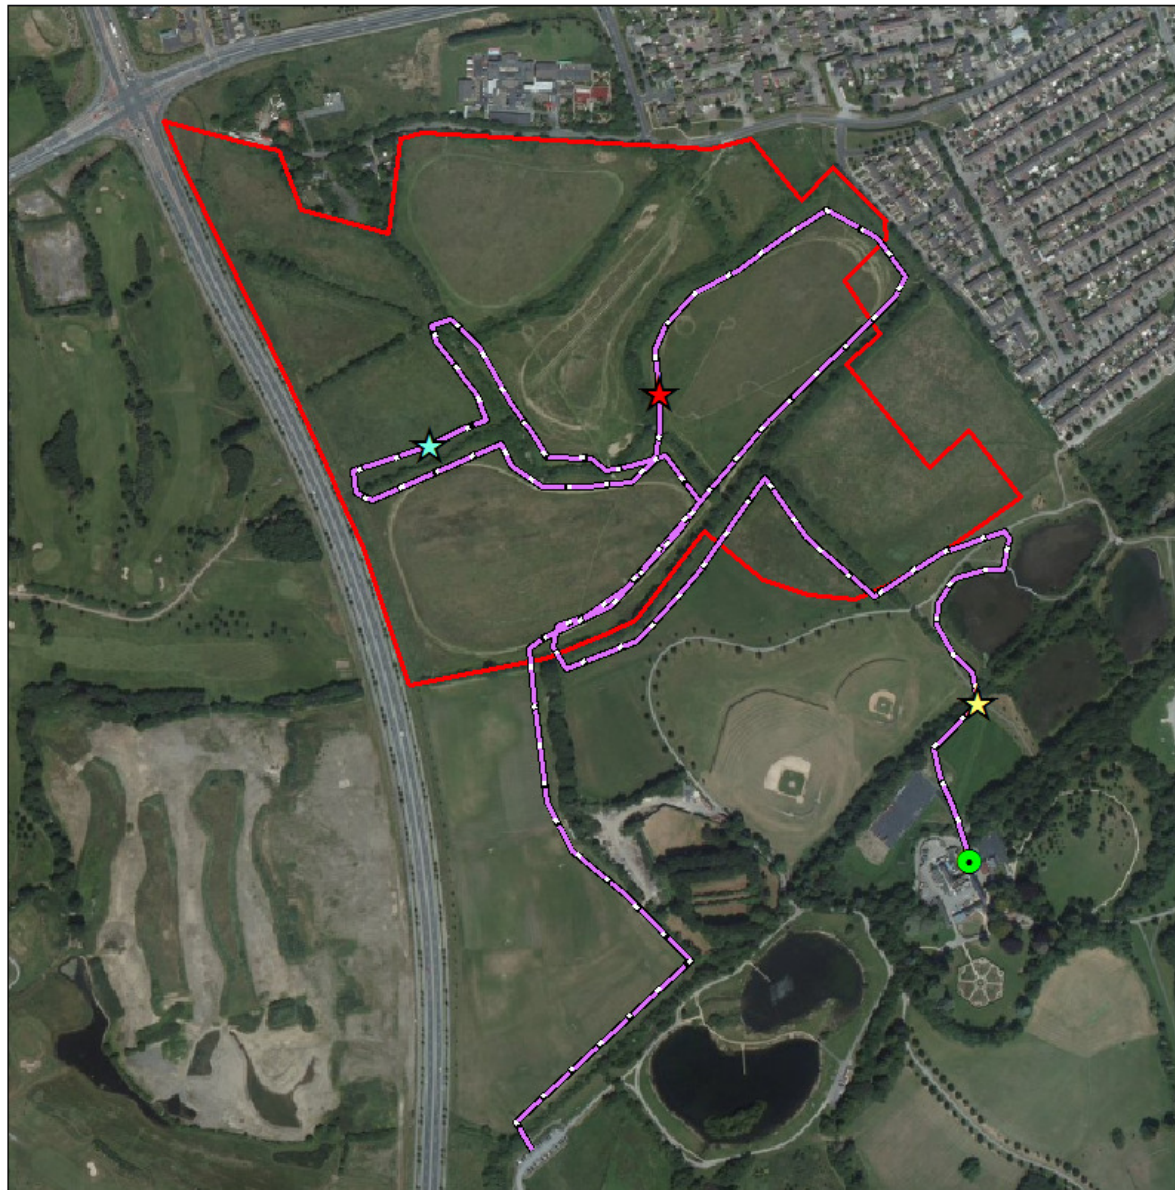
Figure 4.7

The results of the June Manual Transect are shown on Figure 4.7. During the June manual transect the first bat was recorded at 23:15. Leisler's bats were recorded foraging over the amenity grassland field to the south of the River Camac. At least two individual Leisler's bats were foraging at this location. The next bat pass was assigned to a Soprano pipistrelle and was recorded at 23:16 commuting along FB5. The final bat pass recorded was that of an

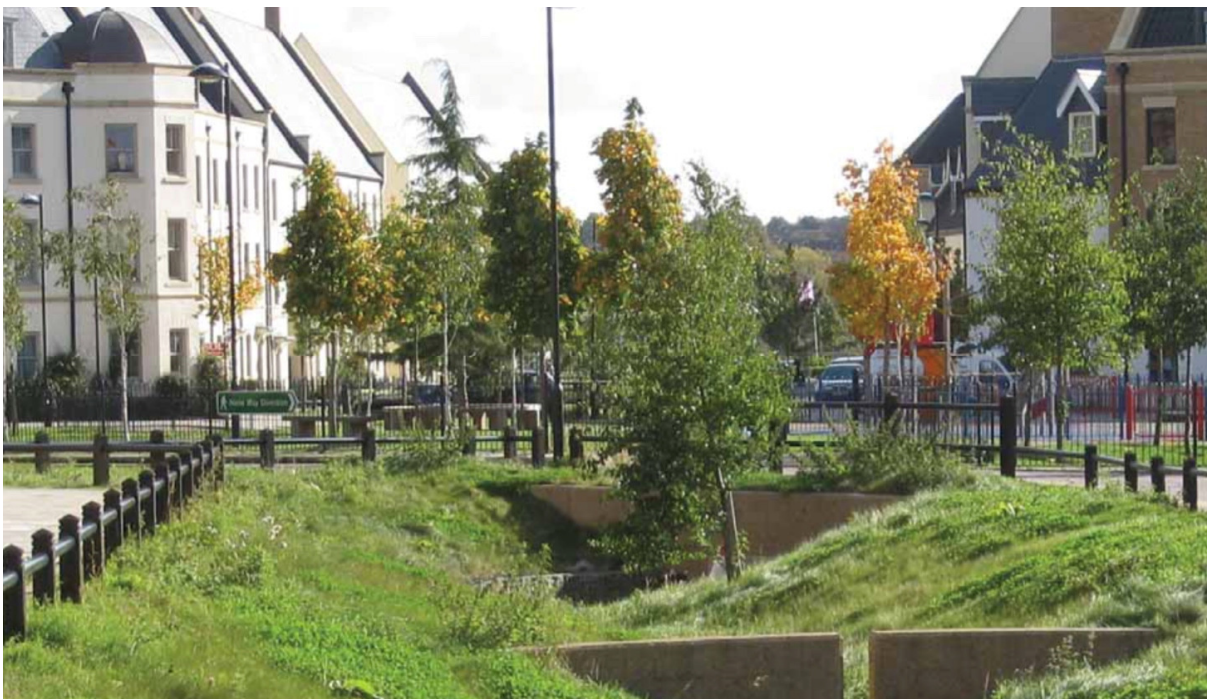
Figure 4: Example of Swale Design Features (source: Graham et al. 2012)

- Check dams should be installed at regular intervals along the swales to promote ponding. Large rocks that are obvious and do not become concealed by vegetation should be used as check dams. Such rocks will create an attractive as well as effective check dam and will provide micro-habitat for species (e.g. basking sites for invertebrates etc.). Figure 5 provides examples of swales.

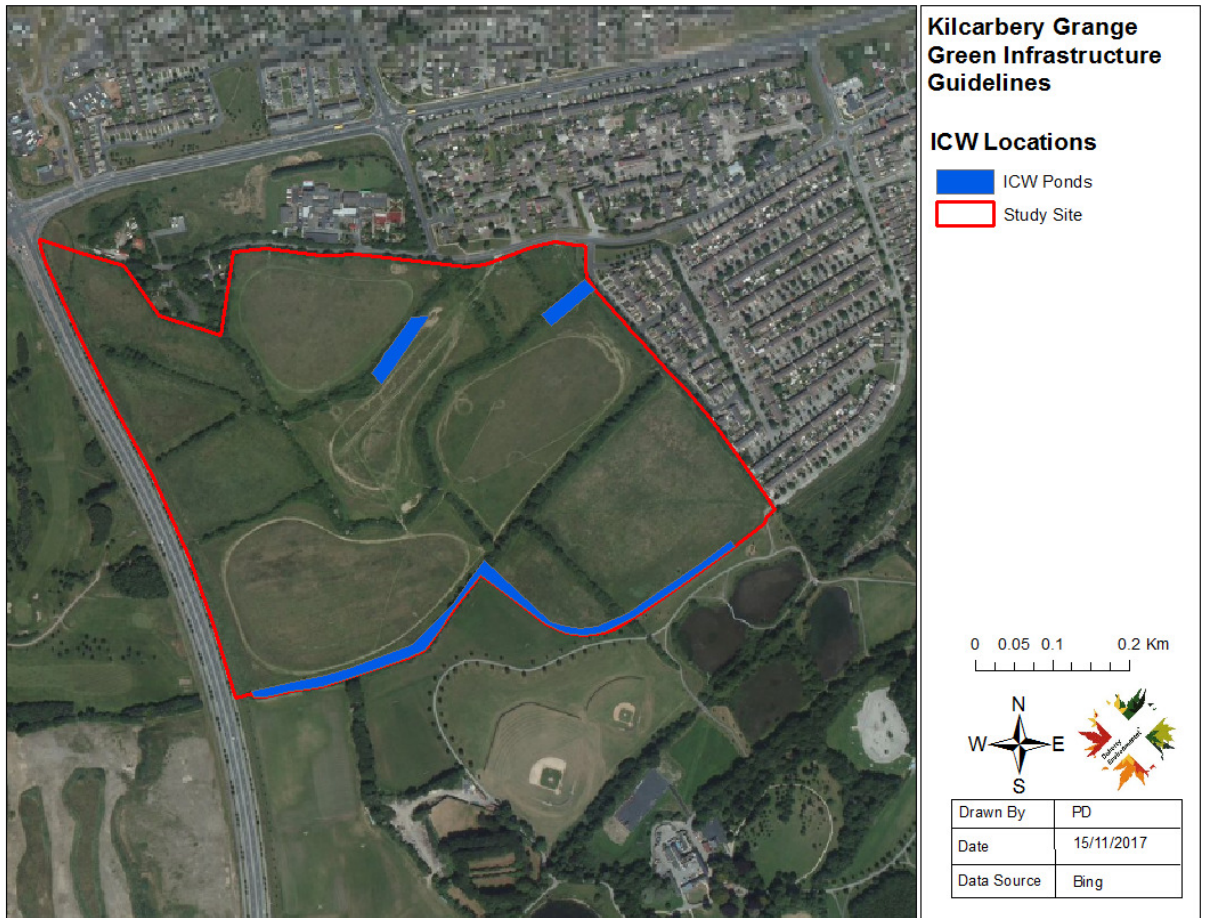
Figure 5 Suggested locations for Integrated Constructed Wetlands (ICW)

- Filtration of all surface water run-off from the site prior to final discharge into existing surface water networks must be incorporated into the design of the SUDS system by way of integrated Constructed Wetland (ICW).
- Suggested locations for ICW are illustrated on Figure 7
- The detailed design of the ICW will comply with all relevant standards and will also be designed to maximise their potential to support biodiversity. A typical sketch of an ICW pond that aims to maximize its potential to support biodiversity is provided as Figure 4 below.

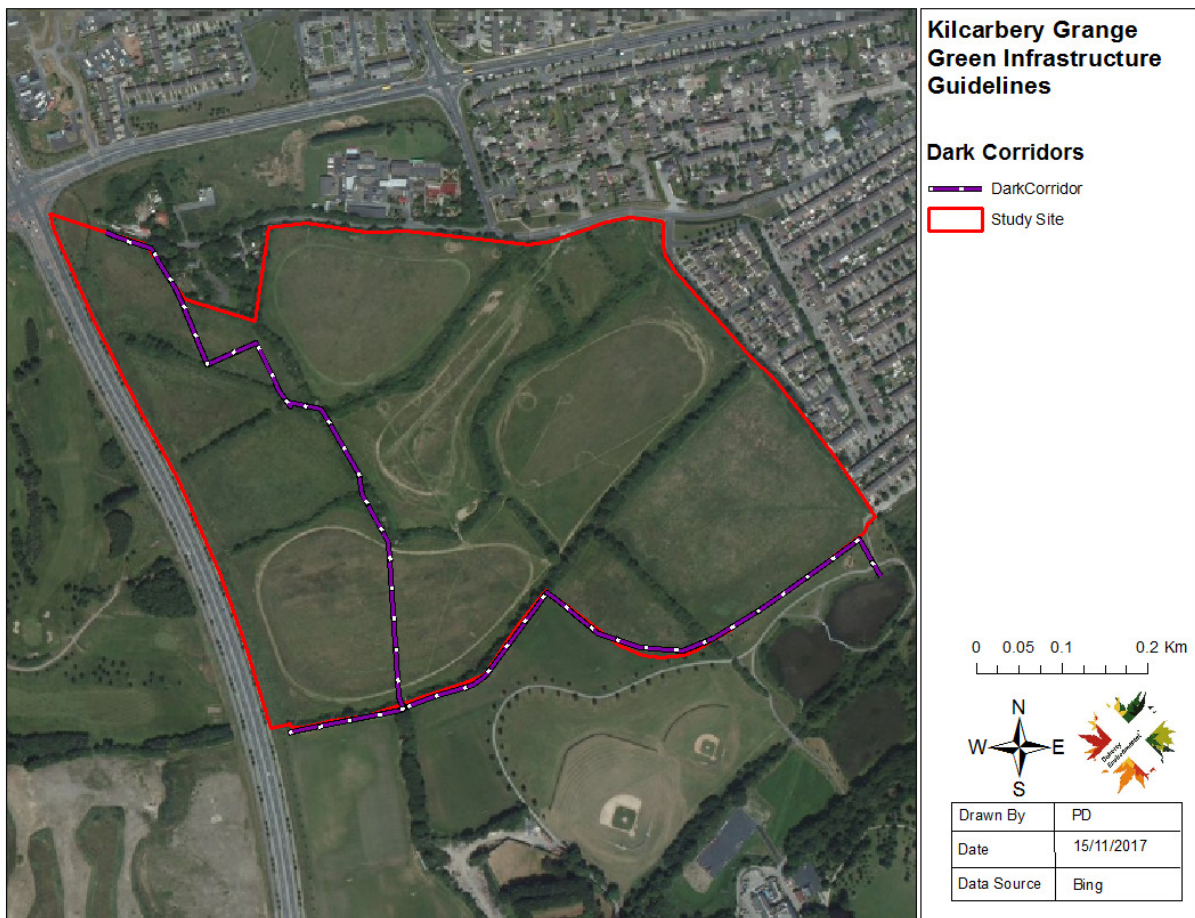
Figure 8 Dark corridors identified for Kilcarbery Grange

- Where feasible a Central Monitoring System (CMS) for lighting should be used for all public lighting within the Masterplan Area. This will facilitate the implementation of a variable lighting regime (VLR) to suit both people and wildlife within the Masterplan Area.
- Maintain a “Dark Corridor” along the southern side of FB11 and along the western side of the Green Corridor shown in Figure 8 below.
- Maximise the spacing between lights to reduce light intensity.

- Reduce light spill by directing light only where it is needed. The upward spread of light above the horizontal plane should be avoided. This will be achieved by installing low beam angle lights, less than 70 above the horizontal plane.
- Blue-white short wavelength lights should be avoided.
- Lights with a high UV content should be avoided.
