Fig 9.10

Tromman Quarry, Rathmolyan

Photo Viewpoint 7

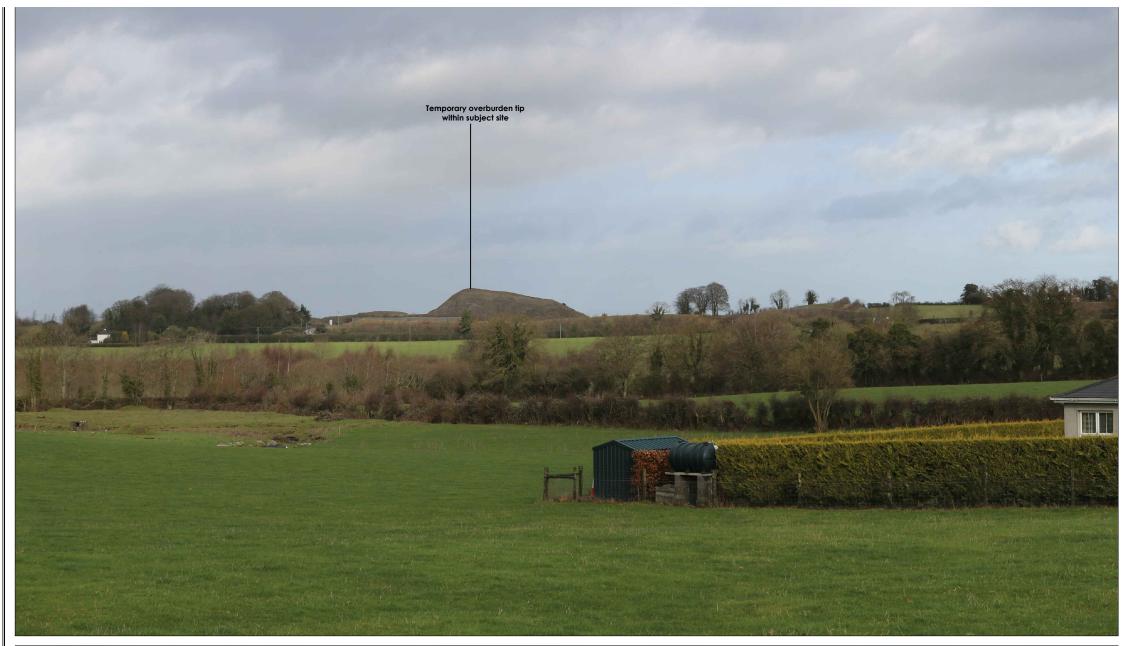
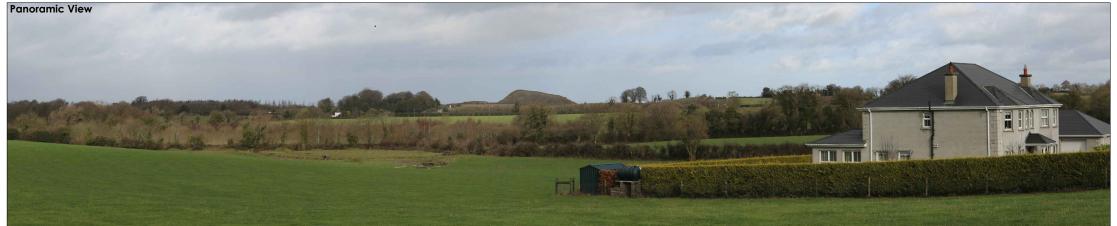
Viewpoint 7 North from L80142.

View South from minor road L80142 approx 1km from the subject site. From this section of road the existing temporary overburden is clearly visible, however areas of proposed extraction would not be visible due to a combination of intervening vegetation and topography.

Landscape & Visual Effects		Baseline Landscape				
Viewpoint	Duration	& Visual Sensitivity	Magnitude	M	Predicted Effect	
7	Long Term	Medium - Low (Landscape) Low (Visual)	Low Medium	Considered sequence of extraction and phased restoration. Review all boundaries for opportunities to improve screening through earthworks and planting. Gradual removal of existing overburden stockpile. Minor (Beneficial)		
Client Keegan Quarries Ltd.			date July. 19	scale NTS@A3	by pjm	notes Image represents an eyelevel impression of view at monocular distance of 30cm
