Viewpoint 8 North from L80142.

Fig 9.11

Tromman Quarry, Rathmolyan

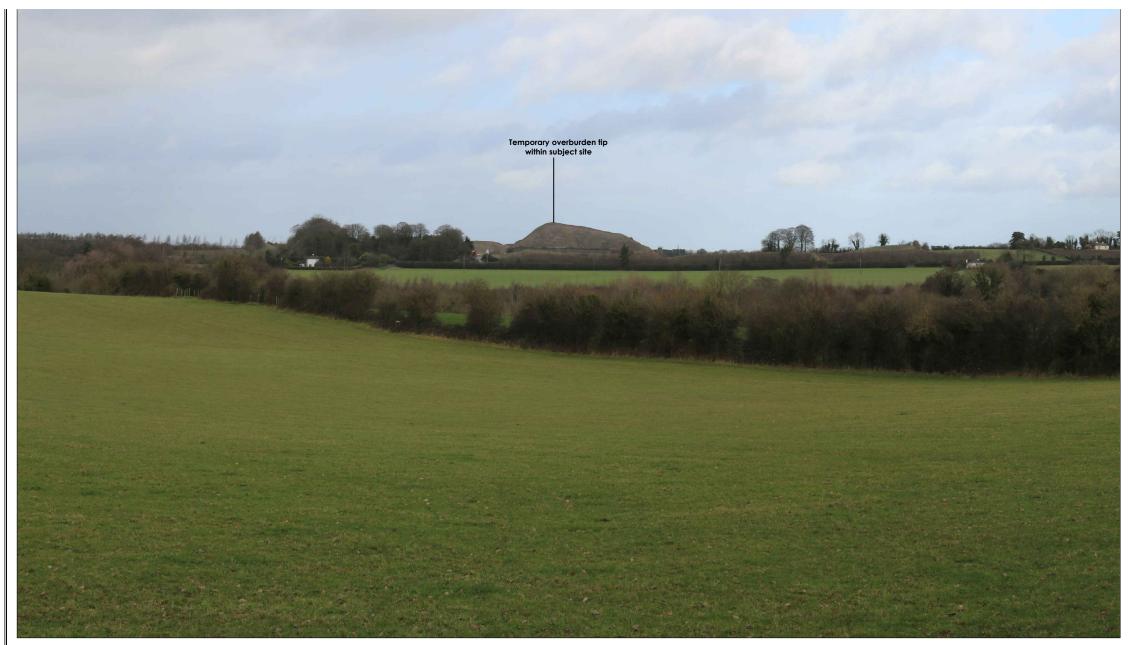
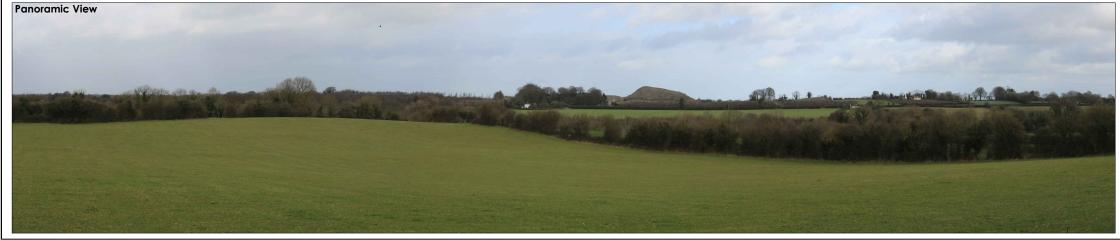
View South from minor road L80142 approx 1km from the subject site. From this section of road the existing temporary overburden is clearly visible, however areas of proposed extraction would not be visible due to a combination of intervening vegetation and topography.

Location: Viewpoint Elevation: Distance to Site: Horizontal Angle of View: Viewpoint 8 81m AOD (Malin Head) 1150m 90 Degrees

Landscape & Visual Effects		Baseline Landscape					
Viewpoint	Duration	& Visual Sensitivity	Magnitude	itude Mitigation		Predicted Effect	
8	Long Term	Medium - Low (Landscape) Low (Visual)	Low Medium	Considered sequence of extraction and phased restoration. Review all boundaries for opportunities to improve screening through earthworks and planting. Gradual removal of existing overburden stockpile. Minor (Beneficial)			1
client Keeg	an Quarries Lto	3.	date July. 19	scale NTS@A3	by pjm	notes Image represents an eyelevel impression of view at monocular distance of 30cm	•
