Fig 9.7

**Tromman Quarry, Rathmolyon**

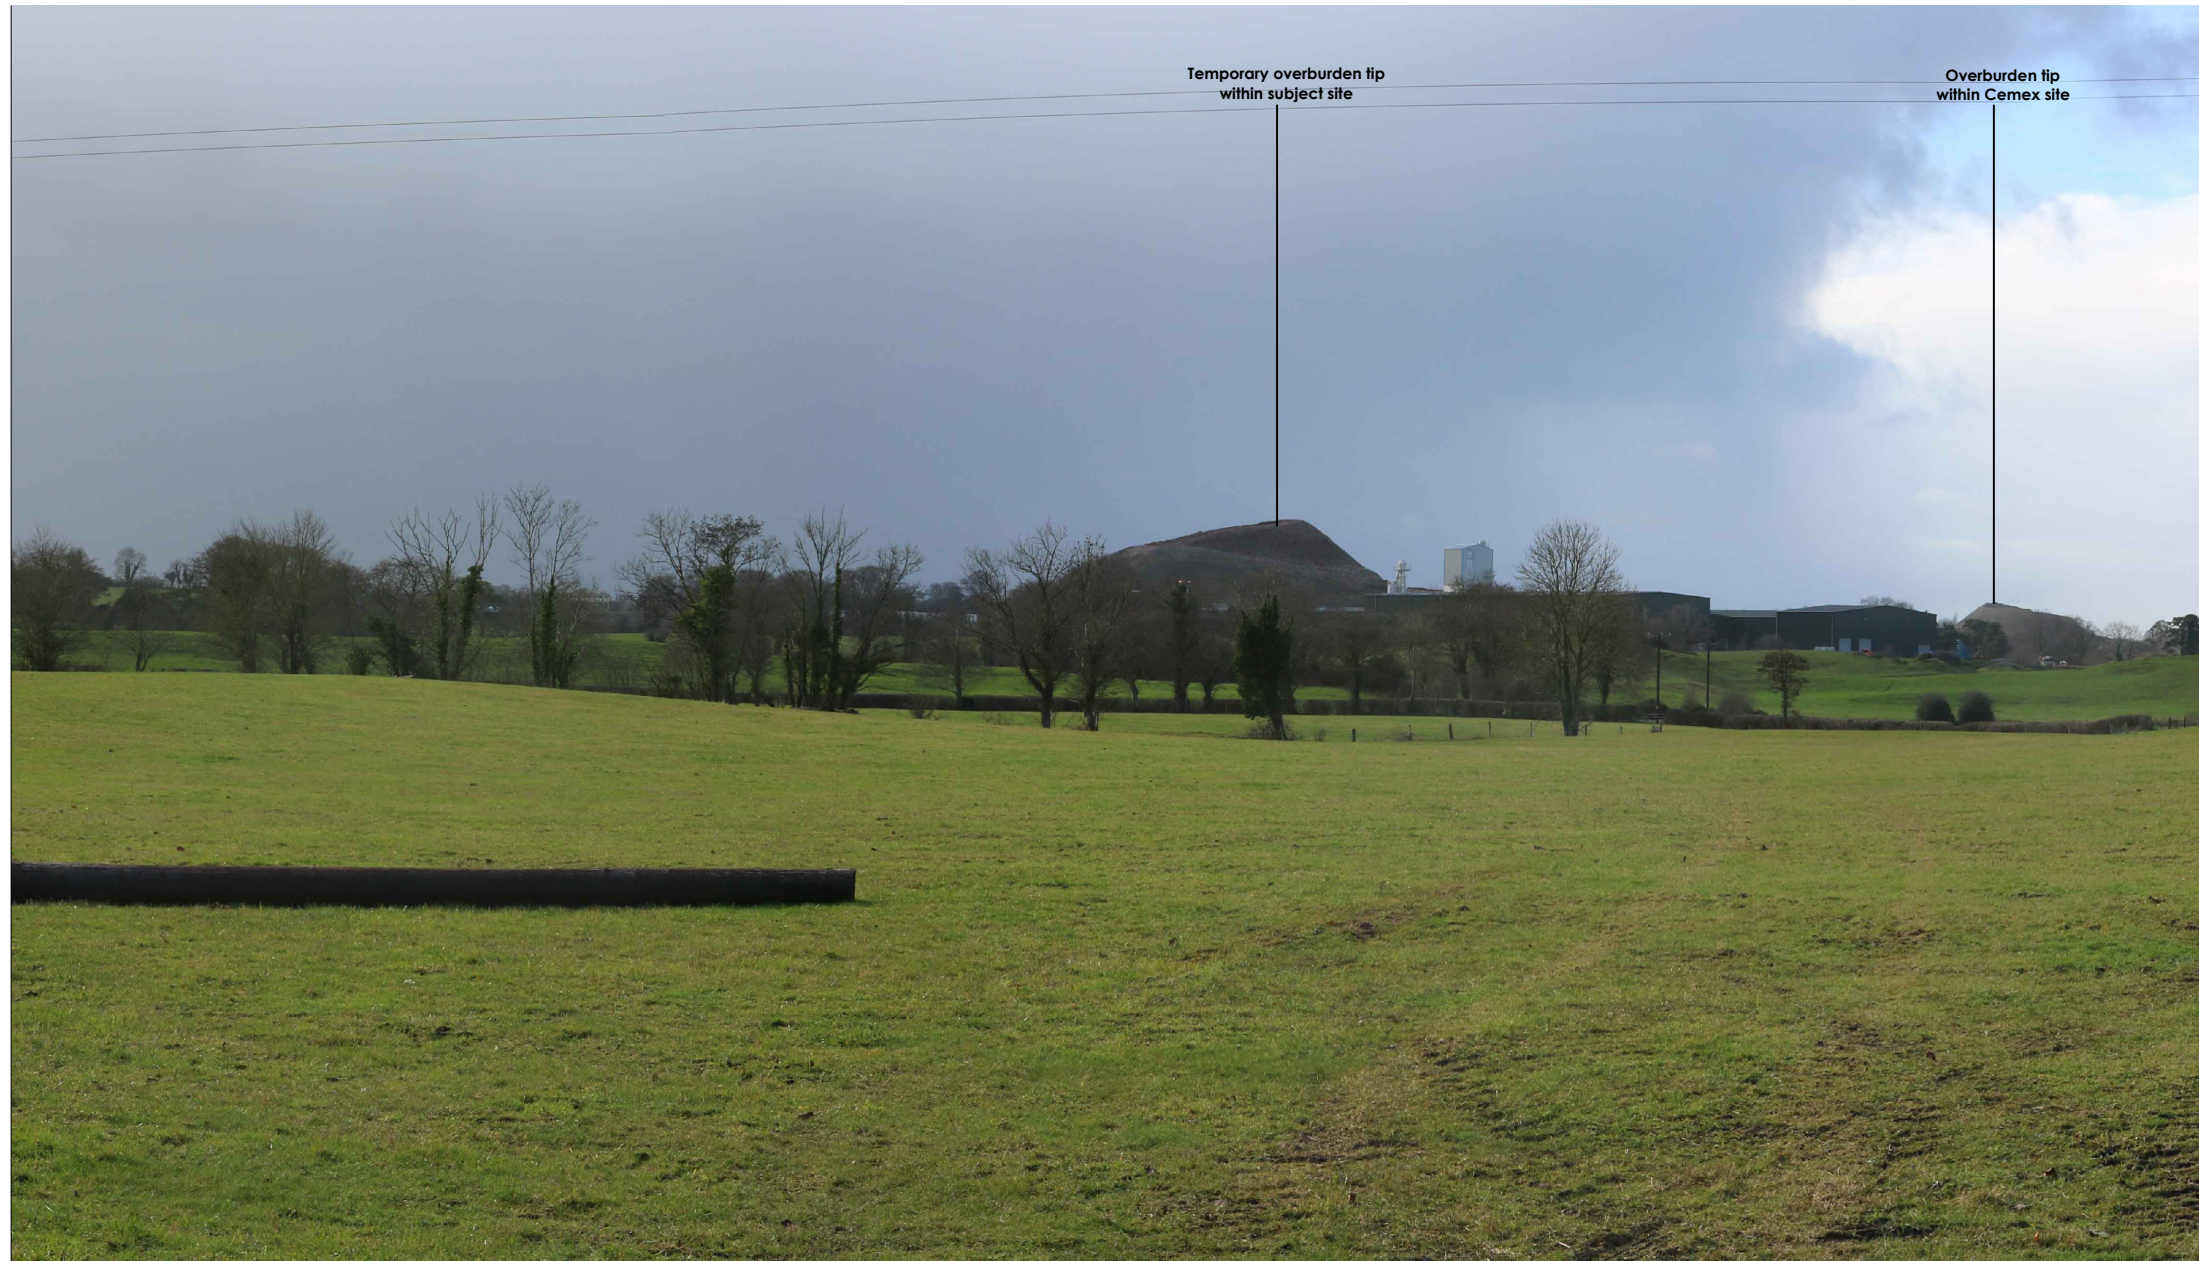
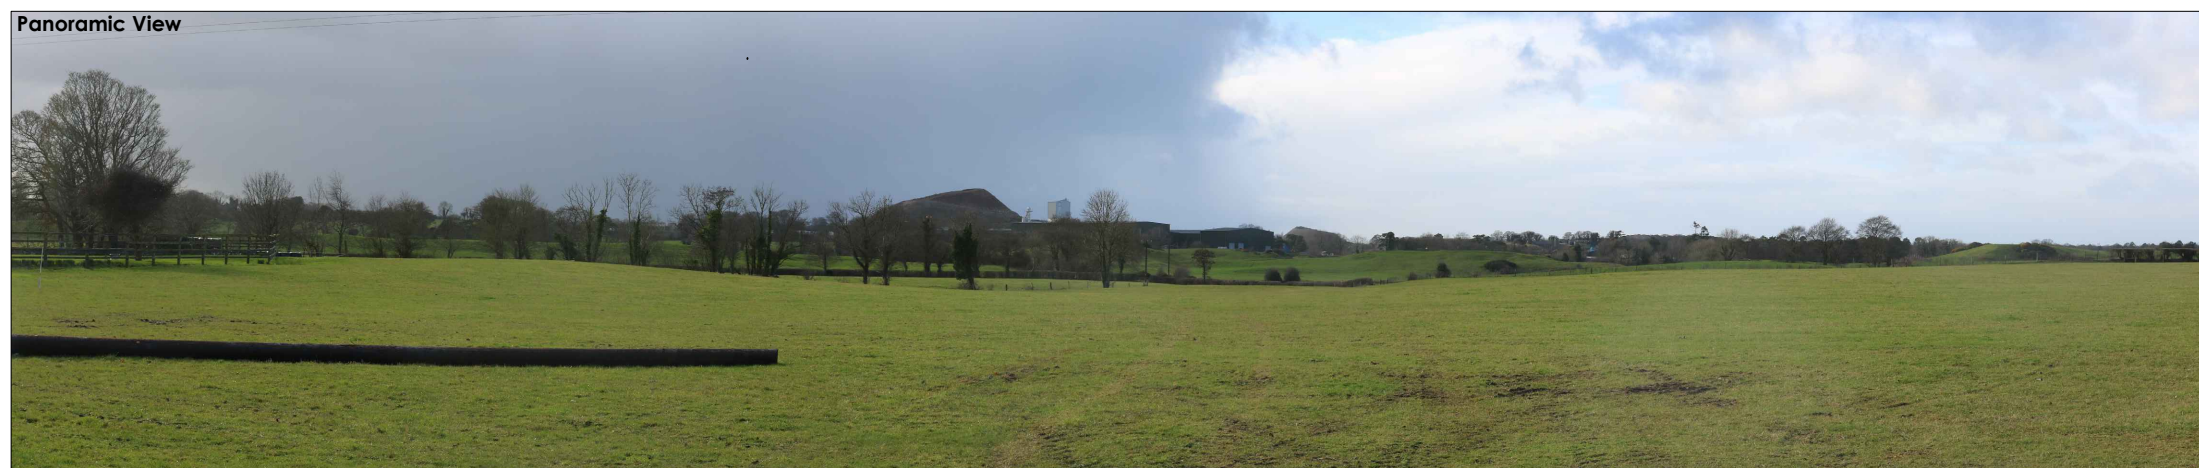
Photo Viewpoint 4

**Location:**  
Viewpoint Elevation: 72m AOD (Malin Head)  
Distance to Site: 993m  
Horizontal Angle of View: 90 Degrees

**Viewpoint 4 Southwest from L80141.**  
View South from minor road L80141 less than 1km from the subject site. From this open section of road the existing temporary overburden is clearly visible, however areas of proposed extraction would not be visible due to a combination of intervening vegetation and topography.

Landscape & Visual Effects		Baseline Landscape & Visual Sensitivity	Magnitude	Mitigation	Predicted Effect
Viewpoint	Duration				
4	Long Term	Medium - Low (Landscape) Low (Visual)	Low Medium	Considered sequence of extraction and phased restoration. Review all boundaries for opportunities to improve screening through earthworks and planting. Gradual removal of existing overburden stockpile.	Minor Minor ( Beneficial )
<b>client</b>	Keegan Quarries Ltd.	<b>date</b>	July. 19	<b>scale</b>	NTS@A3
		<b>by</b>	pjm	<b>notes</b>	Image represents an eyelevel impression of view at monocular distance of 30cm
