Photo Viewpoint 5

Fig 9.8

Tromman Quarry, Rathmolyan

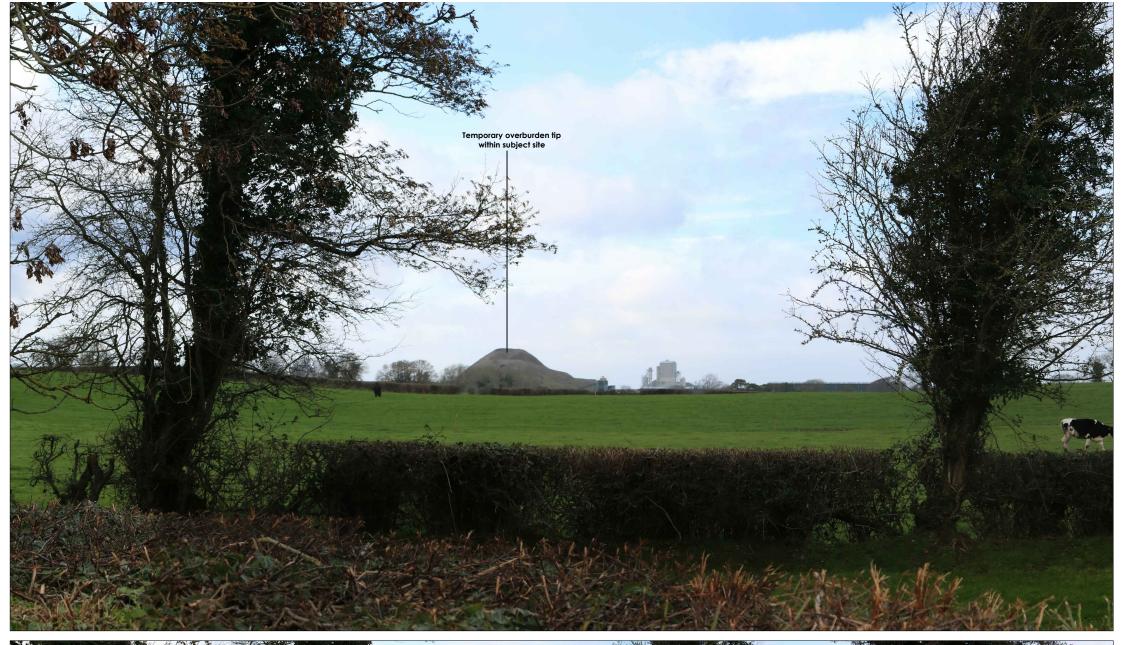
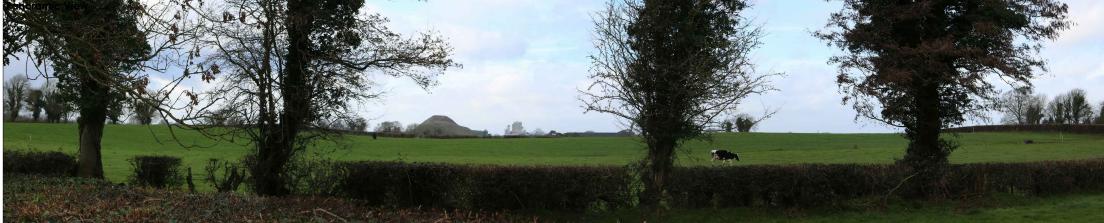
Viewpoint 5 West from L80140.

View South from minor road L80140 approx 1.1km from the subject site. From this section of road the existing temporary overburden is clearly visible, however areas of proposed extraction would not be visible due to a combination of intervening vegetation and topography.

Baseline Landscape **Predicted Effect** Viewpoint Duration Magnitude & Visual Sensitivity Considered sequence of extraction and phased restoration. Review all boundaries for Low Long Term Medium - Low (Landscape) opportunities to improve screening through earthworks and planting. Gradual removal of existing overburden stockpile. Low (Visual) Medium Minor (Beneficial) date **notes** Image represents an eyelevel impression of view at July. 19 Keegan Quarries Ltd. NTS@A3 pjm monocular distance of 30cm
