Photo Viewpoint 6

Viewpoint	Duration	Baseline Landscape & Visual Sensitivity	Magnitude	Mitigation	Predicted Effect					
6	Long Term	Medium - Low (Landscape) Low (Visual)	Low Medium	Considered sequence of extraction and phased restoration. Review all boundaries for opportunities to improve screening through earthworks and planting. Gradual removal of existing overburden stockpile.	Minor Minor ( Beneficial )					
<b>client</b>	Keegan Quarries Ltd.		<b>date</b>	July. 19	<b>scale</b>	NTS@A3	<b>by</b>	pjm	<b>notes</b>	Image represents an eyelevel impression of view at monocular distance of 30cm

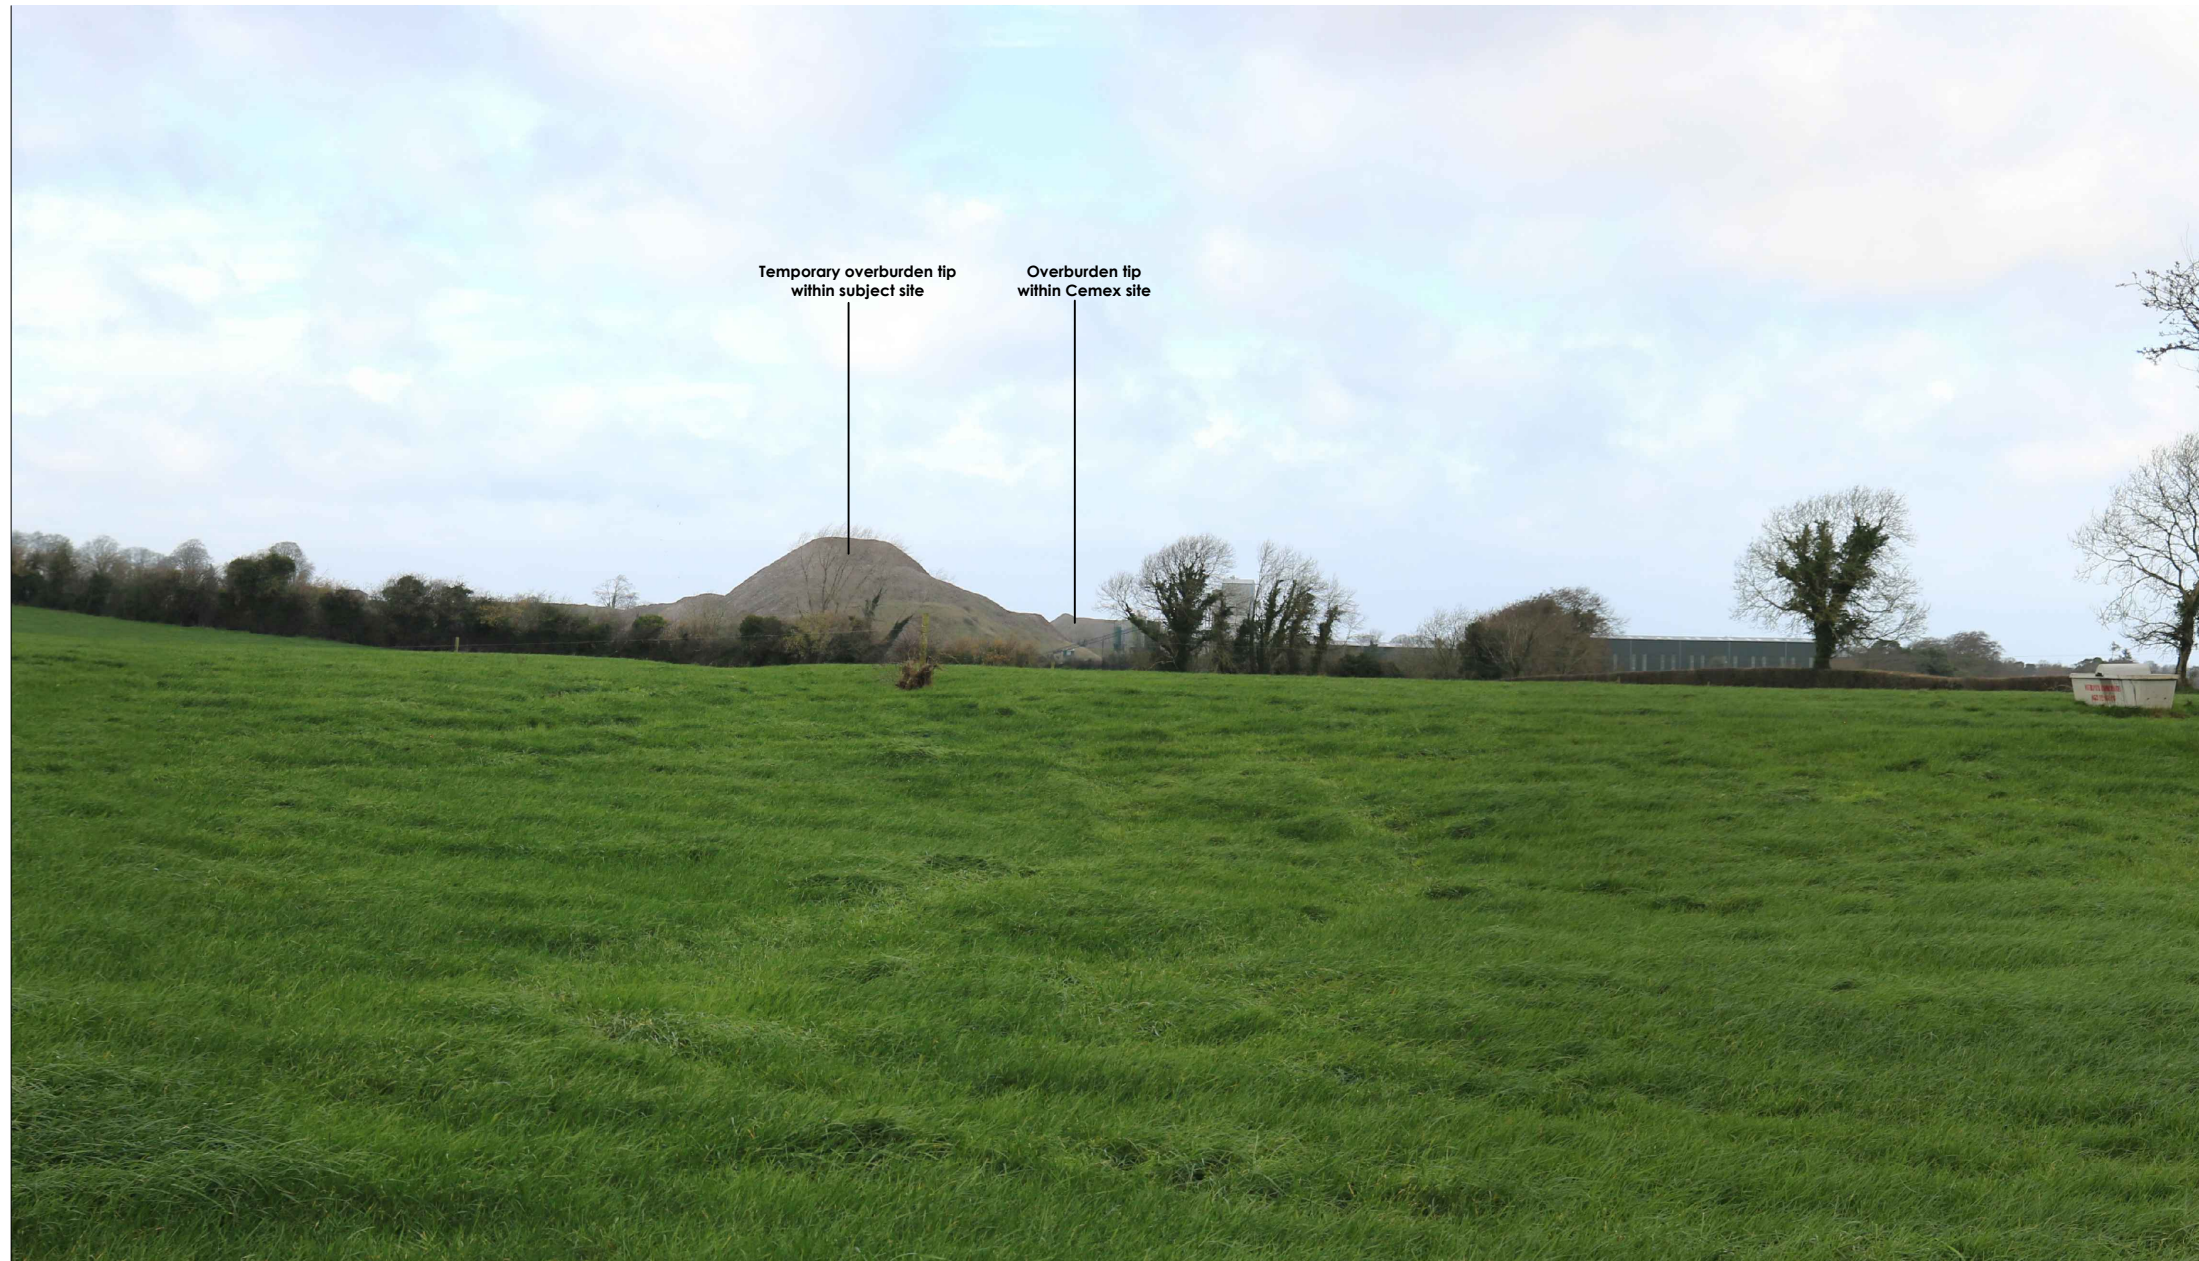
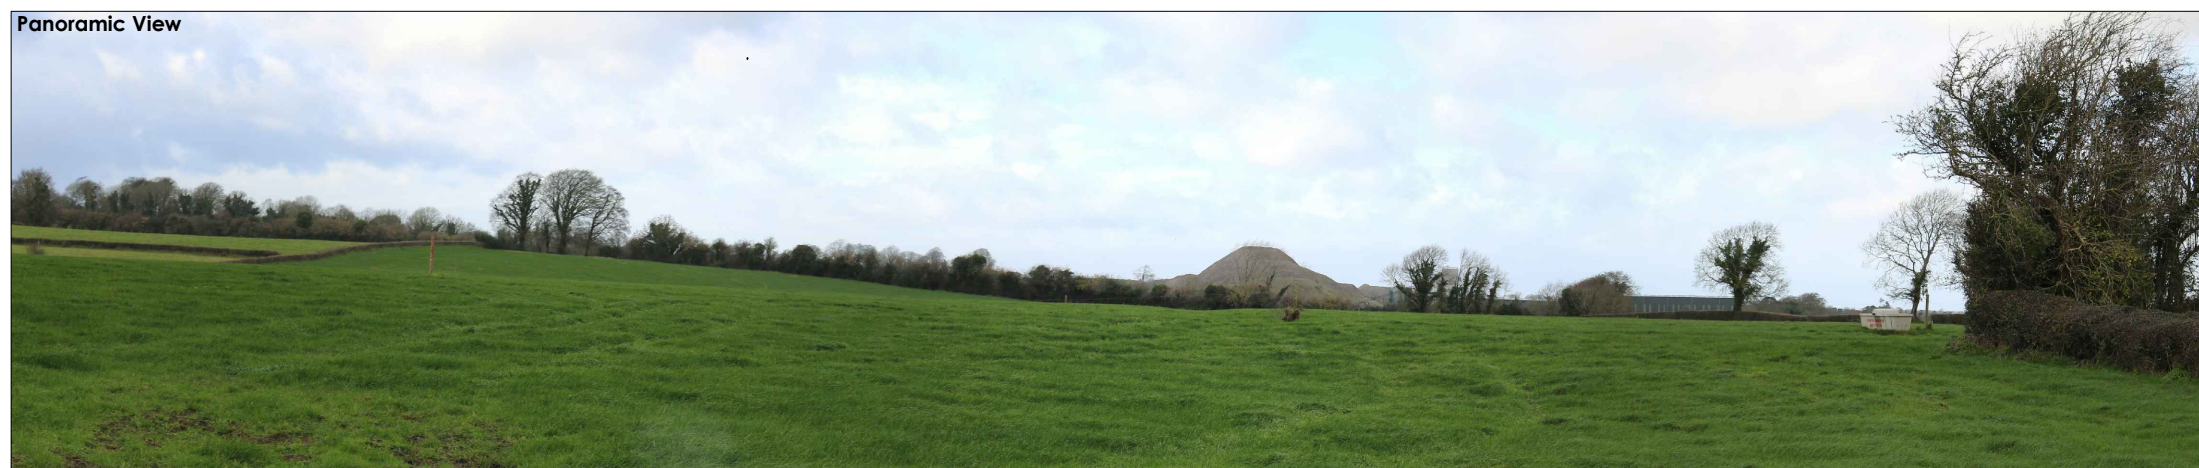
Fig 9.9

**Location:**  
Viewpoint Elevation: 77m AOD (Malin Head)  
Distance to Site: 1096m  
Horizontal Angle of View: 90 Degrees

**Viewpoint 5 West from L80140.**  
View South from minor road L80140 approx 1km from the subject site. From this section of road the existing temporary overburden is clearly visible, however areas of proposed extraction would not be visible due to a combination of intervening vegetation and topography.
