Volume III - Appendices to Environmental Impact Assessment Report

**Proposed Residential Development
Lands at Rathmullan Road, Drogheda, Co. Meath**

Appendix 4.1 Flood Risk Assessment

Flood Risk Assessment Final Report

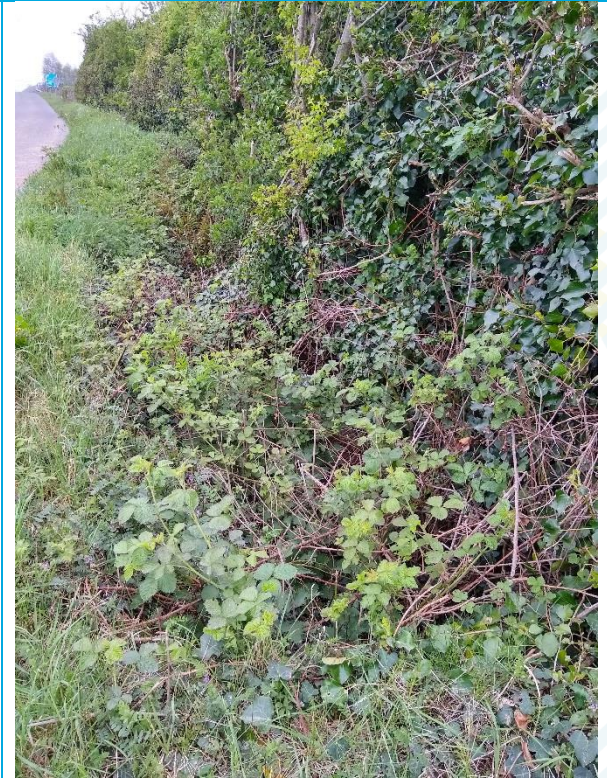
Photo No. 1

Dry ditch located between the southern boundary of the site and Rathmullan Road. The ditch is completely overgrown with vegetation and brambles, contained no water and shows no evidence of fluvial activity

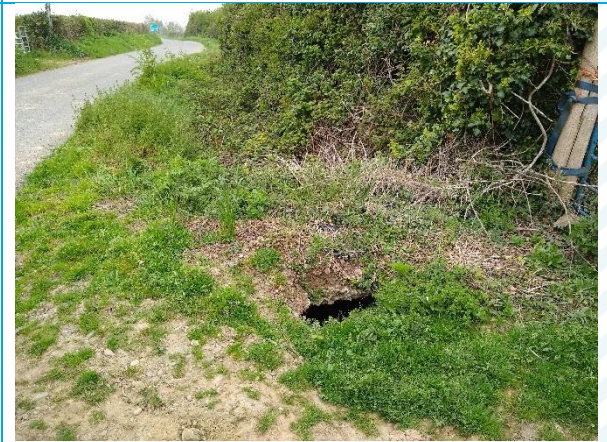
Photo No. 2

Access to farm sheds from Rathmullan Road across the ditch on the southern boundary of the site. The culvert under the vehicular access to the site has been completely collapsed with 100% blockage. The hole at the location of collapse is clearly visible in the photograph.

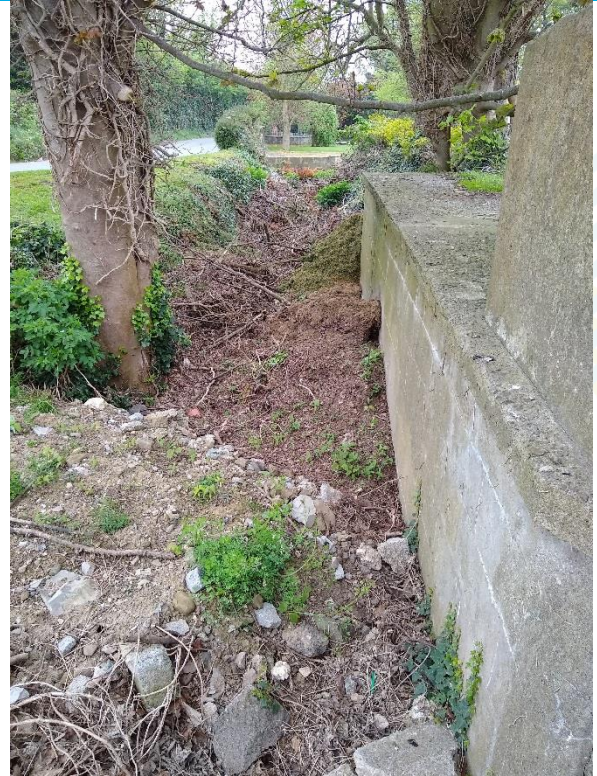
Photo No. 3

The ditch between residential properties and Rathmullan Road adjacent to the south-eastern corner of the site (looking north).

The outlet of the culvert under Rathmullan Road has been completely blocked and is no longer visible. The ditch has been almost entirely infilled with garden refuse and green waste. There is no fluvial connection or possible watercourse remaining within the ditch.

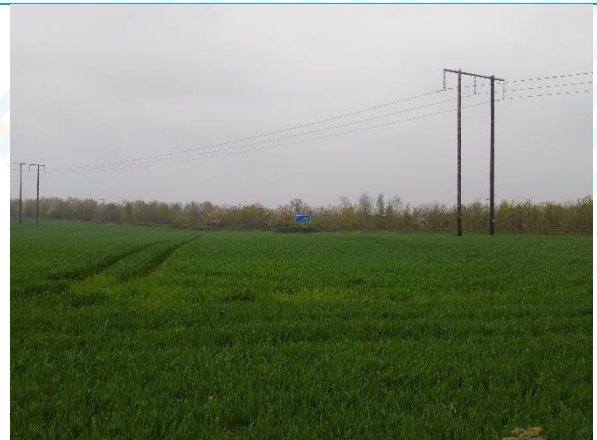
Photo No. 5

View of fields looking south from Rathmullan Road towards the M1. The blue motorway sign is barely visible highlighting the significant cutting of the M1 below natural ground levels. There is no ability for surface water flows to cross the M1.

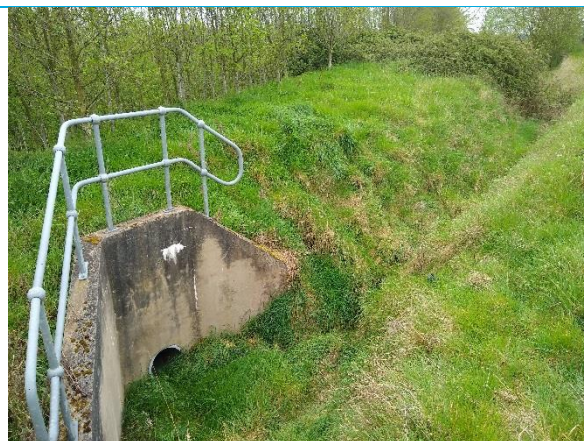
Photo No. 6

Culverted pipe entrance collecting surface water flows from the fields to the west of the M1 and redirecting into the motorway stormwater drainage network.

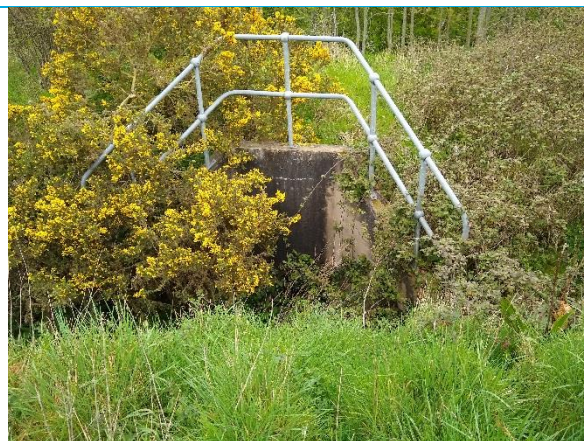
Photo No. 7

Second observed culverted pipe entrance collecting surface water flows from the fields to the west of the M1 and redirecting into the motorway stormwater drainage network.

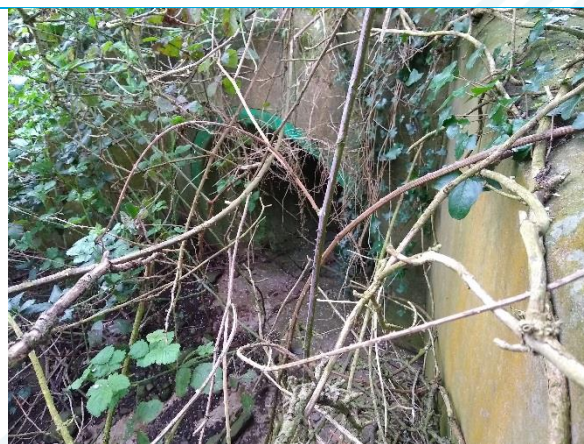
Photo No. 8

Culverted pipe entrance of the former drain upstream of the M1

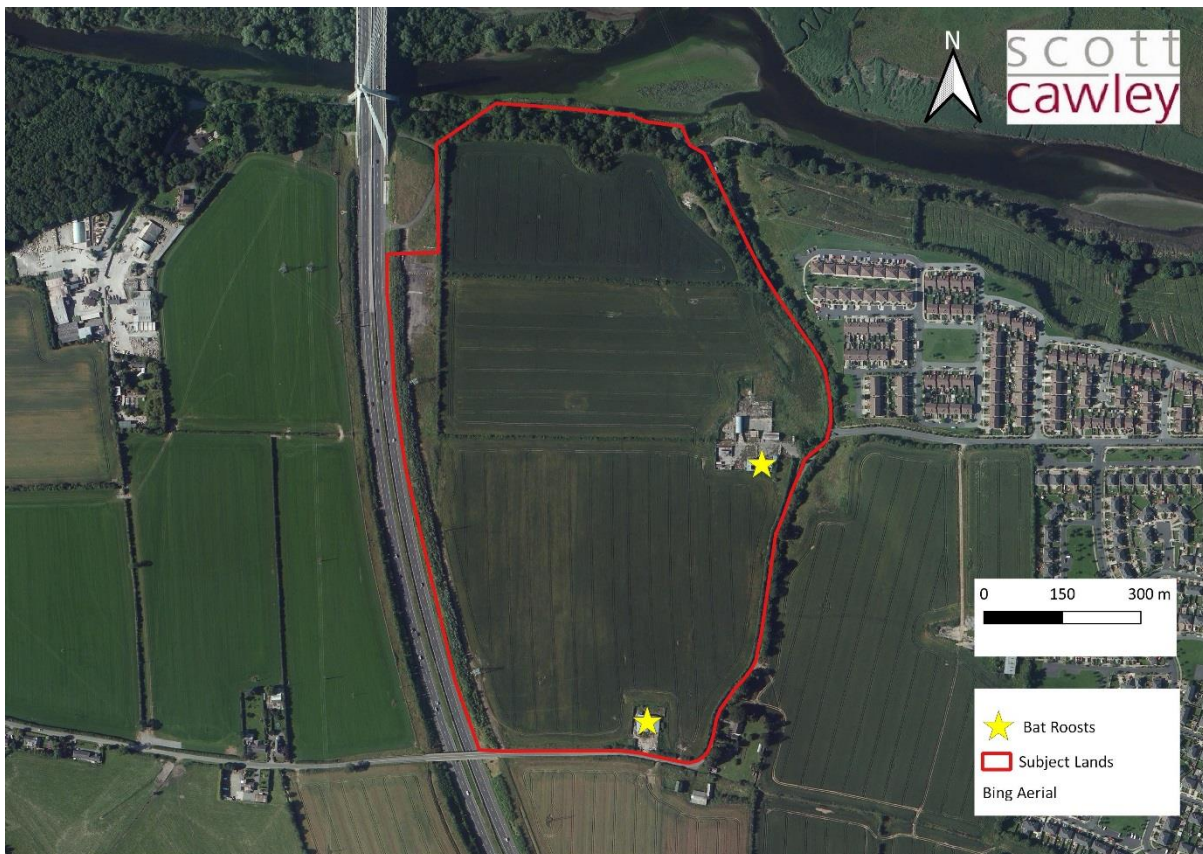
Figure 1: Bat roosts in relation to subject lands and surrounding lands.

The demolition of the sheds within the lands has the potential to result in the disturbance, or in a worst-case scenario, the mortality of bats. If a mortality event occurred, it would affect a small number of bats.

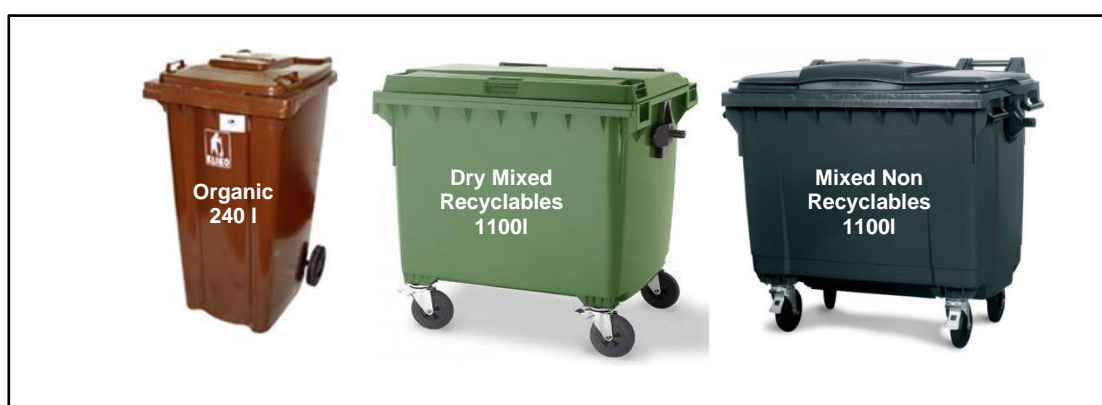
Figure 5.1 Typical waste receptacles of varying size (240L and 1100L)

The types of bins used will vary in size, design and colour dependent on the appointed waste contractor. However, examples of typical receptacles to be provided in the WSAs are shown in Figure 5.1. All waste receptacles used will comply with the IS EN 840 2012 standard for performance requirements of mobile waste containers, where appropriate.
