Residential Development, Scholarstown Road, Dublin 16

Site Specific Flood Risk Assessment

Ardstone Homes Limited

DBFL CONSULTING ENGINEERS

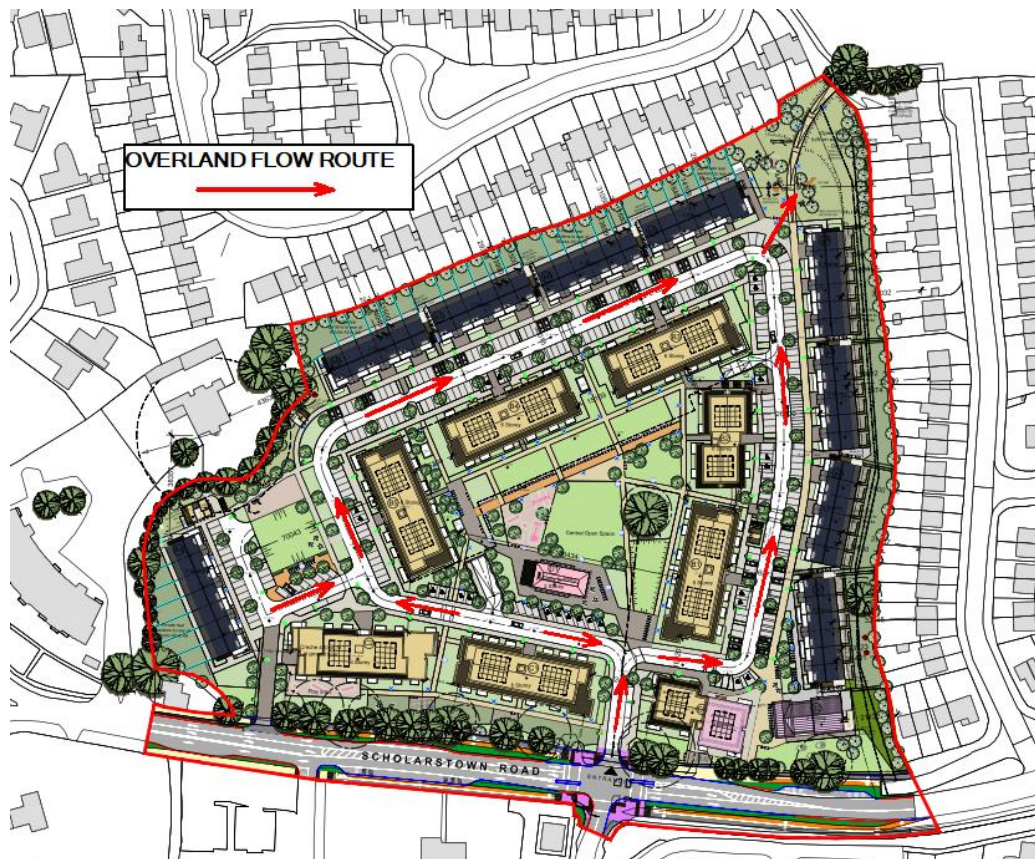
Figure 5.1 – Flood Exceedance (>1%AEP) Overland Flow Routes

During storms greater than the 1% AEP pluvial event, the development's drainage network design may be exceeded and areas with low ground levels will begin to flood.

Proposed road levels fall towards the North-East. Overland flow is therefore directed towards open space areas in Dargle Wood Park to the North-East of the site (refer to Figure 5.1).

Overland flow paths have been identified for pluvial flooding exceeding the capacity of the surface water drainage network.
