## **Appendix to Chapter 11: Water**

### **Appendix 11.1: Inventory & Classification of Watercourses at Crossing Locations**

Photos of UWF GRID CONNECTION Bridges / Culverts along Public Roads

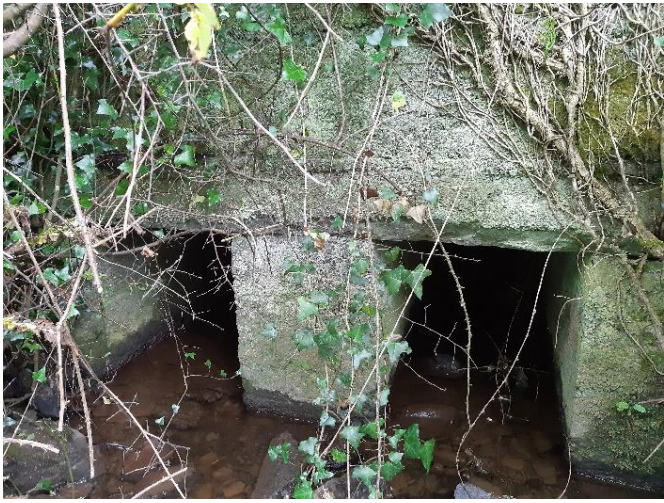
<p><b>Watercrossing Structure W4</b></p> <p>Type: Stream</p> <p><b>Fisheries: Class 3, Sub-optimal Fisheries</b></p> <p>Location/Townland: L2166-0, Coole/Freagh</p> <p>Existing Structure: Concrete Block Box Culvert</p> <p>Works at the Crossing: Cable trenching under structure</p> <p>Ecology Notes: Downstream - Slow flowing, Coble (60), Gravel (40). Overgrown, vegetation shading. 1 metre wide and ~30cm deep.</p>

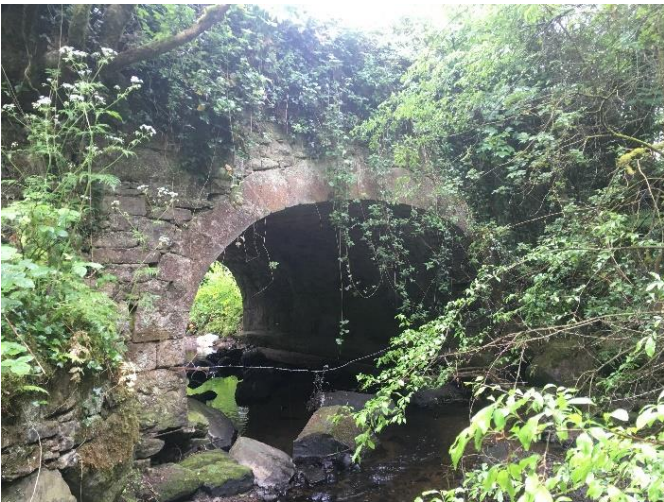
<p><b>Watercrossing Structure W5</b></p> <p>Type: River</p> <p><b>Fisheries: Class1, Optimal Fisheries</b></p> <p>Location/Townland: L6013-0, Foildarrig/Freagh</p> <p>Existing Structure: Masonry Single Arch Bridge</p> <p>Works at the Crossing: Cable trenching over structure</p> <p>Ecology Notes: Upstream - riffle/glide sequence and pool. Bolder (30), cobble (30), sand/gravel (40). Culvert pipe also flowing into river. Downstream - Riffle and pool present. Sand gravel under bridge (60), boulders/cobble(40).</p>

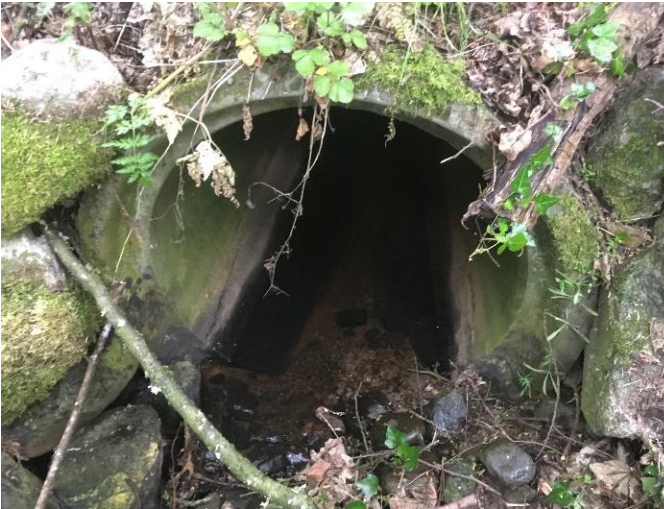
<p><b>Watercrossing Structure W6</b></p> <p>Type: Stream</p> <p><b>Fisheries: Class 3, Sub-Optimal Fisheries</b></p> <p>Location/Townland: L6013-0, Oakhampton</p> <p>Existing Structure: Concrete Circular Culvert</p> <p>Works at the Crossing: Cable trenching over structure</p> <p>Ecology Notes: Pipe culvert with stream through it. Bolder (50), mud/gravel (50).</p>

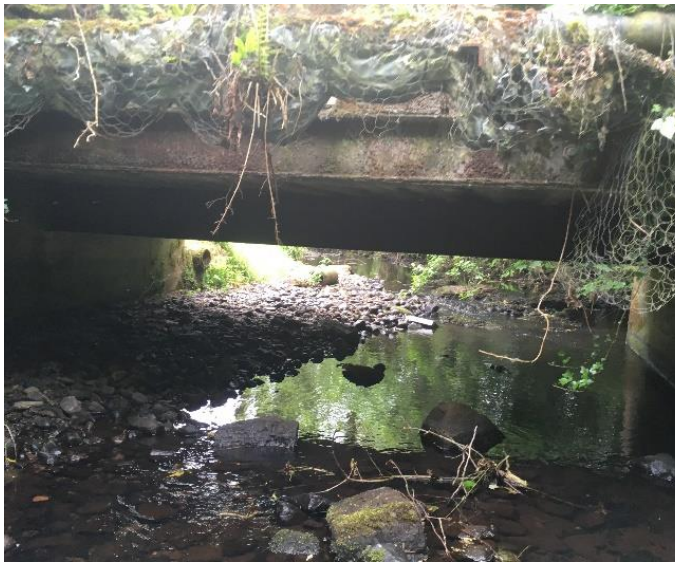
<p><b>Watercrossing Structure W9</b></p> <p>Type: Stream</p> <p><b>Fisheries: Class 1, Optimal Fisheries</b></p> <p>Location/Townland: L6009-0, Castlewaller/Carrowkeale</p> <p>Existing Structure: Concrete Slab Bridge              Works at the Crossing: Directional Drill under stream bed.</p> <p>Ecology Notes: Upstream - riffle and glide and pool (with sand). Sand (30), cobble (50), gravel (20). Downstream - flat rock (40), boulders (30), cobble (30), riffle. Some pooling at edge, no visible build-up of sand. Fast flowing.</p>

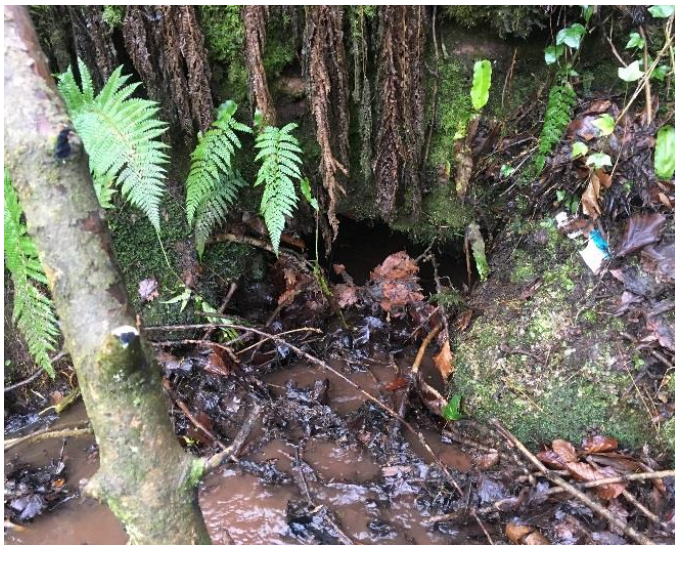
<p><b>Watercrossing Structure W11</b>              Type: Stream  <b>Fisheries: Class 3, Sub-optimal Fisheries</b>              Location/Townland: R503, Scrageen/Derrygareen</p> <p>Existing Structure: Masonry Box Culvert              Works at the Crossing: Cable trenching over structure</p> <p>Ecology Notes: c. 1 m wide, c. 20 cm deep</p>

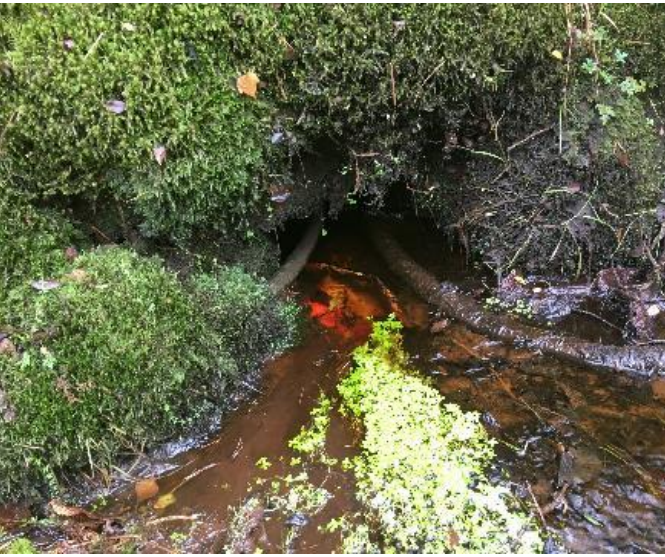
<p><b>Watercrossing Structure W19</b>                      Type: Drain  <b>Fisheries: Class 4, Poor Fisheries</b>                      Location/Townland: R503, Fanit</p> <p>Existing Structure: Masonry Box Culvert</p> <p>Works at the Crossing: Cable trenching under structure. Culvert may need replacing.</p> <p>Ecology Notes: No Fisheries Potential</p>

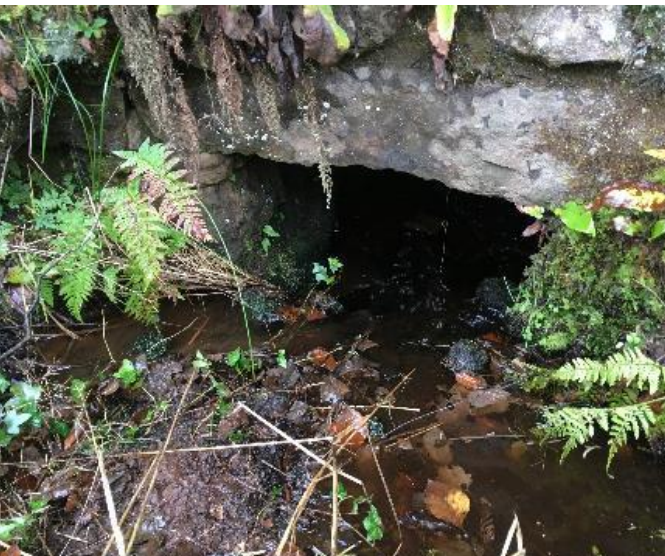
<p><b>Watercrossing Structure W20</b>                      Type: Drain  <b>Fisheries: Class 4, Poor Fisheries</b>                      Location/Townland: R503, Fanit</p> <p>Existing Structure: Masonry Box Culvert</p> <p>Works at the Crossing: Cable trenching under structure. Culvert may need replacing.</p> <p>Ecology Notes: No Fisheries Potential 100% shade downstream</p>

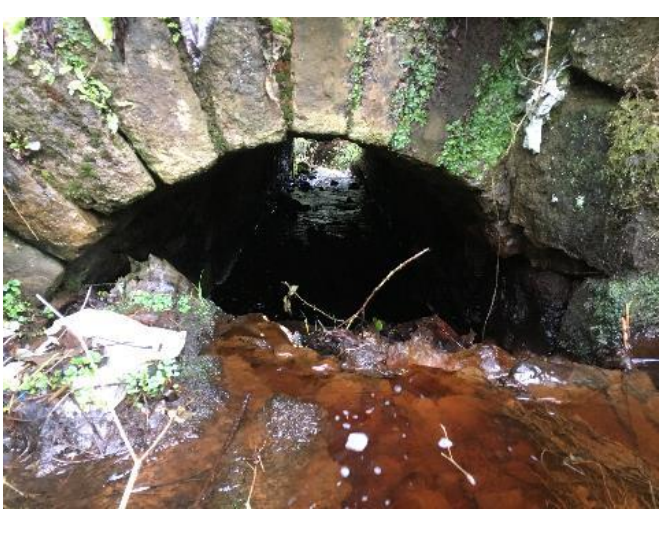
<p><b>Watercrossing Structure W21</b>                      Type: Stream, 1st Order  <b>Fisheries: Class 3, Sub-optimal Fisheries</b>                      Location/Townland: R503, Fanit</p> <p>Existing Structure: Masonry Single Arch Bridge</p> <p>Works at the Crossing: Cable trenching over structure.</p> <p>Ecology Notes: No Fisheries Potential 100% shade downstream</p>

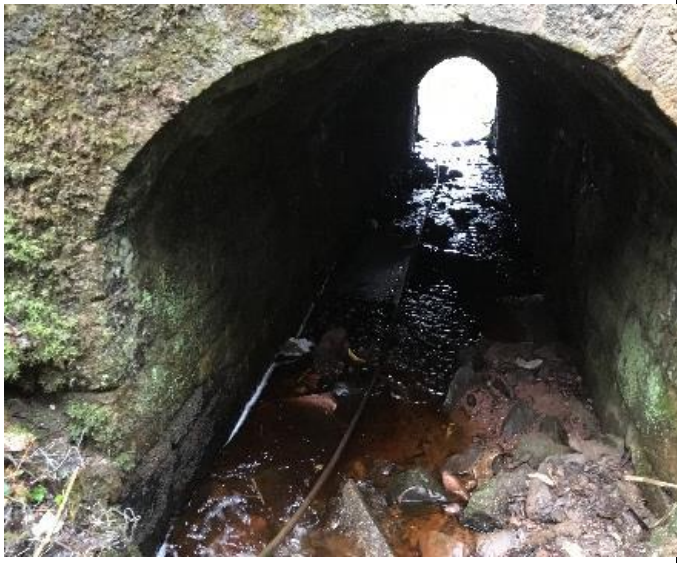
<p><b>Watercrossing Structure W22</b>              Type: Stream, 1st Order  <b>Fisheries: Class 3, Sub-optimal Fisheries</b>              Location/Townland: R503, Fanit/Lackamore</p> <p>Existing Structure: Masonry Single Arch Bridge</p> <p>Works at the Crossing: Cable trenching over structure.</p> <p>Ecology Notes: steep/cascade</p>

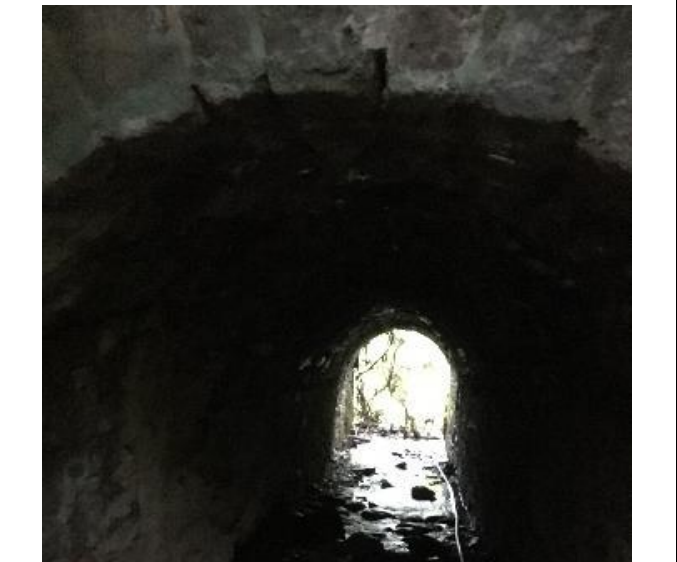
<p><b>Watercrossing Structure W23</b>              Type: Stream  <b>Fisheries: Class 3, Sub-optimal Fisheries</b>              Location/Townland: R503, Lackamore</p> <p>Existing Structure: Masonry Arch Bridge              Works at the Crossing: Cable trenching over structure.</p> <p>Ecology Notes: No Fisheries Potential              Upstream: 100% shade. Minor steep cascades              Downstream: 100% shade</p>

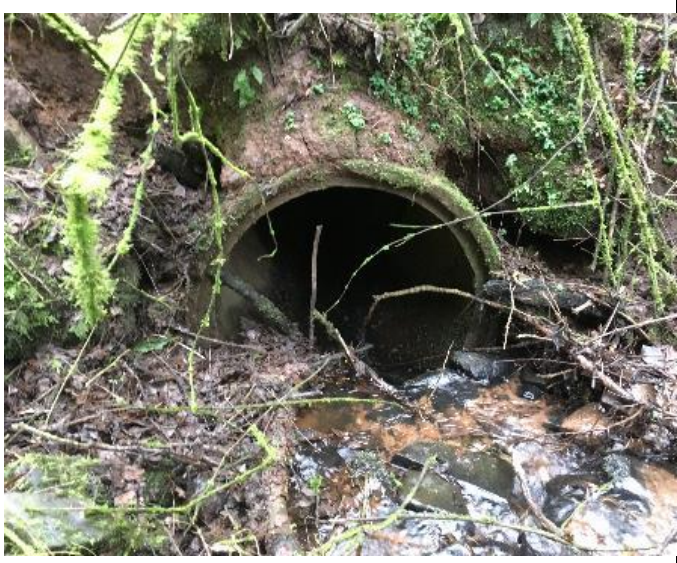
<p><b>Watercrossing Structure W24</b>              Type: Stream, 1<sup>st</sup> Order  <b>Fisheries: Class 3, Sub-optimal Fisheries</b>              Location/Townland: R503, Lackamore</p> <p>Existing Structure: Concrete Circular Culvert              Works at the Crossing: Cable trenching over structure.</p> <p>Ecology Notes: No Fisheries Potential</p>

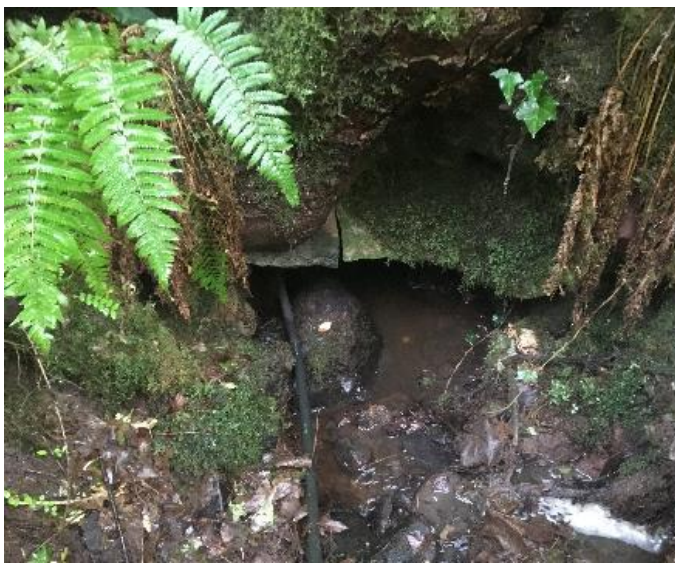
<p><b>Watercrossing Structure W31</b></p> <p>Type: Stream, 1<sup>st</sup> Order</p> <p><b>Fisheries: Class 3, Sub-optimal Fisheries</b></p> <p>Location/Townland: R503, Tooreenbrien Upper</p> <p>Existing Structure: Concrete Circular Culvert</p> <p>Works at the Crossing: Crossing under new existing culvert</p> <p>Ecology Notes: No Fisheries Value, Steep Gradient</p>

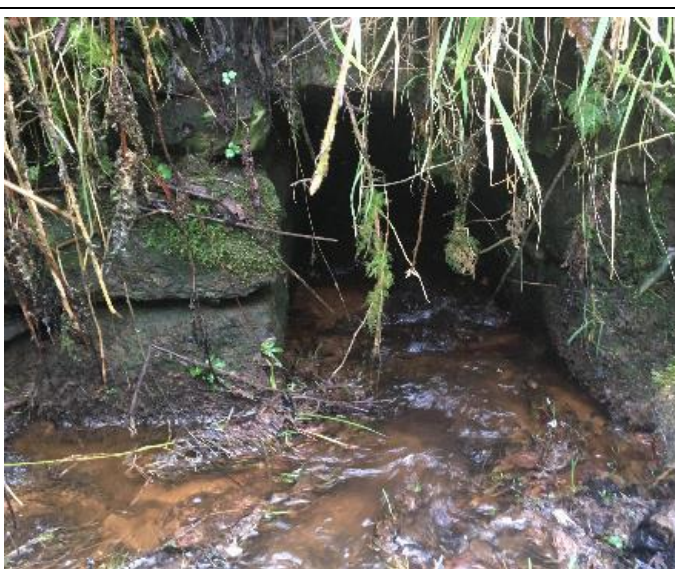
<p><b>Watercrossing Structure W32</b></p> <p>Type: Minor Stream</p> <p><b>Fisheries: Class 3, Sub-optimal Fisheries</b></p> <p>Location/Townland: R503, Tooreenbrien Upper</p> <p>Existing Structure: Masonry Box Culvert</p> <p>Works at the Crossing: Cable trenching under structure. Culvert may need replacing.</p> <p>Ecology Notes: No Fisheries Value</p>

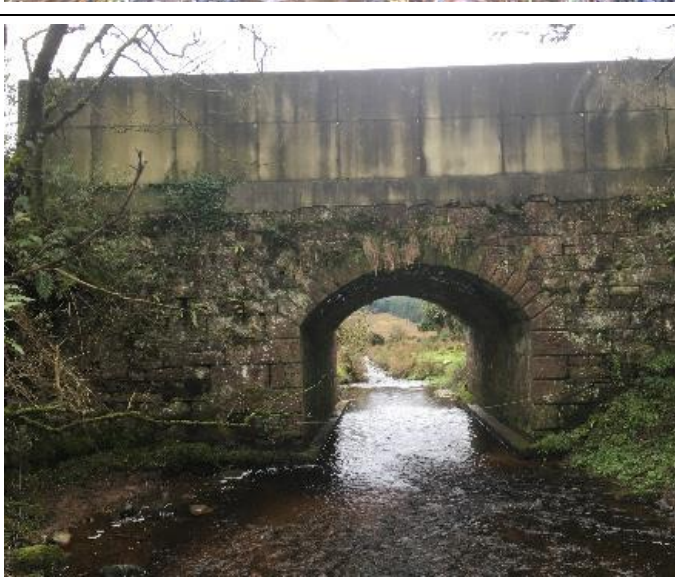
<p><b>Watercrossing Structure W33</b></p> <p>Type: Stream</p> <p><b>Fisheries: Class1, Optimal Fisheries</b></p> <p>Location/Townland: R503, Tooreenbrien Upper/Tooreenbrien Lower</p> <p>Existing Structure: Masonry Arch Bridge - Single</p> <p>Works at the Crossing: Cable trenching over structure.</p> <p>Ecology Notes: cobble substrate, drained, channelised, riffle/glide</p>

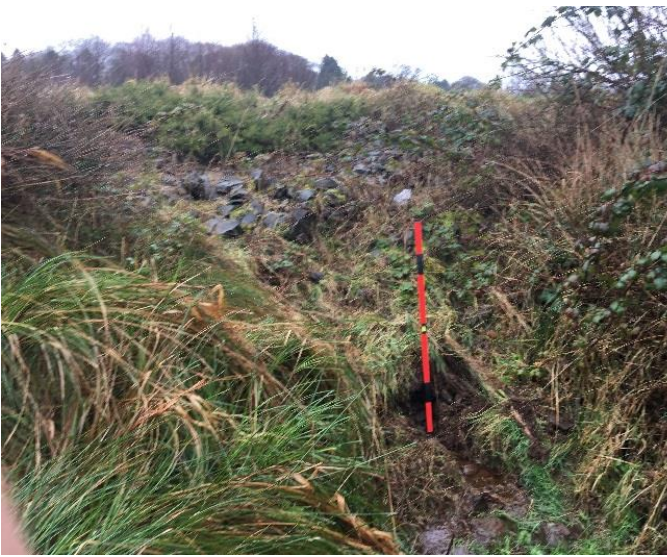
<p><b>Watercrossing Structure W37</b></p> <p>Type: Stream, 1<sup>st</sup> Order</p> <p><b>Fisheries: Class 3, Sub-optimal Fisheries</b></p> <p>Location/Townland: R503, Reardnogy Beg</p> <p>Existing Structure: Masonry Arch</p> <p>Works at the Crossing: Crossing over culvert</p> <p>Ecology Notes: No Fisheries Value</p>

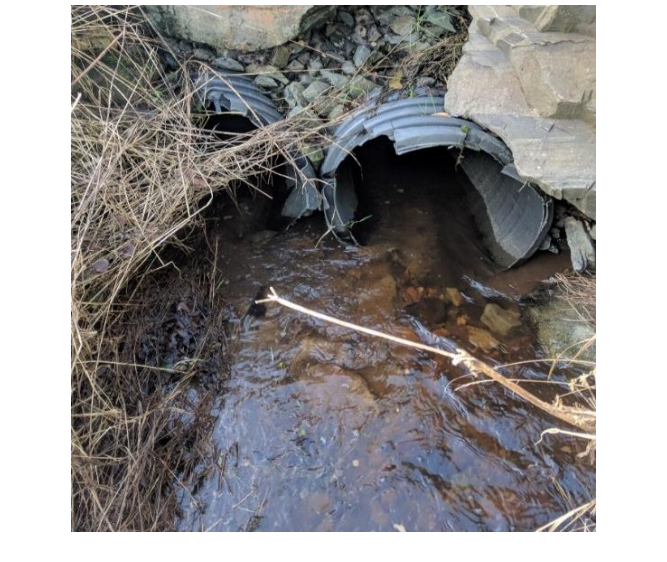
<p><b>Watercrossing Structure W38</b></p> <p>Type: Stream, 1<sup>st</sup> Order</p> <p><b>Fisheries: Class1, Optimal Fisheries</b></p> <p>Location/Townland: R503, Reardnogy Beg/Reardnogy More</p> <p>Existing Structure: Plastic Circular Culvert</p> <p>Works at the Crossing: Cable trenching under structure.</p> <p>Ecology Notes: c. 0.7 m wide, c. 140cm deep</p>

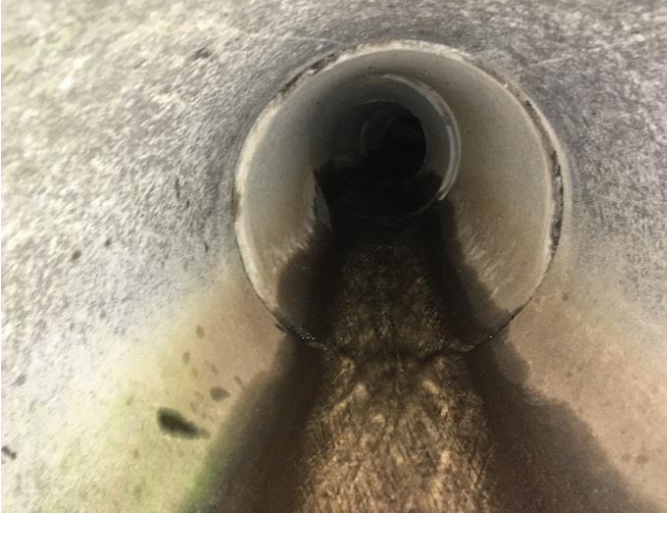
<p><b>Watercrossing Structure W39</b></p> <p>Type: Stream, 2<sup>nd</sup> Order</p> <p><b>Fisheries: Class1, Optimal Fisheries</b></p> <p>Location/Townland: R503, Reardnogy More</p> <p>Existing Structure: Plastic Circular Culvert</p> <p>Works at the Crossing: Cable trenching over structure.</p> <p>Ecology Notes: c. 0.6 m wide, c. 100cm deep</p>

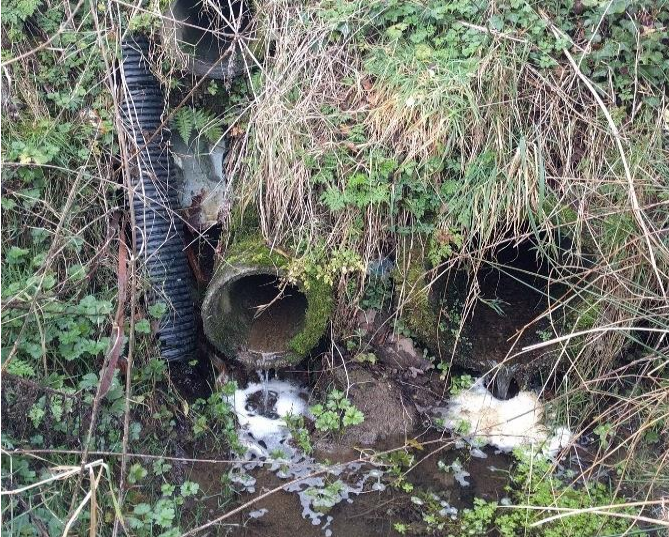
<p><b>Watercrossing Structure W40</b></p> <p>Type: Drain</p> <p><b>Fisheries: Class 4, Poor Fisheries</b></p> <p>Location/Townland: R503, Rear Cross Village, Reardnogy More/ Shanballyedmond</p> <p>Existing Structure: Concrete Circular Culvert X 3</p> <p>Works at the Crossing: Cable trenching under structures.</p> <p>Ecology Notes: No Fisheries Value</p>

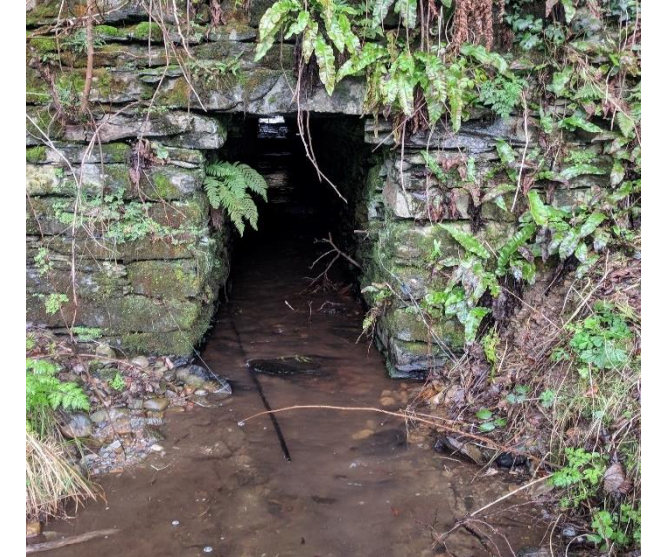
<p><b>Watercrossing Structure W41</b></p> <p>Type: Stream, 1<sup>st</sup> Order</p> <p><b>Fisheries: Class 3, Sub-optimal Fisheries</b></p> <p>Location/Townland: R503, Reardnogy More/Baurnadomeeny</p> <p>Existing Structure: Masonry Box Culvert</p> <p>Works at the Crossing: Cable trenching over structure.</p> <p>Ecology Notes: Downstream:, cobble gravel substrate, riffle, steep banks</p>

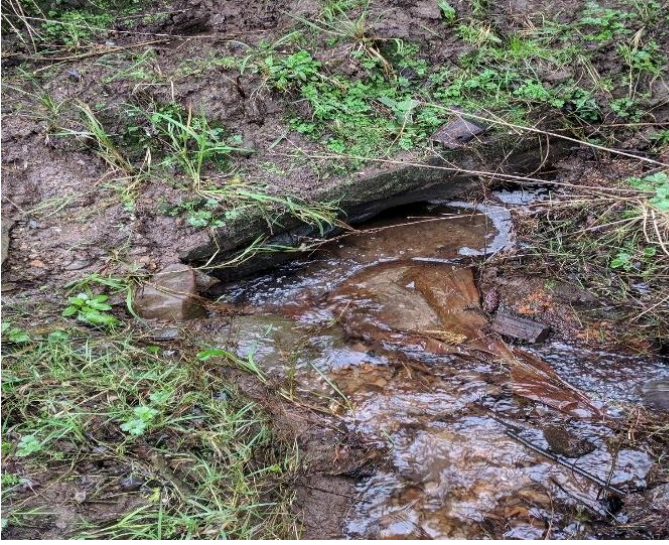
<p><b>Watercrossing Structure W42</b></p> <p>Type: Stream, 1<sup>st</sup> Order</p> <p><b>Fisheries: Class 3, Sub-optimal Fisheries</b></p> <p>Location/Townland: R503, Baurnadomeeny</p> <p>Existing Structure: Masonry Box Culvert</p> <p>Works at the Crossing: Cable trenching over structure.</p> <p>Ecology Notes: No Fisheries Potential</p>

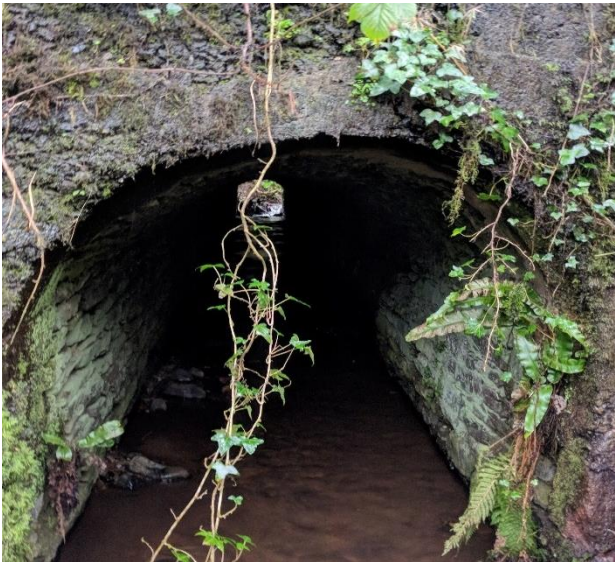
<p><b>Watercrossing Structure W43</b></p> <p>Type: Stream, 1st Order</p> <p><b>Fisheries: Class 3, Sub-optimal Fisheries</b></p> <p>Location/Townland: R503, Bournadomeeny</p> <p>Existing Structure: Masonry Arch</p> <p>Works at the Crossing: Cable trenching over structure.</p> <p>Ecology Notes: cobble gravel substrate, riffle, steep banks</p>

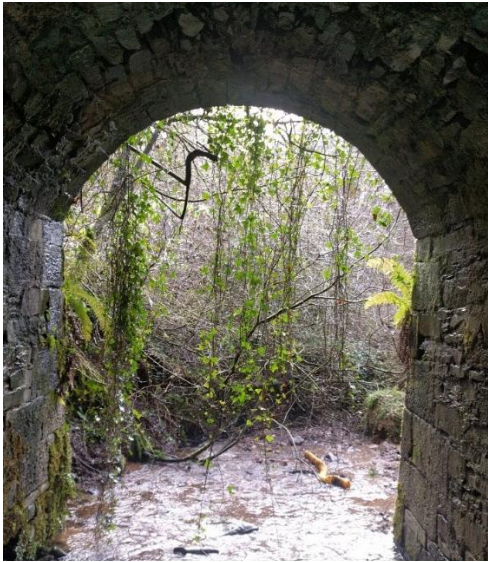
<p><b>Watercrossing Structure W44</b></p> <p>Type: Stream, 1st Order</p> <p><b>Fisheries: Class 3, Sub-optimal Fisheries</b></p> <p>Location/Townland: R503, Bournadomeeny</p> <p>Existing Structure: Masonry Arch</p> <p>Works at the Crossing: Cable trenching over structure.</p> <p>Ecology Notes: cobble gravel substrate, riffle, steep banks</p>

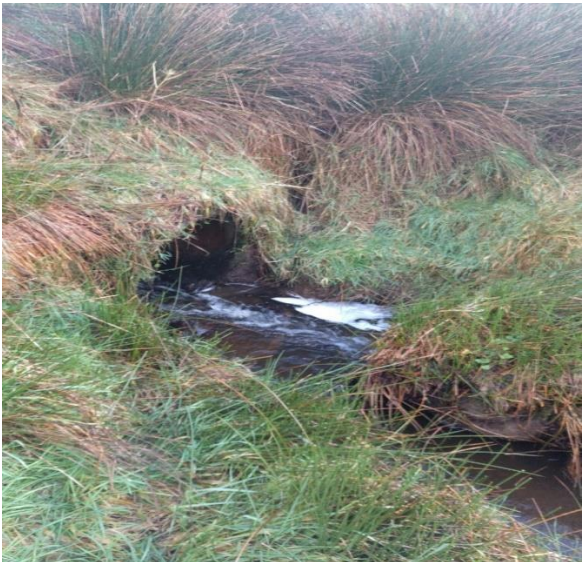
<p><b>Watercrossing Structure W45</b></p> <p>Type: Stream, 1<sup>st</sup> Order</p> <p><b>Fisheries: Class1, Optimal Fisheries</b></p> <p>Location/Townland: R503, Bournadomeeny/Coonmore</p> <p>Existing Structure: Concrete Circular Culvert</p> <p>Works at the Crossing: Cable trenching over structure.</p> <p>Ecology Notes: Riffle / glide, cobble substrate, channelised</p>

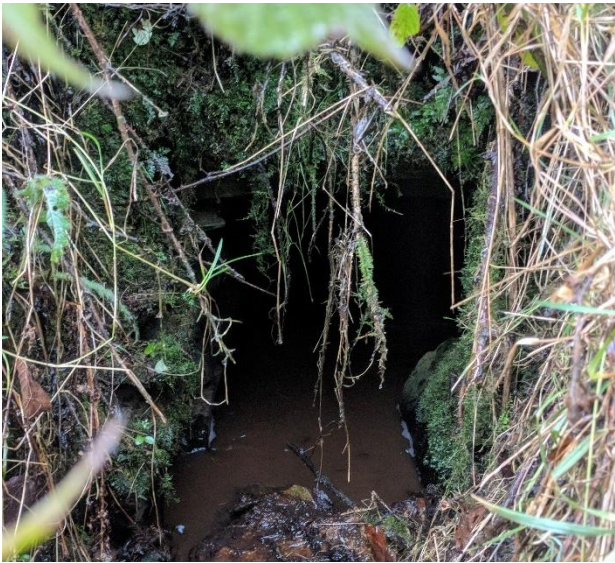
<p><b>Watercrossing Structure W46</b></p> <p>Type: Drain</p> <p><b>Fisheries: Class 4, Poor Fisheries</b></p> <p>Location/Townland: R503, Coonmore</p> <p>Existing Structure: Masonry Box Culvert              Works at the Crossing: Cable trenching over structure.</p> <p>Ecology Notes: No Fisheries Value</p>

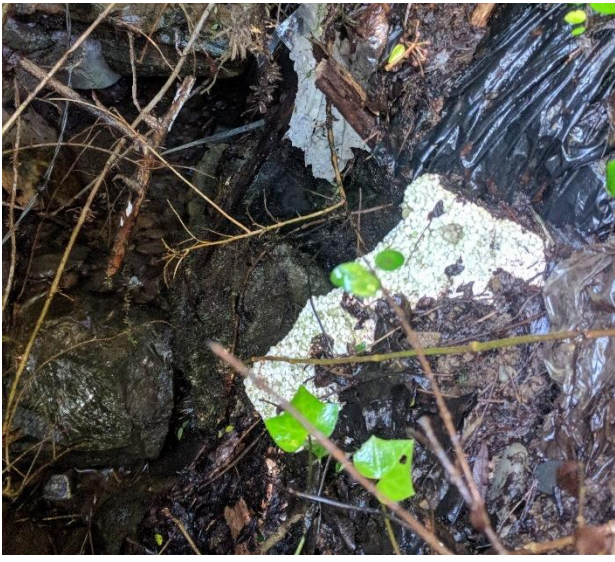
<p><b>Watercrossing Structure W47</b></p> <p>Type: Drain</p> <p><b>Fisheries: Class 4, Poor Fisheries</b></p> <p>Location/Townland: R503, Coonmore</p> <p>Existing Structure: Masonry Box Culvert              Works at the Crossing: Cable trenching over structure.</p> <p>Ecology Notes: No Fisheries Value</p>

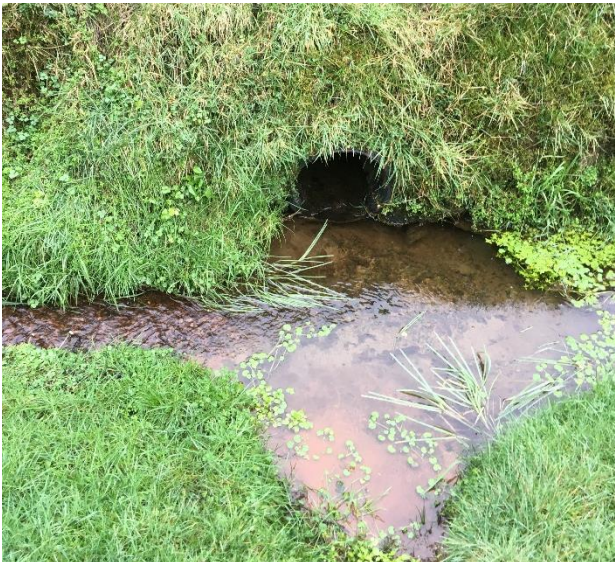
<p><b>Watercrossing Structure W48</b></p> <p>Type: Drain</p> <p><b>Fisheries: Class 4, Poor Fisheries</b></p> <p>Location/Townland: R503, Coonmore</p> <p>Existing Structure: Plastic Circular Culvert              Works at the Crossing: Cable trenching over structure.</p> <p>Ecology Notes: No Fisheries Value</p>

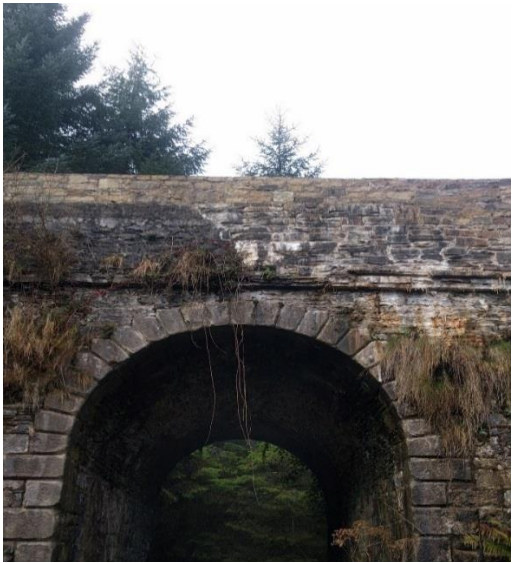
<p><b>Watercrossing Structure W49</b></p> <p>Type: River</p> <p><b>Fisheries: Class1, Optimal Fisheries</b></p> <p>Location/Townland: R503, Coonmore/Foildarragh</p> <p>Existing Structure: Masonry Arch</p> <p>Works at the Crossing: Cable trenching over structure.</p> <p>Ecology Notes: Cobble/gravel, channelised, riffle</p>

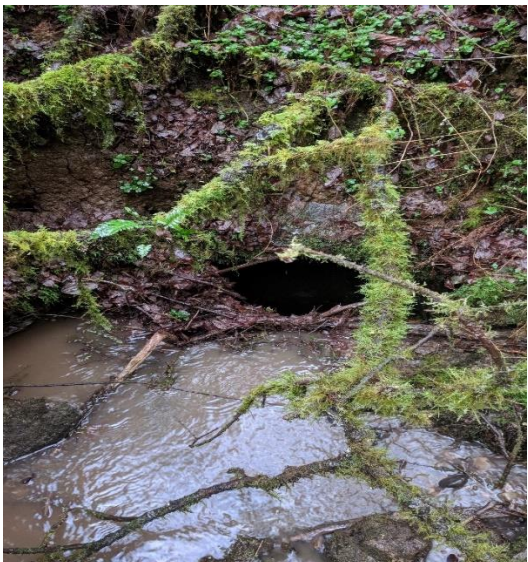
<p><b>Watercrossing Structure W50</b></p> <p>Type: Stream, 1st Order</p> <p><b>Fisheries: Class 3, Sub-optimal Fisheries</b></p> <p>Location/Townland: R503, Foildarragh</p> <p>Existing Structure: Masonry Box Culvert</p> <p>Works at the Crossing: Cable trenching over structure.</p> <p>Ecology Notes: No Fisheries Value, Very steep gradient, in gorge, 100% cover.</p>

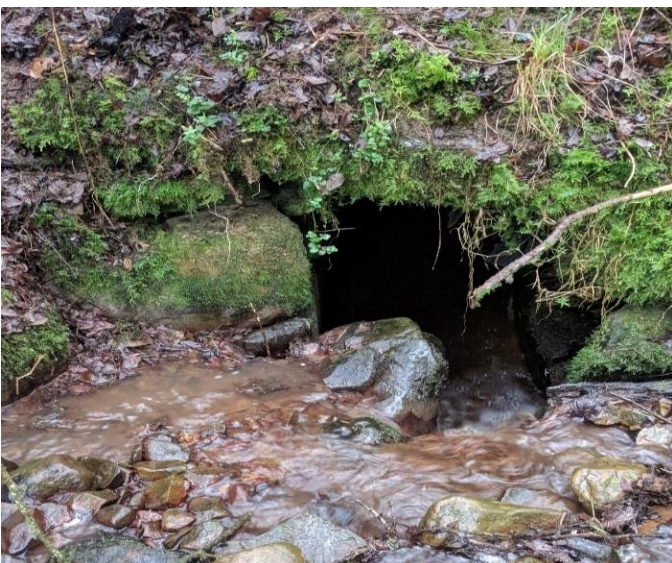
<p><b>Watercrossing Structure W51</b></p> <p>Type: Stream, 1st Order</p> <p><b>Fisheries: Class 3, Sub-optimal Fisheries</b></p> <p>Location/Townland: R503, Foildarragh</p> <p>Existing Structure: Masonry Box Culvert</p> <p>Works at the Crossing: Cable trenching over structure.</p> <p>Ecology Notes: No Fisheries Value, Very steep gradient, in gorge, 100% cover.</p>

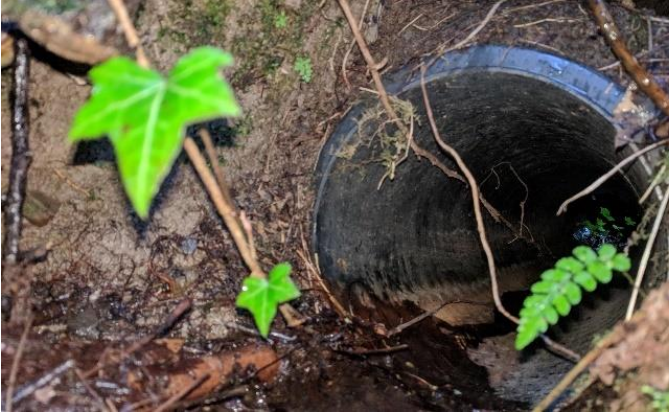
<p><b>Watercrossing Structure W54</b></p> <p>Type: Drain</p> <p><b>Fisheries: Class 4, Poor Fisheries</b></p> <p>Location/Townland: R503, Kilcommon</p> <p>Existing Structure: Plastic Circular Culvert</p> <p>Works at the Crossing: Cable trenching under structure.</p> <p>Ecology Notes: No Fisheries Value</p>

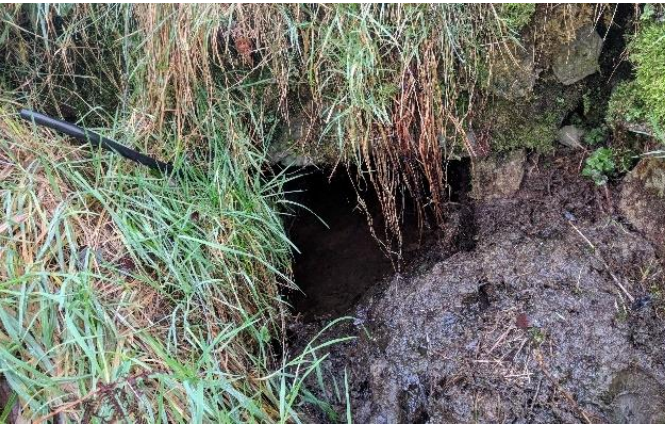
<p><b>Watercrossing Structure W55</b></p> <p>Type: Drain</p> <p><b>Fisheries: Class 4, Poor Fisheries</b></p> <p>Location/Townland: R503, Kilcommon</p> <p>Existing Structure: Masonry Box Culvert</p> <p>Works at the Crossing: Cable trenching under structure. Culvert may need replacing.</p> <p>Ecology Notes: No Fisheries Value</p>

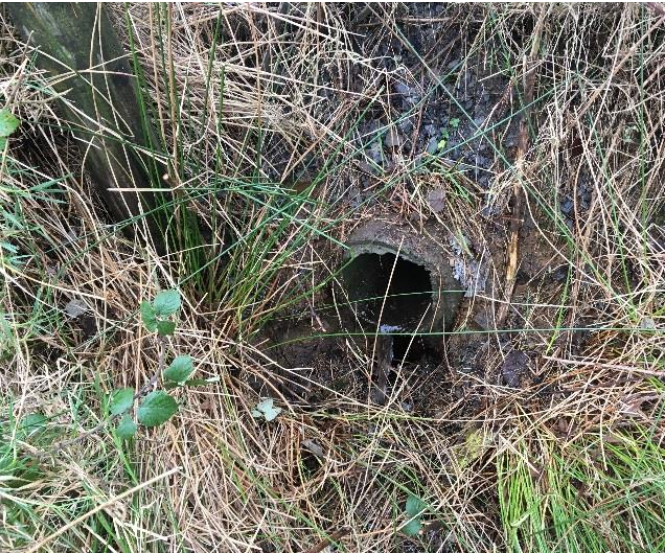
<p><b>Watercrossing Structure W56</b></p> <p>Type: Drain</p> <p><b>Fisheries: Class 3, Sub-optimal Fisheries</b></p> <p>Location/Townland: R503, Kilcommon</p> <p>Existing Structure: Concrete Circular Culvert</p> <p>Works at the Crossing: Cable trenching over structure.</p> <p>Ecology Notes: No Fisheries Value, some flow</p>

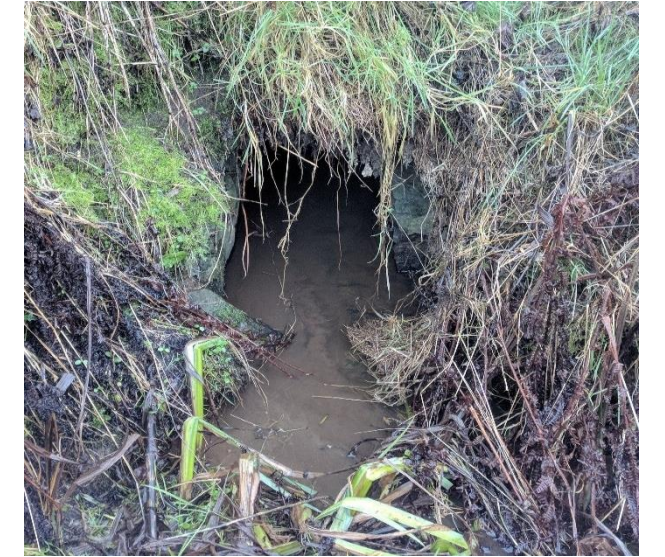
<p><b>Watercrossing Structure W57</b></p> <p>Type: Drain</p> <p><b>Fisheries: Class 4, Poor Fisheries</b></p> <p>Location/Townland: R503, Kilcommon/Loughbrack</p> <p>Existing Structure: Masonry Box Culvert</p> <p>Works at the Crossing: Cable trenching under structure. Culvert may need replacing.</p> <p>Ecology Notes: No Fisheries Value</p>
