Appendix to Chapter 15: Material Assets (Roads)

Appendix 15.5: Peat Probe Survey

Table 1: Peat Probe Survey Results

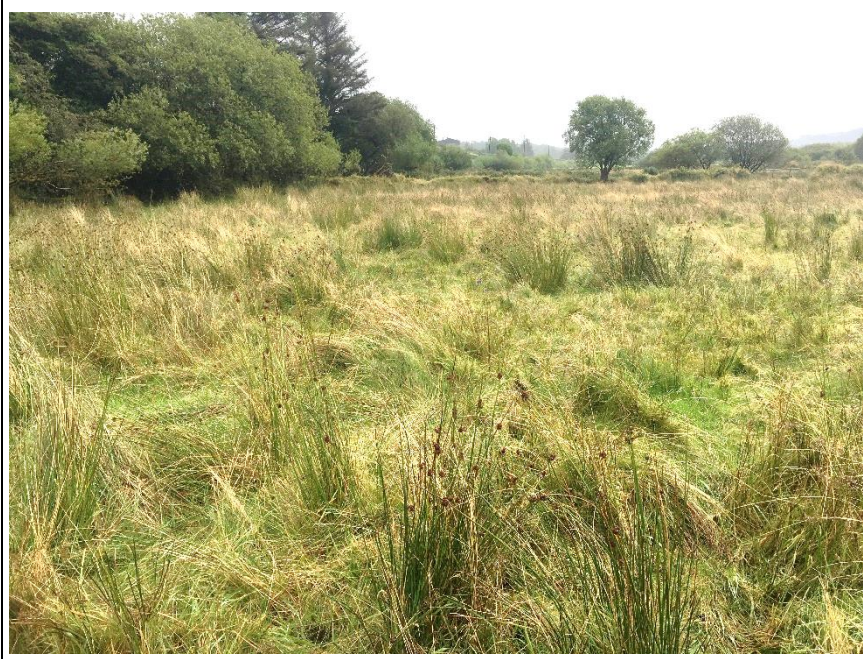
<p><u>Probe Survey Details</u></p> <p><u>Probe ID:</u> P1</p> <p><u>ITM:</u> 580825,660626</p> <p><u>Depth of Probe:</u> 0m, No peat</p> <p><u>Below road level:</u> 1m</p> <p><u>Ground Conditions:</u> Wet ground, grasses</p>

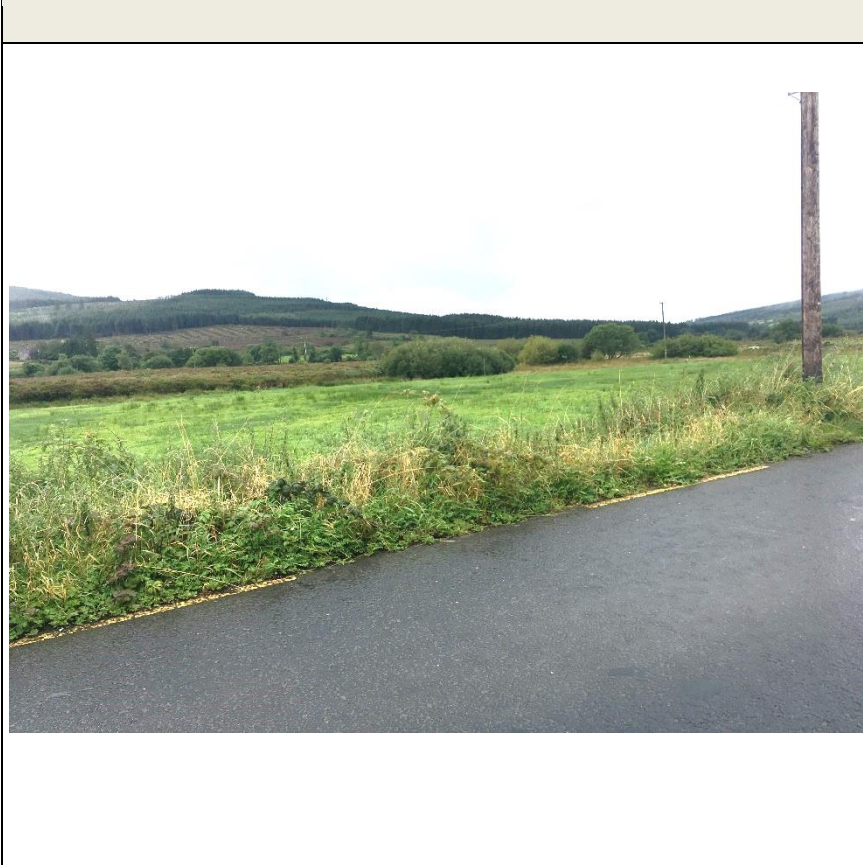
<p><u>Probe Survey Details</u></p> <p><u>Probe ID:</u> P2</p> <p><u>ITM:</u> 581024,660508</p> <p><u>Depth of Probe:</u> 0m, No peat</p> <p><u>Below road level:</u> 2m</p> <p><u>Ground Conditions:</u> Dry ground, grasses</p>

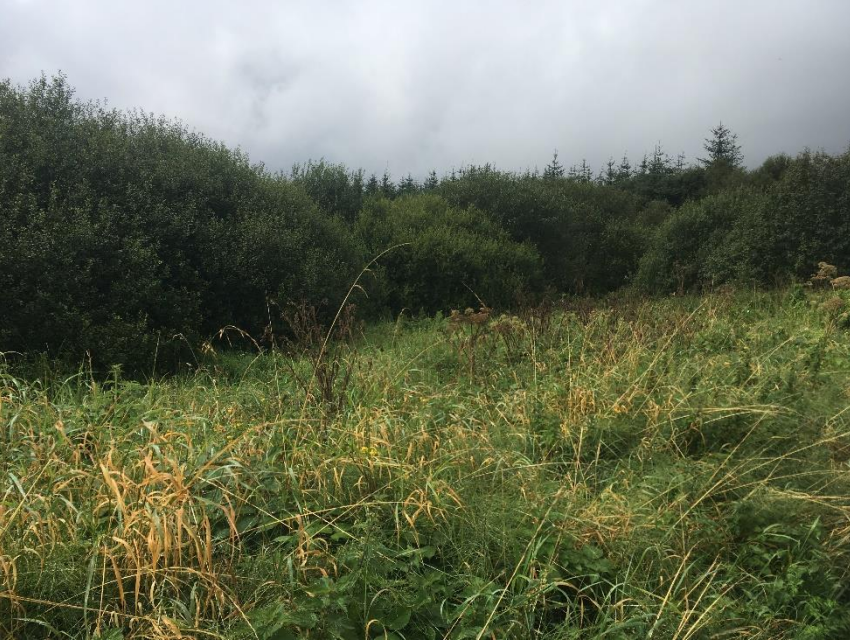
<p><u>Probe Survey Details</u></p> <p><u>Probe ID:</u> P7</p> <p><u>ITM:</u> 581969,659723</p> <p><u>Depth of Probe:</u> 4m</p> <p><u>Below road level:</u> 2m</p> <p><u>Ground Conditions:</u> Boggy ground, however closer to road on south side is firm dry ground. High side of road is firm dry ground.</p>

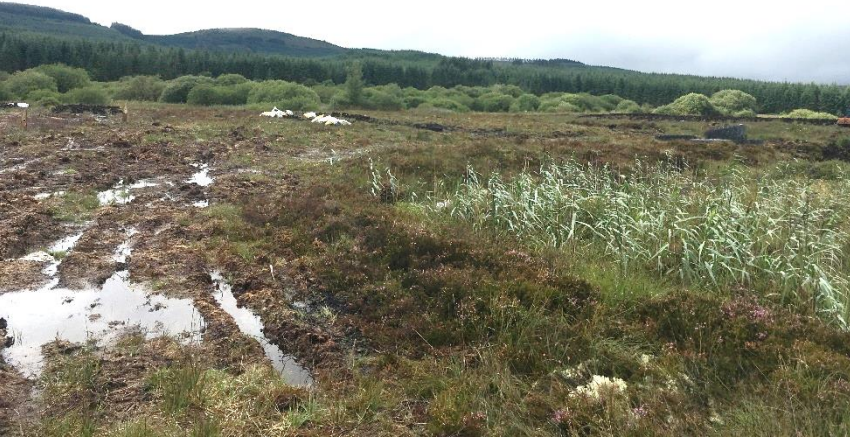
<p><u>Probe Survey Details</u></p> <p><u>Probe ID:</u> P8</p> <p><u>ITM:</u> 582227,659482</p> <p><u>Depth of Probe:</u> 4m</p> <p><u>Below road level:</u> 2m</p> <p><u>Ground Conditions:</u> Boggy ground, however closer to road on south side is firm dry ground. High side of road is firm dry ground.</p>

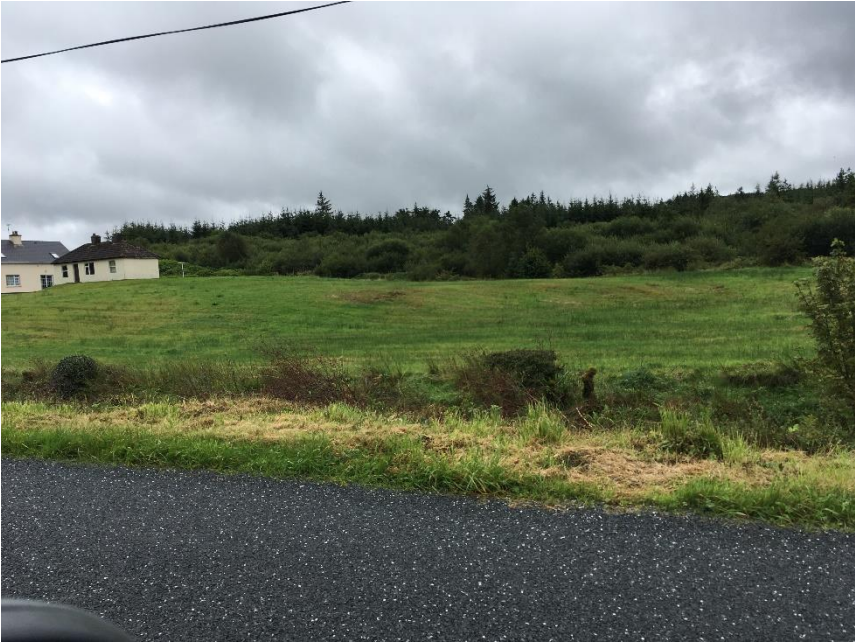
<p><u>Probe Survey Details</u></p> <p><u>Probe ID:</u> P11</p> <p><u>ITM:</u> 583134,659235</p> <p><u>Depth of Probe:</u> 0m, No peat</p> <p><u>Below road level:</u> 2m</p> <p><u>Ground Conditions:</u> Dry ground, grasses</p>

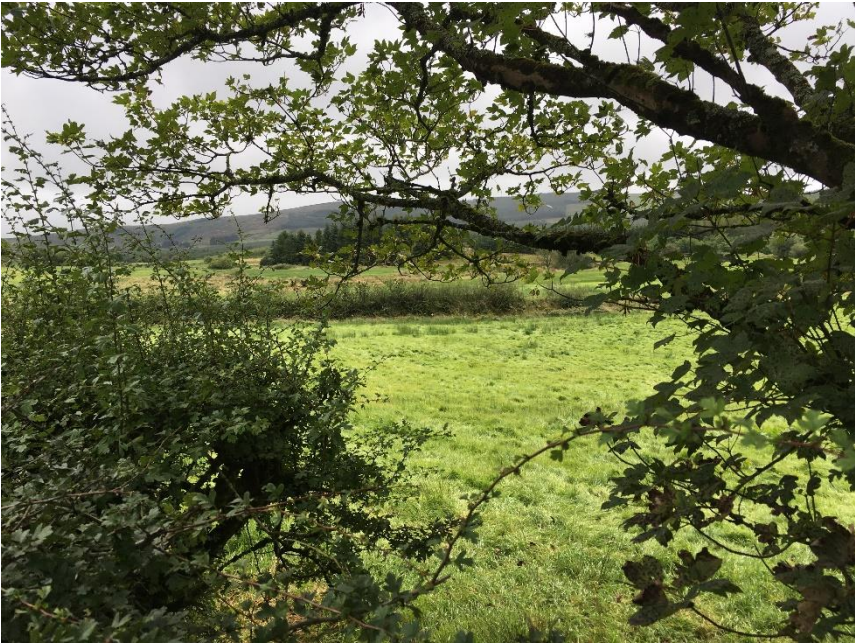
<p><u>Probe Survey Details</u></p> <p><u>Probe ID:</u> P12</p> <p><u>ITM:</u> 589315,658605</p> <p><u>Depth of Probe:</u> 0m, No peat</p> <p><u>Below road level:</u> 2m</p> <p><u>Ground Conditions:</u> Dry ground, grasses</p>

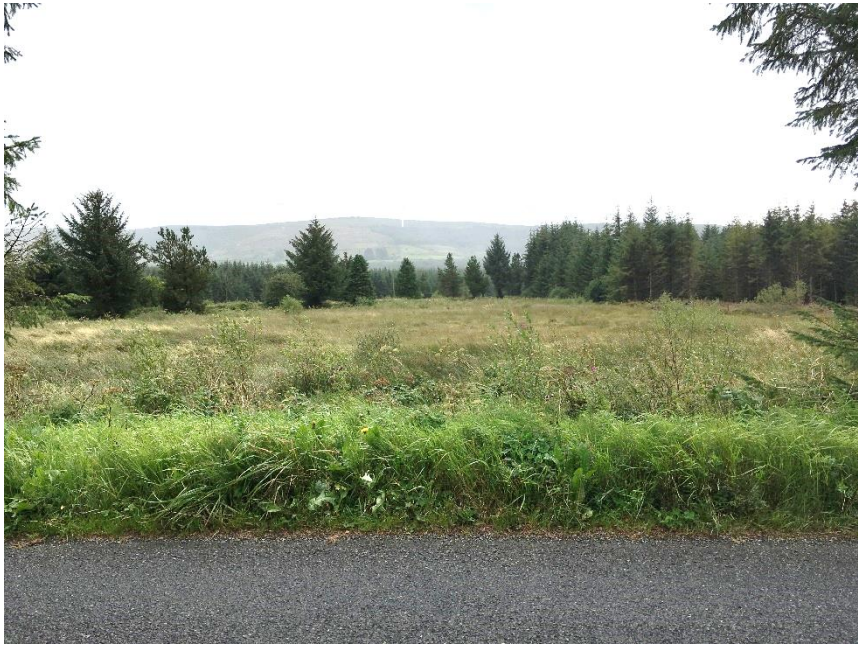
<p><u>Probe Survey Details</u></p> <p><u>Probe ID:</u> P13</p> <p><u>ITM:</u> 590414,658553</p> <p><u>Depth of Probe:</u> 0m, No peat</p> <p><u>Below road level:</u> 1m</p> <p><u>Ground Conditions:</u> Dry ground, grasses & forestry</p>

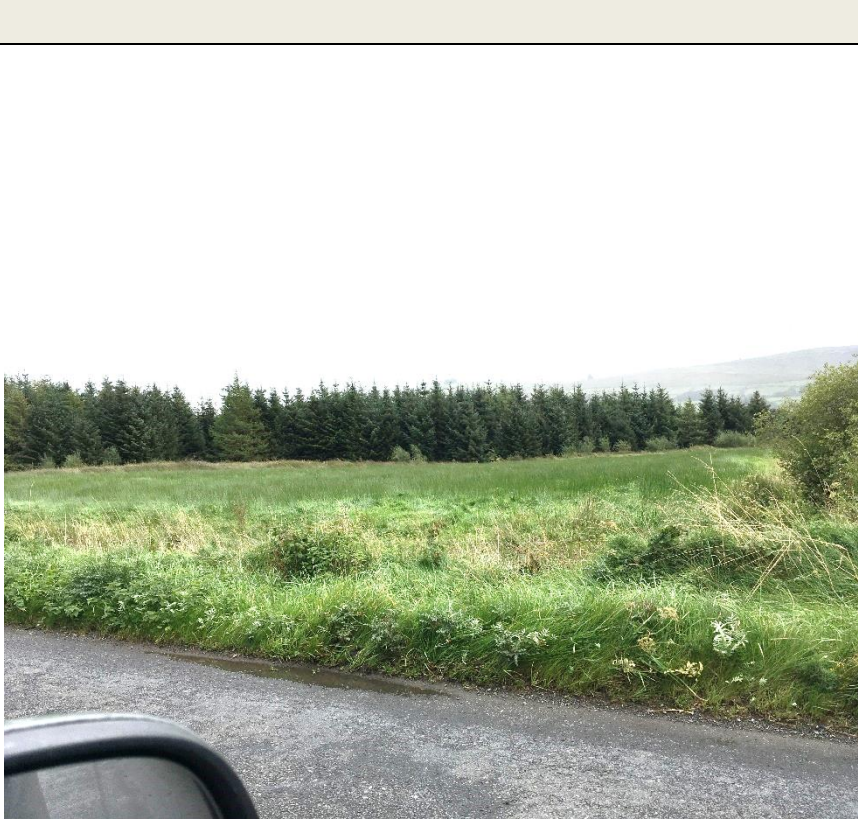
<p><u>Probe Survey Details</u></p> <p><u>Probe ID:</u> P14</p> <p><u>ITM:</u> 590657,658656</p> <p><u>Depth of Probe:</u> 0m, No peat</p> <p><u>Below road level:</u> 1m</p> <p><u>Ground Conditions:</u> Dry ground, grasses & forestry</p>
