Appendix to Chapter 15: Material Assets (Roads)

Appendix 15.6: Inventory & Classification of Watercourses at Crossing Locations

Photos of UWF GRID CONNECTION Bridges / Culverts along Public Roads

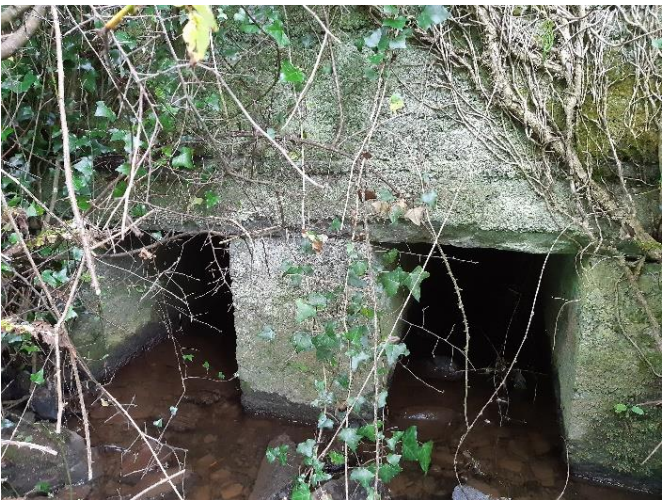
<p>Watercrossing Structure W4</p> <p>Type: Stream</p> <p>Fisheries: Class 3, Sub-optimal Fisheries</p> <p>Location/Townland: L2166-0, Coole/Freagh</p> <p>Existing Structure: Concrete Block Box Culvert</p> <p>Works at the Crossing: Cable trenching under structure</p> <p>Ecology Notes: Downstream - Slow flowing, Coble (60), Gravel (40). Overgrown, vegetation shading. 1 metre wide and ~30cm deep.</p>

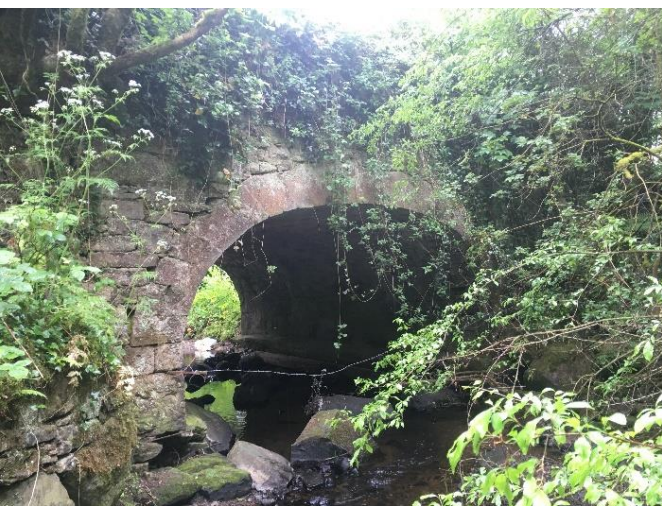
<p>Watercrossing Structure W5</p> <p>Type: River</p> <p>Fisheries: Class1, Optimal Fisheries</p> <p>Location/Townland: L6013-0, Foildarrig/Freagh</p> <p>Existing Structure: Masonry Single Arch Bridge</p> <p>Works at the Crossing: Cable trenching over structure</p> <p>Ecology Notes: Upstream - riffle/glide sequence and pool. Bolder (30), cobble (30), sand/gravel (40). Culvert pipe also flowing into river. Downstream - Riffle and pool present. Sand gravel under bridge (60), boulders/cobble(40).</p>

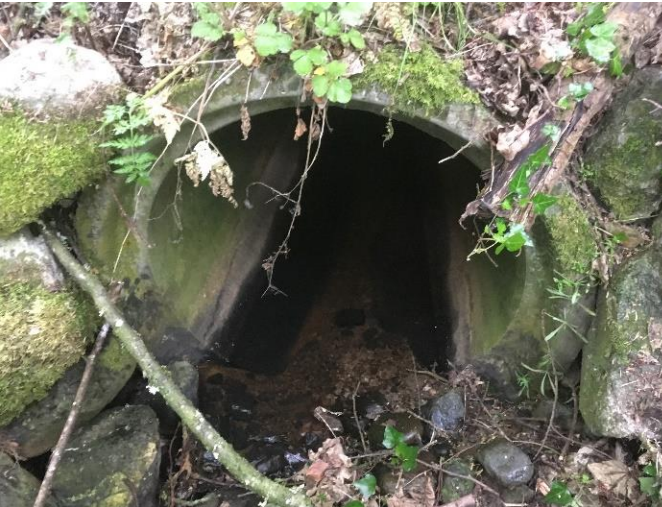
<p>Watercrossing Structure W6</p> <p>Type: Stream</p> <p>Fisheries: Class 3, Sub-Optimal Fisheries</p> <p>Location/Townland: L6013-0, Oakhampton</p> <p>Existing Structure: Concrete Circular Culvert</p> <p>Works at the Crossing: Cable trenching over structure</p> <p>Ecology Notes: Pipe culvert with stream through it. Bolder (50), mud/gravel (50).</p>

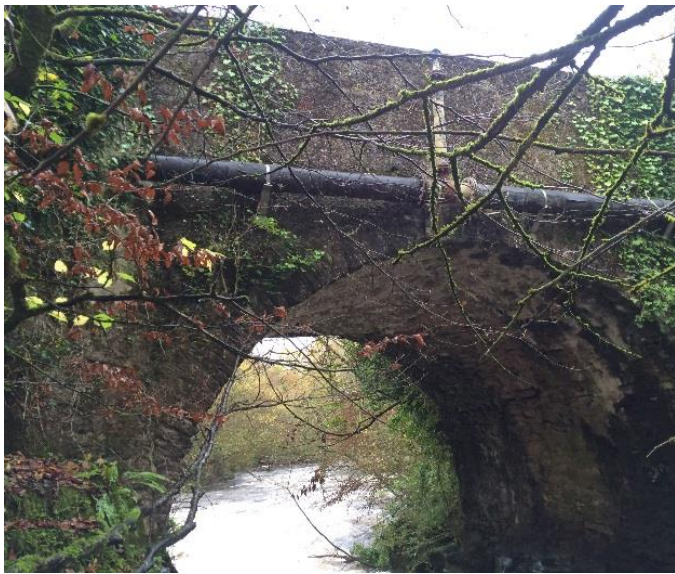
<p>Watercrossing Structure W7</p> <p>Type: River</p> <p>Fisheries: Class1, Optimal Fisheries</p> <p>Location/Townland: Rockvale Bridge, L2156-0, Oakhampton/Rockvale</p> <p>Existing Structure: Masonry Single Arch Bridge</p> <p>Works at the Crossing: Cable trenching over structure. Additional works to raise road level & parapet wall height</p> <p>Ecology Notes: Upstream - riffle and white water. Bedrock (70), cobble (20), sand (10). Deep water - could not judge depth. Downstream - white water, small riffle and some pooling. Deep water.</p>

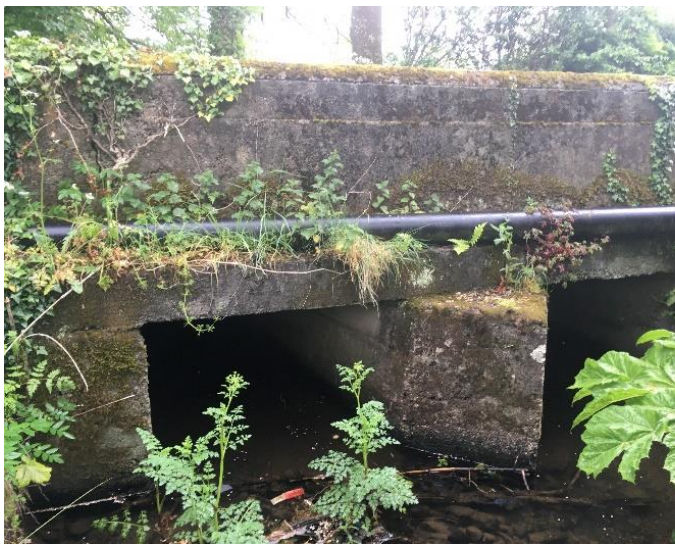
<p>Watercrossing Structure W8</p> <p>Type: Stream</p> <p>Fisheries: Class1, Optimal Fisheries</p> <p>Location/Townland: L6009-0, Ahane/Castlewaller</p> <p>Existing Structure: Concrete Slab Bridge</p> <p>Works at the Crossing: Directional Drill under stream bed.</p> <p>Ecology Notes: Upstream - small riffle and glide. Pooling. Moderate flow. Cobble (70), gravel (30). Downstream - riffle and glide, pool at bridge. Cobble (60), gravel (40).</p>

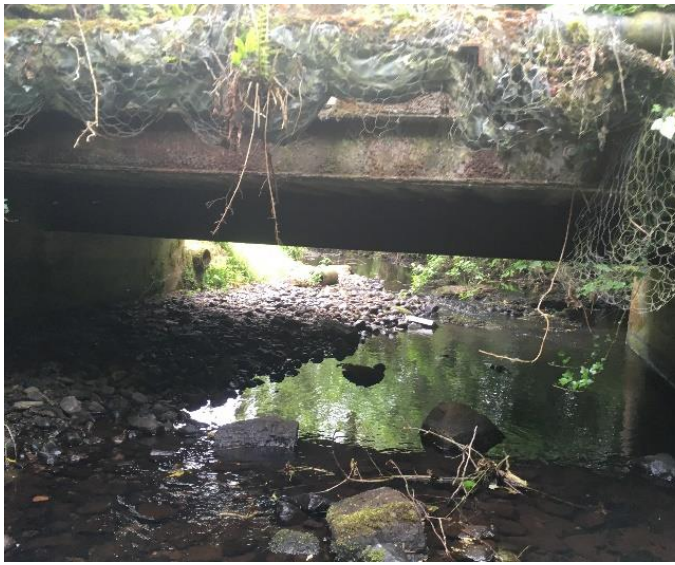
<p>Watercrossing Structure W9</p> <p>Type: Stream</p> <p>Fisheries: Class 1, Optimal Fisheries</p> <p>Location/Townland: L6009-0, Castlewaller/Carrowkeale</p> <p>Existing Structure: Concrete Slab Bridge</p> <p>Works at the Crossing: Directional Drill under stream bed.</p> <p>Ecology Notes: Upstream - riffle and glide and pool (with sand). Sand (30), cobble (50), gravel (20). Downstream - flat rock (40), boulders (30), cobble (30), riffle. Some pooling at edge, no visible build-up of sand. Fast flowing.</p>

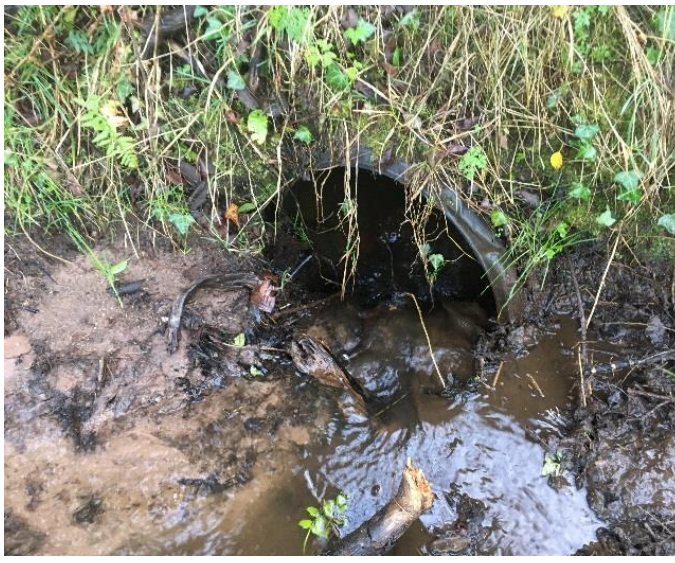
<p>Watercrossing Structure W10 Type: Stream, 1st Order Fisheries: Class 3, Sub-optimal Fisheries Location/Townland: R503, Kilnacappagh</p> <p>Existing Structure: HDPE Plastic Circular Culvert Works at the Crossing: Cable trenching over structure</p> <p>Ecology Notes: deep, drained, flow</p>

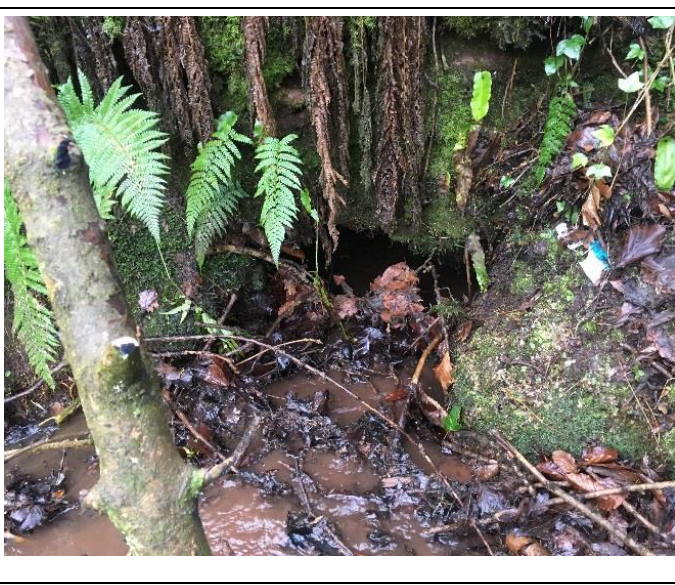
<p>Watercrossing Structure W11 Type: Stream Fisheries: Class 3, Sub-optimal Fisheries Location/Townland: R503, Scrageen/Derrygareen</p> <p>Existing Structure: Masonry Box Culvert Works at the Crossing: Cable trenching over structure</p> <p>Ecology Notes: c. 1 m wide, c. 20 cm deep</p>

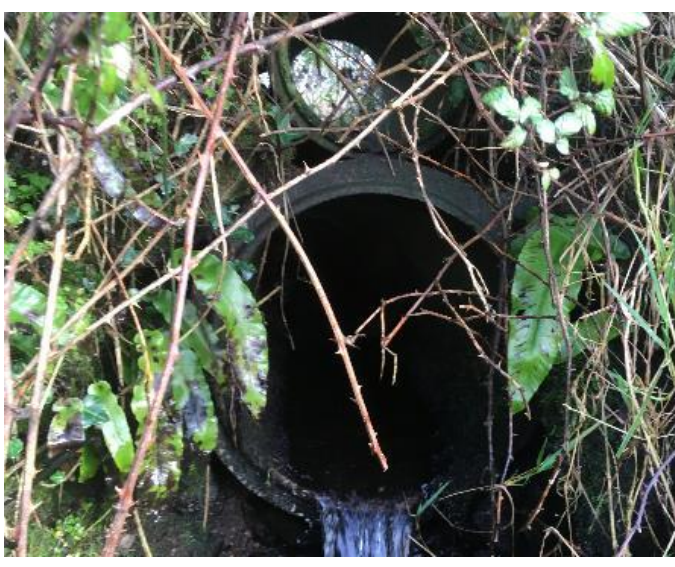
<p>Watercrossing Structure W12 Type: Drain Fisheries: Class 4, Poor Fisheries Location/Townland: R503, Derrygareen</p> <p>Existing Structure: Masonry Box Culvert & Circular Concrete Culvert Works at the Crossing: Cable trenching under structure</p> <p>Ecology Notes: c. 0.8m wide, c. 15 cm deep</p>

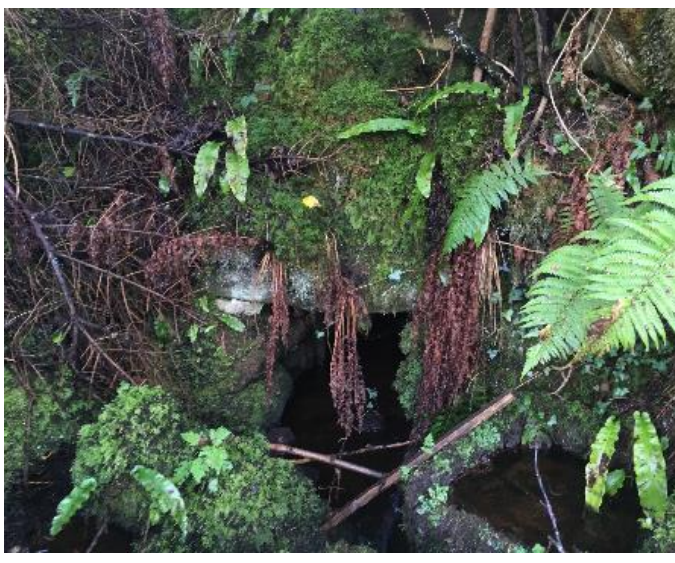
<p>Watercrossing Structure W13</p> <p>Type: Stream, 1st Order</p> <p>Fisheries: Class 4, Poor Fisheries</p> <p>Location/Townland: R503, Knockancullenagh</p> <p>Existing Structure: Masonry Box Culvert</p> <p>Works at the Crossing: Cable trenching under structure. Culvert may need replacing.</p> <p>Ecology Notes: No Fisheries Potential</p>

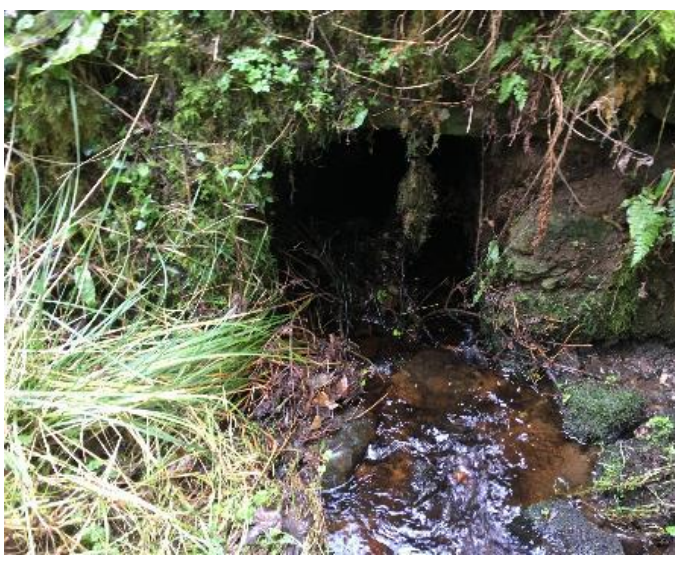
<p>Watercrossing Structure W14</p> <p>Type: Stream, 1st Order</p> <p>Fisheries: Class1, Optimal Fisheries</p> <p>Location/Townland: R503, Knockancullenagh</p> <p>Existing Structure: Masonry Box Culvert</p> <p>Works at the Crossing: Cable trenching under structure. Culvert may need replacing.</p> <p>Ecology Notes: steep gradient, cobble/gravel. 100% shade</p>

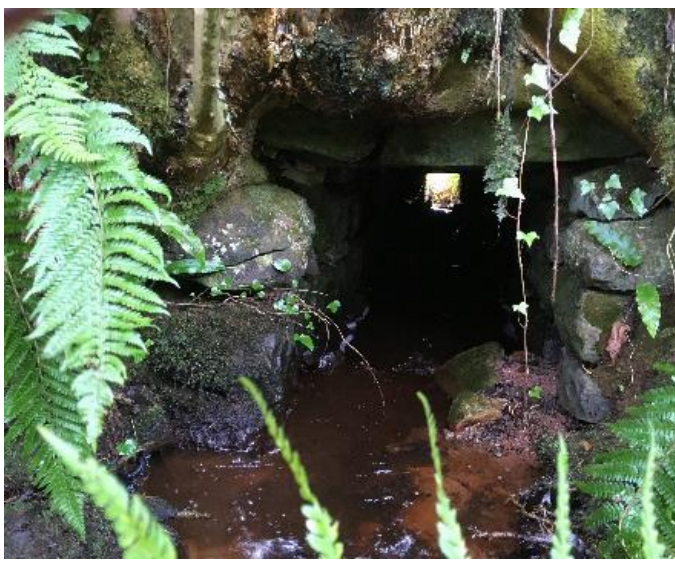
<p>Watercrossing Structure W15</p> <p>Type: Stream, 1st Order</p> <p>Fisheries: Class 3, Sub-optimal Fisheries</p> <p>Location/Townland: R503, Knockancullenagh</p> <p>Existing Structure: Masonry Box Culvert</p> <p>Works at the Crossing: Cable trenching under structure. Culvert may need replacing.</p> <p>Ecology Notes: No Fisheries Potential</p>

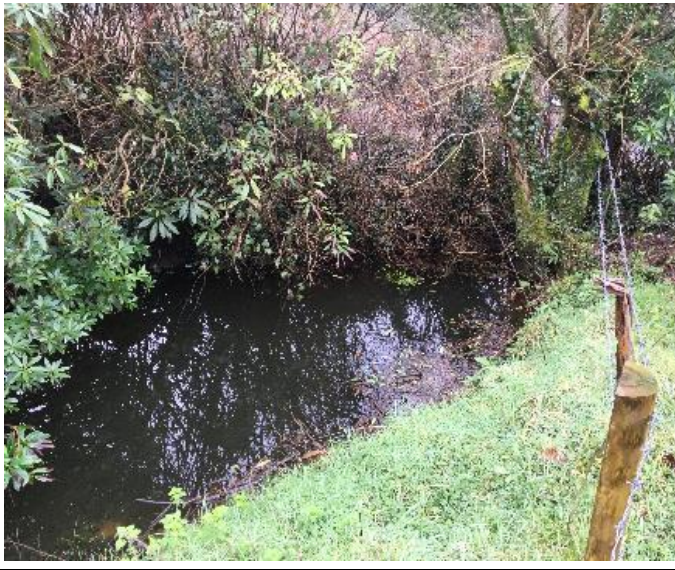
<p>Watercrossing Structure W16</p> <p>Type: Drain</p> <p>Fisheries: Class 4, Poor Fisheries</p> <p>Location/Townland: R503, Knockancullenagh</p> <p>Existing Structure: Plastic Circular Culvert.</p> <p>Works at the Crossing: Cable trenching over structure.</p> <p>Ecology Notes: No Fisheries Potential</p>

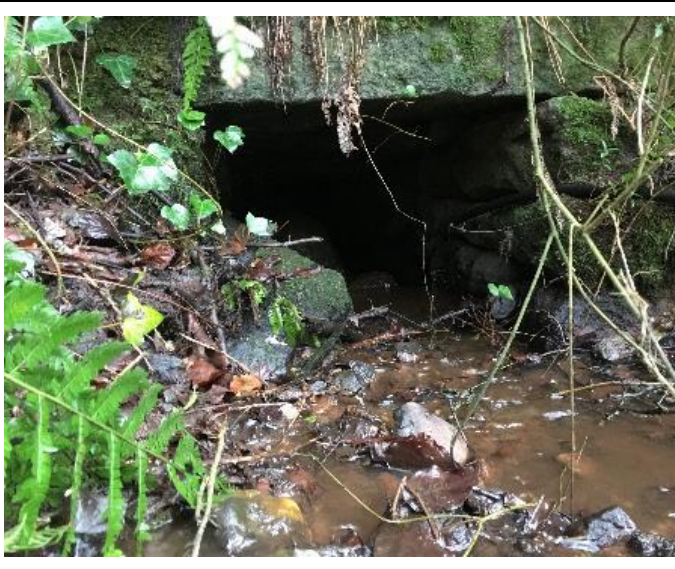
<p>Watercrossing Structure W17</p> <p>Type: Stream, 1st Order</p> <p>Fisheries: Class 3, Sub-optimal Fisheries</p> <p>Location/Townland: R503, Knockancullenagh</p> <p>Existing Structure: Masonry Box Culvert</p> <p>Works at the Crossing: Cable trenching under structure. Culvert may need replacing.</p> <p>Ecology Notes: No Fisheries Potential, steep</p>

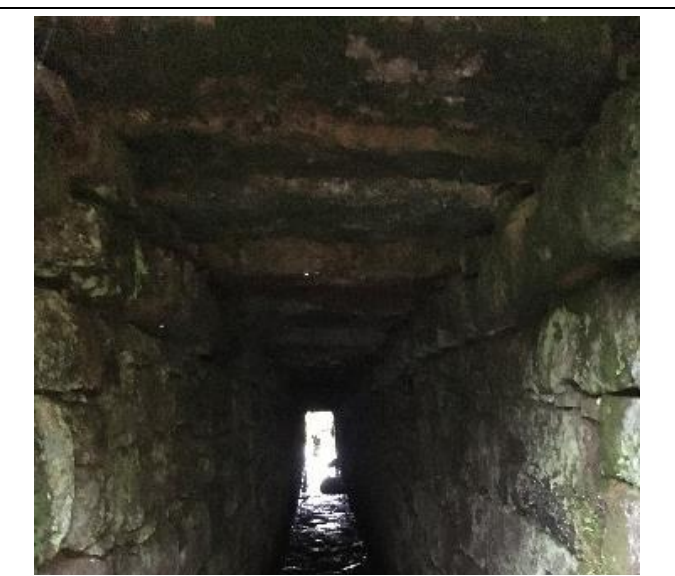
<p>Watercrossing Structure W18</p> <p>Type: Stream, 2nd Order</p> <p>Fisheries: Class1, Optimal Fisheries</p> <p>Location/Townland: R503, Knockancullenagh/Fanit</p> <p>Existing Structure: Masonry Box Culvert</p> <p>Works at the Crossing: Cable trenching over structure.</p> <p>Ecology Notes: steep, boulder cobble pool riffle. Downstream 100% shade, steep gradient</p>

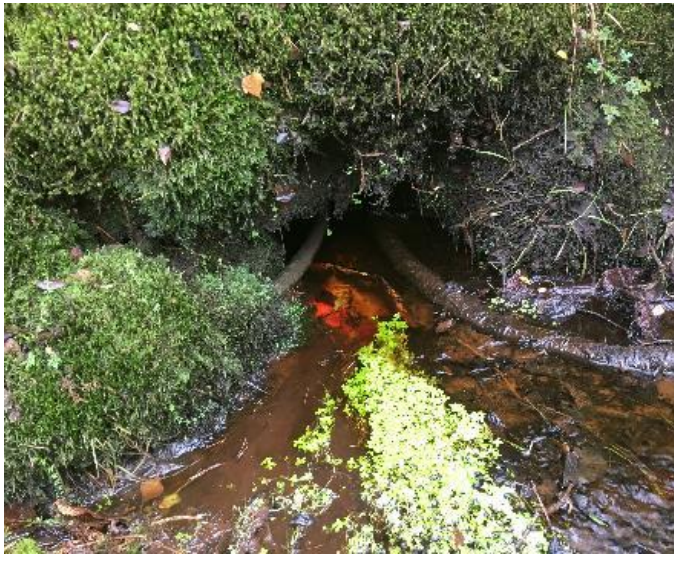
<p>Watercrossing Structure W19 Type: Drain Fisheries: Class 4, Poor Fisheries Location/Townland: R503, Fanit Existing Structure: Masonry Box Culvert Works at the Crossing: Cable trenching under structure. Culvert may need replacing. Ecology Notes: No Fisheries Potential</p>

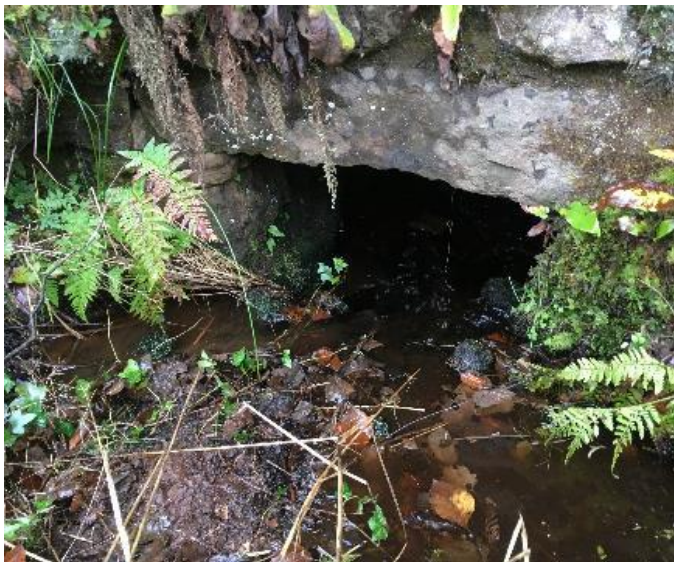
<p>Watercrossing Structure W20 Type: Drain Fisheries: Class 4, Poor Fisheries Location/Townland: R503, Fanit Existing Structure: Masonry Box Culvert Works at the Crossing: Cable trenching under structure. Culvert may need replacing. Ecology Notes: No Fisheries Potential 100% shade downstream</p>

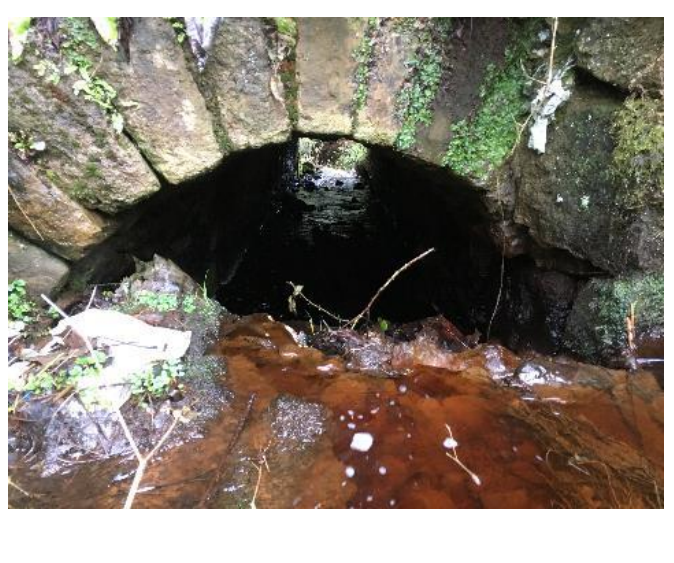
<p>Watercrossing Structure W21 Type: Stream, 1st Order Fisheries: Class 3, Sub-optimal Fisheries Location/Townland: R503, Fanit Existing Structure: Masonry Single Arch Bridge Works at the Crossing: Cable trenching over structure. Ecology Notes: No Fisheries Potential 100% shade downstream</p>

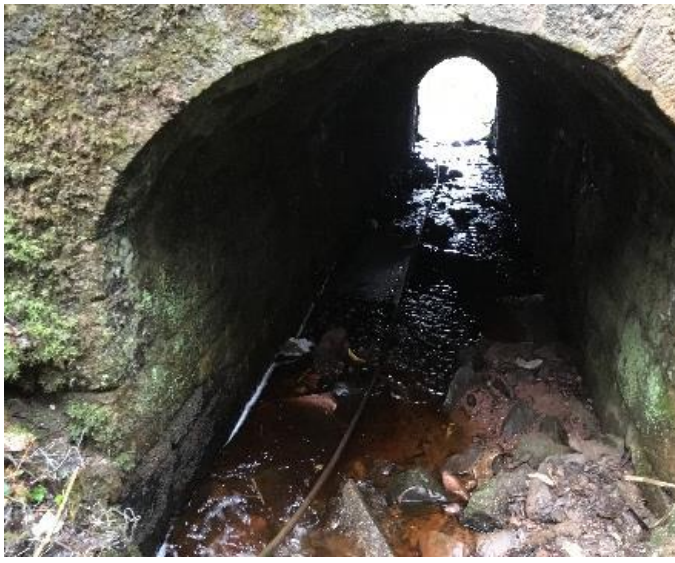
<p>Watercrossing Structure W22 Type: Stream, 1st Order Fisheries: Class 3, Sub-optimal Fisheries Location/Townland: R503, Fanit/Lackamore</p> <p>Existing Structure: Masonry Single Arch Bridge</p> <p>Works at the Crossing: Cable trenching over structure.</p> <p>Ecology Notes: steep/cascade</p>

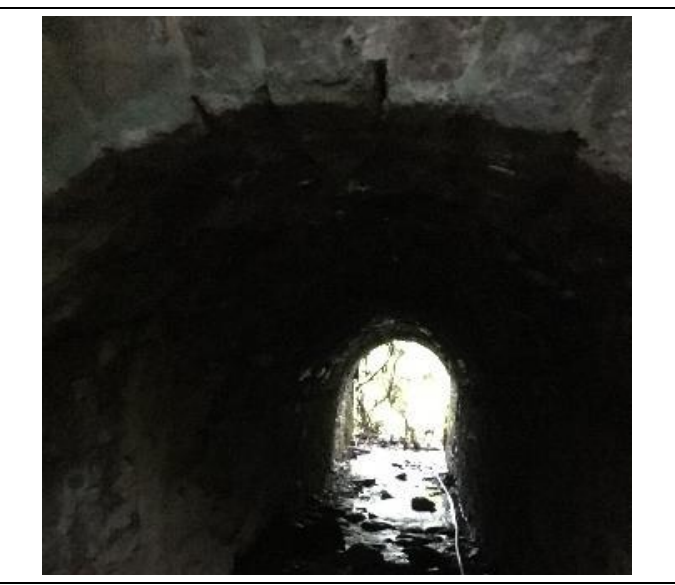
<p>Watercrossing Structure W23 Type: Stream Fisheries: Class 3, Sub-optimal Fisheries Location/Townland: R503, Lackamore</p> <p>Existing Structure: Masonry Arch Bridge Works at the Crossing: Cable trenching over structure.</p> <p>Ecology Notes: No Fisheries Potential Upstream: 100% shade. Minor steep cascades Downstream: 100% shade</p>

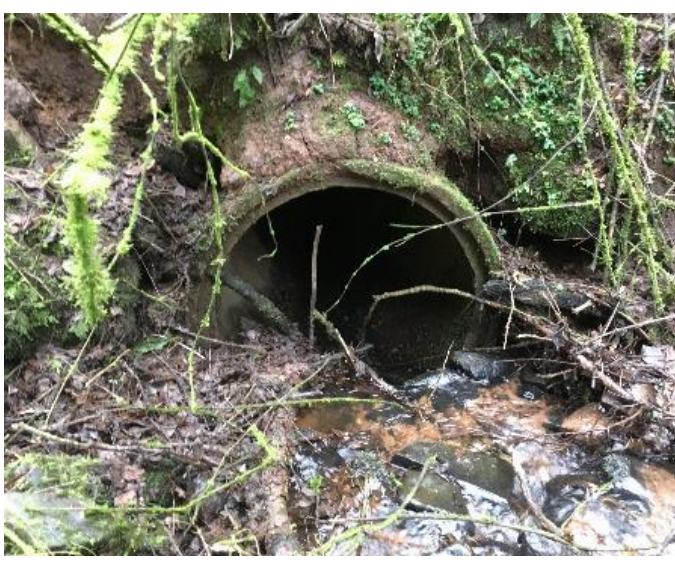
<p>Watercrossing Structure W24 Type: Stream, 1st Order Fisheries: Class 3, Sub-optimal Fisheries Location/Townland: R503, Lackamore</p> <p>Existing Structure: Concrete Circular Culvert Works at the Crossing: Cable trenching over structure.</p> <p>Ecology Notes: No Fisheries Potential</p>

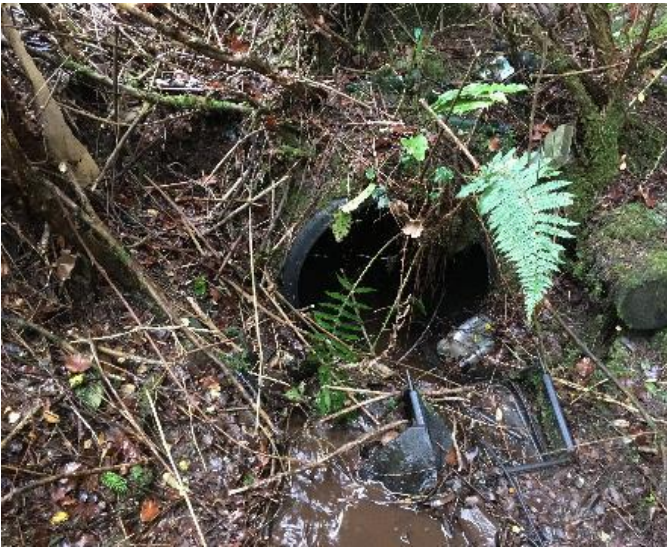
<p>Watercrossing Structure W25</p> <p>Type: Stream, 1st Order</p> <p>Fisheries: Class 3, Sub-optimal Fisheries</p> <p>Location/Townland: R503, Lackamore</p> <p>Existing Structure: Plastic Circular Culvert Works at the Crossing: Cable trenching over structure.</p> <p>Ecology Notes: No Fisheries Potential, Steep Gradient</p>

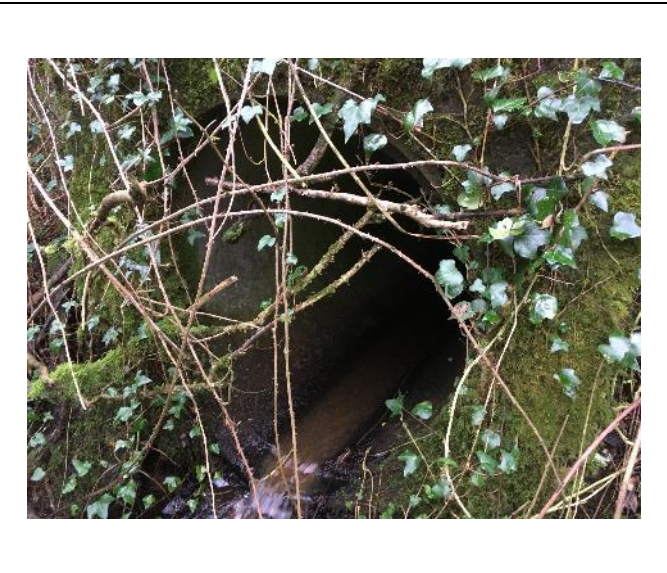
<p>Watercrossing Structure W26</p> <p>Type: Stream, 1st Order</p> <p>Fisheries: Class 3, Sub-optimal Fisheries</p> <p>Location/Townland: R503, Lackamore</p> <p>Existing Structure: Concrete Circular Culvert Works at the Crossing: Cable trenching over structure.</p> <p>Ecology Notes: No Fisheries Potential, Steep Gradient</p>

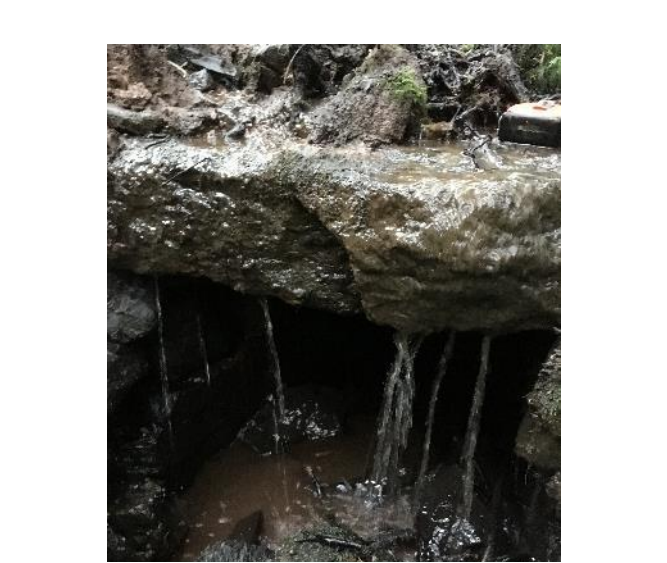
<p>Watercrossing Structure W27</p> <p>Type: Stream, 1st Order</p> <p>Fisheries: Class 3, Sub-optimal Fisheries</p> <p>Location/Townland: R503, Lackamore</p> <p>Existing Structure: Masonry Box Culvert Works at the Crossing: Cable trenching over structure.</p> <p>Ecology Notes: No Fisheries Potential, Steep Gradient</p>

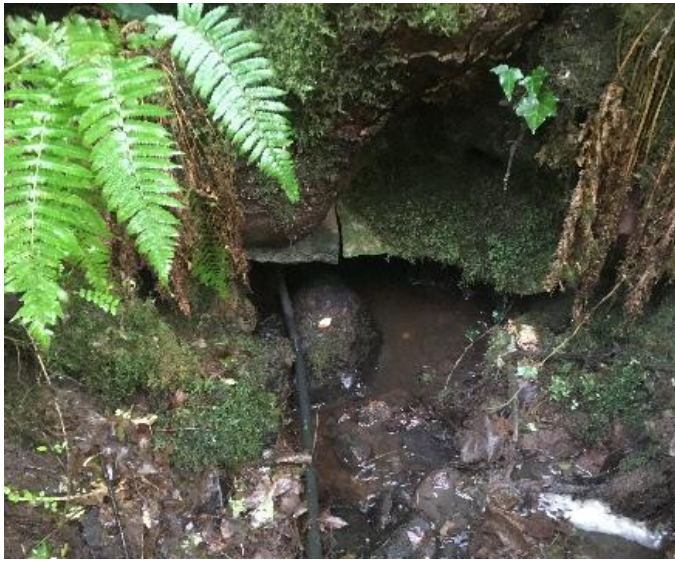
<p>Watercrossing Structure W31</p> <p>Type: Stream, 1st Order</p> <p>Fisheries: Class 3, Sub-optimal Fisheries</p> <p>Location/Townland: R503, Tooreenbrien Upper</p> <p>Existing Structure: Concrete Circular Culvert</p> <p>Works at the Crossing: Crossing under new existing culvert</p> <p>Ecology Notes: No Fisheries Value, Steep Gradient</p>

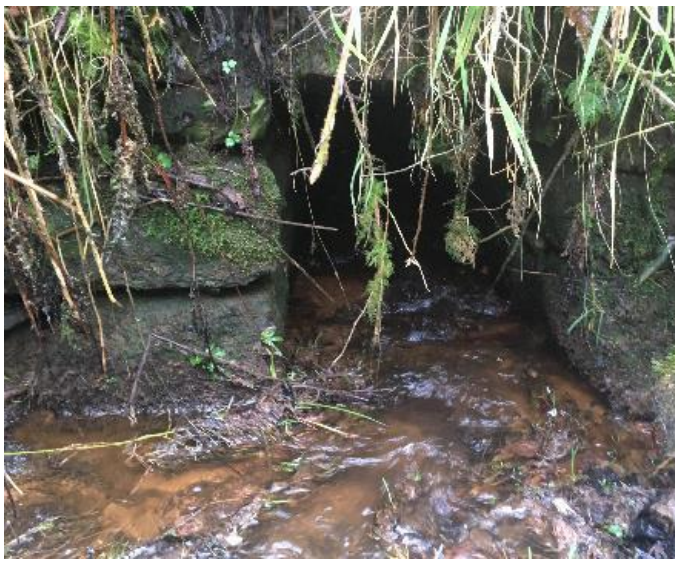
<p>Watercrossing Structure W32</p> <p>Type: Minor Stream</p> <p>Fisheries: Class 3, Sub-optimal Fisheries</p> <p>Location/Townland: R503, Tooreenbrien Upper</p> <p>Existing Structure: Masonry Box Culvert</p> <p>Works at the Crossing: Cable trenching under structure. Culvert may need replacing.</p> <p>Ecology Notes: No Fisheries Value</p>

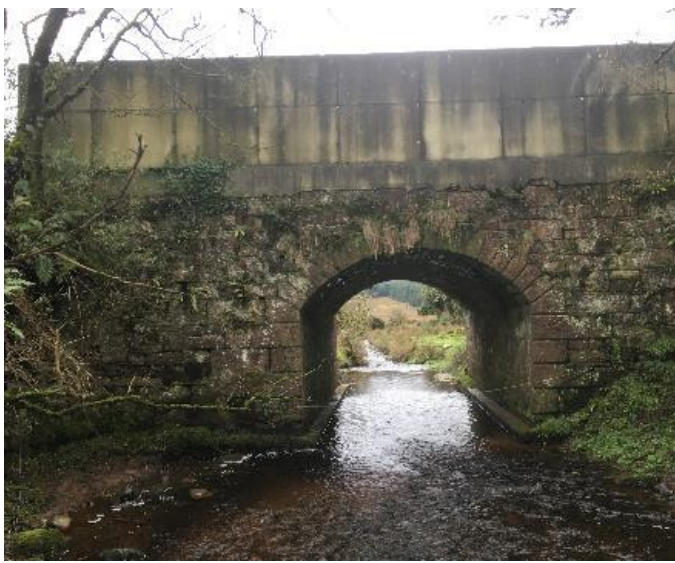
<p>Watercrossing Structure W33</p> <p>Type: Stream</p> <p>Fisheries: Class1, Optimal Fisheries</p> <p>Location/Townland: R503, Tooreenbrien Upper/Tooreenbrien Lower</p> <p>Existing Structure: Masonry Arch Bridge - Single</p> <p>Works at the Crossing: Cable trenching over structure.</p> <p>Ecology Notes: cobble substrate, drained, channelised, riffle/glide</p>

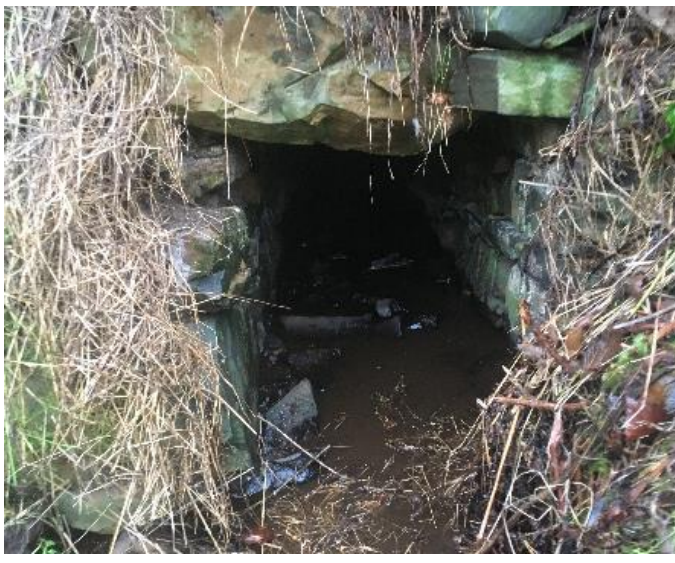
<p>Watercrossing Structure W34</p> <p>Type: Drain</p> <p>Fisheries: Class 4, Poor Fisheries</p> <p>Location/Townland: R503, Tooreenbrien Lower</p> <p>Existing Structure: Masonry Box Culvert</p> <p>Works at the Crossing: Cable trenching under structure. Culvert may need replacing.</p> <p>Ecology Notes: No Fisheries Value</p>

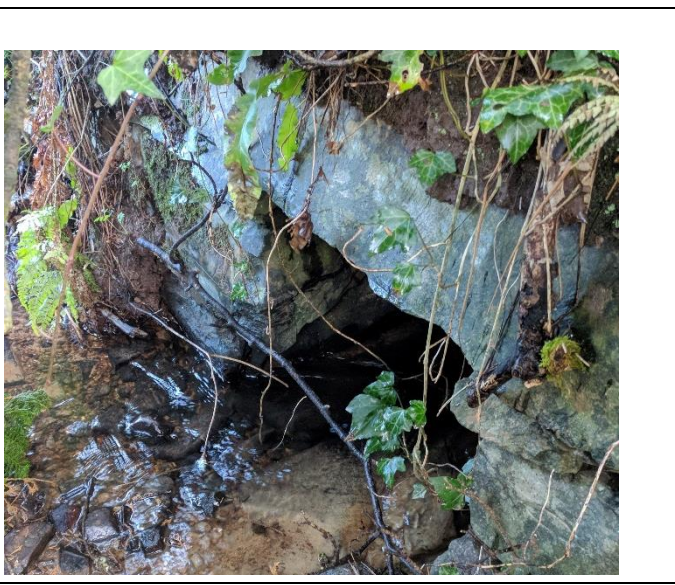
<p>Watercrossing Structure W35</p> <p>Type: Drain</p> <p>Fisheries: Class 4, Poor Fisheries</p> <p>Location/Townland: R503, Tooreenbrien Lower</p> <p>Existing Structure: Masonry Box Culvert</p> <p>Works at the Crossing: Cable trenching over structure.</p> <p>Ecology Notes: No Fisheries Value</p>

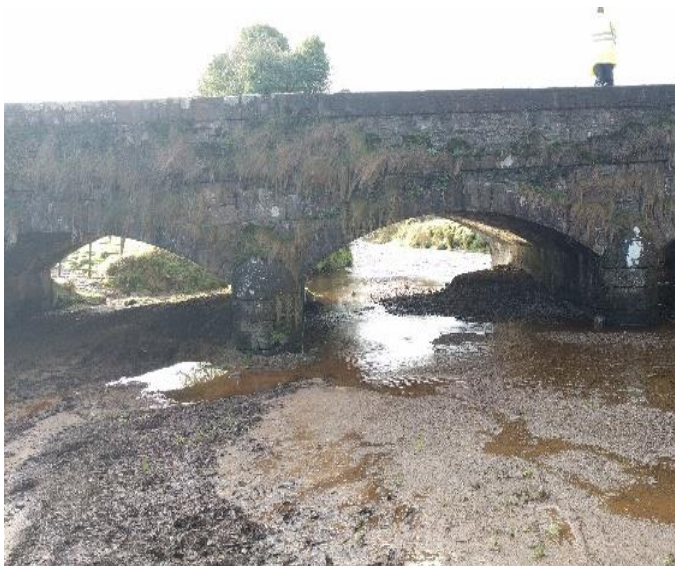
<p>Watercrossing Structure W36</p> <p>Type: River</p> <p>Fisheries: Class1, Optimal Fisheries</p> <p>Location/Townland: Tooreenbrien Bridge, R503, Tooreenbrien Lower/Reardnogy Beg</p> <p>Existing Structure: Masonry Arch Bridge - Double</p> <p>Works at the Crossing: Cable trenching over structure. Additional works to raise road level & parapet wall height</p> <p>Ecology Notes: c. 5 m wide, c. 100cm deep</p>

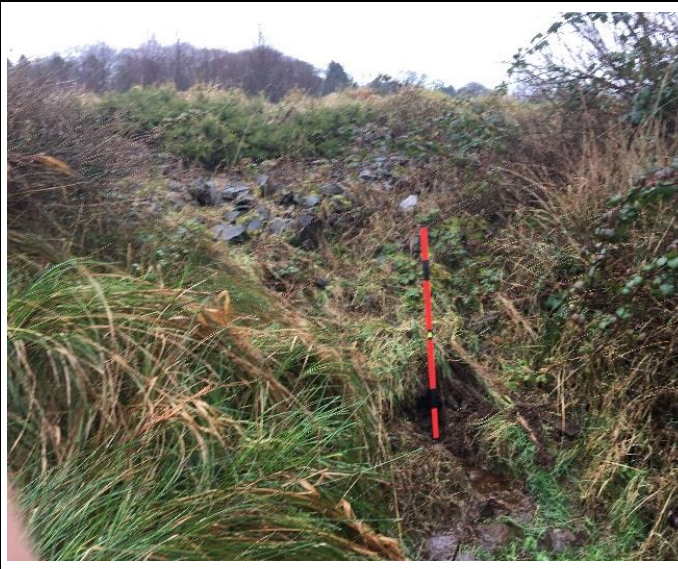
<p>Watercrossing Structure W37</p> <p>Type: Stream, 1st Order</p> <p>Fisheries: Class 3, Sub-optimal Fisheries</p> <p>Location/Townland: R503, Reardnogy Beg</p> <p>Existing Structure: Masonry Arch</p> <p>Works at the Crossing: Crossing over culvert</p> <p>Ecology Notes: No Fisheries Value</p>

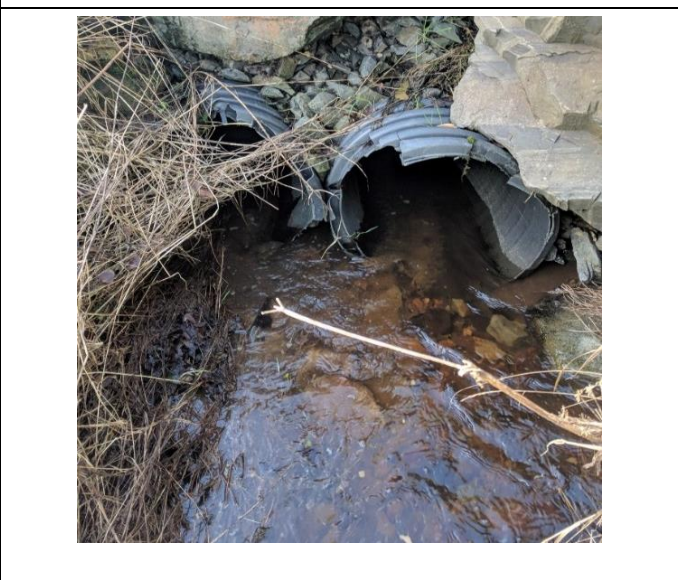
<p>Watercrossing Structure W38</p> <p>Type: Stream, 1st Order</p> <p>Fisheries: Class1, Optimal Fisheries</p> <p>Location/Townland: R503, Reardnogy Beg/Reardnogy More</p> <p>Existing Structure: Plastic Circular Culvert</p> <p>Works at the Crossing: Cable trenching under structure.</p> <p>Ecology Notes: c. 0.7 m wide, c. 140cm deep</p>

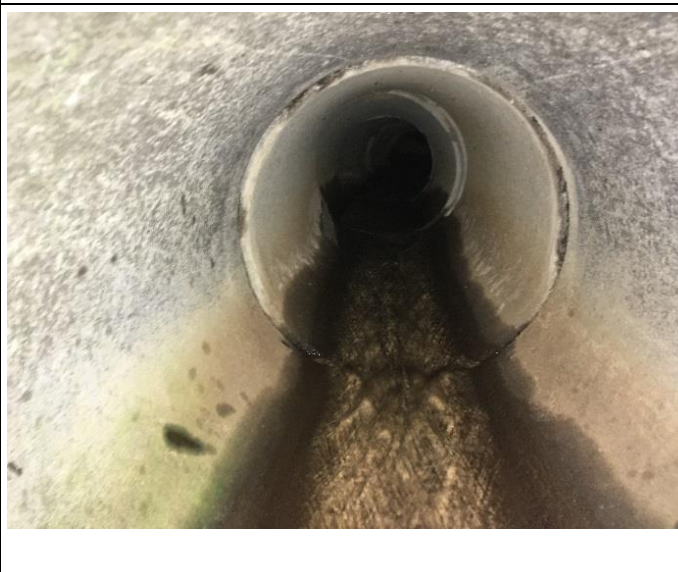
<p>Watercrossing Structure W39</p> <p>Type: Stream, 2nd Order</p> <p>Fisheries: Class1, Optimal Fisheries</p> <p>Location/Townland: R503, Reardnogy More</p> <p>Existing Structure: Plastic Circular Culvert</p> <p>Works at the Crossing: Cable trenching over structure.</p> <p>Ecology Notes: c. 0.6 m wide, c. 100cm deep</p>

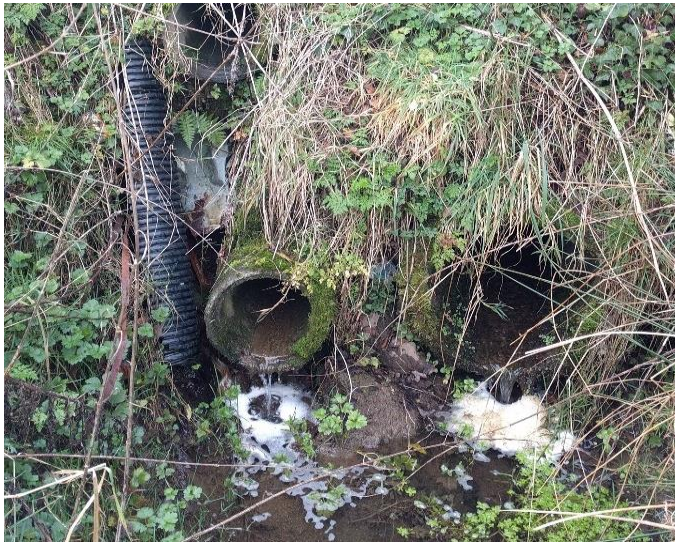
<p>Watercrossing Structure W40</p> <p>Type: Drain</p> <p>Fisheries: Class 4, Poor Fisheries</p> <p>Location/Townland: R503, Rear Cross Village, Reardnogy More/ Shanballyedmond</p> <p>Existing Structure: Concrete Circular Culvert X 3</p> <p>Works at the Crossing: Cable trenching under structures.</p> <p>Ecology Notes: No Fisheries Value</p>

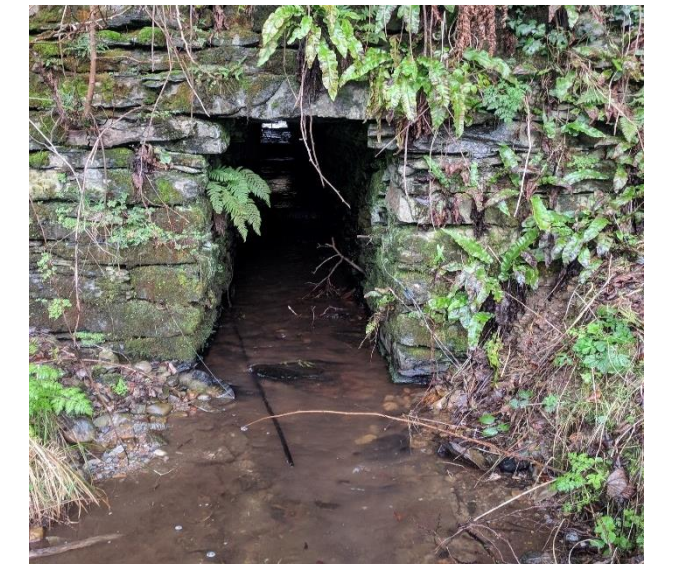
<p>Watercrossing Structure W41</p> <p>Type: Stream, 1st Order</p> <p>Fisheries: Class 3, Sub-optimal Fisheries</p> <p>Location/Townland: R503, Reardnogy More/Baurnadomeeny</p> <p>Existing Structure: Masonry Box Culvert</p> <p>Works at the Crossing: Cable trenching over structure.</p> <p>Ecology Notes: Downstream:, cobble gravel substrate, riffle, steep banks</p>

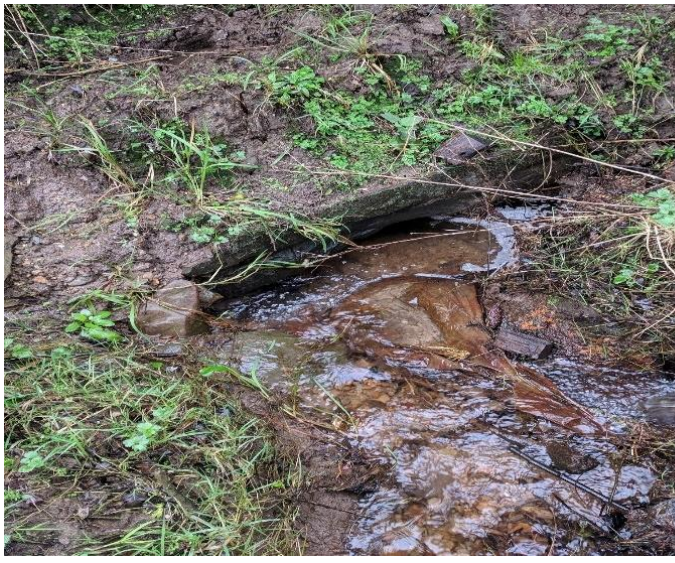
<p>Watercrossing Structure W42</p> <p>Type: Stream, 1st Order</p> <p>Fisheries: Class 3, Sub-optimal Fisheries</p> <p>Location/Townland: R503, Baurnadomeeny</p> <p>Existing Structure: Masonry Box Culvert</p> <p>Works at the Crossing: Cable trenching over structure.</p> <p>Ecology Notes: No Fisheries Potential</p>

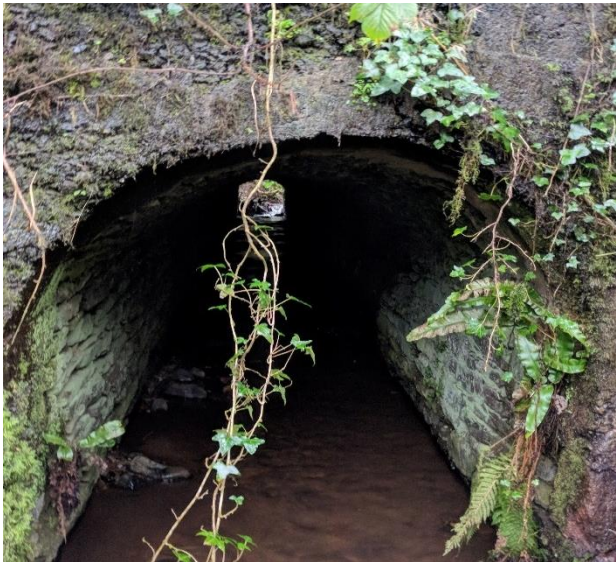
<p>Watercrossing Structure W43</p> <p>Type: Stream, 1st Order</p> <p>Fisheries: Class 3, Sub-optimal Fisheries</p> <p>Location/Townland: R503, Bournadomeeny</p> <p>Existing Structure: Masonry Arch</p> <p>Works at the Crossing: Cable trenching over structure.</p> <p>Ecology Notes: cobble gravel substrate, riffle, steep banks</p>

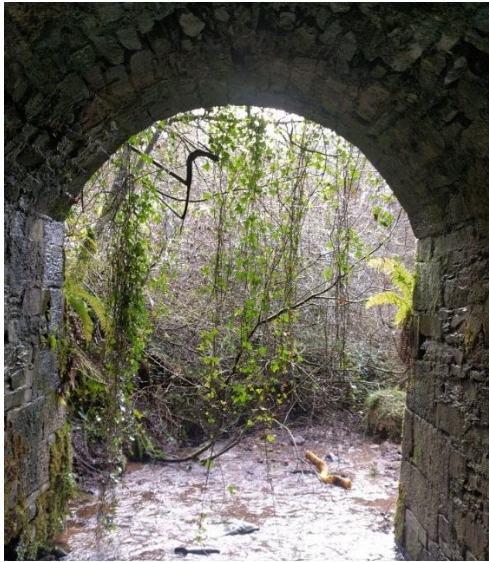
<p>Watercrossing Structure W44</p> <p>Type: Stream, 1st Order</p> <p>Fisheries: Class 3, Sub-optimal Fisheries</p> <p>Location/Townland: R503, Bournadomeeny</p> <p>Existing Structure: Masonry Arch</p> <p>Works at the Crossing: Cable trenching over structure.</p> <p>Ecology Notes: cobble gravel substrate, riffle, steep banks</p>

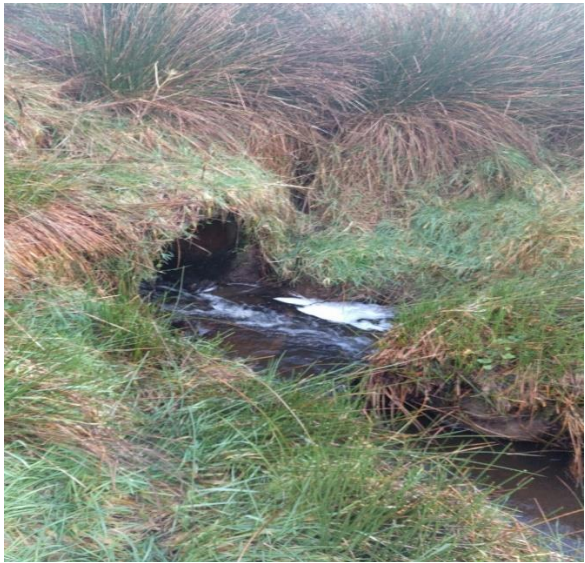
<p>Watercrossing Structure W45</p> <p>Type: Stream, 1st Order</p> <p>Fisheries: Class1, Optimal Fisheries</p> <p>Location/Townland: R503, Bournadomeeny/Coonmore</p> <p>Existing Structure: Concrete Circular Culvert</p> <p>Works at the Crossing: Cable trenching over structure.</p> <p>Ecology Notes: Riffle / glide, cobble substrate, channelised</p>

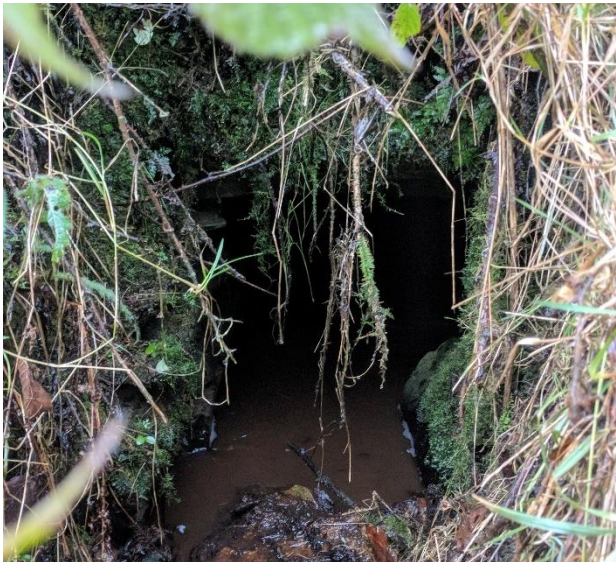
<p>Watercrossing Structure W46</p> <p>Type: Drain</p> <p>Fisheries: Class 4, Poor Fisheries</p> <p>Location/Townland: R503, Coonmore</p> <p>Existing Structure: Masonry Box Culvert Works at the Crossing: Cable trenching over structure.</p> <p>Ecology Notes: No Fisheries Value</p>

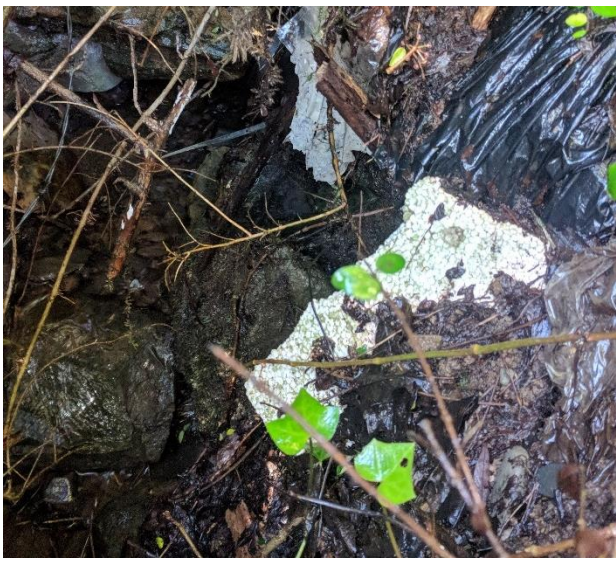
<p>Watercrossing Structure W47</p> <p>Type: Drain</p> <p>Fisheries: Class 4, Poor Fisheries</p> <p>Location/Townland: R503, Coonmore</p> <p>Existing Structure: Masonry Box Culvert Works at the Crossing: Cable trenching over structure.</p> <p>Ecology Notes: No Fisheries Value</p>

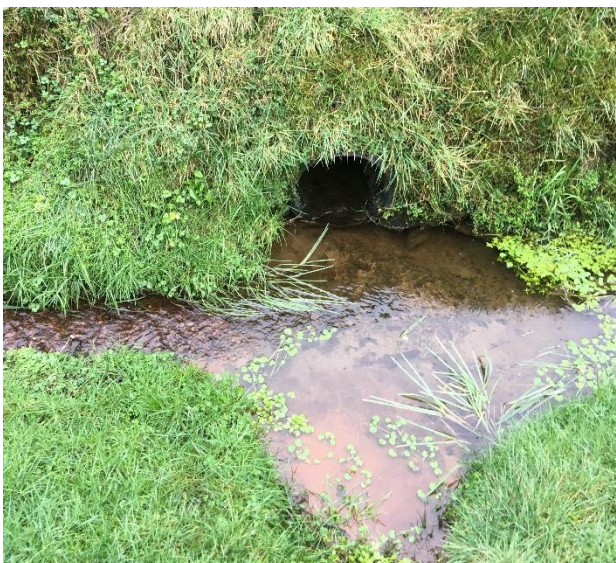
<p>Watercrossing Structure W48</p> <p>Type: Drain</p> <p>Fisheries: Class 4, Poor Fisheries</p> <p>Location/Townland: R503, Coonmore</p> <p>Existing Structure: Plastic Circular Culvert Works at the Crossing: Cable trenching over structure.</p> <p>Ecology Notes: No Fisheries Value</p>

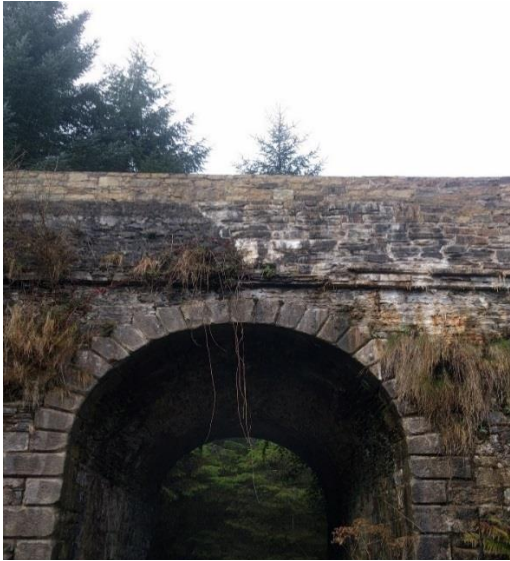
<p>Watercrossing Structure W49</p> <p>Type: River</p> <p>Fisheries: Class1, Optimal Fisheries</p> <p>Location/Townland: R503, Coonmore/Foildarragh</p> <p>Existing Structure: Masonry Arch</p> <p>Works at the Crossing: Cable trenching over structure.</p> <p>Ecology Notes: Cobble/gravel, channelised, riffle</p>

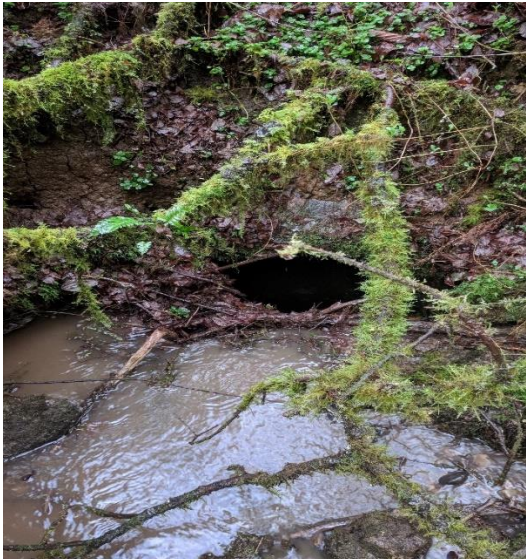
<p>Watercrossing Structure W50</p> <p>Type: Stream, 1st Order</p> <p>Fisheries: Class 3, Sub-optimal Fisheries</p> <p>Location/Townland: R503, Foildarragh</p> <p>Existing Structure: Masonry Box Culvert</p> <p>Works at the Crossing: Cable trenching over structure.</p> <p>Ecology Notes: No Fisheries Value, Very steep gradient, in gorge, 100% cover.</p>

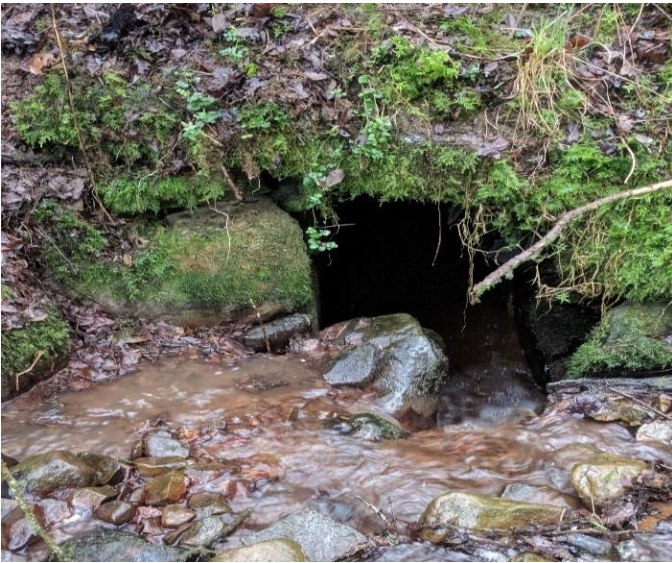
<p>Watercrossing Structure W51</p> <p>Type: Stream, 1st Order</p> <p>Fisheries: Class 3, Sub-optimal Fisheries</p> <p>Location/Townland: R503, Foildarragh</p> <p>Existing Structure: Masonry Box Culvert</p> <p>Works at the Crossing: Cable trenching over structure.</p> <p>Ecology Notes: No Fisheries Value, Very steep gradient, in gorge, 100% cover.</p>

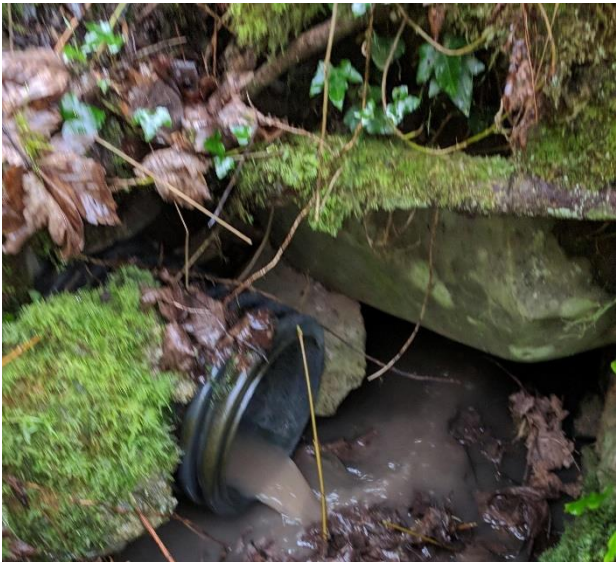
<p>Watercrossing Structure W52</p> <p>Type: Stream, 1st Order</p> <p>Fisheries: Class 3, Sub-optimal Fisheries</p> <p>Location/Townland: R503, Foildarragh</p> <p>Existing Structure: Masonry Box Culvert</p> <p>Works at the Crossing: Cable trenching under structure.</p> <p>Ecology Notes: No Fisheries Value, steep, drained</p>

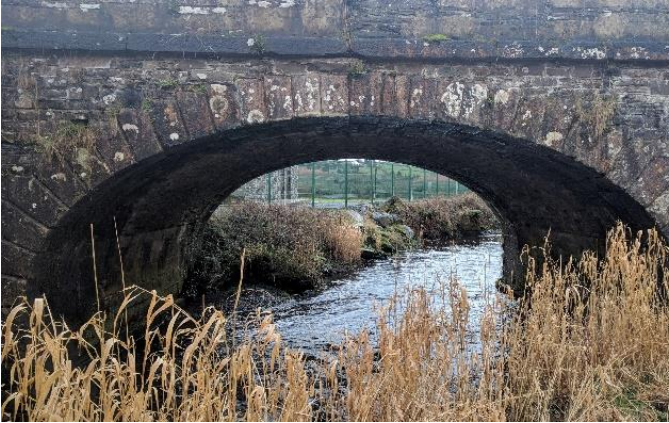
<p>Watercrossing Structure W53</p> <p>Type: River</p> <p>Fisheries: Class1, Optimal Fisheries</p> <p>Location/Townland: Anglesey Bridge, R503, Foildarragh/Kilcommon</p> <p>Existing Structure: Double Masonry Arch</p> <p>Works at the Crossing: Cable trenching over structure, additional works to raise road level & parapet wall height</p> <p>Ecology Notes: U/s: riffle, glide channelized, cobble gravel, sand</p>

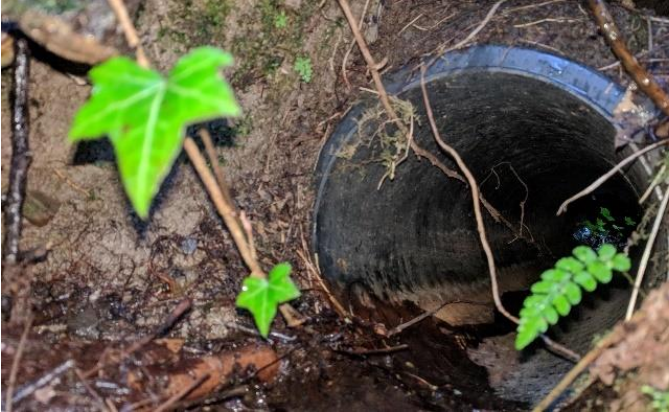
<p>Watercrossing Structure W54</p> <p>Type: Drain</p> <p>Fisheries: Class 4, Poor Fisheries</p> <p>Location/Townland: R503, Kilcommon</p> <p>Existing Structure: Plastic Circular Culvert</p> <p>Works at the Crossing: Cable trenching under structure.</p> <p>Ecology Notes: No Fisheries Value</p>

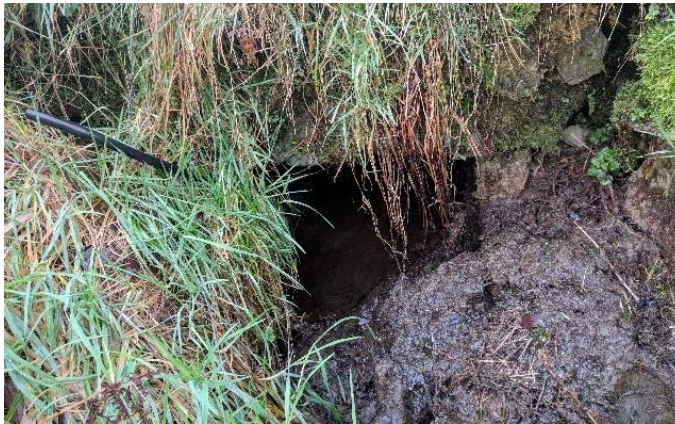
<p>Watercrossing Structure W55</p> <p>Type: Drain</p> <p>Fisheries: Class 4, Poor Fisheries</p> <p>Location/Townland: R503, Kilcommon</p> <p>Existing Structure: Masonry Box Culvert</p> <p>Works at the Crossing: Cable trenching under structure. Culvert may need replacing.</p> <p>Ecology Notes: No Fisheries Value</p>
