Appendix to Chapter 15: Material Assets (Roads)

Appendix 15.6: Inventory & Classification of Watercourses at Crossing Locations

Photos of UWF GRID CONNECTION Bridges / Culverts along Public Roads

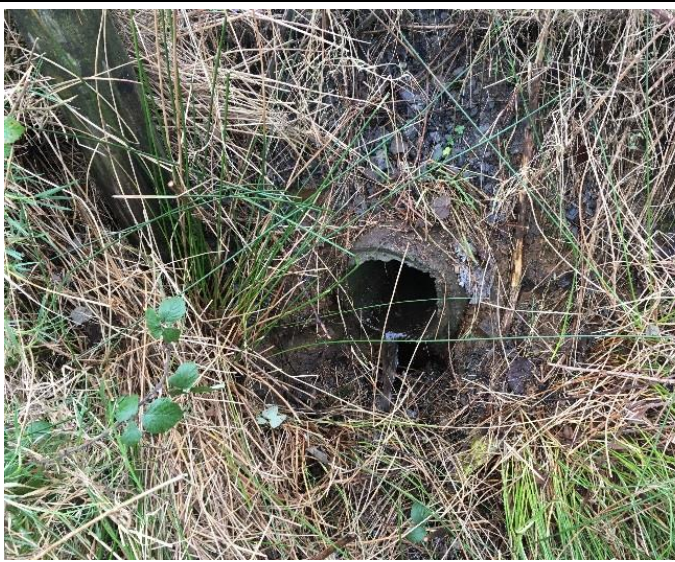
<p>Watercrossing Structure W56</p> <p>Type: Drain</p> <p>Fisheries: Class 3, Sub-optimal Fisheries</p> <p>Location/Townland: R503, Kilcommon</p> <p>Existing Structure: Concrete Circular Culvert</p> <p>Works at the Crossing: Cable trenching over structure.</p> <p>Ecology Notes: No Fisheries Value, some flow</p>

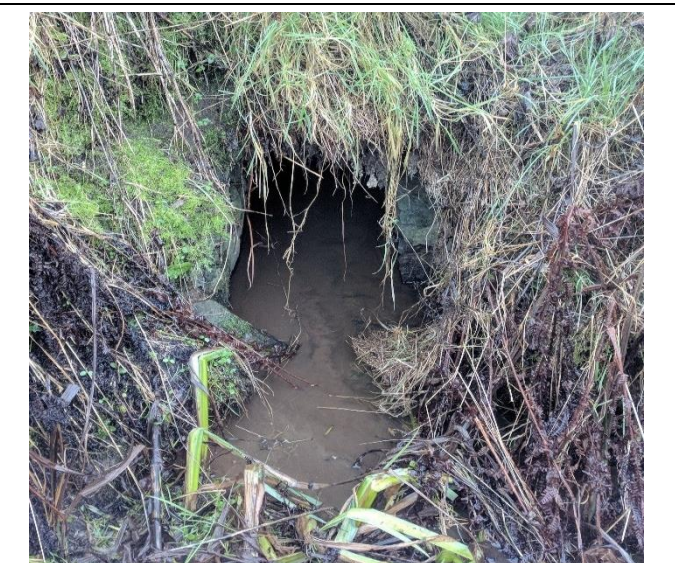
<p>Watercrossing Structure W57</p> <p>Type: Drain</p> <p>Fisheries: Class 4, Poor Fisheries</p> <p>Location/Townland: R503, Kilcommon/Loughbrack</p> <p>Existing Structure: Masonry Box Culvert</p> <p>Works at the Crossing: Cable trenching under structure. Culvert may need replacing.</p> <p>Ecology Notes: No Fisheries Value</p>

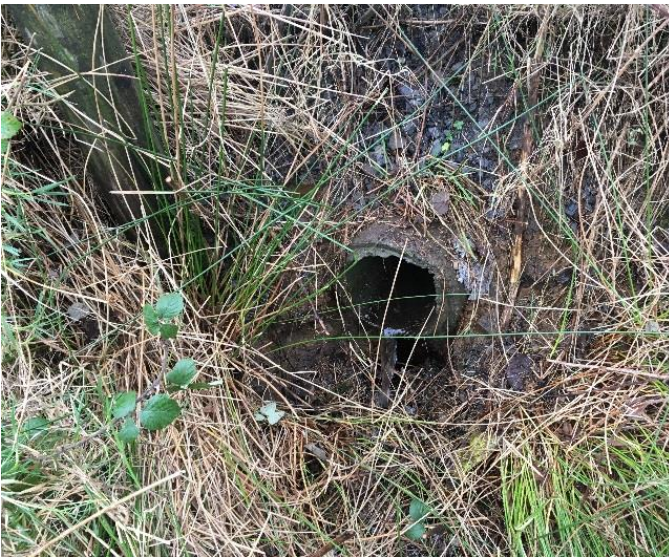
<p>Watercrossing Structure W58</p> <p>Type: Drain</p> <p>Fisheries: Class 4, Poor Fisheries</p> <p>Location/Townland: R503, Loughbrack</p> <p>Existing Structure: Concrete Circular Culvert</p> <p>Works at the Crossing: Cable trenching under structure.</p> <p>Ecology Notes: No Fisheries Value</p>

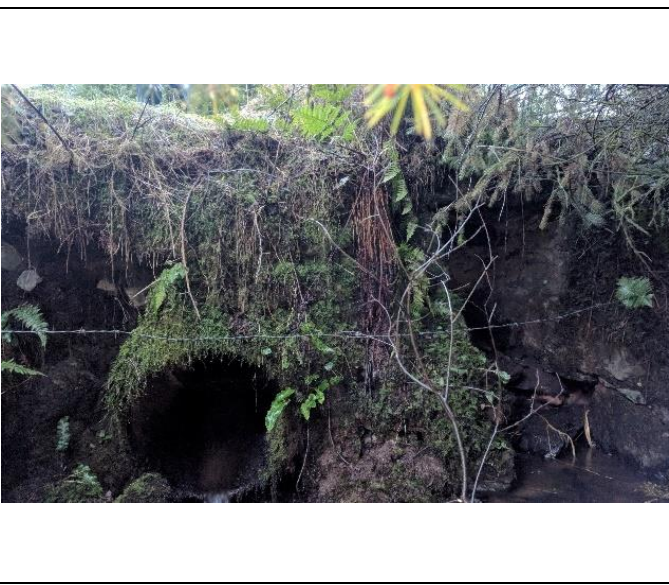
<p>Watercrossing Structure W59</p> <p>Type: Upstream: Drain, Downstream: Stream, 1st Order</p> <p>Fisheries: Class 4, Poor Fisheries</p> <p>Location/Townland: R503, Loughbrack</p> <p>Existing Structure: Concrete Culvert & Masonry Box Culvert</p> <p>Works at the Crossing: Cable trenching under structures.</p> <p>Ecology Notes: No Fisheries Value. Downstream: flow, through forestry</p>

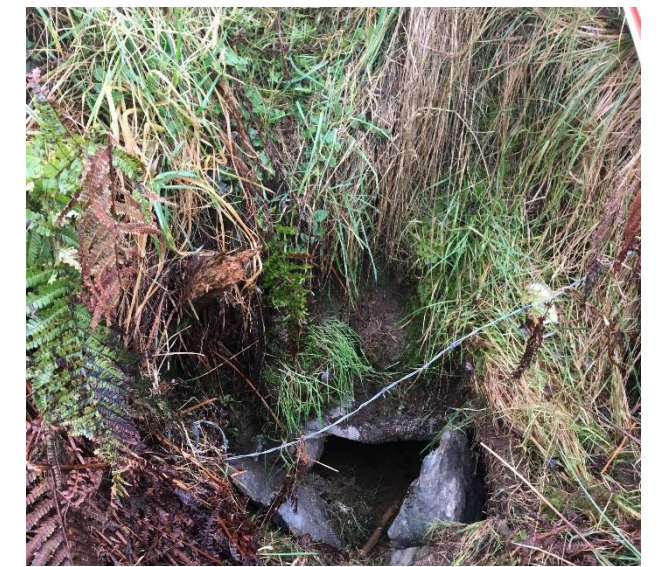
<p>Watercrossing Structure W60</p> <p>Type: Drain</p> <p>Fisheries: Class 4, Poor Fisheries</p> <p>Location/Townland: R503, Loughbrack</p> <p>Existing Structure: Masonry Box Culvert</p> <p>Works at the Crossing: Cable trenching under structure. Culvert may need replacing.</p> <p>Ecology Notes: No Fisheries Value</p>

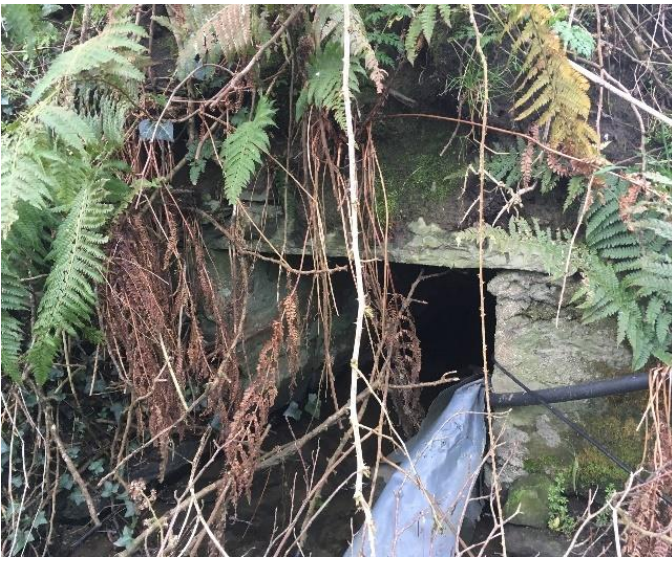
<p>Watercrossing Structure W61</p> <p>Type: Drain</p> <p>Fisheries: Class 4, Poor Fisheries</p> <p>Location/Townland: R503, Knocknabansha/Knockmaroe</p> <p>Existing Structure: Masonry Box Culvert Works at the Crossing: Cable trenching under structure. Culvert may need replacing.</p> <p>Ecology Notes: No Fisheries Value</p>

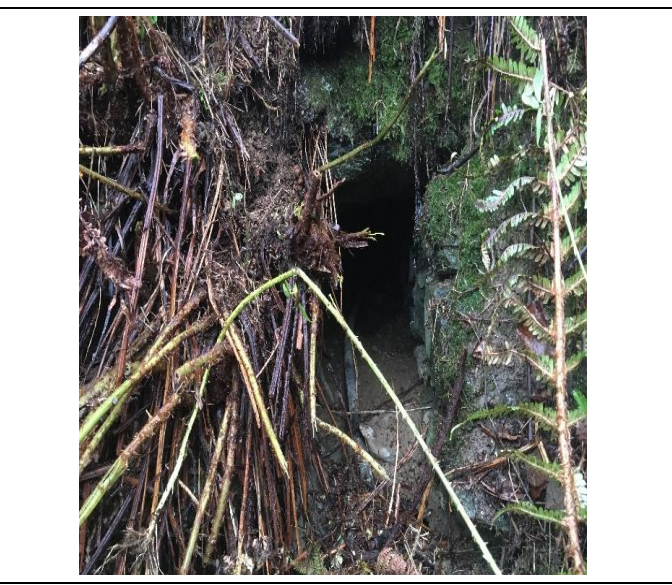
<p>Watercrossing Structure W62</p> <p>Type: Drain</p> <p>Fisheries: Class 4, Poor Fisheries</p> <p>Location/Townland: L2264-50, Knockmaroe</p> <p>Existing Structure: Masonry Box Culvert Works at the Crossing: Cable trenching over structure.</p> <p>Ecology Notes: No Fisheries Value</p>

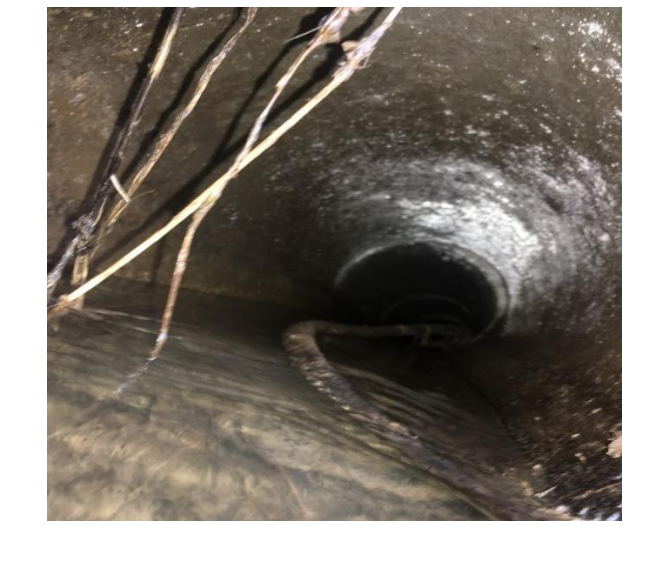
<p>Watercrossing Structure W63</p> <p>Type: Drain</p> <p>Fisheries: Class 4, Poor Fisheries</p> <p>Location/Townland: L2264-50, Knockmaroe/Knockcurraghbola Crownlands</p> <p>Existing Structure: Circular Concrete Culvert Works at the Crossing: Cable trenching under structure.</p> <p>Ecology Notes: No Fisheries Value</p>

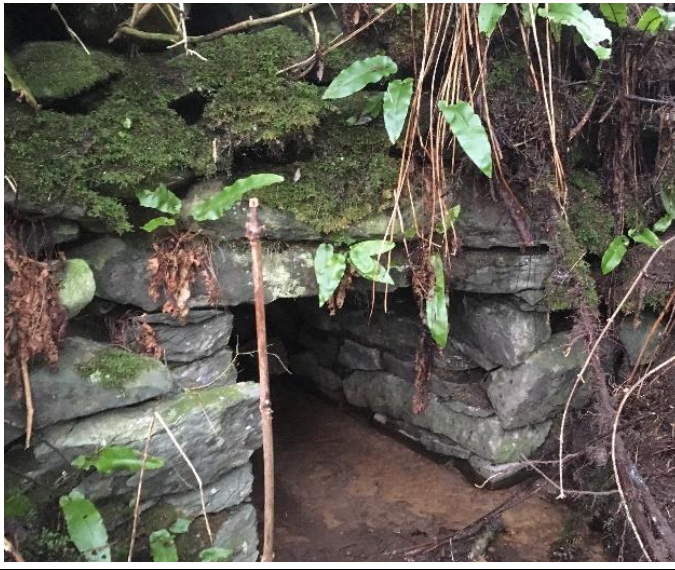
<p>Watercrossing Structure W64</p> <p>Type: Drain</p> <p>Fisheries: Class 4, Poor Fisheries</p> <p>Location/Townland: L2264-50, Knockmaroe</p> <p>Existing Structure: Masonry Box Culvert Works at the Crossing: Cable trenching under structure. Culvert may need replacing.</p> <p>Ecology Notes: No Fisheries Value</p>

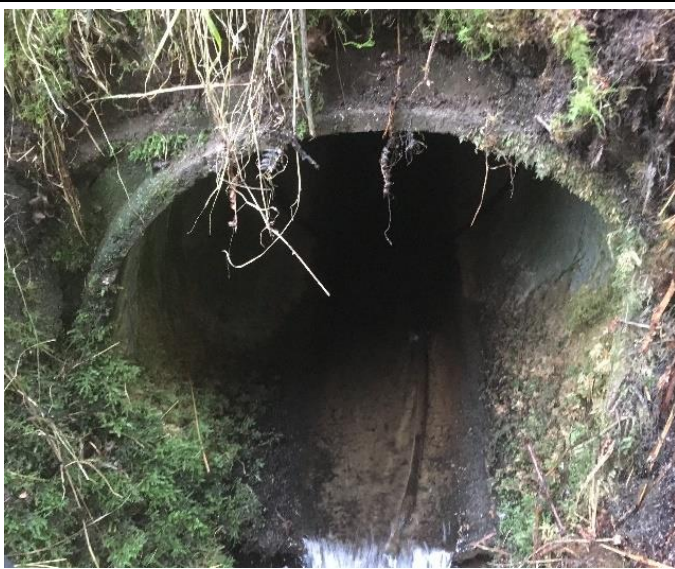
<p>Watercrossing Structure W65</p> <p>Type: Stream</p> <p>Fisheries: Class 2, Optimal Fisheries</p> <p>Location: L6188-0, Knockmaroe</p> <p>Existing Structure: Concrete Circular Culvert Works at Crossing: Cable trenching under structure.</p> <p>Ecology Notes: Steady flow to 20 cm deep with wetted width of c. 1 m. gravel bed.</p>

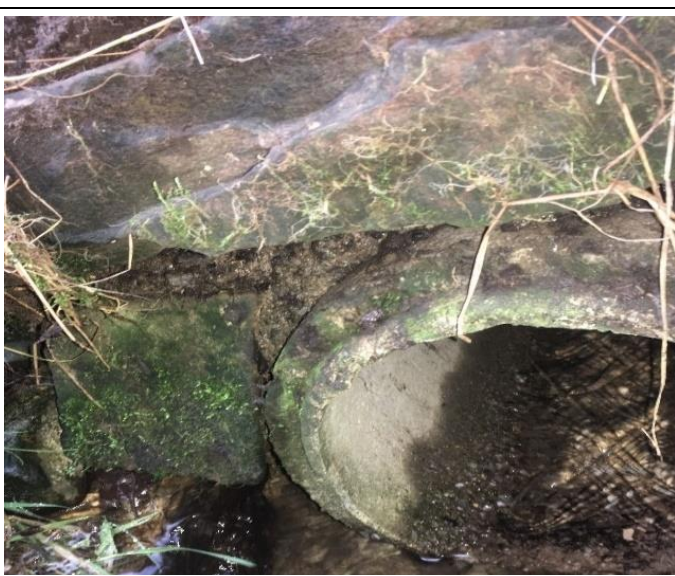
<p>Watercrossing Structure W66</p> <p>Type: Drain</p> <p>Fisheries: Class 4, Poor Fisheries</p> <p>Location/Townland: L6188-0, Knockmaroe</p> <p>Existing Structure: Concrete Circular Culvert Works at the Crossing: Cable trenching under structure.</p> <p>Ecology Notes: No Fisheries Value</p>
