Appendix to Chapter 5: Description of the Development – UWF Grid Connection

Appendix 5.2: Inventory & Classification of Watercourses at Crossing Locations

Photos of UWF GRID CONNECTION Bridges / Culverts along Public Roads

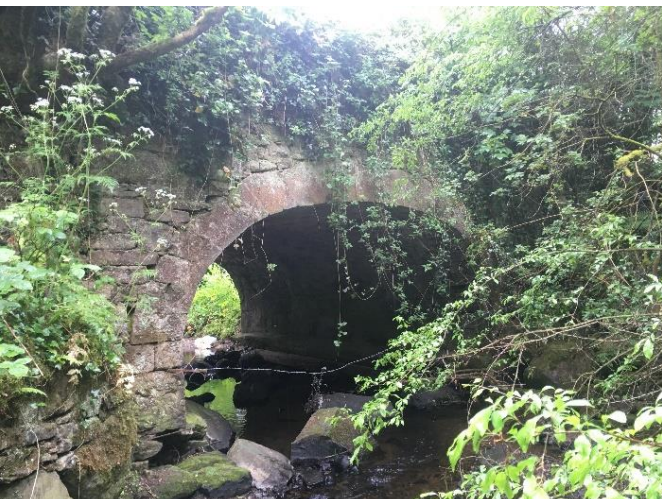
<p>Watercrossing Structure W5</p> <p>Type: River</p> <p>Fisheries: Class1, Optimal Fisheries</p> <p>Location/Townland: L6013-0, Foildarrig/Freagh</p> <p>Existing Structure: Masonry Single Arch Bridge</p> <p>Works at the Crossing: Cable trenching over structure</p> <p>Ecology Notes: Upstream - riffle/glide sequence and pool. Bolder (30), cobble (30), sand/gravel (40). Culvert pipe also flowing into river. Downstream - Riffle and pool present. Sand gravel under bridge (60), boulders/cobble(40).</p>

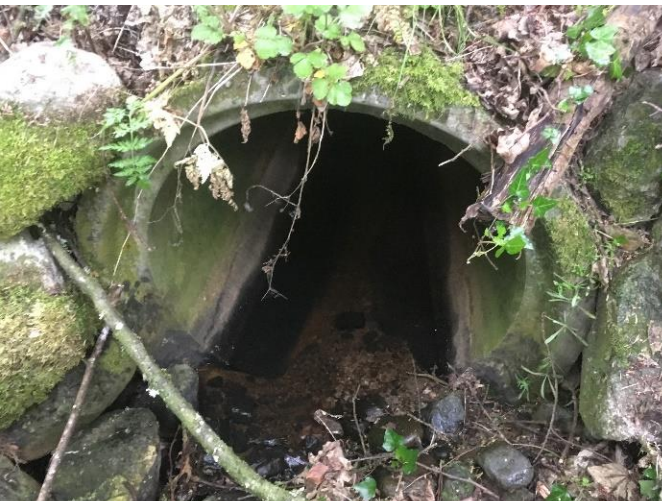
<p>Watercrossing Structure W6</p> <p>Type: Stream</p> <p>Fisheries: Class 3, Sub-Optimal Fisheries</p> <p>Location/Townland: L6013-0, Oakhampton</p> <p>Existing Structure: Concrete Circular Culvert</p> <p>Works at the Crossing: Cable trenching over structure</p> <p>Ecology Notes: Pipe culvert with stream through it. Bolder (50), mud/gravel (50).</p>

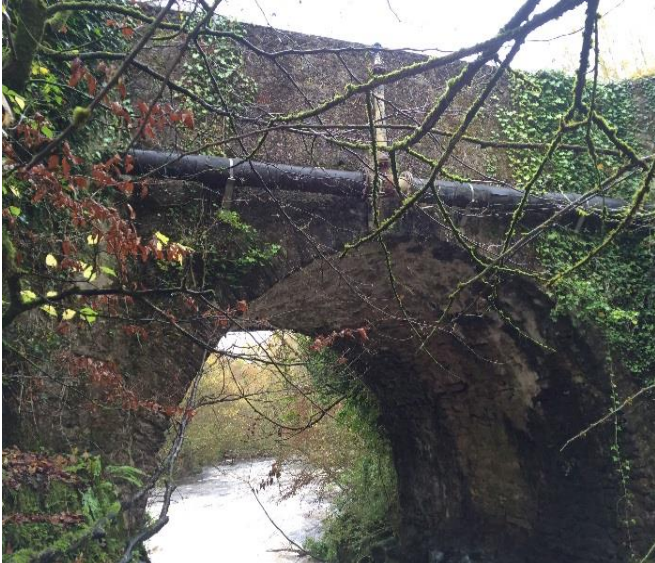
<p>Watercrossing Structure W7</p> <p>Type: River</p> <p>Fisheries: Class1, Optimal Fisheries</p> <p>Location/Townland: Rockvale Bridge, L2156-0, Oakhampton/Rockvale</p> <p>Existing Structure: Masonry Single Arch Bridge</p> <p>Works at the Crossing: Cable trenching over structure. Additional works to raise road level & parapet wall height</p> <p>Ecology Notes: Upstream - riffle and white water. Bedrock (70), cobble (20), sand (10). Deep water - could not judge depth. Downstream - white water, small riffle and some pooling. Deep water.</p>

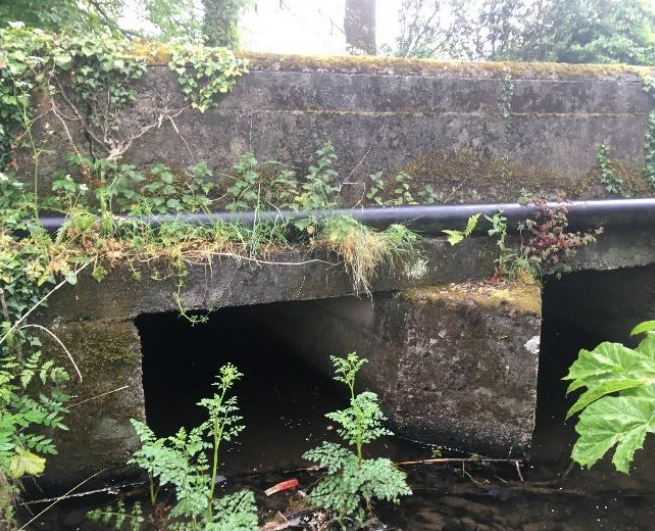
<p>Watercrossing Structure W8</p> <p>Type: Stream</p> <p>Fisheries: Class1, Optimal Fisheries</p> <p>Location/Townland: L6009-0, Ahane/Castlewaller</p> <p>Existing Structure: Concrete Slab Bridge</p> <p>Works at the Crossing: Directional Drill under stream bed.</p> <p>Ecology Notes: Upstream - small riffle and glide. Pooling. Moderate flow. Cobble (70), gravel (30). Downstream - riffle and glide, pool at bridge. Cobble (60), gravel (40).</p>

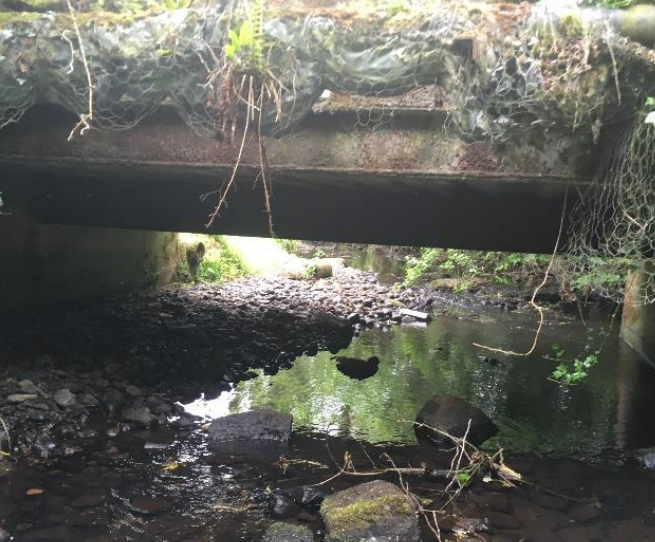
<p>Watercrossing Structure W9</p> <p>Type: Stream</p> <p>Fisheries: Class 1, Optimal Fisheries</p> <p>Location/Townland: L6009-0, Castlewaller/Carrowkeale</p> <p>Existing Structure: Concrete Slab Bridge</p> <p>Works at the Crossing: Directional Drill under stream bed.</p> <p>Ecology Notes: Upstream - riffle and glide and pool (with sand). Sand (30), cobble (50), gravel (20). Downstream - flat rock (40), boulders (30), cobble (30), riffle. Some pooling at edge, no visible build-up of sand. Fast flowing.</p>

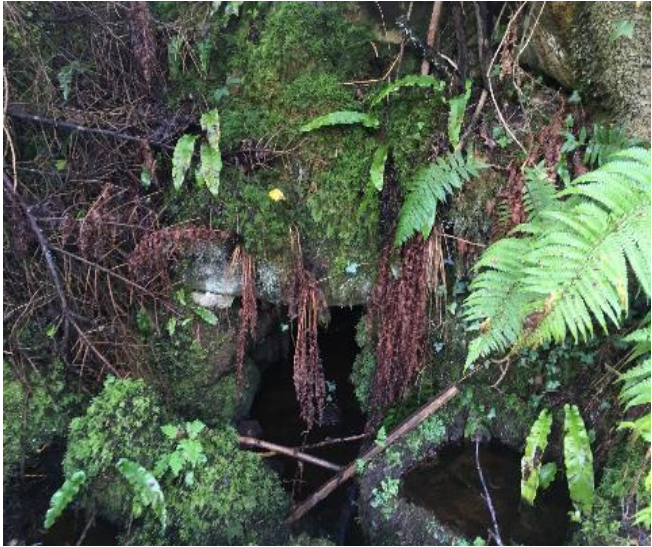
<p>Watercrossing Structure W13</p> <p>Type: Stream, 1st Order</p> <p>Fisheries: Class 4, Poor Fisheries</p> <p>Location/Townland: R503, Knockancullenagh</p> <p>Existing Structure: Masonry Box Culvert</p> <p>Works at the Crossing: Cable trenching under structure. Culvert may need replacing.</p> <p>Ecology Notes: No Fisheries Potential</p>

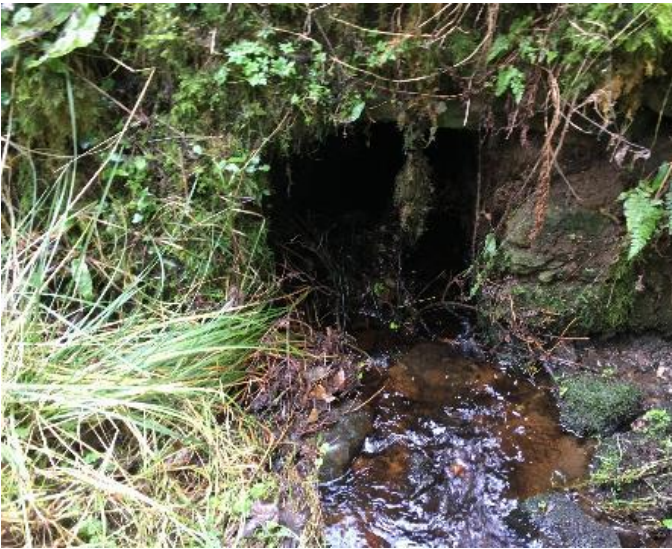
<p>Watercrossing Structure W14</p> <p>Type: Stream, 1st Order</p> <p>Fisheries: Class1, Optimal Fisheries</p> <p>Location/Townland: R503, Knockancullenagh</p> <p>Existing Structure: Masonry Box Culvert</p> <p>Works at the Crossing: Cable trenching under structure. Culvert may need replacing.</p> <p>Ecology Notes: steep gradient, cobble/gravel. 100% shade</p>

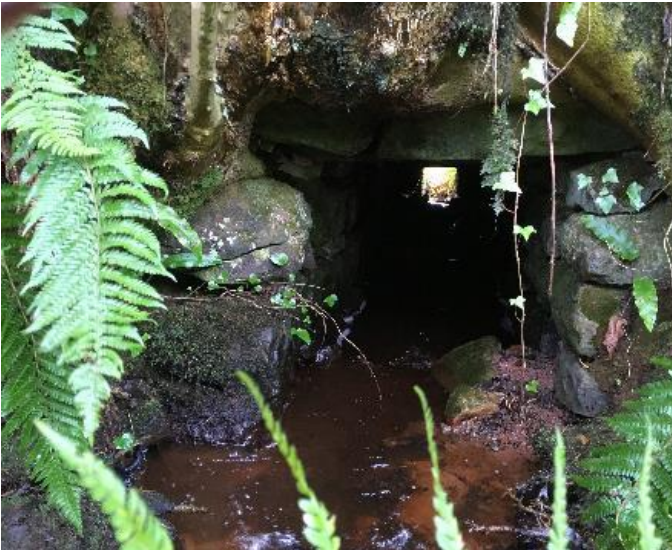
<p>Watercrossing Structure W15</p> <p>Type: Stream, 1st Order</p> <p>Fisheries: Class 3, Sub-optimal Fisheries</p> <p>Location/Townland: R503, Knockancullenagh</p> <p>Existing Structure: Masonry Box Culvert</p> <p>Works at the Crossing: Cable trenching under structure. Culvert may need replacing.</p> <p>Ecology Notes: No Fisheries Potential</p>

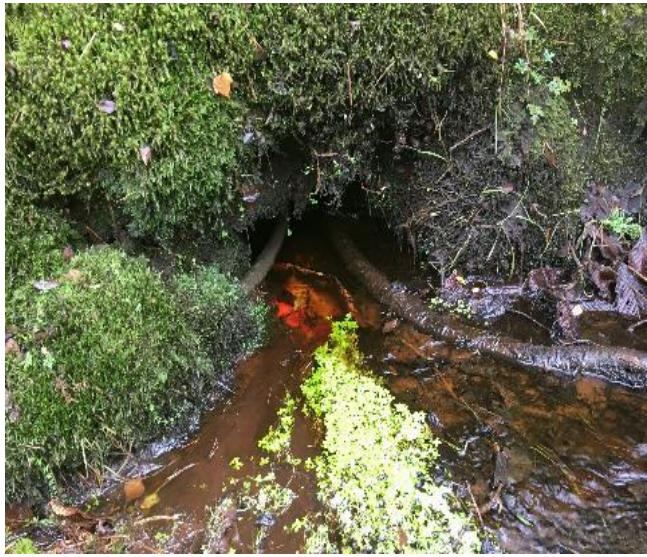
<p>Watercrossing Structure W19 Type: Drain Fisheries: Class 4, Poor Fisheries Location/Townland: R503, Fanit</p> <p>Existing Structure: Masonry Box Culvert</p> <p>Works at the Crossing: Cable trenching under structure. Culvert may need replacing.</p> <p>Ecology Notes: No Fisheries Potential</p>

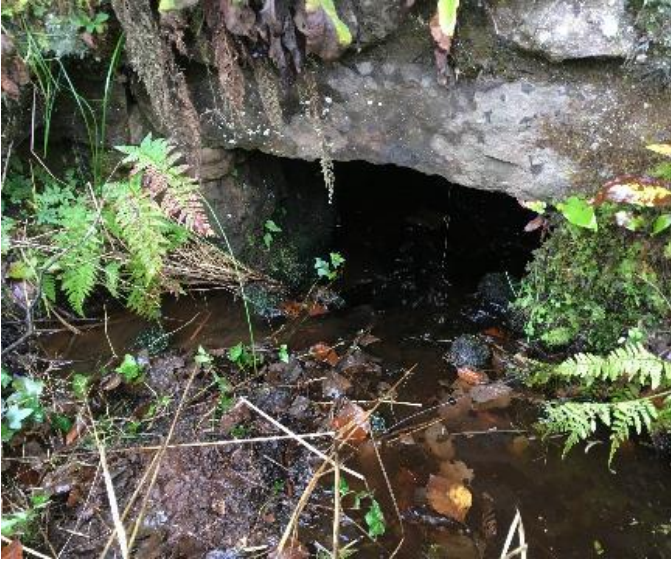
<p>Watercrossing Structure W20 Type: Drain Fisheries: Class 4, Poor Fisheries Location/Townland: R503, Fanit</p> <p>Existing Structure: Masonry Box Culvert</p> <p>Works at the Crossing: Cable trenching under structure. Culvert may need replacing.</p> <p>Ecology Notes: No Fisheries Potential 100% shade downstream</p>

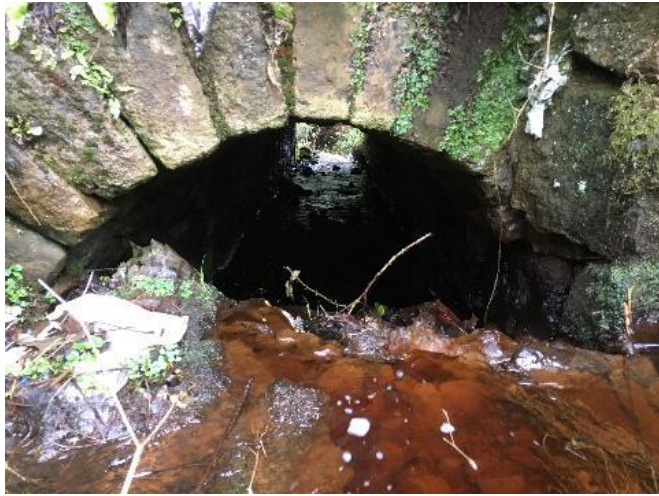
<p>Watercrossing Structure W21 Type: Stream, 1st Order Fisheries: Class 3, Sub-optimal Fisheries Location/Townland: R503, Fanit</p> <p>Existing Structure: Masonry Single Arch Bridge</p> <p>Works at the Crossing: Cable trenching over structure.</p> <p>Ecology Notes: No Fisheries Potential 100% shade downstream</p>

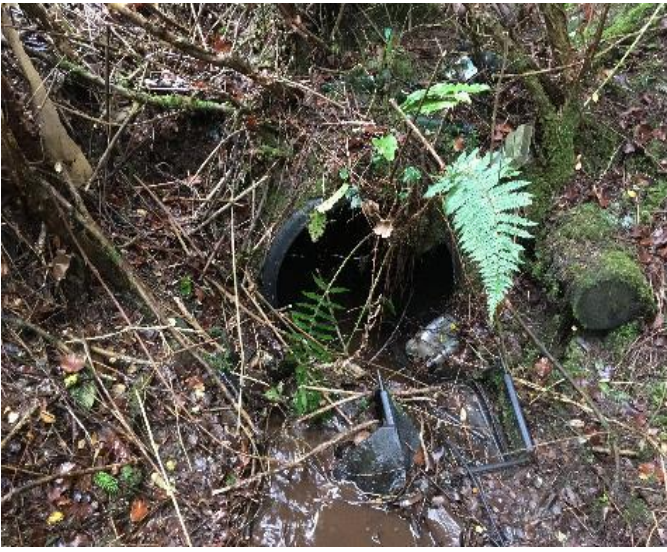
<p>Watercrossing Structure W25</p> <p>Type: Stream, 1st Order</p> <p>Fisheries: Class 3, Sub-optimal Fisheries</p> <p>Location/Townland: R503, Lackamore</p> <p>Existing Structure: Plastic Circular Culvert Works at the Crossing: Cable trenching over structure.</p> <p>Ecology Notes: No Fisheries Potential, Steep Gradient</p>

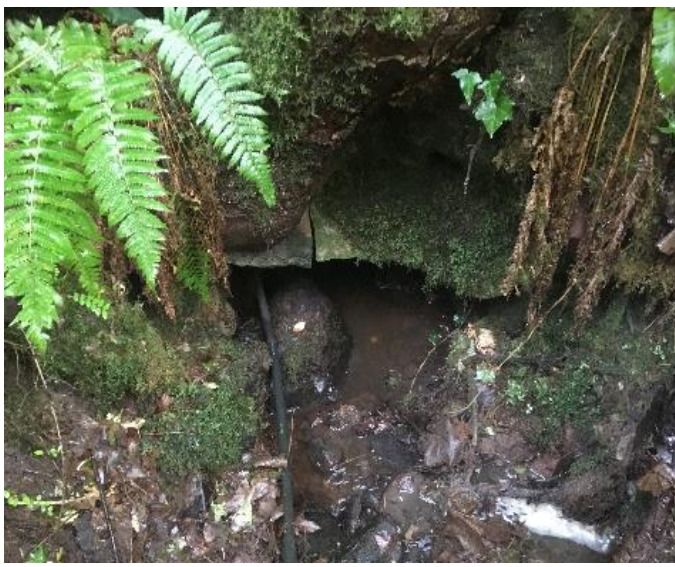
<p>Watercrossing Structure W31</p> <p>Type: Stream, 1st Order</p> <p>Fisheries: Class 3, Sub-optimal Fisheries</p> <p>Location/Townland: R503, Tooreenbrien Upper</p> <p>Existing Structure: Concrete Circular Culvert</p> <p>Works at the Crossing: Crossing under new existing culvert</p> <p>Ecology Notes: No Fisheries Value, Steep Gradient</p>

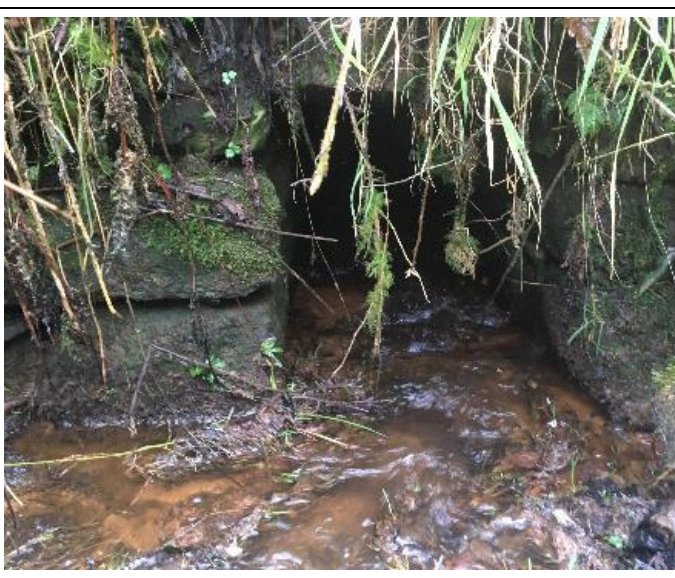
<p>Watercrossing Structure W32</p> <p>Type: Minor Stream</p> <p>Fisheries: Class 3, Sub-optimal Fisheries</p> <p>Location/Townland: R503, Tooreenbrien Upper</p> <p>Existing Structure: Masonry Box Culvert</p> <p>Works at the Crossing: Cable trenching under structure. Culvert may need replacing.</p> <p>Ecology Notes: No Fisheries Value</p>

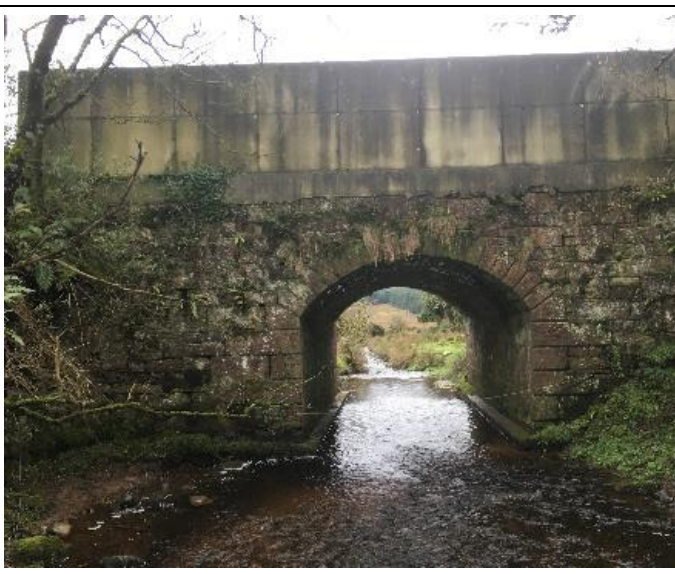
<p>Watercrossing Structure W33</p> <p>Type: Stream</p> <p>Fisheries: Class1, Optimal Fisheries</p> <p>Location/Townland: R503, Tooreenbrien Upper/Tooreenbrien Lower</p> <p>Existing Structure: Masonry Arch Bridge - Single</p> <p>Works at the Crossing: Cable trenching over structure.</p> <p>Ecology Notes: cobble substrate, drained, channelised, riffle/glide</p>

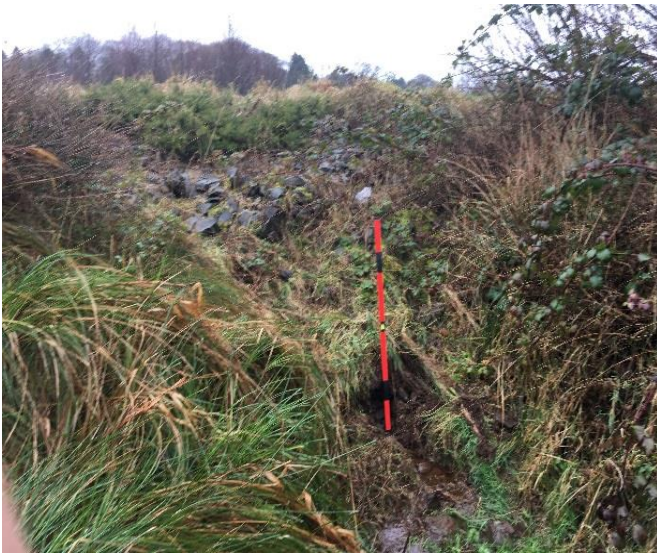
<p>Watercrossing Structure W37</p> <p>Type: Stream, 1st Order</p> <p>Fisheries: Class 3, Sub-optimal Fisheries</p> <p>Location/Townland: R503, Reardnogy Beg</p> <p>Existing Structure: Masonry Arch</p> <p>Works at the Crossing: Crossing over culvert</p> <p>Ecology Notes: No Fisheries Value</p>

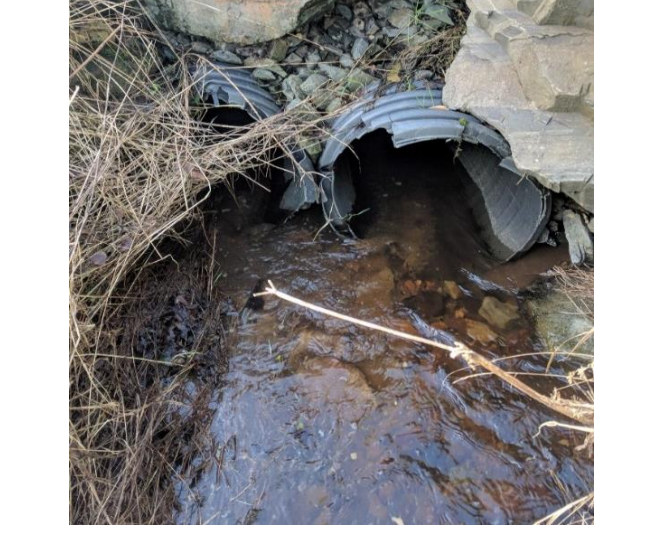
<p>Watercrossing Structure W38</p> <p>Type: Stream, 1st Order</p> <p>Fisheries: Class1, Optimal Fisheries</p> <p>Location/Townland: R503, Reardnogy Beg/Reardnogy More</p> <p>Existing Structure: Plastic Circular Culvert</p> <p>Works at the Crossing: Cable trenching under structure.</p> <p>Ecology Notes: c. 0.7 m wide, c. 140cm deep</p>

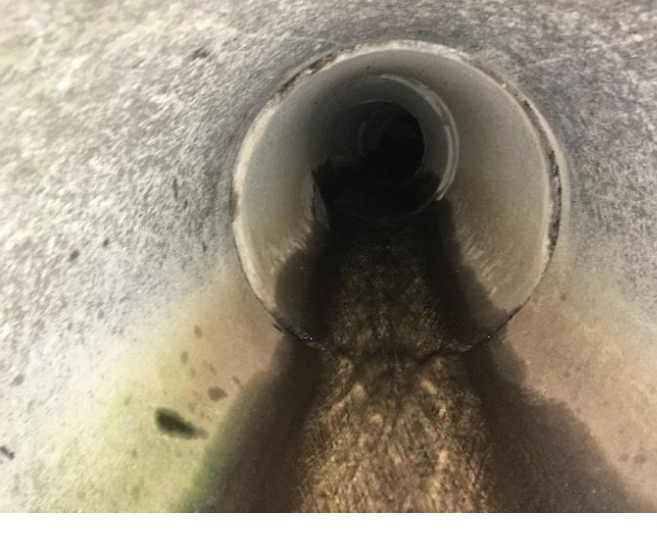
<p>Watercrossing Structure W39</p> <p>Type: Stream, 2nd Order</p> <p>Fisheries: Class1, Optimal Fisheries</p> <p>Location/Townland: R503, Reardnogy More</p> <p>Existing Structure: Plastic Circular Culvert</p> <p>Works at the Crossing: Cable trenching over structure.</p> <p>Ecology Notes: c. 0.6 m wide, c. 100cm deep</p>

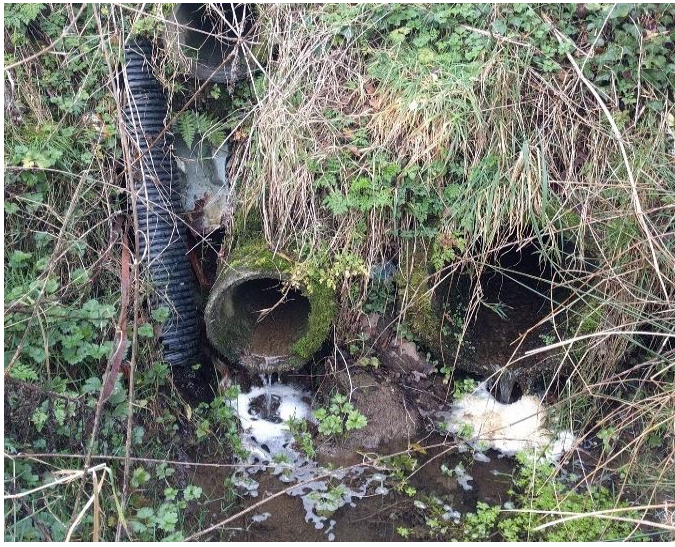
<p>Watercrossing Structure W40</p> <p>Type: Drain</p> <p>Fisheries: Class 4, Poor Fisheries</p> <p>Location/Townland: R503, Rear Cross Village, Reardnogy More/ Shanballyedmond</p> <p>Existing Structure: Concrete Circular Culvert X 3</p> <p>Works at the Crossing: Cable trenching under structures.</p> <p>Ecology Notes: No Fisheries Value</p>

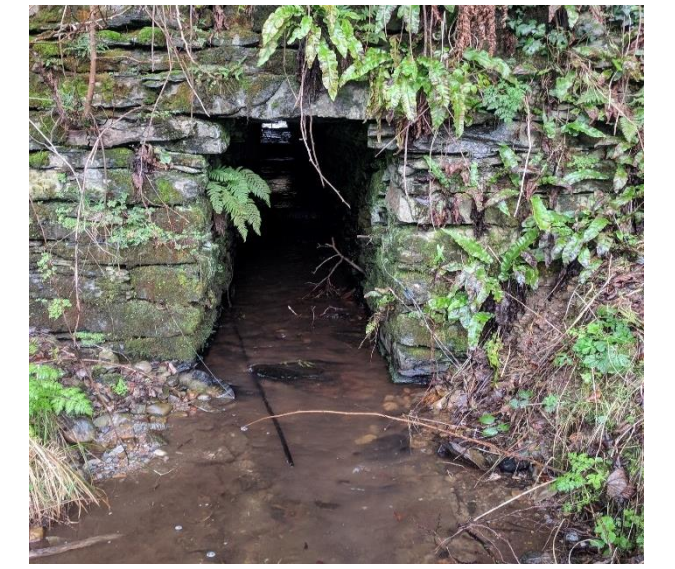
<p>Watercrossing Structure W41</p> <p>Type: Stream, 1st Order</p> <p>Fisheries: Class 3, Sub-optimal Fisheries</p> <p>Location/Townland: R503, Reardnogy More/Baurnadomeeny</p> <p>Existing Structure: Masonry Box Culvert</p> <p>Works at the Crossing: Cable trenching over structure.</p> <p>Ecology Notes: Downstream:, cobble gravel substrate, riffle, steep banks</p>

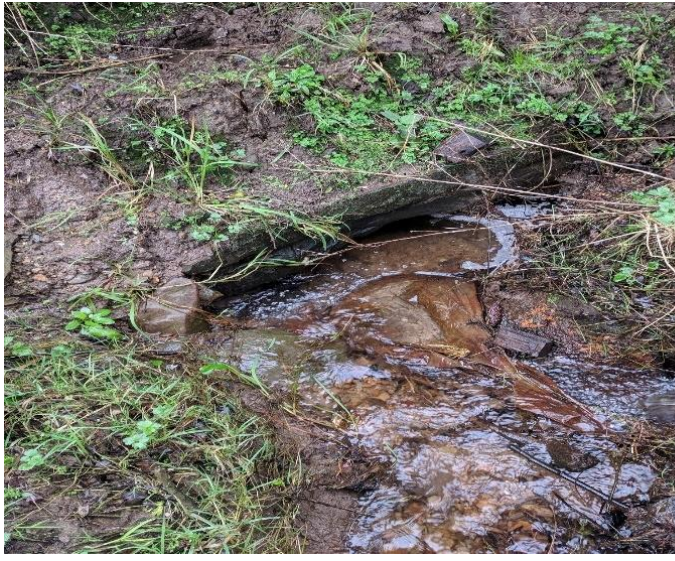
<p>Watercrossing Structure W42</p> <p>Type: Stream, 1st Order</p> <p>Fisheries: Class 3, Sub-optimal Fisheries</p> <p>Location/Townland: R503, Baurnadomeeny</p> <p>Existing Structure: Masonry Box Culvert</p> <p>Works at the Crossing: Cable trenching over structure.</p> <p>Ecology Notes: No Fisheries Potential</p>

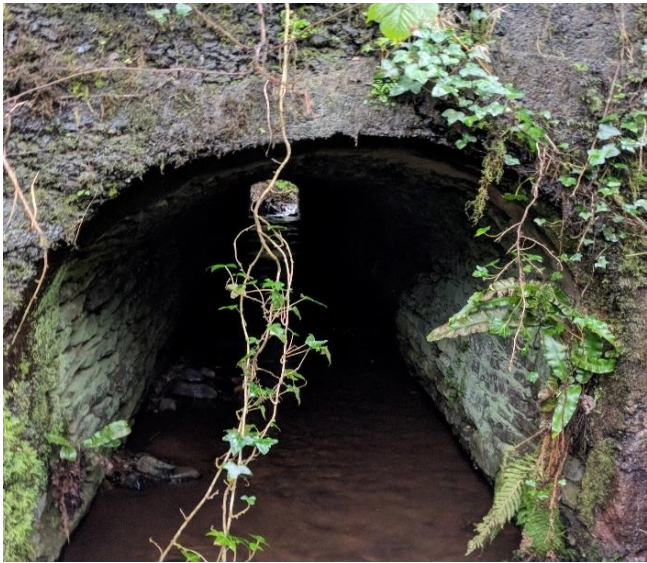
<p>Watercrossing Structure W43</p> <p>Type: Stream, 1st Order</p> <p>Fisheries: Class 3, Sub-optimal Fisheries</p> <p>Location/Townland: R503, Bournadomeeny</p> <p>Existing Structure: Masonry Arch</p> <p>Works at the Crossing: Cable trenching over structure.</p> <p>Ecology Notes: cobble gravel substrate, riffle, steep banks</p>

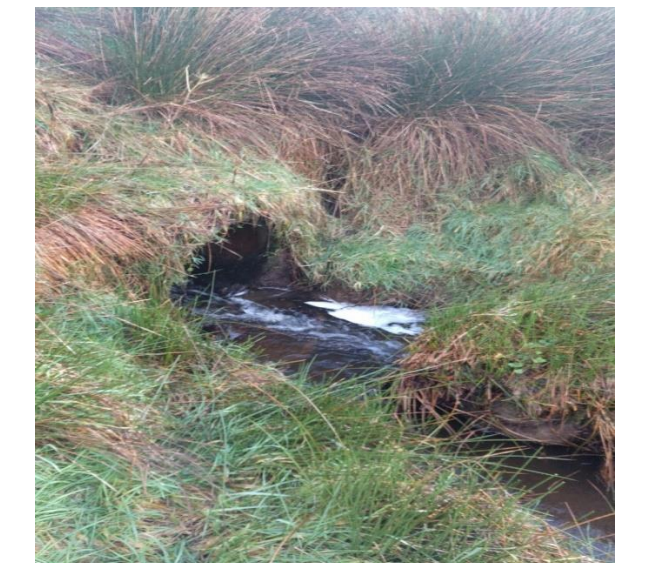
<p>Watercrossing Structure W45</p> <p>Type: Stream, 1st Order</p> <p>Fisheries: Class1, Optimal Fisheries</p> <p>Location/Townland: R503, Bournadomeeny/Coonmore</p> <p>Existing Structure: Concrete Circular Culvert</p> <p>Works at the Crossing: Cable trenching over structure.</p> <p>Ecology Notes: Riffle / glide, cobble substrate, channelised</p>

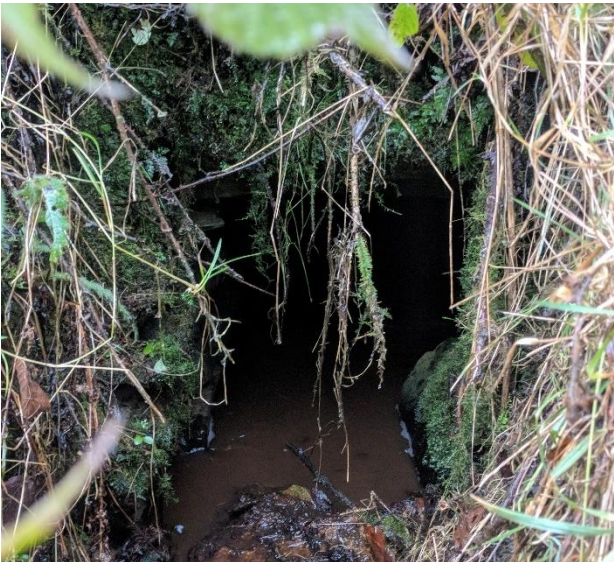
<p>Watercrossing Structure W46</p> <p>Type: Drain</p> <p>Fisheries: Class 4, Poor Fisheries</p> <p>Location/Townland: R503, Coonmore</p> <p>Existing Structure: Masonry Box Culvert Works at the Crossing: Cable trenching over structure.</p> <p>Ecology Notes: No Fisheries Value</p>

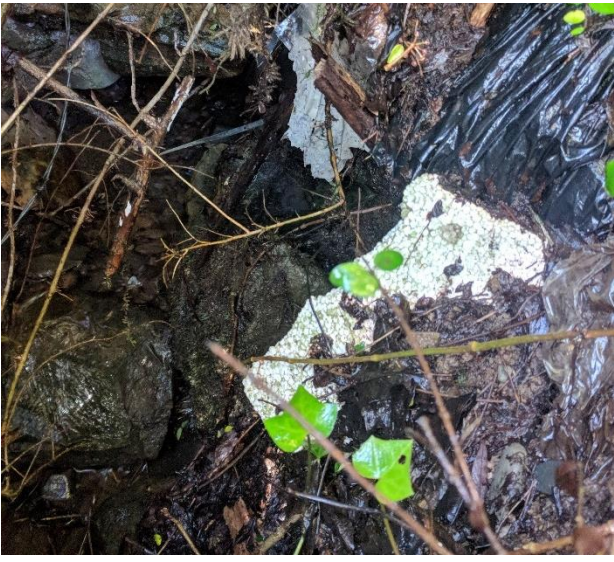
<p>Watercrossing Structure W47</p> <p>Type: Drain</p> <p>Fisheries: Class 4, Poor Fisheries</p> <p>Location/Townland: R503, Coonmore</p> <p>Existing Structure: Masonry Box Culvert Works at the Crossing: Cable trenching over structure.</p> <p>Ecology Notes: No Fisheries Value</p>

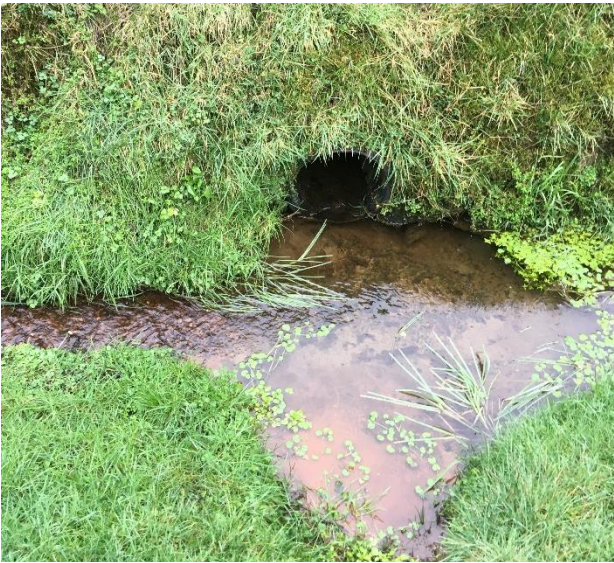
<p>Watercrossing Structure W48</p> <p>Type: Drain</p> <p>Fisheries: Class 4, Poor Fisheries</p> <p>Location/Townland: R503, Coonmore</p> <p>Existing Structure: Plastic Circular Culvert Works at the Crossing: Cable trenching over structure.</p> <p>Ecology Notes: No Fisheries Value</p>

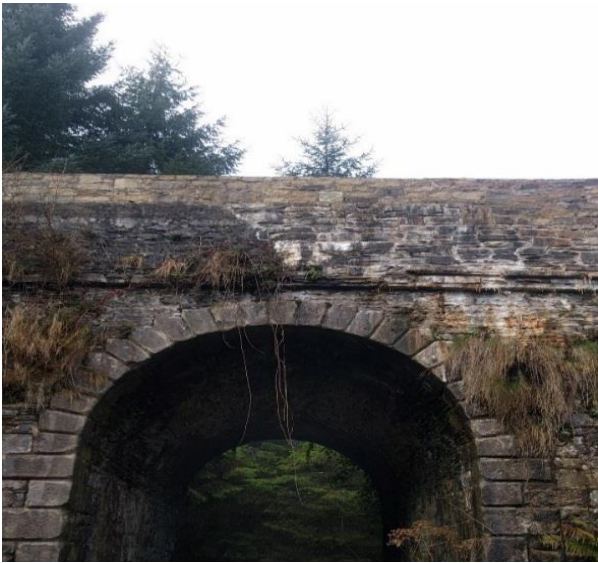
<p>Watercrossing Structure W49</p> <p>Type: River</p> <p>Fisheries: Class1, Optimal Fisheries</p> <p>Location/Townland: R503, Coonmore/Foildarragh</p> <p>Existing Structure: Masonry Arch</p> <p>Works at the Crossing: Cable trenching over structure.</p> <p>Ecology Notes: Cobble/gravel, channelised, riffle</p>

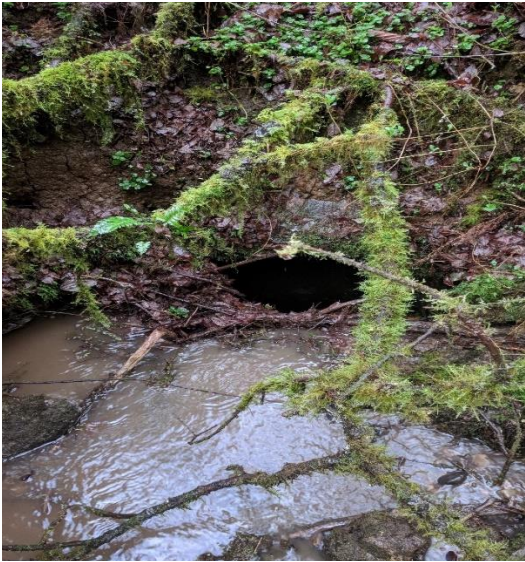
<p>Watercrossing Structure W50</p> <p>Type: Stream, 1st Order</p> <p>Fisheries: Class 3, Sub-optimal Fisheries</p> <p>Location/Townland: R503, Foildarragh</p> <p>Existing Structure: Masonry Box Culvert</p> <p>Works at the Crossing: Cable trenching over structure.</p> <p>Ecology Notes: No Fisheries Value, Very steep gradient, in gorge, 100% cover.</p>

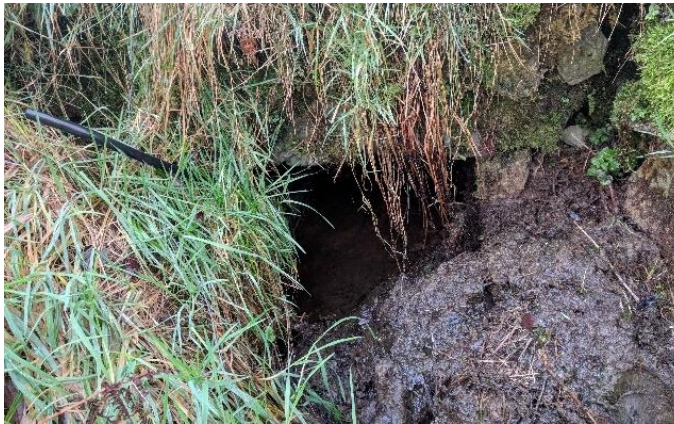
<p>Watercrossing Structure W55</p> <p>Type: Drain</p> <p>Fisheries: Class 4, Poor Fisheries</p> <p>Location/Townland: R503, Kilcommon</p> <p>Existing Structure: Masonry Box Culvert</p> <p>Works at the Crossing: Cable trenching under structure. Culvert may need replacing.</p> <p>Ecology Notes: No Fisheries Value</p>

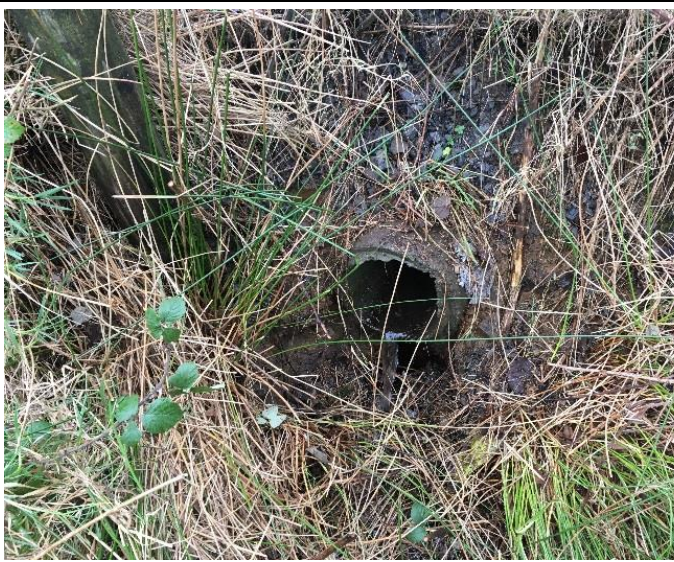
<p>Watercrossing Structure W56</p> <p>Type: Drain</p> <p>Fisheries: Class 3, Sub-optimal Fisheries</p> <p>Location/Townland: R503, Kilcommon</p> <p>Existing Structure: Concrete Circular Culvert</p> <p>Works at the Crossing: Cable trenching over structure.</p> <p>Ecology Notes: No Fisheries Value, some flow</p>

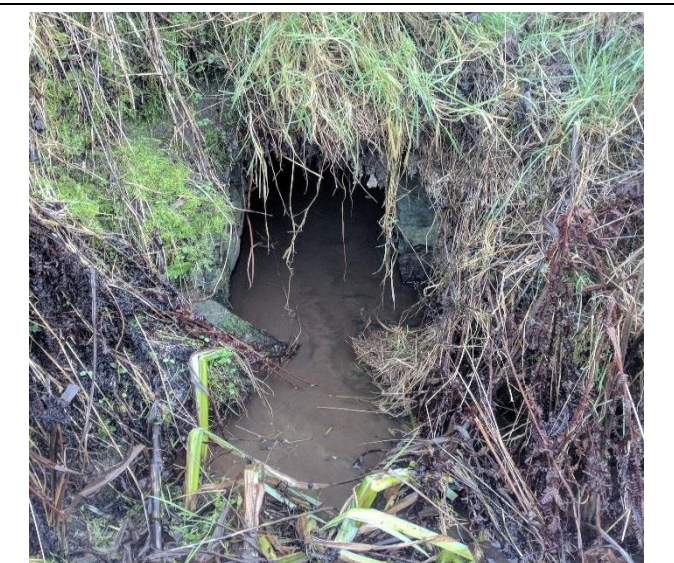
<p>Watercrossing Structure W57</p> <p>Type: Drain</p> <p>Fisheries: Class 4, Poor Fisheries</p> <p>Location/Townland: R503, Kilcommon/Loughbrack</p> <p>Existing Structure: Masonry Box Culvert</p> <p>Works at the Crossing: Cable trenching under structure. Culvert may need replacing.</p> <p>Ecology Notes: No Fisheries Value</p>

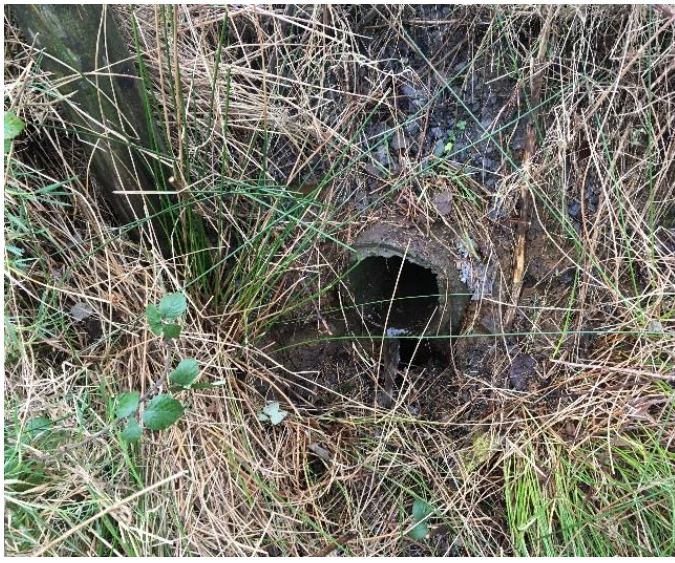
<p>Watercrossing Structure W58</p> <p>Type: Drain</p> <p>Fisheries: Class 4, Poor Fisheries</p> <p>Location/Townland: R503, Loughbrack</p> <p>Existing Structure: Concrete Circular Culvert</p> <p>Works at the Crossing: Cable trenching under structure.</p> <p>Ecology Notes: No Fisheries Value</p>

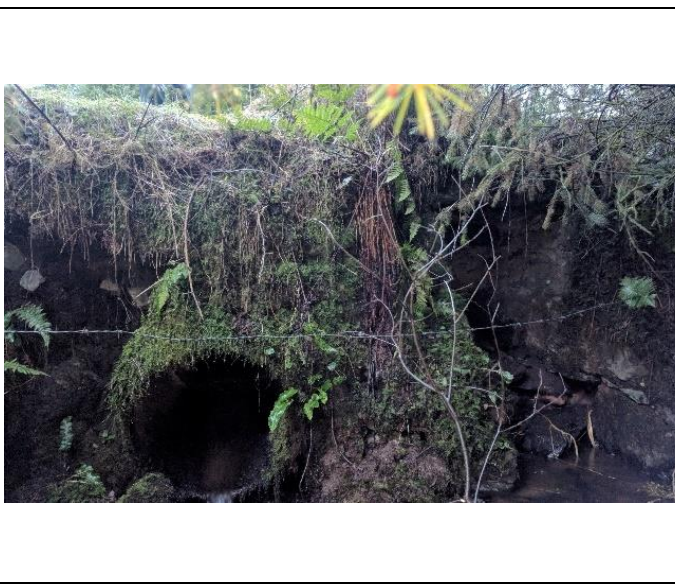
<p>Watercrossing Structure W59</p> <p>Type:</p> <p>Upstream: Drain, Downstream: Stream, 1st Order</p> <p>Fisheries: Class 4, Poor Fisheries</p> <p>Location/Townland: R503, Loughbrack</p> <p>Existing Structure: Concrete Culvert & Masonry Box Culvert</p> <p>Works at the Crossing: Cable trenching under structures.</p> <p>Ecology Notes: No Fisheries Value. Downstream: flow, through forestry</p>

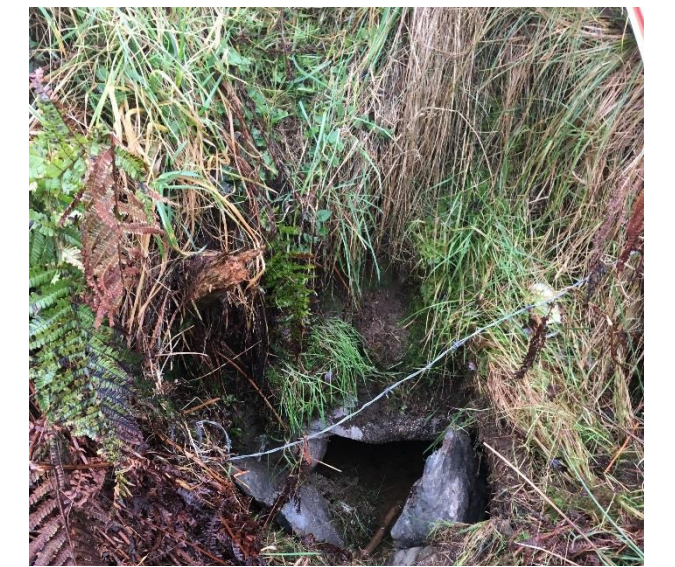
<p>Watercrossing Structure W60</p> <p>Type: Drain</p> <p>Fisheries: Class 4, Poor Fisheries</p> <p>Location/Townland: R503, Loughbrack</p> <p>Existing Structure: Masonry Box Culvert</p> <p>Works at the Crossing: Cable trenching under structure. Culvert may need replacing.</p> <p>Ecology Notes: No Fisheries Value</p>

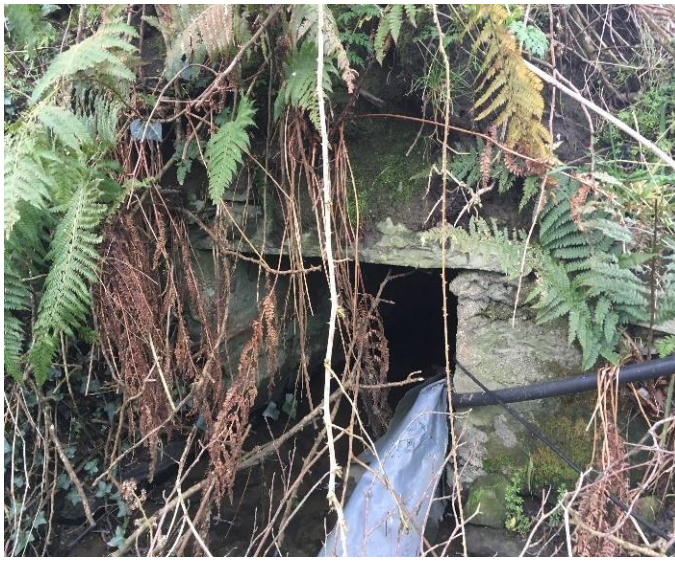
<p>Watercrossing Structure W61</p> <p>Type: Drain</p> <p>Fisheries: Class 4, Poor Fisheries</p> <p>Location/Townland: R503, Knocknabansha/Knockmaroe</p> <p>Existing Structure: Masonry Box Culvert Works at the Crossing: Cable trenching under structure. Culvert may need replacing.</p> <p>Ecology Notes: No Fisheries Value</p>

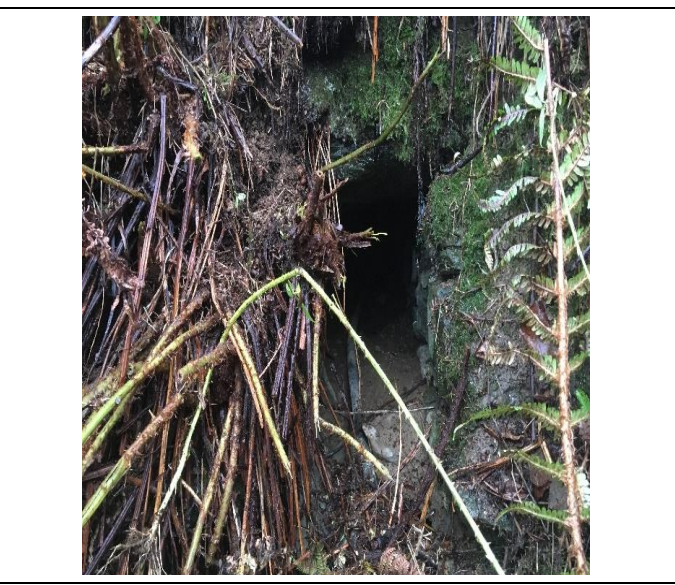
<p>Watercrossing Structure W62</p> <p>Type: Drain</p> <p>Fisheries: Class 4, Poor Fisheries</p> <p>Location/Townland: L2264-50, Knockmaroe</p> <p>Existing Structure: Masonry Box Culvert Works at the Crossing: Cable trenching over structure.</p> <p>Ecology Notes: No Fisheries Value</p>

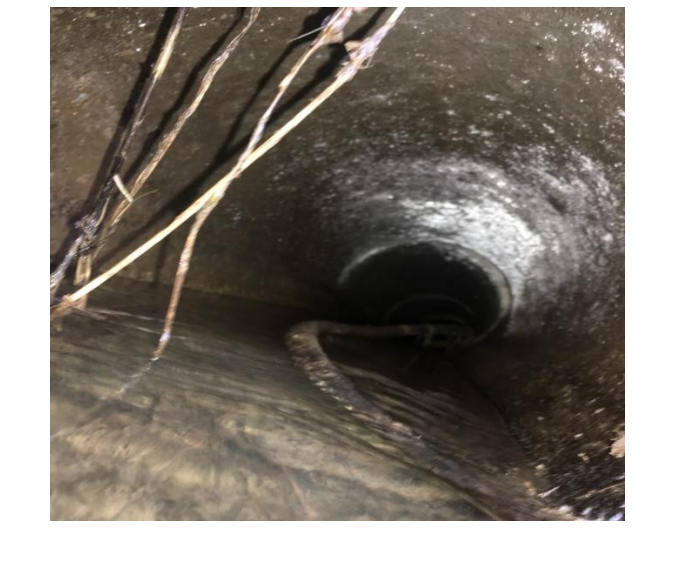
<p>Watercrossing Structure W63</p> <p>Type: Drain</p> <p>Fisheries: Class 4, Poor Fisheries</p> <p>Location/Townland: L2264-50, Knockmaroe/Knockcurraghbola Crownlands</p> <p>Existing Structure: Circular Concrete Culvert Works at the Crossing: Cable trenching under structure.</p> <p>Ecology Notes: No Fisheries Value</p>

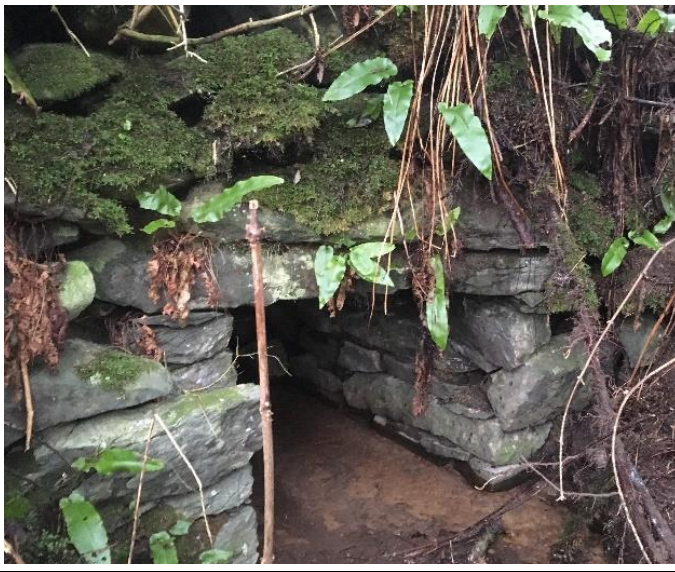
<p>Watercrossing Structure W64</p> <p>Type: Drain</p> <p>Fisheries: Class 4, Poor Fisheries</p> <p>Location/Townland: L2264-50, Knockmaroe</p> <p>Existing Structure: Masonry Box Culvert Works at the Crossing: Cable trenching under structure. Culvert may need replacing.</p> <p>Ecology Notes: No Fisheries Value</p>

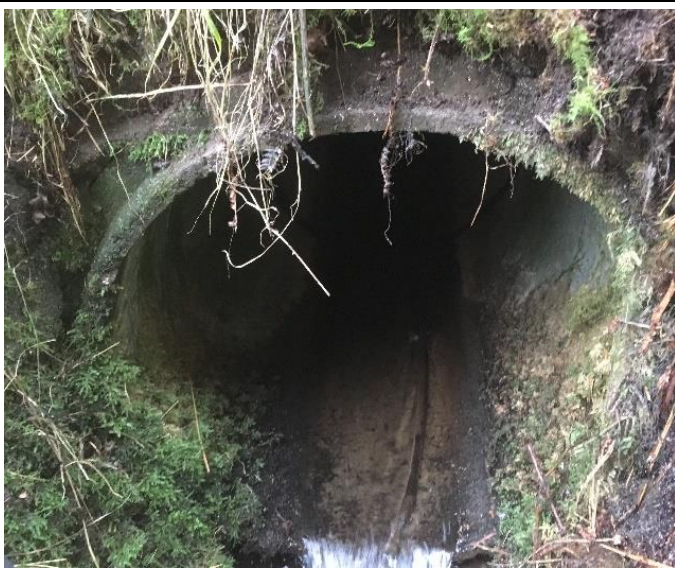
<p>Watercrossing Structure W65</p> <p>Type: Stream</p> <p>Fisheries: Class 2, Optimal Fisheries</p> <p>Location: L6188-0, Knockmaroe</p> <p>Existing Structure: Concrete Circular Culvert Works at Crossing: Cable trenching under structure.</p> <p>Ecology Notes: Steady flow to 20 cm deep with wetted width of c. 1 m. gravel bed.</p>

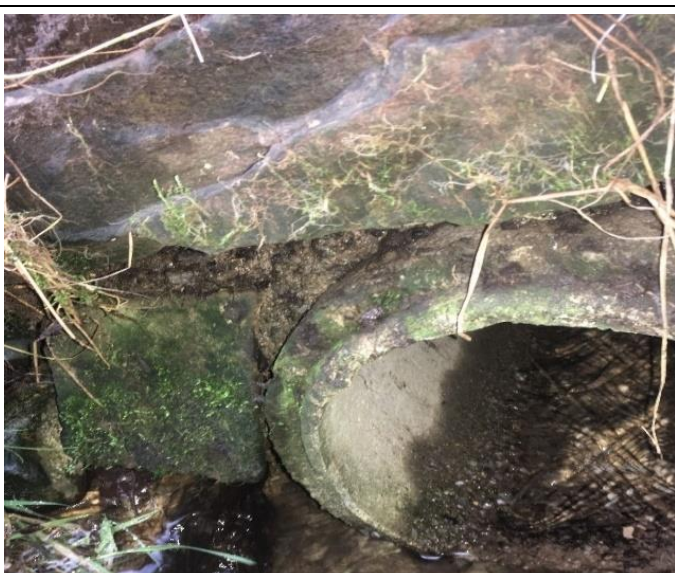
<p>Watercrossing Structure W66</p> <p>Type: Drain</p> <p>Fisheries: Class 4, Poor Fisheries</p> <p>Location/Townland: L6188-0, Knockmaroe</p> <p>Existing Structure: Concrete Circular Culvert Works at the Crossing: Cable trenching under structure.</p> <p>Ecology Notes: No Fisheries Value</p>

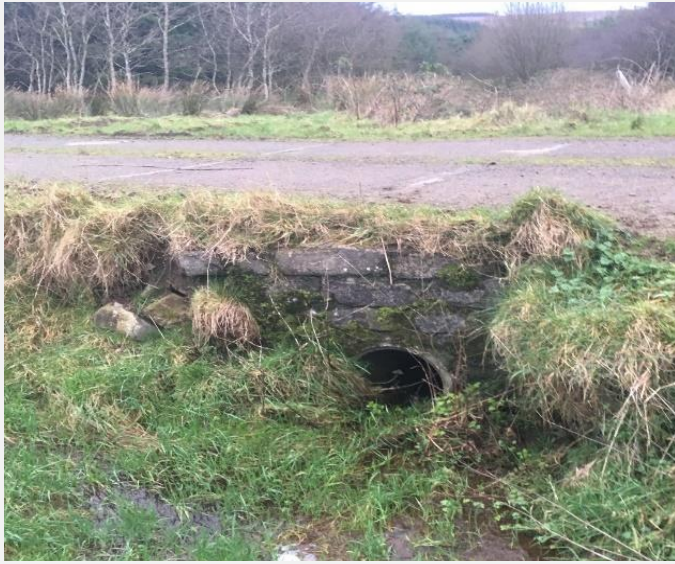
<p>Watercrossing Structure W67</p> <p>Type: Drain</p> <p>Fisheries: Class 4, Poor Fisheries</p> <p>Location/Townland: Private Paved Road, Knockcurraghbola Commons</p> <p>Existing Structure: Concrete Circular Culvert Works at the Crossing: Cable trenching under structure.</p> <p>Ecology Notes: c. 0.5 m wide, 10 cm deep</p>
	<p>Watercrossing Structure W68</p> <p>Type: Drain</p> <p>Fisheries: Class 4, Poor Fisheries</p> <p>Location/Townland: Private Paved Road, Knockcurraghbola Commons</p> <p>Existing Structure: Concrete Circular Culvert Works at the Crossing: Cable trenching under structure.</p> <p>Ecology Notes: No Fisheries Value, Slow flowing</p>
