## Appendix to Chapter 8: Biodiversity

### Appendix 8.2: Aquatic Habitats & Species Fieldwork & Survey Results

## A8-2.2 Survey Results - Inventory & Classification of Watercourses at Crossing Locations

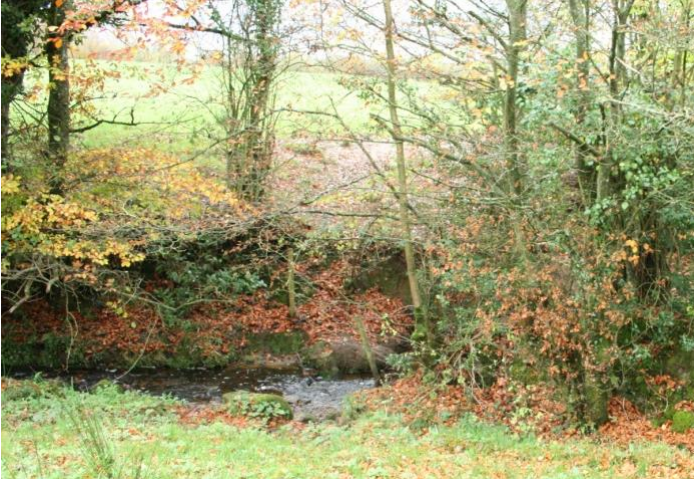
<p><b>Watercrossing Structure W1</b> (<i>Temporary Crossing</i>)</p> <p>Type: 1<sup>st</sup> Order Stream</p> <p><b>Fisheries: Class 2, Optimal Fisheries</b></p> <p>Location: Mountphilips Substation Site</p> <p>Existing Structure: No existing crossing structure</p> <p>Works at Crossing: Cable trenching under stream bed using dam &amp; pump (flume) method. Temporary Bailey Bridge.</p> <p>Ecology Notes: c. 2 m wide, c. 10 cm deep, gravel (70), cobbles (5), boulders (5), sands/silts (20)</p>

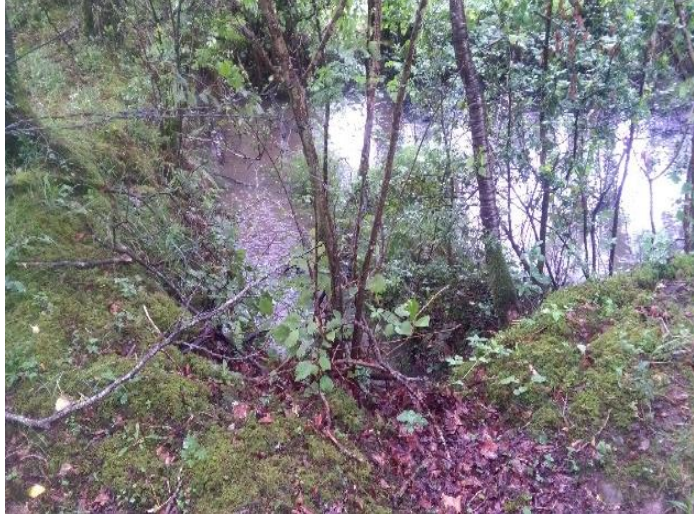
<p><b>Watercrossing Structure W2</b></p> <p>Type: Drainage Ditch</p> <p><b>Fisheries: Sub-Optimal Fisheries</b></p> <p>Location: Mountphilips Substation Site</p> <p>Existing Structure: No existing crossing structure</p> <p>Works at Crossing: Installation of new permanent culvert. Cable trenching under new culvert.</p> <p>Ecology Notes: c. 0.5 m wide, c. 10 cm deep, silts/muds (100)</p>

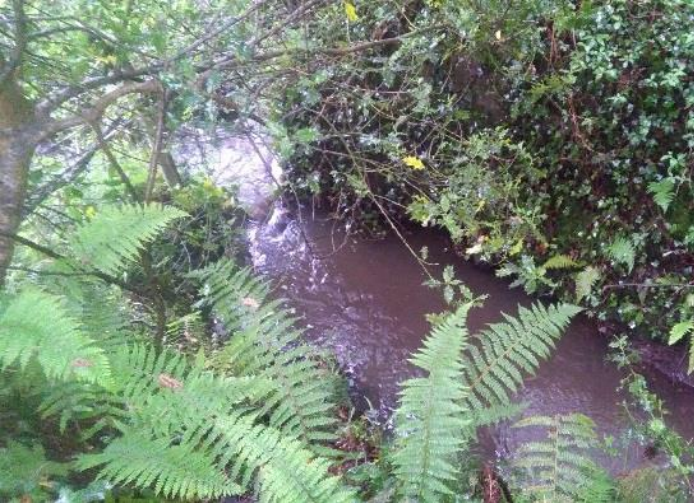
<p><b>Watercrossing Structure W3</b></p> <p>Type: 1<sup>st</sup> Order Stream</p> <p><b>Fisheries: Class 2, Optimal Fisheries</b></p> <p>Location: Mountphilips Substation Site</p> <p>Existing Structure: No existing crossing structure</p> <p>Works at Crossing: Installation of new permanent culvert. Cable trenching under new culvert.</p> <p>Ecology Notes: c. 1 m wide, c. 10 cm deep, cobbles (20), gravels (40), sands/silts (40)</p>

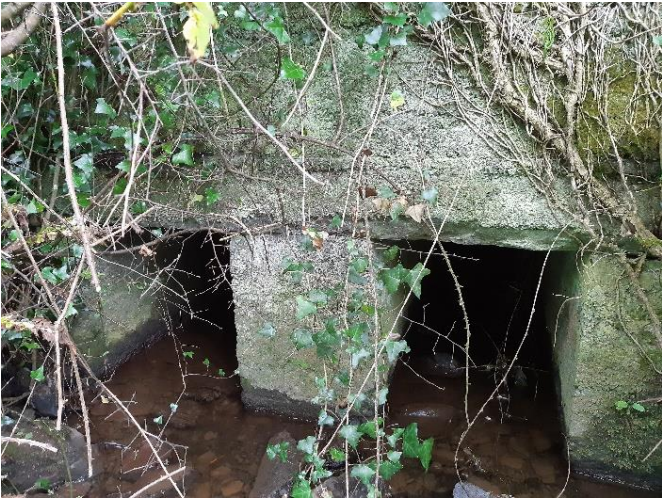
<p><b>Watercrossing Structure W4</b></p> <p>Type: Stream</p> <p><b>Fisheries: Class 3, Sub-optimal Fisheries</b></p> <p>Location/Townland: L2166-0, Coole/Freagh</p> <p>Existing Structure: Concrete Block Box Culvert</p> <p>Works at the Crossing: Cable trenching under structure</p> <p>Ecology Notes: Downstream - Slow flowing, Coble (60), Gravel (40). Overgrown, vegetation shading. 1 metre wide and ~30cm deep.</p>

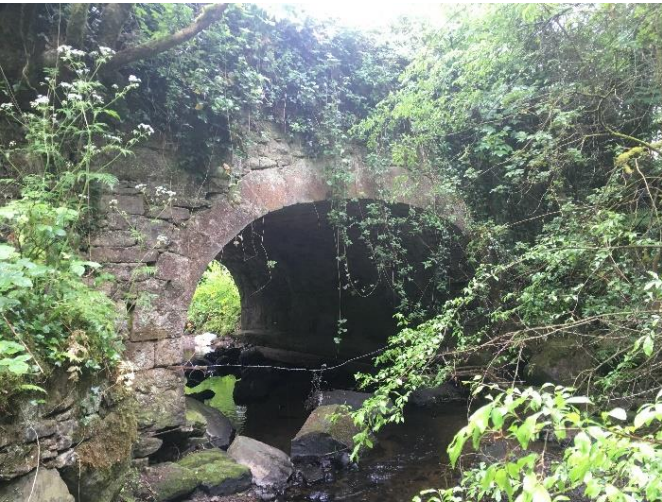
<p><b>Watercrossing Structure W5</b></p> <p>Type: River</p> <p><b>Fisheries: Class1, Optimal Fisheries</b></p> <p>Location/Townland: L6013-0, Foildarrig/Freagh</p> <p>Existing Structure: Masonry Single Arch Bridge</p> <p>Works at the Crossing: Cable trenching over structure</p> <p>Ecology Notes: Upstream - riffle/glide sequence and pool. Bolder (30), cobble (30), sand/gravel (40). Culvert pipe also flowing into river. Downstream - Riffle and pool present. Sand gravel under bridge (60), boulders/cobble(40).</p>

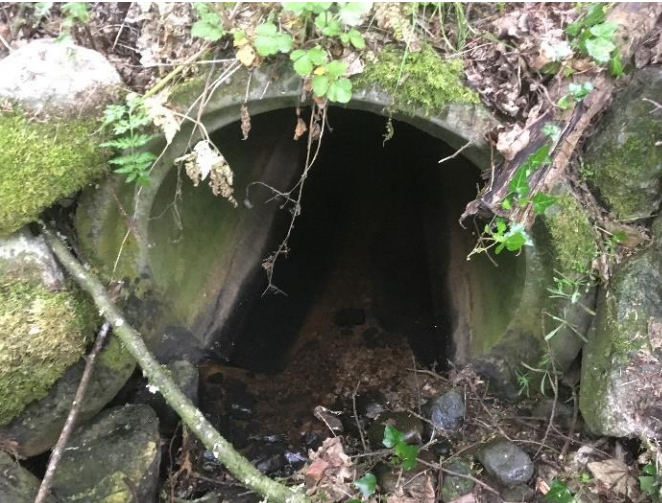
<p><b>Watercrossing Structure W6</b></p> <p>Type: Stream</p> <p><b>Fisheries: Class 3, Sub-Optimal Fisheries</b></p> <p>Location/Townland: L6013-0, Oakhampton</p> <p>Existing Structure: Concrete Circular Culvert</p> <p>Works at the Crossing: Cable trenching over structure</p> <p>Ecology Notes: Pipe culvert with stream through it. Bolder (50), mud/gravel (50).</p>

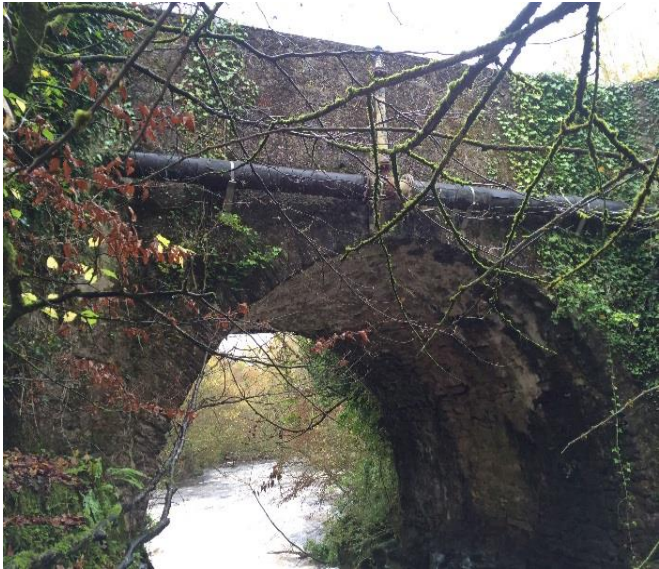
<p><b>Watercrossing Structure W7</b></p> <p>Type: River</p> <p>Fisheries: Class1, Optimal Fisheries</p> <p>Location/Townland: Rockvale Bridge, L2156-0, Oakhampton/Rockvale</p> <p>Existing Structure: Masonry Single Arch Bridge</p> <p>Works at the Crossing: Cable trenching over structure. Additional works to raise road level &amp; parapet wall height</p> <p>Ecology Notes: Upstream - riffle and white water. Bedrock (70), cobble (20), sand (10). Deep water - could not judge depth. Downstream - white water, small riffle and some pooling. Deep water.</p>

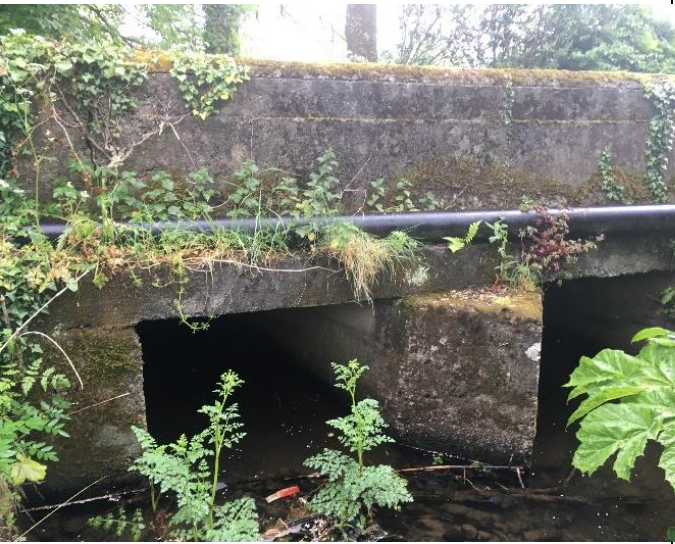
<p><b>Watercrossing Structure W8</b></p> <p>Type: Stream</p> <p>Fisheries: Class1, Optimal Fisheries</p> <p>Location/Townland: L6009-0, Ahane/Castlewaller</p> <p>Existing Structure: Concrete Slab Bridge</p> <p>Works at the Crossing: Directional Drill under stream bed.</p> <p>Ecology Notes: Upstream - small riffle and glide. Pooling. Moderate flow. Cobble (70), gravel (30). Downstream - riffle and glide, pool at bridge. Cobble (60), gravel (40).</p>

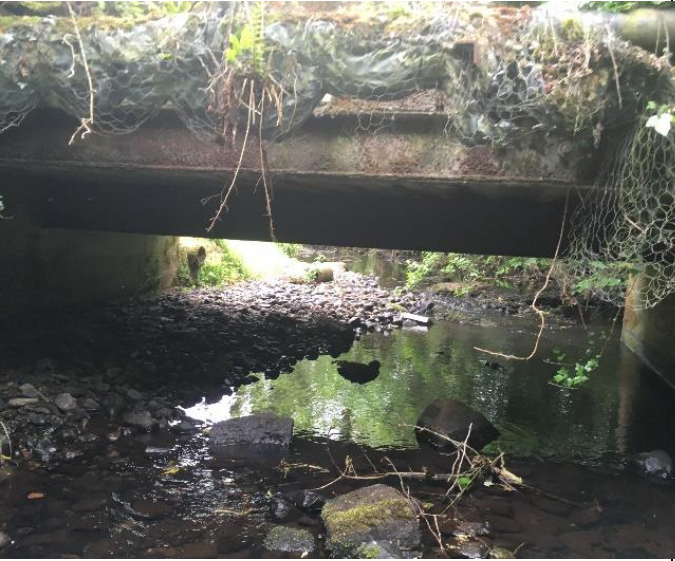
<p><b>Watercrossing Structure W9</b></p> <p>Type: Stream</p> <p>Fisheries: Class 1, Optimal Fisheries</p> <p>Location/Townland: L6009-0, Castlewaller/Carrowkeale</p> <p>Existing Structure: Concrete Slab Bridge</p> <p>Works at the Crossing: Directional Drill under stream bed.</p> <p>Ecology Notes: Upstream - riffle and glide and pool (with sand). Sand (30), cobble (50), gravel (20). Downstream - flat rock (40), boulders (30), cobble (30), riffle. Some pooling at edge, no visible build-up of sand. Fast flowing.</p>

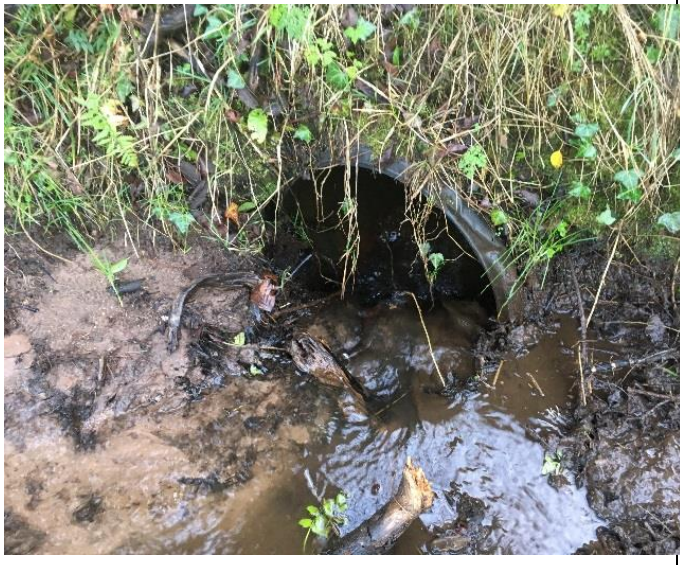
<p><b>Watercrossing Structure W10</b>          Type: Stream, 1<sup>st</sup> Order  <b>Fisheries: Class 3, Sub-optimal Fisheries</b>          Location/Townland: R503, Kilnacappagh            Existing Structure: HDPE Plastic Circular Culvert          Works at the Crossing: Cable trenching over structure            Ecology Notes: deep, drained, flow</p>

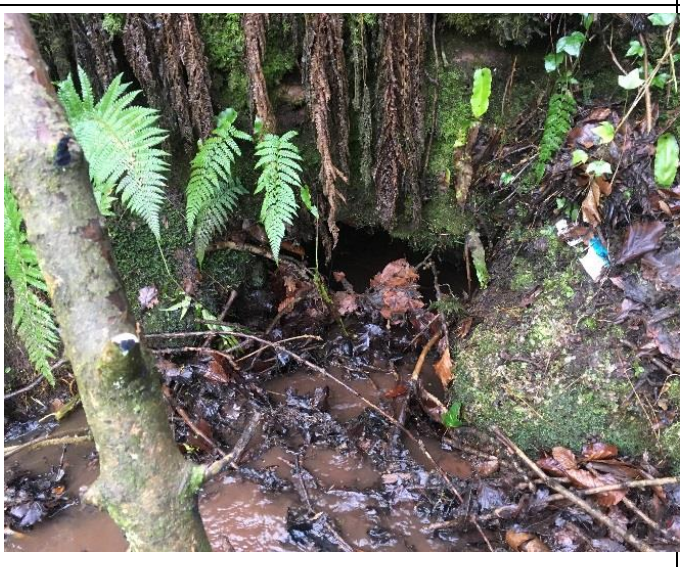
<p><b>Watercrossing Structure W11</b>          Type: Stream  <b>Fisheries: Class 3, Sub-optimal Fisheries</b>          Location/Townland: R503, Scragreen/Derrygareen            Existing Structure: Masonry Box Culvert          Works at the Crossing: Cable trenching over structure            Ecology Notes: c. 1 m wide, c. 20 cm deep</p>

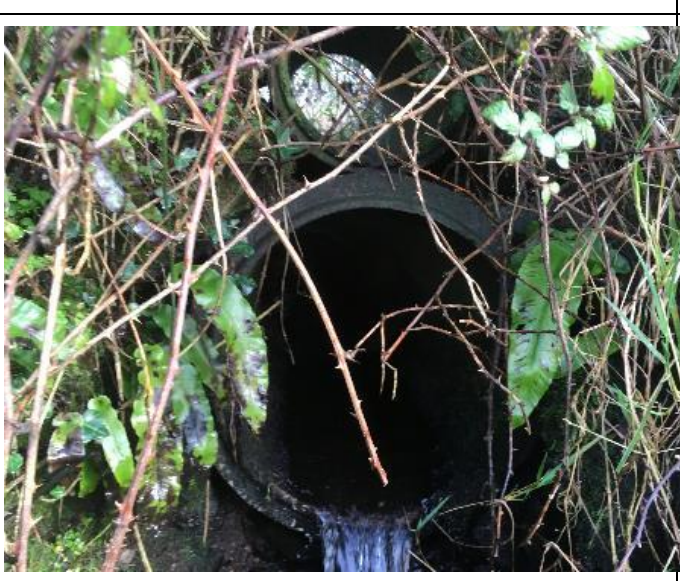
<p><b>Watercrossing Structure W12</b>          Type: Drain  <b>Fisheries: Class 4, Poor Fisheries</b>          Location/Townland: R503, Derrygareen            Existing Structure: Masonry Box Culvert &amp; Circular Concrete Culvert          Works at the Crossing: Cable trenching under structure            Ecology Notes: c. 0.8m wide, c. 15 cm deep</p>

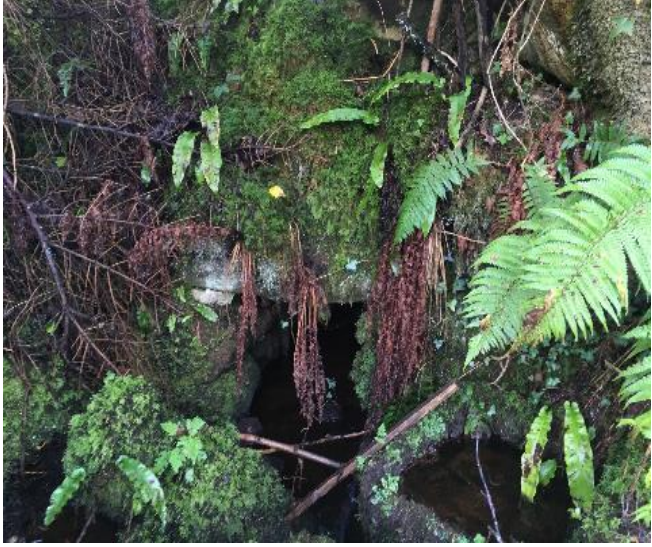
<p><b>Watercrossing Structure W13</b></p> <p>Type: Stream, 1<sup>st</sup> Order</p> <p><b>Fisheries: Class 4, Poor Fisheries</b></p> <p>Location/Townland: R503, Knockancullenagh</p> <p>Existing Structure: Masonry Box Culvert</p> <p>Works at the Crossing: Cable trenching under structure. Culvert may need replacing.</p> <p>Ecology Notes: No Fisheries Potential</p>

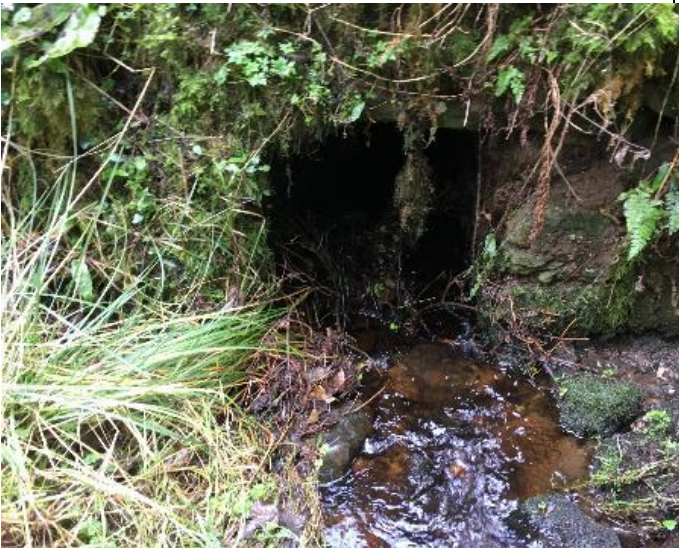
<p><b>Watercrossing Structure W14</b></p> <p>Type: Stream, 1<sup>st</sup> Order</p> <p><b>Fisheries: Class1, Optimal Fisheries</b></p> <p>Location/Townland: R503, Knockancullenagh</p> <p>Existing Structure: Masonry Box Culvert</p> <p>Works at the Crossing: Cable trenching under structure. Culvert may need replacing.</p> <p>Ecology Notes: steep gradient, cobble/gravel. 100% shade</p>

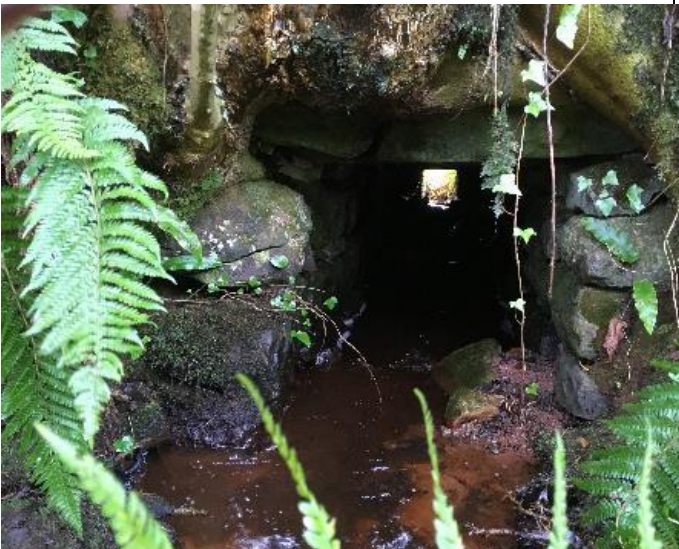
<p><b>Watercrossing Structure W15</b></p> <p>Type: Stream, 1st Order</p> <p><b>Fisheries: Class 3, Sub-optimal Fisheries</b></p> <p>Location/Townland: R503, Knockancullenagh</p> <p>Existing Structure: Masonry Box Culvert</p> <p>Works at the Crossing: Cable trenching under structure. Culvert may need replacing.</p> <p>Ecology Notes: No Fisheries Potential</p>

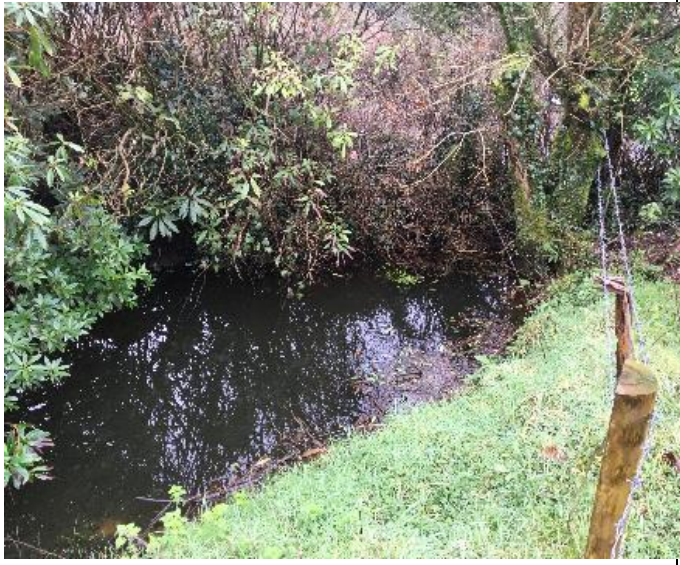
<p><b>Watercrossing Structure W16</b></p> <p>Type: Drain</p> <p><b>Fisheries: Class 4, Poor Fisheries</b></p> <p>Location/Townland: R503, Knockancullenagh</p> <p>Existing Structure: Plastic Circular Culvert.</p> <p>Works at the Crossing: Cable trenching over structure.</p> <p>Ecology Notes: No Fisheries Potential</p>

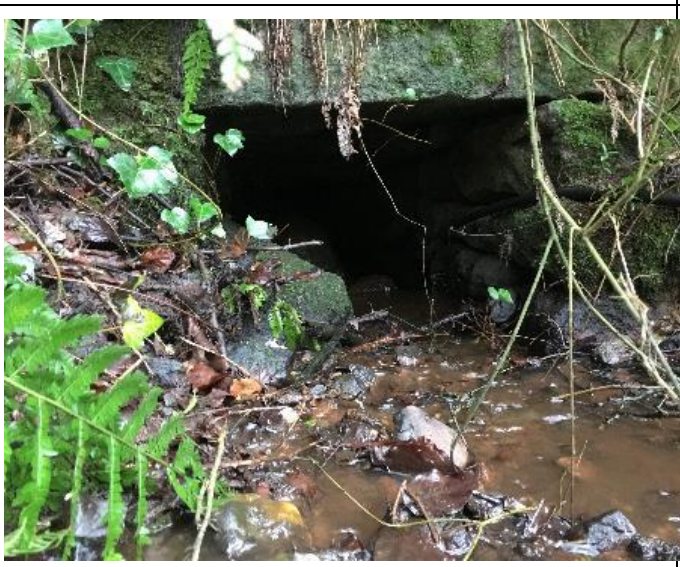
<p><b>Watercrossing Structure W17</b></p> <p>Type: Stream, 1st Order</p> <p><b>Fisheries: Class 3, Sub-optimal Fisheries</b></p> <p>Location/Townland: R503, Knockancullenagh</p> <p>Existing Structure: Masonry Box Culvert</p> <p>Works at the Crossing: Cable trenching under structure. Culvert may need replacing.</p> <p>Ecology Notes: No Fisheries Potential, steep</p>

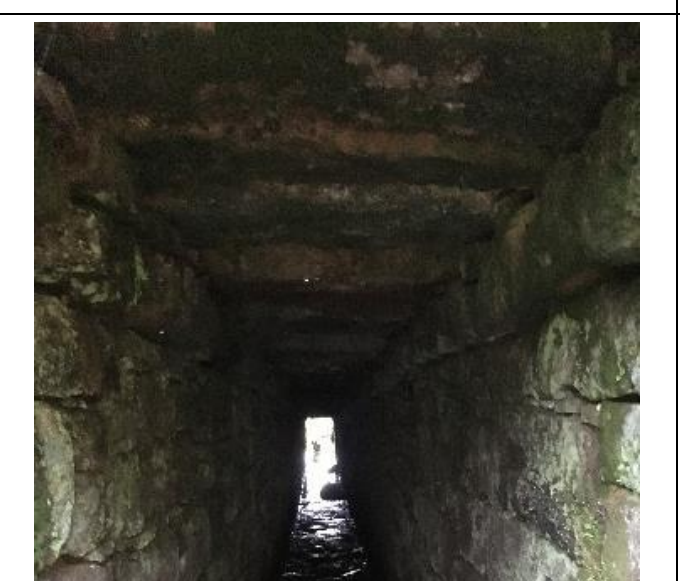
<p><b>Watercrossing Structure W18</b></p> <p>Type: Stream, 2<sup>nd</sup> Order</p> <p><b>Fisheries: Class1, Optimal Fisheries</b></p> <p>Location/Townland: R503, Knockancullenagh/Fanit</p> <p>Existing Structure: Masonry Box Culvert</p> <p>Works at the Crossing: Cable trenching over structure.</p> <p>Ecology Notes: steep, boulder cobble pool riffle. Downstream 100% shade, steep gradient</p>

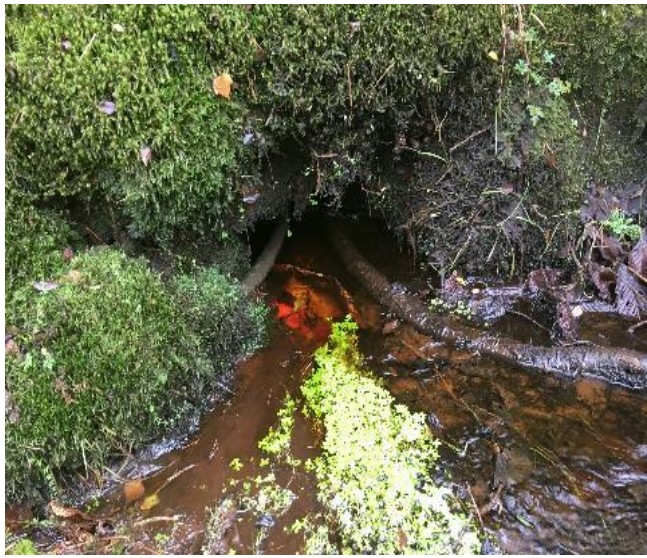
<p><b>Watercrossing Structure W19</b>                      Type: Drain  <b>Fisheries: Class 4, Poor Fisheries</b>                      Location/Townland: R503, Fanit                        Existing Structure: Masonry Box Culvert                        Works at the Crossing: Cable trenching under structure. Culvert may need replacing.                        Ecology Notes: No Fisheries Potential</p>

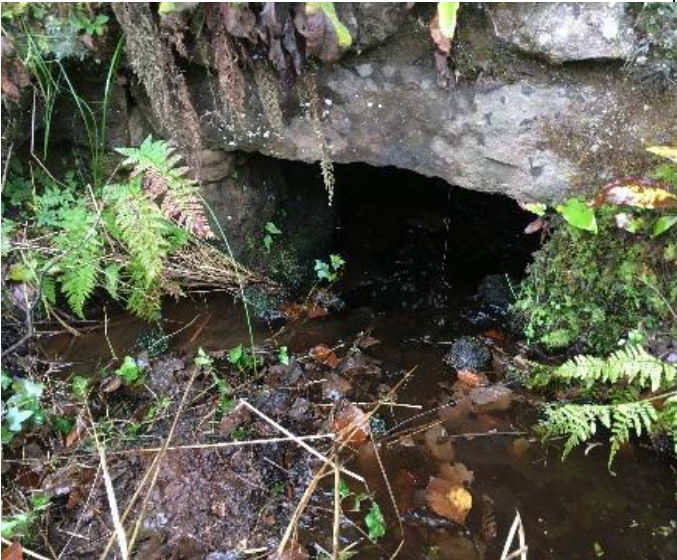
<p><b>Watercrossing Structure W20</b>                      Type: Drain  <b>Fisheries: Class 4, Poor Fisheries</b>                      Location/Townland: R503, Fanit                        Existing Structure: Masonry Box Culvert                        Works at the Crossing: Cable trenching under structure. Culvert may need replacing.                        Ecology Notes: No Fisheries Potential 100% shade downstream</p>

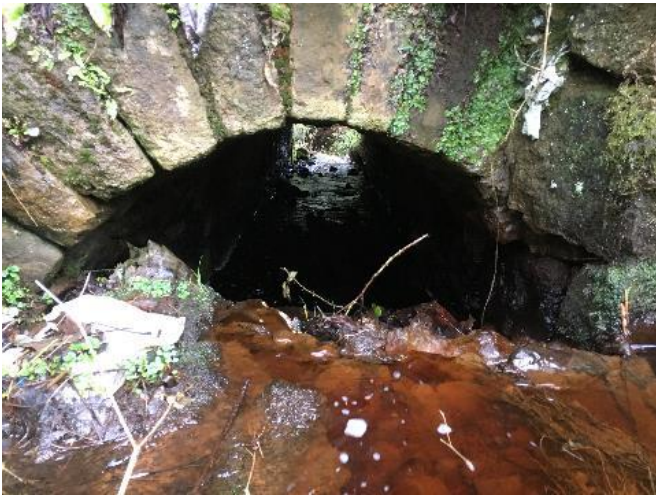
<p><b>Watercrossing Structure W21</b>                      Type: Stream, 1st Order  <b>Fisheries: Class 3, Sub-optimal Fisheries</b>                      Location/Townland: R503, Fanit                        Existing Structure: Masonry Single Arch Bridge                        Works at the Crossing: Cable trenching over structure.                        Ecology Notes: No Fisheries Potential 100% shade downstream</p>

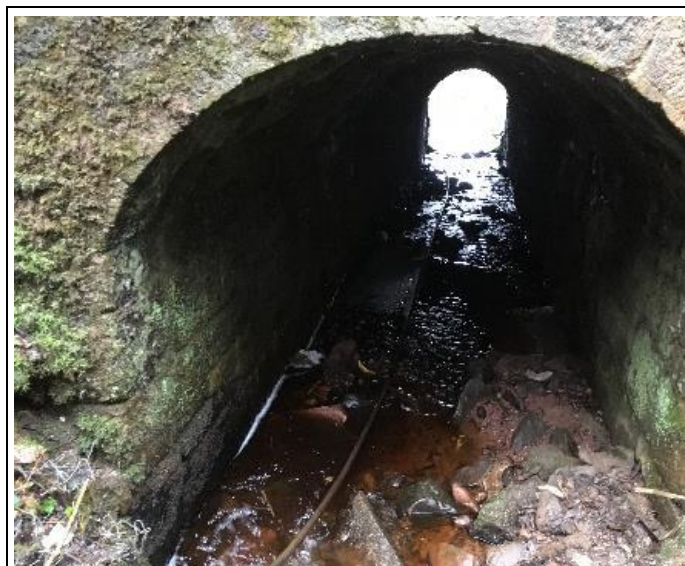
**Watercrossing Structure W22**

Type: Stream, 1st Order

**Fisheries: Class 3, Sub-optimal Fisheries**

Existing Structure: Masonry Single Arch Bridge

Works at the Crossing: Cable trenching over structure.

Ecology Notes: steep/cascade

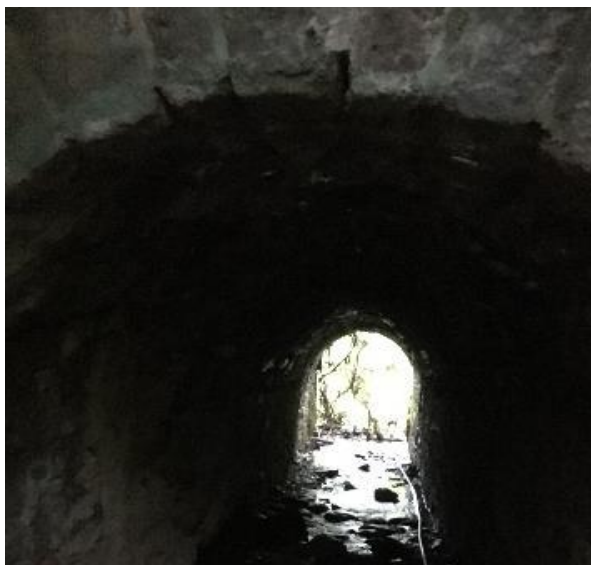
**Watercrossing Structure W23**

Type: Stream

**Fisheries: Class 3, Sub-optimal Fisheries**

Existing Structure: Masonry Arch Bridge

Works at the Crossing: Cable trenching over structure.

Ecology Notes: No Fisheries Potential

Upstream: 100% shade. Minor steep cascades

Downstream: 100% shade

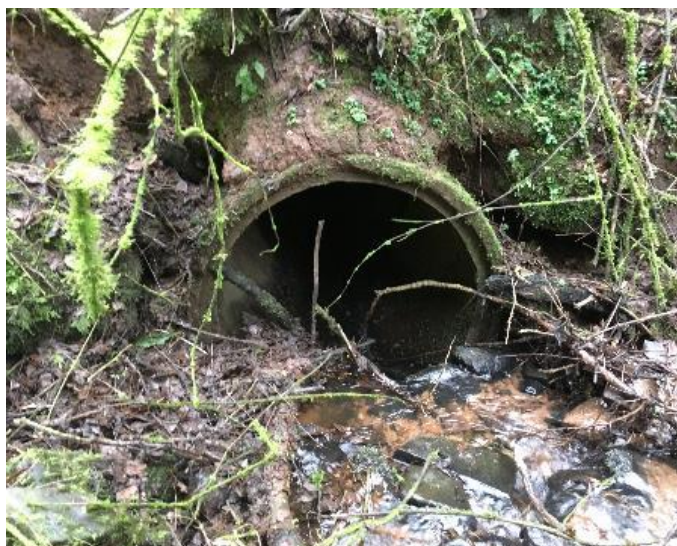
**Watercrossing Structure W24**

Type: Stream, 1<sup>st</sup> Order

**Fisheries: Class 3, Sub-optimal Fisheries**

Existing Structure: Concrete Circular Culvert

Works at the Crossing: Cable trenching over structure.

Ecology Notes: No Fisheries Potential

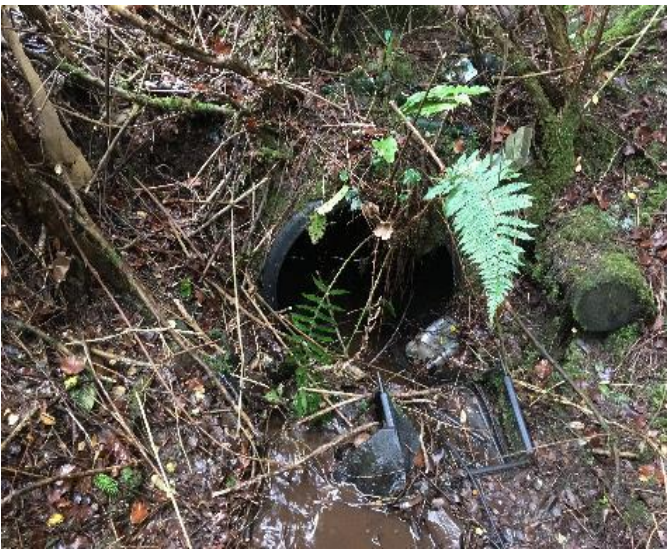
<p><b>Watercrossing Structure W25</b></p> <p>Type: Stream, 1<sup>st</sup> Order</p> <p><b>Fisheries: Class 3, Sub-optimal Fisheries</b></p> <p>Location/Townland: R503, Lackamore</p> <p>Existing Structure: Plastic Circular Culvert          Works at the Crossing: Cable trenching over structure.</p> <p>Ecology Notes: No Fisheries Potential, Steep Gradient</p>

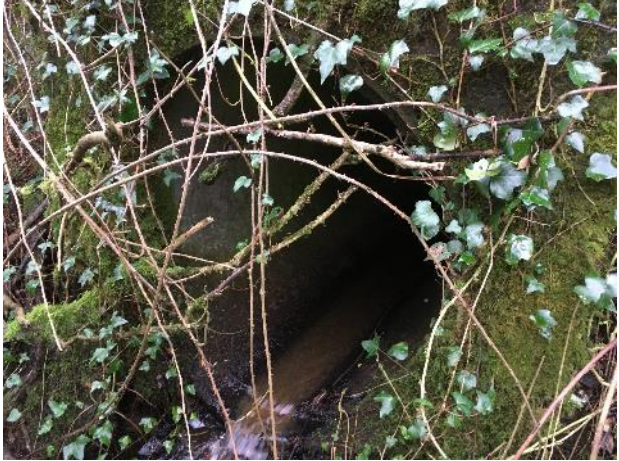
<p><b>Watercrossing Structure W26</b></p> <p>Type: Stream, 1<sup>st</sup> Order</p> <p><b>Fisheries: Class 3, Sub-optimal Fisheries</b></p> <p>Location/Townland: R503, Lackamore</p> <p>Existing Structure: Concrete Circular Culvert          Works at the Crossing: Cable trenching over structure.</p> <p>Ecology Notes: No Fisheries Potential, Steep Gradient</p>

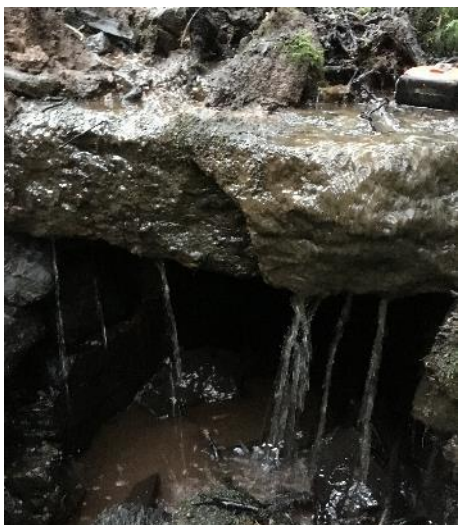
<p><b>Watercrossing Structure W27</b></p> <p>Type: Stream, 1<sup>st</sup> Order</p> <p><b>Fisheries: Class 3, Sub-optimal Fisheries</b></p> <p>Location/Townland: R503, Lackamore</p> <p>Existing Structure: Masonry Box Culvert          Works at the Crossing: Cable trenching over structure.</p> <p>Ecology Notes: No Fisheries Potential, Steep Gradient</p>

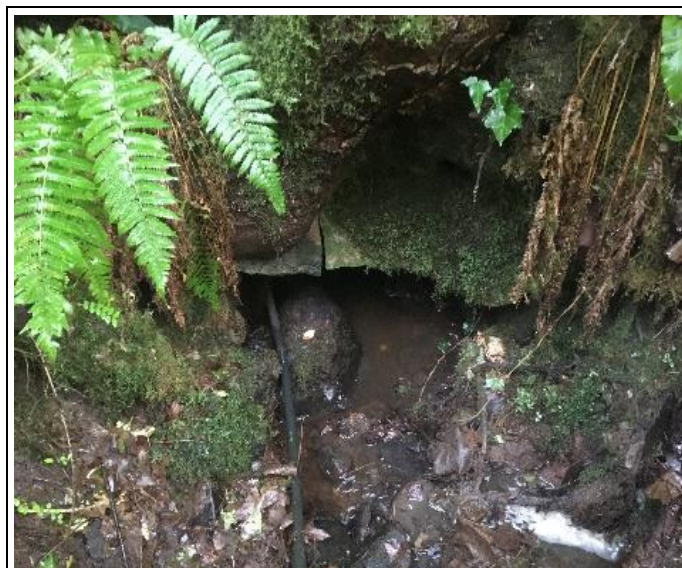
#### Watercrossing Structure W31

Type: Stream, 1<sup>st</sup> Order

Fisheries: Class 3, Sub-optimal Fisheries

Existing Structure: Concrete Circular Culvert  
 Works at the Crossing: Crossing under new existing culvert

Ecology Notes: No Fisheries Value, Steep Gradient

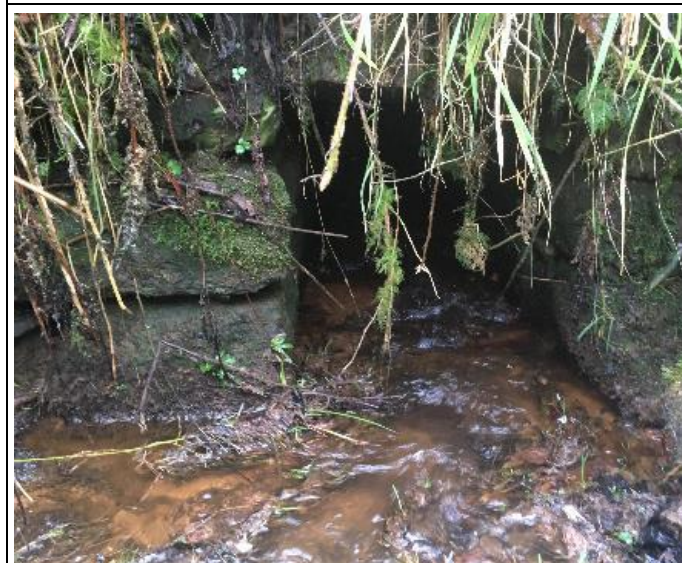
#### Watercrossing Structure W32

Type: Minor Stream

Fisheries: Class 3, Sub-optimal Fisheries

Existing Structure: Masonry Box Culvert  
 Works at the Crossing: Cable trenching under structure. Culvert may need replacing.

Ecology Notes: No Fisheries Value

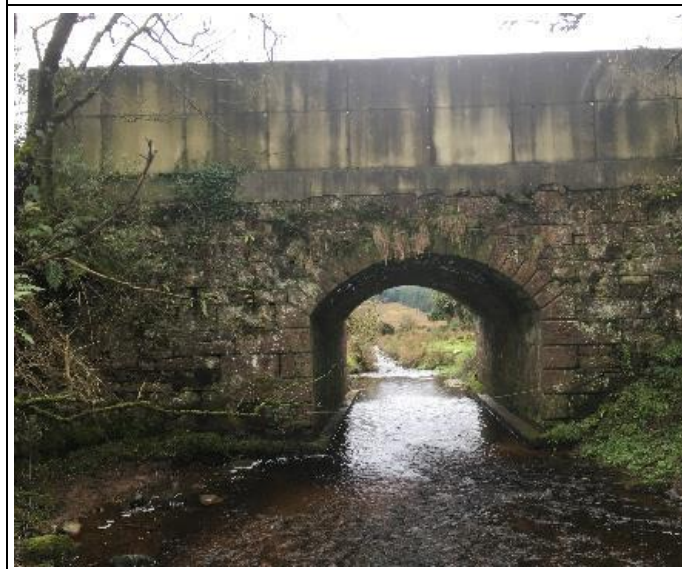
#### Watercrossing Structure W33

Type: Stream

Fisheries: Class1, Optimal Fisheries

Existing Structure: Masonry Arch Bridge - Single  
 Works at the Crossing: Cable trenching over structure.

Ecology Notes: cobble substrate, drained, channelised, riffle/glide

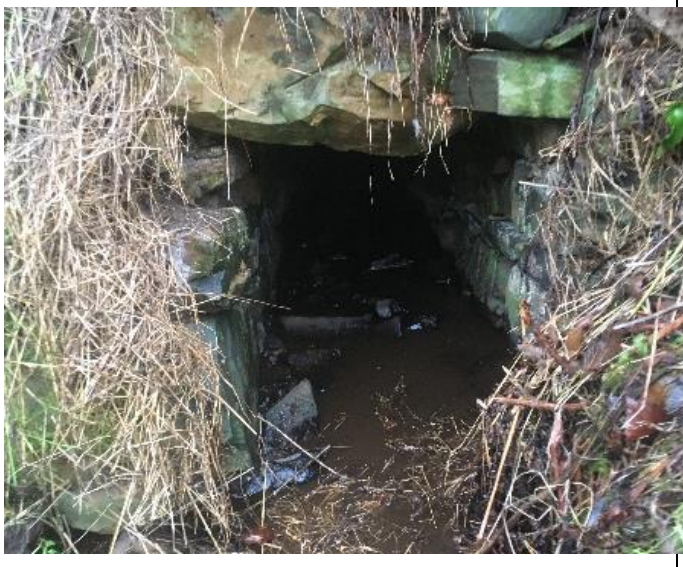
<p><b>Watercrossing Structure W34</b></p> <p>Type: Drain</p> <p><b>Fisheries: Class 4, Poor Fisheries</b></p> <p>Location/Townland: R503, Tooreenbrien Lower</p> <p>Existing Structure: Masonry Box Culvert</p> <p>Works at the Crossing: Cable trenching under structure. Culvert may need replacing.</p> <p>Ecology Notes: No Fisheries Value</p>

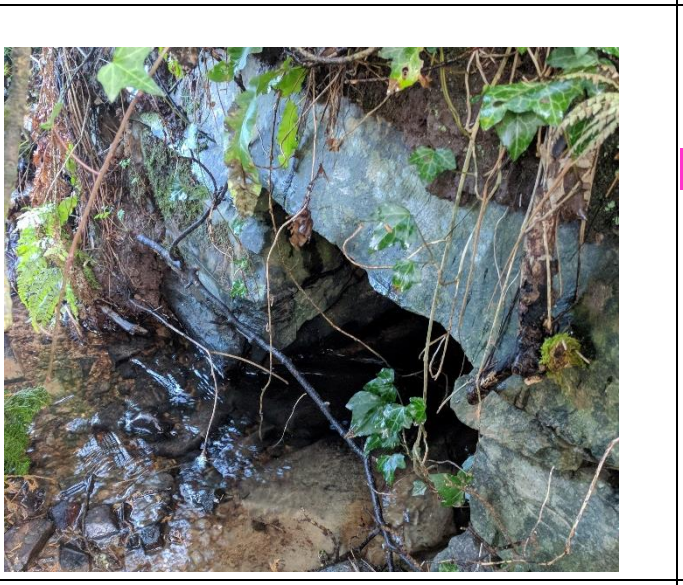
<p><b>Watercrossing Structure W35</b></p> <p>Type: Drain</p> <p><b>Fisheries: Class 4, Poor Fisheries</b></p> <p>Location/Townland: R503, Tooreenbrien Lower</p> <p>Existing Structure: Masonry Box Culvert</p> <p>Works at the Crossing: Cable trenching over structure.</p> <p>Ecology Notes: No Fisheries Value</p>

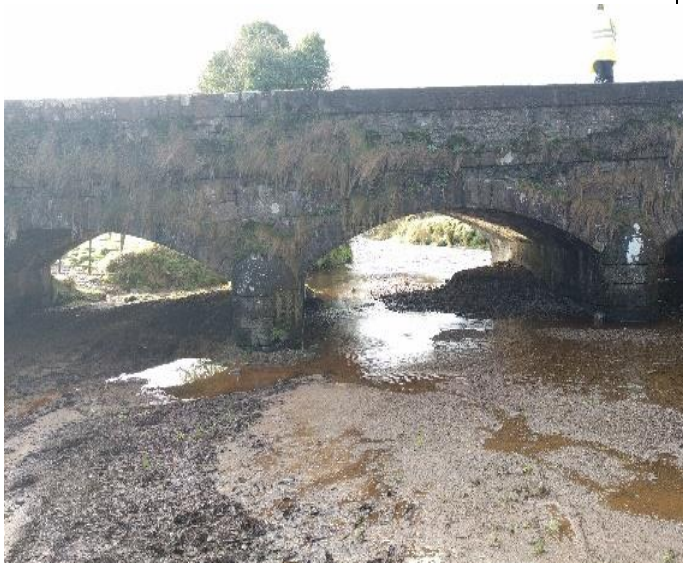
<p><b>Watercrossing Structure W36</b></p> <p>Type: River</p> <p><b>Fisheries: Class1, Optimal Fisheries</b></p> <p>Location/Townland: Tooreenbrien Bridge, R503, Tooreenbrien Lower/Reardnogy Beg</p> <p>Existing Structure: Masonry Arch Bridge - Double</p> <p>Works at the Crossing: Cable trenching over structure. Additional works to raise road level &amp; parapet wall height</p> <p>Ecology Notes: c. 5 m wide, c. 100cm deep</p>

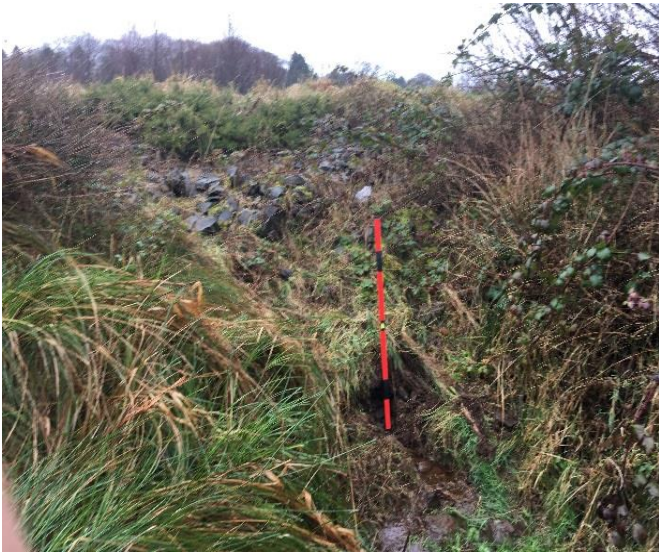
<p><b>Watercrossing Structure W37</b></p> <p>Type: Stream, 1<sup>st</sup> Order</p> <p><b>Fisheries: Class 3, Sub-optimal Fisheries</b></p> <p>Location/Townland: R503, Reardnogy Beg</p> <p>Existing Structure: Masonry Arch</p> <p>Works at the Crossing: Crossing over culvert</p> <p>Ecology Notes: No Fisheries Value</p>

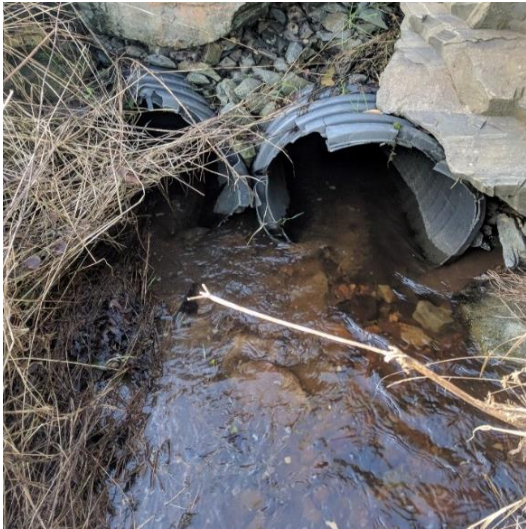
<p><b>Watercrossing Structure W38</b></p> <p>Type: Stream, 1<sup>st</sup> Order</p> <p><b>Fisheries: Class1, Optimal Fisheries</b></p> <p>Location/Townland: R503, Reardnogy Beg/Reardnogy More</p> <p>Existing Structure: Plastic Circular Culvert</p> <p>Works at the Crossing: Cable trenching under structure.</p> <p>Ecology Notes: c. 0.7 m wide, c. 140cm deep</p>

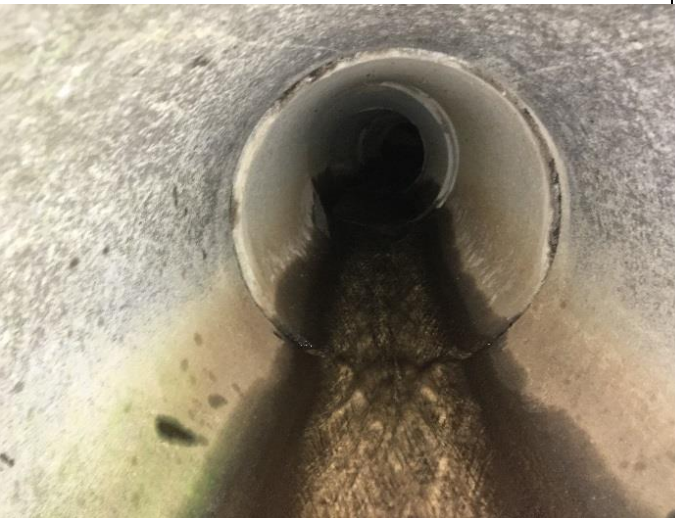
<p><b>Watercrossing Structure W39</b></p> <p>Type: Stream, 2<sup>nd</sup> Order</p> <p><b>Fisheries: Class1, Optimal Fisheries</b></p> <p>Location/Townland: R503, Reardnogy More</p> <p>Existing Structure: Plastic Circular Culvert</p> <p>Works at the Crossing: Cable trenching over structure.</p> <p>Ecology Notes: c. 0.6 m wide, c. 100cm deep</p>

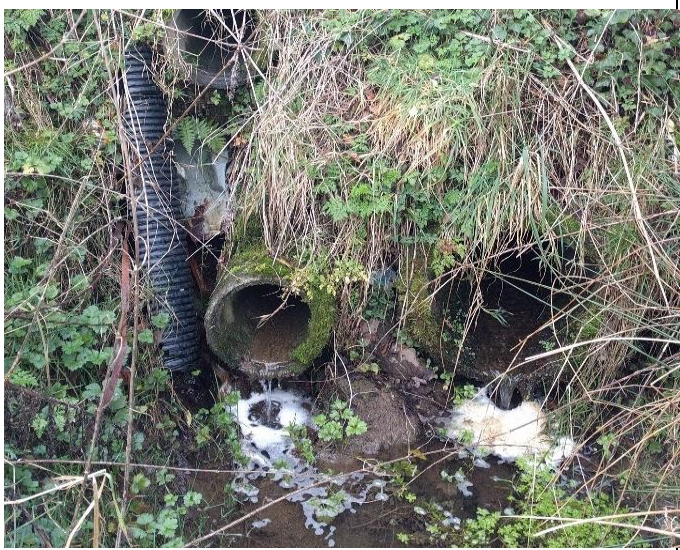
<p><b>Watercrossing Structure W40</b></p> <p>Type: Drain</p> <p><b>Fisheries: Class 4, Poor Fisheries</b></p> <p>Location/Townland: R503, Rear Cross Village, Reardnogy More/ Shanballyedmond</p> <p>Existing Structure: Concrete Circular Culvert X 3</p> <p>Works at the Crossing: Cable trenching under structures.</p> <p>Ecology Notes: No Fisheries Value</p>

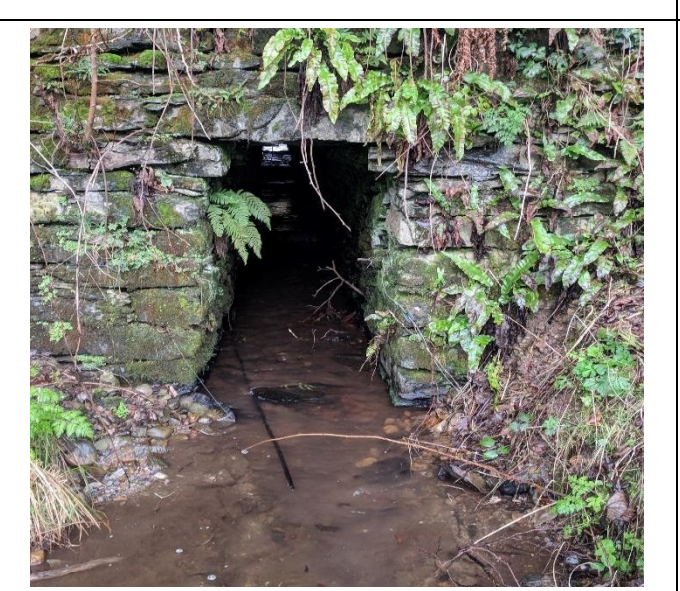
<p><b>Watercrossing Structure W41</b></p> <p>Type: Stream, 1<sup>st</sup> Order</p> <p><b>Fisheries: Class 3, Sub-optimal Fisheries</b></p> <p>Location/Townland: R503, Reardnogy More/Baurnadomeeny</p> <p>Existing Structure: Masonry Box Culvert</p> <p>Works at the Crossing: Cable trenching over structure.</p> <p>Ecology Notes: Downstream:, cobble gravel substrate, riffle, steep banks</p>

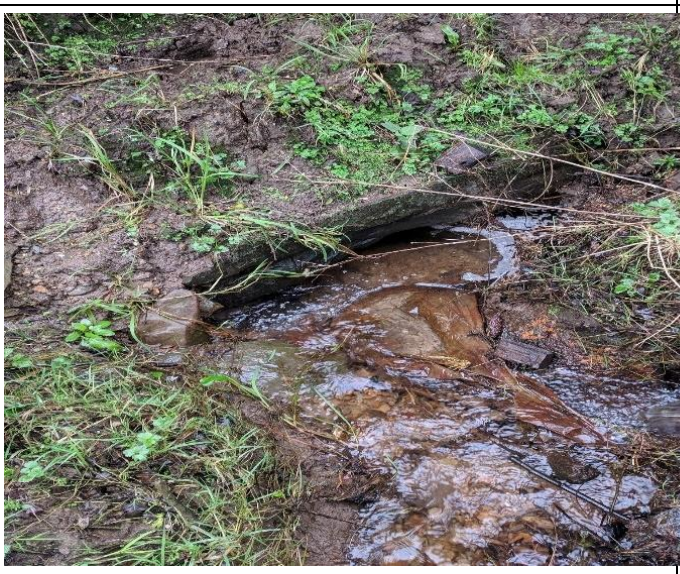
<p><b>Watercrossing Structure W42</b></p> <p>Type: Stream, 1st Order</p> <p><b>Fisheries: Class 3, Sub-optimal Fisheries</b></p> <p>Location/Townland: R503, Baurnadomeeny</p> <p>Existing Structure: Masonry Box Culvert</p> <p>Works at the Crossing: Cable trenching over structure.</p> <p>Ecology Notes: No Fisheries Potential</p>

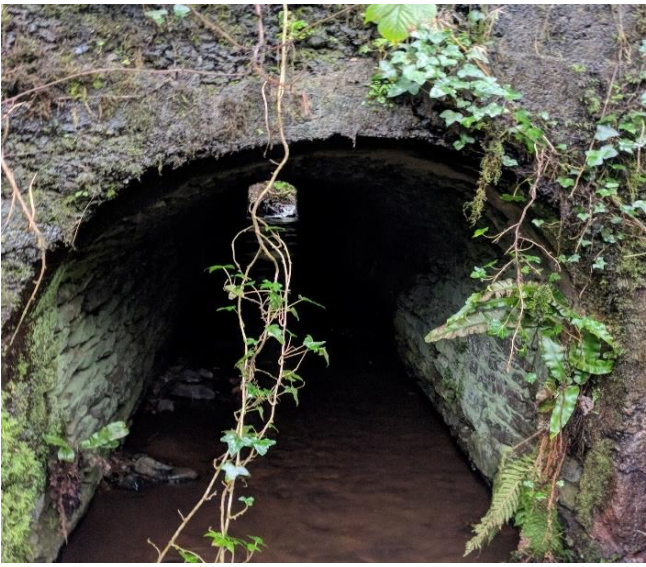
<p><b>Watercrossing Structure W43</b></p> <p>Type: Stream, 1st Order</p> <p><b>Fisheries: Class 3, Sub-optimal Fisheries</b></p> <p>Location/Townland: R503, Bournadomeeny</p> <p>Existing Structure: Masonry Arch</p> <p>Works at the Crossing: Cable trenching over structure.</p> <p>Ecology Notes: cobble gravel substrate, riffle, steep banks</p>

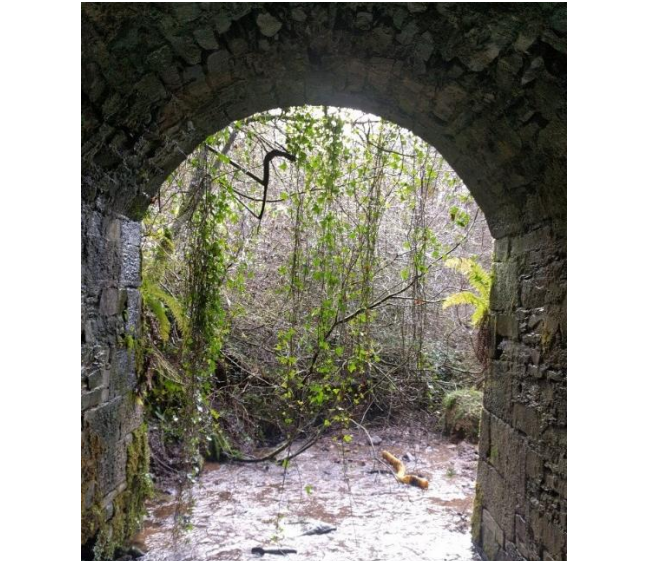
<p><b>Watercrossing Structure W44</b></p> <p>Type: Stream, 1st Order</p> <p><b>Fisheries: Class 3, Sub-optimal Fisheries</b></p> <p>Location/Townland: R503, Bournadomeeny</p> <p>Existing Structure: Masonry Arch</p> <p>Works at the Crossing: Cable trenching over structure.</p> <p>Ecology Notes: cobble gravel substrate, riffle, steep banks</p>

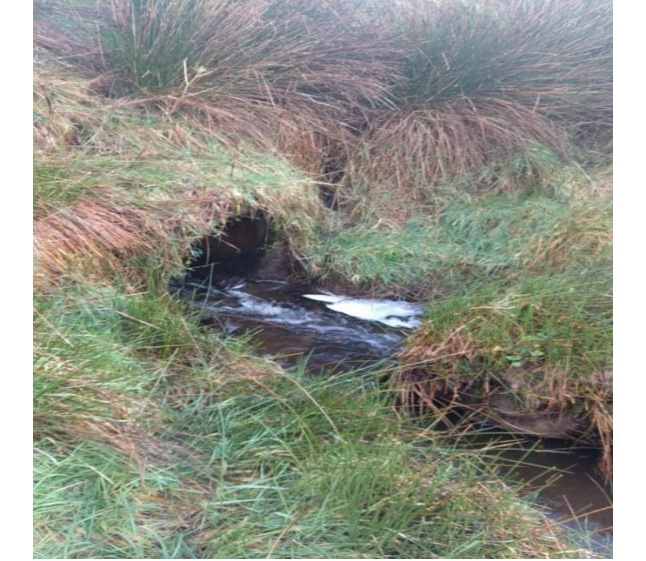
<p><b>Watercrossing Structure W45</b></p> <p>Type: Stream, 1<sup>st</sup> Order</p> <p><b>Fisheries: Class1, Optimal Fisheries</b></p> <p>Location/Townland: R503, Bournadomeeny/Coonmore</p> <p>Existing Structure: Concrete Circular Culvert</p> <p>Works at the Crossing: Cable trenching over structure.</p> <p>Ecology Notes: Riffle / glide, cobble substrate, channelised</p>

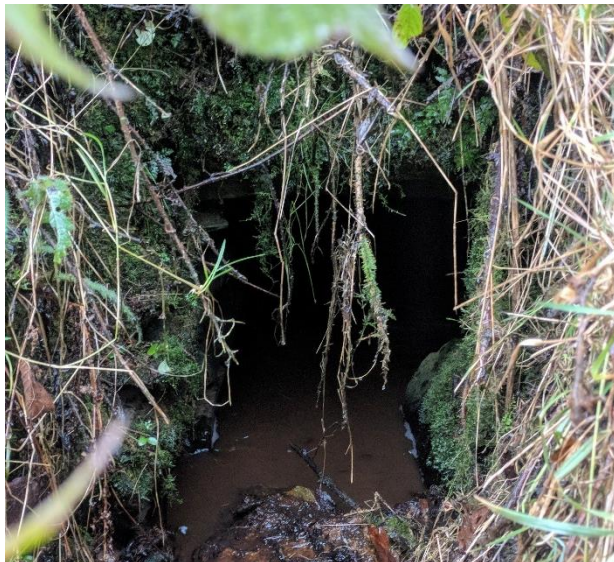
#### Watercrossing Structure W46

Type: Drain

Fisheries: Class 4, Poor Fisheries

Existing Structure: Masonry Box Culvert  
 Works at the Crossing: Cable trenching over structure.

Ecology Notes: No Fisheries Value

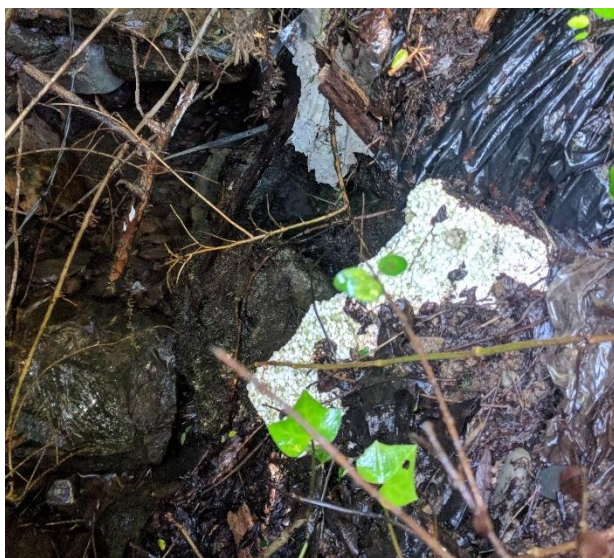
#### Watercrossing Structure W47

Type: Drain

Fisheries: Class 4, Poor Fisheries

Existing Structure: Masonry Box Culvert  
 Works at the Crossing: Cable trenching over structure.

Ecology Notes: No Fisheries Value

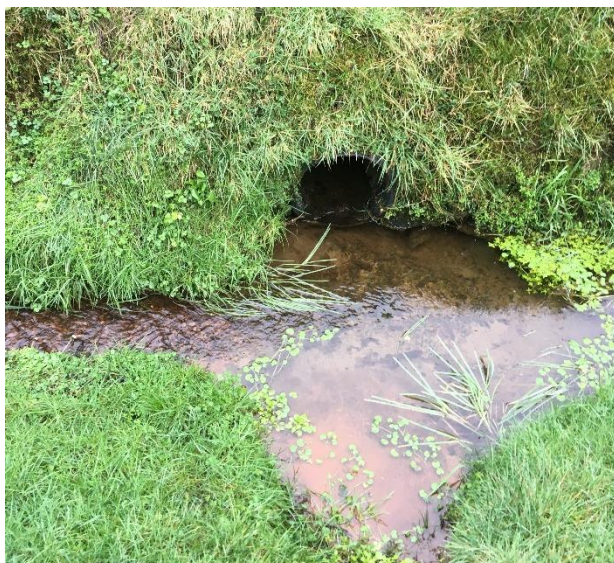
#### Watercrossing Structure W48

Type: Drain

Fisheries: Class 4, Poor Fisheries

Existing Structure: Plastic Circular Culvert  
 Works at the Crossing: Cable trenching over structure.

Ecology Notes: No Fisheries Value

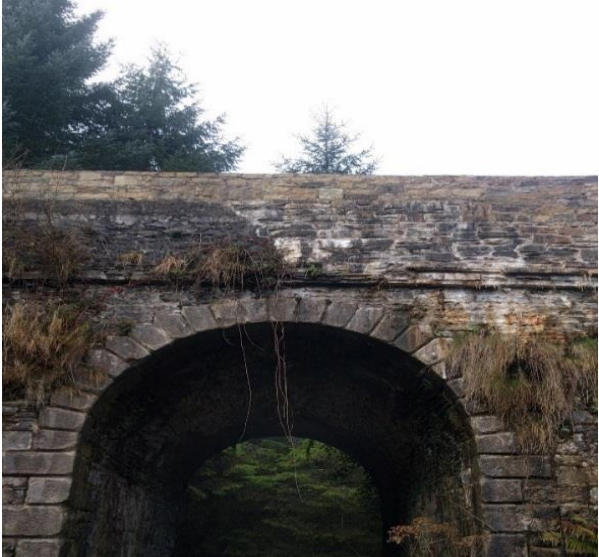
<p><b>Watercrossing Structure W49</b></p> <p>Type: River</p> <p><b>Fisheries: Class1, Optimal Fisheries</b></p> <p>Location/Townland: R503, Coonmore/Foildarragh</p> <p>Existing Structure: Masonry Arch</p> <p>Works at the Crossing: Cable trenching over structure.</p> <p>Ecology Notes: Cobble/gravel, channelised, riffle</p>

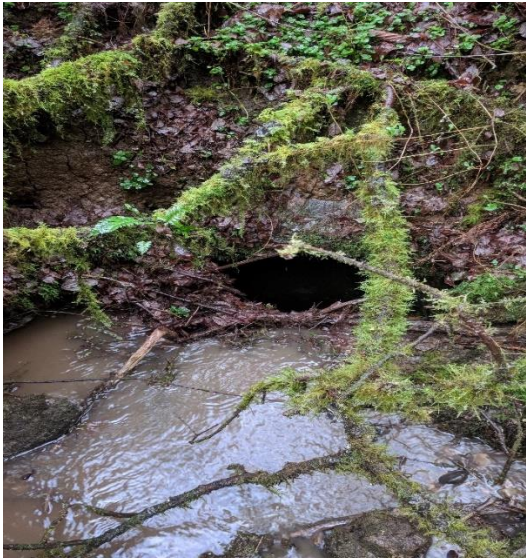
<p><b>Watercrossing Structure W50</b></p> <p>Type: Stream, 1st Order</p> <p><b>Fisheries: Class 3, Sub-optimal Fisheries</b></p> <p>Location/Townland: R503, Foildarragh</p> <p>Existing Structure: Masonry Box Culvert</p> <p>Works at the Crossing: Cable trenching over structure.</p> <p>Ecology Notes: No Fisheries Value, Very steep gradient, in gorge, 100% cover.</p>

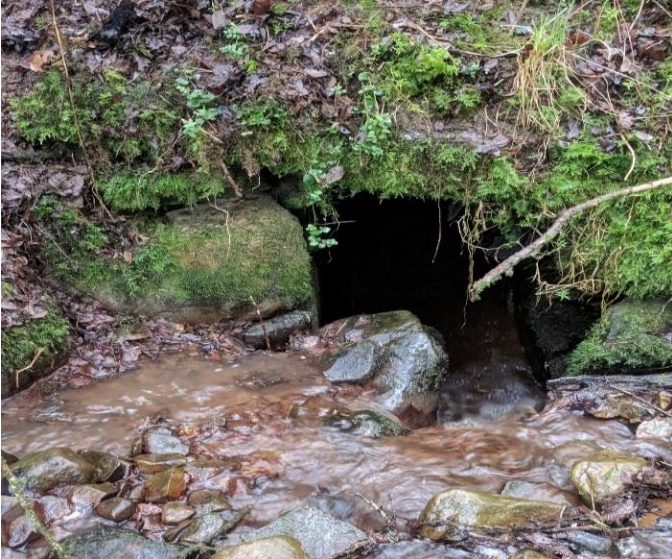
<p><b>Watercrossing Structure W51</b></p> <p>Type: Stream, 1st Order</p> <p><b>Fisheries: Class 3, Sub-optimal Fisheries</b></p> <p>Location/Townland: R503, Foildarragh</p> <p>Existing Structure: Masonry Box Culvert</p> <p>Works at the Crossing: Cable trenching over structure.</p> <p>Ecology Notes: No Fisheries Value, Very steep gradient, in gorge, 100% cover.</p>

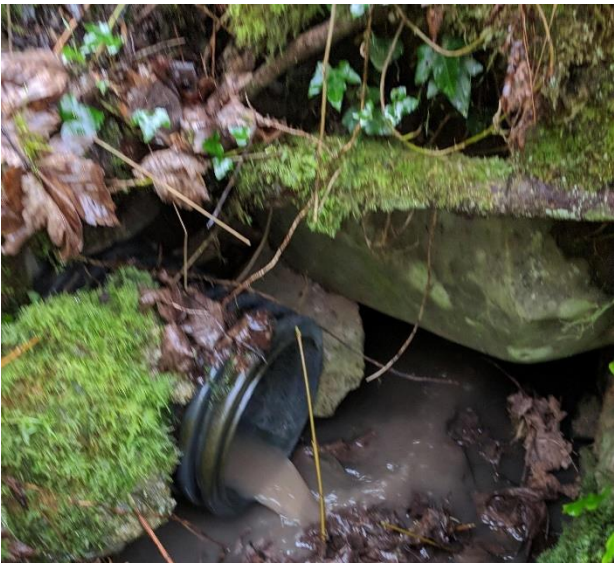
<p><b>Watercrossing Structure W52</b></p> <p>Type: Stream, 1st Order</p> <p><b>Fisheries: Class 3, Sub-optimal Fisheries</b></p> <p>Location/Townland: R503, Foildarragh</p> <p>Existing Structure: Masonry Box Culvert</p> <p>Works at the Crossing: Cable trenching under structure.</p> <p>Ecology Notes: No Fisheries Value, steep, drained</p>
