## Appendix to Chapter 8: Biodiversity

### Appendix 8.2: Aquatic Habitats & Species Fieldwork & Survey Results

## A8-2.2 Survey Results - Inventory & Classification of Watercourses at Crossing Locations

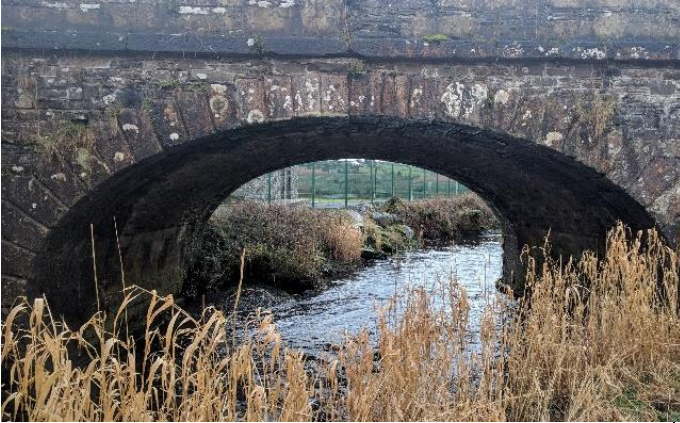
<p><b>Watercrossing Structure W53</b></p> <p>Type: River</p> <p><b>Fisheries: Class1, Optimal Fisheries</b></p> <p>Location/Townland: Anglesey Bridge, R503, Foildarragh/Kilcommon</p> <p>Existing Structure: Double Masonry Arch</p> <p>Works at the Crossing: Cable trenching over structure, additional works to raise road level &amp; parapet wall height</p> <p>Ecology Notes: U/s: riffle, glide channelized, cobble gravel, sand</p>

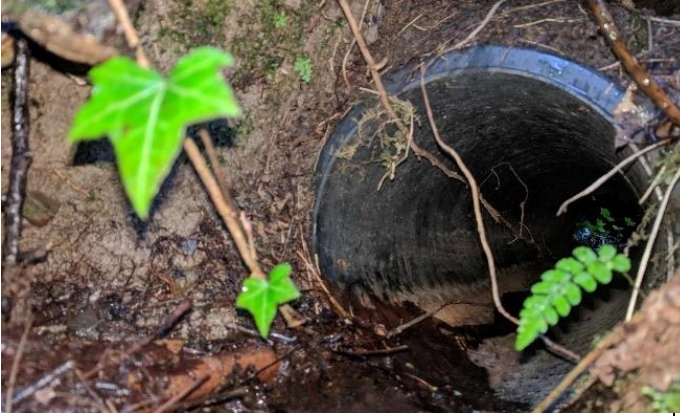
<p><b>Watercrossing Structure W54</b></p> <p>Type: Drain</p> <p><b>Fisheries: Class 4, Poor Fisheries</b></p> <p>Location/Townland: R503, Kilcommon</p> <p>Existing Structure: Plastic Circular Culvert</p> <p>Works at the Crossing: Cable trenching under structure.</p> <p>Ecology Notes: No Fisheries Value</p>

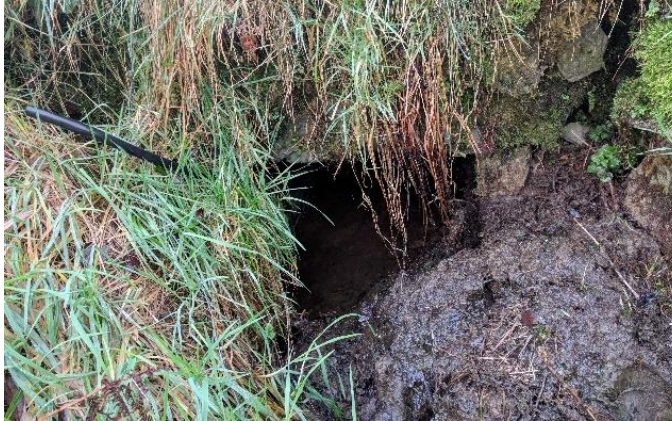
<p><b>Watercrossing Structure W55</b></p> <p>Type: Drain</p> <p><b>Fisheries: Class 4, Poor Fisheries</b></p> <p>Location/Townland: R503, Kilcommon</p> <p>Existing Structure: Masonry Box Culvert</p> <p>Works at the Crossing: Cable trenching under structure. Culvert may need replacing.</p> <p>Ecology Notes: No Fisheries Value</p>

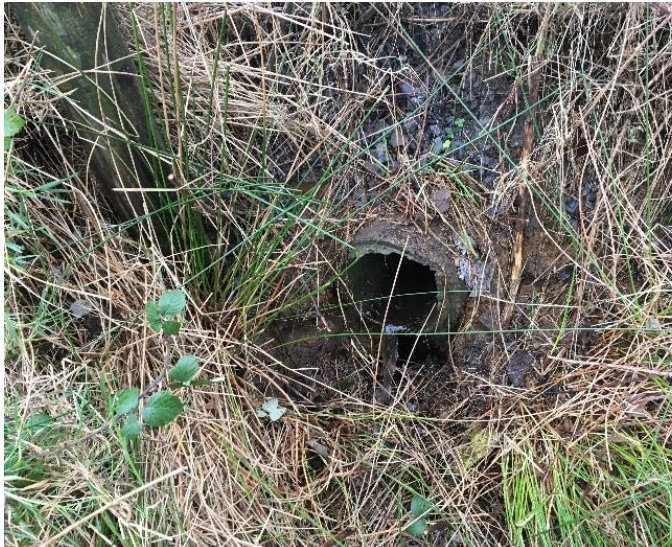
<p><b>Watercrossing Structure W56</b></p> <p>Type: Drain</p> <p><b>Fisheries: Class 3, Sub-optimal Fisheries</b></p> <p>Location/Townland: R503, Kilcommon</p> <p>Existing Structure: Concrete Circular Culvert</p> <p>Works at the Crossing: Cable trenching over structure.</p> <p>Ecology Notes: No Fisheries Value, some flow</p>

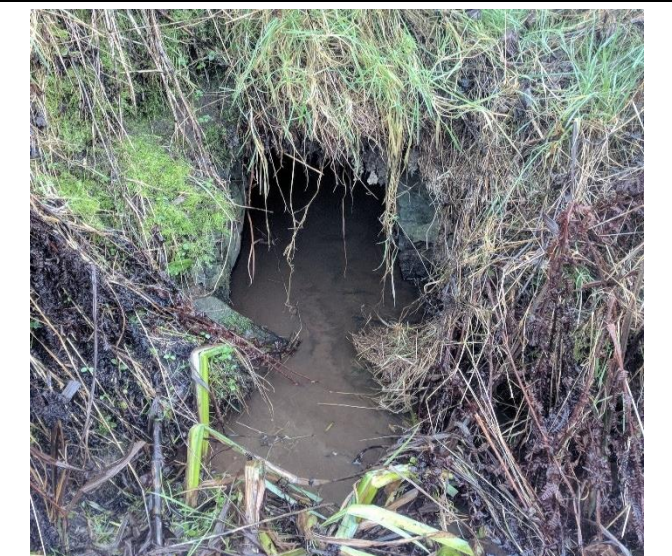
<p><b>Watercrossing Structure W57</b></p> <p>Type: Drain</p> <p><b>Fisheries: Class 4, Poor Fisheries</b></p> <p>Location/Townland: R503, Kilcommon/Loughbrack</p> <p>Existing Structure: Masonry Box Culvert</p> <p>Works at the Crossing: Cable trenching under structure. Culvert may need replacing.</p> <p>Ecology Notes: No Fisheries Value</p>

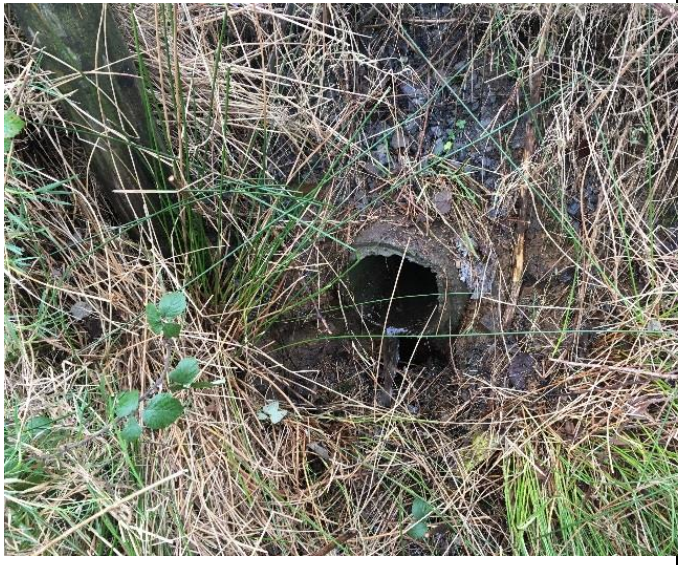
<p><b>Watercrossing Structure W58</b></p> <p>Type: Drain</p> <p><b>Fisheries: Class 4, Poor Fisheries</b></p> <p>Location/Townland: R503, Loughbrack</p> <p>Existing Structure: Concrete Circular Culvert</p> <p>Works at the Crossing: Cable trenching under structure.</p> <p>Ecology Notes: No Fisheries Value</p>

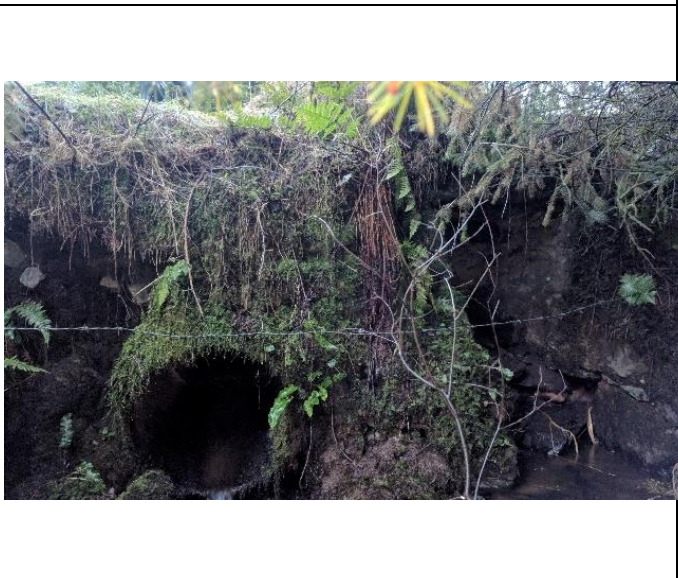
<p><b>Watercrossing Structure W59</b></p> <p>Type:</p> <p>Upstream: Drain, Downstream: Stream, 1st Order</p> <p><b>Fisheries: Class 4, Poor Fisheries</b></p> <p>Location/Townland: R503, Loughbrack</p> <p>Existing Structure: Concrete Culvert &amp; Masonry Box Culvert</p> <p>Works at the Crossing: Cable trenching under structures.</p> <p>Ecology Notes: No Fisheries Value. Downstream: flow, through forestry</p>

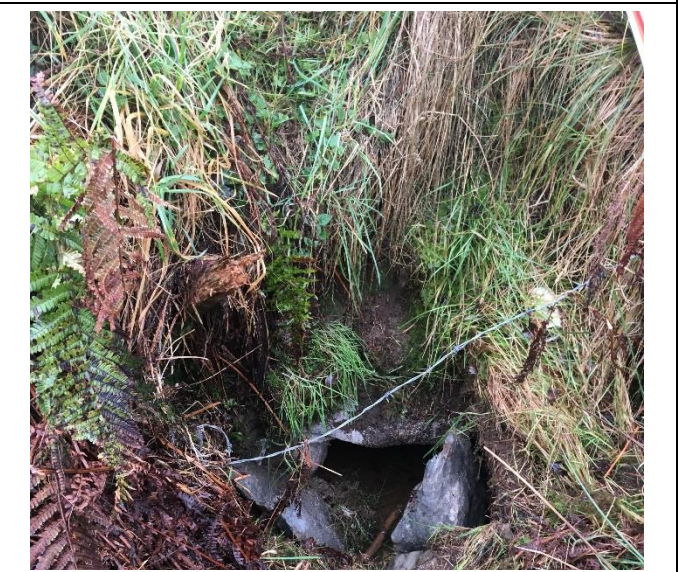
<p><b>Watercrossing Structure W60</b></p> <p>Type: Drain</p> <p><b>Fisheries: Class 4, Poor Fisheries</b></p> <p>Location/Townland: R503, Loughbrack</p> <p>Existing Structure: Masonry Box Culvert</p> <p>Works at the Crossing: Cable trenching under structure. Culvert may need replacing.</p> <p>Ecology Notes: No Fisheries Value</p>

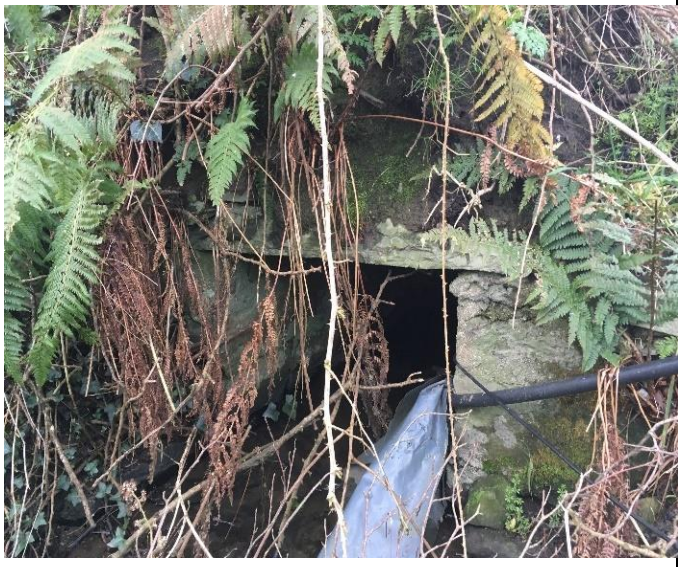
<p><b>Watercrossing Structure W61</b></p> <p>Type: Drain</p> <p><b>Fisheries: Class 4, Poor Fisheries</b></p> <p>Location/Townland: R503, Knocknabansha/Knockmaroe</p> <p>Existing Structure: Masonry Box Culvert              Works at the Crossing: Cable trenching under structure. Culvert may need replacing.</p> <p>Ecology Notes: No Fisheries Value</p>

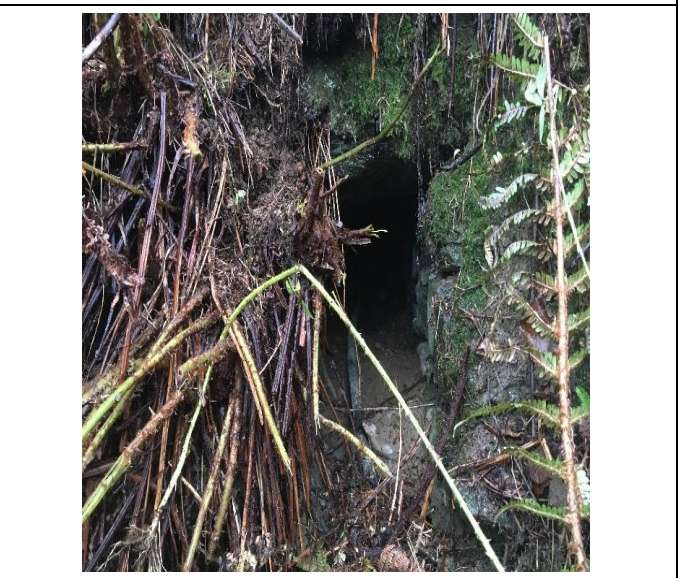
<p><b>Watercrossing Structure W62</b></p> <p>Type: Drain</p> <p><b>Fisheries: Class 4, Poor Fisheries</b></p> <p>Location/Townland: L2264-50, Knockmaroe</p> <p>Existing Structure: Masonry Box Culvert              Works at the Crossing: Cable trenching over structure.</p> <p>Ecology Notes: No Fisheries Value</p>

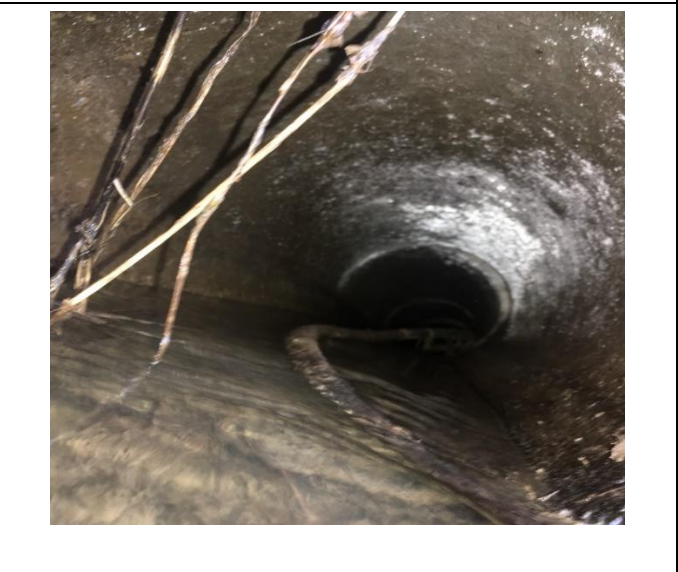
<p><b>Watercrossing Structure W63</b></p> <p>Type: Drain</p> <p><b>Fisheries: Class 4, Poor Fisheries</b></p> <p>Location/Townland: L2264-50, Knockmaroe/Knockcurraghbola Crownlands</p> <p>Existing Structure: Circular Concrete Culvert              Works at the Crossing: Cable trenching under structure.</p> <p>Ecology Notes: No Fisheries Value</p>

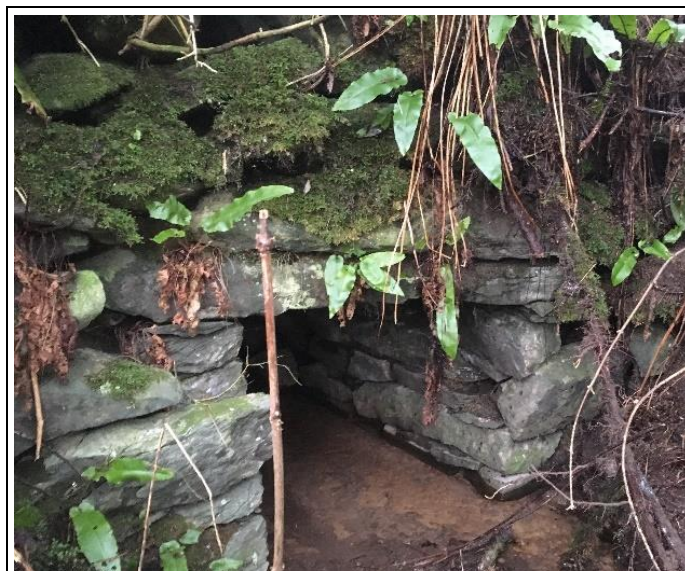
#### Watercrossing Structure W64

Type: Drain

Fisheries: Class 4, Poor Fisheries

Existing Structure: Masonry Box Culvert  
 Works at the Crossing: Cable trenching under structure. Culvert may need replacing.

Ecology Notes: No Fisheries Value

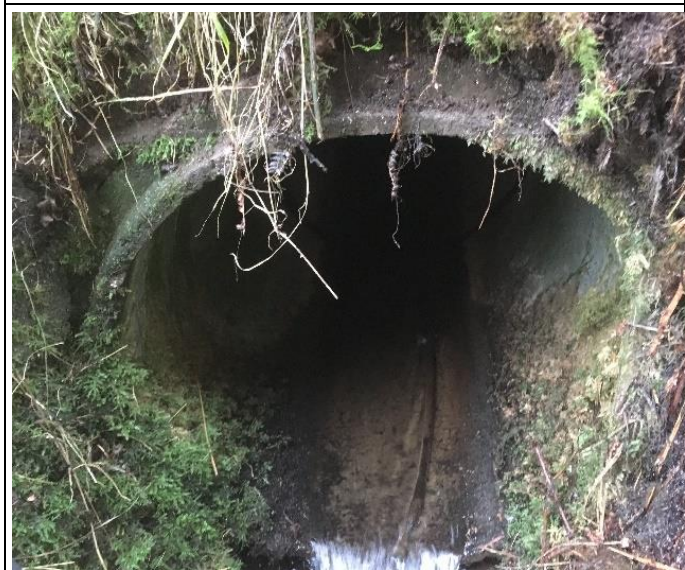
#### Watercrossing Structure W65

Type: Stream

Fisheries: Class 2, Optimal Fisheries

Existing Structure: Concrete Circular Culvert  
 Works at Crossing: Cable trenching under structure.

Ecology Notes: Steady flow to 20 cm deep with wetted width of c. 1 m. gravel bed.

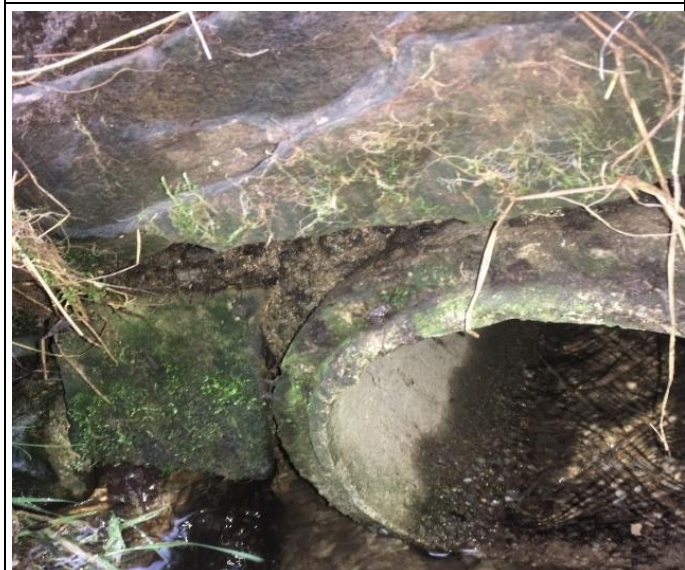
#### Watercrossing Structure W66

Type: Drain

Fisheries: Class 4, Poor Fisheries

Existing Structure: Concrete Circular Culvert  
 Works at the Crossing: Cable trenching under structure.

Ecology Notes: No Fisheries Value
